**ENVIRONMENTAL ASSESSMENT
REHABILITATION AND REPAIR
ROOT RIVER AND RUSH CREEK FLOOD CONTROL PROJECT
RUSHFORD, MINNESOTA**

**U.S ARMY CORPS OF ENGINEERS
ST. PAUL DISTRICT**

MAY 2008

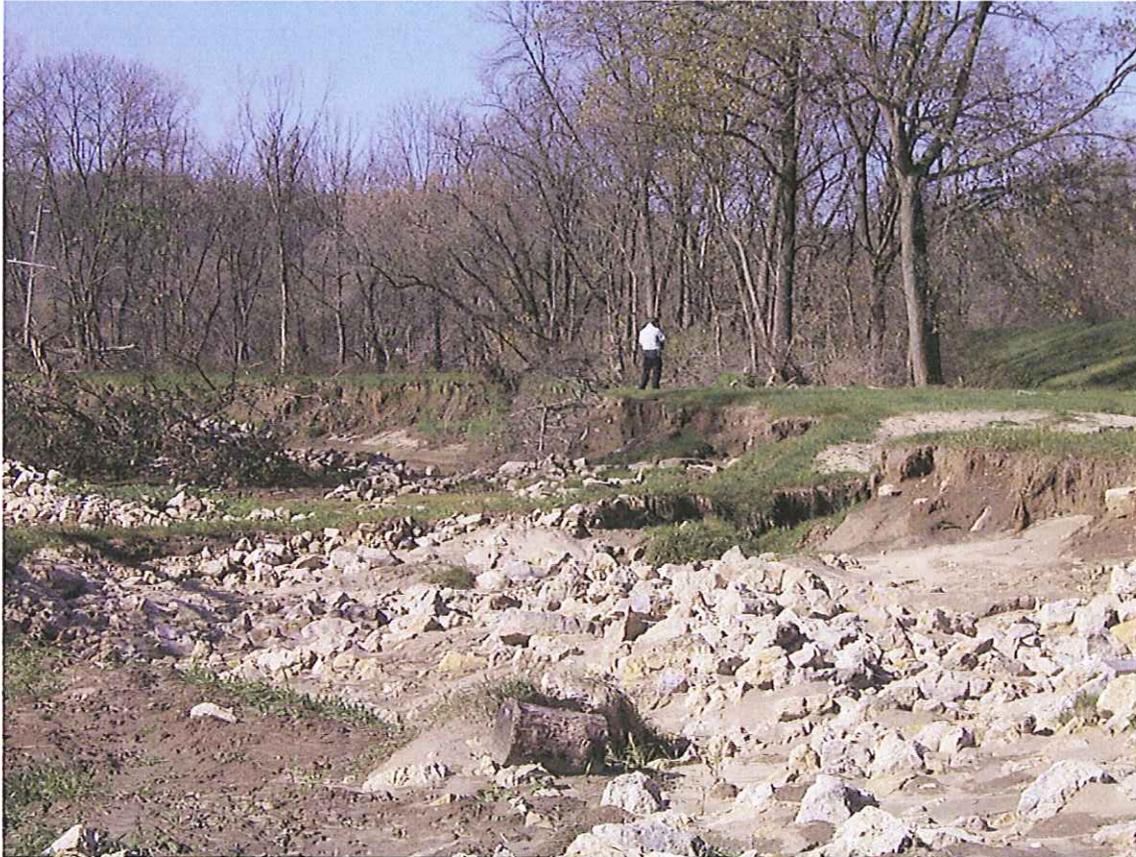
Photo - Site A

- Site A - Left descending bank, upstream of Highway 43 Bridge. The flow during the flood event began to cut a new channel above Outfall J in Levee "C". Debris deposited in the new cut would be removed, the freshly cut banks would be reshaped to a more stable slope and the drainage swale associated with Outfall J would be repaired.

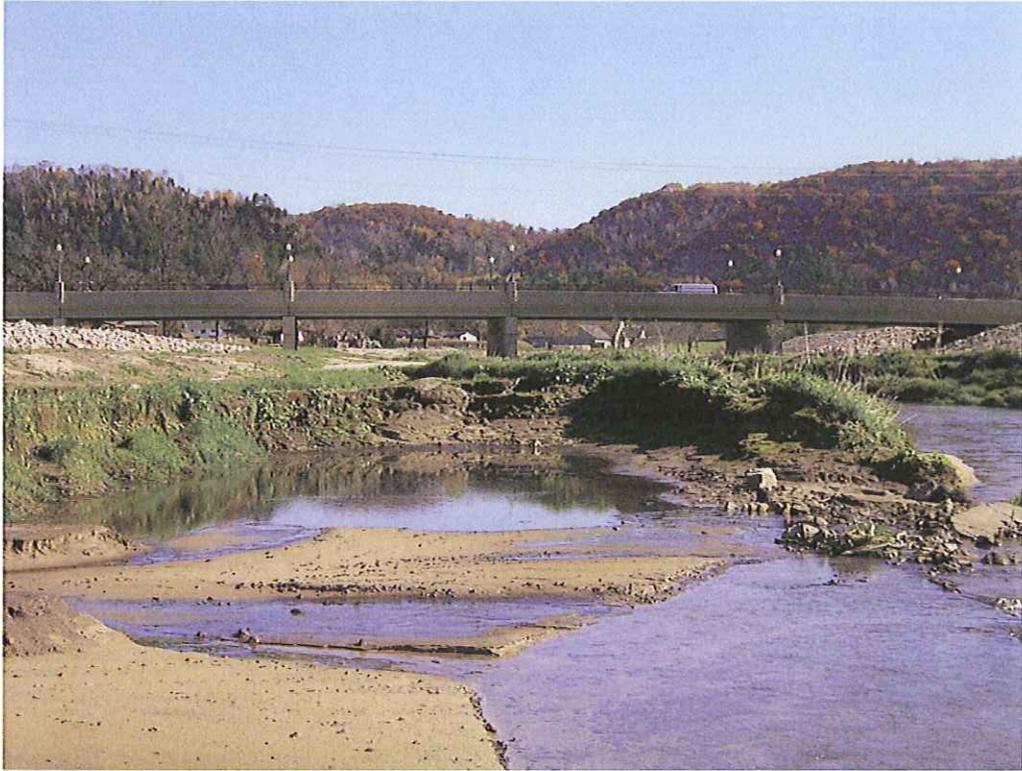
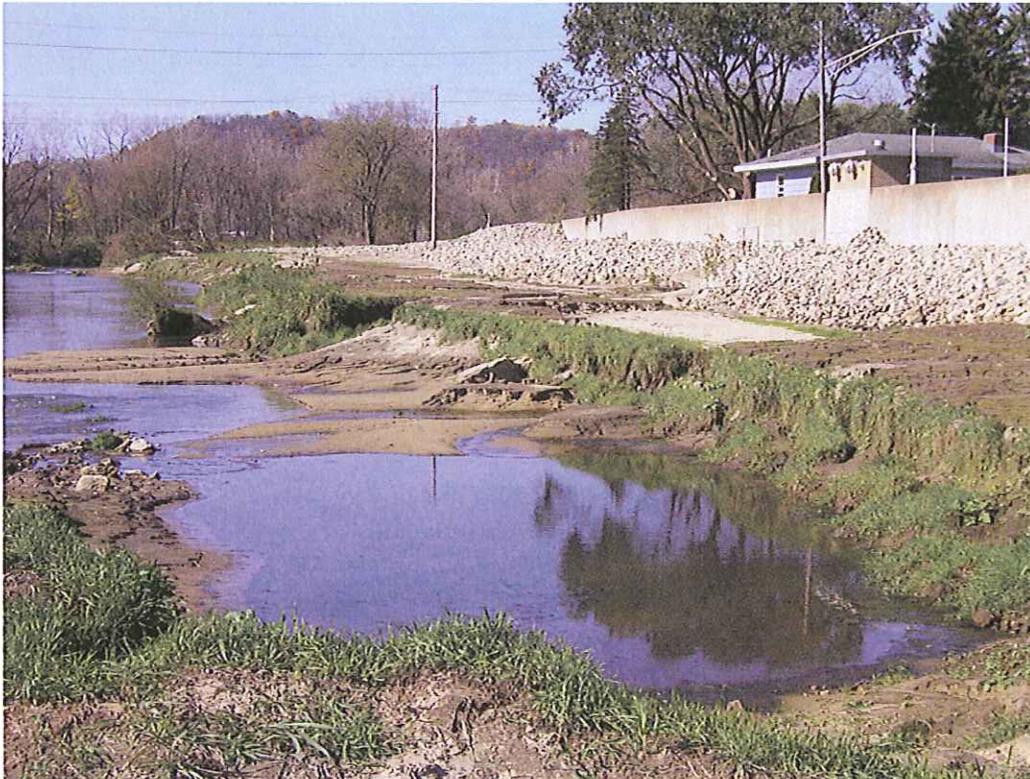
Photo Site B

- Site B - Left descending bank, upstream of Highway 43 Bridge. During the flooding and subsequent dewatering of the area behind levee "C", extensive erosion occurred to the channel bank and the built up sediment located between the rock protection and the creek channel leaving unstable, vertical banks along the channel. These banks would be reshaped to a more stable slope and the drainage swale for Outfall K would be re-established.

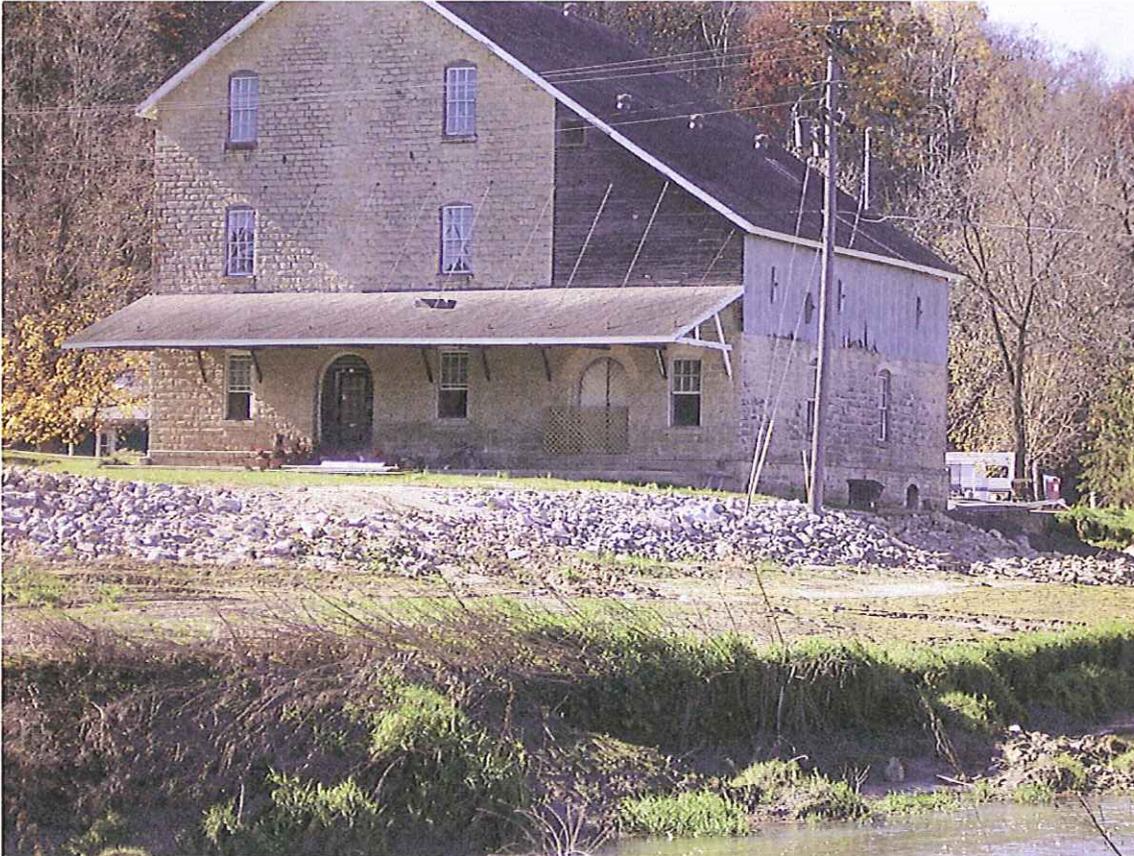
Photo Site C

- Site C - Right descending bank, upstream of Highway 43 Bridge. The erosion to the channel bank would be repaired by placing compacted fill material, riprap replacement, and topsoil.

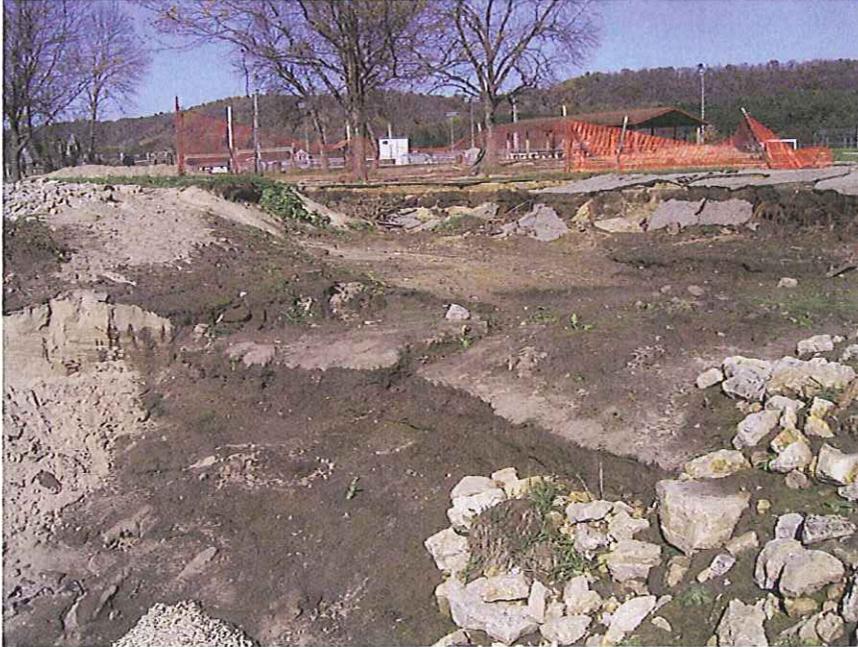
Photo Site D

- Site D - Left descending bank, downstream of Highway 43 Bridge. Substantial bank erosion occurred at several locations downstream of the Highway 43 Bridge. The repair to the bank would include the placement of compacted fill material and reshaping the bank to a more stable slope. Those areas where the existing riprap protection had been damaged or washed away would be resurfaced with similar rock protection.

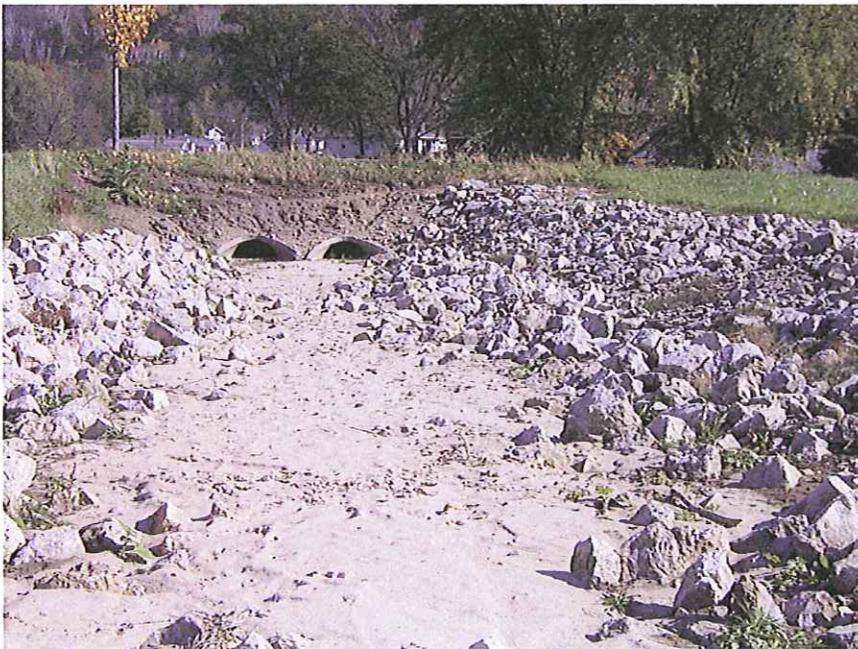
Photo Site E

- Site E - Dry Run carrying water from coulee entering from north. Riprap along the run and two culverts passing the water under a road were damaged. It is proposed to salvage any riprap, restore the channel using compacted random fill, placing topsoil, and replacing the riprap. Sediment carried down from higher elevations and deposited in the channel would be removed.

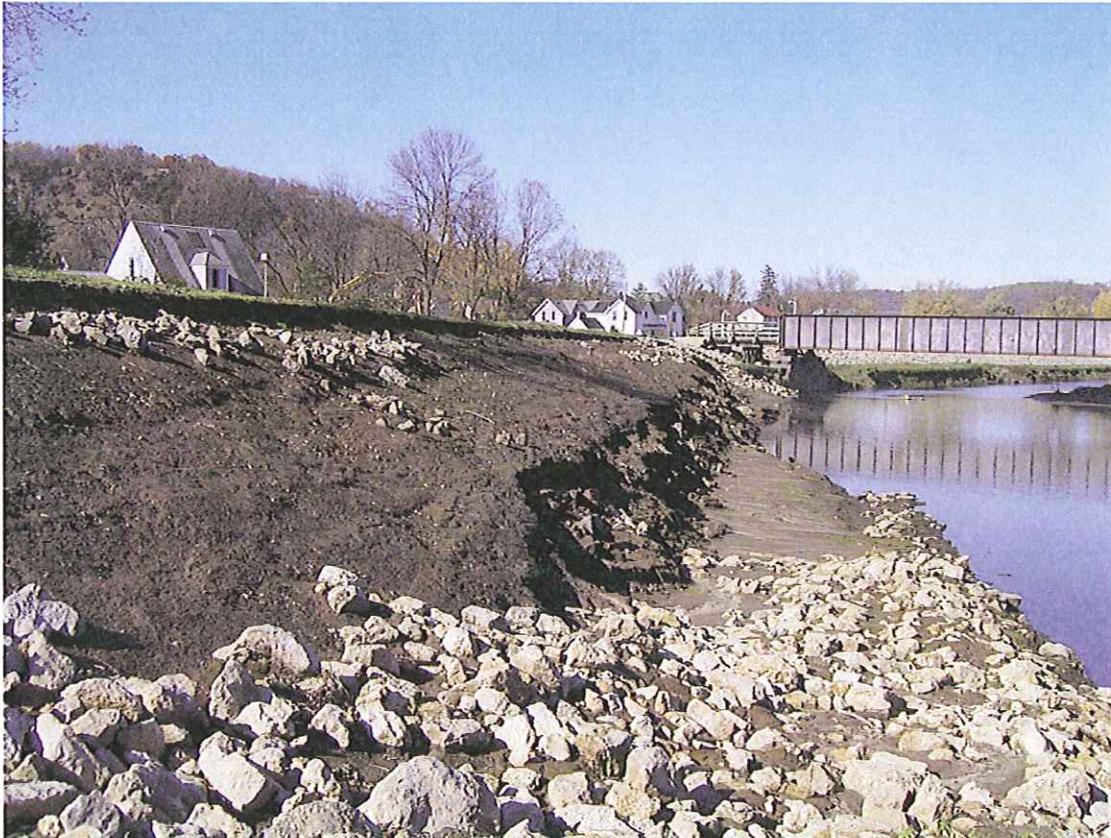
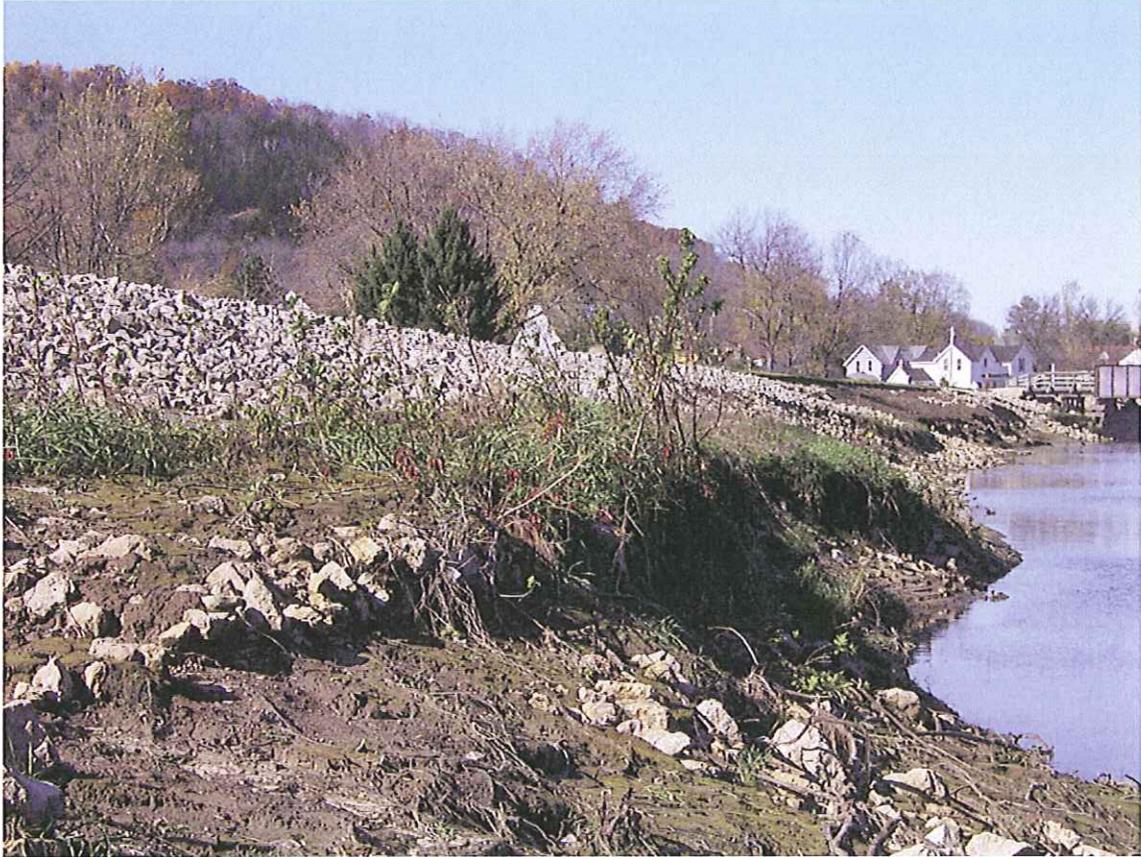
Photo Site G

- Site G - Rush Creek Channel/Downstream of DNR Recreational Trail Bridge. This site experienced the most extensive damage of any site along Rush Creek. The combination of diverted flood flows and the channel restriction caused by the bridge increased the velocity within Rush Creek causing extensive scour of the creek bed and right descending bank which is also the wet the side of the levee. The riprap along the entire length of the levee downstream of the railway bridge (approx. 700 feet) would need to be stripped to expose the levee material. The eroded and sloughed areas would then be excavated to stable material and impervious fill would be placed and compacted. Once the slope is re-established bedding material and new riprap would be placed to restore the protection.

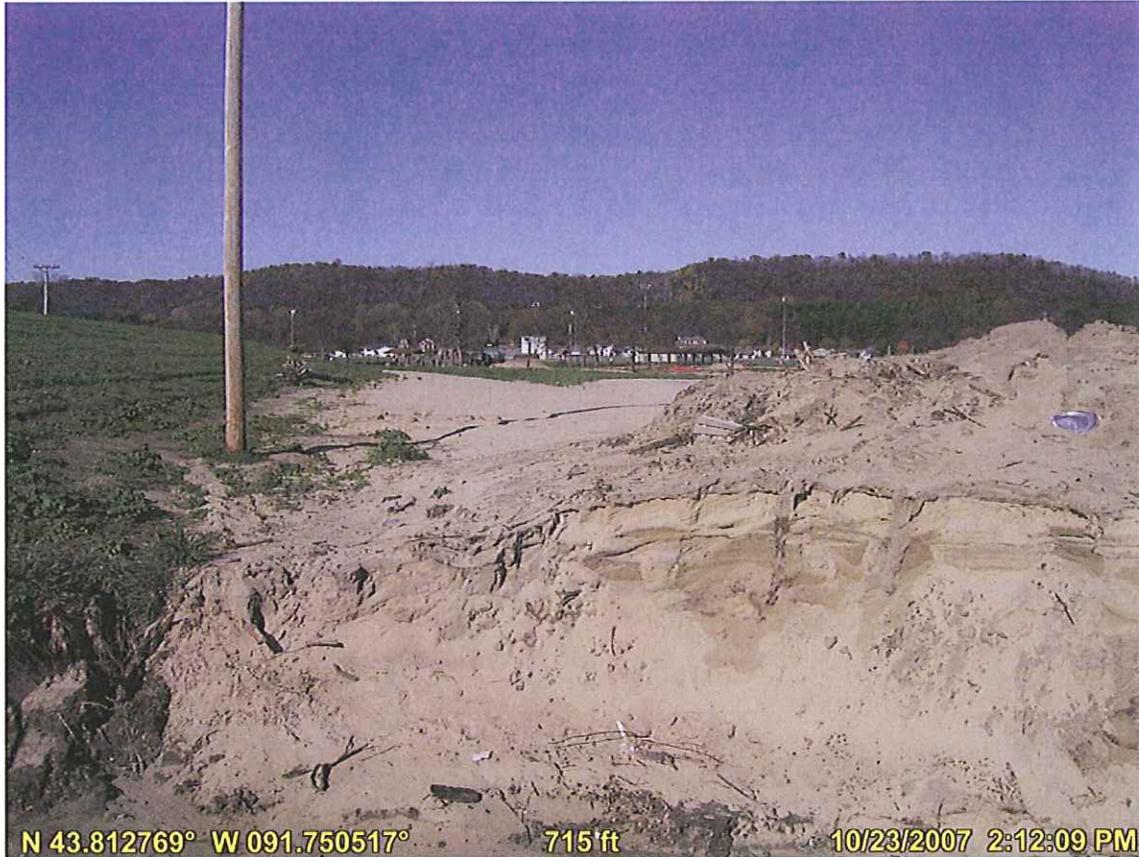
Photo Site H

- Site H - Right Descending Bank between Highway 43 Bridge and Rushford Avenue Bridge. During the flood event there was an extensive amount of sediment deposited between the levees in this portion of Rush Creek. The amount of sediment varied from a few inches to over 4 feet. The vast majority of sediment accumulated in the flat area on the west side of the creek directly across from the dry run channel. All material deposited by the 2007 flood event would be removed in order to maintain channel capacity.

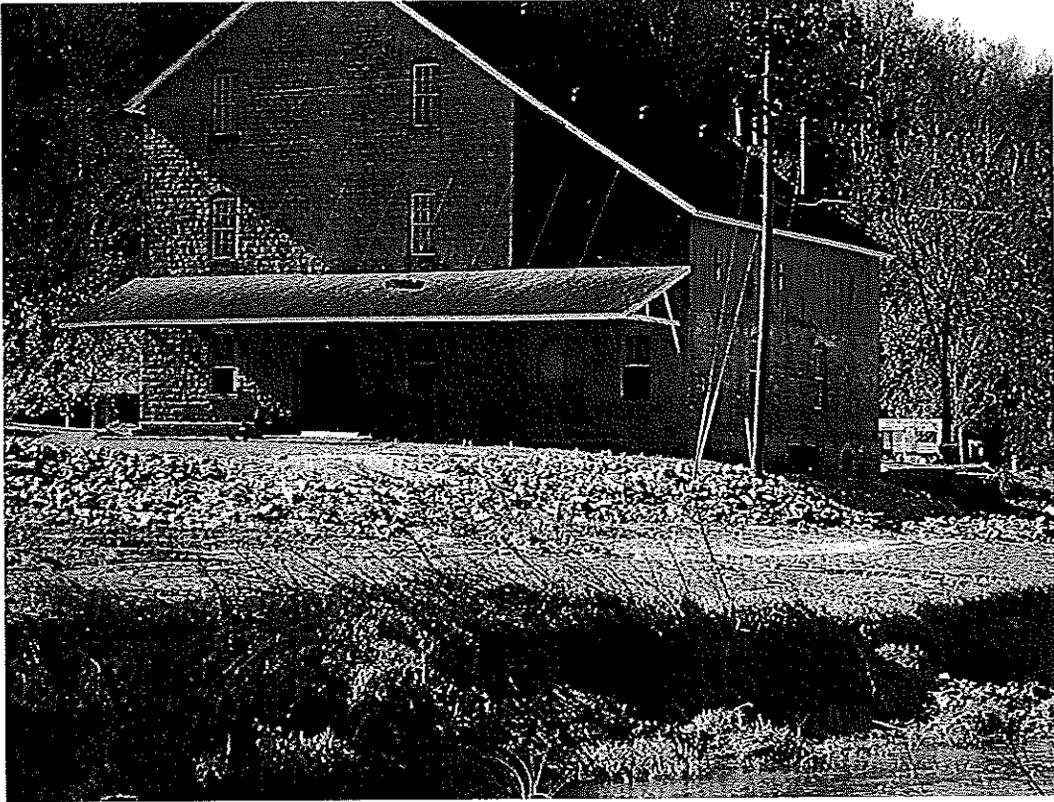
- C. Right descending bank above the Highway 43 bridge, replace riprap (Figure 2).
- D. Left descending bank below the Highway 43 bridge, remove sediment, reshape slopes and replace riprap.

Figure 2. View of proposed riprap repair near the historic Rushford City Mill at proposed action C, looking west.

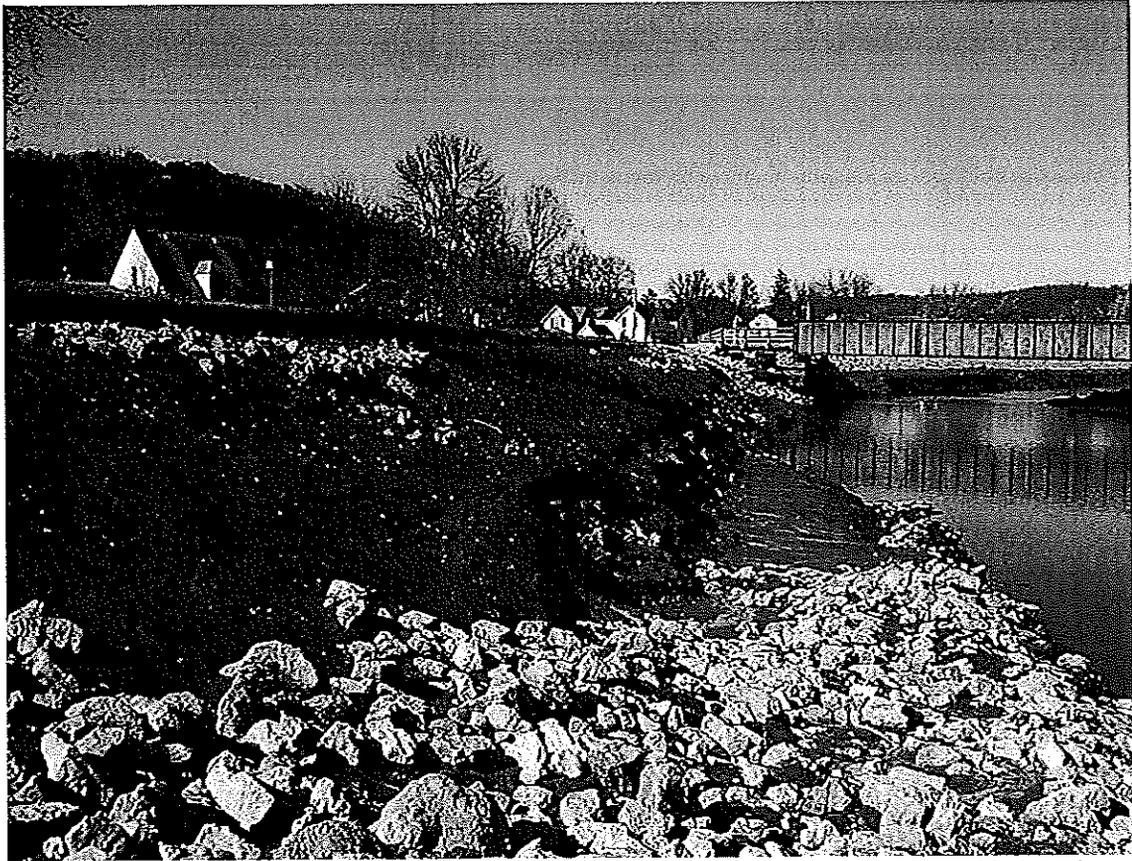
- G. Rush Creek channel below the Milwaukee Road railroad bridge/recreation trail, remove sediment, reshape slope, replace riprap (Figure 3).
- H. Right descending bank between the Highway 43 bridge and Rushford Avenue, remove sediment.

Figure 3. View of proposed riprap repair, sediment removal and reshaping of levee slope at proposed action G, view to north.

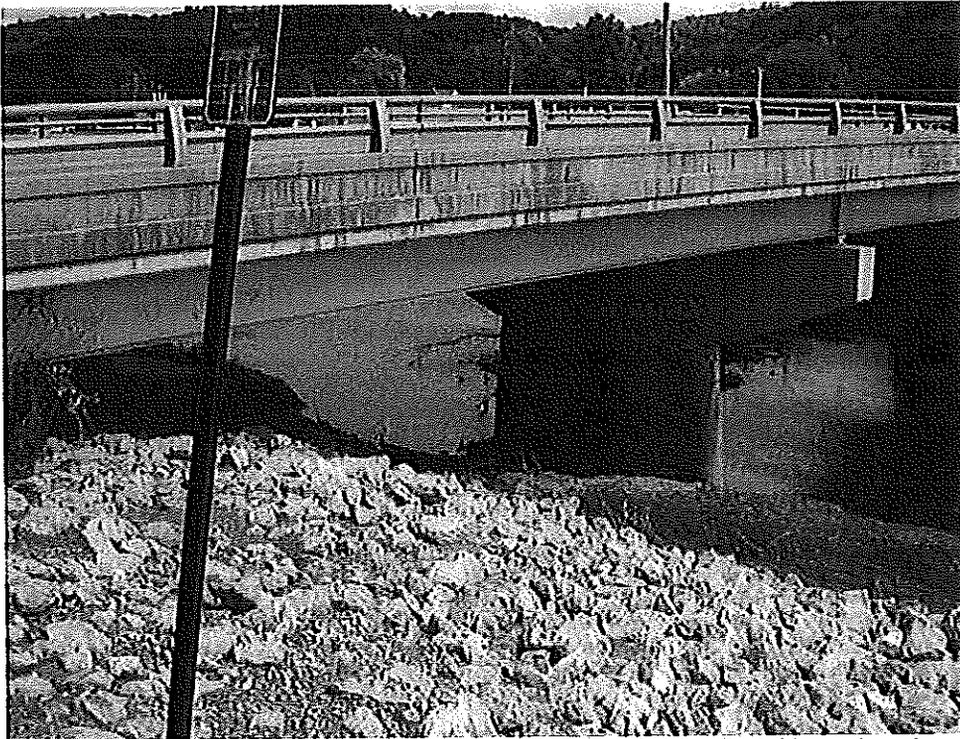
62. Levee "B" – Photo of the Park Street bridge pier, missing riprap under bridge and erosion.

Comment – 1) Note, the height of the graffiti on the bridge pier, gives an idea of how much channel erosion occurred.

2) Like the left bridge abutment the rock protection was also displaced on the right bank under the bridge

- Site F - Bank repair near Park Street Bridge. The flood caused some undermining of the abutments of the Park Street bridge. Repairs would entail placing impervious fill material under the abutment, restoration of the bank, and placing bedding material and riprap.

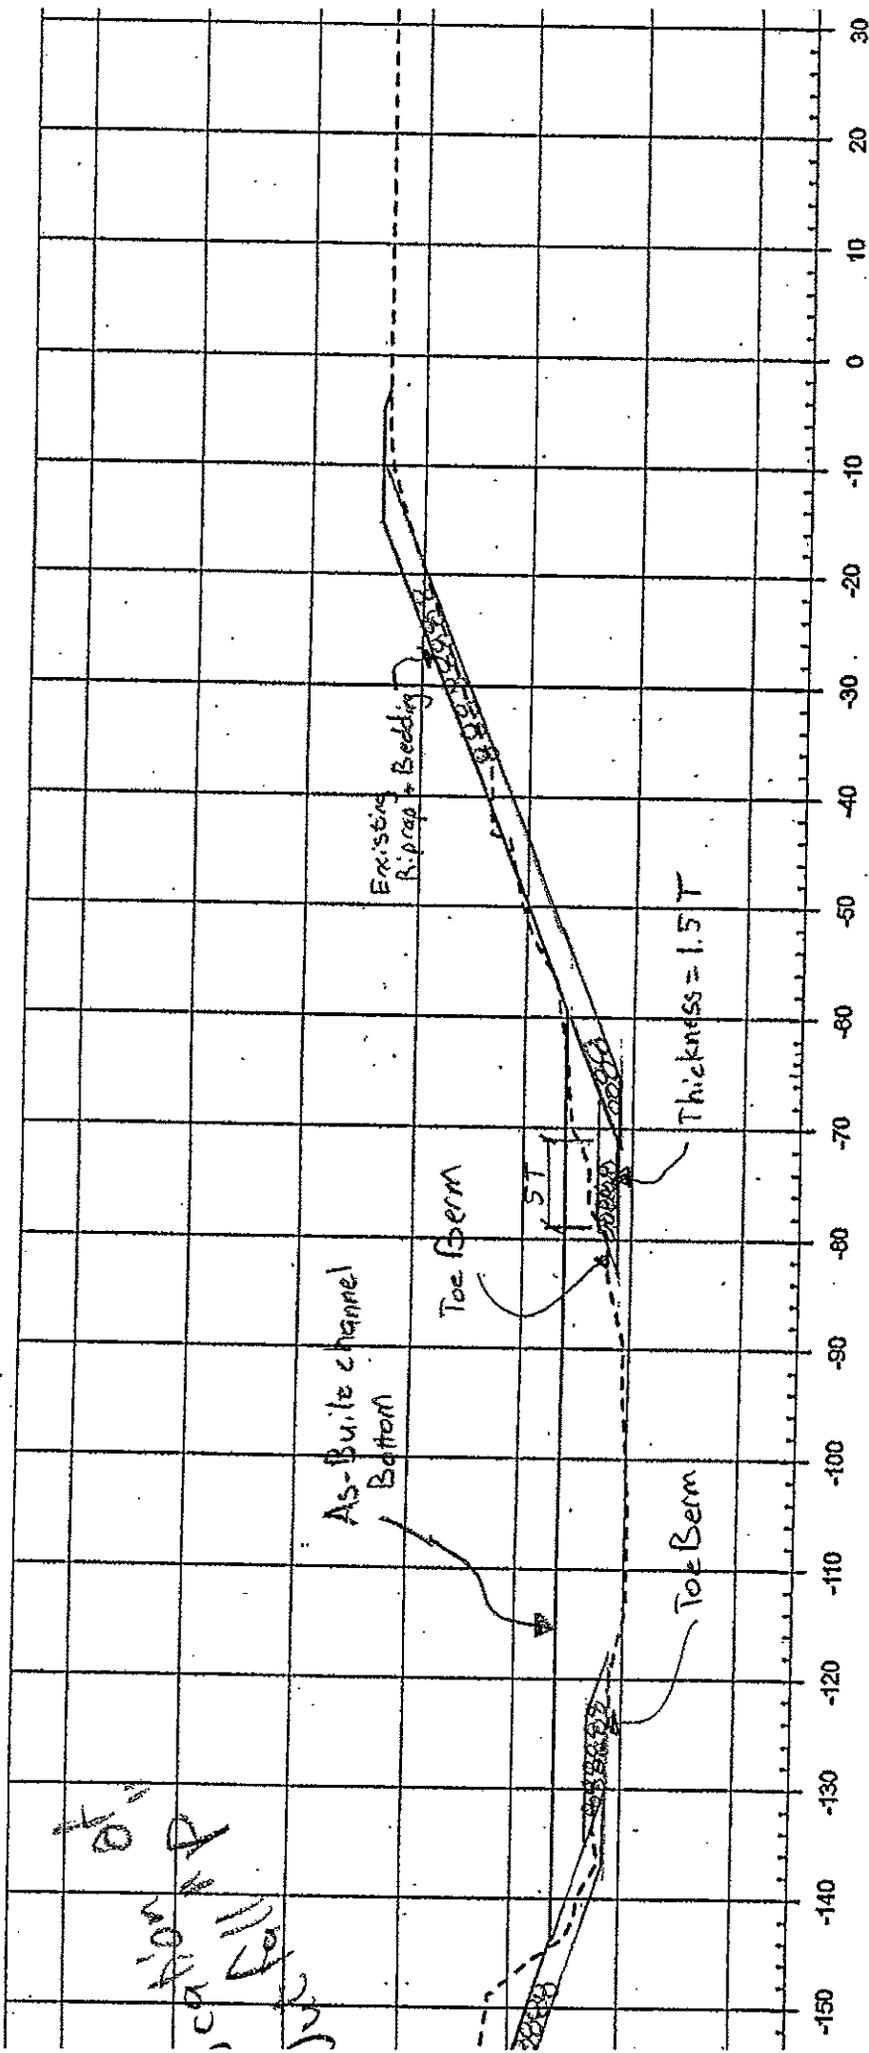
Typical Riprap Toe Berm

As you know the EA for the Rushford repairs is out for review. For the most part, all of the work proposed involves repairing damaged sections of the project and restoring it to pre-flood event conditions in accordance with the original design. This primarily involves repairing eroded embankments, replacement of riprap and clean out of outfalls/gatewells. I recently received information about additional work that needs to be done in conjunction with the project. Along two reaches of the project (see attached map), the channel has cut down so much that the toe of the riprap is in danger of potentially being undercut during high flow events. Such a situation could result in future embankment failure along reaches of the project if this is not corrected.

6.05. On-site evaluations subsequent to the distribution of the EA for public review identified the need to construct a riprap berm along selected reaches of the project to preclude future bank failure. Any minor changes to the footprint associated with the fill are anticipated to total less than one half acre, and therefore would qualify as a maintenance activity in the Corps' Clean Water Act Section 404 Regional General Permit (RGP) 003-MN. As the Section 404(b)(1) analysis was previously performed for RGP-003-MN, a separate Section 404(b)(1) analysis is not required. This determination was coordinated with the MN PCA, MN DNR and U.S. Fish and Wildlife Service. No negative comments were received.
