LOWER APPR. TO LD 7 & UPPER APPR. TO LD 2

Presentation for

MISSISSIPPI MANAGERS MEETING

3 February 2021

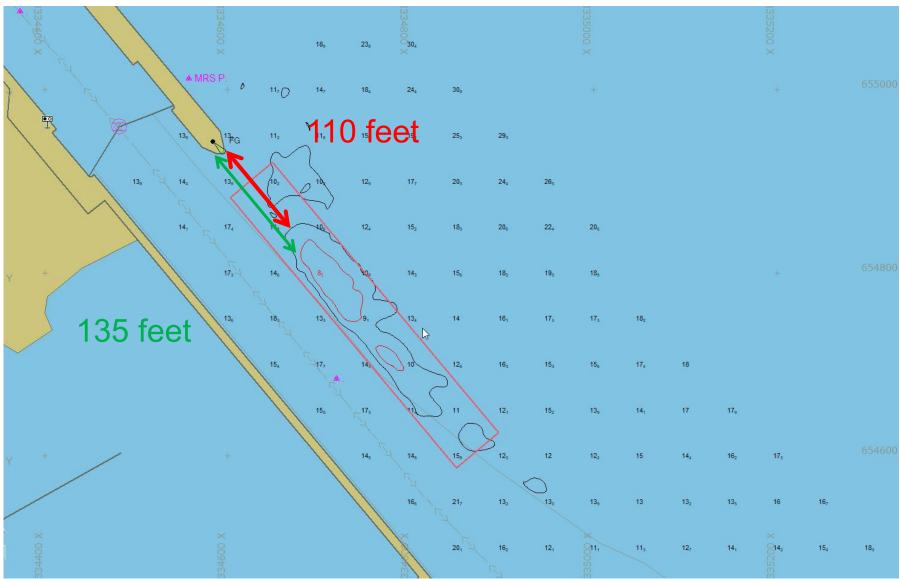
SOUNDINGS

September 14, 2020: Surveyed – shows shoaling below the bull nose on the left descending side. Records show that hasn't been dredged since 1973.

October 1, 2020: Pole soundings completed to determine sand or rock, estimated that upper 50 feet of the cut is rock otherwise sand.

- 1) Monitor for a season it may have changed.
- 2) Do environmental and plan to dredge.
- 3) Do more analysis to see what the material is.
- 4) Other ideas?

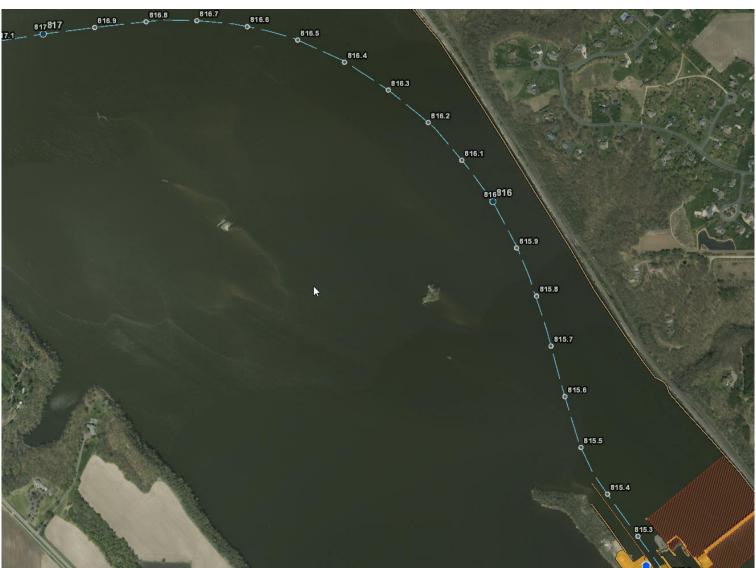
UPPER APPROACH TO LD 2

Mentioned at previous Mississippi Managers Meetings that the cross channel flows above LD 2 have increased.

- 1) Expected that loss of islands in that reach have impacted flows.
- 2) It was looked at and found that mussels were relocated in the area in the late 90's
- 3) Likely that the mussels here contain some endangered species and not likely be able to restore an island.

- 1) After the 2018 and 2019 rock construction upstream does is seem better or worse or the same?
 - 2) Should we investigate other solutions that don't include mussel impacts?
