Waterbody Data Sheet

Description			
Project Name: Line 5 Relocation Project		Date: 2020-06-12	Waterbody Survey ID: sbad1001e
State: Wisconsin	County/Parish: Bayfield	USGS Waterbody Name: None	
Company: Enbridge	Crew Member Initials: KDF/AGG	Latitude: 46.575124	Longitude: -91.032516
Survey Type: <input checked="" type="checkbox"/> Centerline <input type="checkbox"/> Re-Route <input type="checkbox"/> Access Road <input type="checkbox"/> Facility <input type="checkbox"/> Other <small>(check one)</small>			
Waterbody Type: <input type="checkbox"/> River <input checked="" type="checkbox"/> Stream <input type="checkbox"/> Ditch <input type="checkbox"/> Swale <input type="checkbox"/> Canal <input type="checkbox"/> Other <small>(check one)</small>			
Water Appearance: <input type="checkbox"/> No Water <input checked="" type="checkbox"/> Clear <input type="checkbox"/> Turbid <input type="checkbox"/> Sheen on Surface <input type="checkbox"/> Surface Scum <input type="checkbox"/> Algal Mats <input type="checkbox"/> Other <small>(check one)</small>

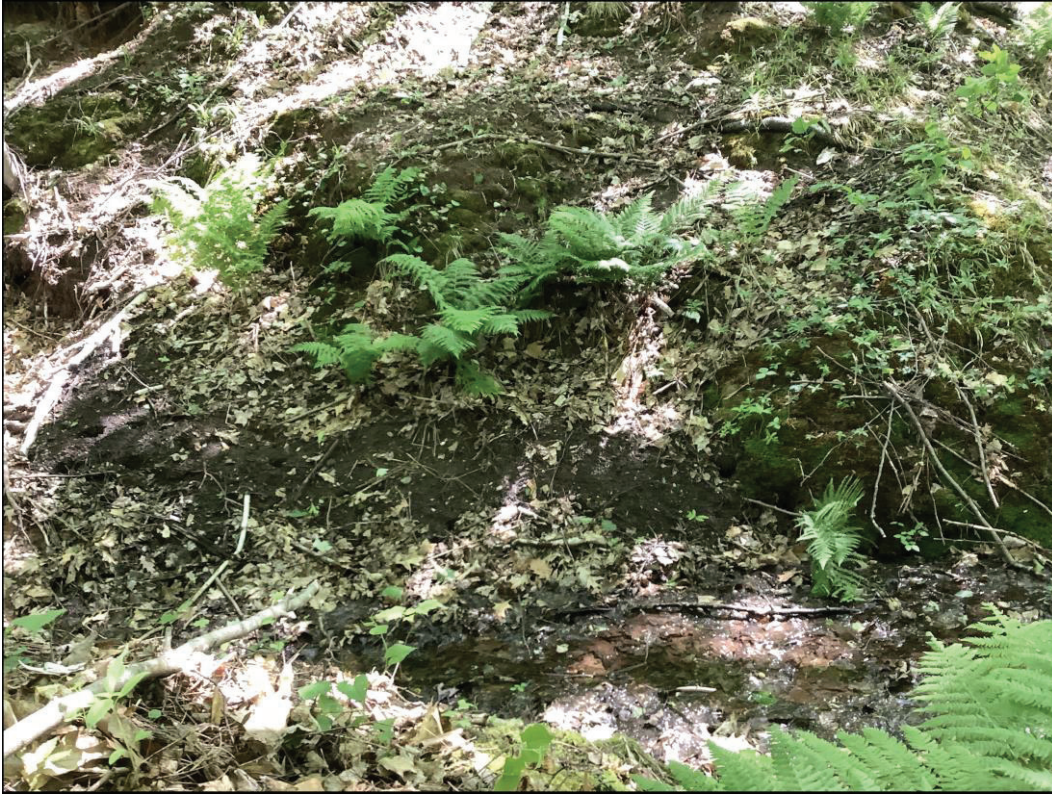
sbad1001e_N (across)

Existing Condition^a: <input checked="" type="checkbox"/> Highly Functional Stream <input type="checkbox"/> Moderately Functional Stream <input type="checkbox"/> Functionally Impaired Stream <small>(check one)</small>			
Feature Description: <input type="checkbox"/> Natural <input type="checkbox"/> Artificial, man-made <input checked="" type="checkbox"/> Manipulated <small>(check one)</small>			
Flow Regime: <input checked="" type="checkbox"/> Ephemeral <input type="checkbox"/> Intermittent <input type="checkbox"/> Perennial <input type="checkbox"/> Connecting Swale <small>(check one)</small>			
Sinuosity within Survey Corridor: <input type="checkbox"/> Straight <input checked="" type="checkbox"/> Meandering <small>(check one)</small>			
Description Notes: The ephemeral stream begins at a non-functional culvert to the northwest and terminates into a roadside ditch wetland (wbad1001e) to the south. The feature is fed by seepage, and there is no evidence that water flows through the culvert.

Observations			
Riparian Zone Present: <input type="checkbox"/> Yes <input checked="" type="checkbox"/> No <small>(check one)</small>			
Vegetation Layers: <input checked="" type="checkbox"/> Trees <input checked="" type="checkbox"/> Saplings/Shrubs <input checked="" type="checkbox"/> Herbs <small>(check all that apply)</small>			
Dominant Bank Vegetation (list): Athyrium filix-femina, Betula papyrifera, Acer rubrum			
Aquatic Habitats (ex: submerged or emerged aquatic vegetation, overhanging banks/roots, leaf packs, large submerged wood, riffles, deep pools, etc.): None.			
Aquatic Organisms Observed (list): None.			
Disturbances (ex: livestock access, manure in waterbody, waste discharge pipes): Moderate bank erosion, garbage debris.			
Observation Notes: None.

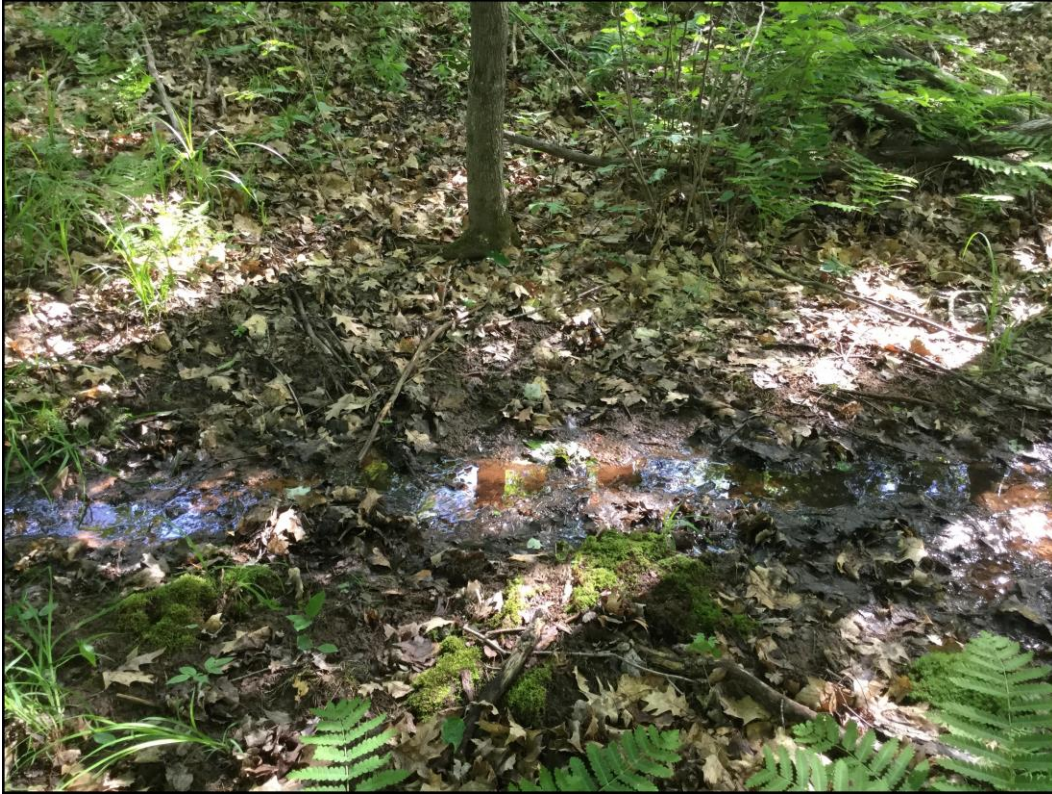
sbad1002e_E (across)

Vegetation Layers: <small>(check all that apply)</small> <input checked="" type="checkbox"/> Trees <input checked="" type="checkbox"/> Saplings/Shrubs <input checked="" type="checkbox"/> Herbs			
Dominant Bank Vegetation (list): Abies balsamea, Acer saccharum, Carex crinita, Osmunda claytoniana			
Aquatic Habitats (ex: submerged or emerged aquatic vegetation, overhanging banks/roots, leaf packs, large submerged wood, riffles, deep pools, etc.): None.			
Aquatic Organisms Observed (list): None.			
Disturbances (ex: livestock access, manure in waterbody, waste discharge pipes): There is a powerline corridor to the north.			
Observation Notes: The feature begins at wetland wbad1002 and flows south. The stream abruptly stops within the forest. Another ephemeral stream is present to the south of this feature.

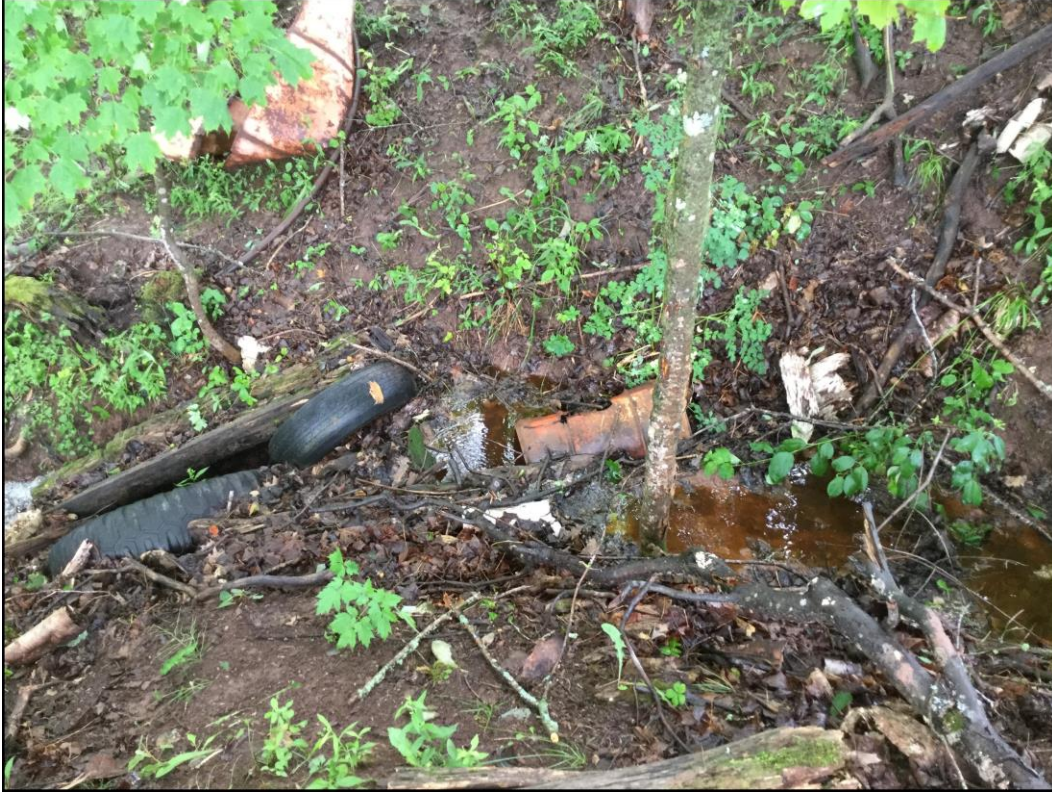
sbad1005e_SW (across)

Vegetation Layers: <input checked="" type="checkbox"/> Trees <input type="checkbox"/> Saplings/Shrubs <input checked="" type="checkbox"/> Herbs <i>(check all that apply)</i>			
Dominant Bank Vegetation (list): Acer saccharum, Thalictrum dasycarpum			
Aquatic Habitats (ex: submerged or emerged aquatic vegetation, overhanging banks/roots, leaf packs, large submerged wood, riffles, deep pools, etc.): Pools, riffles, runs, and woody debris.			
Aquatic Organisms Observed (list): None.			
Disturbances (ex: livestock access, manure in waterbody, waste discharge pipes): There is a substantial amount of trash in the stream. The trash consists of barrels, tires, paint buckets, and toys.			
Observation Notes: The feature is an ephemeral stream that flows southeast into a small perennial stream. The feature occurs within a swale that has steep banks. The stream has been significantly disturbed by humans.

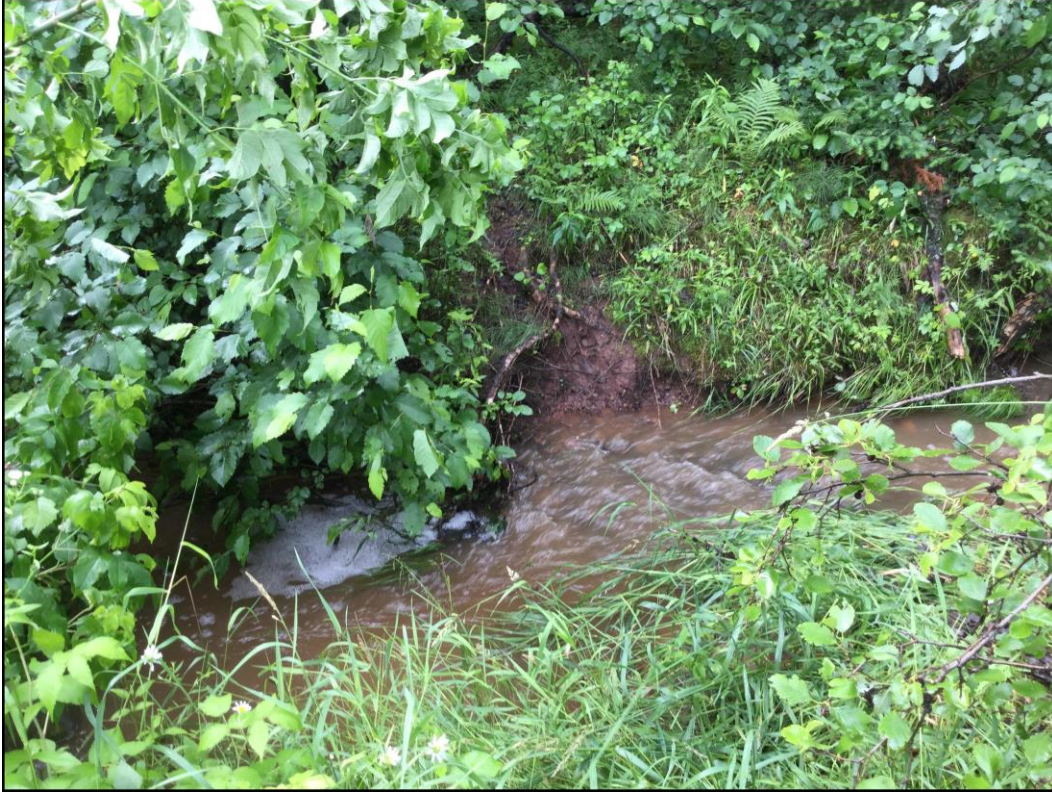
sbad1004p_S (across)

Vegetation Layers: <input checked="" type="checkbox"/> Trees <input checked="" type="checkbox"/> Saplings/Shrubs <input checked="" type="checkbox"/> Herbs <small>(check all that apply)</small>			
Dominant Bank Vegetation (list): Abies balsamea, Acer negundo, Alnus incana, Glyceria striata, Phalaris arundinacea			
Aquatic Habitats (ex: submerged or emerged aquatic vegetation, overhanging banks/roots, leaf packs, large submerged wood, riffles, deep pools, etc.): Riffles, pools, runs, overhanging vegetation, and large woody debris.			
Aquatic Organisms Observed (list): None.			
Disturbances (ex: livestock access, manure in waterbody, waste discharge pipes): A pipeline corridor cuts through the survey area. The trees within the area have been cleared.			
Observation Notes: The feature is a small perennial stream that flows through a woodland. The stream is located within a swale that has very steep banks. Part of the feature has been manipulated by past pipeline construction.

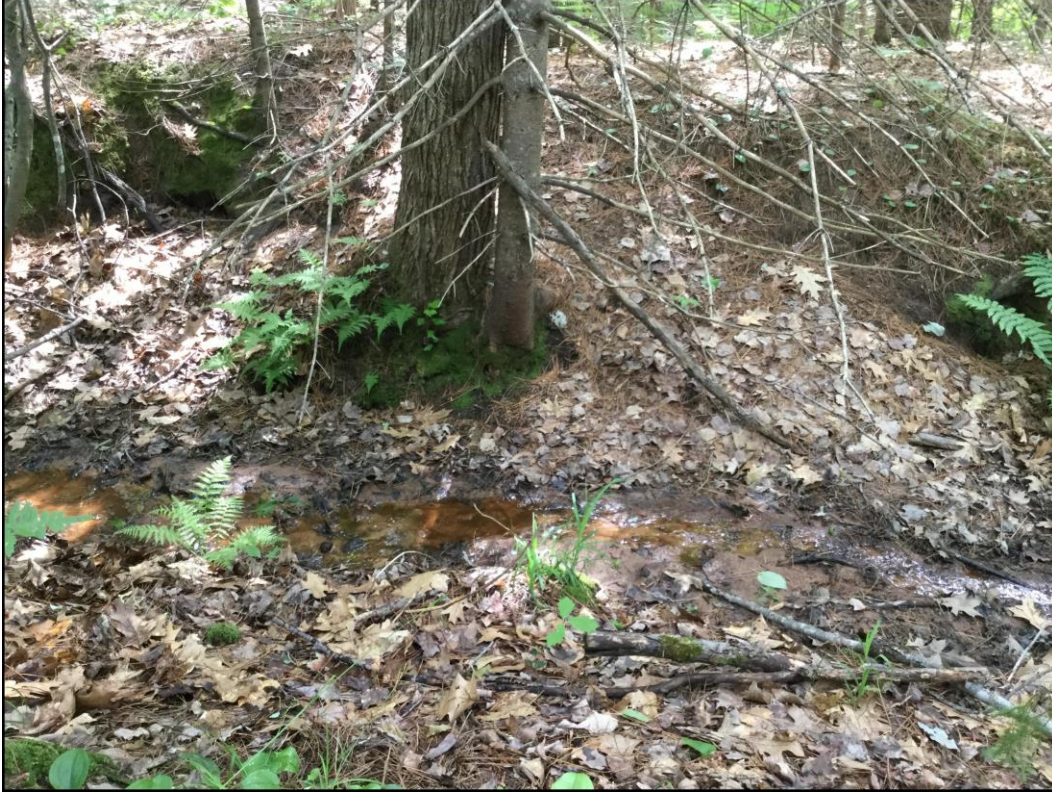
sbad1003e_E (across)

Vegetation Layers: <input checked="" type="checkbox"/> Trees <input type="checkbox"/> Saplings/Shrubs <input checked="" type="checkbox"/> Herbs <small>(check all that apply)</small>			
Dominant Bank Vegetation (list): Abies balsamea, Pteridium aquilinum, Athyrium filix-femina			
Aquatic Habitats (ex: submerged or emerged aquatic vegetation, overhanging banks/roots, leaf packs, large submerged wood, riffles, deep pools, etc.): None.			
Aquatic Organisms Observed (list): None.			
Disturbances (ex: livestock access, manure in waterbody, waste discharge pipes): The feature flows into a roadside ditch to the south.			
Observation Notes: The ephemeral stream begins within a woodland and flows south into wetland wbaa1001. The banks of surrounding the stream are relatively steep and eroded.

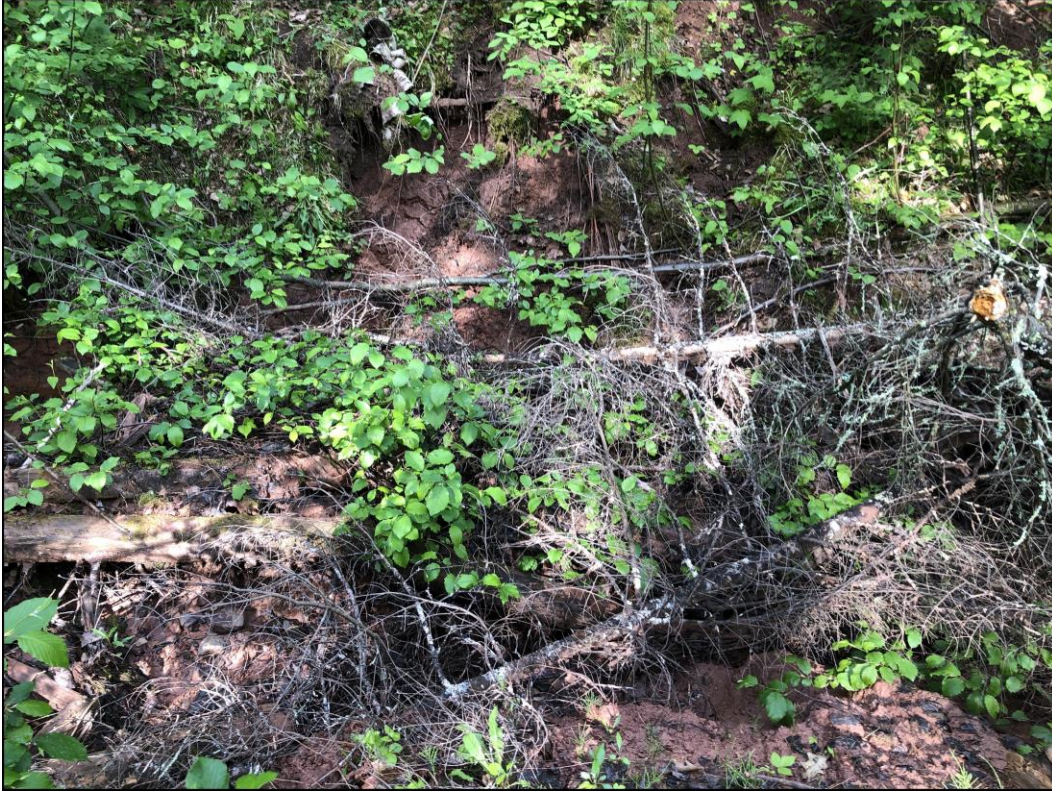
sasa1022i_W (across)

Observations			
Riparian Zone Present: <input checked="" type="checkbox"/> Yes <input type="checkbox"/> No <small>(check one)</small>			
Vegetation Layers: <input type="checkbox"/> Trees <input checked="" type="checkbox"/> Saplings/Shrubs <input checked="" type="checkbox"/> Herbs <small>(check all that apply)</small>			
Dominant Bank Vegetation (list): Corylus cornuta, Alnus incana, Eurybia macrophylla			
Aquatic Habitats (ex: submerged or emerged aquatic vegetation, overhanging banks/roots, leaf packs, large submerged wood, riffles, deep pools, etc.): Some small pools.			
Aquatic Organisms Observed (list): None observed.			
Disturbances (ex: livestock access, manure in waterbody, waste discharge pipes): Downed woody debris throughout most of stream channel.			
Observation Notes: Steep banks with exposed soil.

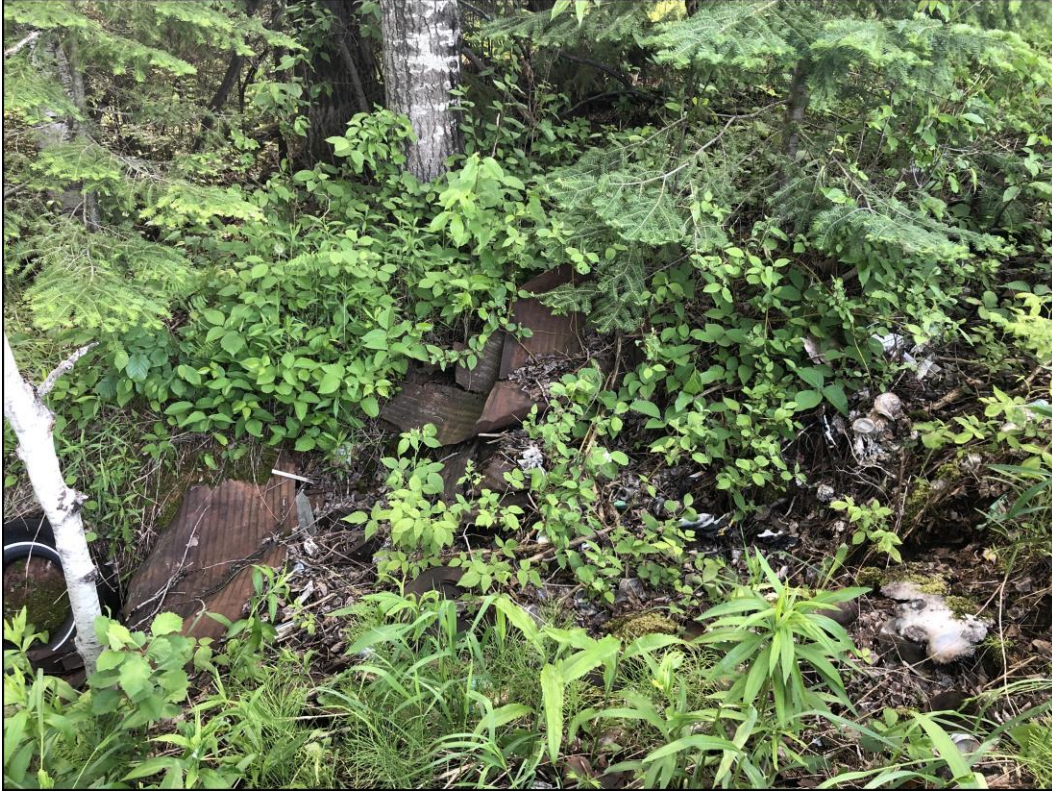
sasa1014e_S (across)

Vegetation Layers: <input checked="" type="checkbox"/> Trees <input checked="" type="checkbox"/> Saplings/Shrubs <input checked="" type="checkbox"/> Herbs <small>(check all that apply)</small>			
Dominant Bank Vegetation (list): Abies balsamea, Populus tremuloides, Toxicodendron rydbergii, Equisetum pratense			
Aquatic Habitats (ex: submerged or emerged aquatic vegetation, overhanging banks/roots, leaf packs, large submerged wood, riffles, deep pools, etc.): None.			
Aquatic Organisms Observed (list): None.			
Disturbances (ex: livestock access, manure in waterbody, waste discharge pipes): Potential runoff from the nearby agricultural field.			
Observation Notes: The stream channel has been used as a place to dump household garbage.

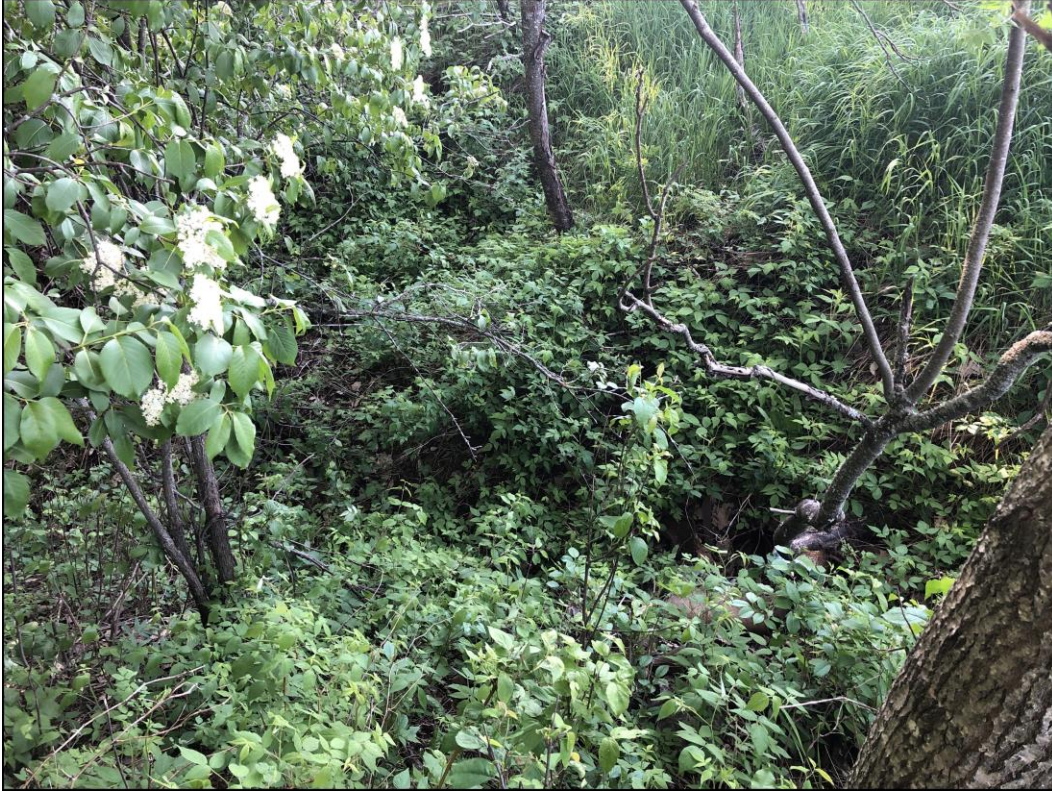
sasa1015e_E (across)

Vegetation Layers: <input checked="" type="checkbox"/> Trees <input checked="" type="checkbox"/> Saplings/Shrubs <input checked="" type="checkbox"/> Herbs <small>(check all that apply)</small>			
Dominant Bank Vegetation (list): Bromus inermis, Rhus typhina, Populus grandidentata, Rubus idaeus			
Aquatic Habitats (ex: submerged or emerged aquatic vegetation, overhanging banks/roots, leaf packs, large submerged wood, riffles, deep pools, etc.): None.			
Aquatic Organisms Observed (list): None.			
Disturbances (ex: livestock access, manure in waterbody, waste discharge pipes): Potential runoff from the agricultural field by the steam head.			
Observation Notes: There is garbage dumped in the stream channel.

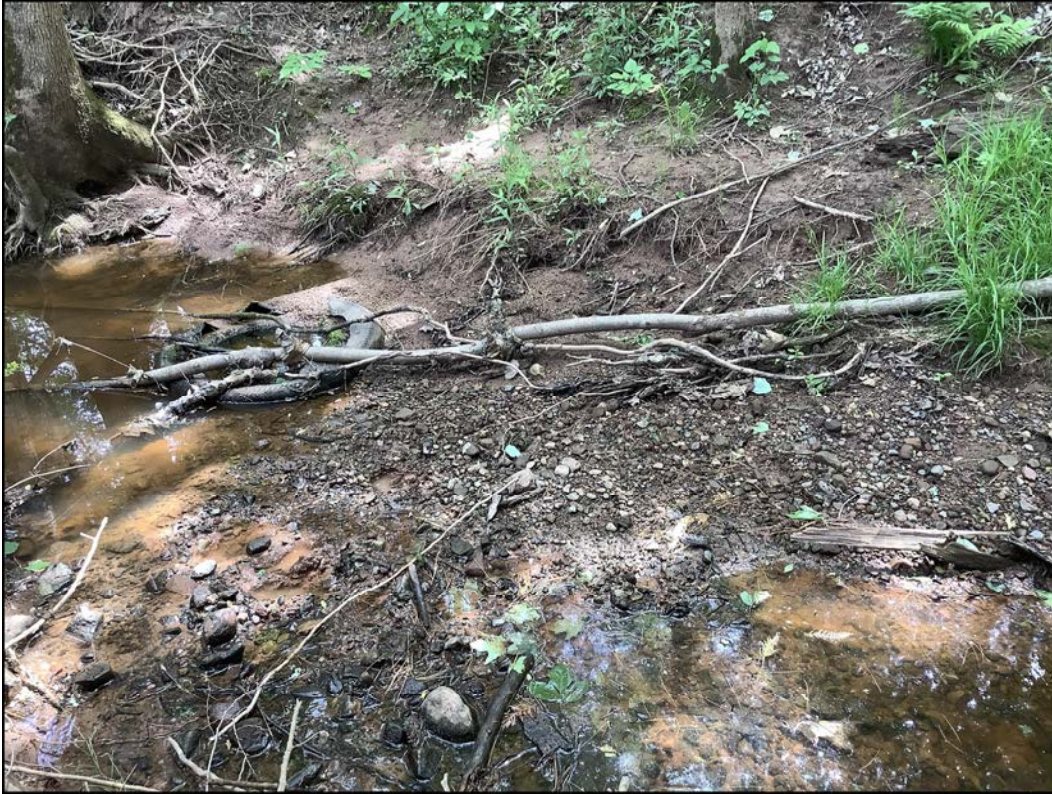
sasc041p_x (across)

Observations			
Riparian Zone Present: <input type="checkbox"/> Yes <input checked="" type="checkbox"/> No <small>(check one)</small>			
Vegetation Layers: <input checked="" type="checkbox"/> Trees <input checked="" type="checkbox"/> Saplings/Shrubs <input checked="" type="checkbox"/> Herbs <small>(check all that apply)</small>			
Dominant Bank Vegetation (list): Prunus virginiana, Fraxinus nigra, Acer saccharum			
Aquatic Habitats (ex: submerged or emerged aquatic vegetation, overhanging banks/roots, leaf packs, large submerged wood, riffles, deep pools, etc.): Pools, downed woody debris, exposed sand bars.			
Aquatic Organisms Observed (list): Frogs, aquatic invertebrates.			
Disturbances (ex: livestock access, manure in waterbody, waste discharge pipes): Moderate bank erosion, garbage debris.			
Observation Notes: None.

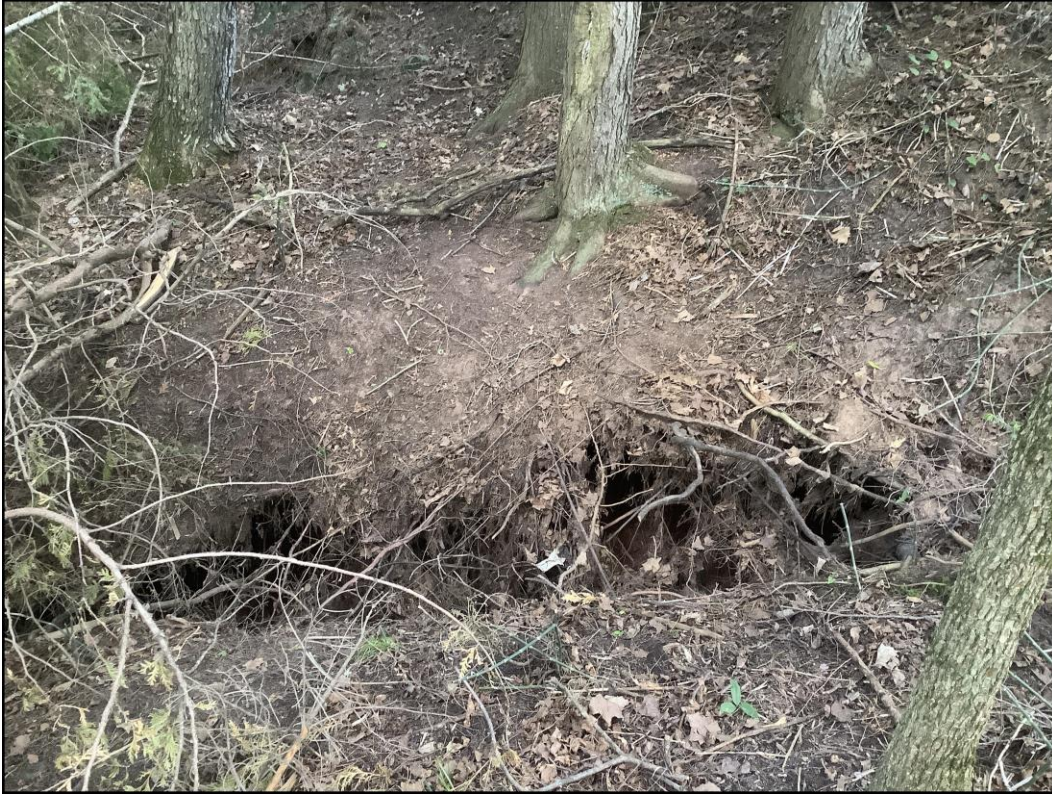
sase1021e_E (across)

Vegetation Layers: <input checked="" type="checkbox"/> Trees <input type="checkbox"/> Saplings/Shrubs <input checked="" type="checkbox"/> Herbs <small>(check all that apply)</small>			
Dominant Bank Vegetation (list): Thuja occidentalis, Tsuga canadensis, Acer saccharum, Anemone quinquefolia, Equisetum hyemale, Maianthemum canadense, Aralia nudicaulis			
Aquatic Habitats (ex: submerged or emerged aquatic vegetation, overhanging banks/roots, leaf packs, large submerged wood, riffles, deep pools, etc.): No aquatic habitat was observed.			
Aquatic Organisms Observed (list): No aquatic organisms were observed.			
Disturbances (ex: livestock access, manure in waterbody, waste discharge pipes): An agricultural swale leads to the feature.			
Observation Notes: The ephemeral stream is a washout feature that is derived from an agricultural swale to the south. The banks are eroded and there is a downed tree within the channel.
