**US Army Corps
of Engineers®**
St. Paul District

Appendix C – Hydrology and Hydraulics

Riverbank Stabilization Project Feasibility Report and Integrated Environmental Assessment Section 203 Tribal Partnership Program

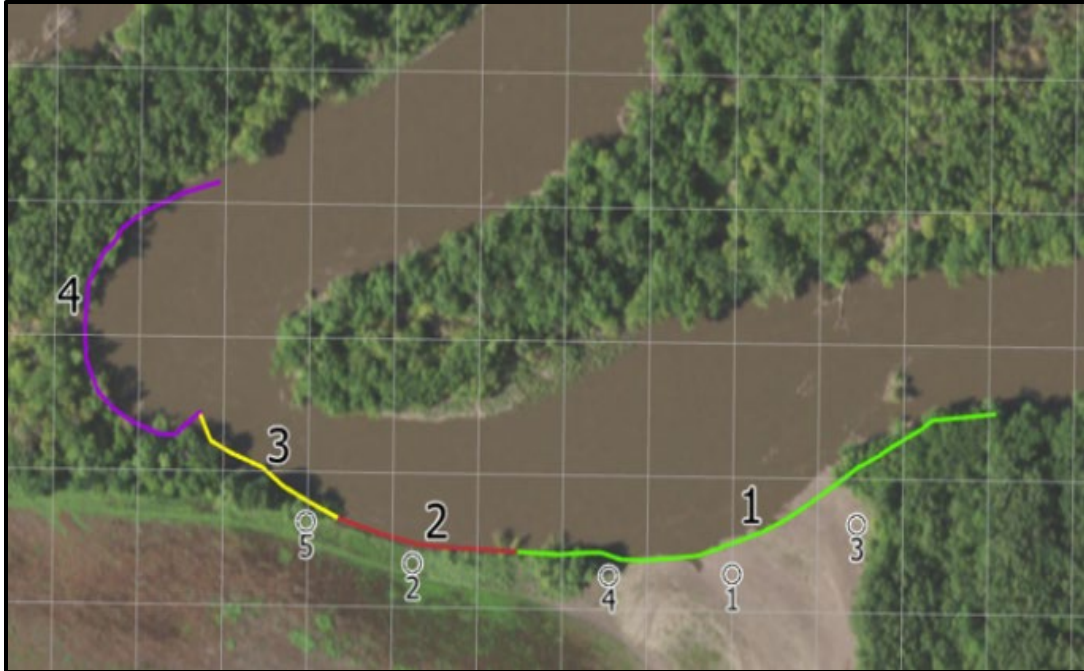
Figure 1: Project area with reaches labeled. Smaller numbers represent the locations of subsurface borings.

The study area was broken up into four separate reaches due to the unique hydraulic characteristics present within each reach. Reach 1 is the most downstream reach, defined by unvegetated vertical banks, and encompasses the area of maximum lateral bank retreat. Reach 2 appears to be a transition reach with more vertical banks near Reach 1 that taper into a sloped vegetated bank near Reach 3. A bedrock outcropping is the defining feature of Reach 3 where vertical unvegetated banks appear to be partially stabilized by tree roots. Reach 4 is the upstream-most reach of the project area and encompasses a meander pool with lower bank heights at the location of an apparent overflow area. A lack of quantifiable erosion within Reach 4 led the PDT to determine that no bank protection measures were needed for this reach.

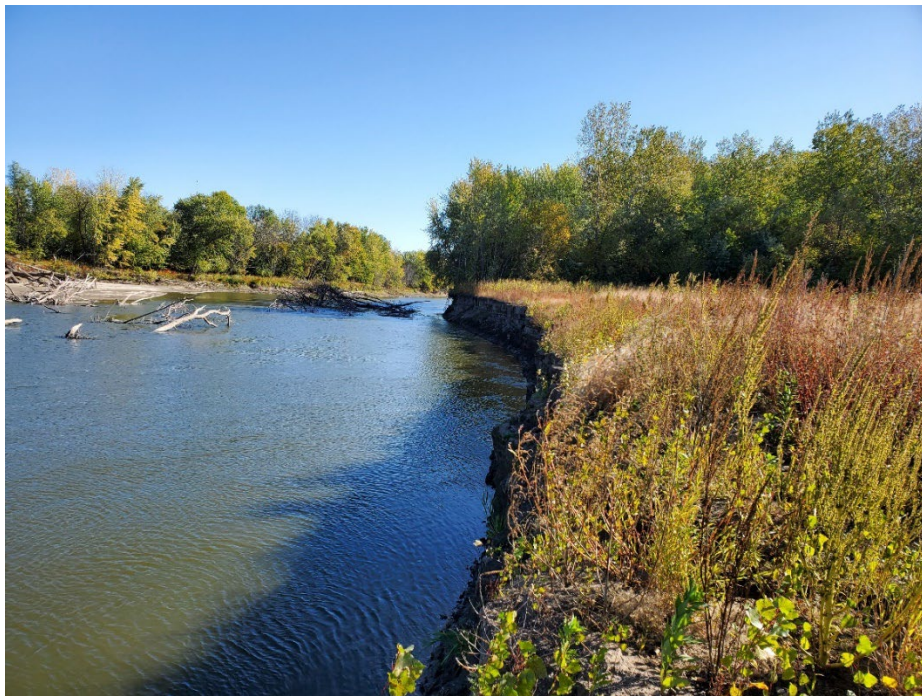
Figure 2: Unvegetated vertical banks along Reach 1

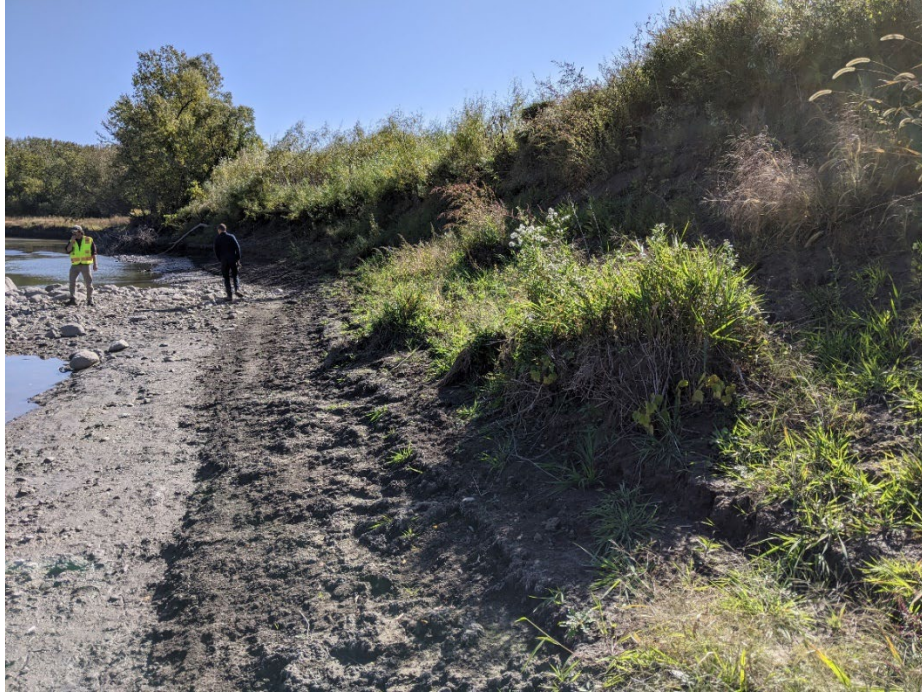
Figure 3: Reach 2 with more vertical banks at the downstream extent and shallower sloped banks at the upstream extent

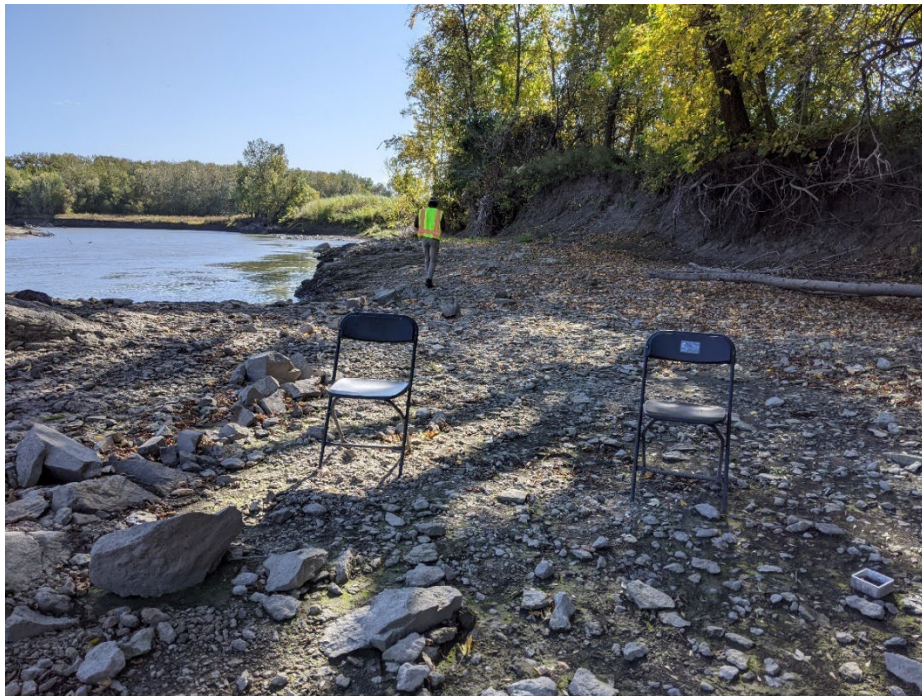
Figure 4: Exposed bedrock outcrop and unvegetated vertical bank define Reach 3

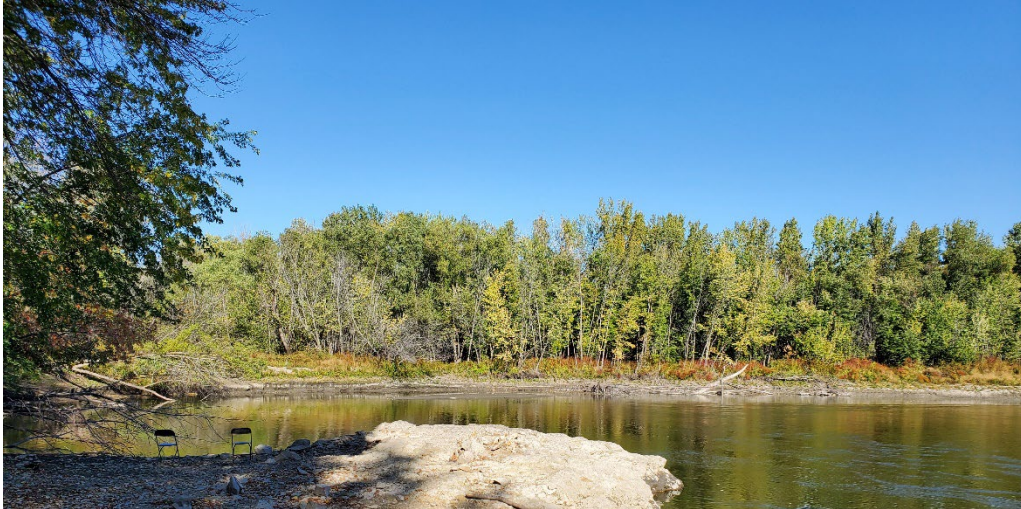
Figure 5: Reach 4 consists of a meander pool with vegetated banks. Portions of the bank are unvegetated but observed erosion has not been significant enough to justify erosion countermeasures.

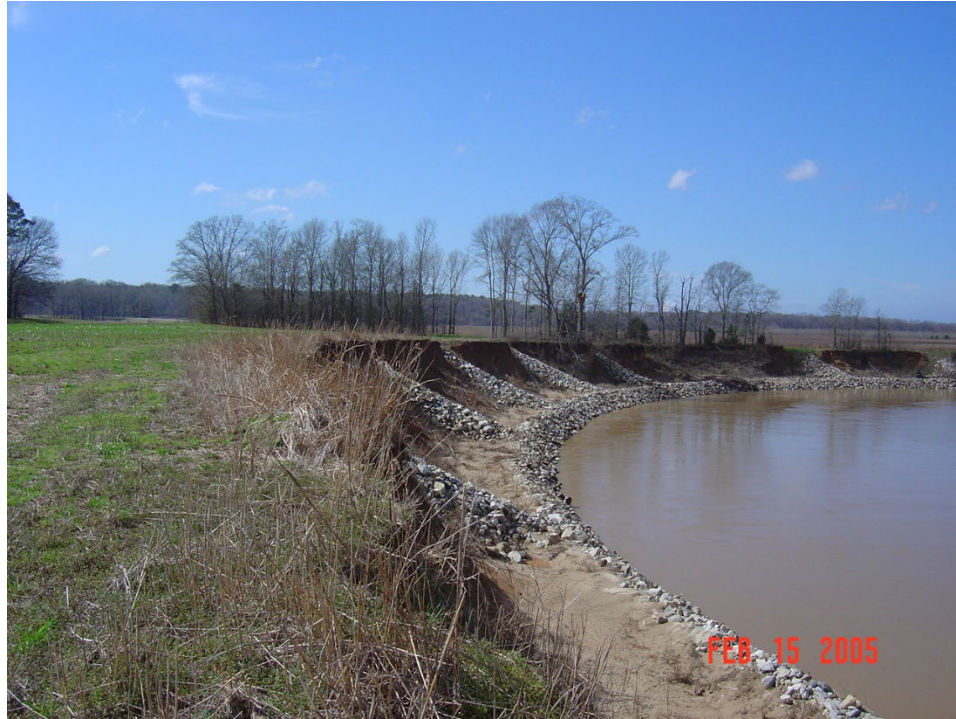
Figure 7: Bayou Pierre River, MS; Illustrating EWN-LPSTP Approximately 2-years After Construction-Sediment Infilling Behind LPSTP and Keys

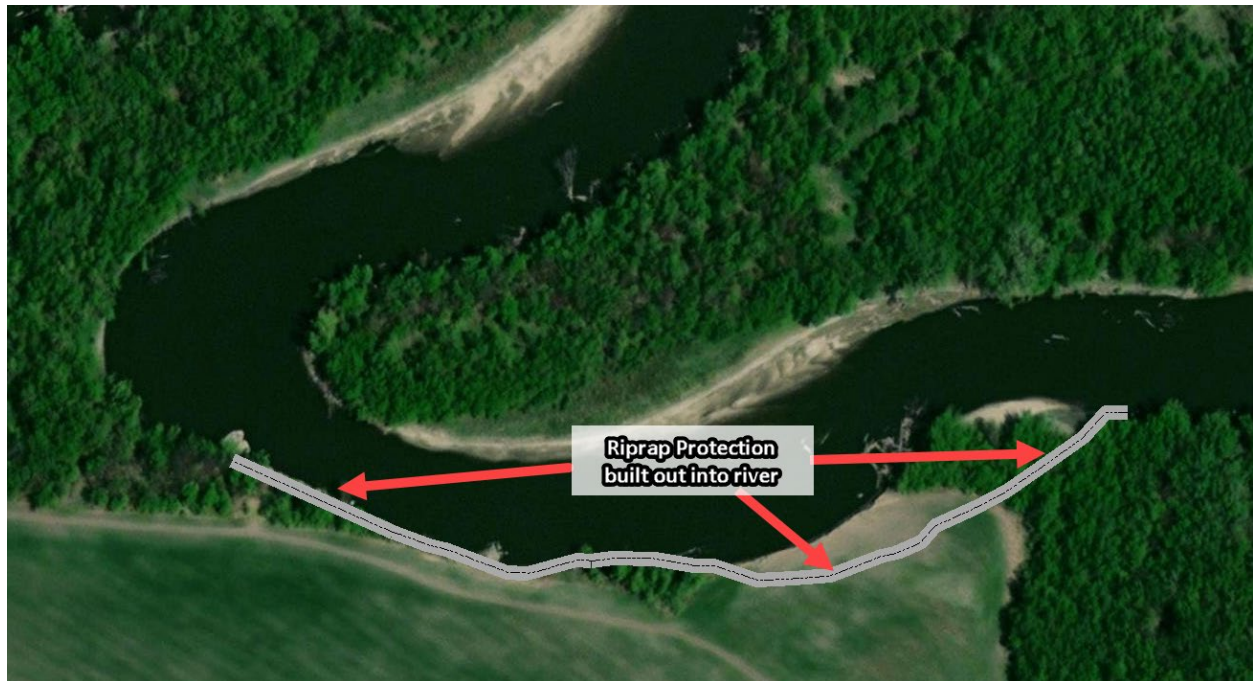
Figure 9: Alternative 2 (2015 aerial imagery)

Alternative 2 consists of riprap built out into the river from the bank of Reaches 1, 2, and 3 at a 1.5H:1V slope. No grading, bedding, or geotextile is proposed for this alternative. No action is proposed for Reach 4. Riprap has been shown to effectively protect against flow velocities and would be used to protect Reaches 1, 2, and 3. The riprap would extend from the toe of the bank to the top of the bank in Reach 1, Reach 2, and Reach 3 at a 1.5H:1V slope. The rock would be placed at the toe of the bank and built up without any grading of the existing vertical banks to minimize cost. This would reduce the amount of vegetation that could be incorporated into the design. Additional description of the riprap protection is described in Section 5.4 Riprap Design.

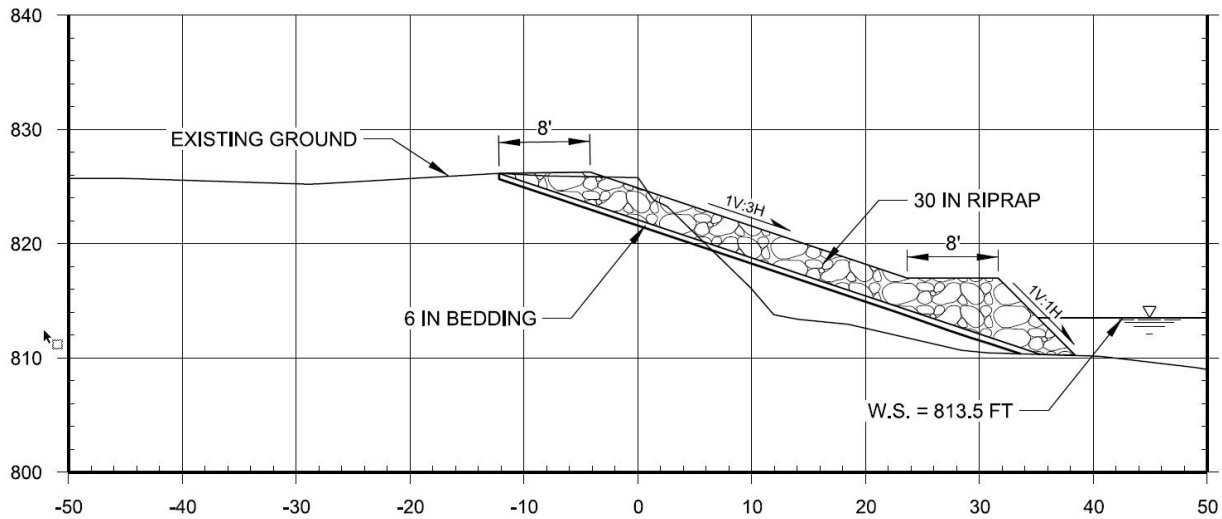
Figure 11: Alternative 4 bank cutback/mass balance and riprap protection for Reaches 1 and 2

Alternative 4 provides erosion protection by cutting the vertical banks in Reaches 1, 2, and 3 back to a stable 3H:1V slope and placing 30 inches of riprap revetment overtop of 6 inches of bedding material. Launchable stone toe at the toe of the slope will protect against any scour that may occur during a 24,000 cfs flow event. The vertical riprap extents will be from the toe of the bank to the top of the bank in Reaches 1 and 2 and from the bedrock outcropping to the top of the bank in Reach 3. Additional description of the riprap protection is described in Section 5.4 Riprap Design. This design will result in wetland impacts that can be offset by purchasing wetland credits.

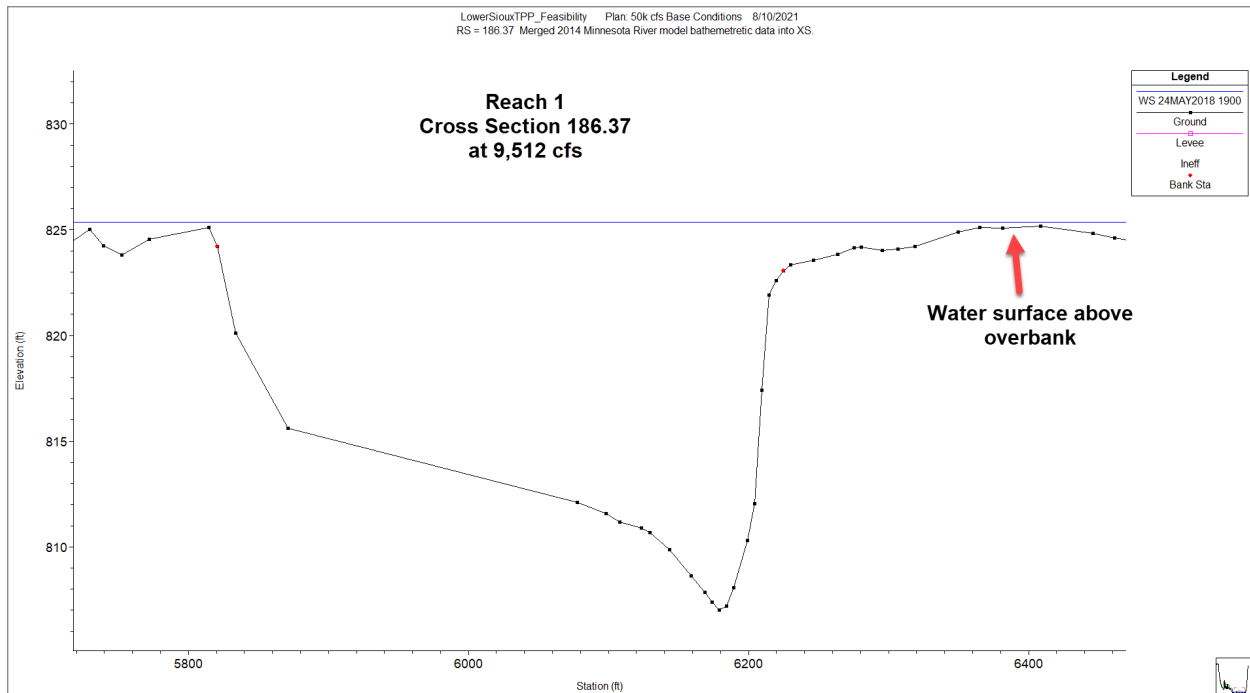
Figure 15: Water surface elevation at Reach 1 cross section (RM 186.37) at 9,512 cfs

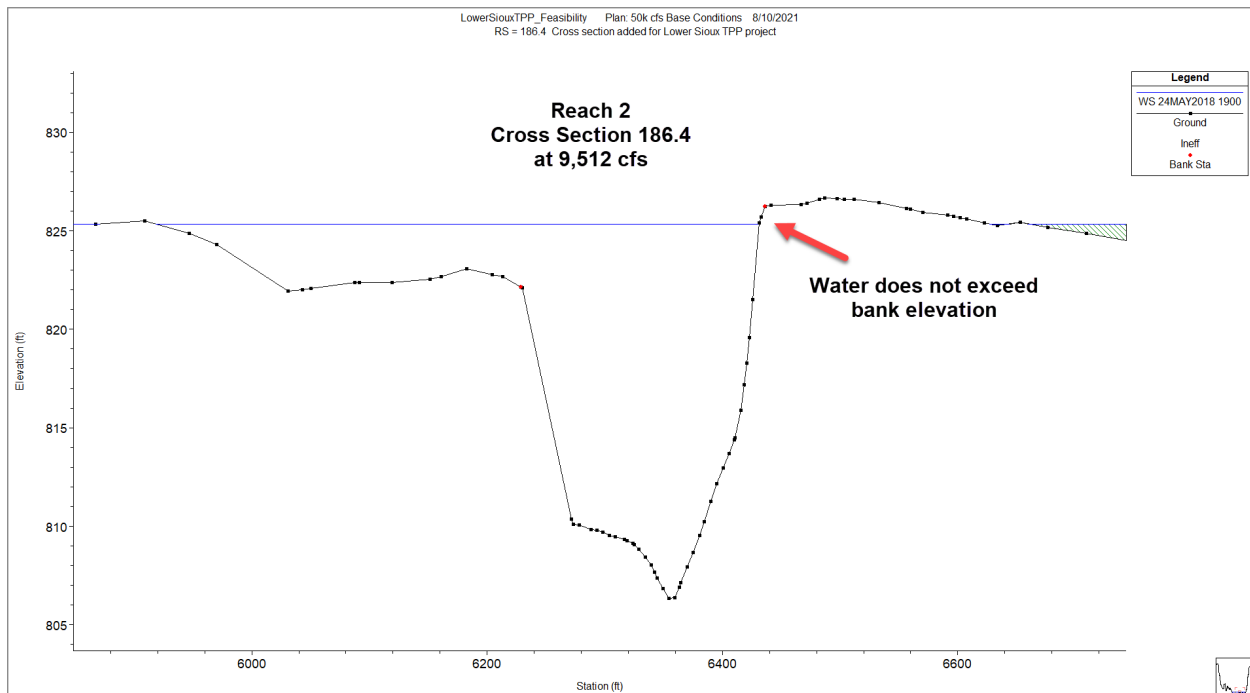
Figure 16: Water surface elevation at Reach 2 cross section (RM 186.4) at 9,512 cfs

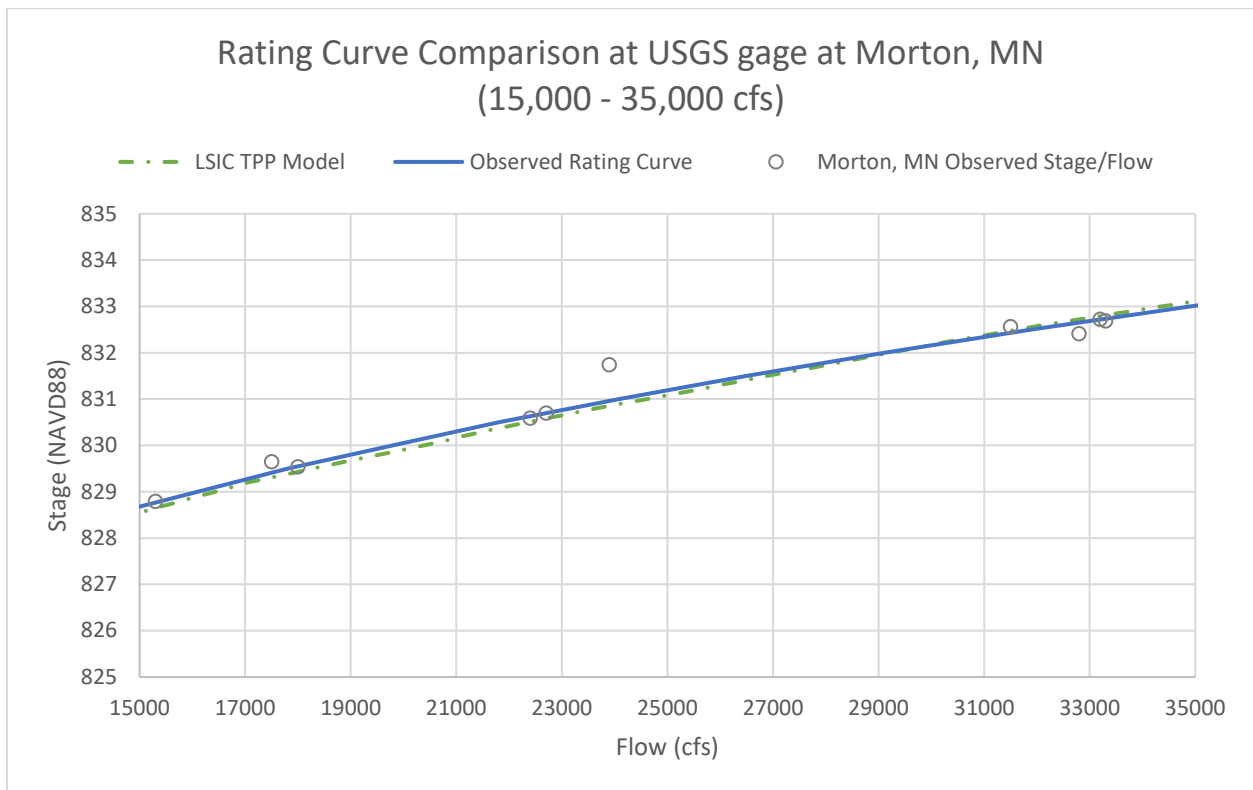
Figure 19: Rating curve comparison from 15,000 to 35,000 cfs

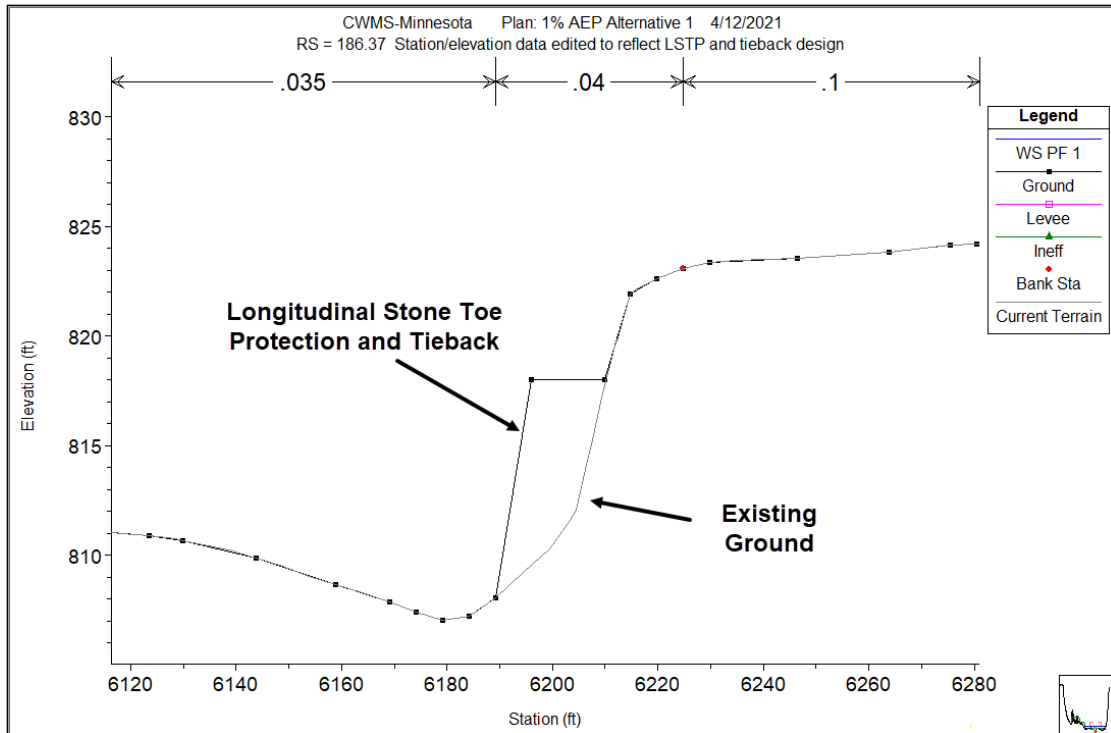
Figure 22: Station-elevation data at cross section 186.37 edited to reflect Alternative 1 features in Reach 1 and Reach 2

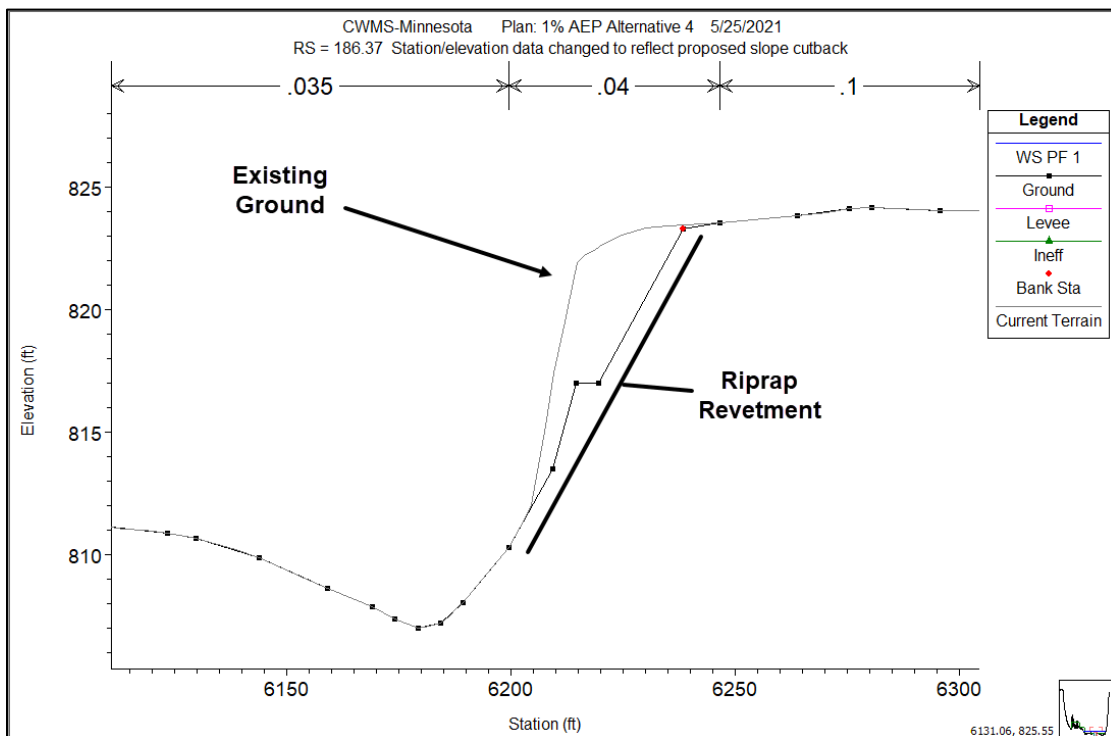
Figure 23: Station-elevation data at cross section 186.37 edited to reflect Alternative 4 features in Reach 1 and Reach 2

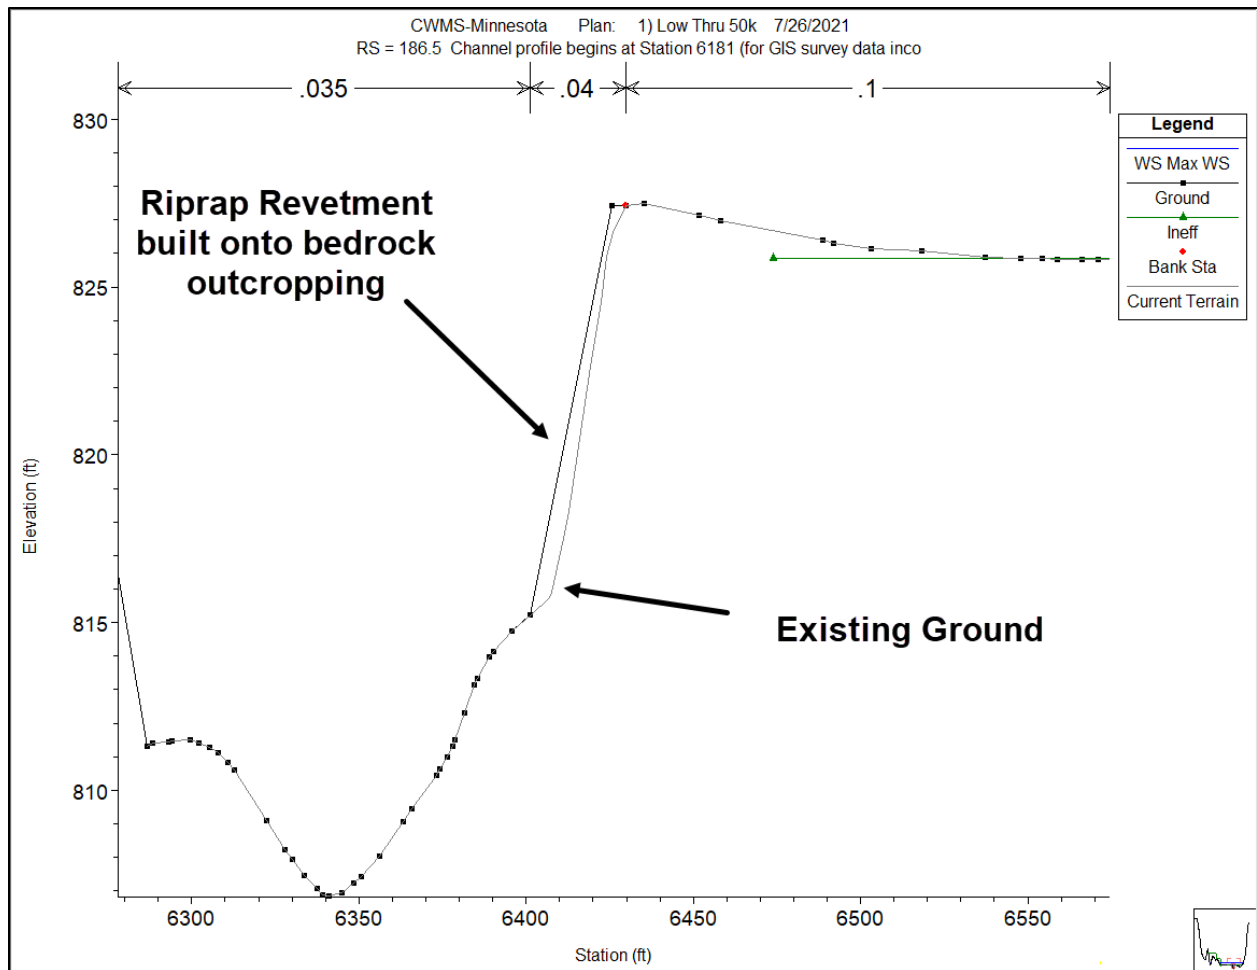
Figure 24: Station-elevation data at cross section 186.5 edited to reflect Alternative 1 and 4 features in Reach 3 (features are the same in both alternatives)

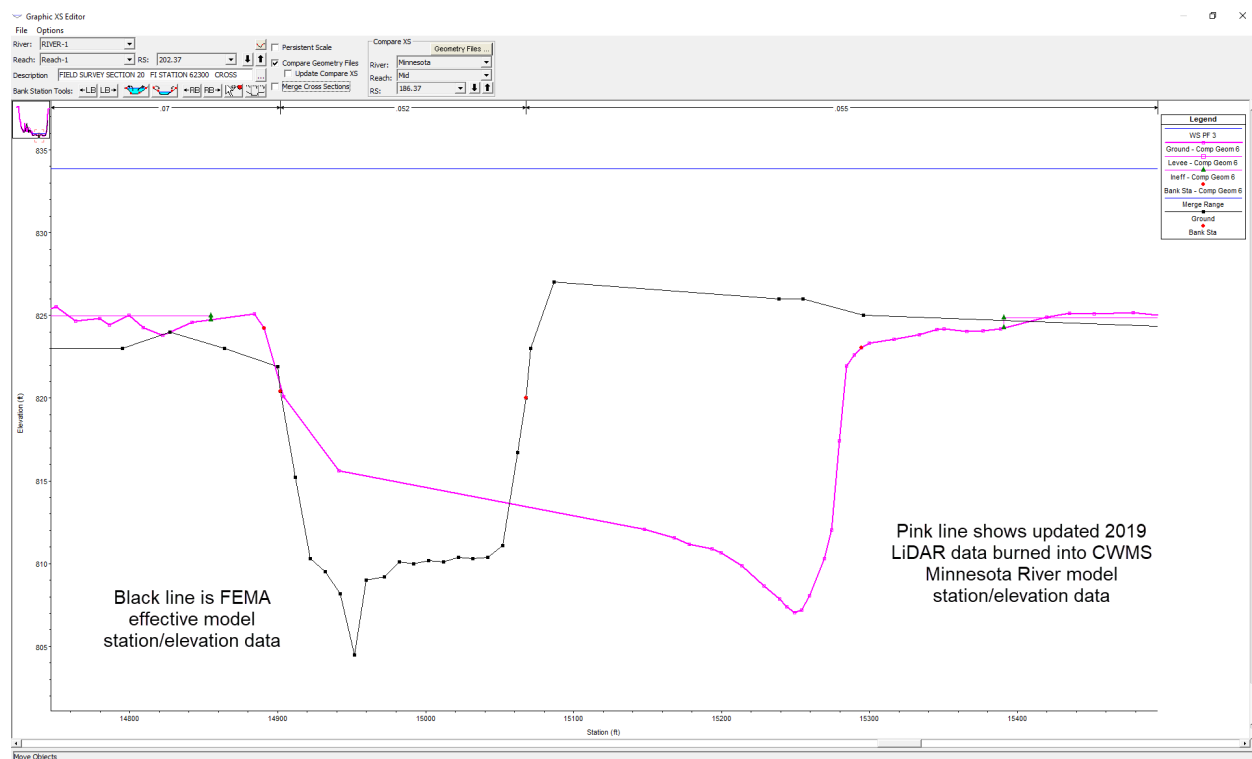
Figure 26: Changes between effective FEMA model station/elevation data (black) and 2019 bathymetry data (pink).

The effective FEMA model was run using the current information related to the 100-year flood event, a Steady Flow file with a profile set to 61,000 cfs and a geometry intended for use with the 100-year flood event. This produced an elevation of 833.85 feet (NAVD88) at cross section 202.37. The cross section station/elevation data was updated with bathymetry data collected in 2019. This illustrated the lateral retreat that was the main driver for this feasibility study and represents the geometry used for the LSIC TPP Base Conditions model run (Figure 25).

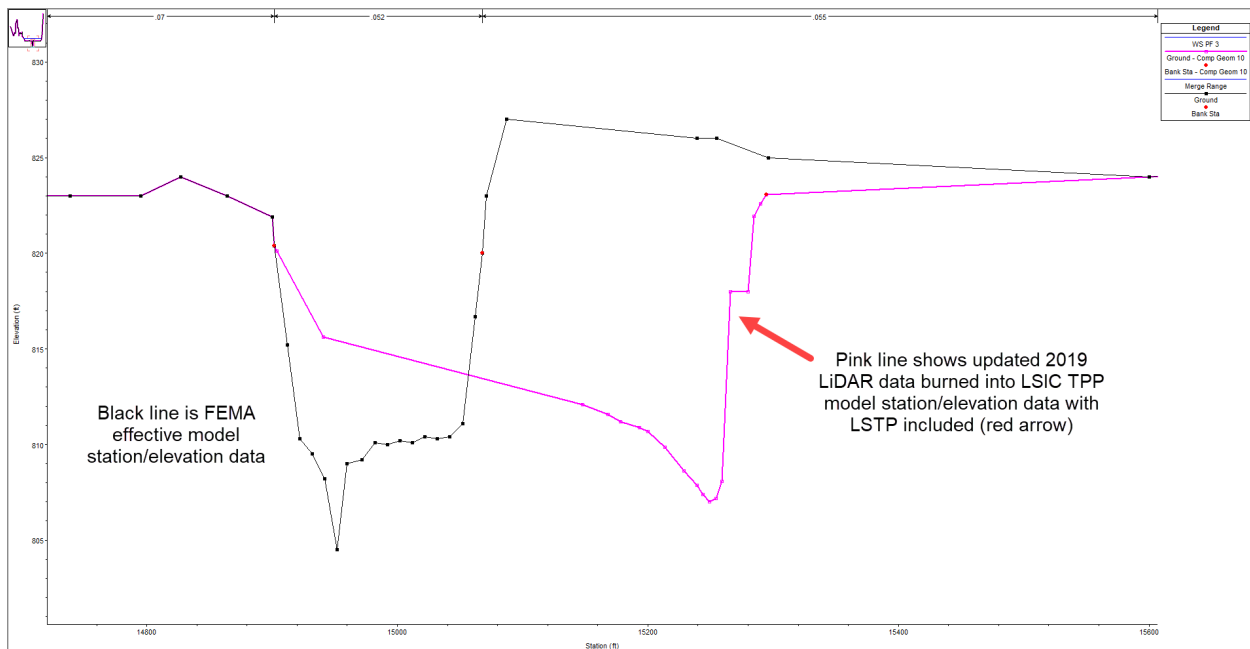
Figure 27: Changes between effective FEMA model station/elevation data (black) and Alternative 1 (pink)

The updated cross section was then modified to reflect the four proposed alternatives (Figure 26 - Figure 29). The FEMA 100-year flood steady flow file was then run through the modified geometries to calculate water surface elevations (WSEs) that would be compared against the WSE from the effective FEMA model (Table 5).

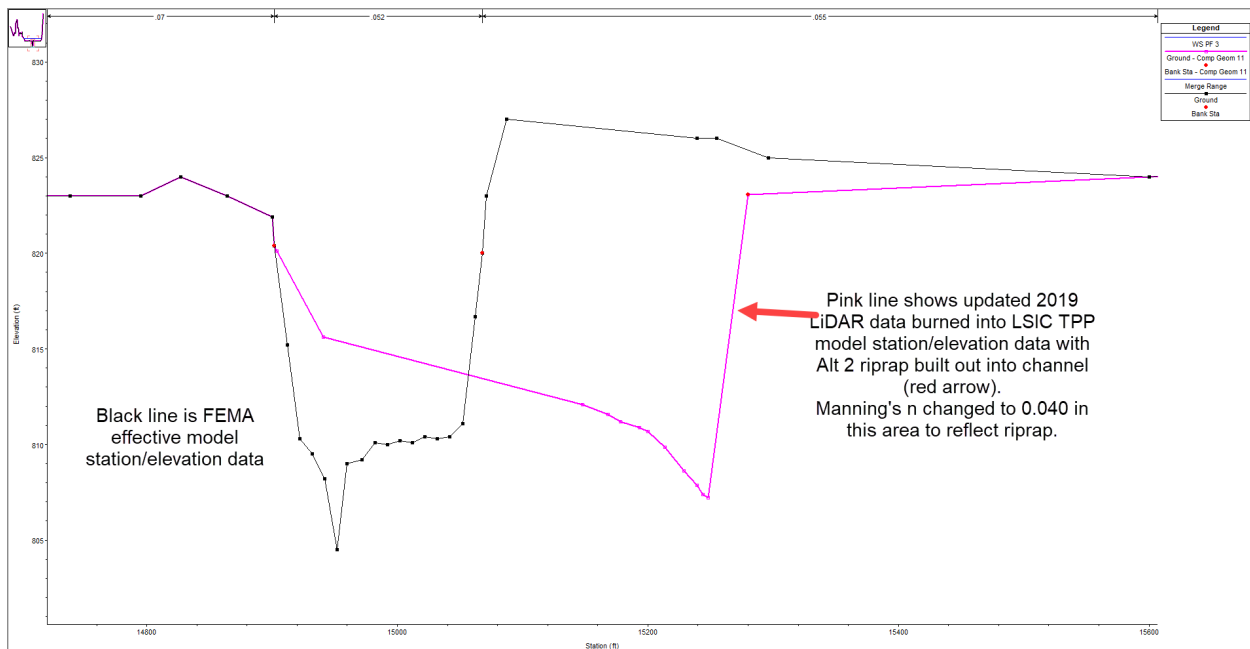
Figure 29: Changes between effective FEMA model station/elevation data (black) and Alternative 3 (pink)

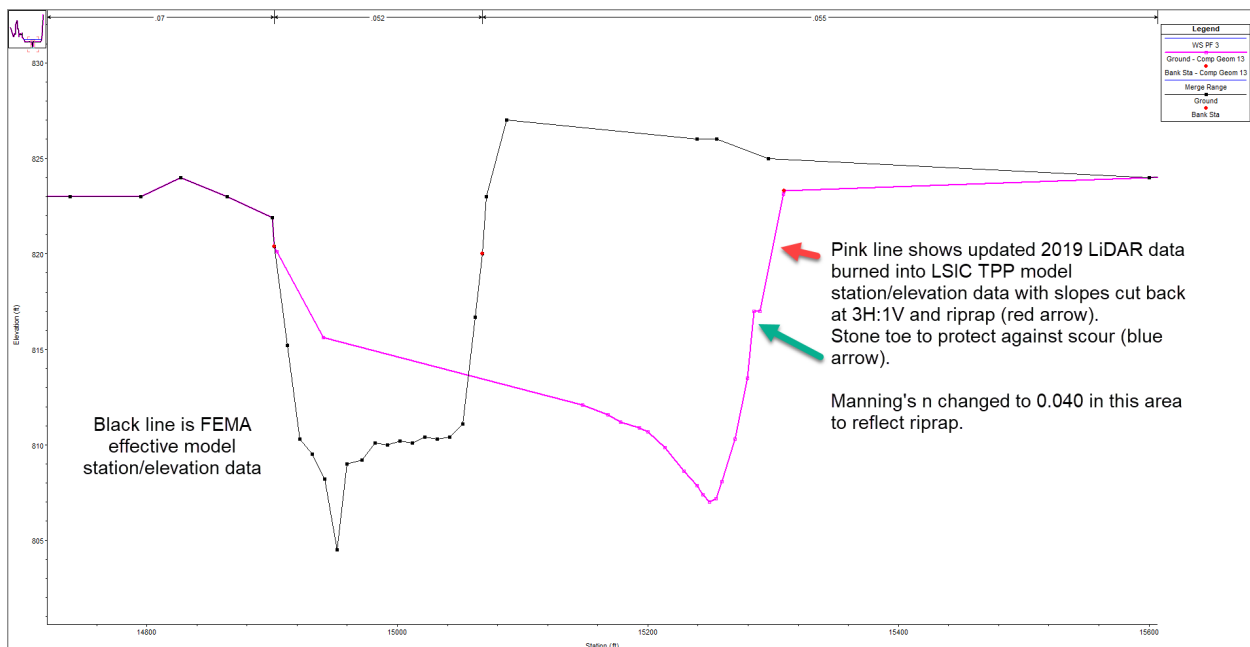
Figure 30: Changes between effective FEMA model station/elevation data (black) and Alternative 4 (pink)

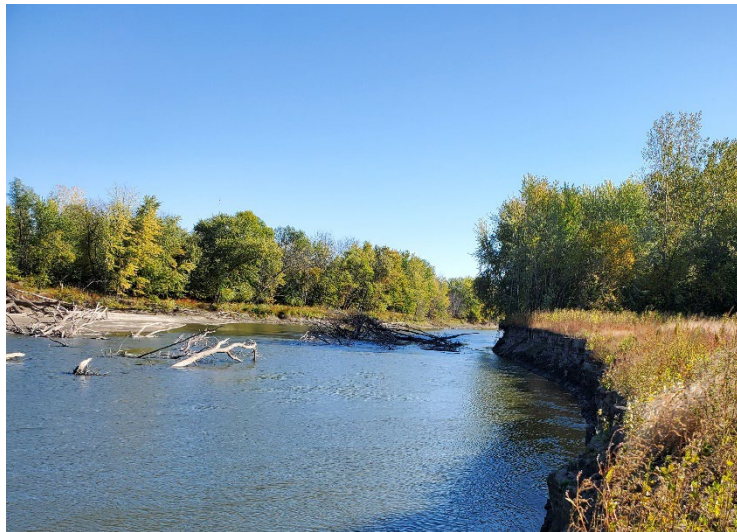
Figure 36: Large trees within the main channel near Reach 1

An applied factor of safety of 1.5 due to the presence of large trees within the main channel and the associated risk of debris impact upon the study area (Figure 29).

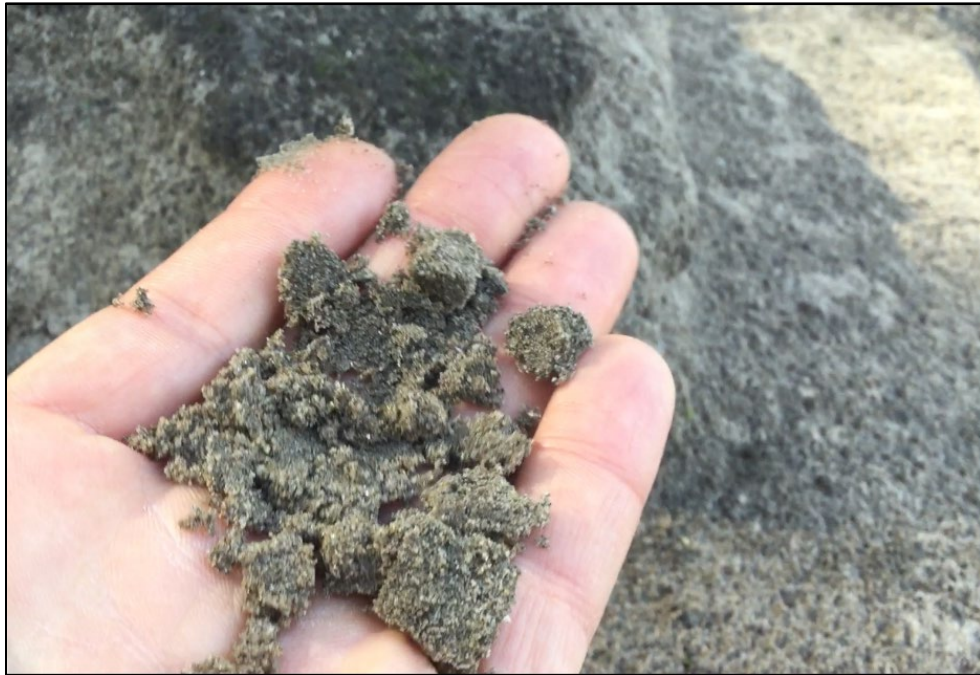
Figure 37: Sediment taken from a sand bar just downstream of the study area consisting of well-graded sand.

A channel bed gradation is necessary for any scour analysis. Bed gradations were not collected for the feasibility study (RM 186) but collected bed gradation data of the Minnesota River at Mankato (RM 104) were available and used for the feasibility-level scour analysis. The channel bed at Mankato consisted of a well-graded sand which appeared to match the bed at the study area (Figure 30).
