APPROVED JURISDICTIONAL DETERMINATION FORM
U.S. Army Corps of Engineers

B. ST PAUL, MN DISTRICT OFFICE, FILE NAME, AND NUMBER: MVP-2016-00596-EMN, Camp Phillips Center Development

**MVP-2016-00596-EMN Approved Jurisdictional Determination (AJD)
Supporting Information for AJD – Photo log, September 6, 2017**

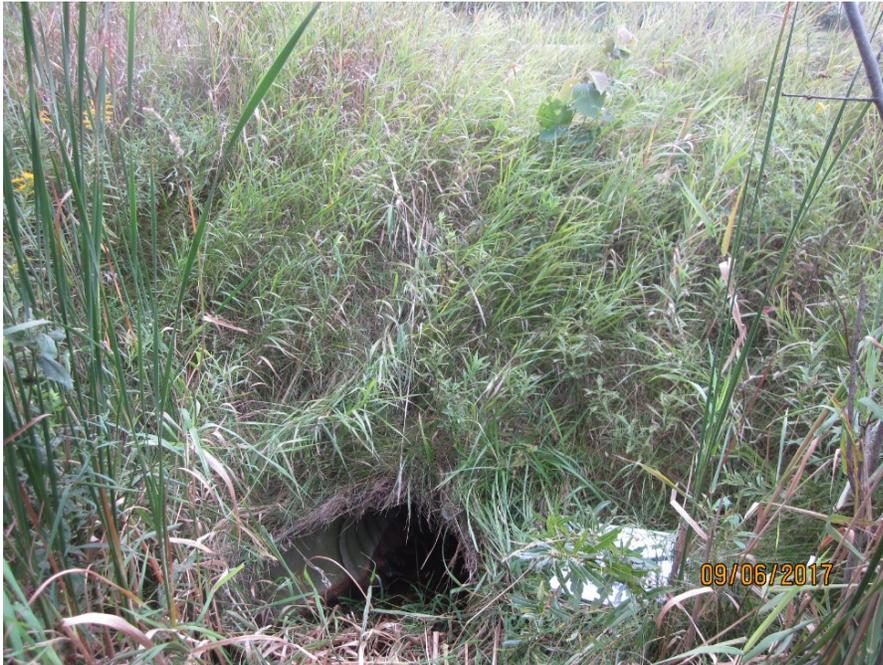
P1. Looking south at culvert between W8 and W1. Surface water was observed in the wetland and culvert and was flowing downslope to W1 showing a continuous surface water connection through the man-made barrier that bisects this portion of the wetland complex (comprised of W1, W4, W5, W8, and M1-M7).

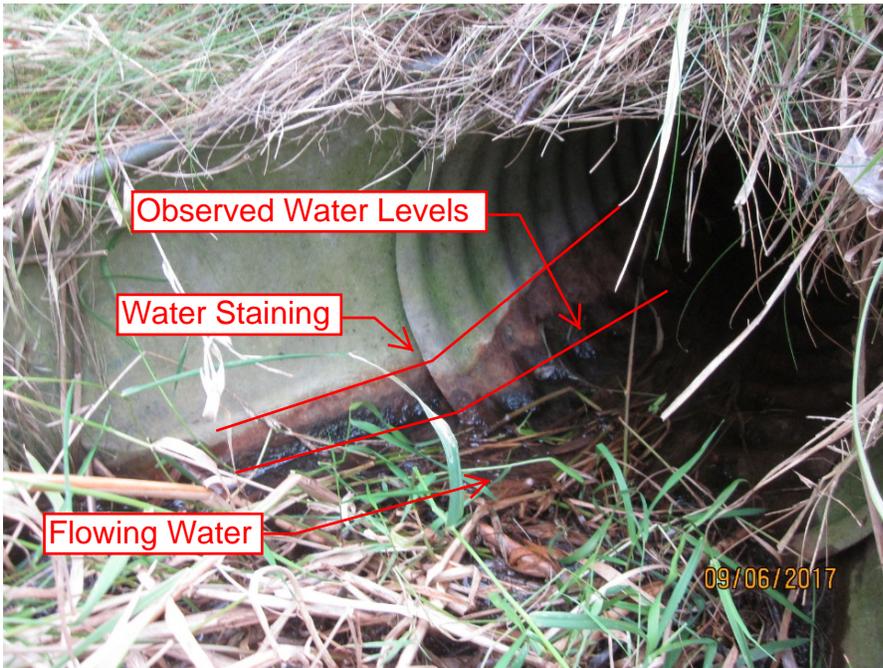
P2. Closer look at culvert showing flowing water and water staining in culvert. The water staining suggests that water levels are higher during the growing season on a yearly basis.

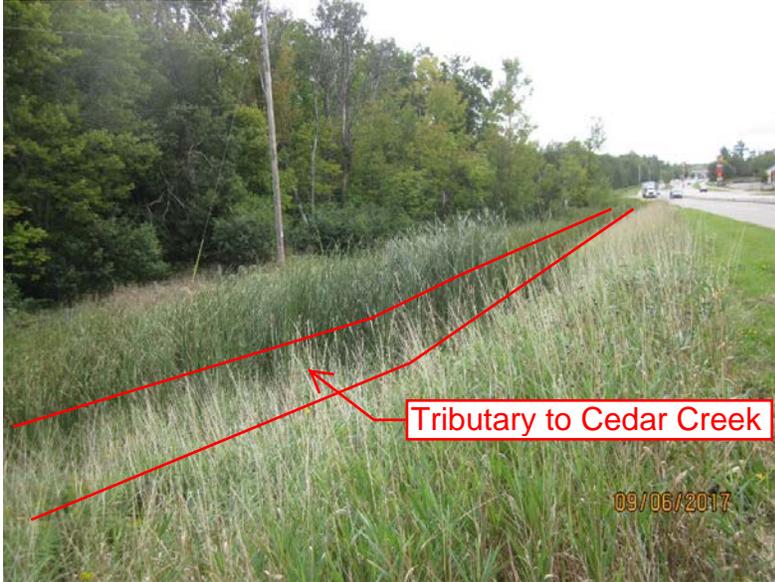
P3. Looking south at W4 on the east side of Camp Phillips Road.

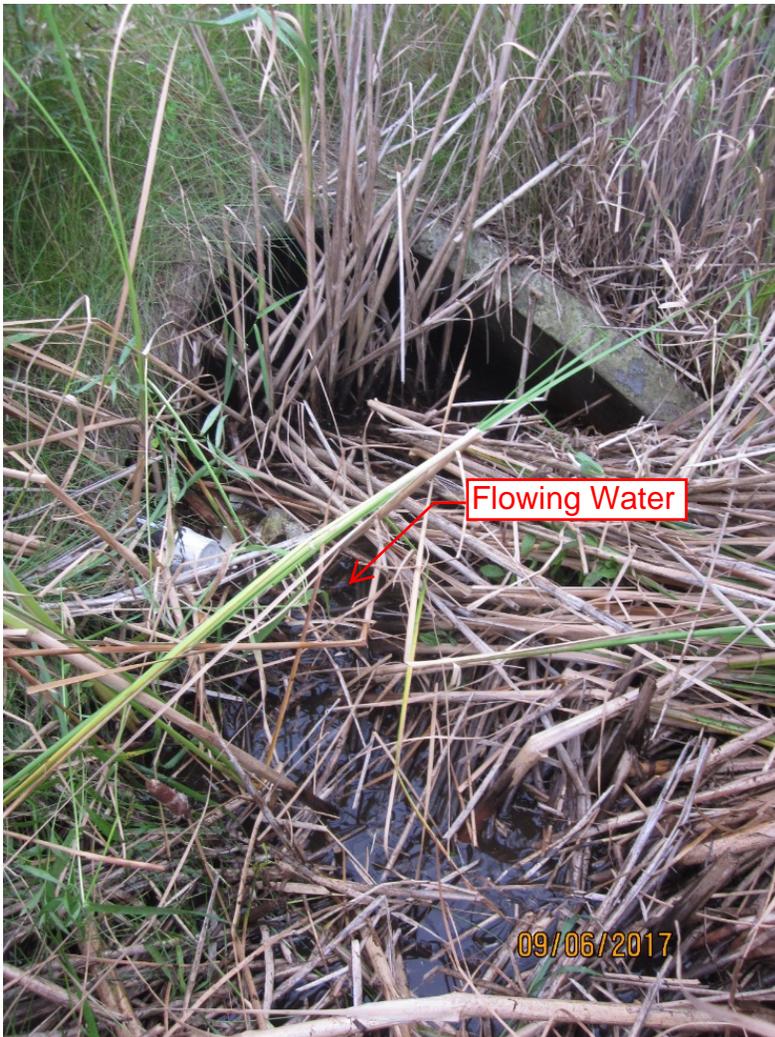
P4. Looking north at culvert between W1 and W4. Observed water staining in the culvert and flowing water was observed in the wetland and culvert showing a continuous surface water connection through the man-made barrier that bisects this portion of the large wetland complex (comprised of W1, W4, W5, W8, and M1-M7). Noted the channel is approximately 3 feet wide in this segment of the tributary and exhibits a bed and bank with a mineral soil substrate.

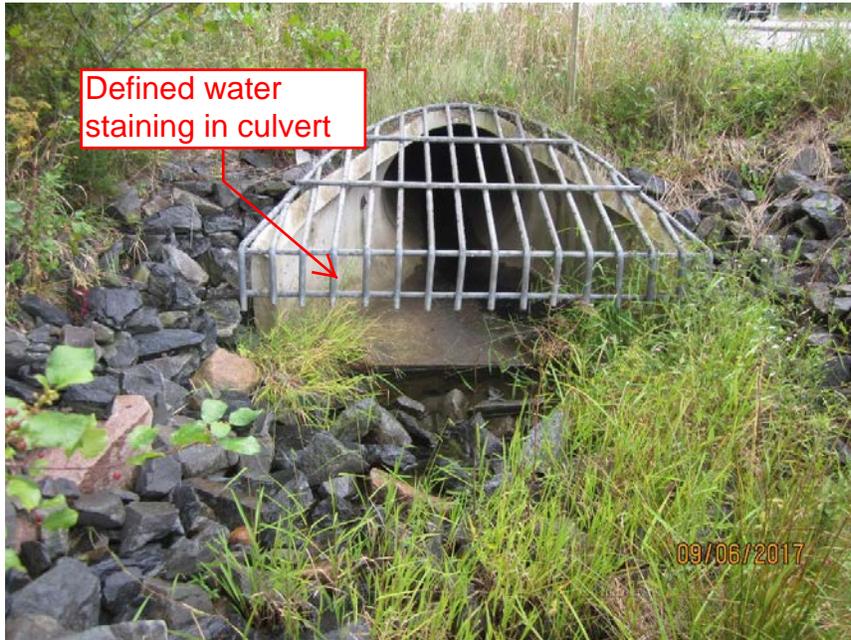
P5. Looking south at culvert underneath Weston Avenue at the NE corner of the intersection with Camp Phillips Road. The tributary flows south through this culvert along the east side of Camp Phillips Road and flows out of the culvert approximately 1,500 feet to the south.

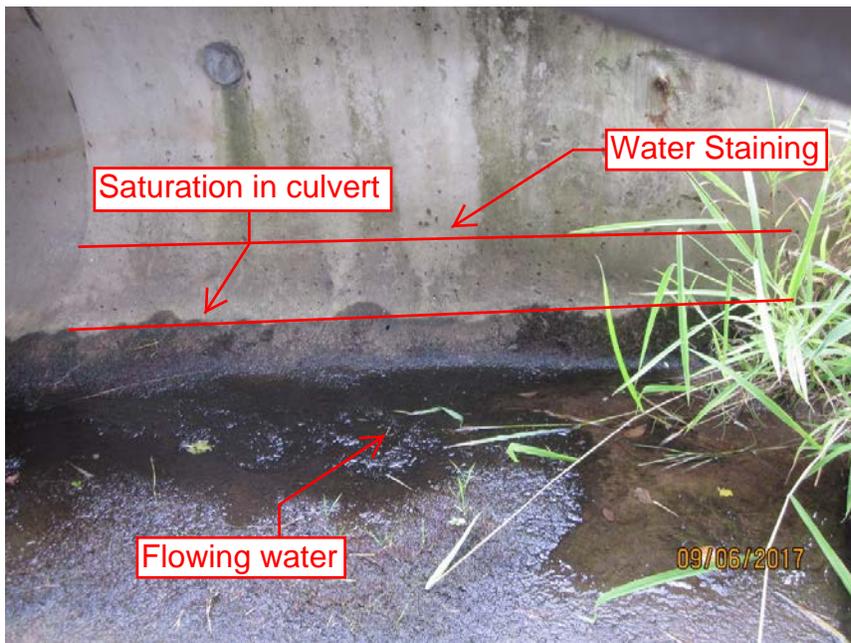
P6. This photo shows the inside of the culvert shown in P5. A small amount of flow was observed as the concrete culvert apron appears to be slightly perched. However, flowing water was observed in the bottom of the culvert and saturation is present approximately 3-4 inches above the observed water levels. Noted water staining in the culvert above this elevation that indicates water levels are seasonally higher.

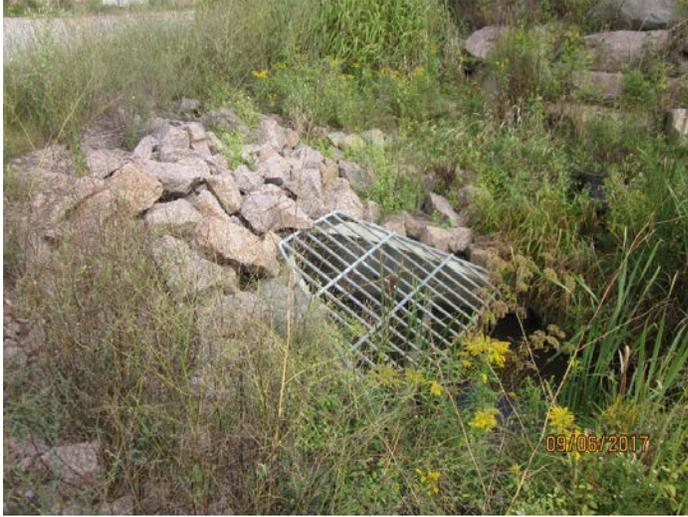
P7. Looking east. This photo shows the culvert from P5 where it daylights approximately 1,500 feet downstream of the review area.

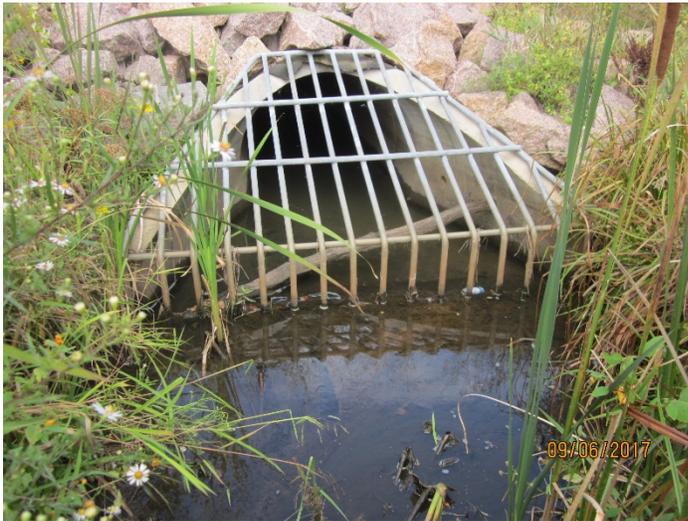
P8. Looking north. This photo shows flowing water in the tributary exiting the culvert from upstream.

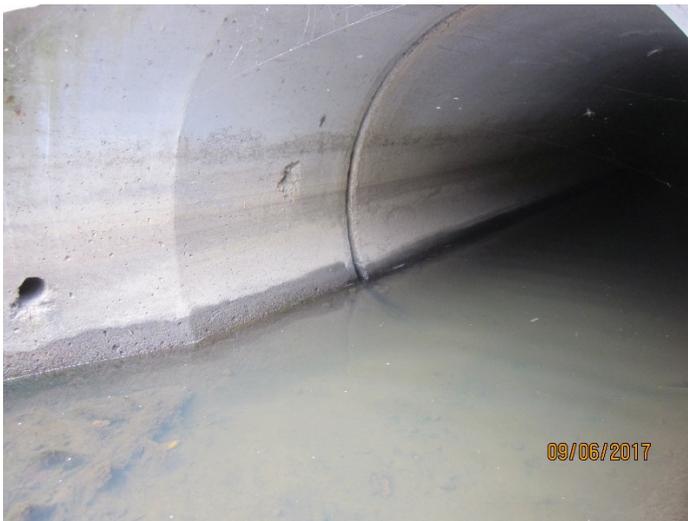
P9. This photo shows the inside of the culvert in P7 and P8. Water depths were observed at approximately 4 inches at the time the photo was taken. Saturation was present in the pipe approximately 3-4 inches above the observed water levels indicating the water was recently higher. In addition, water staining was observed in the culvert that indicates water levels are seasonally higher than the observed water levels on the date of the field visit.

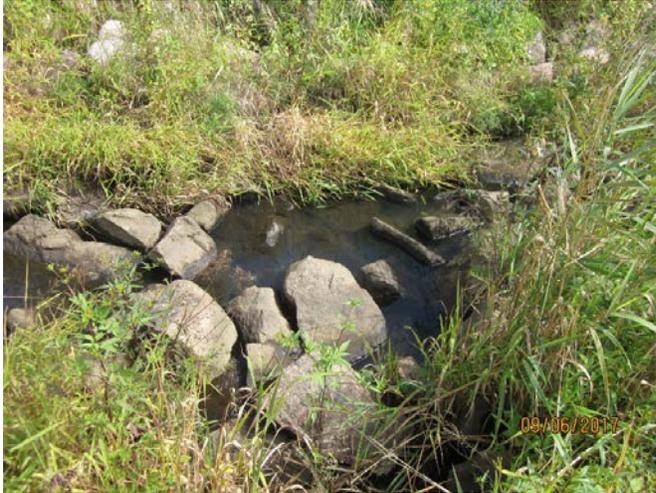
P10. Looking east. This photo shows the tributary and flowing water is observed. The tributary is approximately 5 feet wide in this segment, has a defined bed and bank with cobble and sand substrate, and water depths of approximately 6 inches.

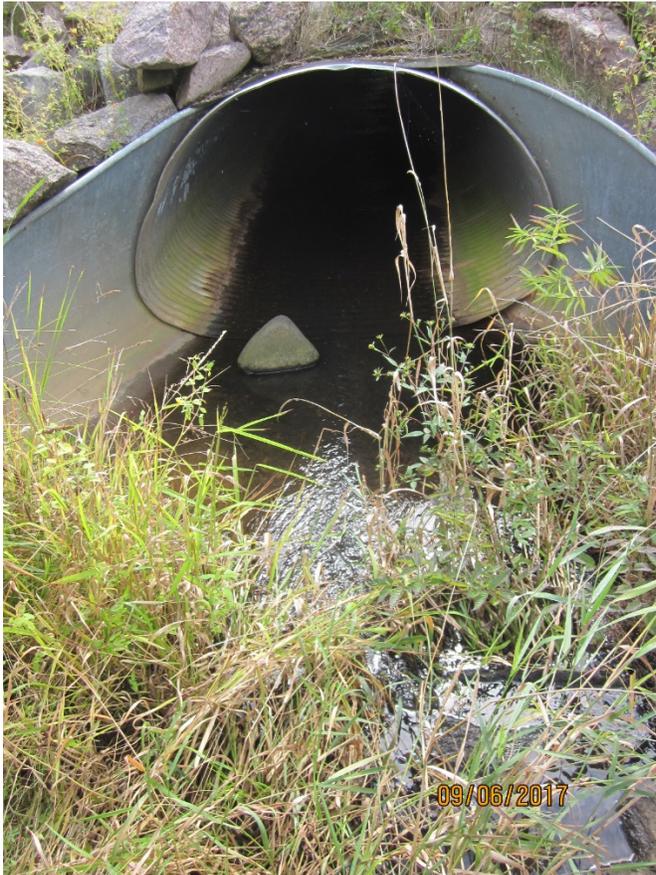
P11. Looking south. This photo shows the tributary passing through a culvert south of the culvert shown in P7, P8, and P9.

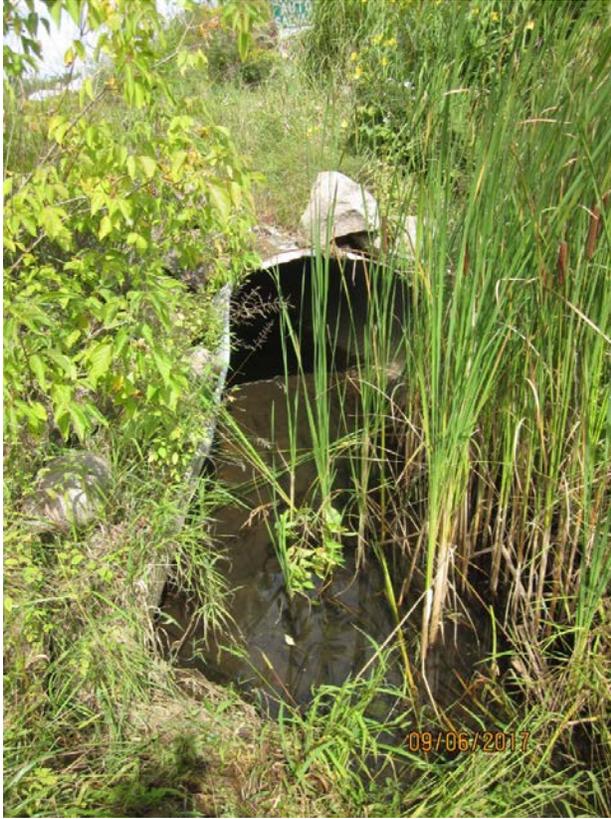
P12. Looking north. This shows the tributary exiting the culvert shown in P11. Flowing water is observed and the characteristics of the tributary are similar as described in P10.

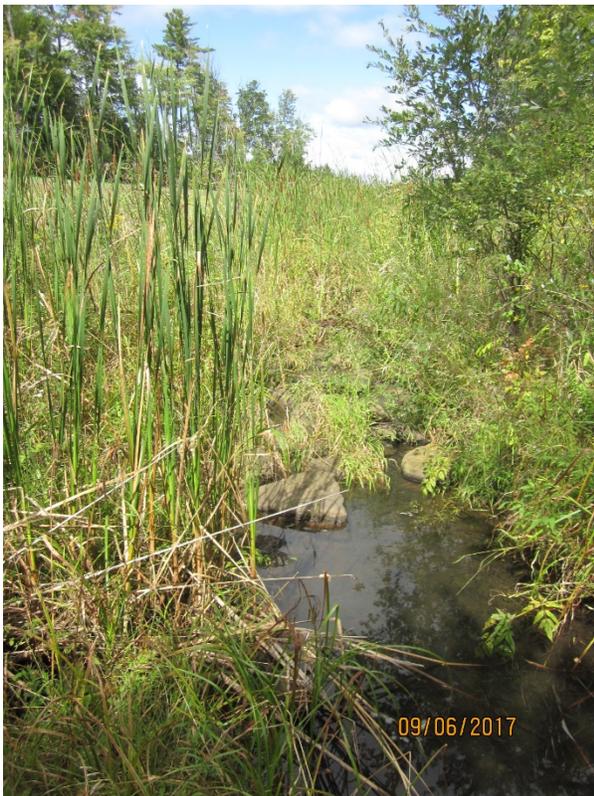
P13. Looking north. This photo shows the tributary as the channel exits the roadside ditch along the east side of Camp Phillips Road. The tributary no longer has a linear channel and exhibits some channel sinuosity. The channel was measured at approximately 6 feet wide, water depths were observed between 6-12 inches (shallower in riffles and deeper in pools). The tributary has a defined bed and bank with a cobble and sand substrate.

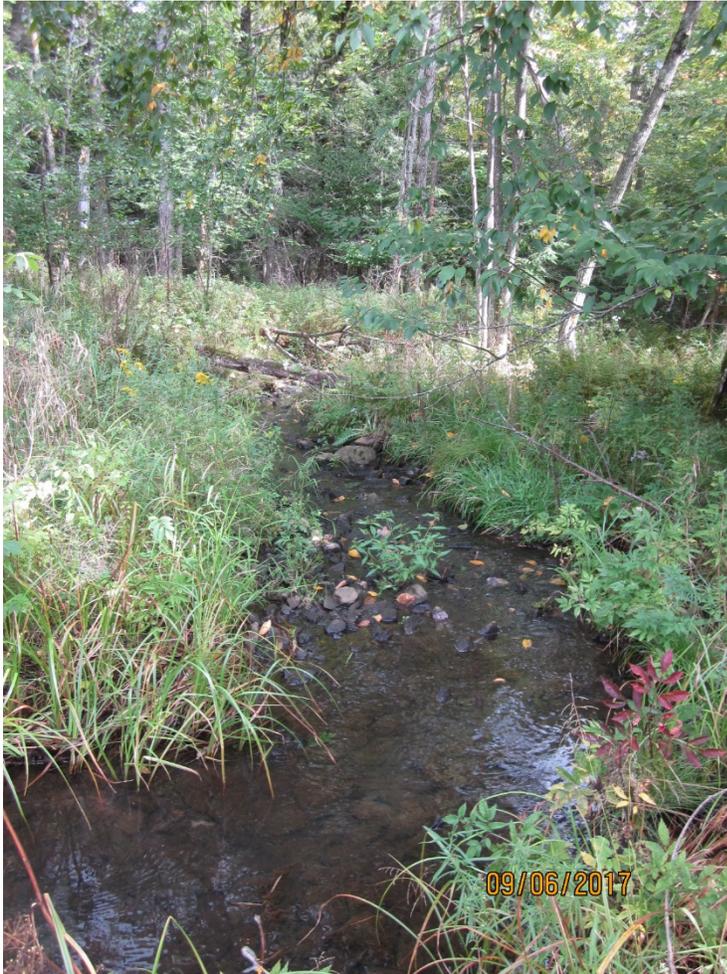
P14. Looking east. The tributary flows east approximately 200 feet to its convergence with Cedar Creek. The characteristics of the tributary are the same as described in P13.
