US Army Corps
of Engineers
St Paul District

Public Notice

REFER TO: MVP-2013-04093-TSM

Operations - Regulatory (2013-04093-TSM)
SUBJECT: Fuller (Bogus Brook) Wetland Bank

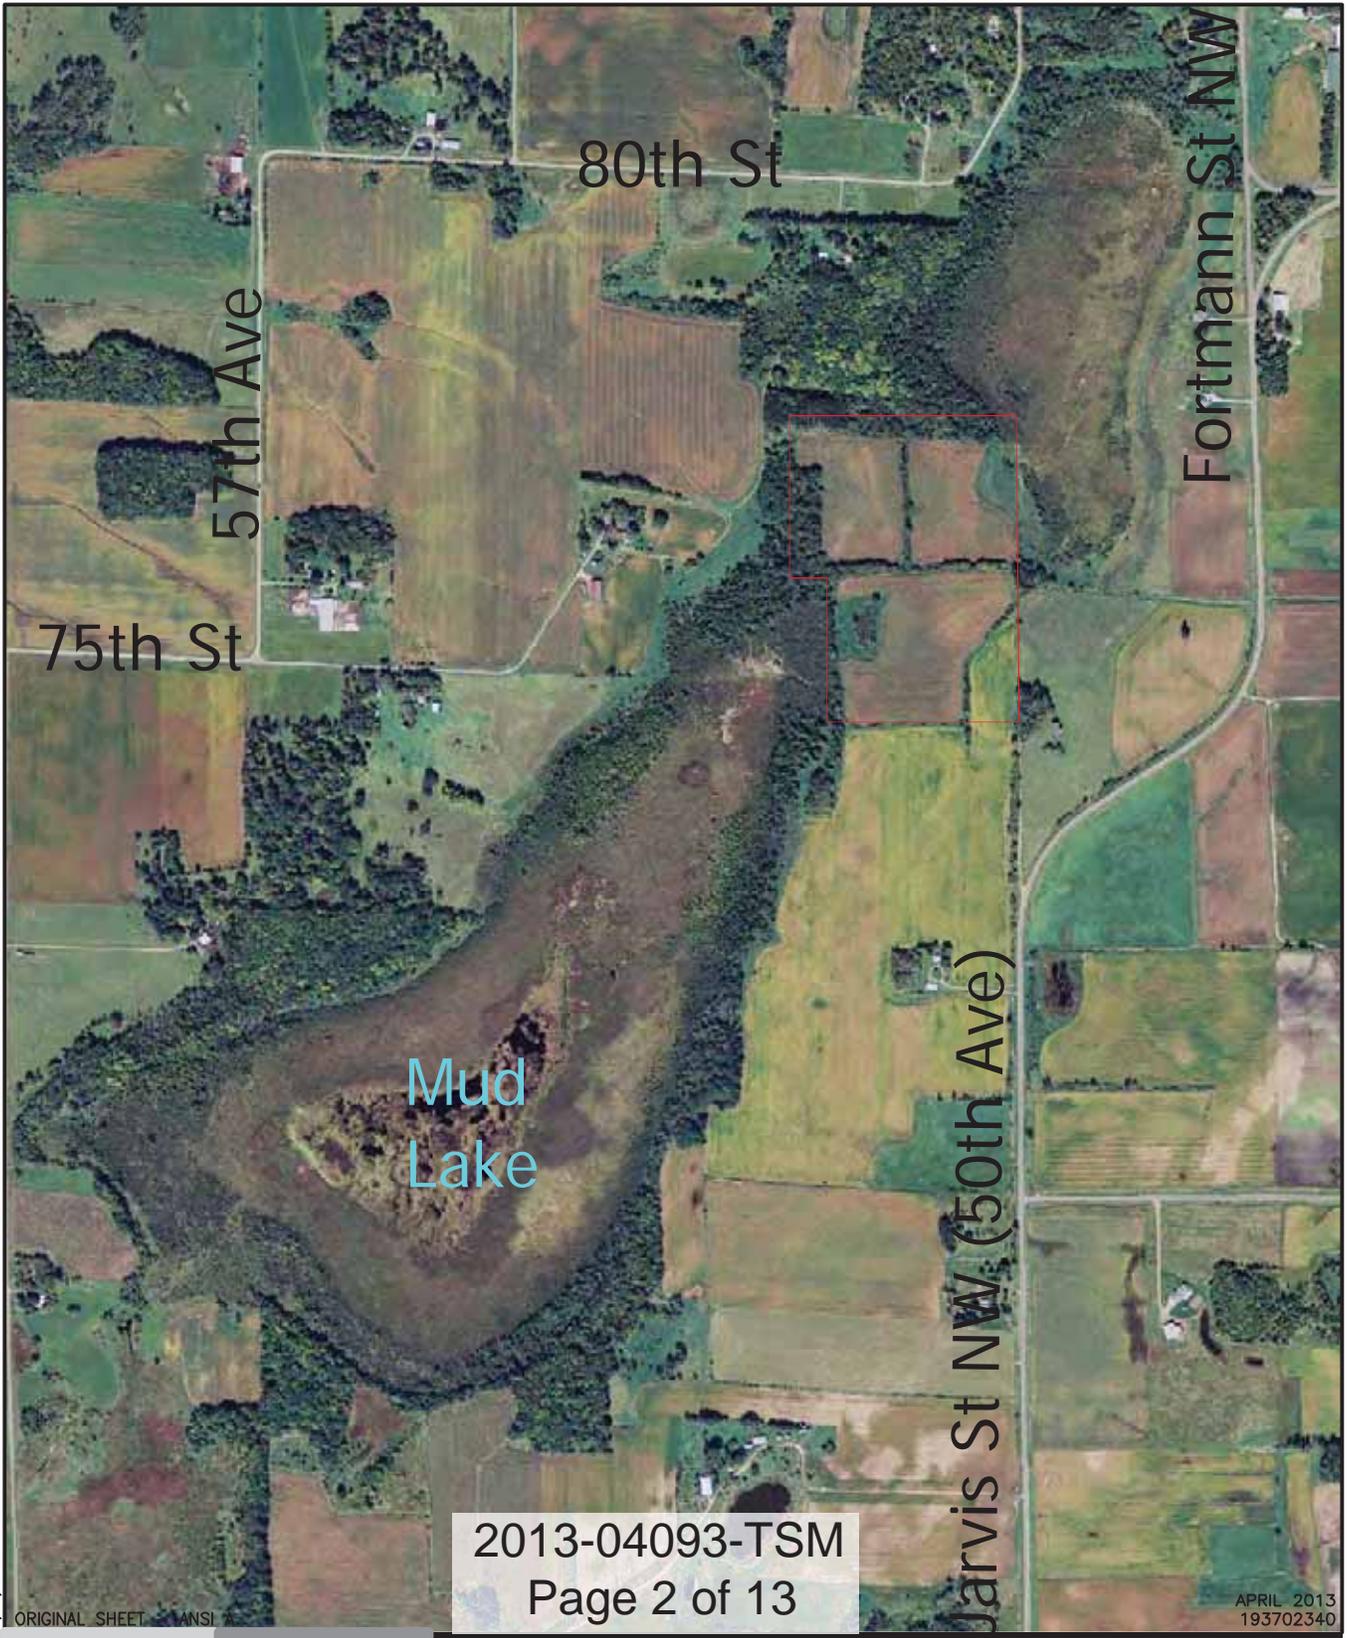
Client/Project
FULLER
WETLAND BANK
MILLE LACS COUNTY
Figure No.
2.0
Title
**EXISTING
LAND USE**

2010 FSA Aerial Photo

CURRENT LAND USE ON THE SITE: Current land use on the site is agricultural. The history of cultivation on the site dates back to at least 1938, based on a review of historic aerial photography. There are three drainageways (ditches) within the site. There is an approximately 1.93-square-mile watershed that provides surface flows to this site. A large portion of the water that reaches the site is from the local high water table. The site has pattern tile at approximately 60-foot spacing, with the tile system draining into surface ditches. Some wetlands have been identified on site, primarily along the riparian areas of the main ditch. All but one of the mapped wetlands has a substantial history of cultivation, with most approaching 20 years of documented cultivation out of the 20 years of crop slides reviewed. The mitigation site is part of the 170-acre+ Mud Lake wetland complex, the periphery

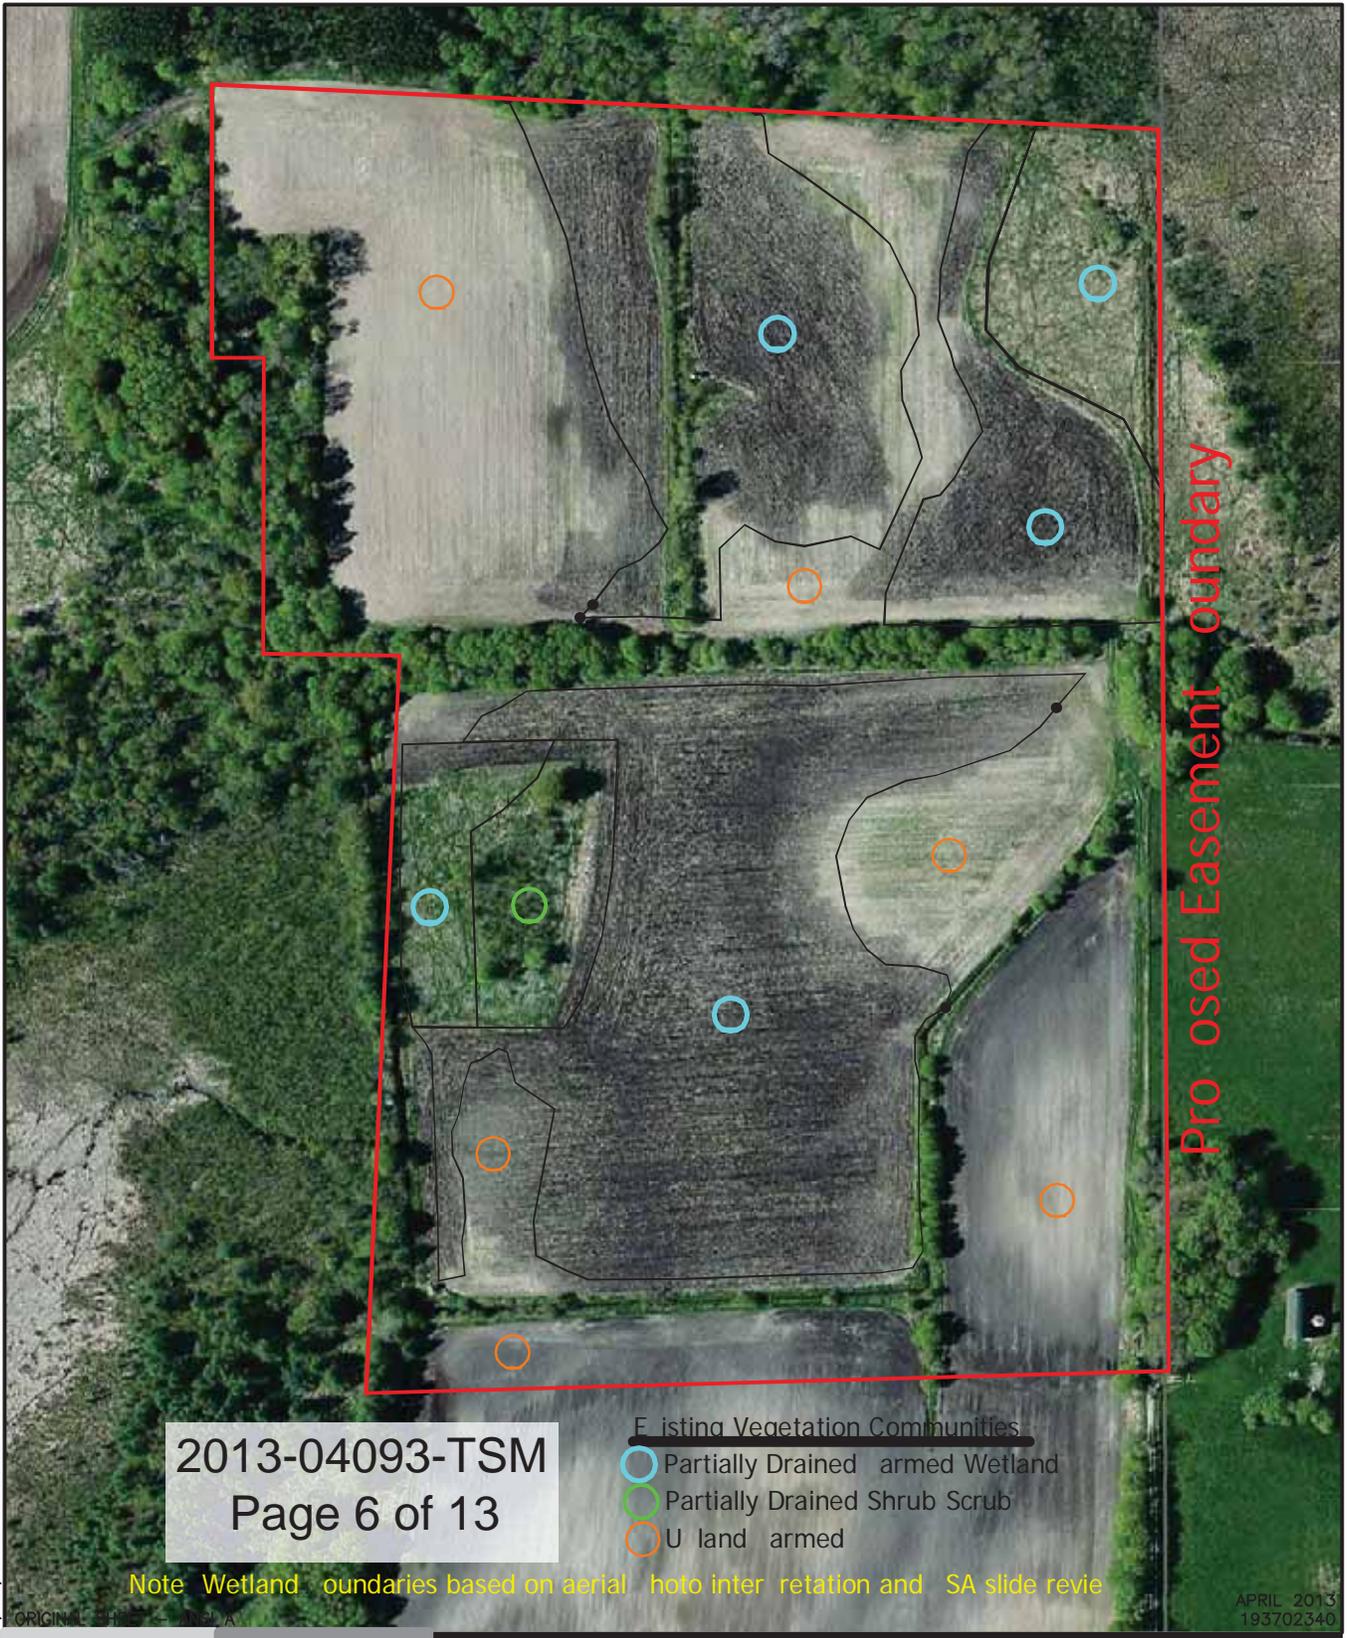
Figure No.
6.0

- Existing Vegetation Communities
- Partially Drained / Armed Wetland
 - Partially Drained Shrub Scrub
 - Upland / Armed

Note: Wetland boundaries based on aerial photo interpretation and SA slide review

Title
**EXISTING WETLANDS
MAP**

of which has been drained by agricultural ditching and tile, while the central core remains relatively intact. The sponsor has indicated that the mitigation site was most likely a scrub- and shrub-dominated community prior to agricultural development.

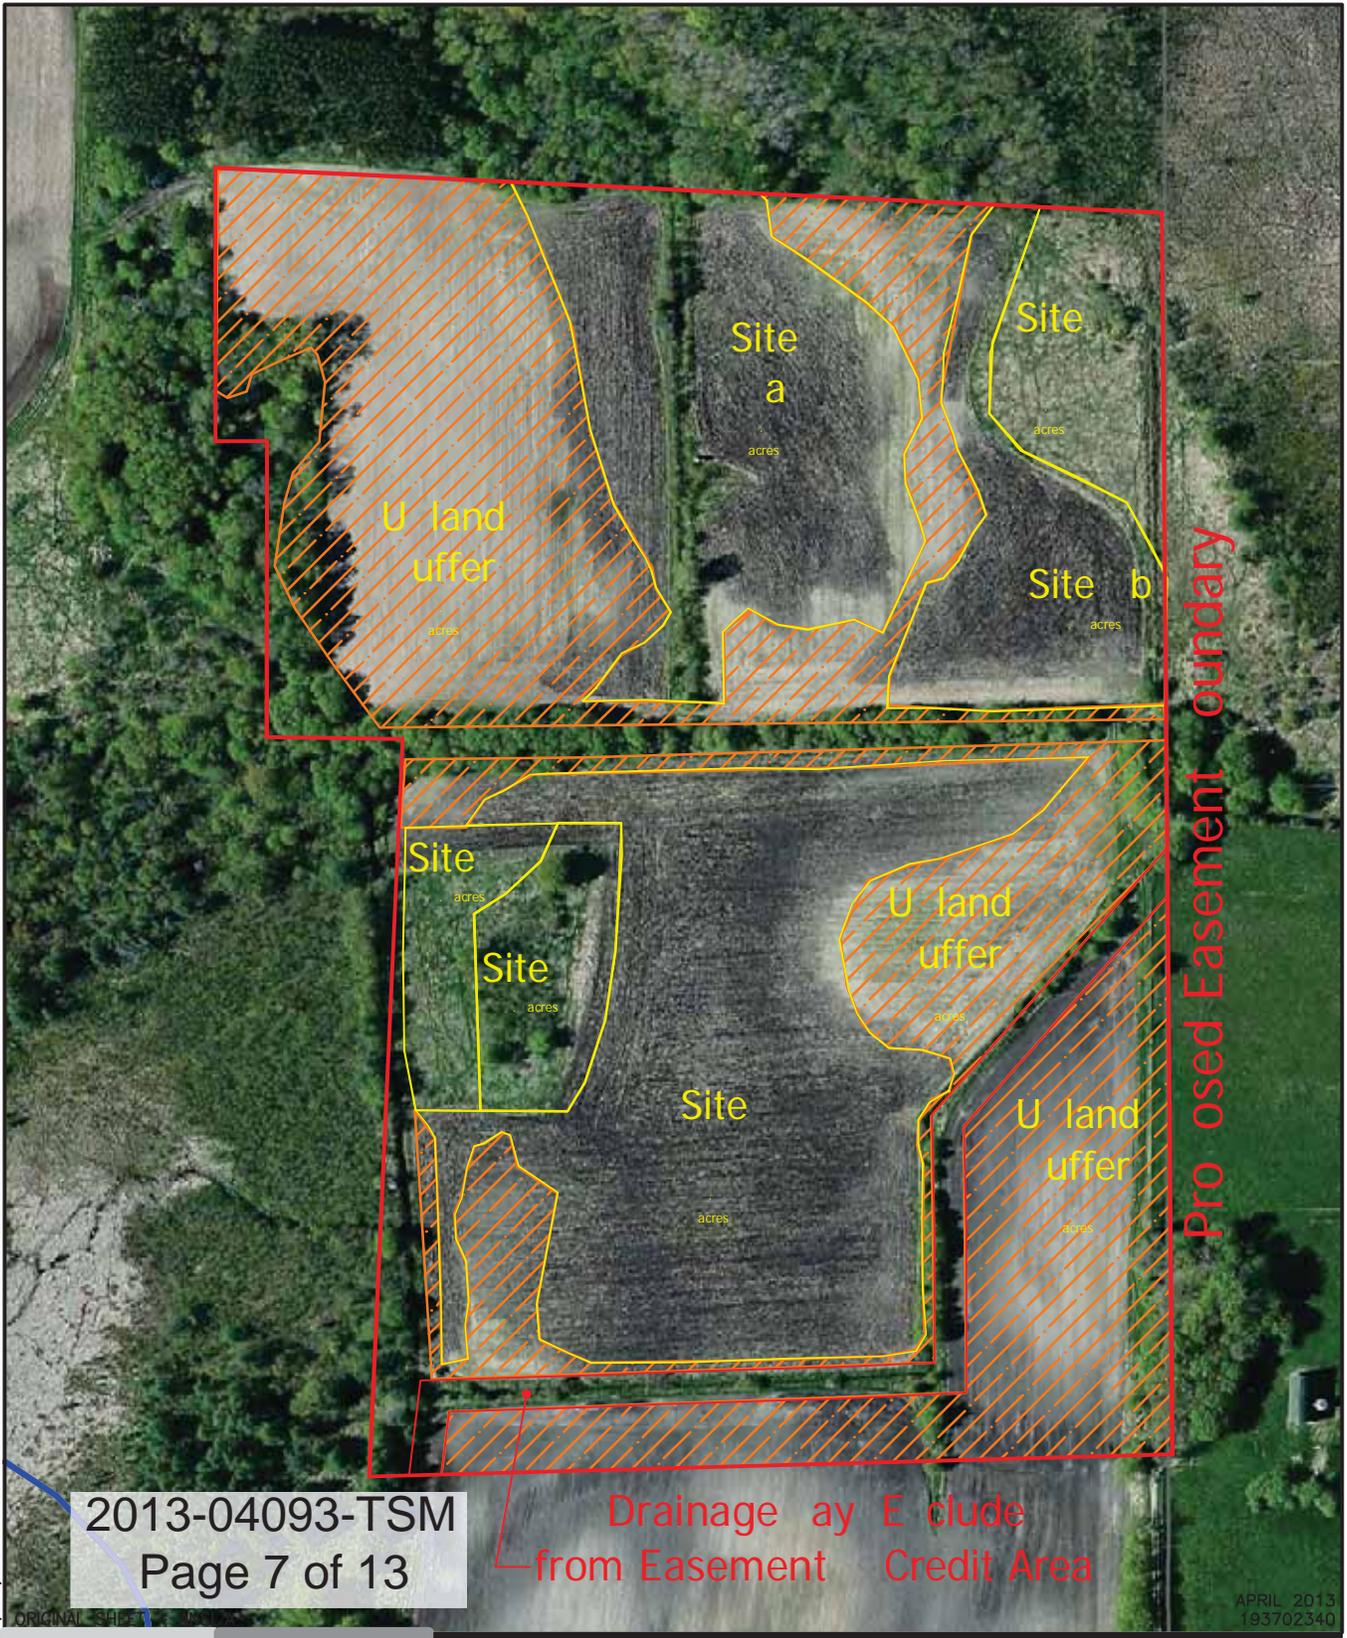
Client/Project
FULLER
WETLAND BANK
MILLE LACS COUNTY
Figure No.
7.0
Title
**CREDIT AREA
MAP**

Drainage by Eclude
from Easement Credit Area

MODIFICATIONS PROPOSED TO RESTORE, ESTABLISH, ENHANCE AND/OR PRESERVE WETLANDS ON THE SITE: The sponsor proposes to restore approximately 19 acres of wetlands with an additional 17 acres of restored and preserved upland buffer, with an additional 2 acres of existing wetland preserved within the proposed easement boundary. The site contains about 36 acres of annually cultivated land, including farmed wetland, drained wetland, and upland. The sponsor proposes to re-establish areas of effectively-drained hydric soil and rehabilitate degraded, partially-drained wetlands on the site. The target communities for restoration are shrub carr, wet meadow, and sedge meadow with typical vegetation and hydrology. In addition, the sponsor proposes to restore farmed upland within the site to native perennial upland communities typical of the area. Any intact upland or wetland within the final easement boundaries will be preserved. The sponsor has proposed that this project would generate from 22.2 to 26.3 compensatory mitigation credits.

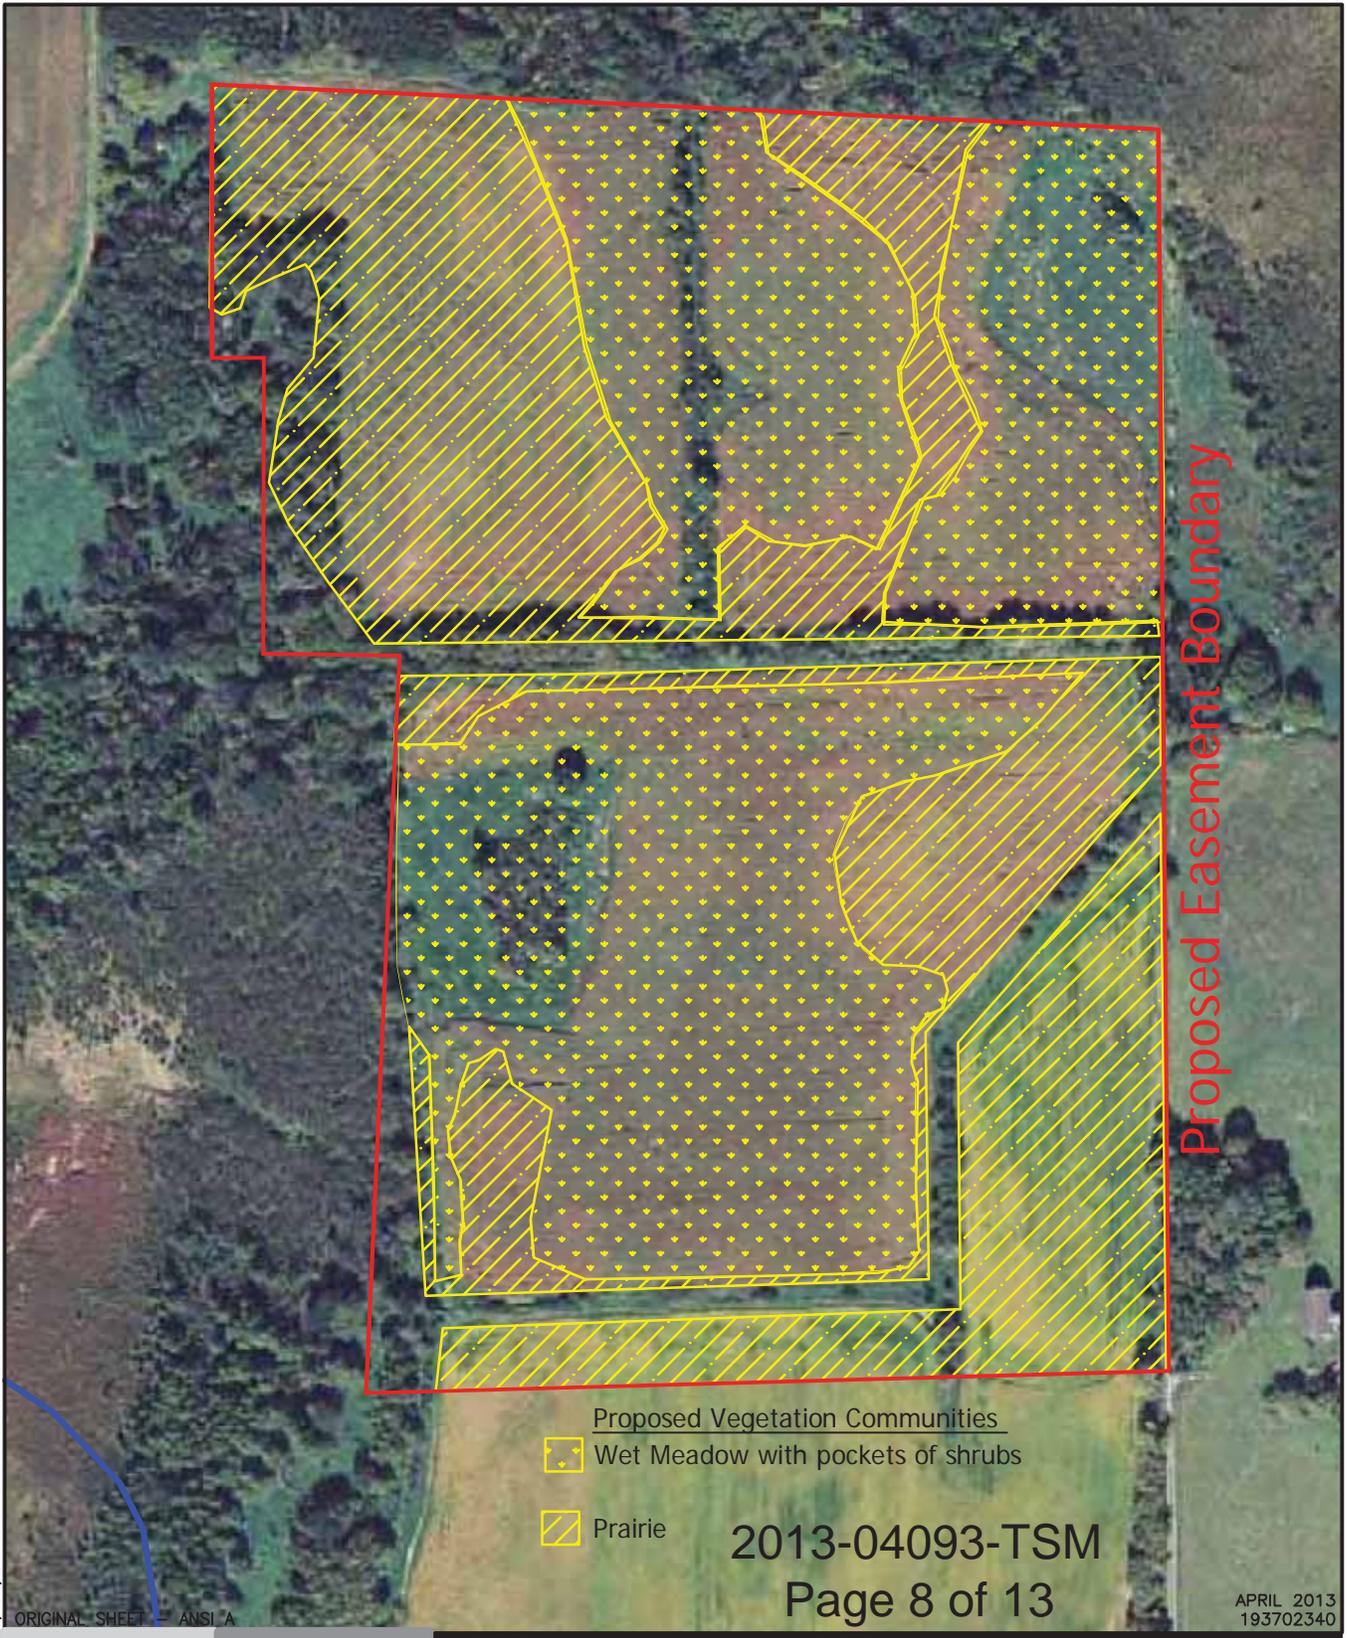
Figure No.
8.0

- Proposed Vegetation Communities
-

Wet Meadow with pockets of shrubs
 -

Prairie

Title
**PROPOSED VEGETATION
 MAP**

Removal of the ditches and dikes would restore the pre-disturbance hydrological regime, thereby facilitating the site's reversion to a wet meadow and shrub carr wetland community. Sprayed areas and disturbed soil would be seeded with native wetland species according to a vegetation establishment and management plan. The sponsor would be responsible for control and eradication of invasives and nonnative vegetation, and the bank would be subject to performance standards for hydrology and vegetation.

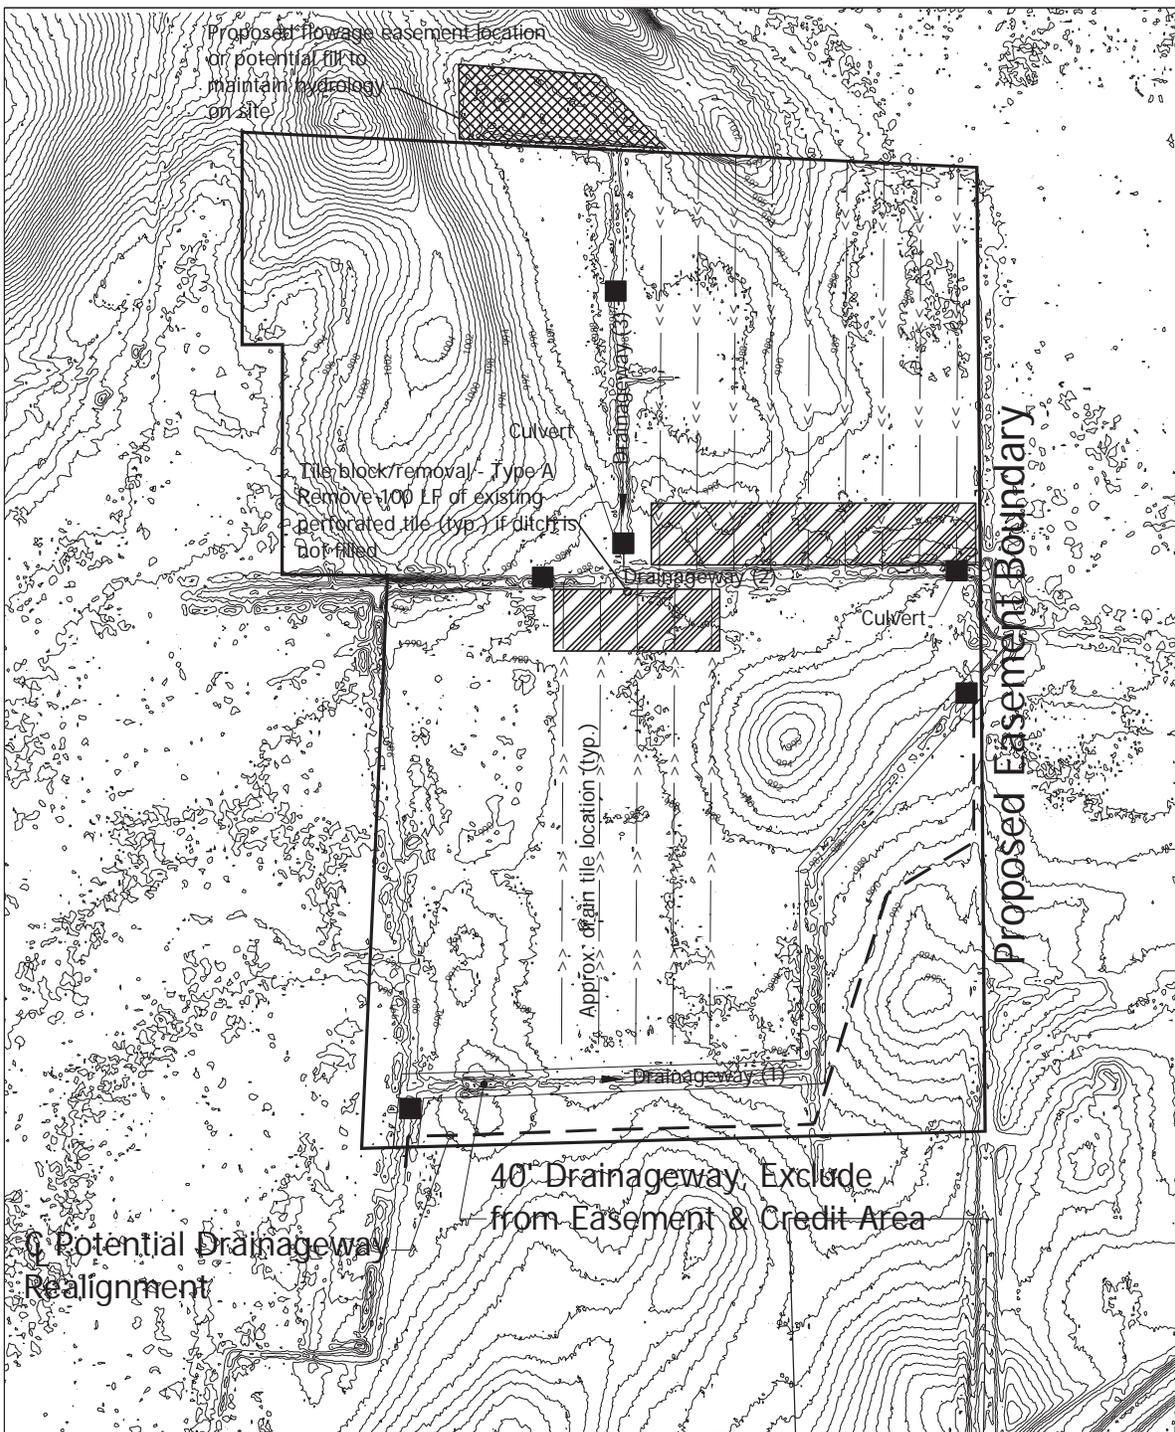
Client/Project
FULLER
WETLAND BANK
MILLE LACS COUNTY
Figure No.
10.0
Title
**CONCEPT PLAN
UPDATED JULY 19, 2013**

CONSTRUCTION SPECIFICATIONS (TILE DRAINAGE BLOCKS):

The work shall include all labor, materials, and equipment required to complete the excavation and removal of all tile drainage systems as required by the drawings or as stated. Unless otherwise specified, the drainage tile shall be excavated and removed for the length stated or as specified by the Project Technician. All fragments of the drainage tile shall be removed from the excavated trench.

Each end of the exposed drainage tile in the excavated trench shall be blocked to prevent water from entering or exiting the tile. The blocking of the tile ends shall be performed as shown on the drawings or by any of the following methods:

- 1) Plug each tile end with an impervious material, such as concrete, that will remain securely in the tile.
 - 2) Cap each tile end with a tile cap for the appropriate size and type of tile that is securely cemented or grouted. After sealing with cement or grout, cap may be held in place with wood or metal stake.

- 3) Block each tile end with a 24" x 24" sheet of 0.4 retention pressure treated plywood (minimum thickness 3/8") which is centered and held firmly against the tile end with a steel fence post.

- Backfill and tamp by hand a minimum distance of two feet around each sealed tile end with suitable soil material. Backfill the remaining trench with the most suitable material available and compact to a density equal to or greater than that of the surrounding undisturbed soil. Do not backfill with any soil containing broken tile fragments. The moisture content of the backfill material shall be maintained within the limits required to:

■ This symbol is located in ditches that may be filled or blocked. Filling of the ditch is preferred if fill is available. Final location and extent of fill will be dependent on the findings from additional engineering analysis by Stantec.

The proposed restoration will involve disabling the existing pattern tile and blocking or filling at least one of the ditches. The sponsor anticipates that this will restore hydrology to the entire basin with the exception of the portion directly adjacent to the area they have labeled Drainageway 1 - no credit is being requested for areas expected to be effectively drained by remaining drainage infrastructure. The sponsor anticipates that the scope and effect of intact drainageways will be limited due to the shallow depth of these ditches.

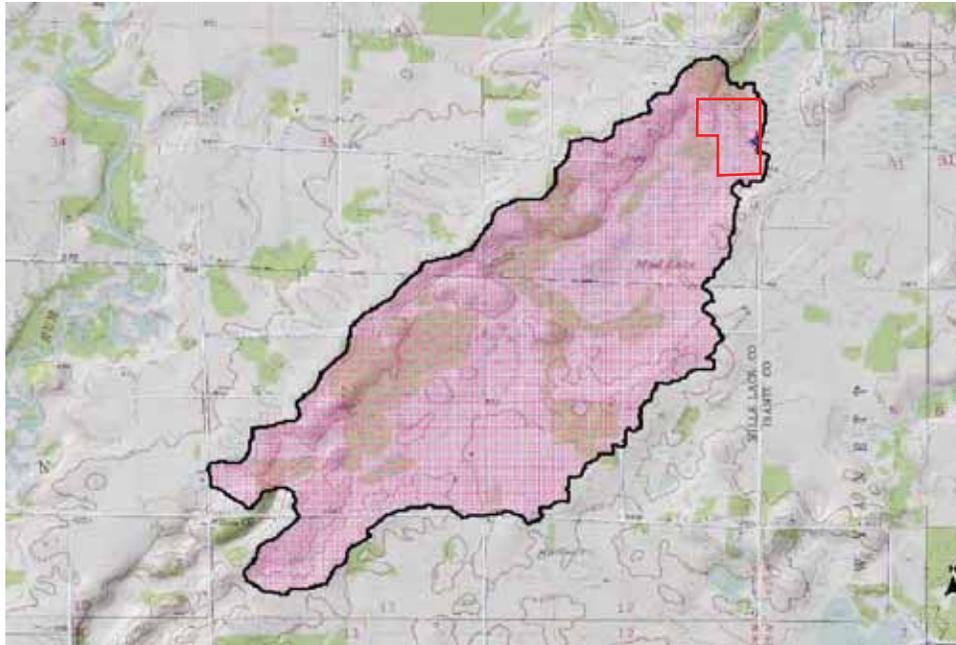
FULLER
WETLAND BANK
MILLE LACS COUNTY
Figure No.
11.0
Watershed Map

Watershed Area: 1.93 square miles
