Enbridge Line 5 Wisconsin Segment Relocation Project
2020 Wetland/Waterbody Datasheets Photograph Errors

On May 6, 2021, the Great Lakes Indian Fish and Wildlife Commission (GLIFWC) submitted a comment to the U.S. Army Corps of Engineers (USACE) identifying six stream datasheets where the photograph included with the data sheet did not appear to match the stream description. Environmental Resources Management (ERM), in coordination with Midwest Natural Resources Inc. (MNR), reviewed the six stream datasheets and determined that they contained the incorrect photographs. After reviewing the data, it was determined that the error was the result of an issue with a software program used to process the large number of photographs taken during the 2020 field surveys. After the error was identified, the entire 2020 dataset was reviewed, resulting in the identification of additional stream datasheets, wetland datasheets, and no-points that had the incorrect photographs included on the form.

Enbridge Line 5 Wetland/Waterbody Datasheet Photograph Corrections	
Streams	
Feature ID	Near Milepost
Sasb006p_x1	24.2
Sasb006p_x2	24.2
Sasb1003e	17.1
Sasb1004e	17.2
Sase006p_x	0.6
Sase1001e	9.3
Sase10

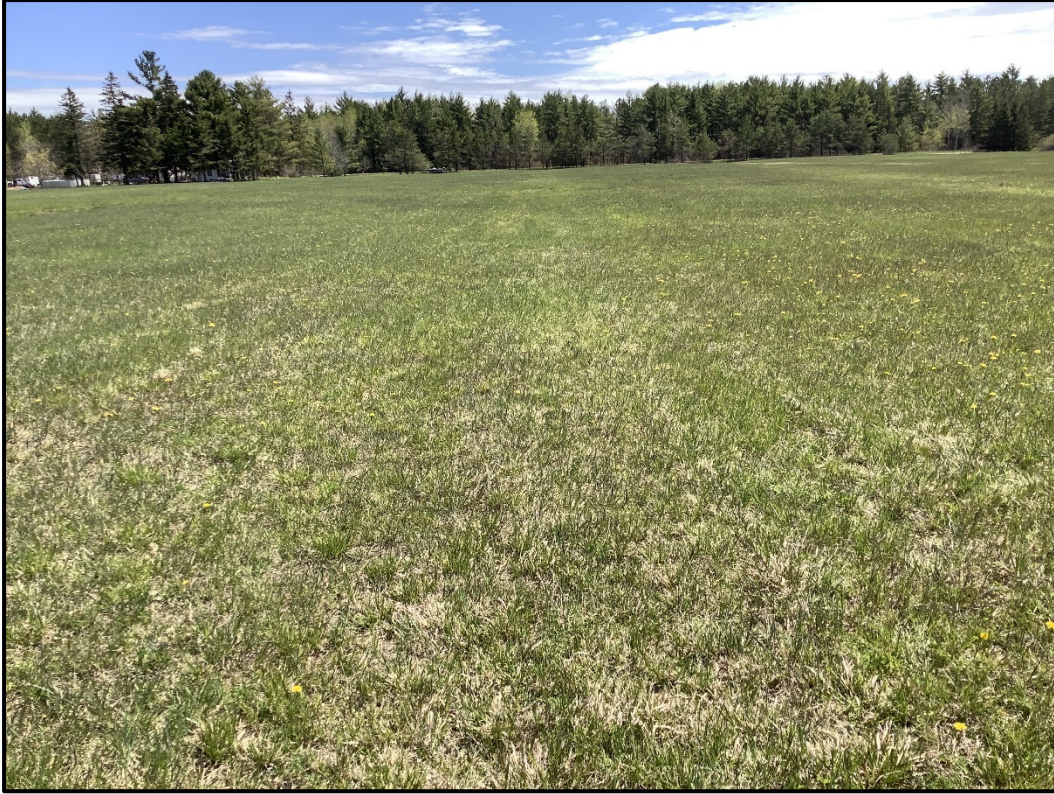
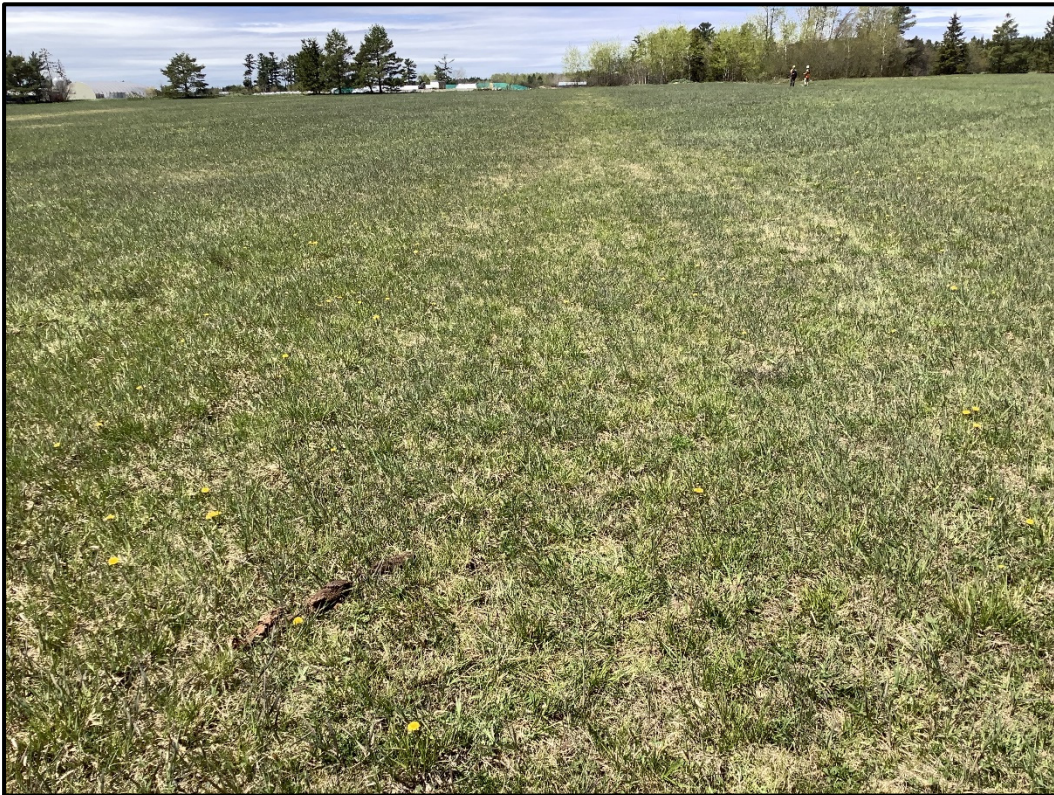
Remarks:
 The sample plot is located within a slight depression in the landscape, however no other hydrology indicators were observed.

The vegetation is representative of the depression. Sample plot contains vegetation that was found in the surrounding uplands and wetlands.

Remarks:
 The soil profile consists of a dark clay loam over a red clay. No hydric soil indicators were observed.

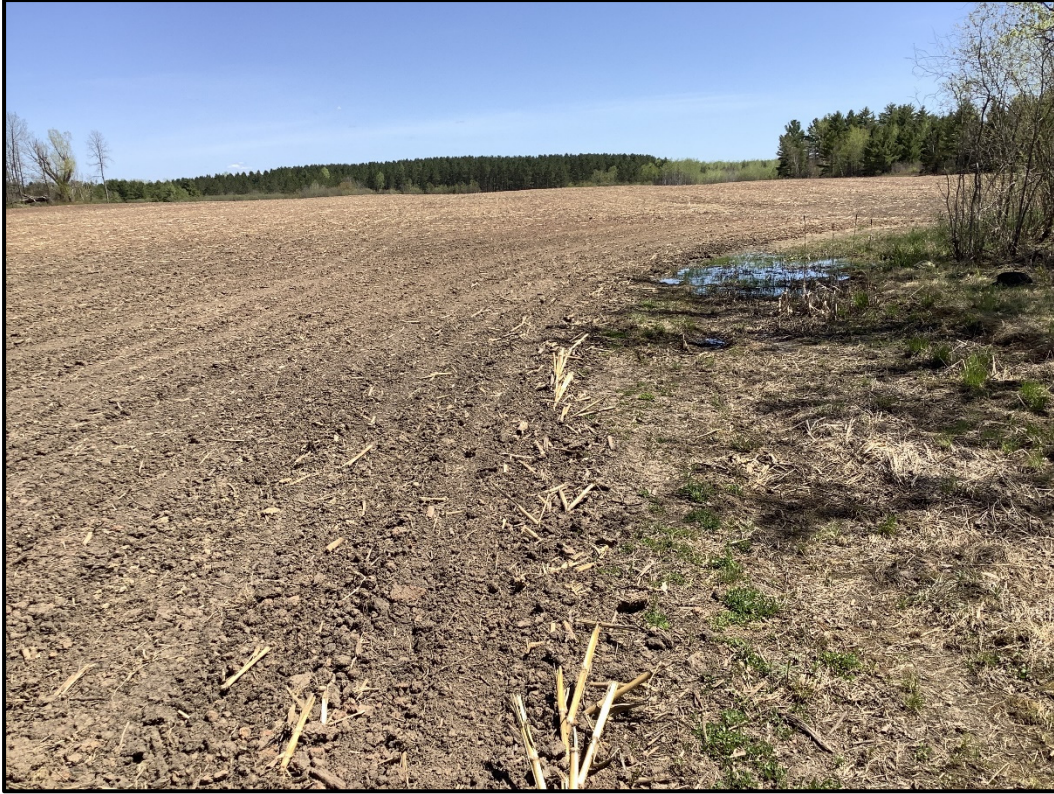
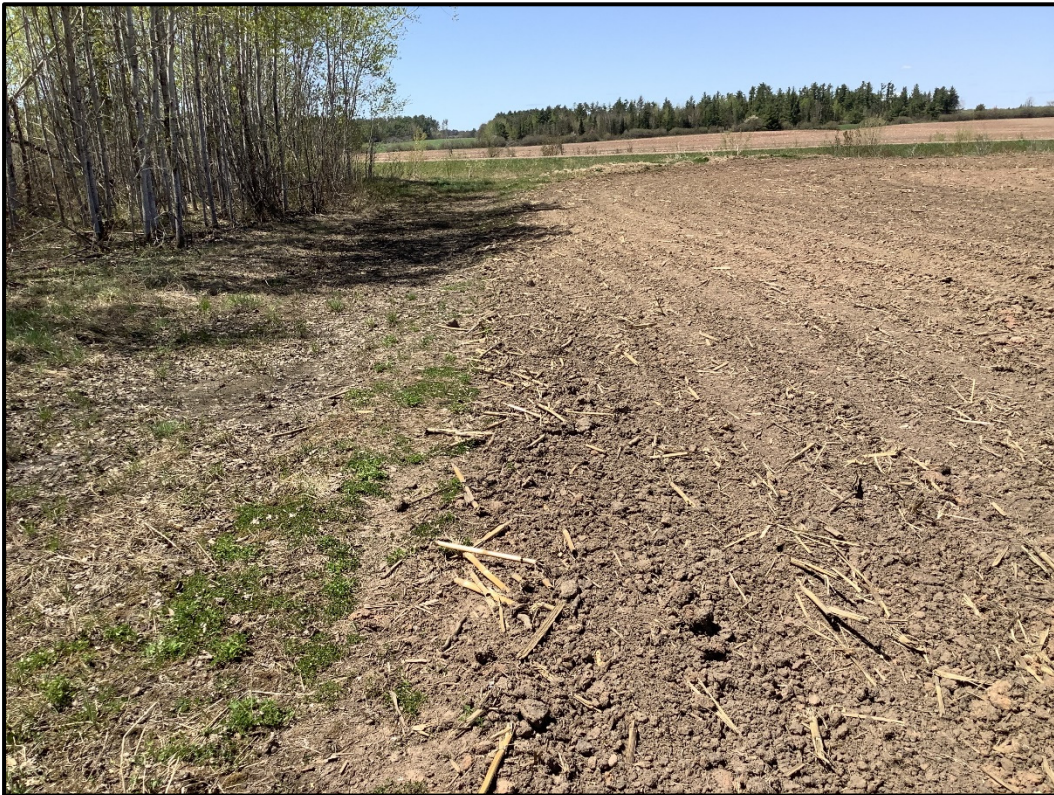
Remarks: (Explain alternative procedures here or in a separate report.)
 The non-wetland sample point was taken within a recently tilled agricultural field. There is a PEM/PFO wetland complex located just outside of the survey area to the south. The sample area is at a slightly higher elevation than the wetland. Hydric soils were observed, however no other wetland indicators were met. The pictures show the wetland just at the edge of the crop field, but it is not within the survey boundary. See General Form noase1005 for additional photos.

Remarks:
 The sample point was taken within a depression, however no other hydrology indicators were observed.

The vegetation within the sample point has been significantly disturbed by tillage. *Juncus effusus*, *Scirpus cyperinus*, *Eleocharis cf ovata*, *Alisma triviale*, and *Typha* sp. were observed just outside of the survey area in a wet meadow community.

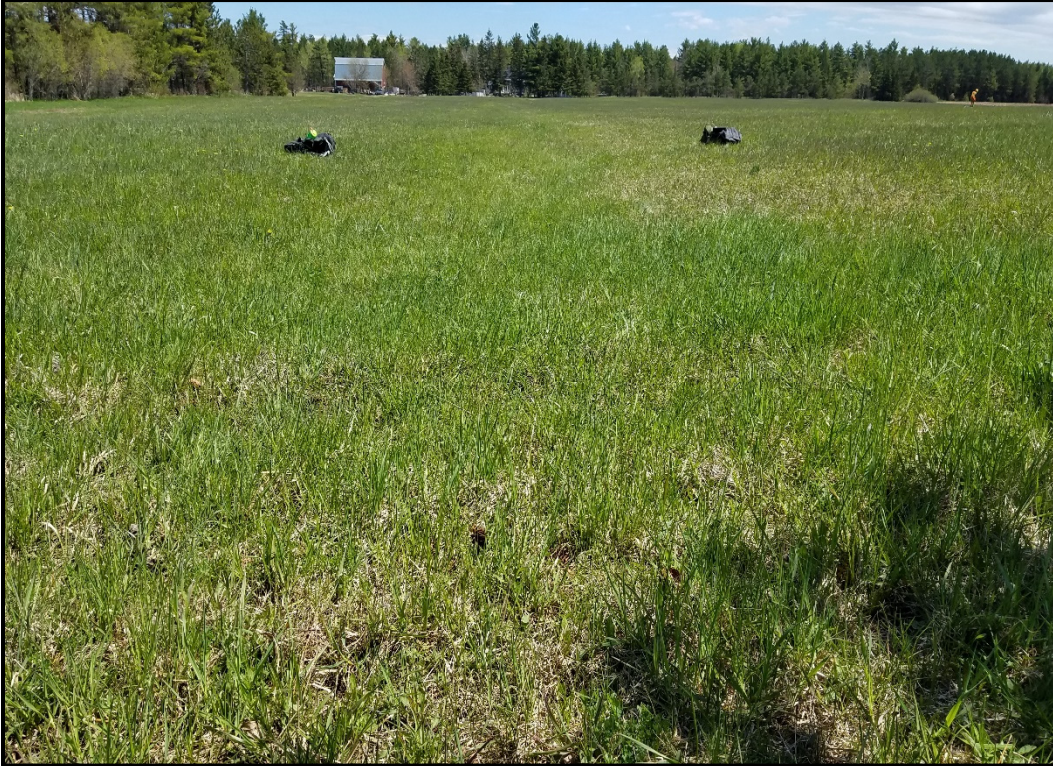
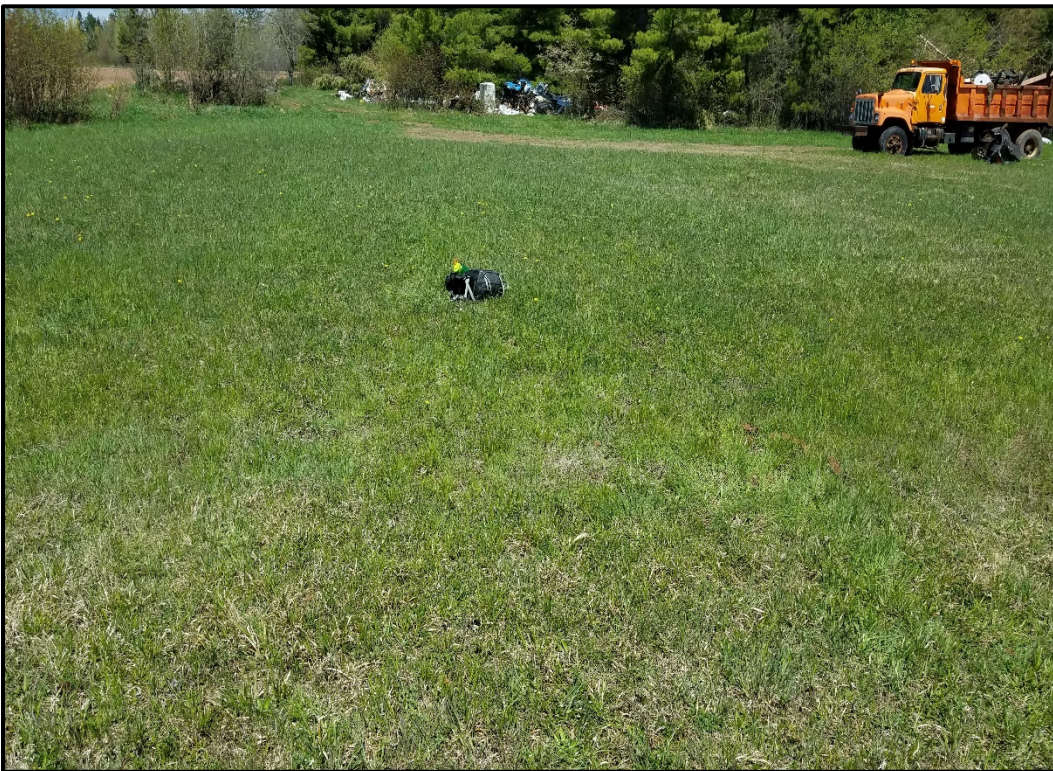
Hydrophytic Vegetation Present? Yes _____ No <input checked="" type="checkbox"/> Hydric Soil Present? Yes _____ No <input checked="" type="checkbox"/> Wetland Hydrology Present? Yes _____ No <input checked="" type="checkbox"/>	Is the Sampled Area within a Wetland? Yes _____ No <input checked="" type="checkbox"/> If yes, optional Wetland Site ID: _____
Remarks: (Explain alternative procedures here or in a separate report.) Moist depression in a hay field. This was assessed as a possible wetland before determining that it did not meet soil or vegetation parameters.

Remarks: (Include photo numbers here or on a separate sheet.)
Sampled vegetation is representative of the feature.

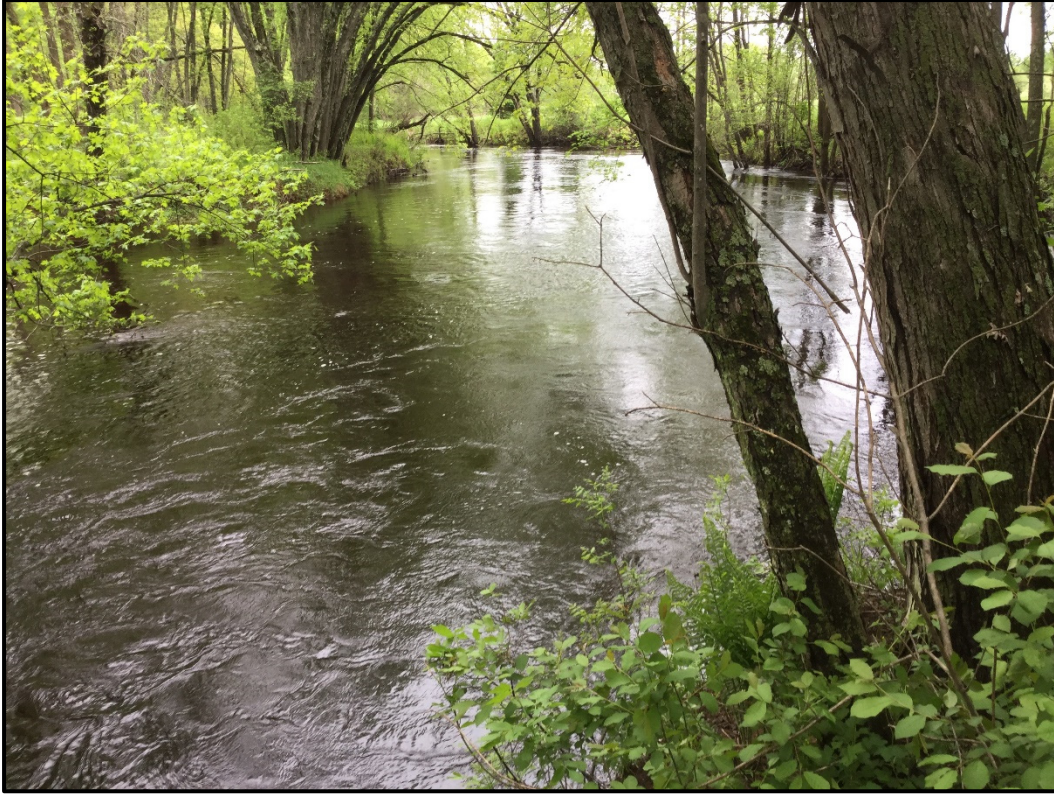
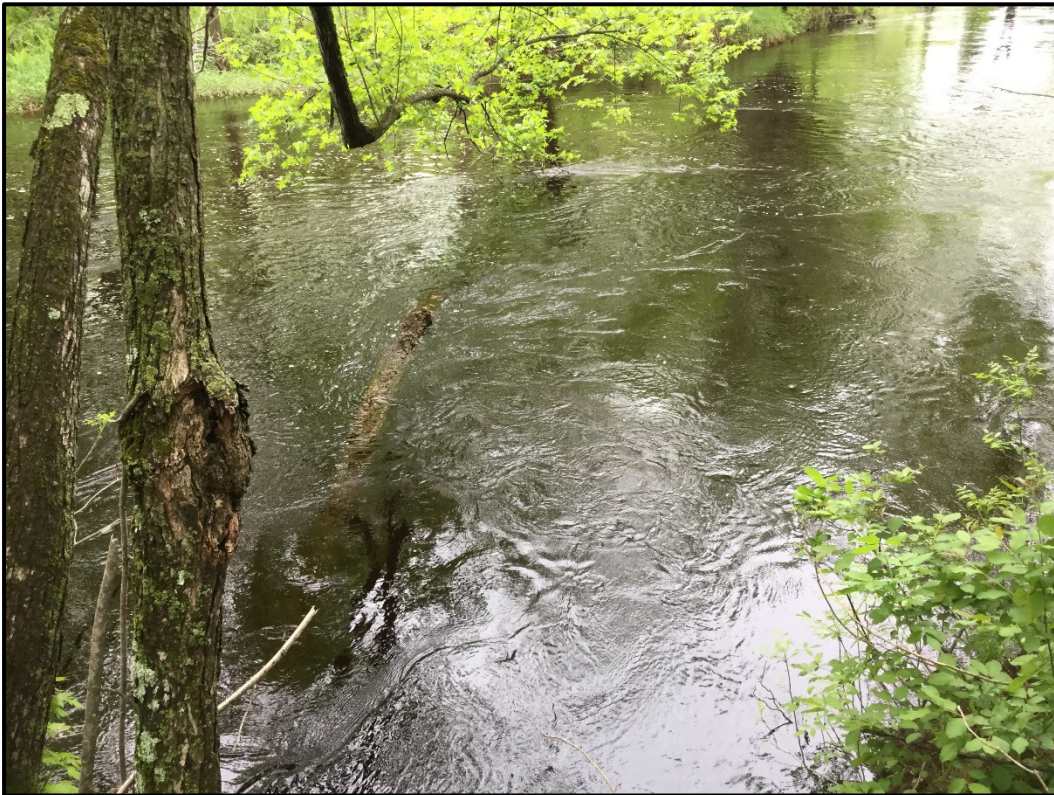
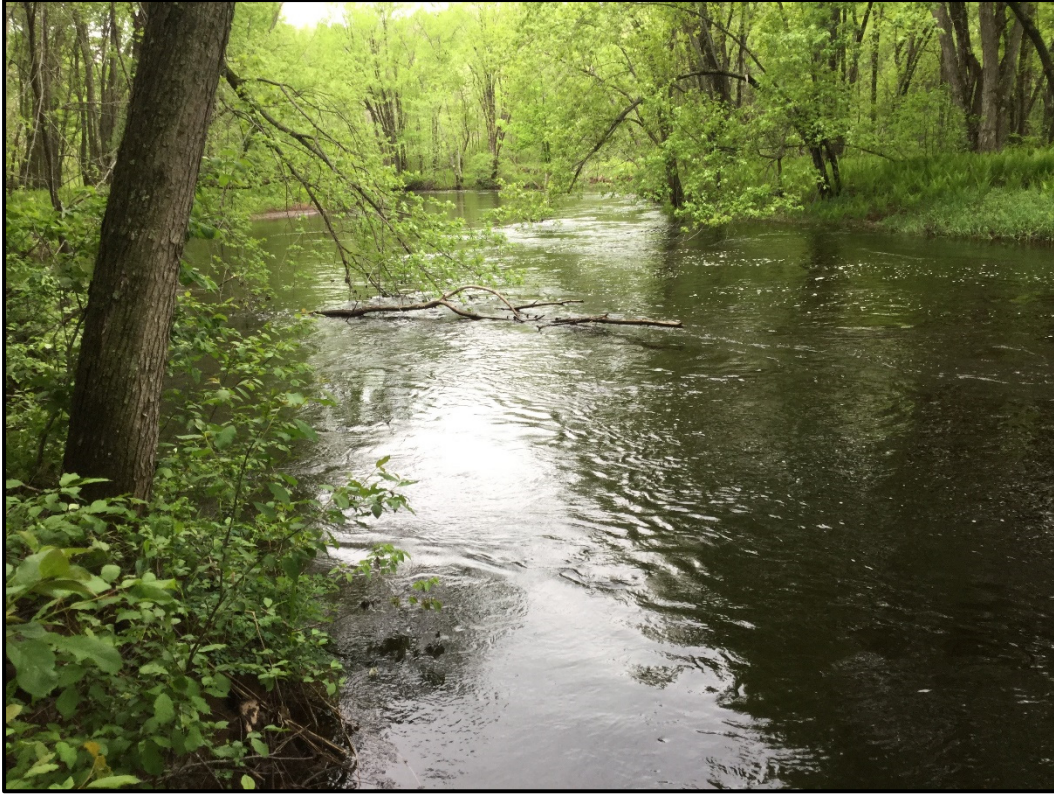
Existing Condition^a: <i>(check one)</i>	<input checked="" type="checkbox"/> Highly Functional Stream <input type="checkbox"/> Moderately Functional Stream <input type="checkbox"/> Functionally Impaired Stream		
Feature Description: <i>(check one)</i>	<input checked="" type="checkbox"/> Natural <input type="checkbox"/> Artificial, man-made <input type="checkbox"/> Manipulated		
Flow Regime: <i>(check one)</i>	<input type="checkbox"/> Ephemeral <input type="checkbox"/> Intermittent <input checked="" type="checkbox"/> Perennial <input type="checkbox"/> Connecting Swale		
Sinuosity within Survey Corridor: <i>(check one)</i>	<input type="checkbox"/> Straight <input checked="" type="checkbox"/> Meandering		
Description Notes: Southern bank of the Bad River at the edge of the survey corridor.			
Measurements			
Depth of Water: <u>5</u> ft. N/A <input type="checkbox"/> Unknown <input type="checkbox"/>		Water Edge to Water Edge: <u>50</u> ft. N/A <input type="checkbox"/>

Vegetation Layers: <input checked="" type="checkbox"/> Trees <input checked="" type="checkbox"/> Saplings/Shrubs <input checked="" type="checkbox"/> Herbs <i>(check all that apply)</i>			
Dominant Bank Vegetation (list): Acer saccharinum, Fraxinus pennsylvanica, Matteuccia struthiopteris, Prunus virginiana			
Aquatic Habitats (ex: submerged or emergent aquatic vegetation, overhanging banks/roots, leaf packs, large submerged wood, riffles, deep pools, etc.): Runs, pools, woody debris, overhanging vegetation.			
Aquatic Organisms Observed (list): None.			
Disturbances (ex: livestock access, manure in waterbody, waste discharge pipes): Road, bridges.			
Observation Notes: The Bad River is a perennial waterbody that flows through surrounding floodplain forest.

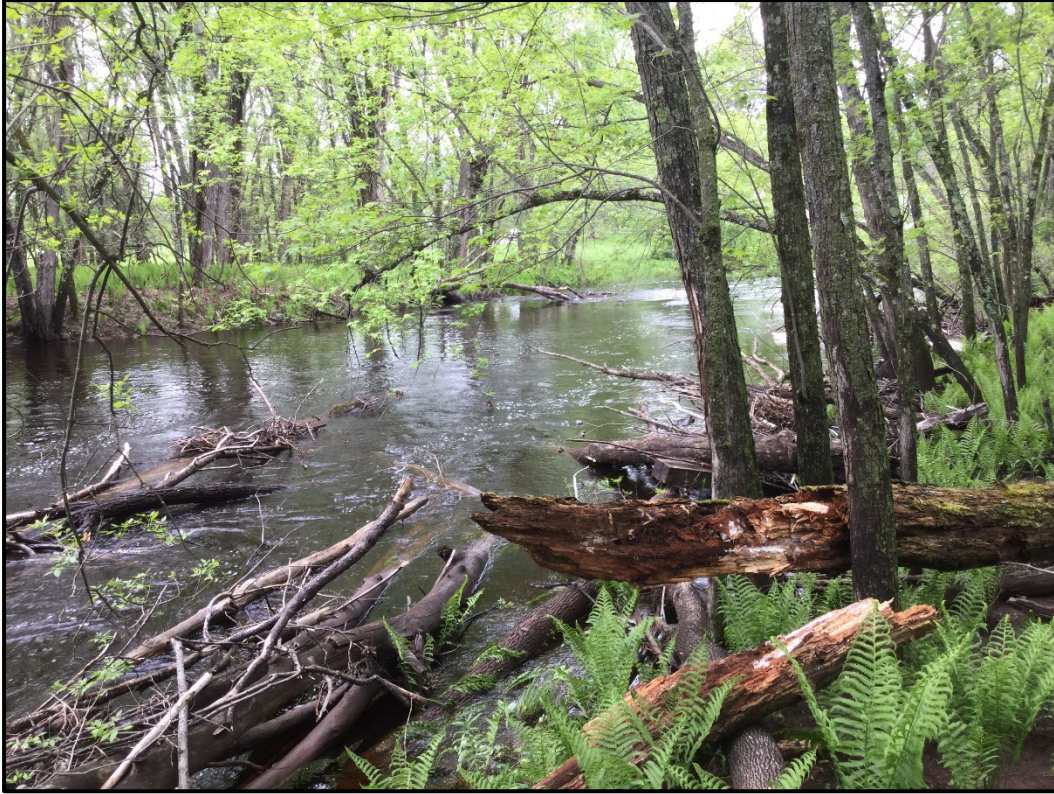
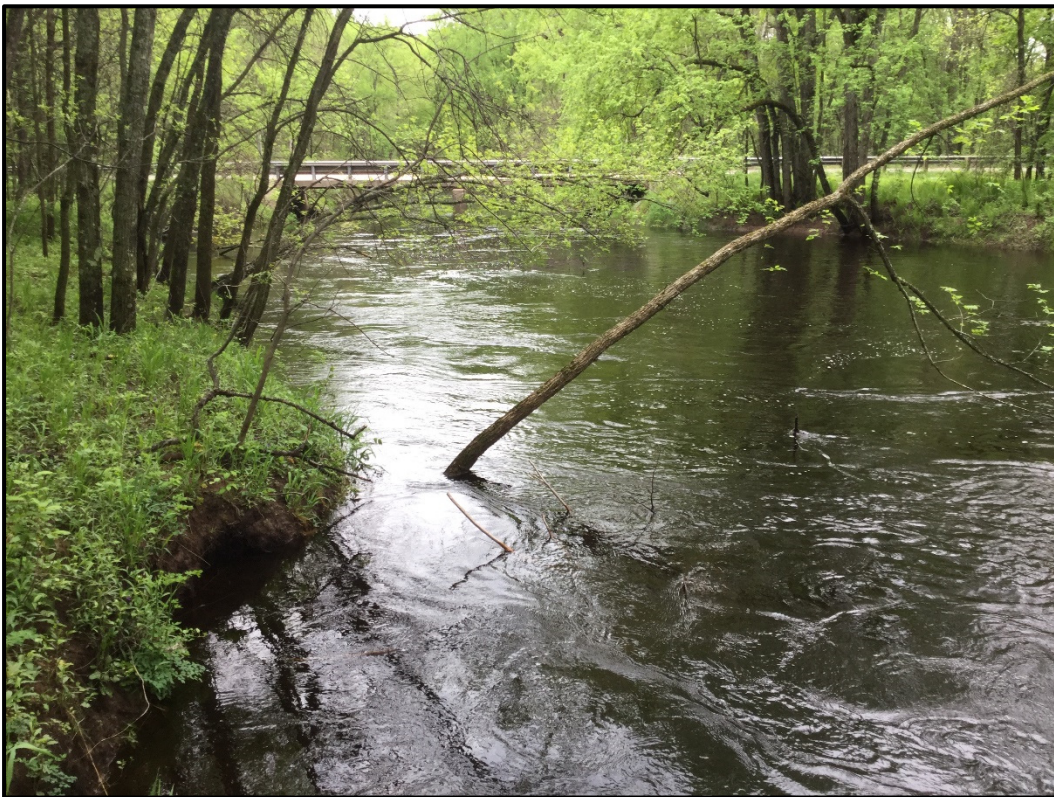
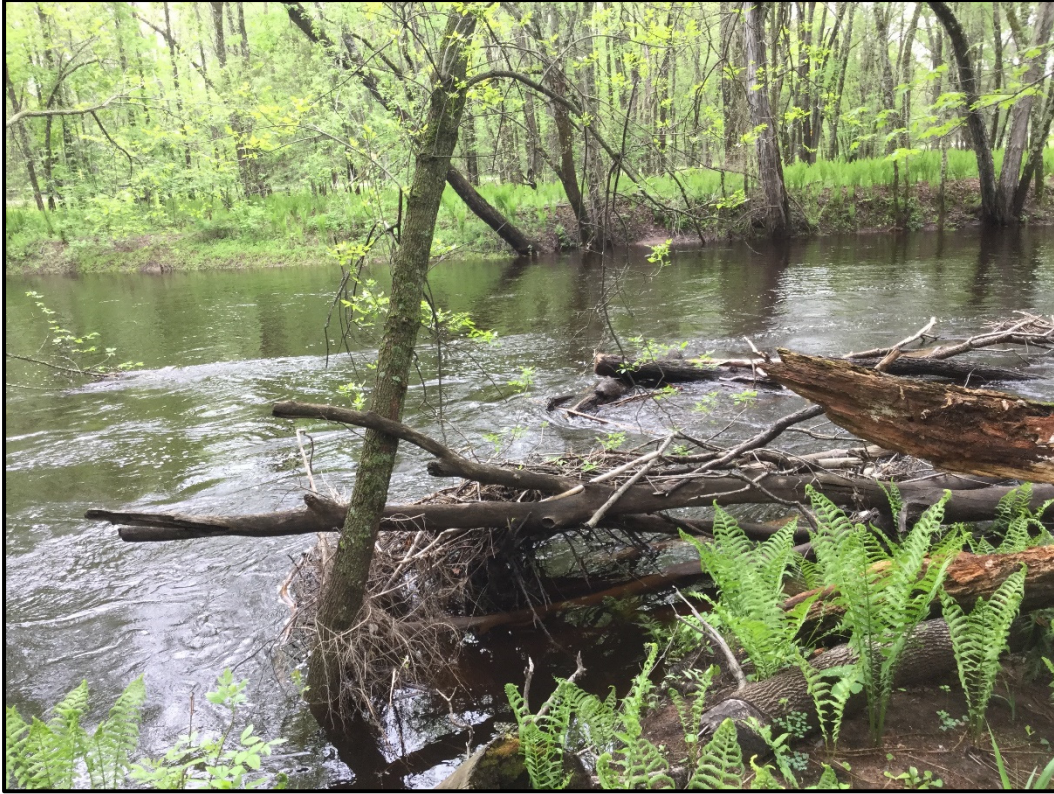
Existing Condition^a: <i>(check one)</i>	<input checked="" type="checkbox"/> Highly Functional Stream <input type="checkbox"/> Moderately Functional Stream <input type="checkbox"/> Functionally Impaired Stream		
Feature Description: <i>(check one)</i>	<input checked="" type="checkbox"/> Natural <input type="checkbox"/> Artificial, man-made <input type="checkbox"/> Manipulated		
Flow Regime: <i>(check one)</i>	<input type="checkbox"/> Ephemeral <input type="checkbox"/> Intermittent <input checked="" type="checkbox"/> Perennial <input type="checkbox"/> Connecting Swale		
Sinuosity within Survey Corridor: <i>(check one)</i>	<input type="checkbox"/> Straight <input checked="" type="checkbox"/> Meandering		
Description Notes: Northern bank of the Bad River at the edge of the survey corridor.			
Measurements			
Depth of Water: <u>5</u> ft. N/A <input type="checkbox"/> Unknown <input type="checkbox"/>		Water Edge to Water Edge: <u>50</u> ft. N/A <input type="checkbox"/>

Vegetation Layers: <input checked="" type="checkbox"/> Trees <input checked="" type="checkbox"/> Saplings/Shrubs <input checked="" type="checkbox"/> Herbs <i>(check all that apply)</i>			
Dominant Bank Vegetation (list): Acer saccharinum, Fraxinus pennsylvanica, Matteuccia struthiopteris			
Aquatic Habitats (ex: submerged or emerged aquatic vegetation, overhanging banks/roots, leaf packs, large submerged wood, riffles, deep pools, etc.): Runs, pools, woody debris, overhanging vegetation.			
Aquatic Organisms Observed (list): None.			
Disturbances (ex: livestock access, manure in waterbody, waste discharge pipes): Road, bridges.			
Observation Notes: The Bad River is a perennial waterbody that flows through floodplain forest.

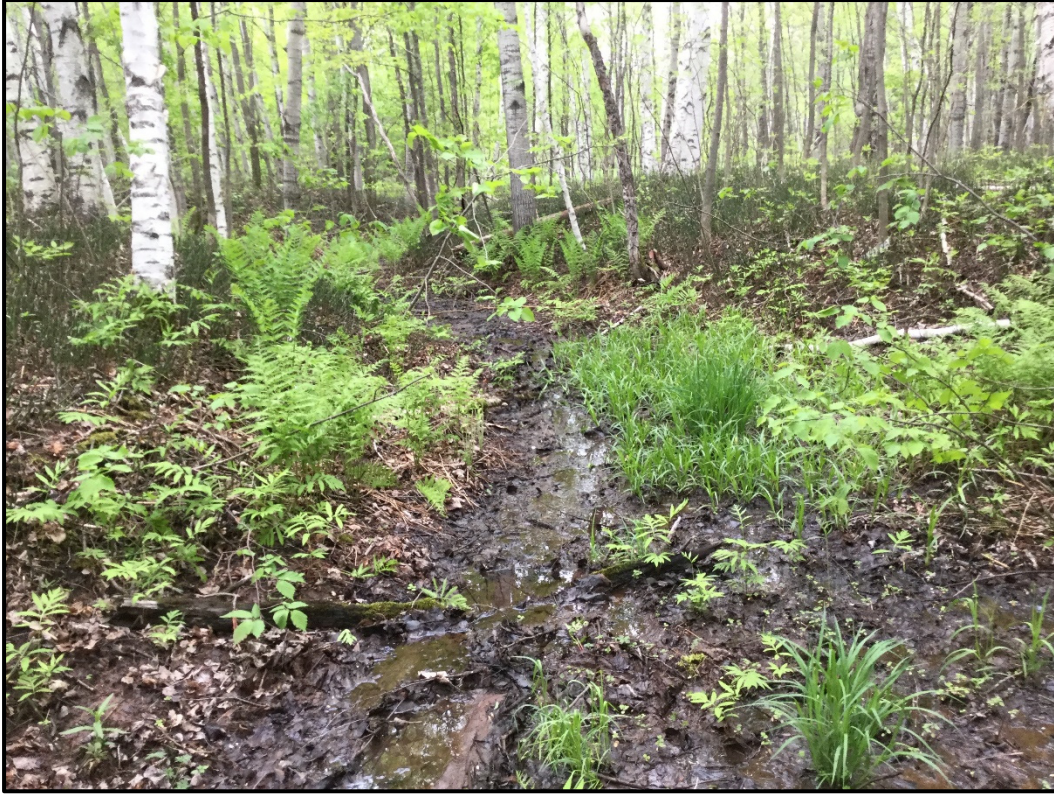
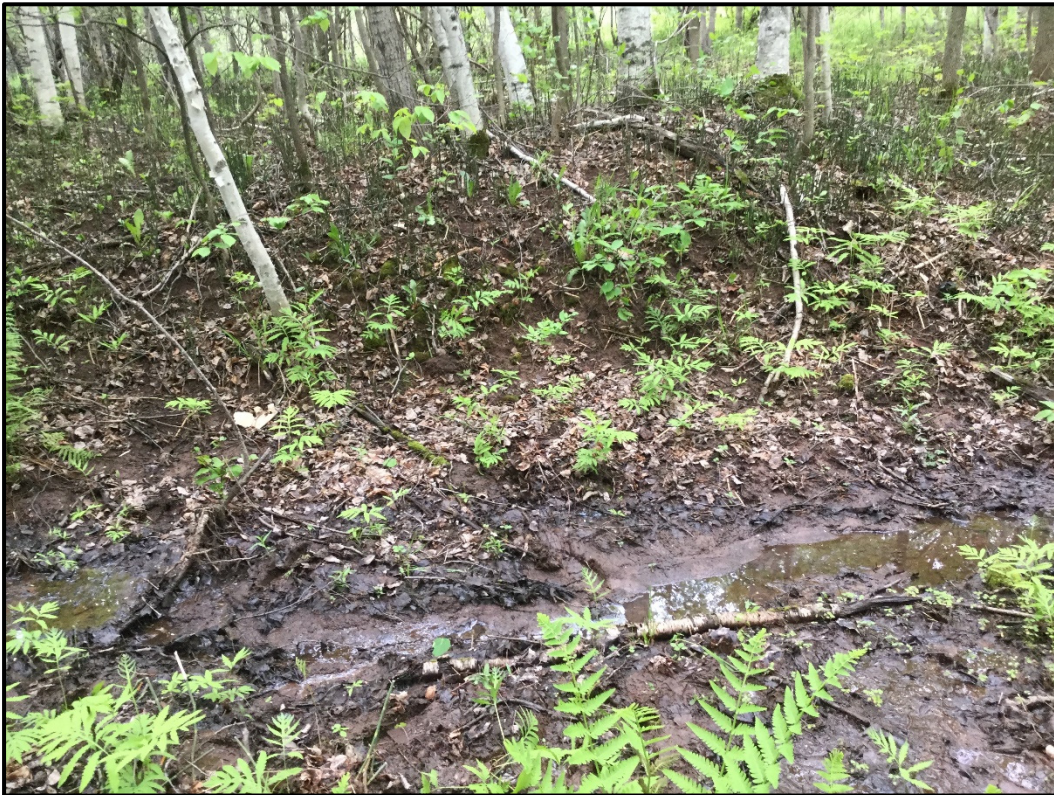
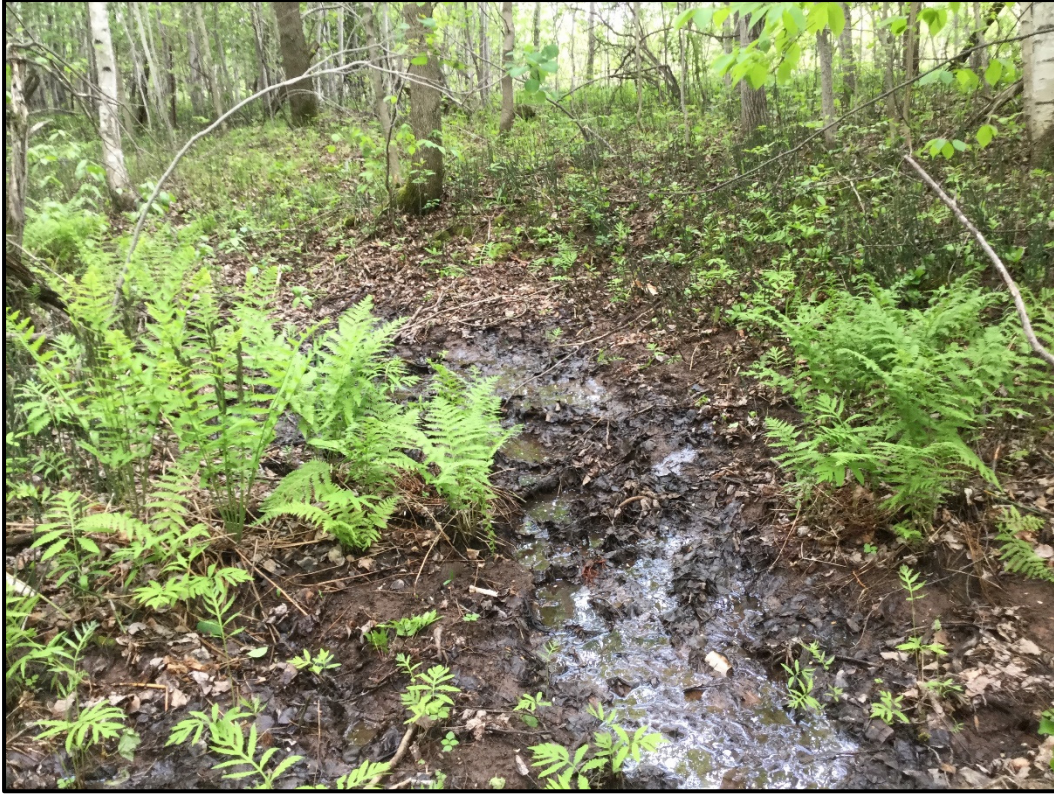
Existing Condition^a: <i>(check one)</i>	<input type="checkbox"/> Highly Functional Stream <input checked="" type="checkbox"/> Moderately Functional Stream <input type="checkbox"/> Functionally Impaired Stream		
Feature Description: <i>(check one)</i>	<input checked="" type="checkbox"/> Natural <input type="checkbox"/> Artificial, man-made <input type="checkbox"/> Manipulated		
Flow Regime: <i>(check one)</i>	<input checked="" type="checkbox"/> Ephemeral <input type="checkbox"/> Intermittent <input type="checkbox"/> Perennial <input type="checkbox"/> Connecting Swale		
Sinuosity within Survey Corridor: <i>(check one)</i>	<input type="checkbox"/> Straight <input checked="" type="checkbox"/> Meandering		
Description Notes: The ephemeral stream is fed by groundwater discharge at the south end and overflow of surface water traveling downslope. There is a narrow fringe wetland present on either side of the feature.

Observations			
Riparian Zone Present: <input checked="" type="checkbox"/> Yes <input type="checkbox"/> No <i>(check one)</i>			
Vegetation Layers: <input checked="" type="checkbox"/> Trees <input checked="" type="checkbox"/> Saplings/Shrubs <input checked="" type="checkbox"/> Herbs <i>(check all that apply)</i>			
Dominant Bank Vegetation (list): Onoclea sensibilis, Osmunda claytoniana, Equisetum hyemale, Betula papyrifera			
Aquatic Habitats (ex: submerged or emerged aquatic vegetation, overhanging banks/roots, leaf packs, large submerged wood, riffles, deep pools, etc.): None.			
Aquatic Organisms Observed (list): None.			
Disturbances (ex: livestock access, manure in waterbody, waste discharge pipes): Feature appears to receive polluted runoff resulting in a sheen on the surface of the water.			
Observation Notes: None.

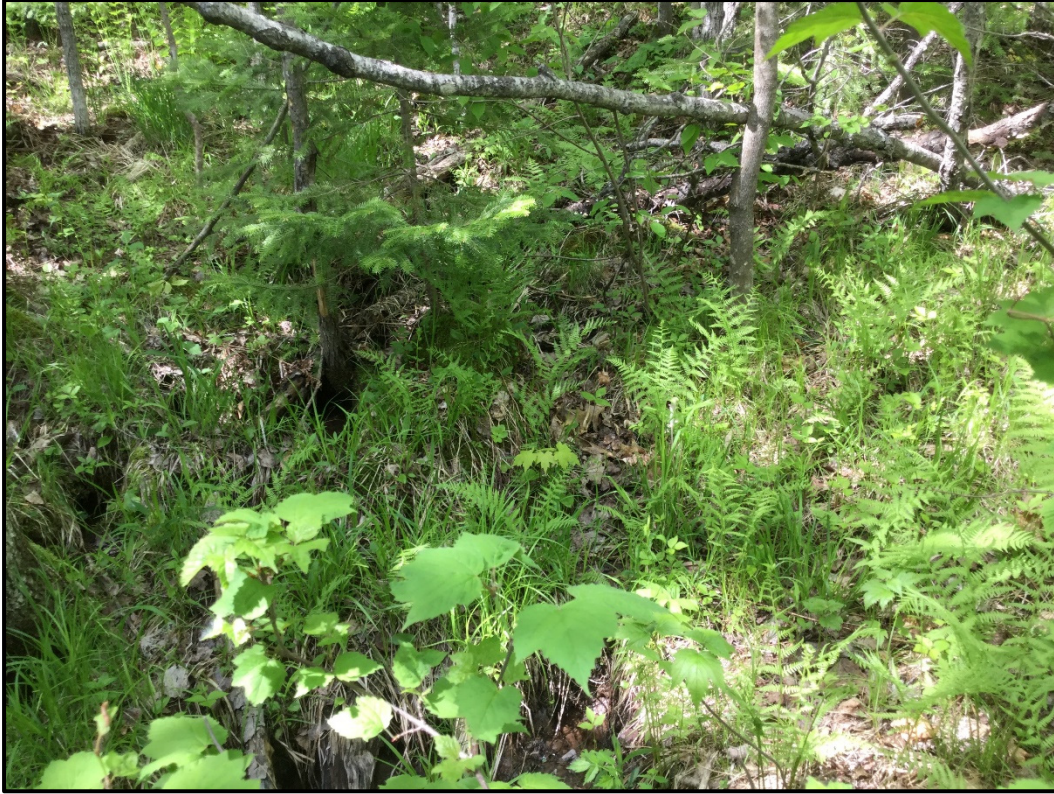
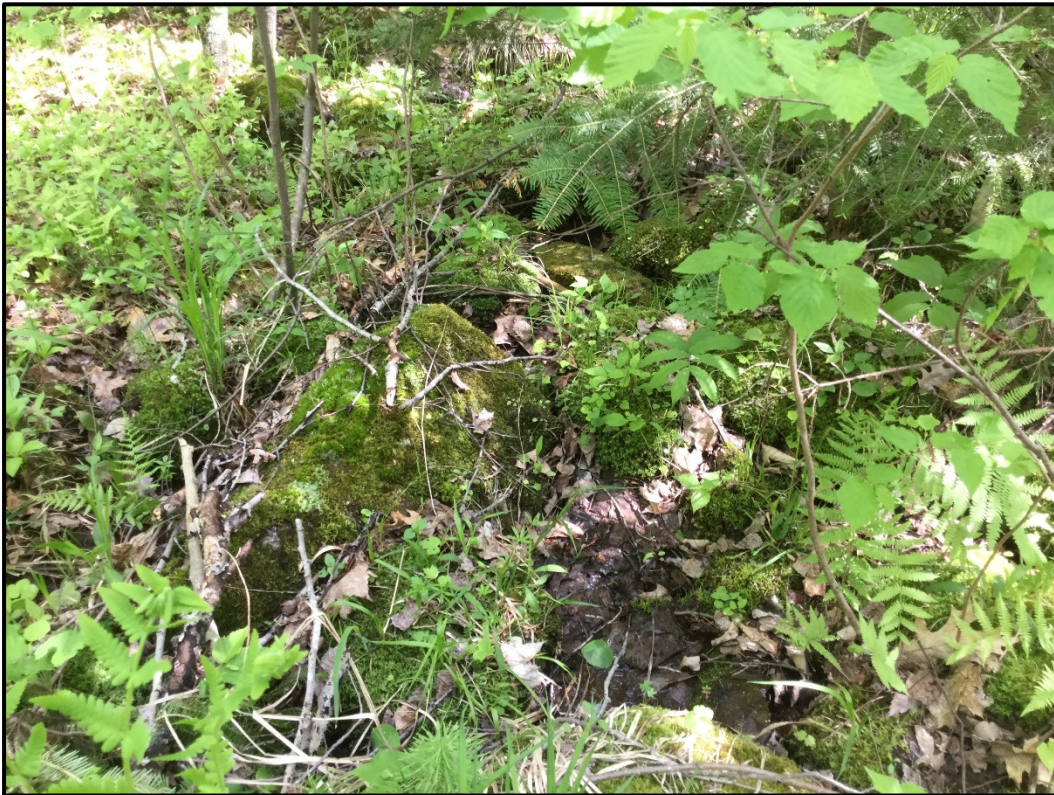
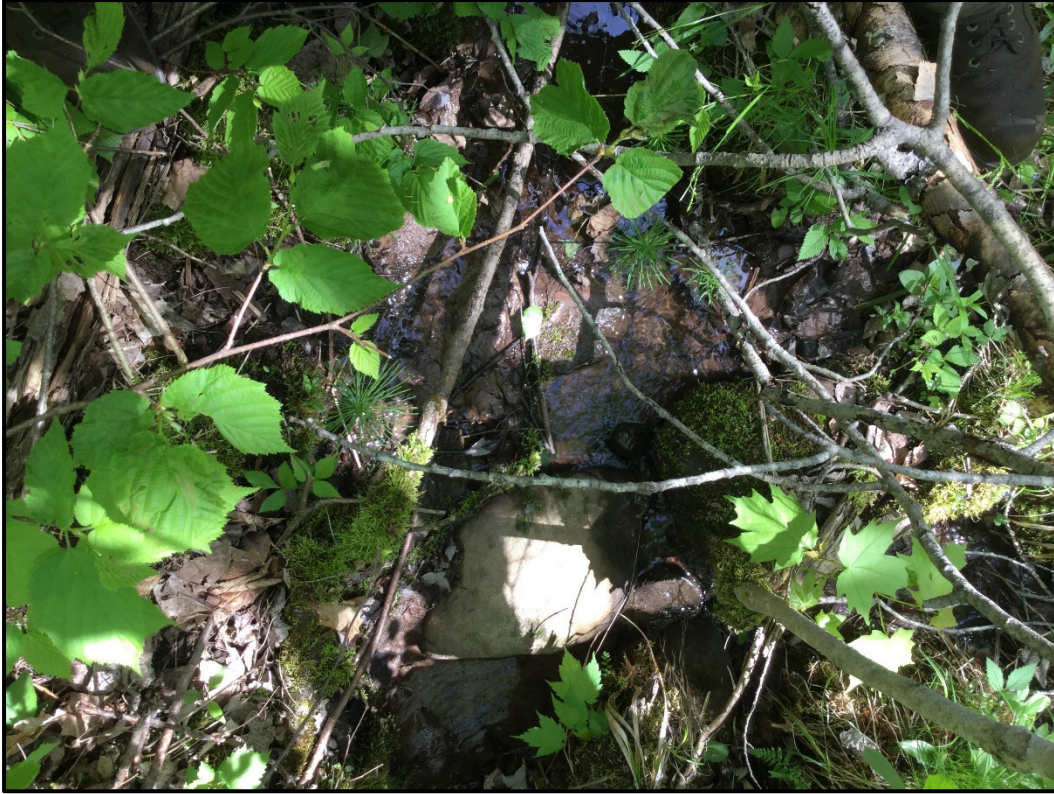
Existing Condition^a: <input checked="" type="checkbox"/> Highly Functional Stream <input checked="" type="checkbox"/> Moderately Functional Stream <input type="checkbox"/> Functionally Impaired Stream <i>(check one)</i>			
Feature Description: <input checked="" type="checkbox"/> Natural <input type="checkbox"/> Artificial, man-made <input type="checkbox"/> Manipulated <i>(check one)</i>			
Flow Regime: <input checked="" type="checkbox"/> Ephemeral <input type="checkbox"/> Intermittent <input type="checkbox"/> Perennial <input type="checkbox"/> Connecting Swale <i>(check one)</i>			
Sinuosity within Survey Corridor: <input type="checkbox"/> Straight <input checked="" type="checkbox"/> Meandering <i>(check one)</i>			
Description Notes: Natural ephemeral stream flowing through a forest.			
Measurements			
Depth of Water: <u>0.25</u> ft. N/A <input type="checkbox"/> Unknown <input type="checkbox"/>		Water Edge to Water Edge: <u>0.5</u> ft. N/A <input type="checkbox"/>

Vegetation Layers: <input checked="" type="checkbox"/> Trees <input checked="" type="checkbox"/> Saplings/Shrubs <input checked="" type="checkbox"/> Herbs <i>(check all that apply)</i>			
Dominant Bank Vegetation (list): Abies balsamea, Populus tremuloides, Athyrium filix-femina, Carex sp.			
Aquatic Habitats (ex: submerged or emerged aquatic vegetation, overhanging banks/roots, leaf packs, large submerged wood, riffles, deep pools, etc.): None.			
Aquatic Organisms Observed (list): None.			
Disturbances (ex: livestock access, manure in waterbody, waste discharge pipes): None.			
Observation Notes: The feature is a very narrow defined channel with flowing water between two hills. There are exposed rocks present within portions of the channel. There are areas of the feature where the flow goes below ground and then comes back up.

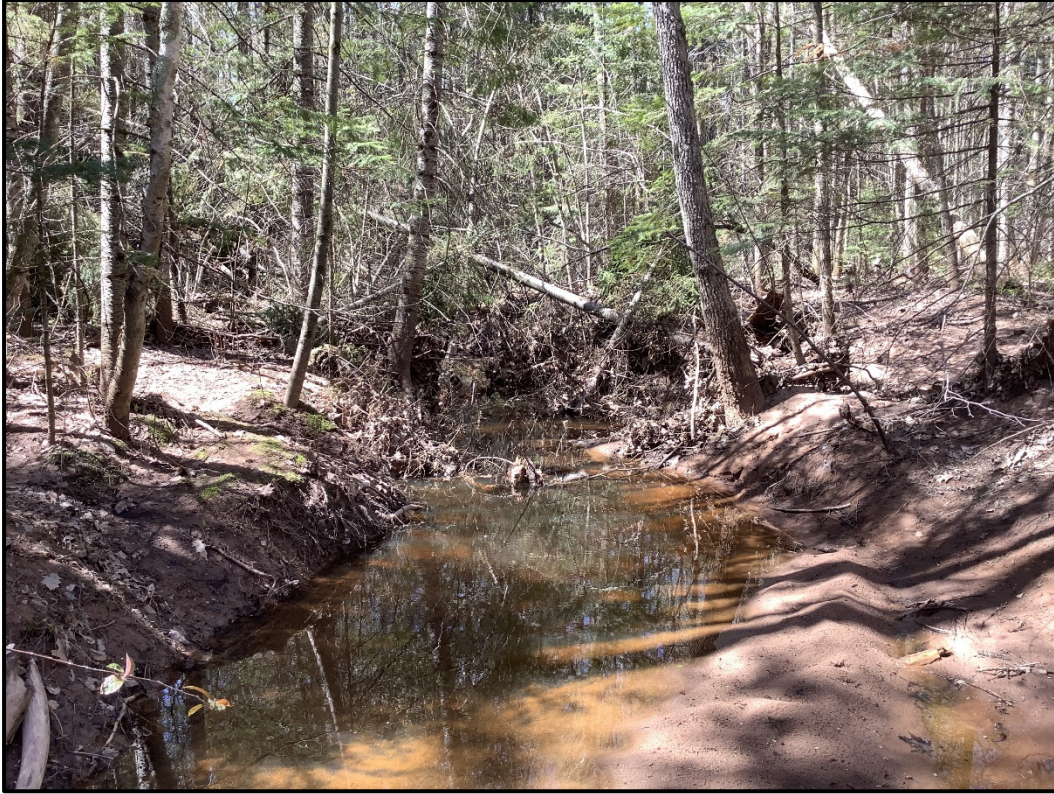
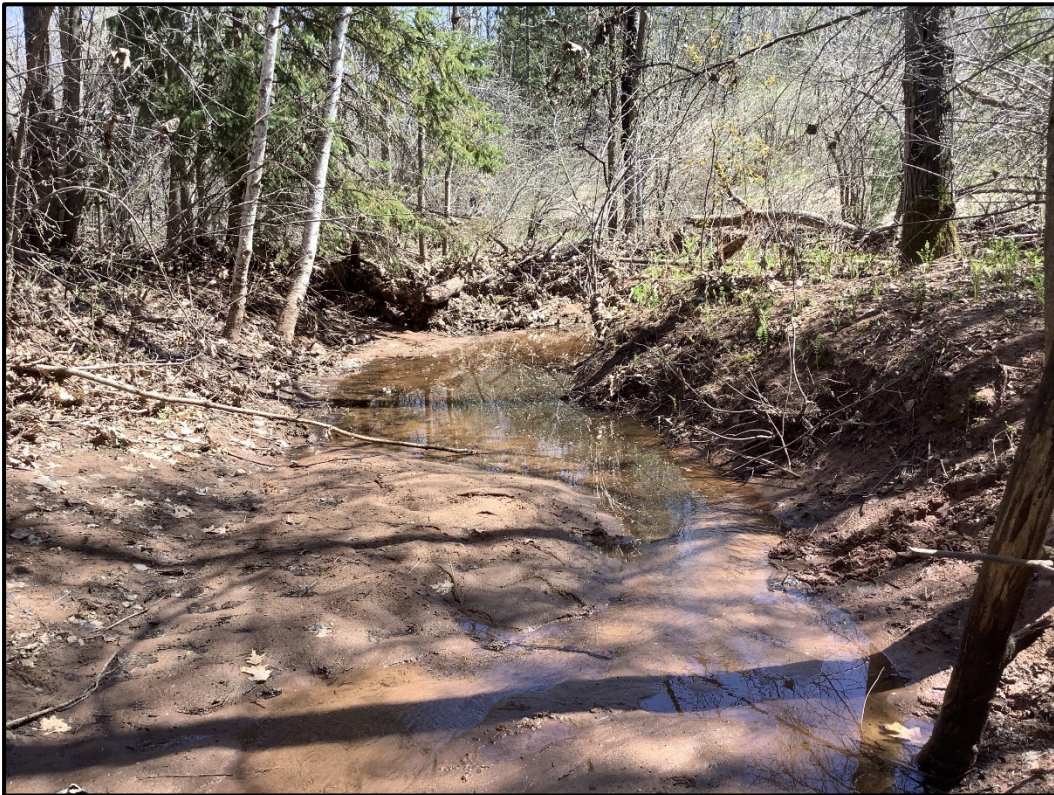
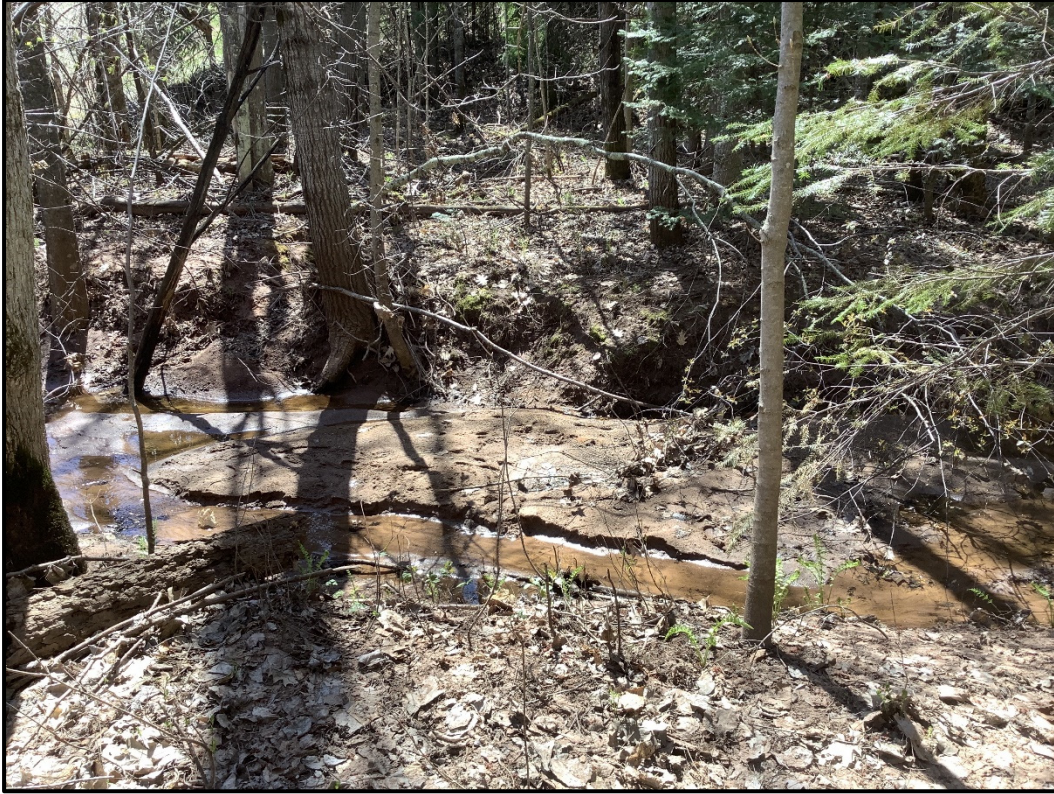
Existing Condition^a: <i>(check one)</i>	<input type="checkbox"/> Highly Functional Stream <input checked="" type="checkbox"/> Moderately Functional Stream <input type="checkbox"/> Functionally Impaired Stream		
Feature Description: <i>(check one)</i>	<input checked="" type="checkbox"/> Natural <input type="checkbox"/> Artificial, man-made <input type="checkbox"/> Manipulated		
Flow Regime: <i>(check one)</i>	<input type="checkbox"/> Ephemeral <input type="checkbox"/> Intermittent <input checked="" type="checkbox"/> Perennial <input type="checkbox"/> Connecting Swale		
Sinuosity within Survey Corridor: <i>(check one)</i>	<input type="checkbox"/> Straight <input checked="" type="checkbox"/> Meandering		
Description Notes: The feature is a perennial stream that weakly meanders with clear, moving water.			
Measurements			
Depth of Water: <u>0.3</u> ft. N/A <input type="checkbox"/> Unknown <input type="checkbox"/>		Water Edge to Water Edge: <u>8</u> ft. N/A <input type="checkbox"/>

Vegetation Layers: <input checked="" type="checkbox"/> Trees <input checked="" type="checkbox"/> Saplings/Shrubs <input checked="" type="checkbox"/> Herbs <i>(check all that apply)</i>			
Dominant Bank Vegetation (list): Abies balsamea, Populus tremuloides, Equisetum arvense, Matteuccia struthiopteris			
Aquatic Habitats (ex: submerged or emerged aquatic vegetation, overhanging banks/roots, leaf packs, large submerged wood, riffles, deep pools, etc.): Shallow pools and downed woody debris are likely habitats for aquatic organisms.			
Aquatic Organisms Observed (list): Minnows were observed in the stream.			
Disturbances (ex: livestock access, manure in waterbody, waste discharge pipes): Erosion from the steep banks is possible.			
Observation Notes: The stream flows from a forested area into an open area.
