Enbridge Line 5 Wisconsin Segment Relocation Project
2020 Wetland/Waterbody Datasheets Photograph Errors

On May 6, 2021, the Great Lakes Indian Fish and Wildlife Commission (GLIFWC) submitted a comment to the U.S. Army Corps of Engineers (USACE) identifying six stream datasheets where the photograph included with the data sheet did not appear to match the stream description. Environmental Resources Management (ERM), in coordination with Midwest Natural Resources Inc. (MNR), reviewed the six stream datasheets and determined that they contained the incorrect photographs. After reviewing the data, it was determined that the error was the result of an issue with a software program used to process the large number of photographs taken during the 2020 field surveys. After the error was identified, the entire 2020 dataset was reviewed, resulting in the identification of additional stream datasheets, wetland datasheets, and no-points that had the incorrect photographs included on the form.

Enbridge Line 5 Wetland/Waterbody Datasheet Photograph Corrections	
Streams	
Feature ID	Near Milepost
Sasb006p_x1	24.2
Sasb006p_x2	24.2
Sasb1003e	17.1
Sasb1004e	17.2
Sase006p_x	0.6
Sase1001e	9.3
Sase10

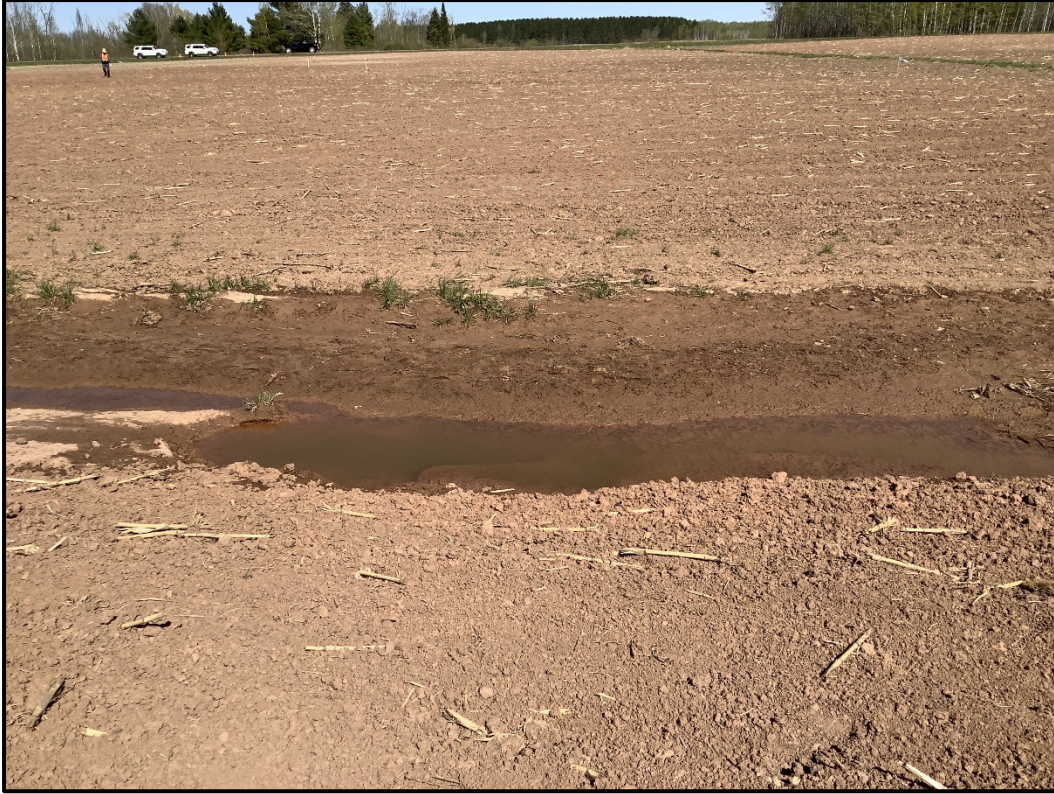
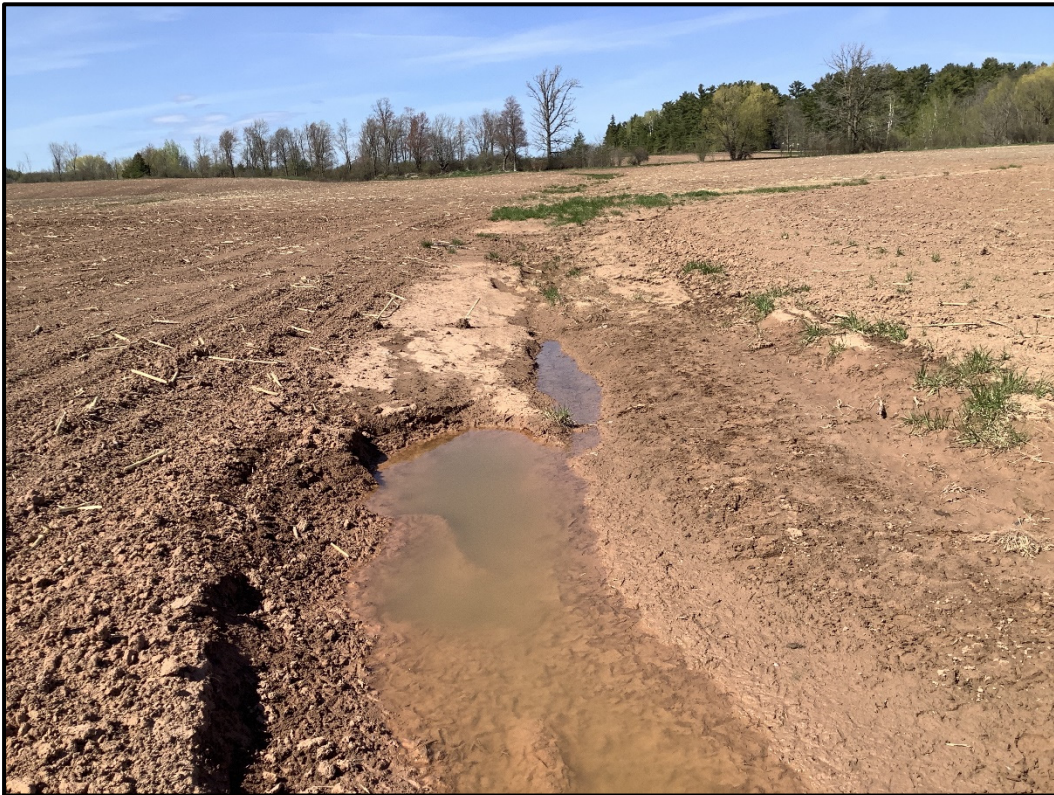
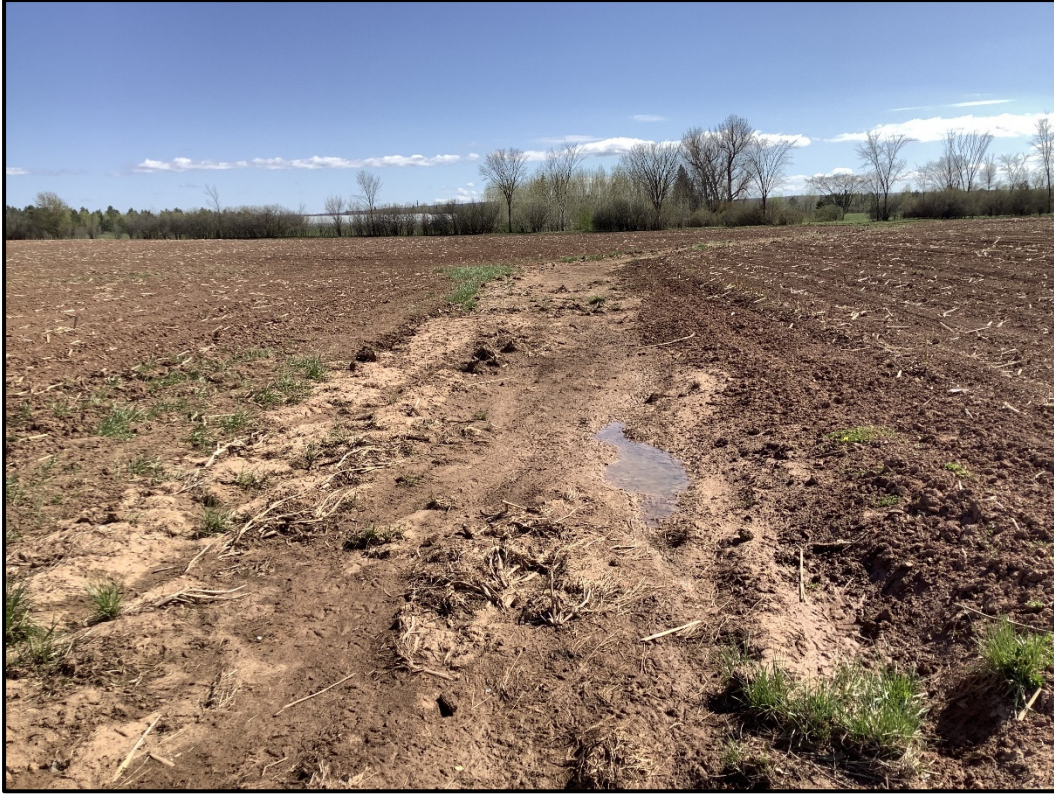
Existing Condition^a: <i>(check one)</i>	<input checked="" type="checkbox"/> Highly Functional Stream <input checked="" type="checkbox"/> Moderately Functional Stream <input type="checkbox"/> Functionally Impaired Stream		
Feature Description: <i>(check one)</i>	<input type="checkbox"/> Natural <input checked="" type="checkbox"/> Artificial, man-made <input type="checkbox"/> Manipulated		
Flow Regime: <i>(check one)</i>	<input checked="" type="checkbox"/> Ephemeral <input type="checkbox"/> Intermittent <input type="checkbox"/> Perennial <input type="checkbox"/> Connecting Swale		
Sinuosity within Survey Corridor: <i>(check one)</i>	<input type="checkbox"/> Straight <input checked="" type="checkbox"/> Meandering		
Description Notes: The artificial swale feature meanders through a tilled agricultural field. Water was not flowing at the time of survey, however there are pools of turbid water.

Observations			
Riparian Zone Present: <input type="checkbox"/> Yes <input checked="" type="checkbox"/> No <i>(check one)</i>			
Vegetation Layers: <input type="checkbox"/> Trees <input type="checkbox"/> Saplings/Shrubs <input checked="" type="checkbox"/> Herbs <i>(check all that apply)</i>			
Dominant Bank Vegetation (list): Lolium perenne			
Aquatic Habitats (ex: submerged or emerged aquatic vegetation, overhanging banks/roots, leaf packs, large submerged wood, riffles, deep pools, etc.): Pools of standing water were observed.			
Aquatic Organisms Observed (list): There were minnows observed in the pools of stream.			
Disturbances (ex: livestock access, manure in waterbody, waste discharge pipes): The stream is artificial and occurs within an agricultural field.			
Observation Notes: The ephemeral stream is artificial and occurs within an agricultural field.

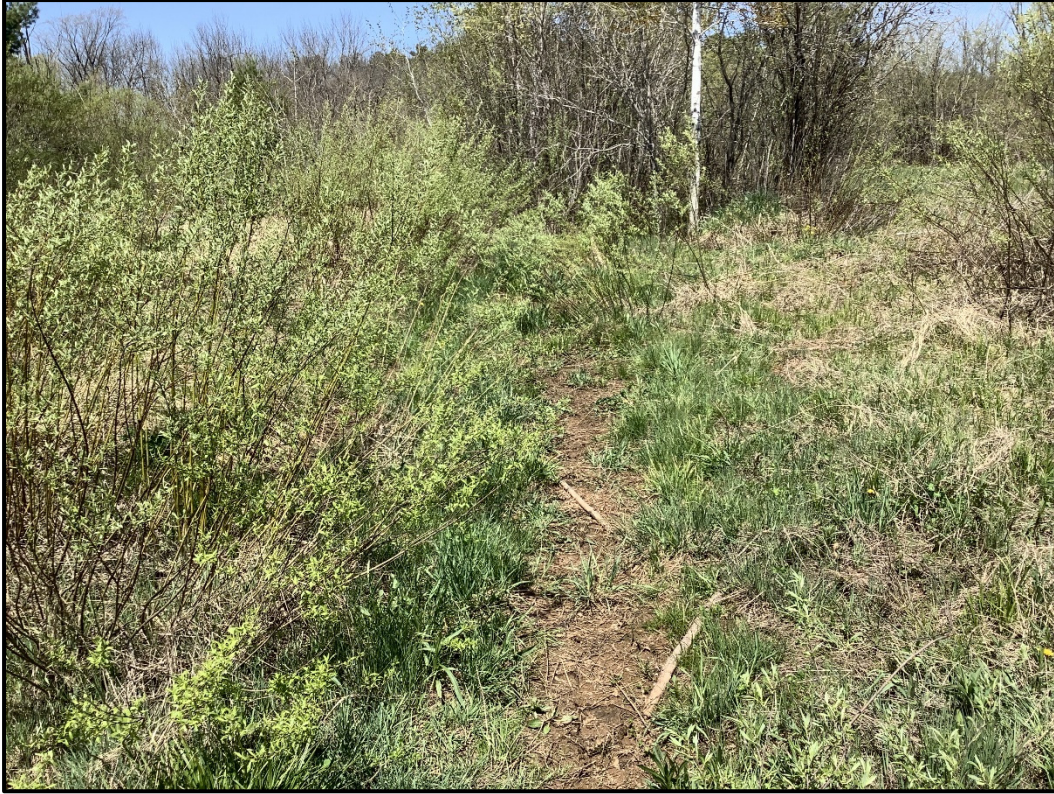
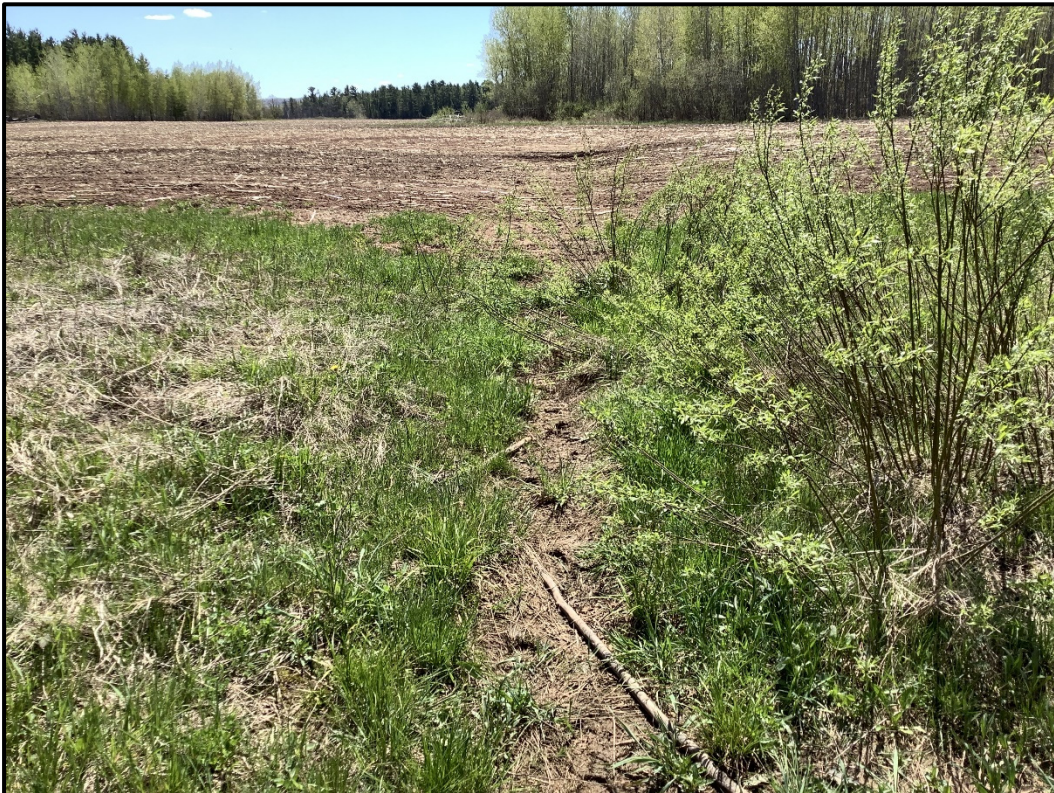
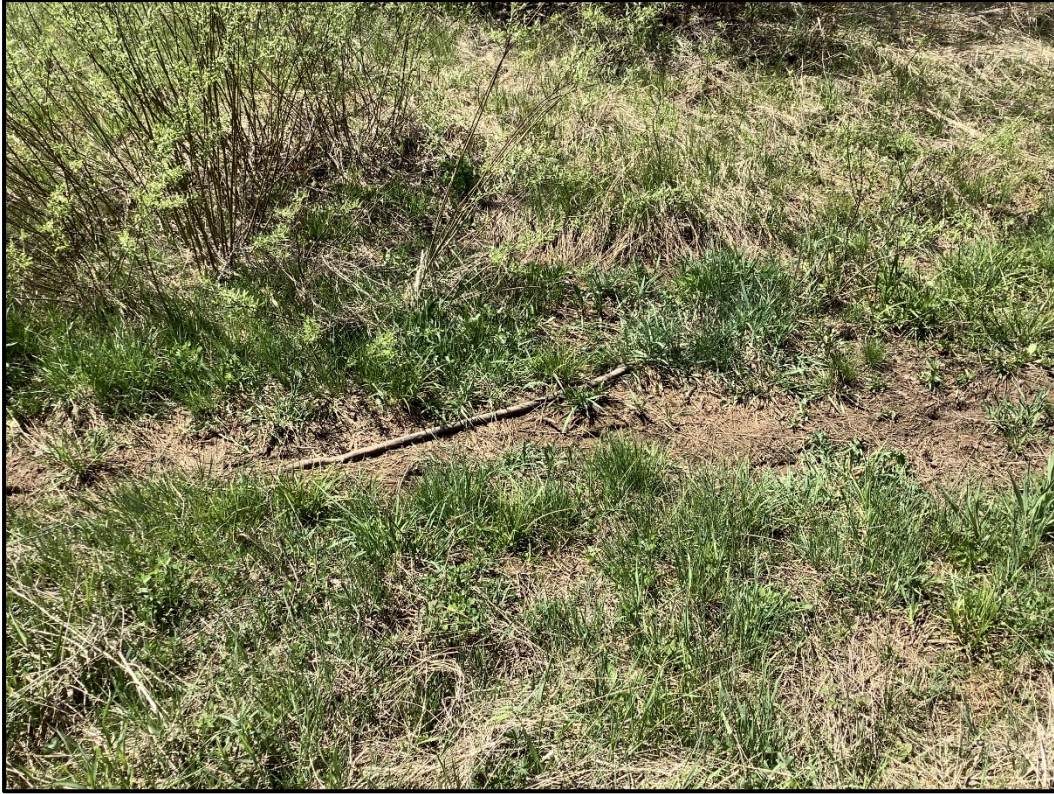
Existing Condition^a: <input checked="" type="checkbox"/> Highly Functional Stream <input type="checkbox"/> Moderately Functional Stream <input checked="" type="checkbox"/> Functionally Impaired Stream <i>(check one)</i>			
Feature Description: <input type="checkbox"/> Natural <input type="checkbox"/> Artificial, man-made <input checked="" type="checkbox"/> Manipulated <i>(check one)</i>			
Flow Regime: <input checked="" type="checkbox"/> Ephemeral <input type="checkbox"/> Intermittent <input type="checkbox"/> Perennial <input type="checkbox"/> Connecting Swale <i>(check one)</i>			
Sinuosity within Survey Corridor: <input checked="" type="checkbox"/> Straight <input type="checkbox"/> Meandering <i>(check one)</i>			
Description Notes: There was no water observed within the feature during the field survey.			
Measurements			
Depth of Water: <u>N/A</u> ft. <input type="checkbox"/> N/A <input checked="" type="checkbox"/> <input type="checkbox"/> Unknown		Water Edge to Water Edge: <u>N/A</u> ft. <input type="checkbox"/> N/A <input checked="" type="checkbox"/> OHWM Width: <u>1</u> ft.

Vegetation Layers: <input type="checkbox"/> Trees <input checked="" type="checkbox"/> Saplings/Shrubs <input checked="" type="checkbox"/> Herbs <i>(check all that apply)</i>			
Dominant Bank Vegetation (list): Salix petiolaris, Phleum pratense, Scirpus cyperinus			
Aquatic Habitats (ex: submerged or emerged aquatic vegetation, overhanging banks/roots, leaf packs, large submerged wood, riffles, deep pools, etc.): No aquatic habitat was observed.			
Aquatic Organisms Observed (list): No aquatic organisms were observed.			
Disturbances (ex: livestock access, manure in waterbody, waste discharge pipes): The feature occurs at the edge of a tilled crop field.			
Observation Notes: The ephemeral swale flows south to north and begins at the edge of a tilled crop field.

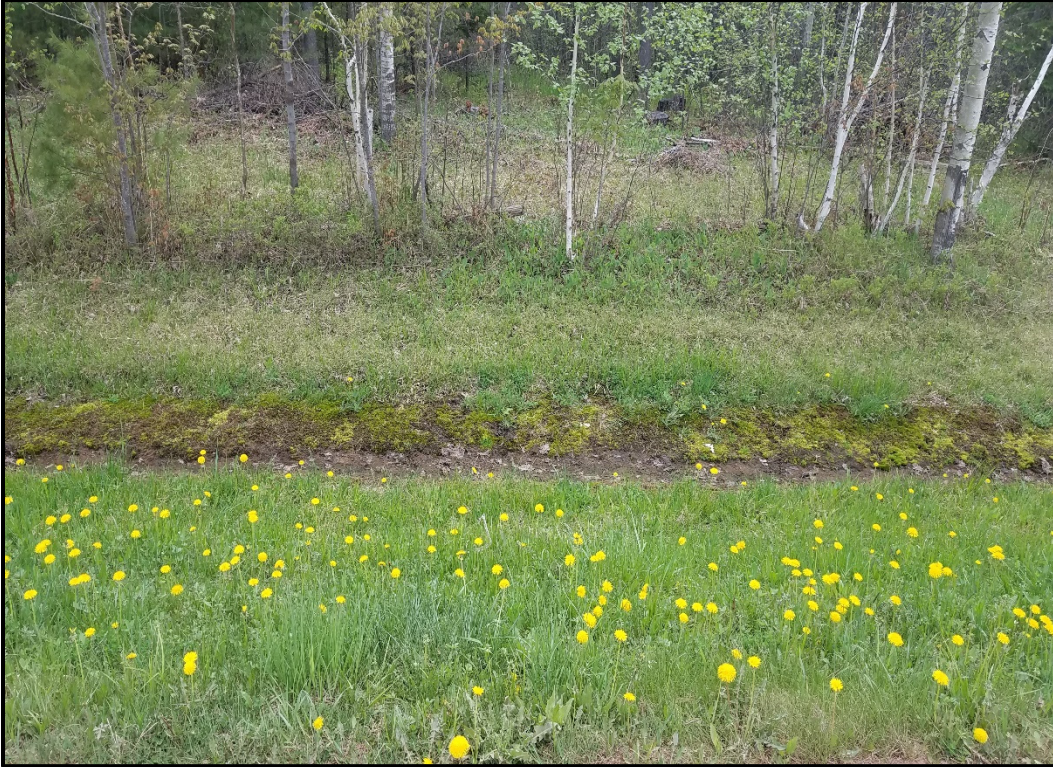
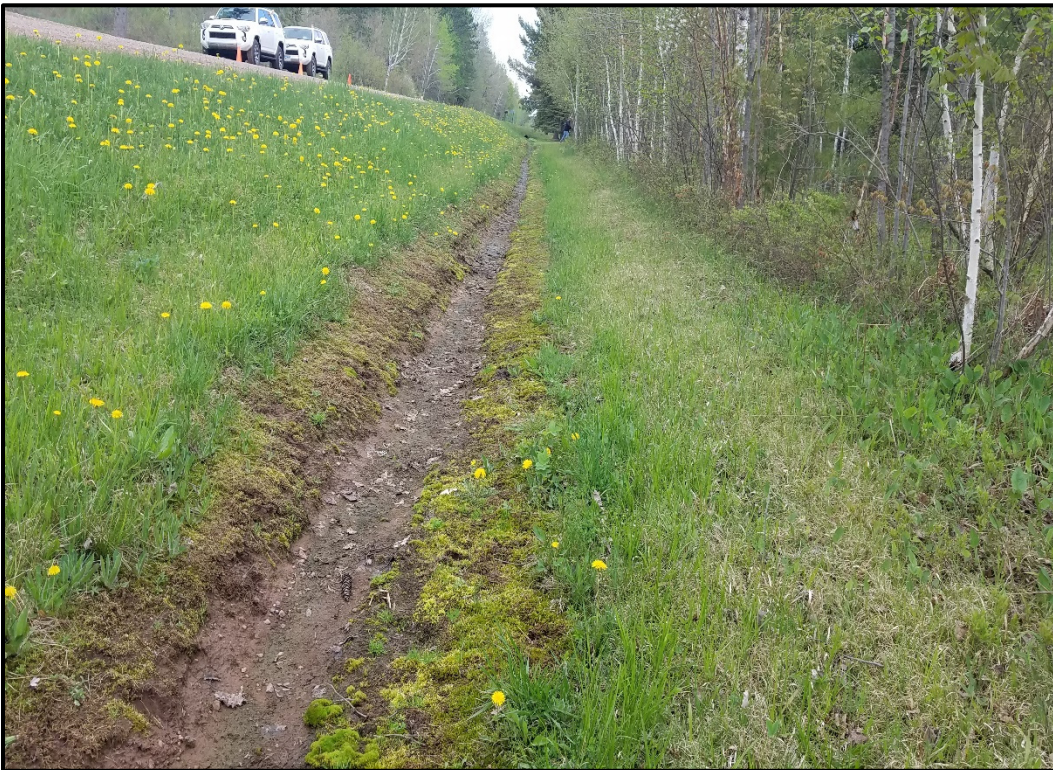
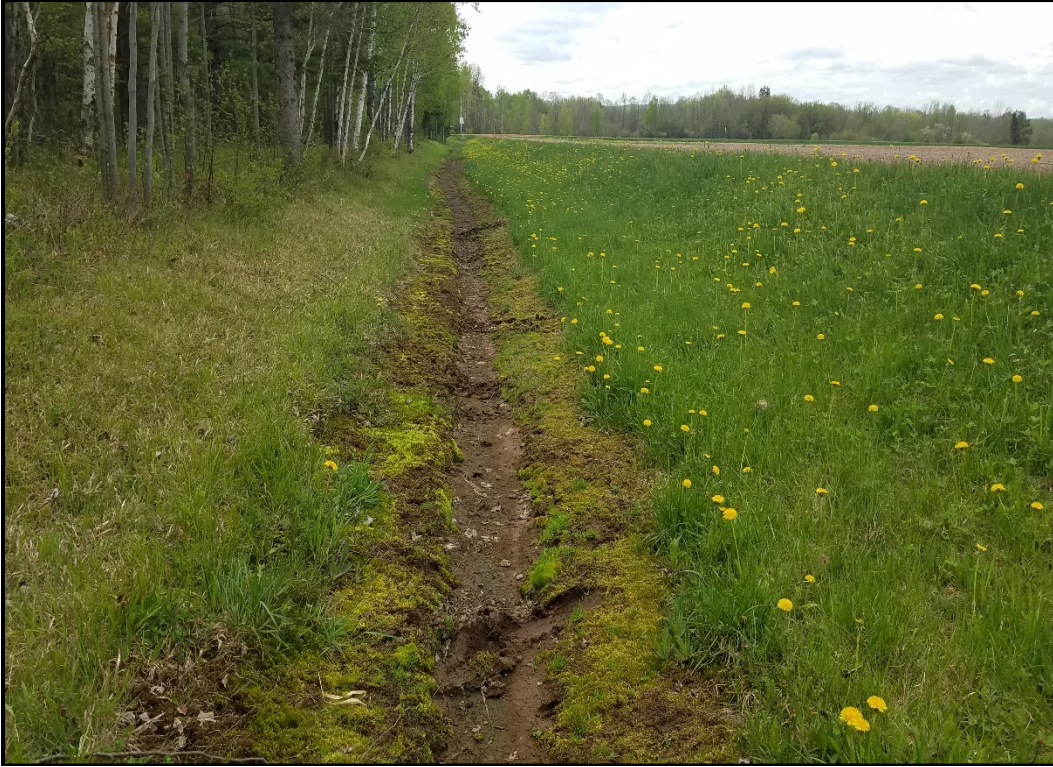
Existing Condition^a: <i>(check one)</i>	<input type="checkbox"/> Highly Functional Stream <input checked="" type="checkbox"/> Moderately Functional Stream <input type="checkbox"/> Functionally Impaired Stream		
Feature Description: <i>(check one)</i>	<input type="checkbox"/> Natural <input checked="" type="checkbox"/> Artificial, man-made <input type="checkbox"/> Manipulated		
Flow Regime: <i>(check one)</i>	<input checked="" type="checkbox"/> Ephemeral <input type="checkbox"/> Intermittent <input type="checkbox"/> Perennial <input type="checkbox"/> Connecting Swale		
Sinuosity within Survey Corridor: <i>(check one)</i>	<input checked="" type="checkbox"/> Straight <input type="checkbox"/> Meandering		
Description Notes: Ephemeral feature with bed and bank naturally formed in the bottom of a roadside ditch. Bank measurements indicate naturally formed banks within the ditch, where the water would rise to at flood stage, and not the higher, constructed banks. Water is supplied from a culvert to the north, as well as from runoff from the adjacent gravel road and forest.

Observations			
Riparian Zone Present: <input checked="" type="checkbox"/> Yes <input type="checkbox"/> No <i>(check one)</i>			
Vegetation Layers: <input type="checkbox"/> Trees <input type="checkbox"/> Saplings/Shrubs <input checked="" type="checkbox"/> Herbs <i>(check all that apply)</i>			
Dominant Bank Vegetation (list): Mosses, Hieracium cf. aurantiacum, Poa annua			
Aquatic Habitats (ex: submerged or emerged aquatic vegetation, overhanging banks/roots, leaf packs, large submerged wood, riffles, deep pools, etc.): None.			
Aquatic Organisms Observed (list): None.			
Disturbances (ex: livestock access, manure in waterbody, waste discharge pipes): Mowing.			
Observation Notes: No water present at time of survey.

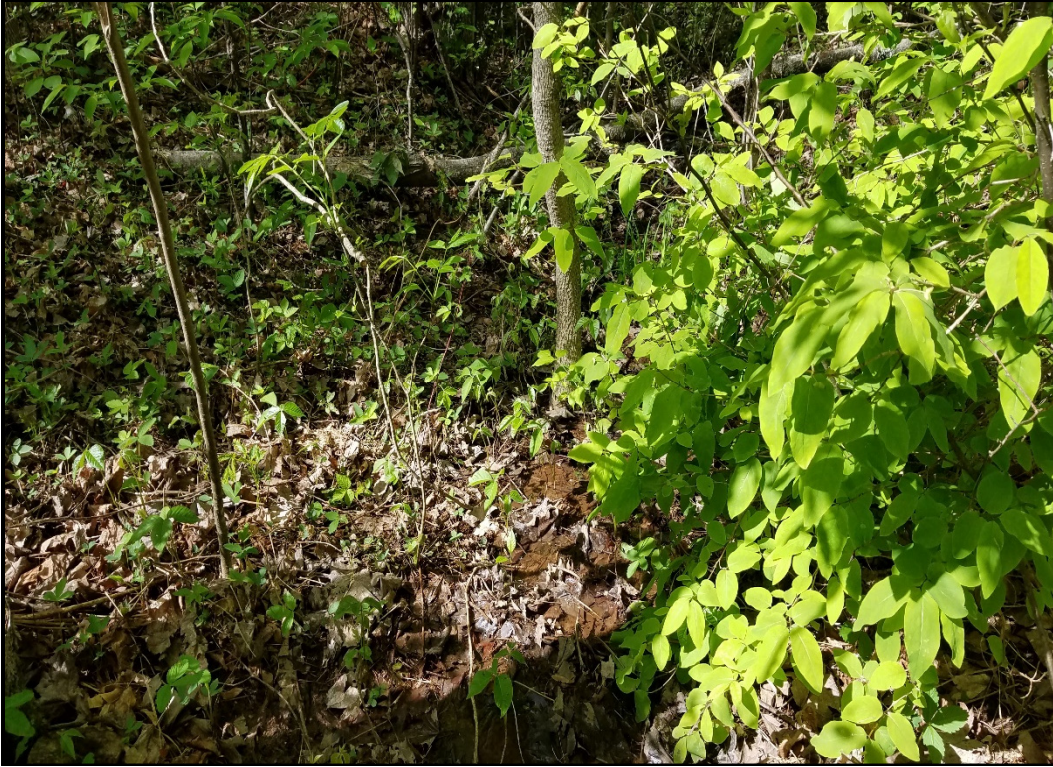
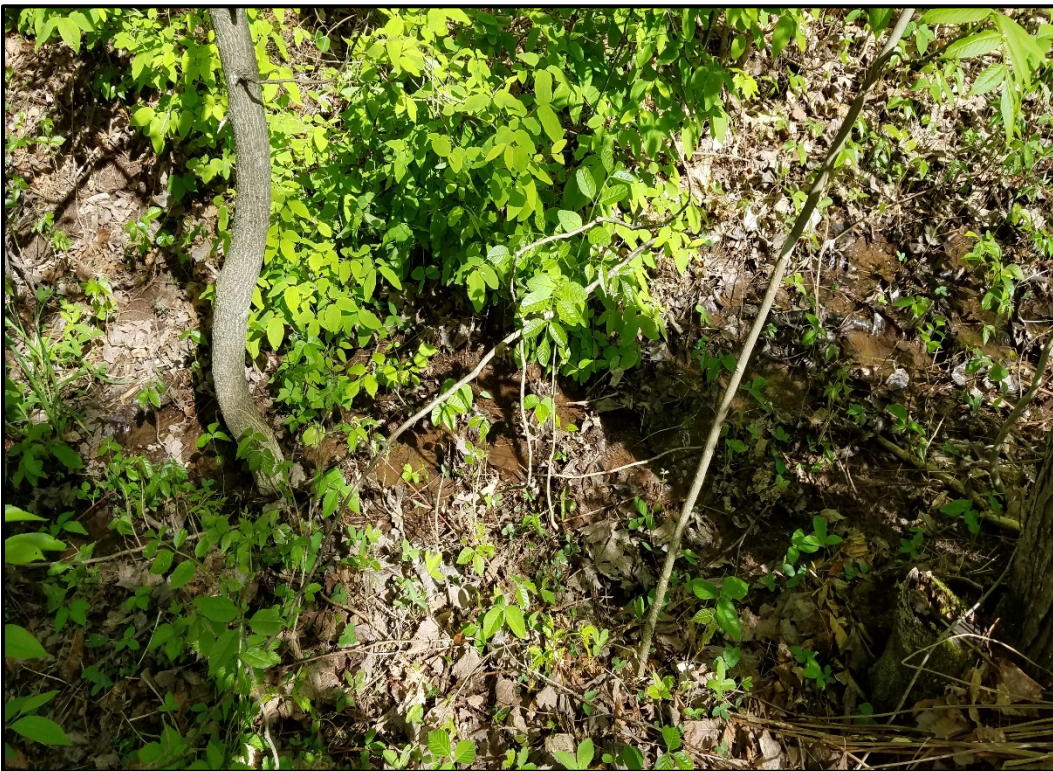
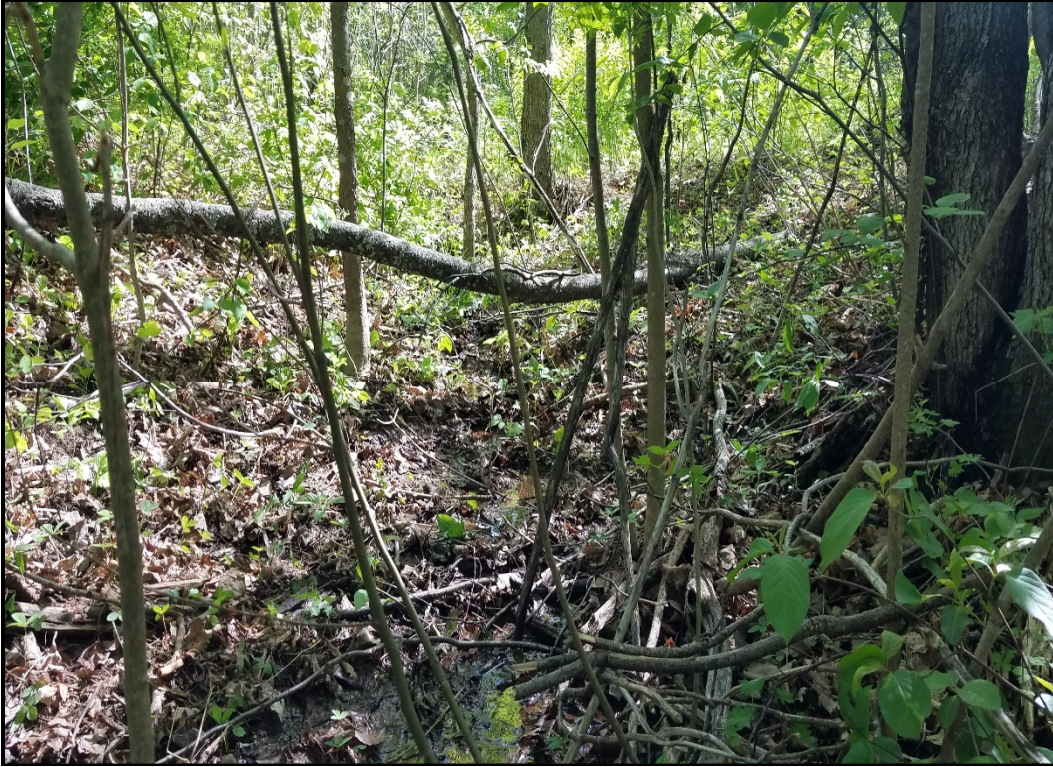
Existing Condition^a: <i>(check one)</i>	<input checked="" type="checkbox"/> Highly Functional Stream <input type="checkbox"/> Moderately Functional Stream <input type="checkbox"/> Functionally Impaired Stream		
Feature Description: <i>(check one)</i>	<input checked="" type="checkbox"/> Natural <input type="checkbox"/> Artificial, man-made <input type="checkbox"/> Manipulated		
Flow Regime: <i>(check one)</i>	<input checked="" type="checkbox"/> Ephemeral <input type="checkbox"/> Intermittent <input type="checkbox"/> Perennial <input type="checkbox"/> Connecting Swale		
Sinuosity within Survey Corridor: <i>(check one)</i>	<input type="checkbox"/> Straight <input checked="" type="checkbox"/> Meandering		
Description Notes: Ephemeral feature with a poorly developed bed and bank, located in a forested swale. Conveys stormwater concentrated from higher in the landscape to a wetland outside the survey area.

Observations			
Riparian Zone Present: <input type="checkbox"/> Yes <input checked="" type="checkbox"/> No <i>(check one)</i>			
Vegetation Layers: <input checked="" type="checkbox"/> Trees <input checked="" type="checkbox"/> Saplings/Shrubs <input checked="" type="checkbox"/> Herbs <i>(check all that apply)</i>			
Dominant Bank Vegetation (list): Acer saccharum, Onoclea sensibilis, Toxicodendron radicans			
Aquatic Habitats (ex: submerged or emerged aquatic vegetation, overhanging banks/roots, leaf packs, large submerged wood, riffles, deep pools, etc.): None.			
Aquatic Organisms Observed (list): None.			
Disturbances (ex: livestock access, manure in waterbody, waste discharge pipes): None.			
Observation Notes: There is less vegetation in the bed of the channel than there is on the adjacent slopes.

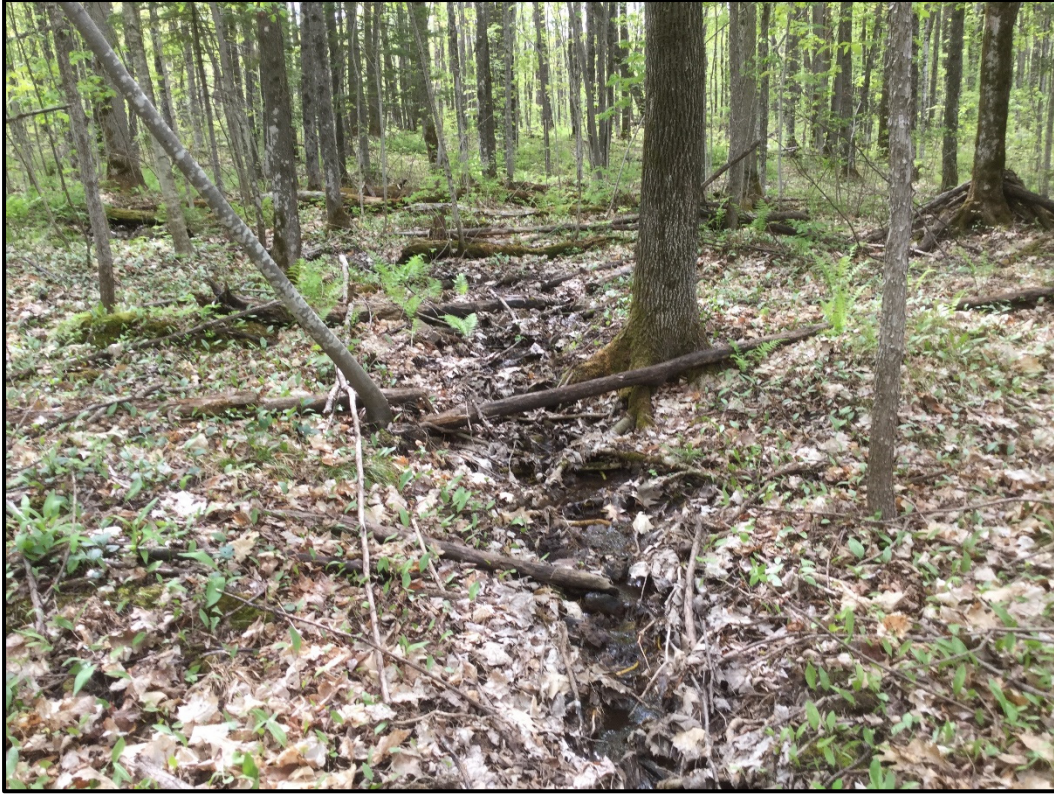
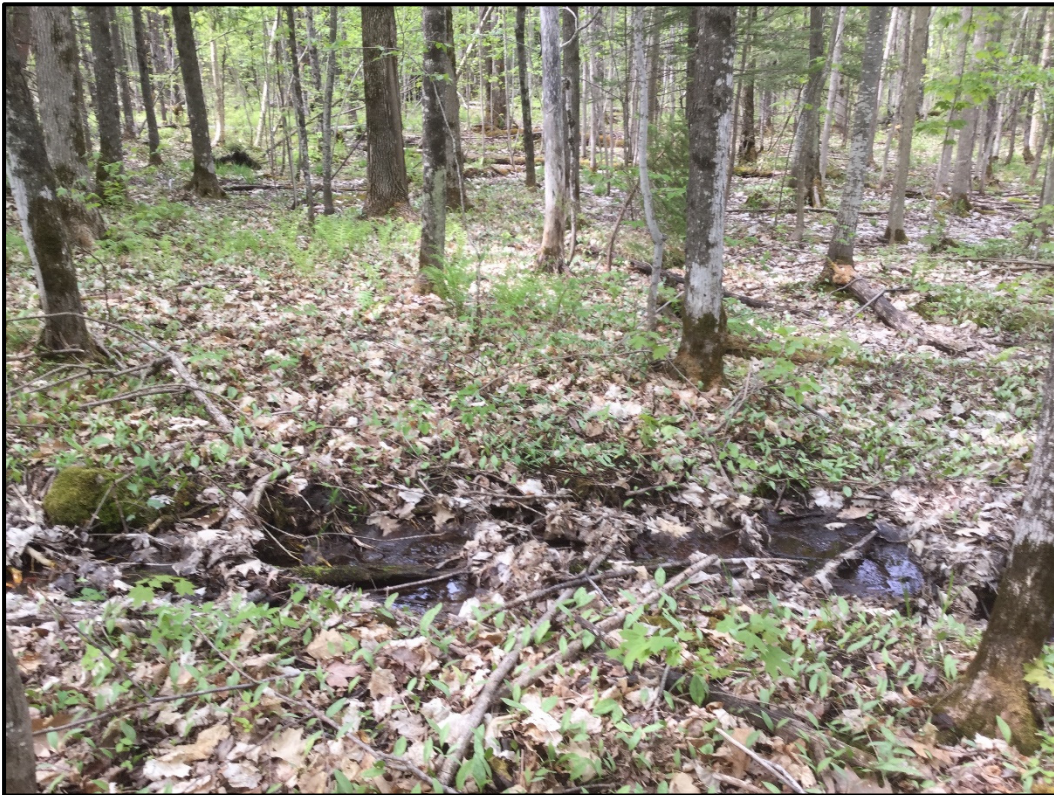
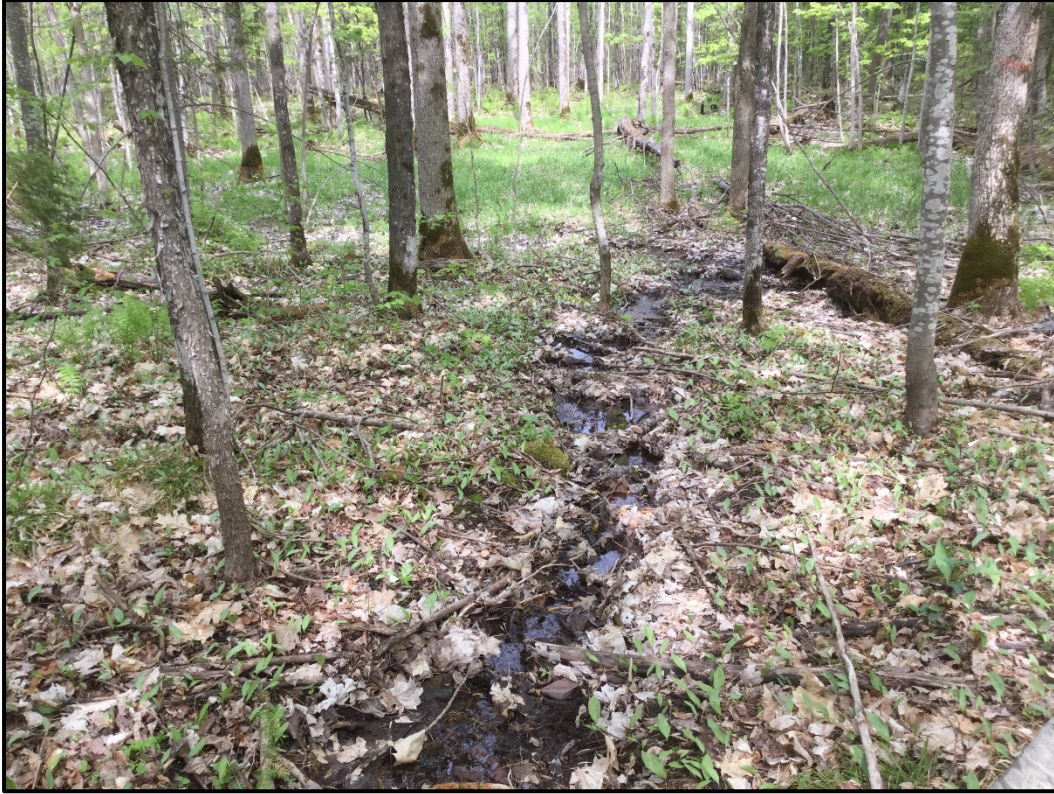
Existing Condition^a: <i>(check one)</i>	<input checked="" type="checkbox"/> Highly Functional Stream <input type="checkbox"/> Moderately Functional Stream <input type="checkbox"/> Functionally Impaired Stream		
Feature Description: <i>(check one)</i>	<input checked="" type="checkbox"/> Natural <input type="checkbox"/> Artificial, man-made <input type="checkbox"/> Manipulated		
Flow Regime: <i>(check one)</i>	<input checked="" type="checkbox"/> Ephemeral <input type="checkbox"/> Intermittent <input type="checkbox"/> Perennial <input type="checkbox"/> Connecting Swale		
Sinuosity within Survey Corridor: <i>(check one)</i>	<input type="checkbox"/> Straight <input checked="" type="checkbox"/> Meandering		
Description Notes: The stream is located within mesic hardwood forest, connecting two forested wetlands.			
Measurements			
Depth of Water: <0.25 ft. N/A <input type="checkbox"/> Unknown <input type="checkbox"/>		Water Edge to Water Edge: 1 ft. N/A <input type="checkbox"/>

Vegetation Layers: <input checked="" type="checkbox"/> Trees <input checked="" type="checkbox"/> Saplings/Shrubs <input checked="" type="checkbox"/> Herbs <i>(check all that apply)</i>			
Dominant Bank Vegetation (list): Ostrya virginiana, Fraxinus nigra, Erythronium americanum, Athyrium filix-femina, Matteuccia struthiopteris			
Aquatic Habitats (ex: submerged or emerged aquatic vegetation, overhanging banks/roots, leaf packs, large submerged wood, riffles, deep pools, etc.): Downed woody debris is present along the streambed.			
Aquatic Organisms Observed (list): American Toad, Wood Frog, Northern Leopard Frog.			
Disturbances (ex: livestock access, manure in waterbody, waste discharge pipes): Minor erosion is evident along the stream channel.			
Observation Notes: None.

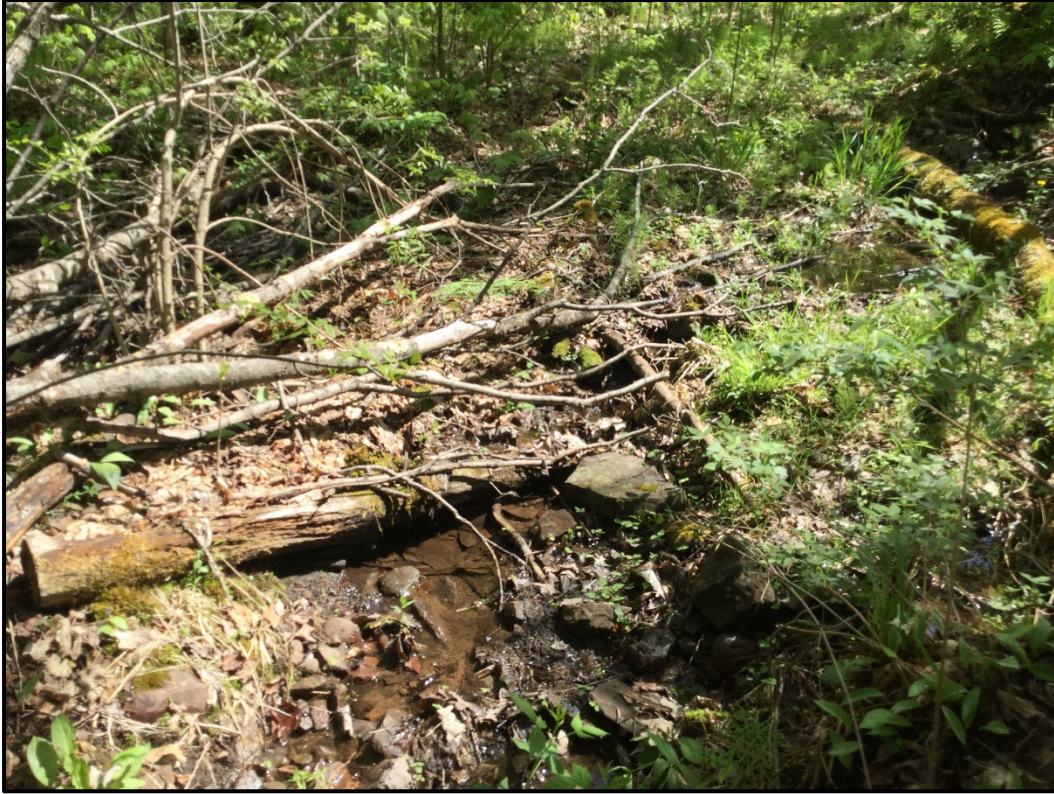
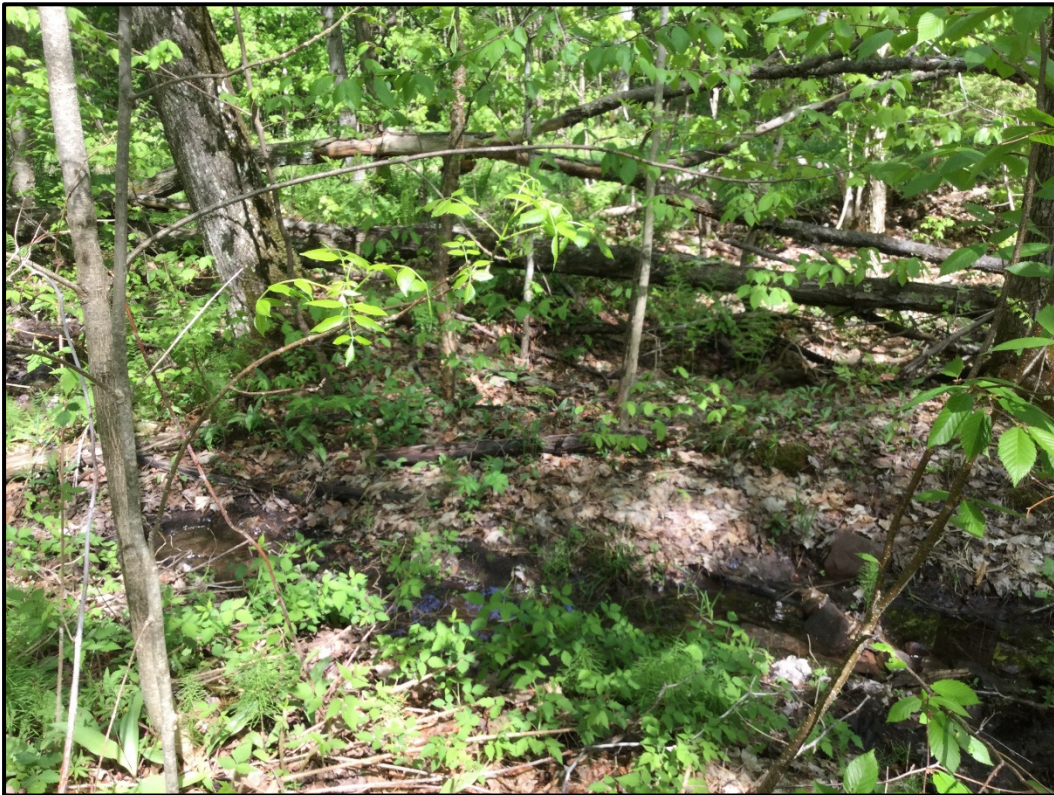
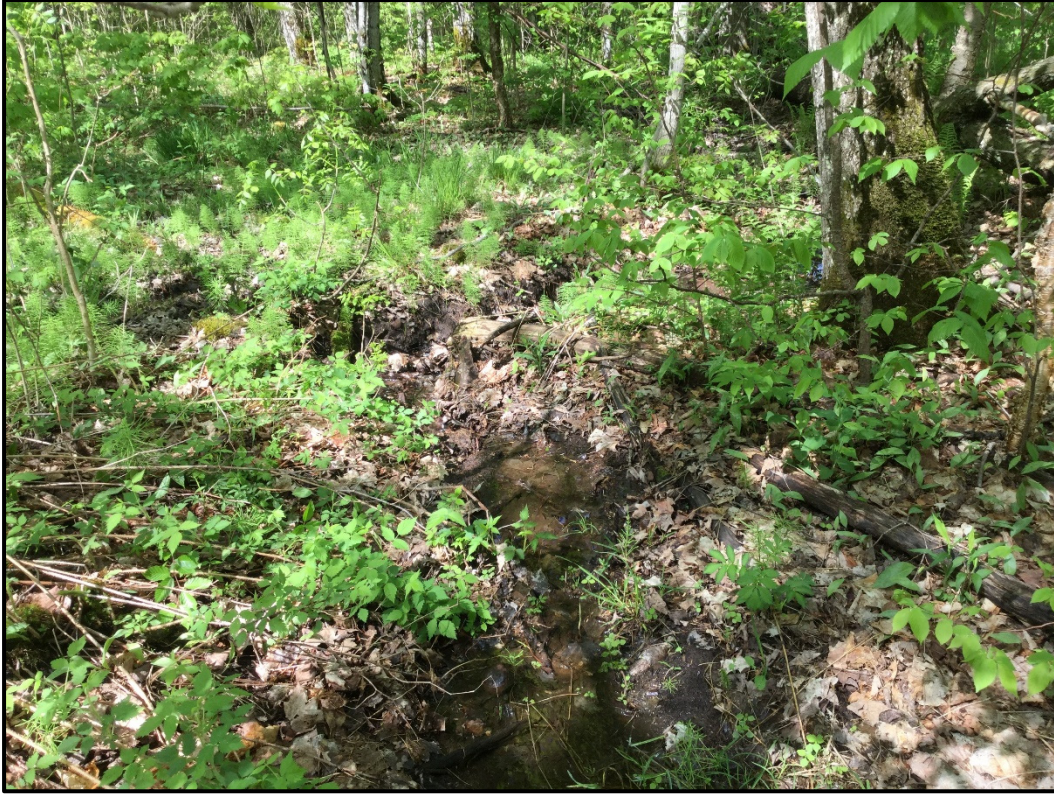
Existing Condition^a: <i>(check one)</i>	<input checked="" type="checkbox"/> Highly Functional Stream <input type="checkbox"/> Moderately Functional Stream <input type="checkbox"/> Functionally Impaired Stream		
Feature Description: <i>(check one)</i>	<input checked="" type="checkbox"/> Natural <input type="checkbox"/> Artificial, man-made <input type="checkbox"/> Manipulated		
Flow Regime: <i>(check one)</i>	<input checked="" type="checkbox"/> Ephemeral <input type="checkbox"/> Intermittent <input type="checkbox"/> Perennial <input type="checkbox"/> Connecting Swale		
Sinuosity within Survey Corridor: <i>(check one)</i>	<input type="checkbox"/> Straight <input checked="" type="checkbox"/> Meandering		
Description Notes: The feature is an ephemeral stream fed by discharge, flowing from a forested wetland.			
Measurements			
Depth of Water: <u>0.25</u> ft. N/A <input type="checkbox"/> Unknown <input type="checkbox"/>		Water Edge to Water Edge: <u>2</u> ft. N/A <input type="checkbox"/>

Vegetation Layers: <input checked="" type="checkbox"/> Trees <input checked="" type="checkbox"/> Saplings/Shrubs <input checked="" type="checkbox"/> Herbs <i>(check all that apply)</i>			
Dominant Bank Vegetation (list): Acer saccharum, Fraxinus nigra, Rubus idaeus, Equisetum pratense			
Aquatic Habitats (ex: submerged or emerged aquatic vegetation, overhanging banks/roots, leaf packs, large submerged wood, riffles, deep pools, etc.): Downed woody debris is present within the feature.			
Aquatic Organisms Observed (list): None.			
Disturbances (ex: livestock access, manure in waterbody, waste discharge pipes): Minor erosion evident along the shallow banks.			
Observation Notes: None.

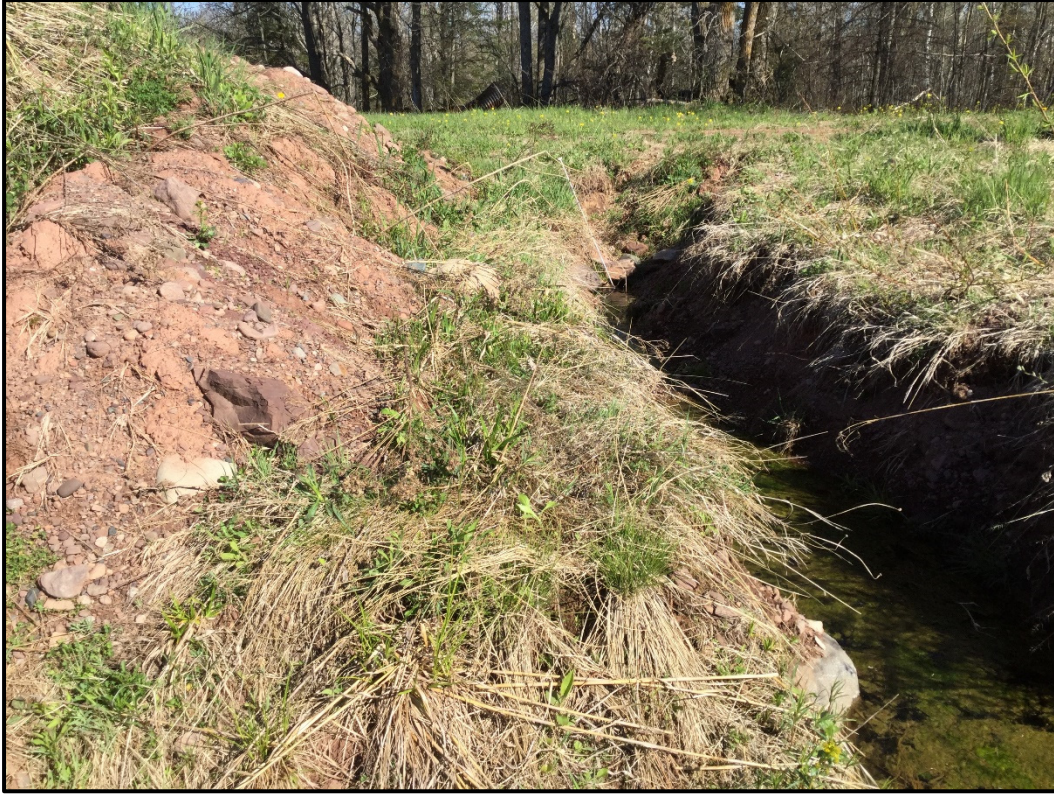
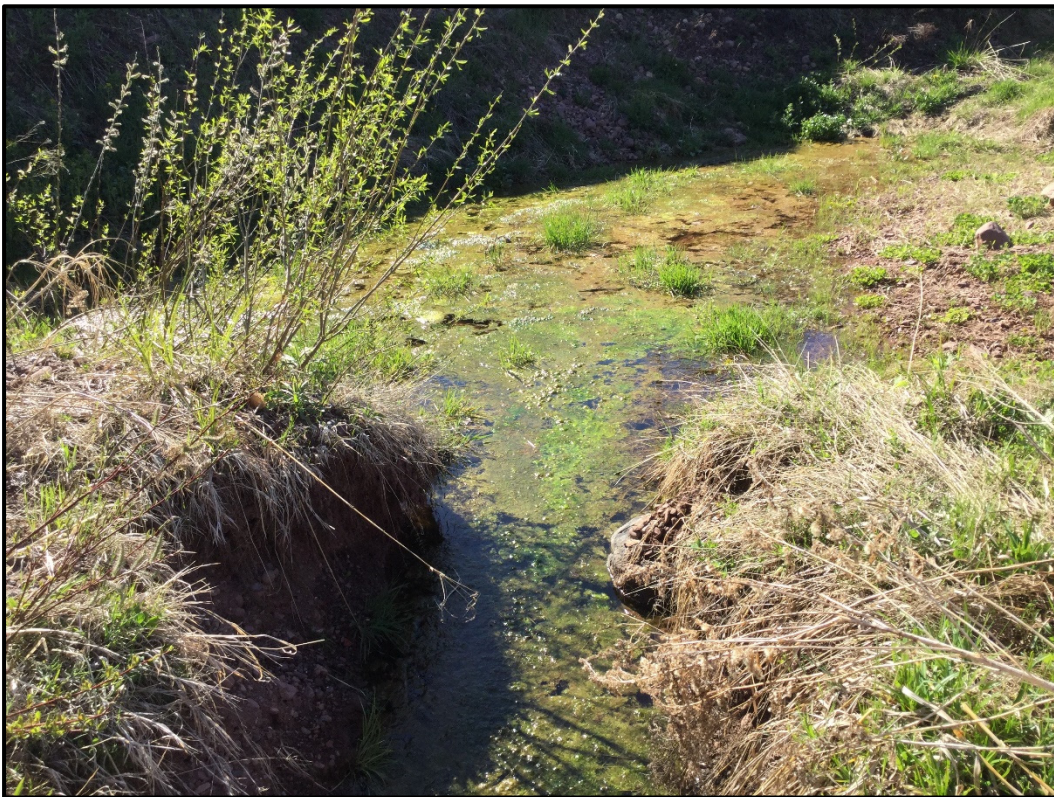
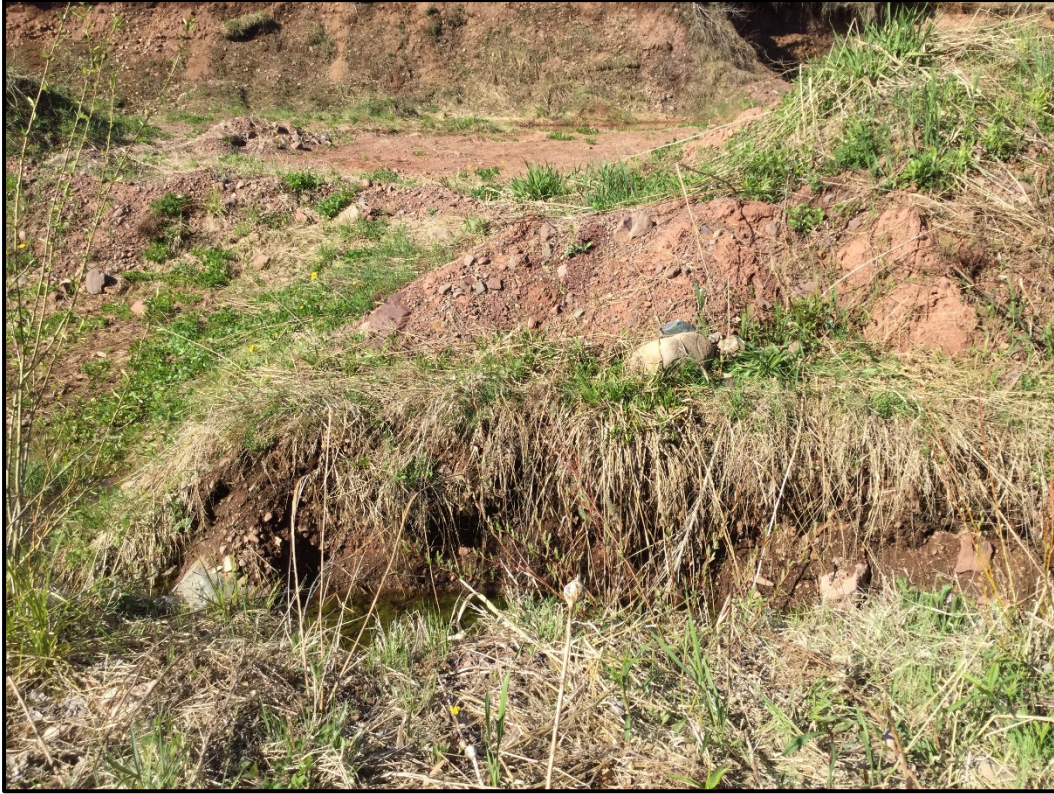
Existing Condition^a: <i>(check one)</i>	<input type="checkbox"/> Highly Functional Stream <input checked="" type="checkbox"/> Moderately Functional Stream <input type="checkbox"/> Functionally Impaired Stream		
Feature Description: <i>(check one)</i>	<input type="checkbox"/> Natural <input checked="" type="checkbox"/> Artificial, man-made <input type="checkbox"/> Manipulated		
Flow Regime: <i>(check one)</i>	<input checked="" type="checkbox"/> Ephemeral <input type="checkbox"/> Intermittent <input type="checkbox"/> Perennial <input type="checkbox"/> Connecting Swale		
Sinuosity within Survey Corridor: <i>(check one)</i>	<input type="checkbox"/> Straight <input checked="" type="checkbox"/> Meandering		
Description Notes: Feature is a small stream running through excavated area/gravel pit.			
Measurements			
Depth of Water: <u>0.5</u> ft. N/A <input type="checkbox"/> Unknown <input type="checkbox"/>		Water Edge to Water Edge: <u>2</u> ft. N/A <input type="checkbox"/>

Vegetation Layers: <input type="checkbox"/> Trees <input checked="" type="checkbox"/> Saplings/Shrubs <input checked="" type="checkbox"/> Herbs <i>(check all that apply)</i>			
Dominant Bank Vegetation (list): Salix sp., Plantago cf. lanceolata, Trifolium repens, Agrostis gigantea			
Aquatic Habitats (ex: submerged or emerged aquatic vegetation, overhanging banks/roots, leaf packs, large submerged wood, riffles, deep pools, etc.): Low quality pool present.			
Aquatic Organisms Observed (list): None observed.			
Disturbances (ex: livestock access, manure in waterbody, waste discharge pipes): Waterbody located within excavated gravel pit.			
Observation Notes: Feature runs through gravel pit, flows under culvert, and drains outside of survey area to forest to the north.
