Enbridge Line 5 Wisconsin Segment Relocation Project
2020 Wetland/Waterbody Datasheets Photograph Errors

On May 6, 2021, the Great Lakes Indian Fish and Wildlife Commission (GLIFWC) submitted a comment to the U.S. Army Corps of Engineers (USACE) identifying six stream datasheets where the photograph included with the data sheet did not appear to match the stream description. Environmental Resources Management (ERM), in coordination with Midwest Natural Resources Inc. (MNR), reviewed the six stream datasheets and determined that they contained the incorrect photographs. After reviewing the data, it was determined that the error was the result of an issue with a software program used to process the large number of photographs taken during the 2020 field surveys. After the error was identified, the entire 2020 dataset was reviewed, resulting in the identification of additional stream datasheets, wetland datasheets, and no-points that had the incorrect photographs included on the form.

Enbridge Line 5 Wetland/Waterbody Datasheet Photograph Corrections	
Streams	
Feature ID	Near Milepost
Sasb006p_x1	24.2
Sasb006p_x2	24.2
Sasb1003e	17.1
Sasb1004e	17.2
Sase006p_x	0.6
Sase1001e	9.3
Sase10

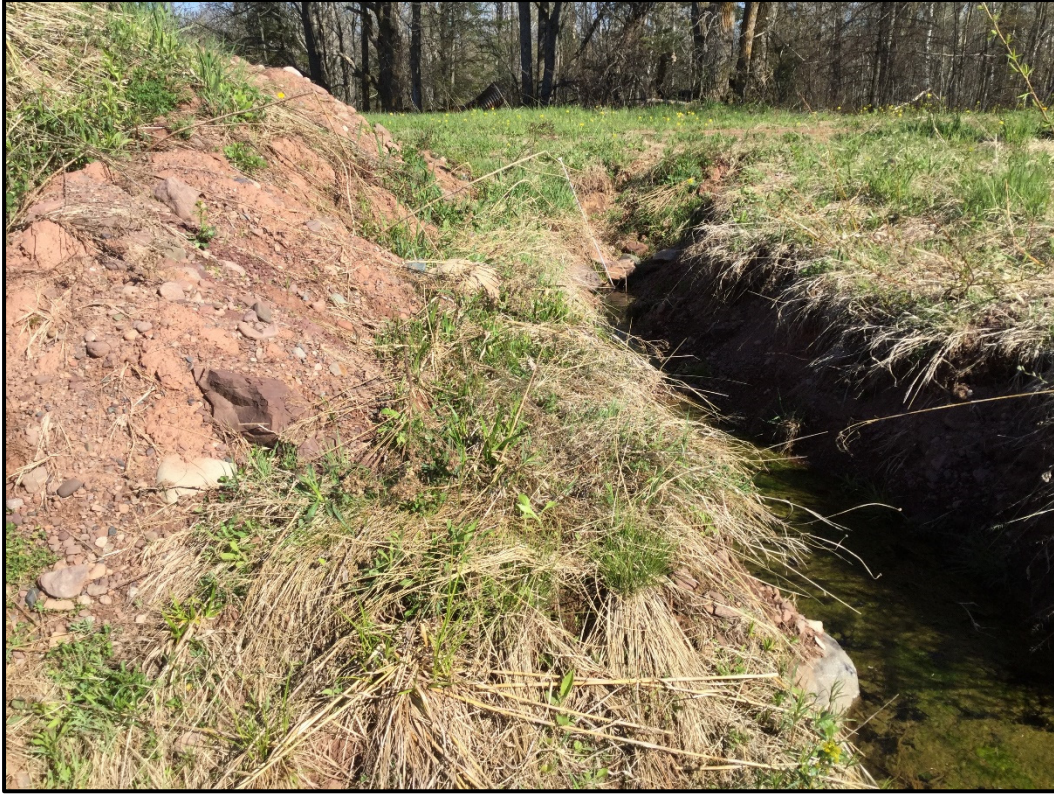
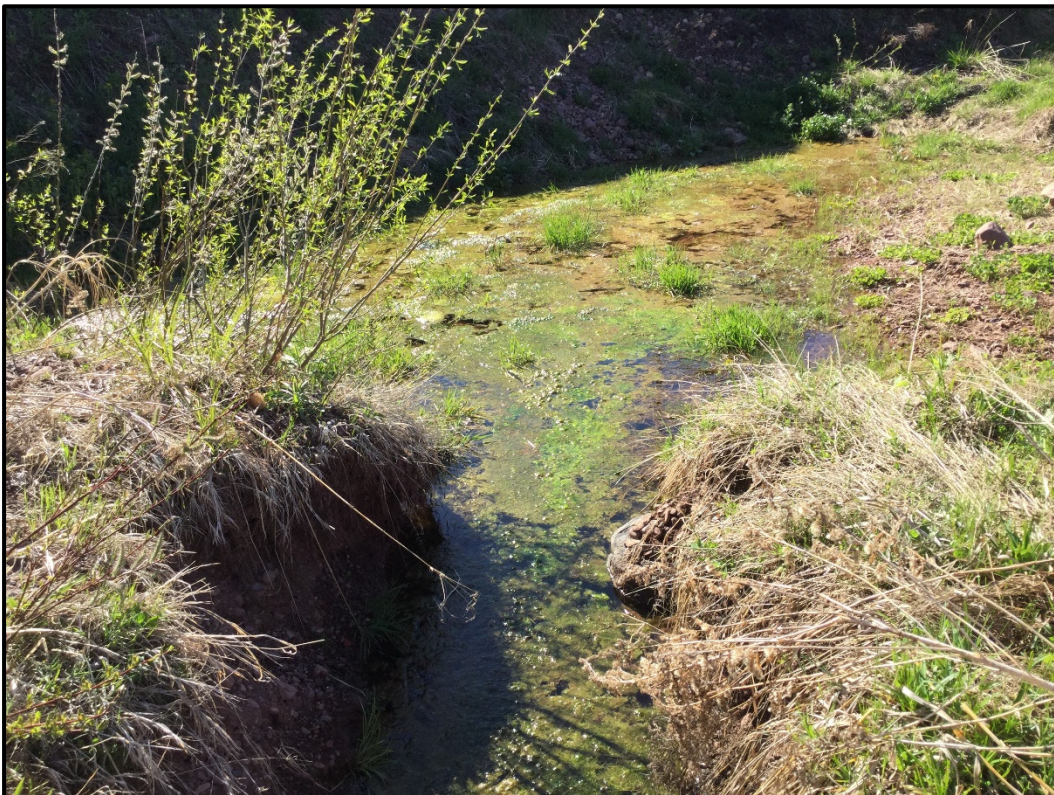
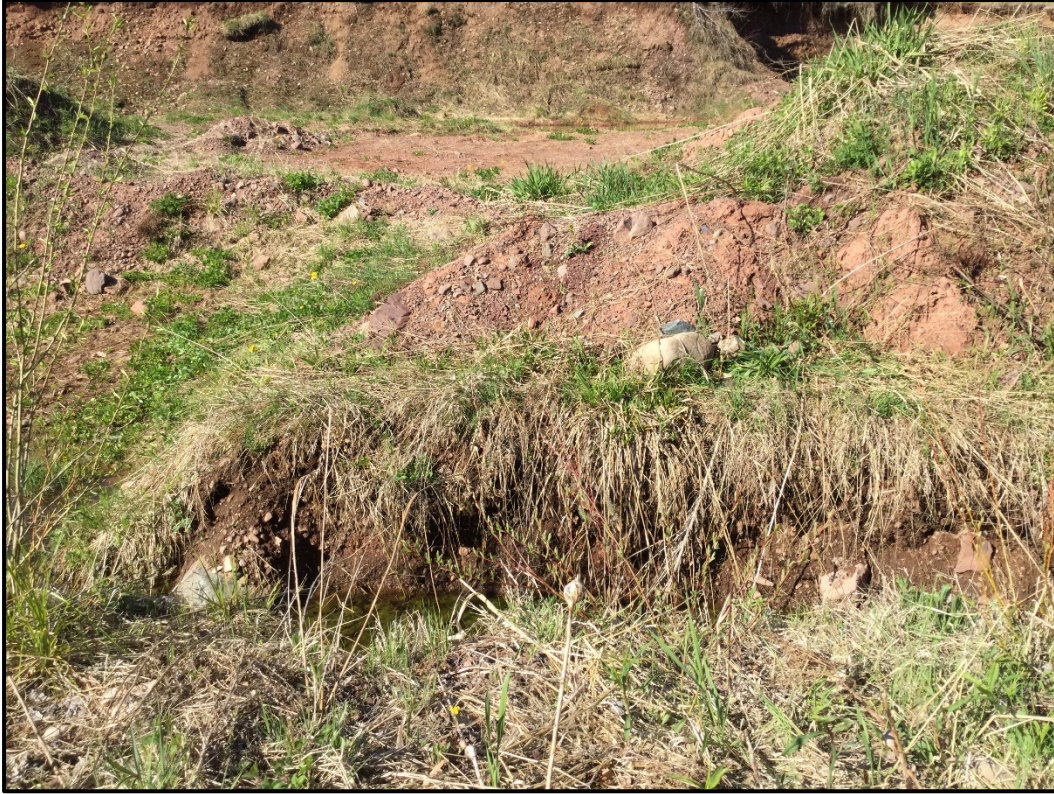
Existing Condition^a: <small>(check one)</small> <input type="checkbox"/> Highly Functional Stream <input checked="" type="checkbox"/> Moderately Functional Stream <input type="checkbox"/> Functionally Impaired Stream			
Feature Description: <small>(check one)</small> <input type="checkbox"/> Natural <input checked="" type="checkbox"/> Artificial, man-made <input type="checkbox"/> Manipulated			
Flow Regime: <small>(check one)</small> <input checked="" type="checkbox"/> Ephemeral <input type="checkbox"/> Intermittent <input type="checkbox"/> Perennial <input type="checkbox"/> Connecting Swale			
Sinuosity within Survey Corridor: <small>(check one)</small> <input type="checkbox"/> Straight <input checked="" type="checkbox"/> Meandering			
Description Notes: Feature is a small stream running through excavated area/gravel pit.			
Measurements			
Depth of Water: <u>0.5</u> ft. N/A <input type="checkbox"/> Unknown <input type="checkbox"/>		Water Edge to Water Edge: <u>2</u> ft. N/A <input type="checkbox"/>

Vegetation Layers: <small>(check all that apply)</small> <input type="checkbox"/> Trees <input checked="" type="checkbox"/> Saplings/Shrubs <input checked="" type="checkbox"/> Herbs			
Dominant Bank Vegetation (list): Salix sp., Plantago cf. lanceolata, Trifolium repens, Agrostis gigantea			
Aquatic Habitats (ex: submerged or emerged aquatic vegetation, overhanging banks/roots, leaf packs, large submerged wood, riffles, deep pools, etc.): Low quality pool present.			
Aquatic Organisms Observed (list): None observed.			
Disturbances (ex: livestock access, manure in waterbody, waste discharge pipes): Waterbody located within excavated gravel pit.			
Observation Notes: Feature runs through gravel pit, flows under culvert, and drains outside of survey area to forest to the north.

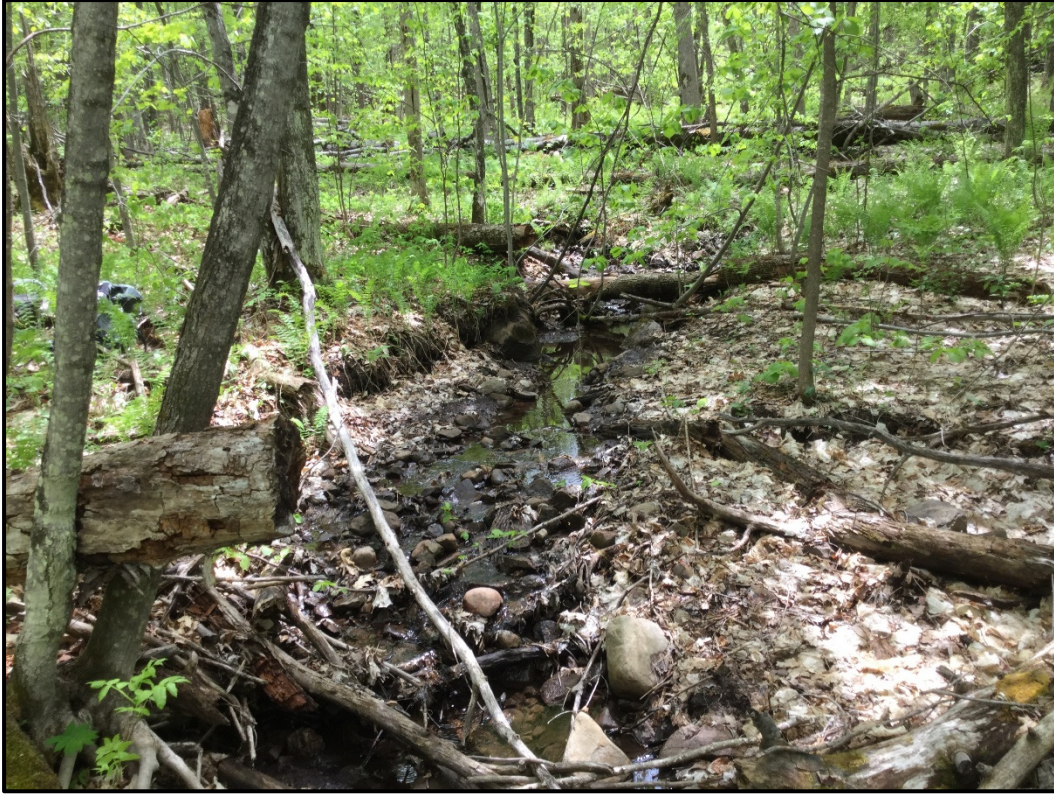
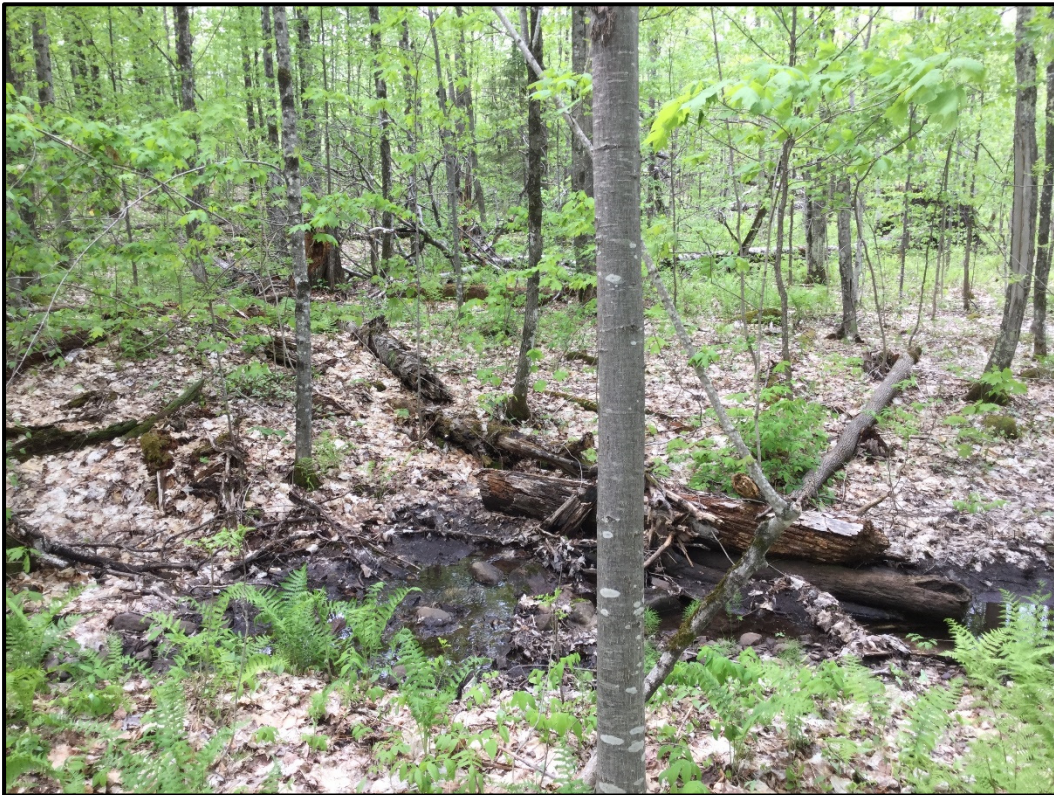
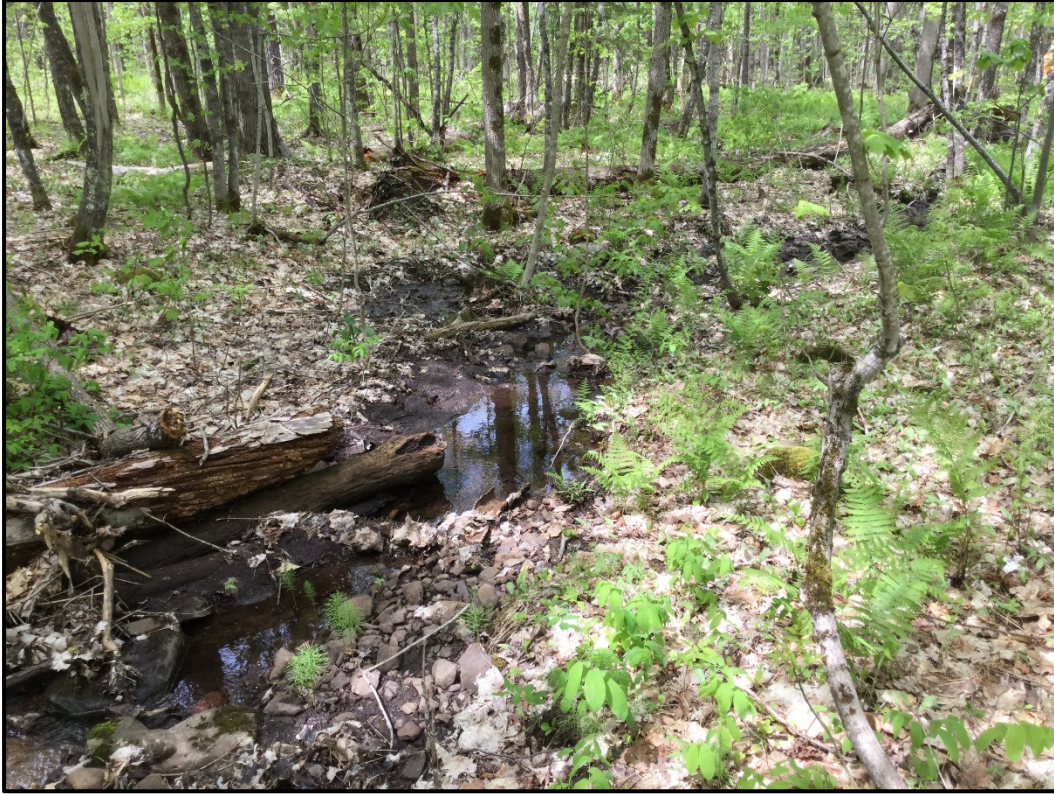
Existing Condition^a: <i>(check one)</i>	<input type="checkbox"/> Highly Functional Stream <input checked="" type="checkbox"/> Moderately Functional Stream <input type="checkbox"/> Functionally Impaired Stream		
Feature Description: <i>(check one)</i>	<input checked="" type="checkbox"/> Natural <input type="checkbox"/> Artificial, man-made <input type="checkbox"/> Manipulated		
Flow Regime: <i>(check one)</i>	<input type="checkbox"/> Ephemeral <input checked="" type="checkbox"/> Intermittent <input type="checkbox"/> Perennial <input type="checkbox"/> Connecting Swale		
Sinuosity within Survey Corridor: <i>(check one)</i>	<input type="checkbox"/> Straight <input checked="" type="checkbox"/> Meandering		
Description Notes: Intermittent feature meandering through a large forested wetland.			
Measurements			
Depth of Water: <u>0.75</u> ft. N/A <input type="checkbox"/> Unknown <input type="checkbox"/>		Water Edge to Water Edge: <u>1.5</u> ft. N/A <input type="checkbox"/>

Vegetation Layers: <input checked="" type="checkbox"/> Trees <input checked="" type="checkbox"/> Saplings/Shrubs <input checked="" type="checkbox"/> Herbs <i>(check all that apply)</i>			
Dominant Bank Vegetation (list): Athyrium filix-femina, Acer rubrum, Fraxinus nigra			
Aquatic Habitats (ex: submerged or emerged aquatic vegetation, overhanging banks/roots, leaf packs, large submerged wood, riffles, deep pools, etc.): None.			
Aquatic Organisms Observed (list): None.			
Disturbances (ex: livestock access, manure in waterbody, waste discharge pipes): None.			
Observation Notes: None.

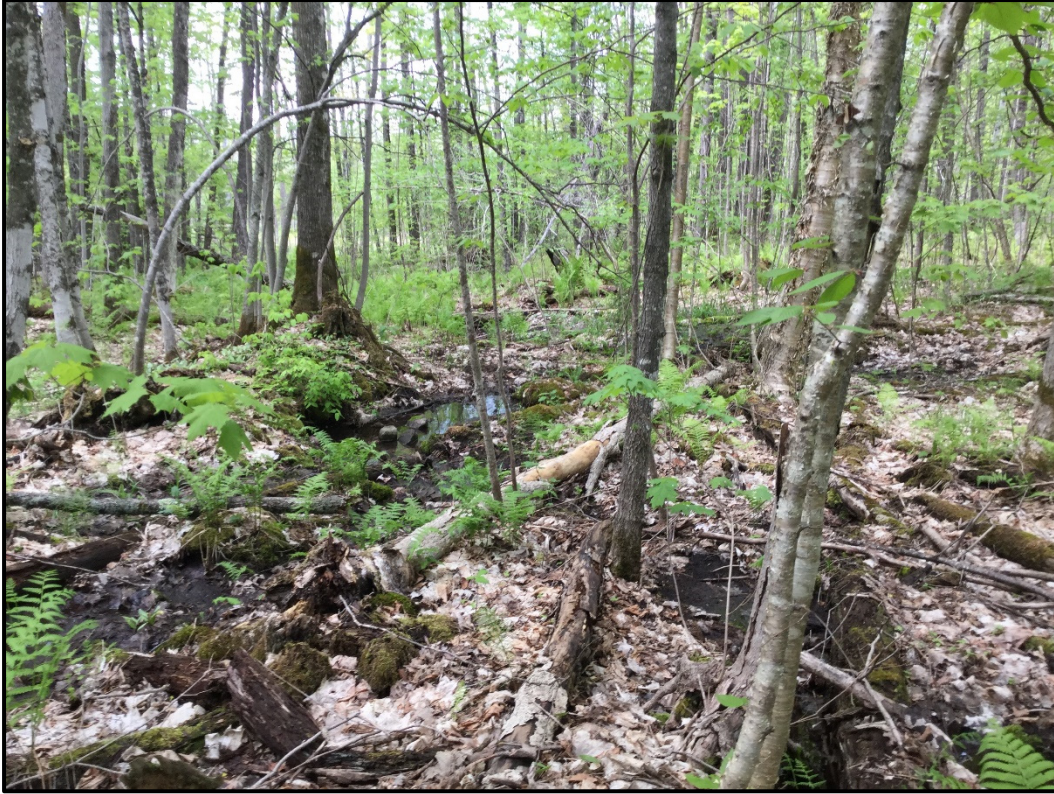
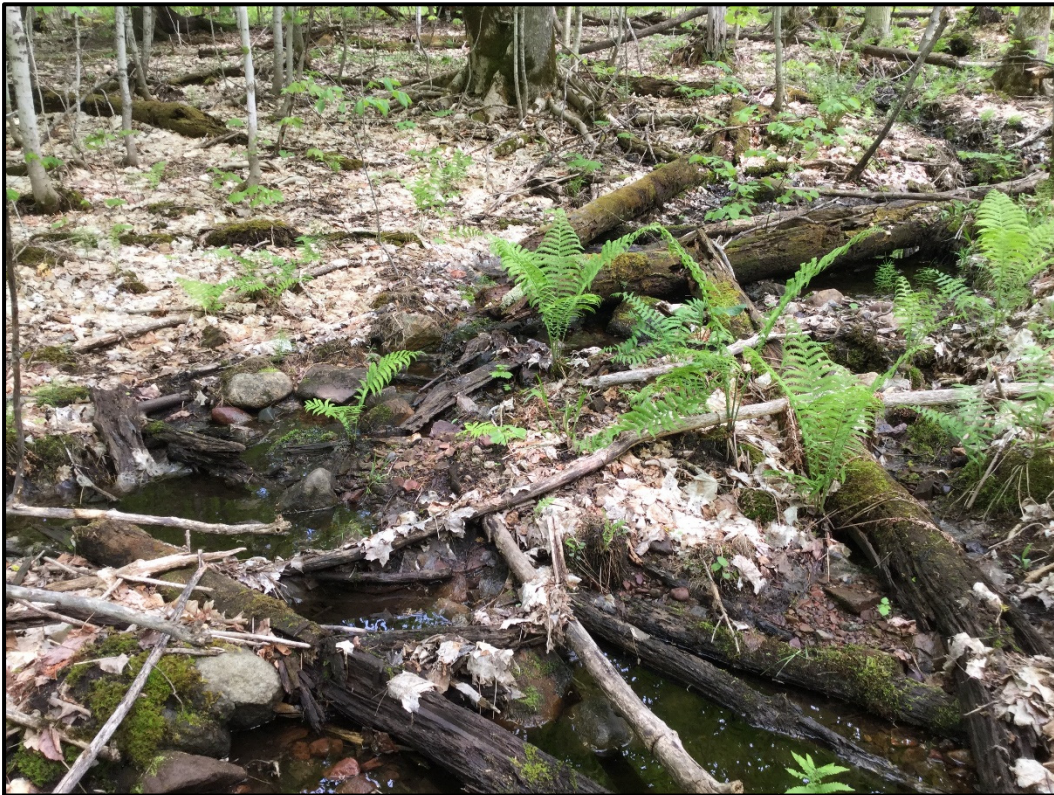
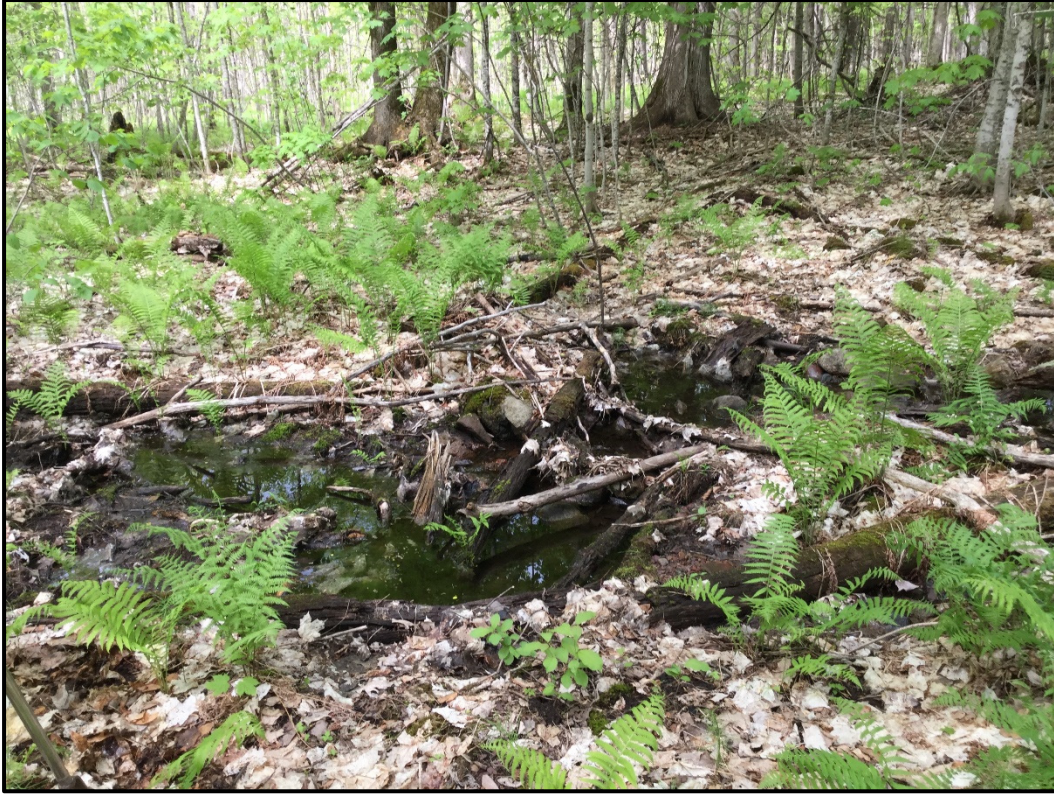
Existing Condition^a: <i>(check one)</i>	<input type="checkbox"/> Highly Functional Stream <input checked="" type="checkbox"/> Moderately Functional Stream <input type="checkbox"/> Functionally Impaired Stream		
Feature Description: <i>(check one)</i>	<input checked="" type="checkbox"/> Natural <input type="checkbox"/> Artificial, man-made <input type="checkbox"/> Manipulated		
Flow Regime: <i>(check one)</i>	<input type="checkbox"/> Ephemeral <input checked="" type="checkbox"/> Intermittent <input type="checkbox"/> Perennial <input type="checkbox"/> Connecting Swale		
Sinuosity within Survey Corridor: <i>(check one)</i>	<input type="checkbox"/> Straight <input checked="" type="checkbox"/> Meandering		
Description Notes: The intermittent stream is located within mesic hardwood forest and fed by discharge from an adjacent forested wetland.			
Measurements			
Depth of Water: <u>0.25</u> ft. N/A <input type="checkbox"/> Unknown <input type="checkbox"/>		Water Edge to Water Edge: <u>3</u> ft. N/A <input type="checkbox"/>

Vegetation Layers: <input checked="" type="checkbox"/> Trees <input checked="" type="checkbox"/> Saplings/Shrubs <input checked="" type="checkbox"/> Herbs <i>(check all that apply)</i>			
Dominant Bank Vegetation (list): Betula alleghaniensis, Matteuccia struthiopteris, Fraxinus nigra, Athyrium filix-femina			
Aquatic Habitats (ex: submerged or emerged aquatic vegetation, overhanging banks/roots, leaf packs, large submerged wood, riffles, deep pools, etc.): Downed woody debris and small pools are present within the feature.			
Aquatic Organisms Observed (list): Frogs.			
Disturbances (ex: livestock access, manure in waterbody, waste discharge pipes): Erosion of banks is more evident along the north end of the feature.			
Observation Notes: None.

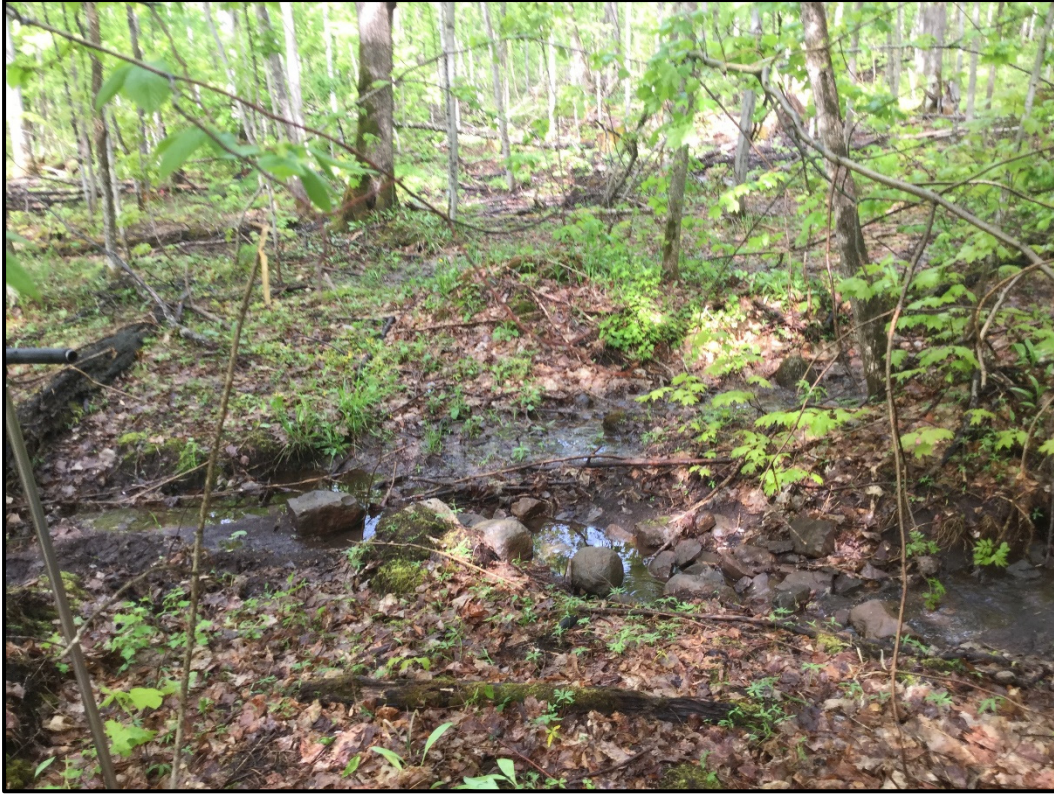
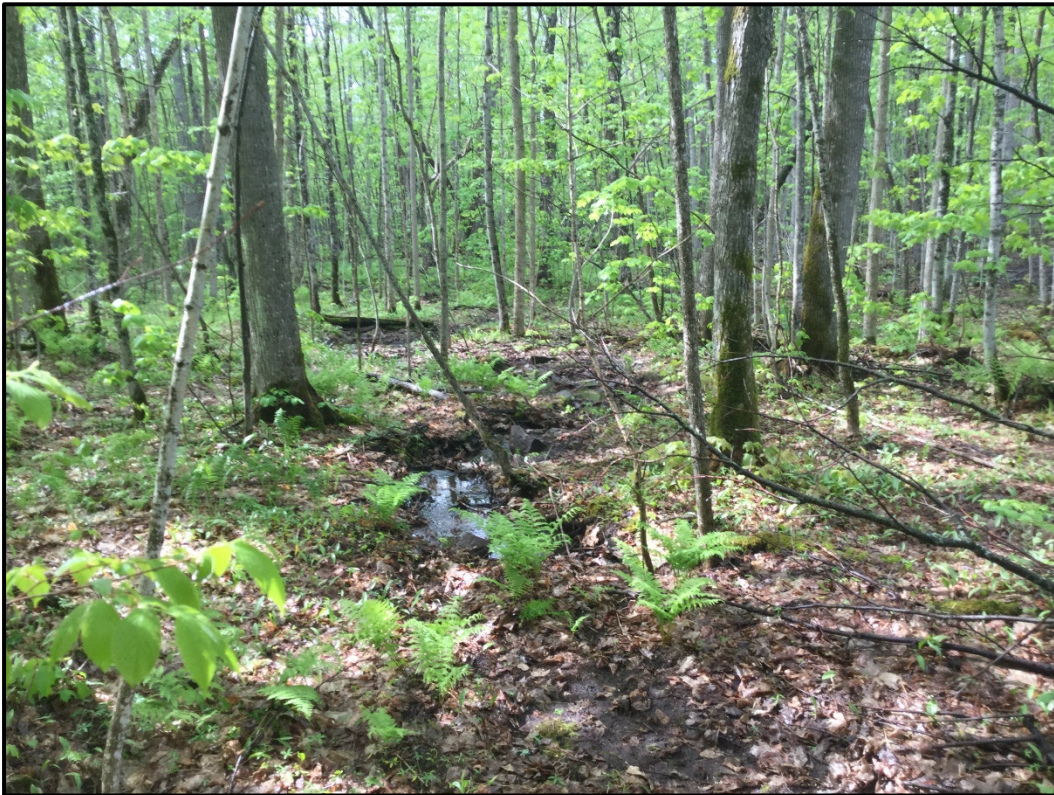
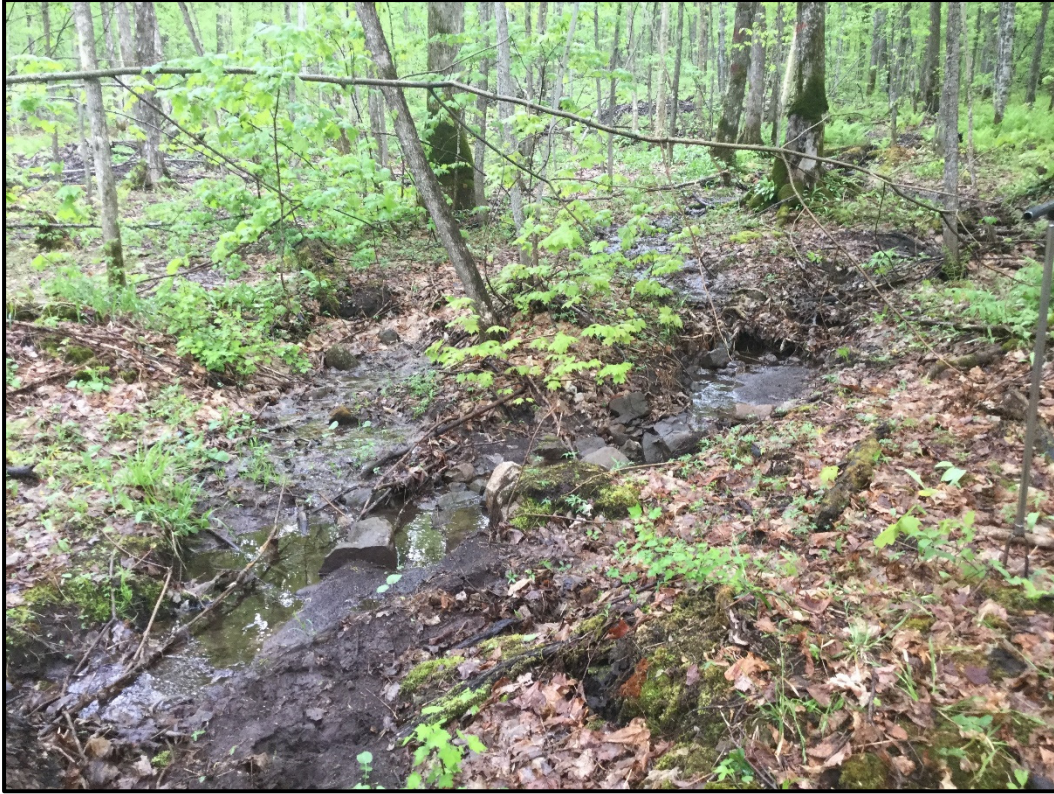
Existing Condition^a: <i>(check one)</i>	<input type="checkbox"/> Highly Functional Stream <input checked="" type="checkbox"/> Moderately Functional Stream <input type="checkbox"/> Functionally Impaired Stream		
Feature Description: <i>(check one)</i>	<input checked="" type="checkbox"/> Natural <input type="checkbox"/> Artificial, man-made <input type="checkbox"/> Manipulated		
Flow Regime: <i>(check one)</i>	<input checked="" type="checkbox"/> Ephemeral <input type="checkbox"/> Intermittent <input type="checkbox"/> Perennial <input type="checkbox"/> Connecting Swale		
Sinuosity within Survey Corridor: <i>(check one)</i>	<input type="checkbox"/> Straight <input checked="" type="checkbox"/> Meandering		
Description Notes: The ephemeral stream is located within mesic hardwood forest flowing through a forested wetland and fed by discharge.			
Measurements			
Depth of Water: <u>0.25</u> ft. N/A <input type="checkbox"/> Unknown <input type="checkbox"/>		Water Edge to Water Edge: <u>1</u> ft. N/A <input type="checkbox"/>

Vegetation Layers: <input checked="" type="checkbox"/> Trees <input checked="" type="checkbox"/> Saplings/Shrubs <input checked="" type="checkbox"/> Herbs <i>(check all that apply)</i>			
Dominant Bank Vegetation (list): Fraxinus nigra, Ostrya virginiana, Athyrium filix-femina, Erythronium americanum			
Aquatic Habitats (ex: submerged or emerged aquatic vegetation, overhanging banks/roots, leaf packs, large submerged wood, riffles, deep pools, etc.): Downed woody debris is present within the feature.			
Aquatic Organisms Observed (list): None.			
Disturbances (ex: livestock access, manure in waterbody, waste discharge pipes): Minor bank erosion is evident in areas of the stream.			
Observation Notes: None.

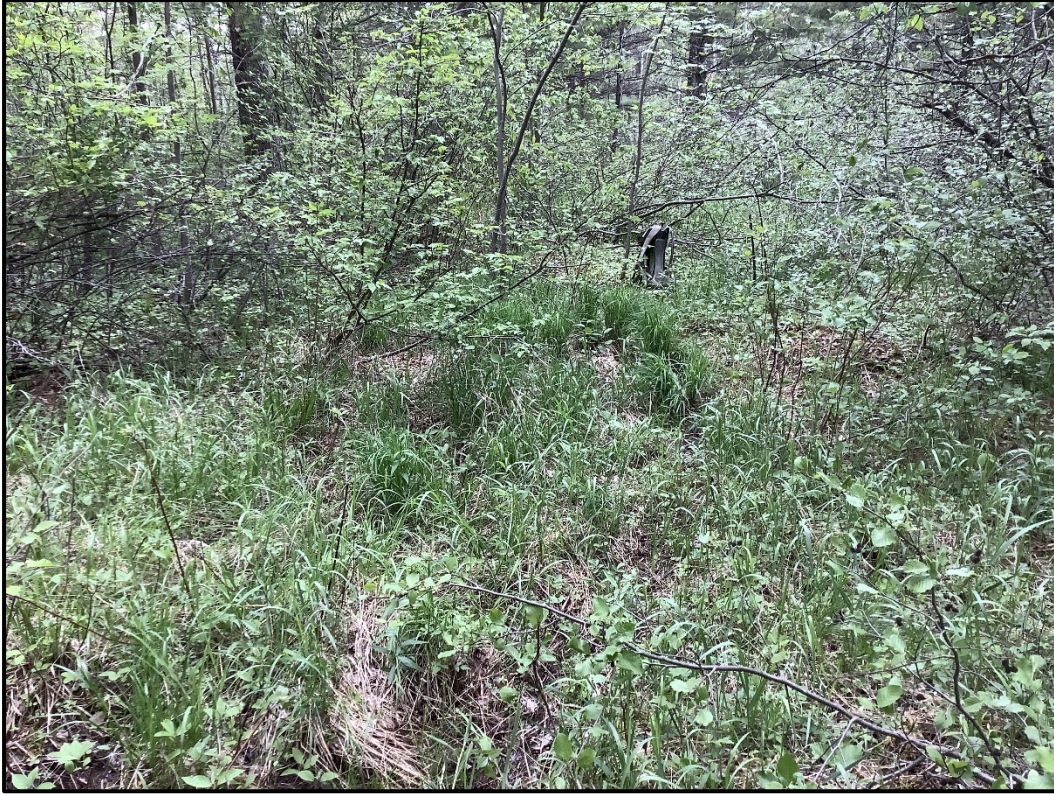
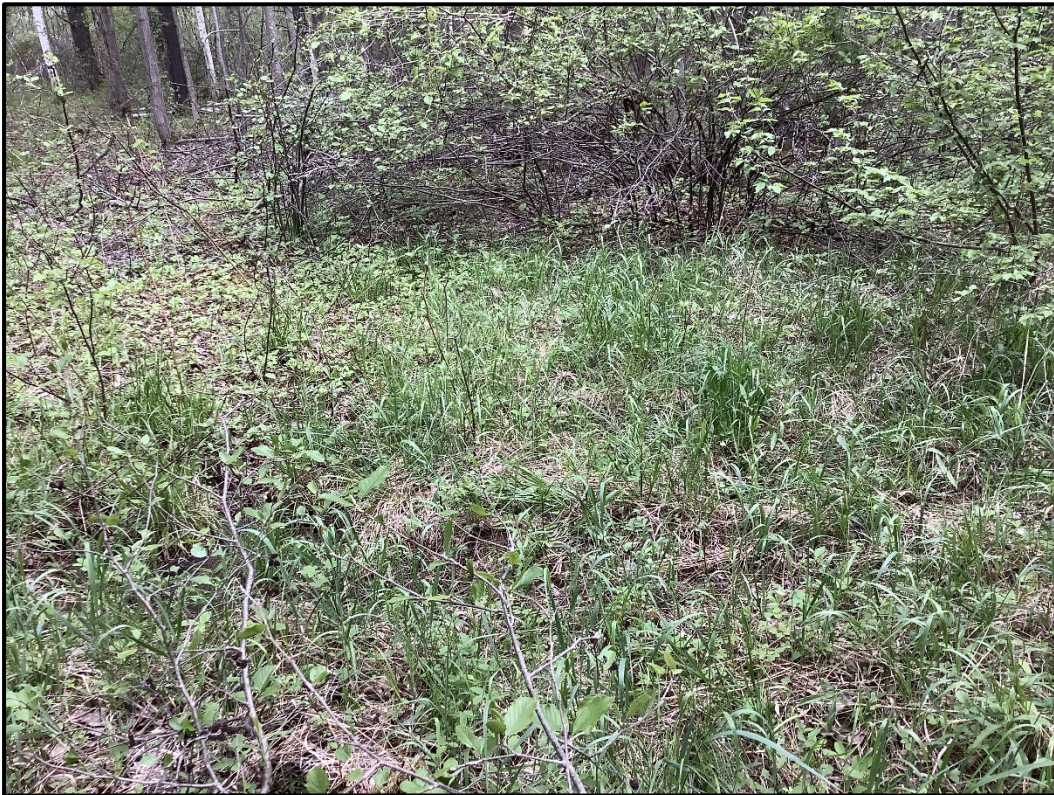
1. _____	_____	_____	_____	
2. _____	_____	_____	_____	
3. _____	_____	_____	_____	
4. _____	_____	_____	_____	
<u>0</u> = Total Cover				
Remarks: (Include photo numbers here or on a separate sheet.) The vegetation is representative of the wetland. Red maple, black ash, quaking aspen, and paper birch trees are overhanging the wetland, but are not rooted within it.

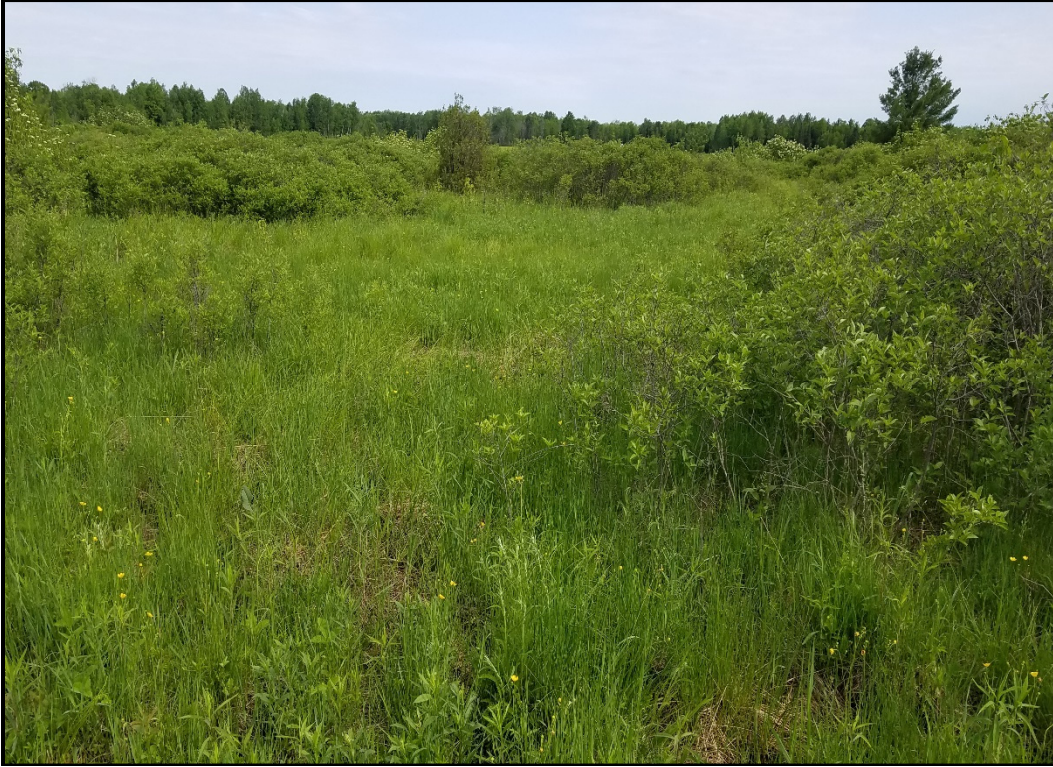
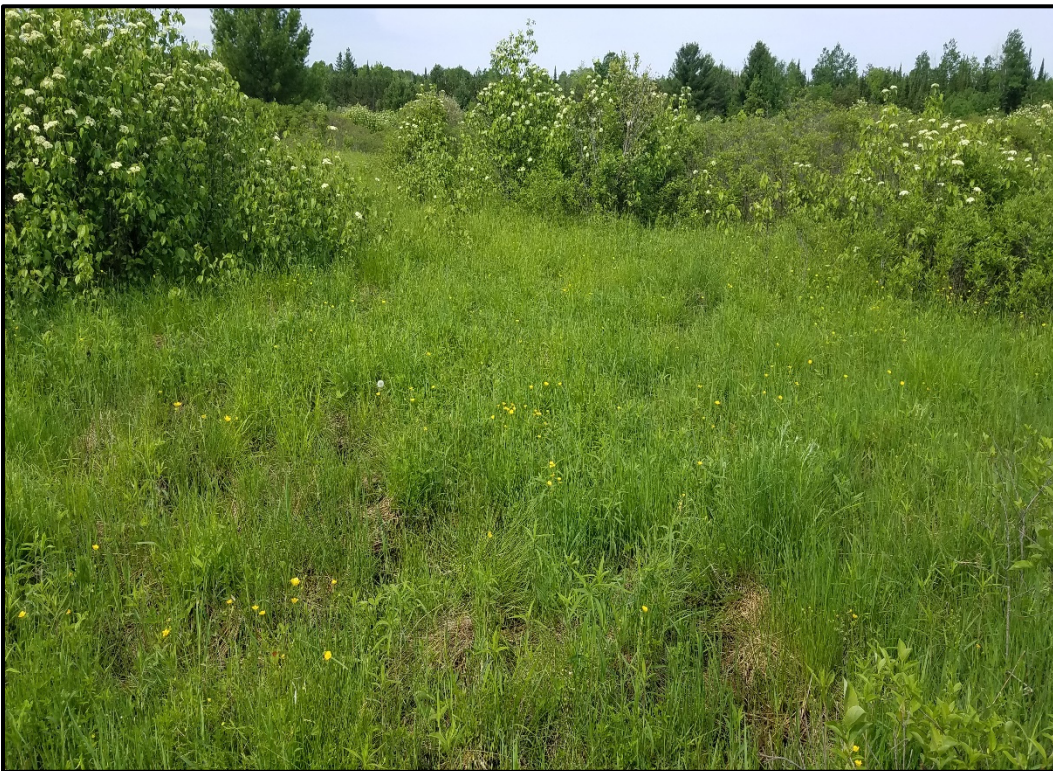
Remarks:
Clay with redox.

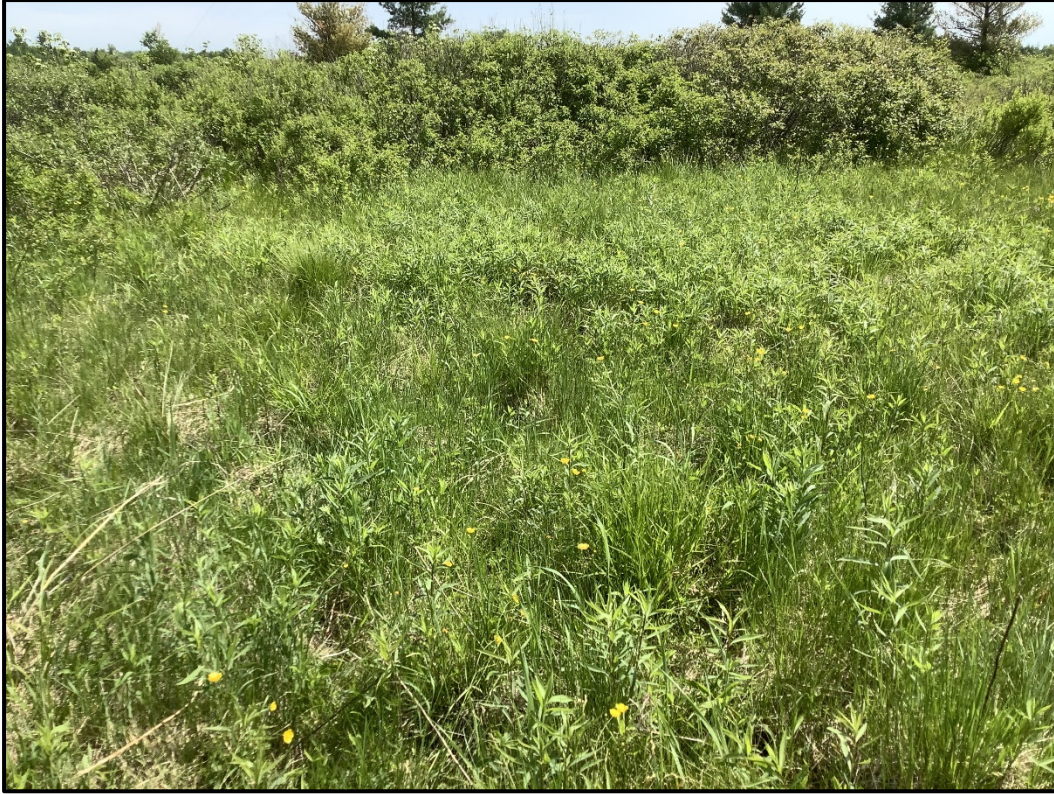
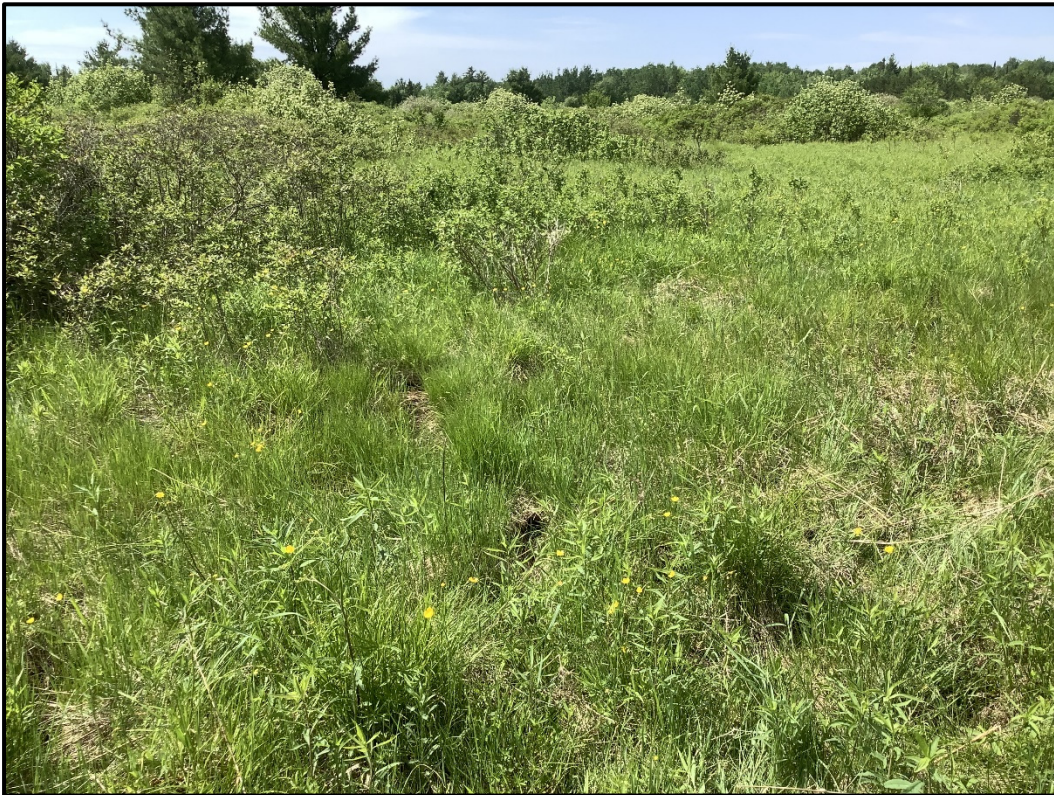
Remarks:
Seasonally saturated depression. Water table observed at 20 inches below surface.
