Appendix A Correspondence and Coordination Pigs Eye Lake Ramsey County, MN Section 204

Feasibility Study Report with Integrated Environmental Assessment

St. Paul District U.S. Army Corps of Engineers May 2018 (This Page Intentionally Left Blank)

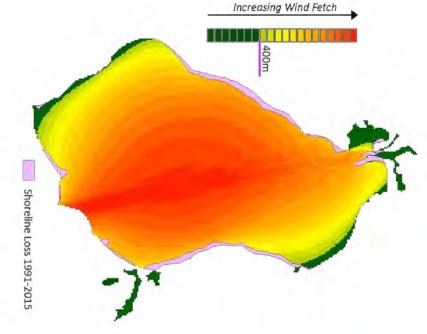
First, the baseline conditions were examined to assess the associations between current wind fetch levels and shoreline loss. Figure 2 shows the weighted wind fetch of the existing conditions and the areas which have experienced shoreline erosion in the last 24 years. Shorelines exhibiting weighted wind fetch values of less than 400m did not experience significant shoreline loss during this

Figure 2 – Existing Conditions. Weighted wind fetch values overlain with areas which have experienced shoreline loss. Note that the weighted wind fetch is greater than 400m in the areas where shoreline loss has occurred.

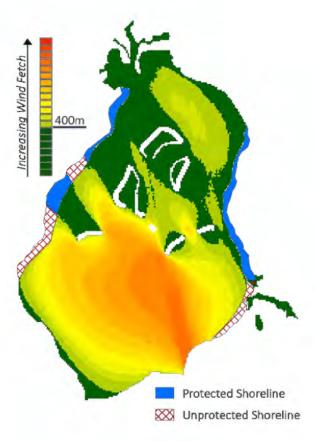
Wind fetch model results for each FWP alternative were evaluated along the two most vulnerable shorelines (along the east and west, shown in Figure 3). Shorelines where weighted wind fetch would be reduced below 400m were considered 'protected'. Shorelines where weighted wind fetch would remain above 400m were considered 'unprotected'. For each alternative, the annual FWOP shoreline loss (0.75 acres/year) was multiplied by the percentage of vulnerable shoreline that would remain 'unprotected,' resulting in the predicted FWP annual shoreline loss. The predicted annual shoreline loss rate was annualized throughout the planning period to calculate the AAHU gain for each alternative under the marsh wren HSI model.

Figure 3 – Shorelines with greater than 400m weighted wind fetch were assumed to be 'unprotected' and would continue to experience erosion under project conditions. Pictured above is Alternative 6m. Proposed islands are shown in white.

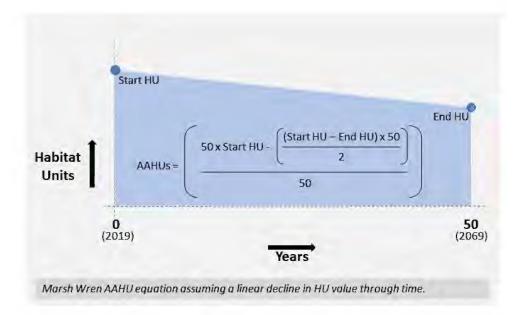
AAHUs for the Marsh Wren model were calculated using the equation displayed in the figure below:

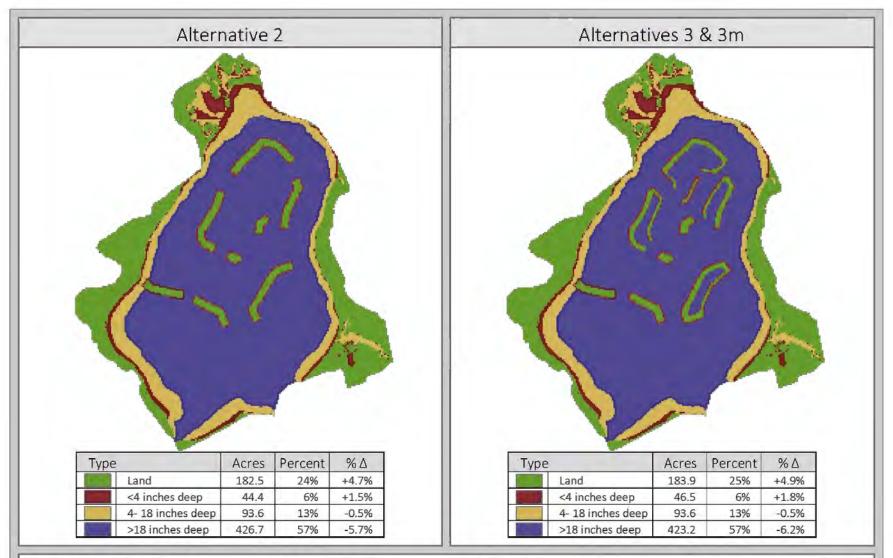
Dabbling Duck Migration Model: Existing and Projected Fall Inundation Levels

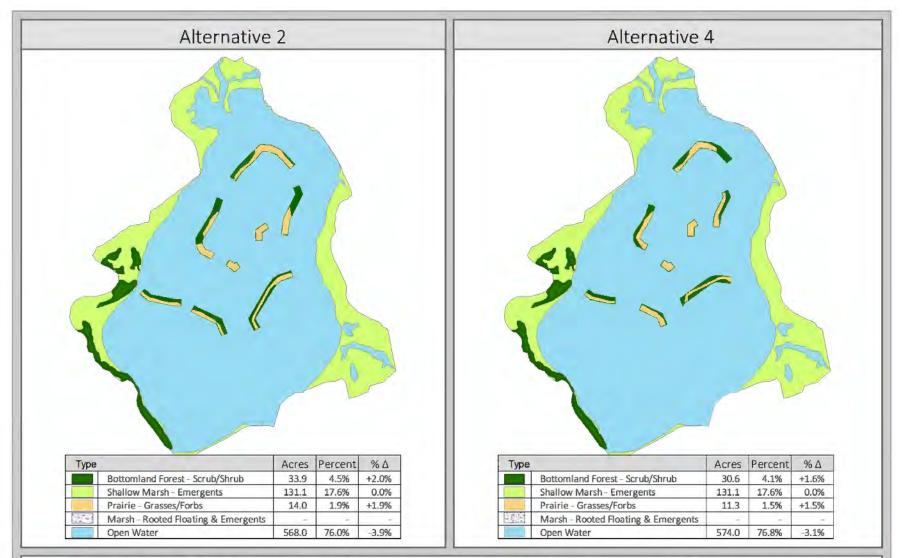
Broad and approximate locations of the vegetation communities in the project area are shown. Boundaries were delineated using a combination of on-site observation and interpretation from aerial imagery from multiple years and sources. Vegetation community grouping was based on criteria provided for Variable #6 of the Dabling Duck Migration Habitat Model (Devendorf 2013).

Dabbling Duck Migration Model: Projected Vegetation Communities

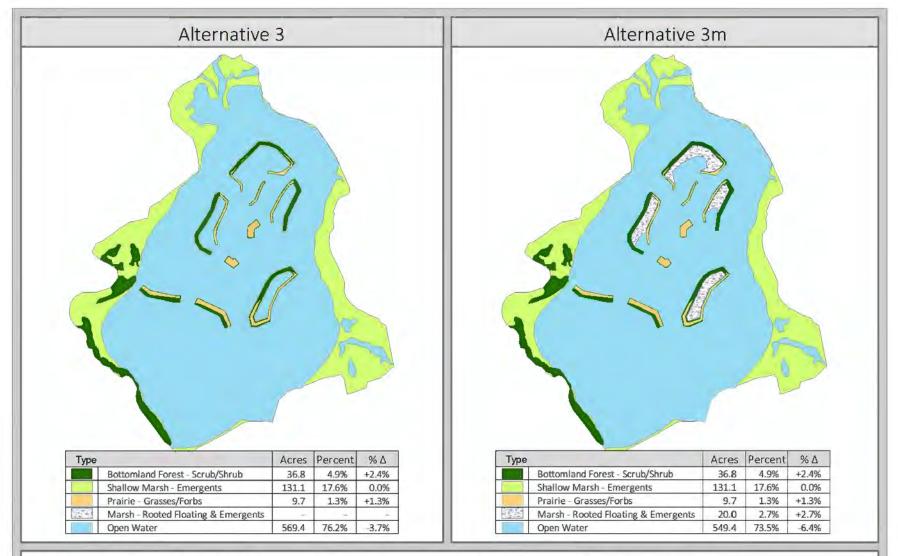
L. Paul District switchmeetral. 0 0.25 0.5 1 of Engineera Miles Broad and approximate locations of the vegetation communities in the project area are shown. Boundaries were delineated using a combination of on-site observation and interpretation from aerial imagery from multiple years and sources. Vegetation community grouping was based on criteria provided for Variable #6 of the Dabling Duck Migration Habitat Model (Devendorf 2013).

Dabbling Duck Migration Model: Projected Vegetation Communities

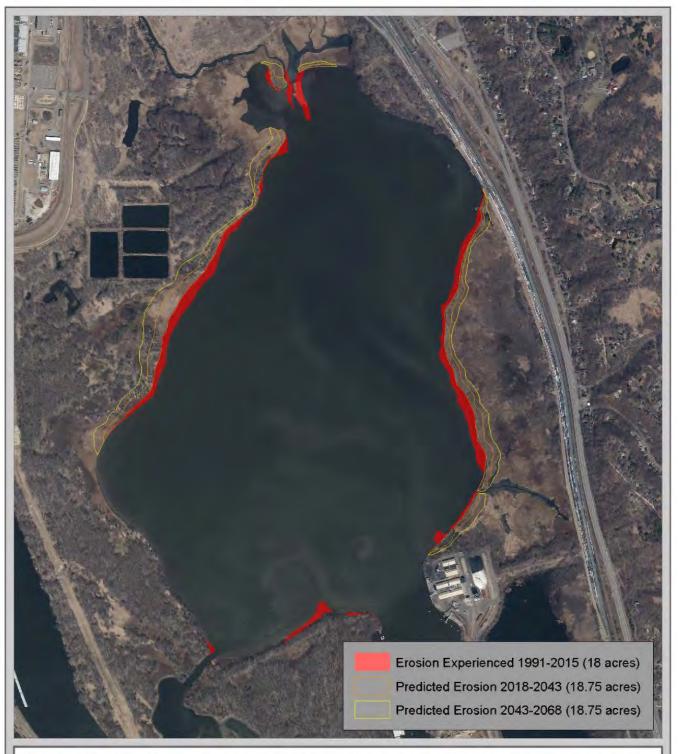
Shoreline Erosion - Predicted Future Without Project Conditions Pigs Eye Lake Section 204 Beneficial Use of Dredged Material In the absense of a project, the shoreline of Pig's Eye Lake is predicted to lose approximately

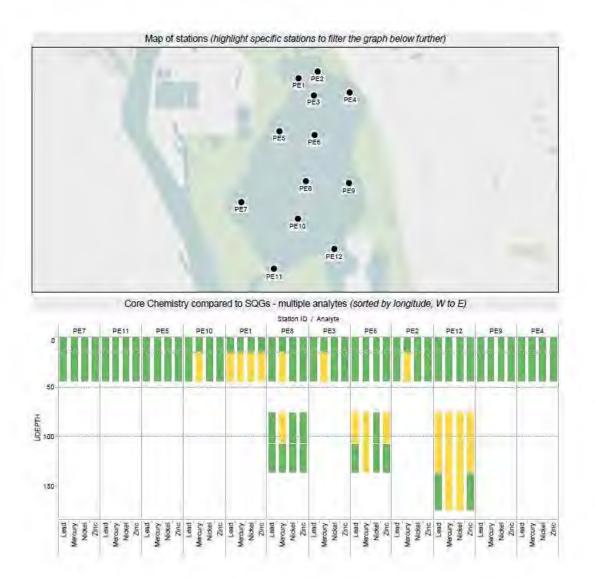
Figure 2. Spatial distribution of SQT I exceedances for mercury, lead, nickel and zinc. MPCA 2007-2008 survey (green = below SQT level I, yellow = between level I and level II SQT)

The 2007-2008 MPCA sediment chemistry survey of Pigs Eye Lake included 11 locations at multiple depth increments. The sediment samples were tested for metals, PCBs, PAHs and pesticides. In general the results were in-line with the MCES survey. But due to the increased number of locations and depths of the samples a spatial distribution of the contamination was detected. For example, in Figure 2, SQT I exceedances of lead, mercury, nickel and zinc show the exceedances occur below the surficial sediment (yellow bar) and mainly located along the centerline between the creek outlet and the lake outlet. In contrast, PAHs and PCBs seem to be ubiquitous throughout the lake at multiple depths (Figure 3).

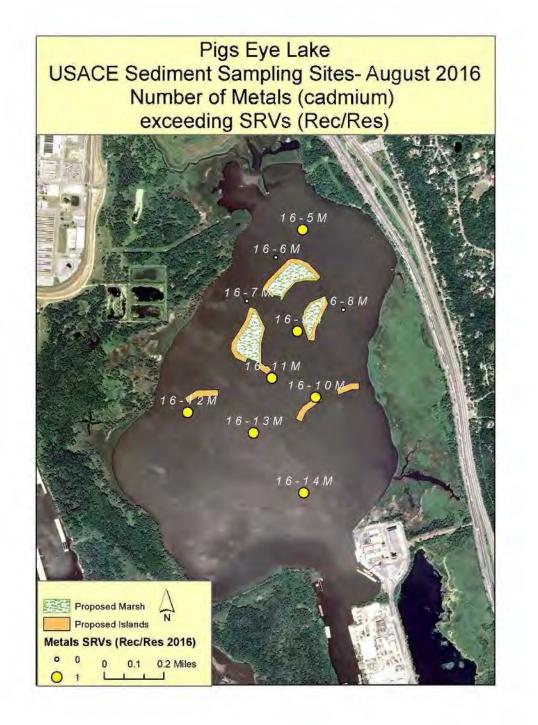
Figure 11. Number of metals tested in 2016 that exceeded MPCAs SRVs (2016 Res/Rec) guidelines.

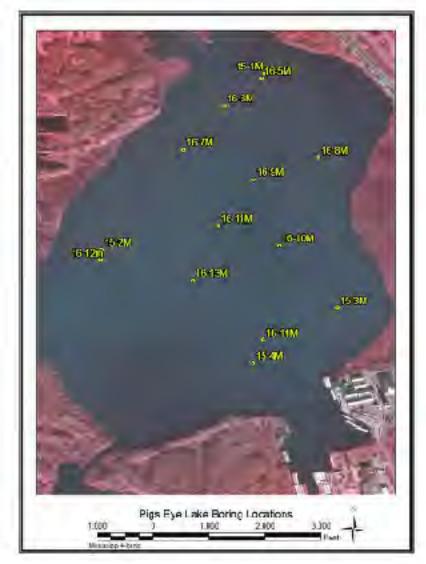
Figure 1 Boring Locations at Pigs Eye Lake (replace with updated map)

Four soil borings (15-1M, 15-2M, 15-3M, and 15-4M) were performed during late October 2015 by USACE personnel. The boring locations (Figure 1) were selected in order to characterize conditions throughout the lake, and generally corresponded with the locations of conceptual project features. Additional borings (16-5M through 16-14M) were performed in July 2016 for the purposes of obtaining environmental samples and some bag samples for index testing.

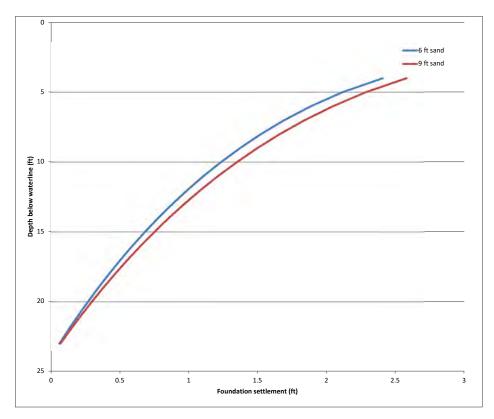
Figure 8 - Plot of predicted settlement for 6 ft and 9 ft of dredge sand fill

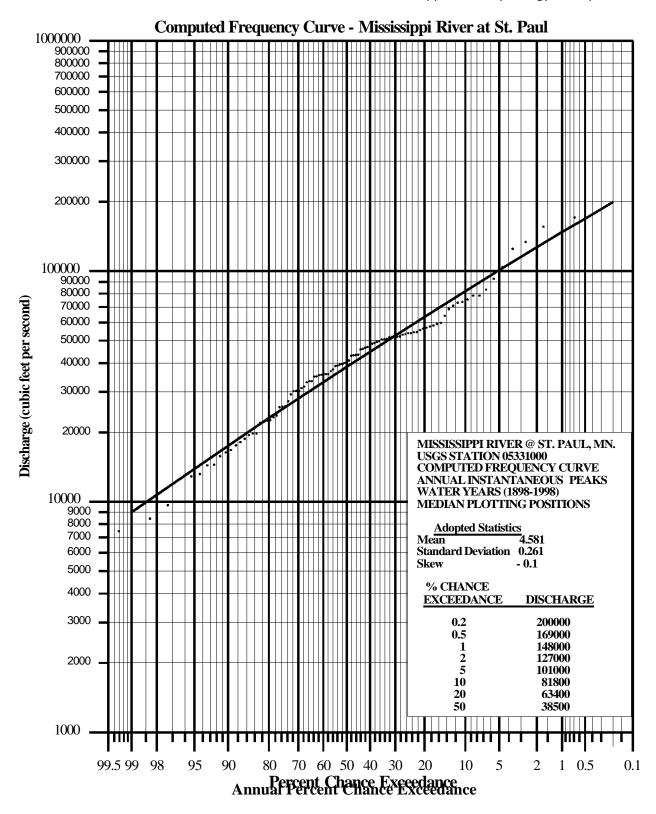
Figure 1 Discharge/ Annual Percent Exceedance Curve

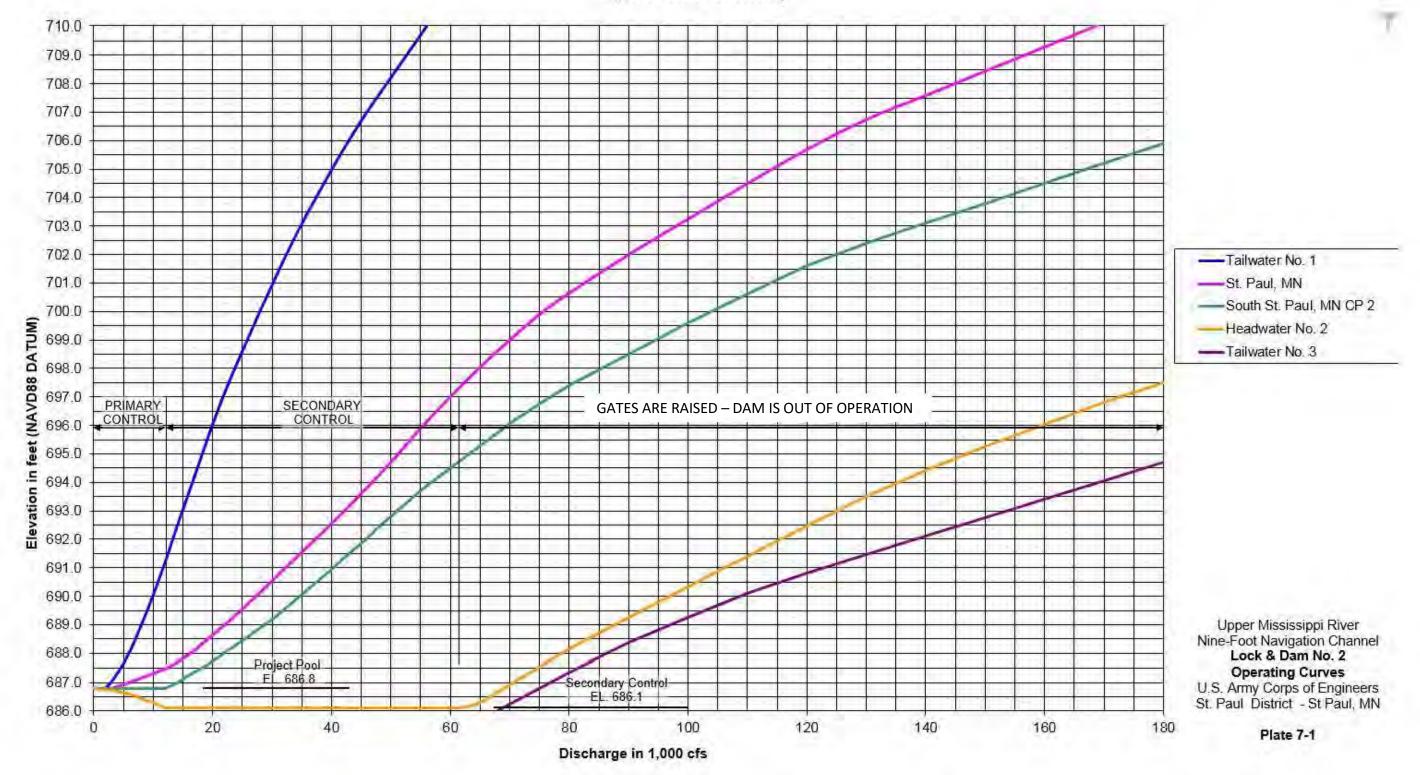
Figure 4 Pool 2 Operating Curve (NAVD88 Datum)

The following figure shows the Operating Curve for Lock and Dam 2 on the Mississippi River. The green curve shows the Control Point in South Saint Paul. This control point is directly across the river from Pigs Eye Lake. The river stage at Pigs Eye Lake is held constant at 686.8 feet NAVD (687.2 (1912 datum) for discharges below 12,500 cfs. At a river discharge of 12,500 cfs, the river stages begin to rise with discharge.

LOCK & DAM NO. 2 OPERATING CURVES (NAVD88 Datum)

Figure 4 includes the operating curves for Lock and Dam 2 on the Mississippi River. The curve for the South Saint Paul Control Point (CP) can be used to estimate water elevations in Pigs Eye Lake.

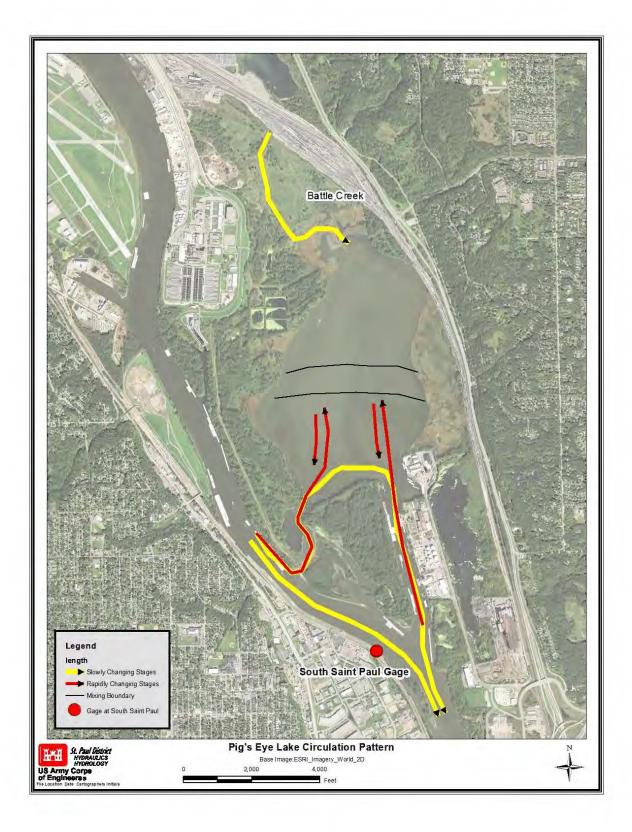
It appears that water entering from Battle Creek is a more dominant source of water in the upper lake than in the lower lake.

Figure 5 General Lake Circulation and the Relative Location of the South Saint Paul Gage

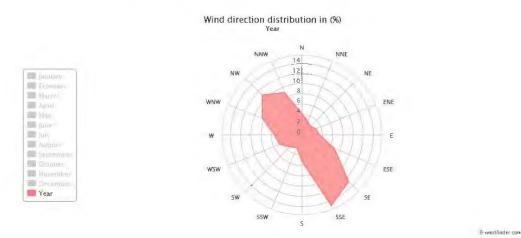
Figure 6 Wind Rose and Other Statistics at Holman Field (graphics from windfinder.com)

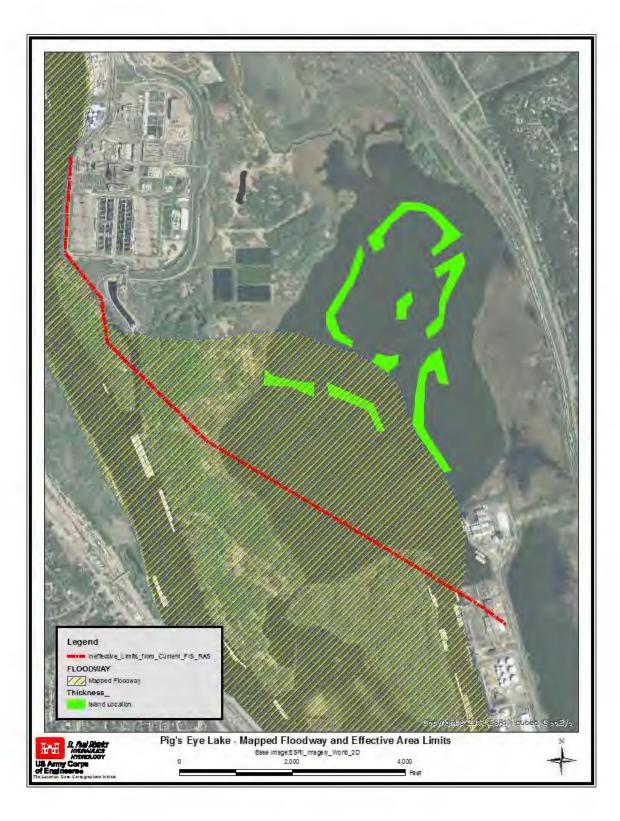
There should be no stage impact to the regulatory floodway or to the 1 percent annual chance exceedance flood stages (100 Year) because all of the proposed construction is outside of the effective flow limits shown in the latest modeling.

Figure 10 Mapped Floodway and Effective Flow Area Limits

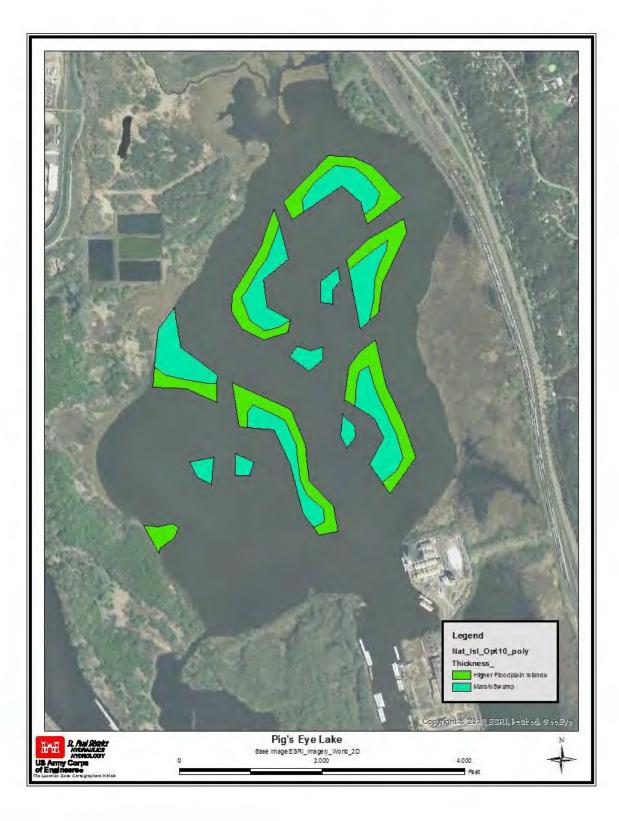
Figure 15 Idealized Island Layout

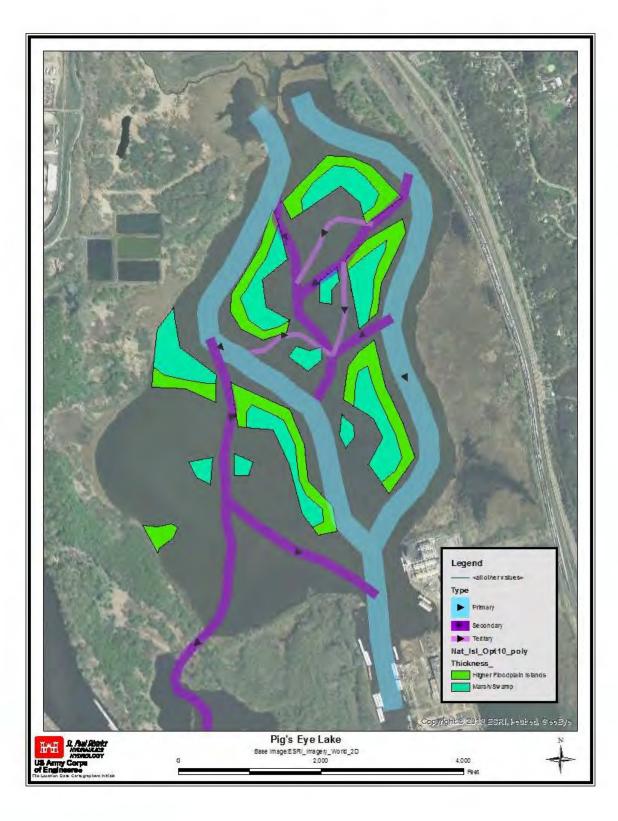
Figure 16 Idealized Island Layout showing Flow Paths

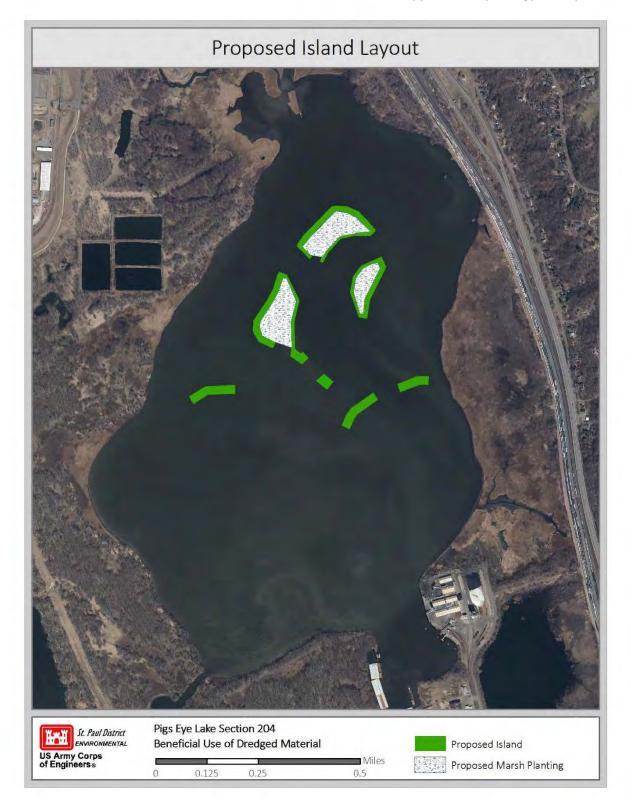
Alternative 5m adds a sand layer (approximate 1 foot thickness) to the interior of the embayments of Alternative 5 (The "m" in the alternative name stands for "marsh"). Alternatives 6m and 7m are similar layouts that were reduced in size to lower project costs while retaining as much of the function of the larger alternatives as was possible. The selected alternative is Alternative 6m (Figure 21).

Figure 21 Selected Alternative (Alternative 6M)

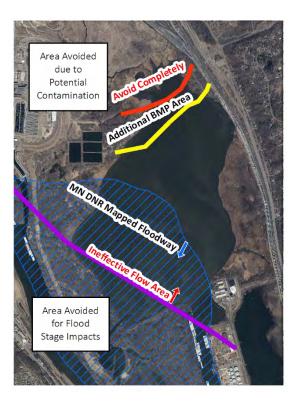
Figure 1. Planning Constraints in Pigs Eye Lake – Contaminants and Flood Stage

Two of the project constraints highly limited the acceptable geographical placement of measures. First was avoiding disturbance to the contamination in the northern part of the lake, adjacent to the former landfill. Available contaminant testing data was collected, reviewed, and assessed, and additional sampling needs were identified and collected (see Appendix E – Sediment Report). The data and analysis were coordinated with internal and external stakeholders through a specially-formed group of members of the interagency project team, formed to analyze contaminant concerns related to the project. The consensus of the group was to avoid disturbance to the area in the northernmost part of the lake (shown in Figure 1).

A second factor that limited the geographical placement of measures is the constraint to avoid impacting flood stages. Hydraulic modeling was used to identify the effective flow limit boundary within the lake, as shown in Figure 1. By keeping project features to the north of this boundary, they are kept within the ineffective flow area and do not have an effect on flood stages. The Minnesota DNR's regulatory floodway boundary (also shown in Figure 1) extends further into the lake, so islands within this zone were aligned roughly parallel to the expected flowlines in order to ensure that stage impacts would be negligible if flood waters were to move through this region.

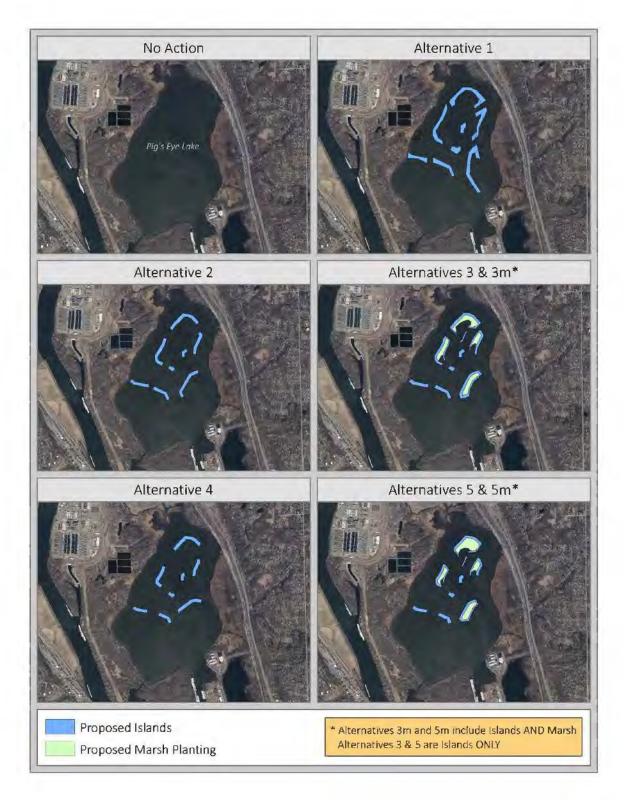
Figure 2. Initial Array of Alternatives (1-5m)
