Appendix E

Wetland Assessment 2018

Pool 5 Dredged Material Management Plan

Steps taken to estimate potential wetlands: Sheehan Property [Wabasha County, MN]

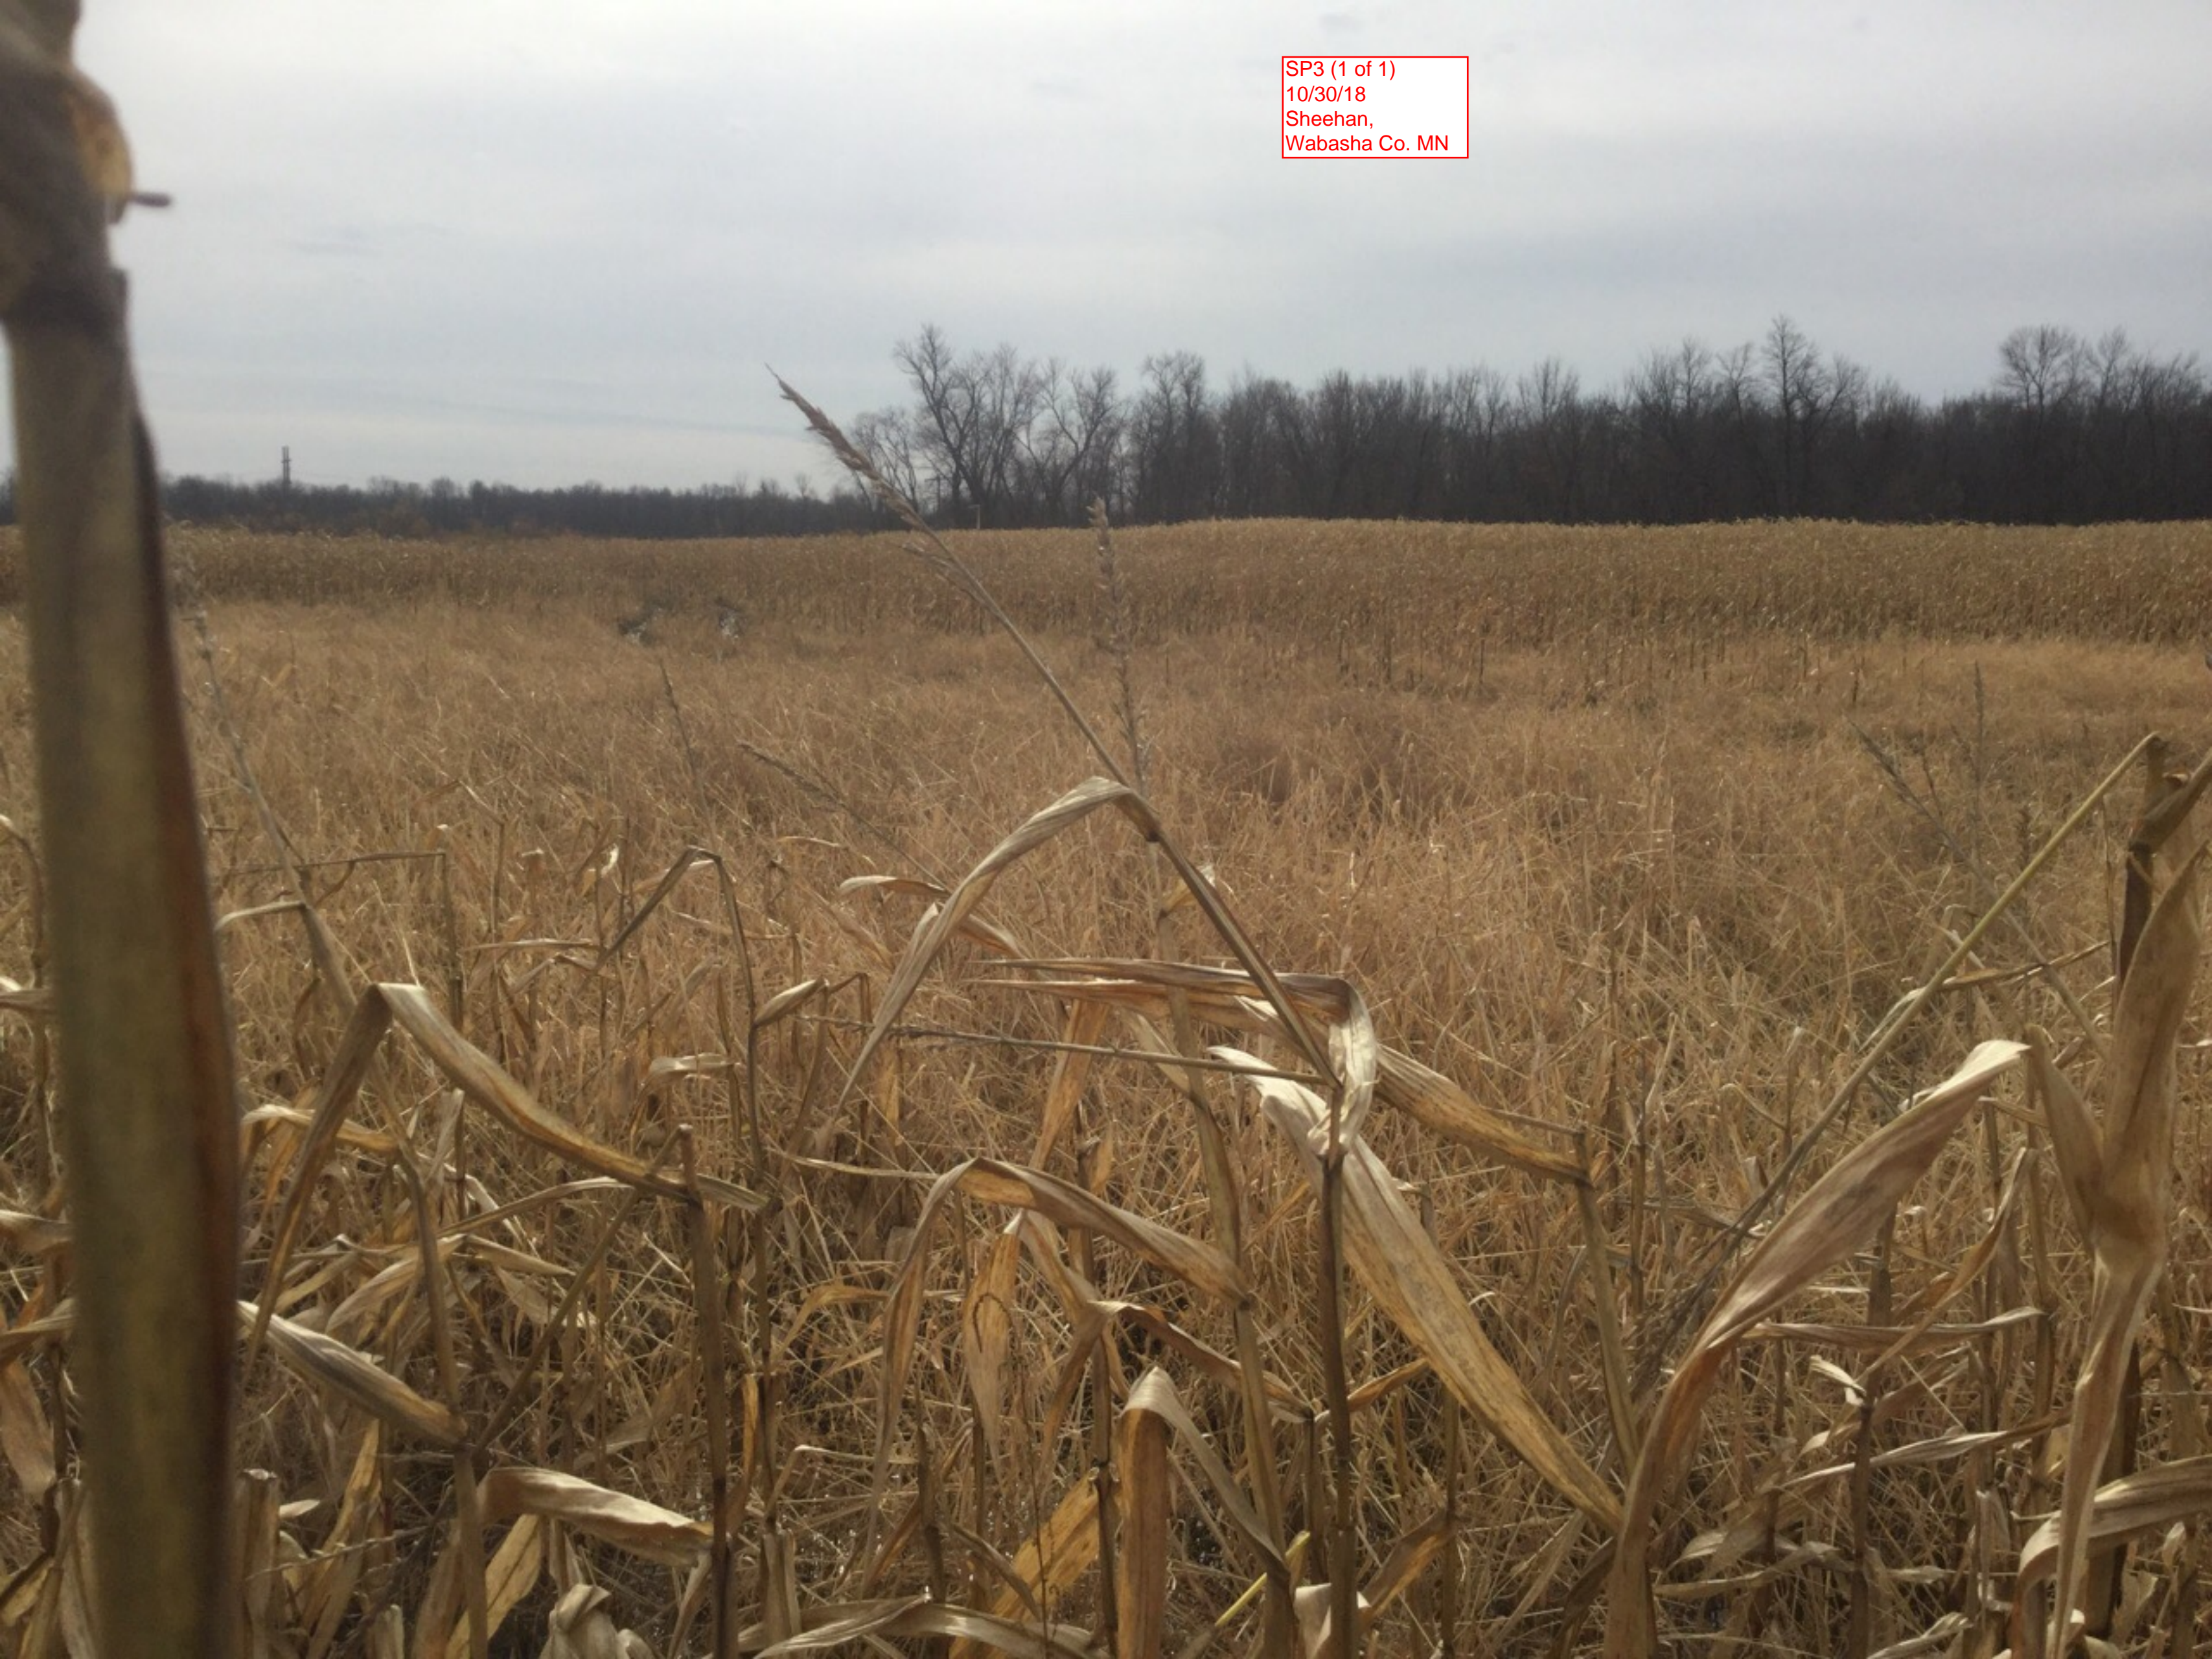
SP3 (1 of 1)
10/30/18
Sheehan,
Wabasha Co. MN

¹ Sample point 3, Sheehan Collection, was a non-hydric soil on a back slope, yet the signature was “dark”.
