# Lock & Dam No. 7 Upper Approach Outdraft

## Mississippi Managers Meeting February 2020

Jon Hendrickson and Emily Moe  
St. Paul District, H&H Branch

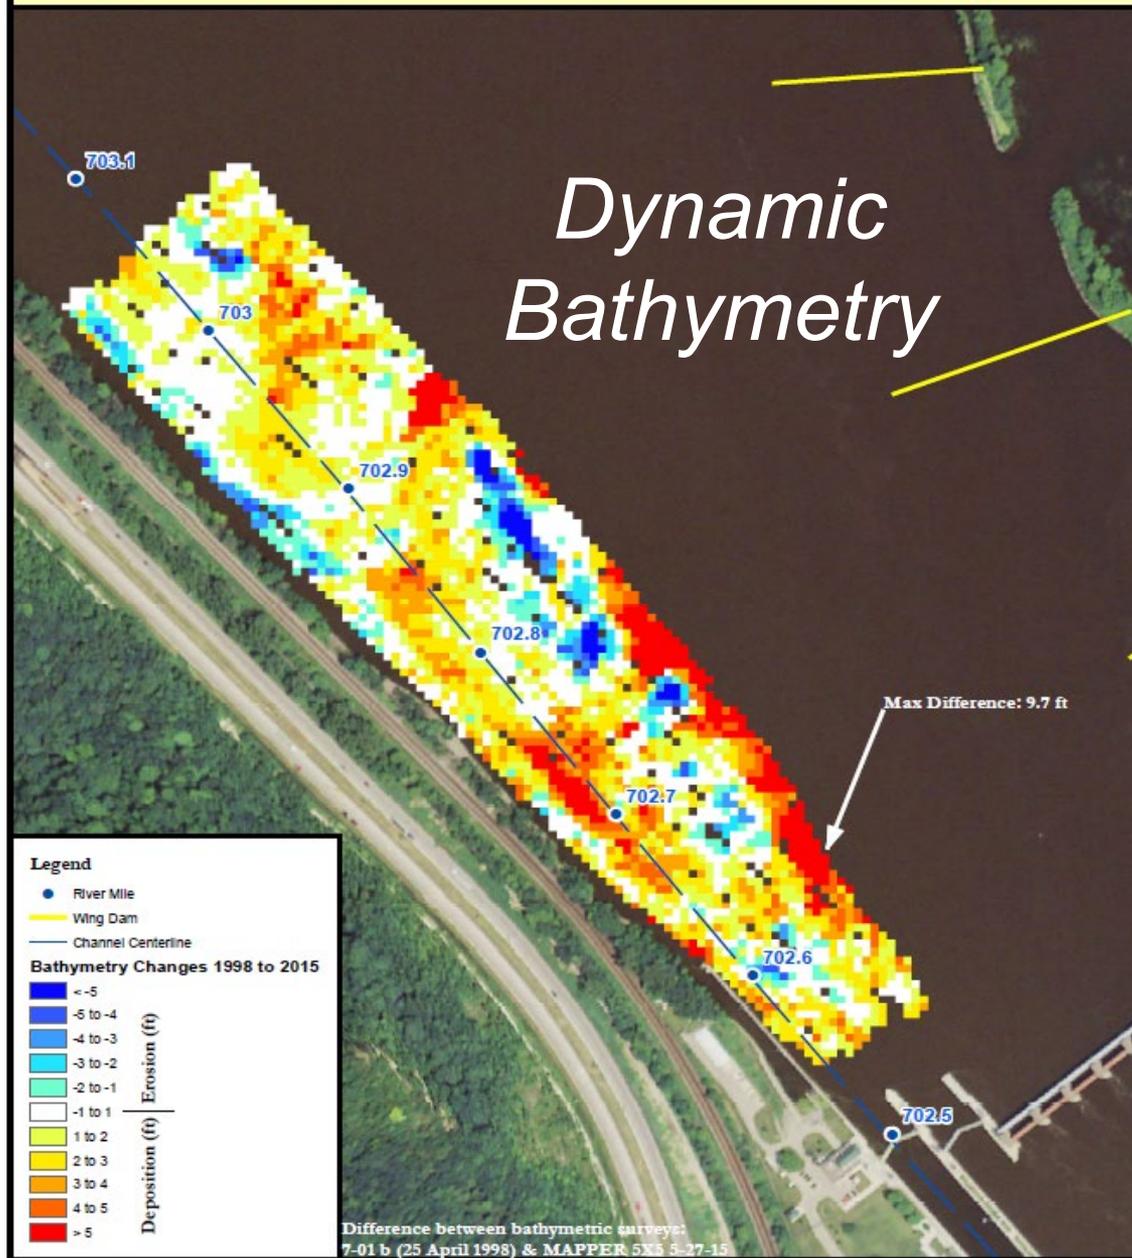
# Mississippi River - Lock and Dam 7

## Upper Approach Bathymetry Changes - 1998 to 2015

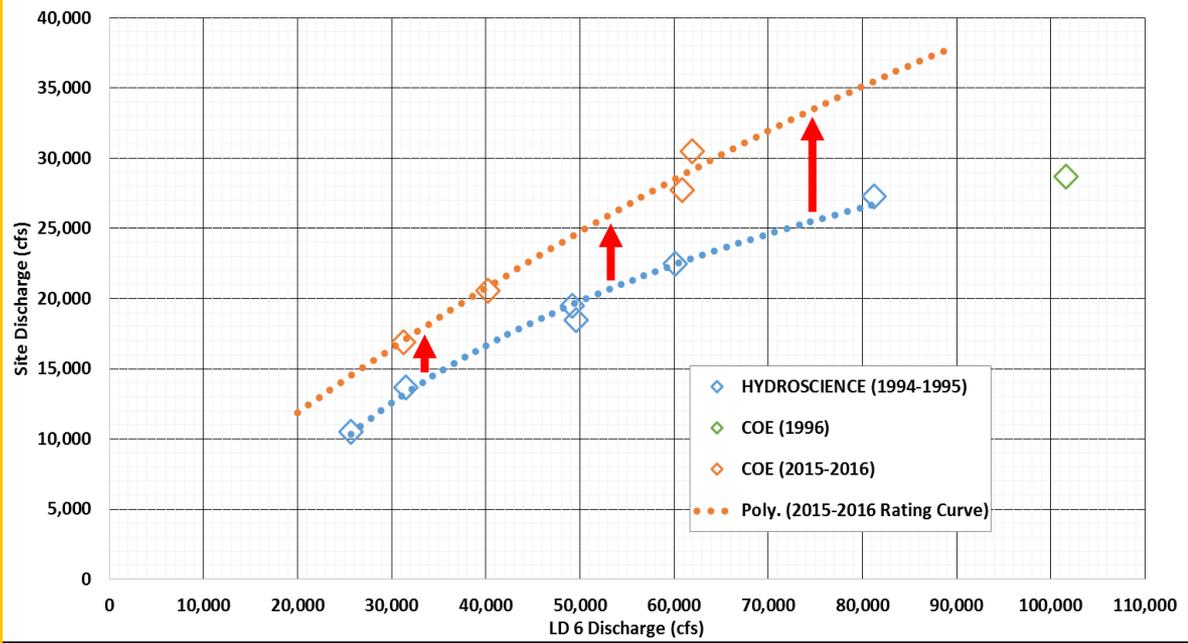
Mississippi River - Pool 7  
RM 705.00 SW (2000') - Dresbach Slough

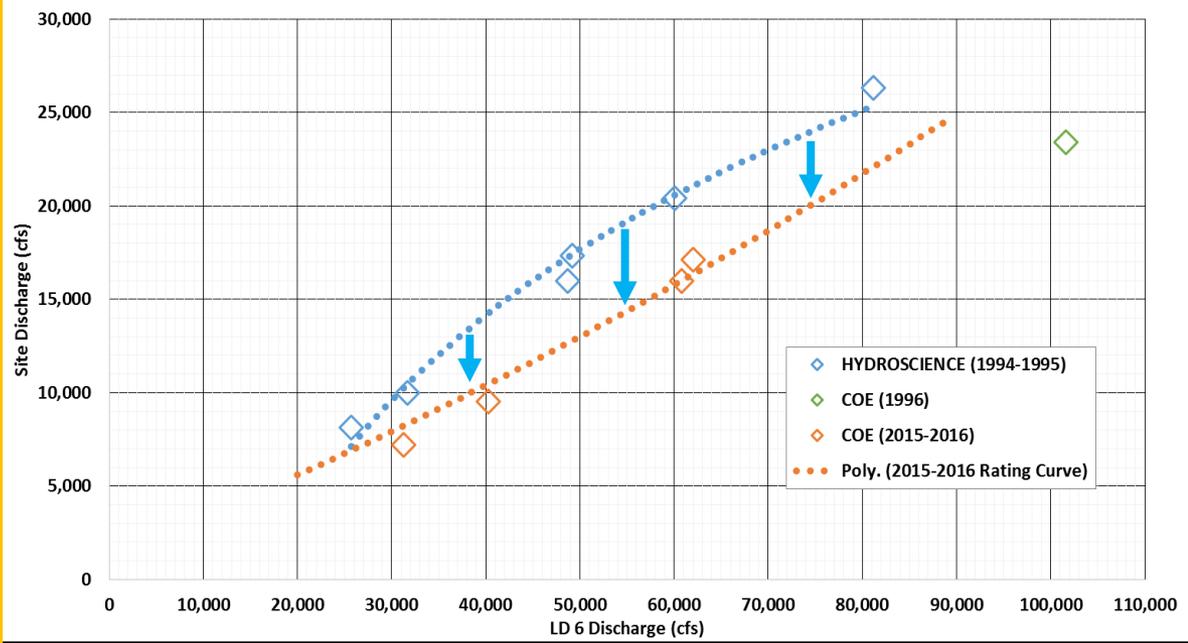
Mississippi River - Pool 7  
RM 704.80 - Old Navigation Channel

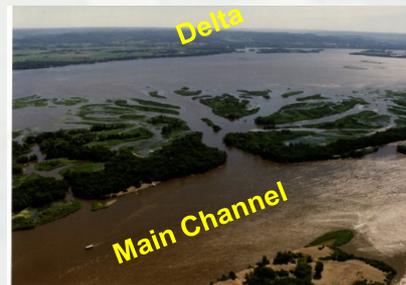
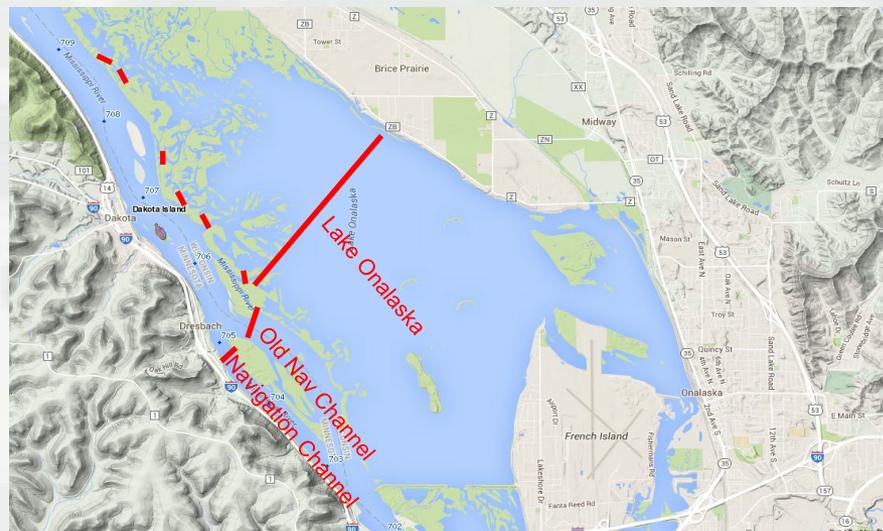
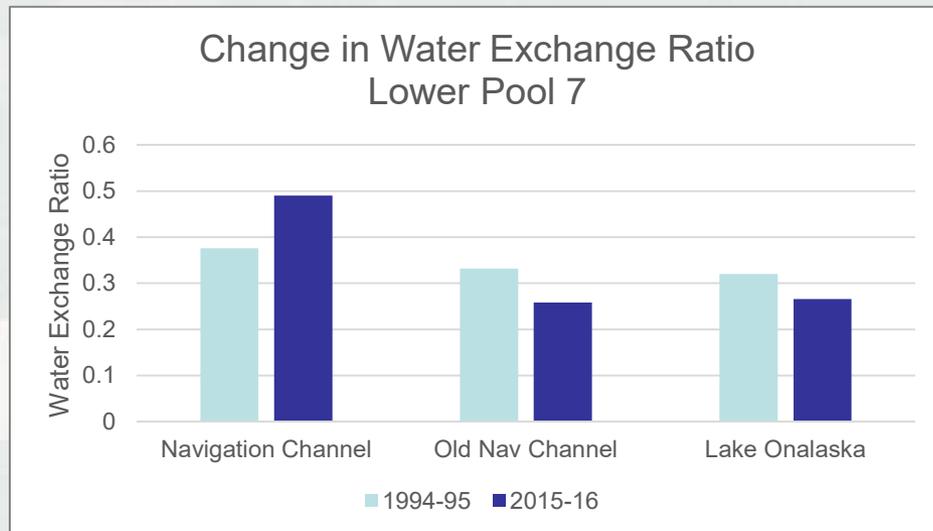
## Water exchange – a surrogate for geomorphic change

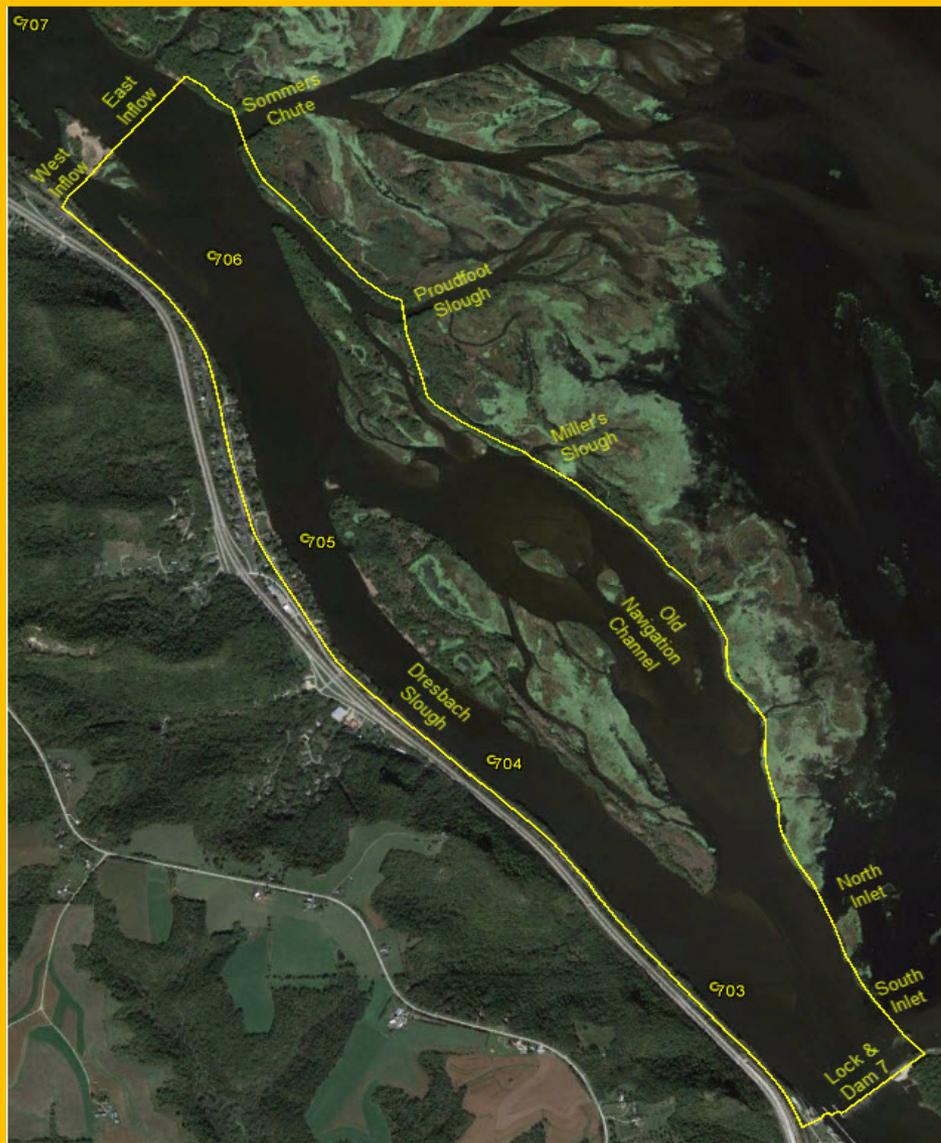
- 2D Model Developed
- ~4 River Miles
- Assess existing conditions/Validate
- Test Alternatives
- ***Goal: Reduce Velocities around Upper Approach***

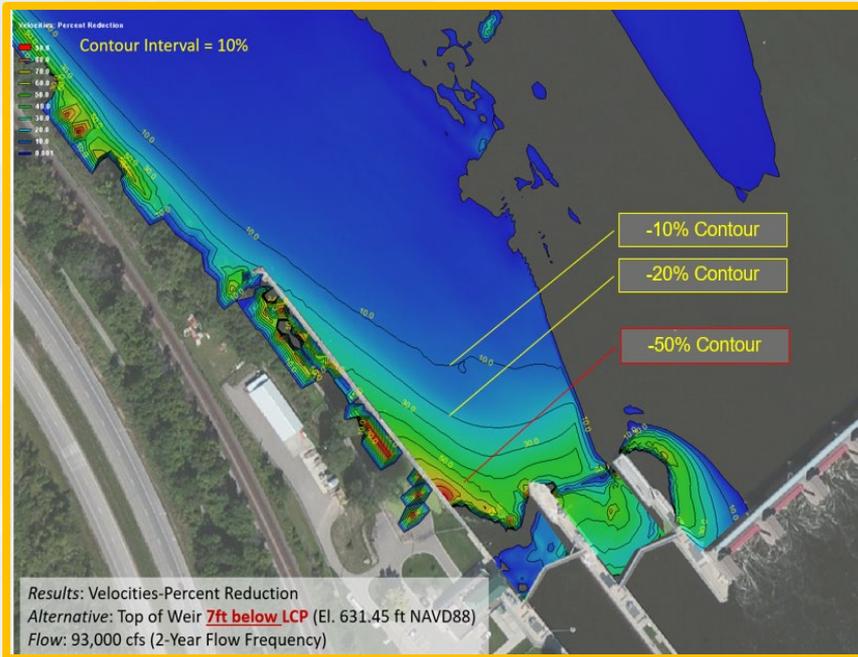
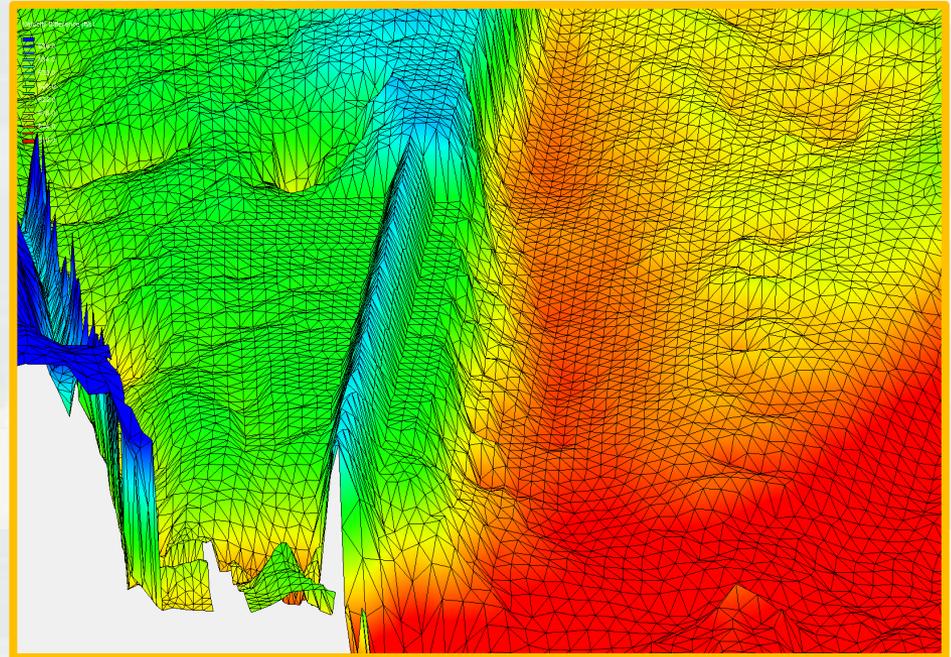
- Rock Weir at **7ft below LCP** (El. 631.45 ft NAVD88)
  - Lowers velocities by 20-50% (near Upper Approach)
    - ▷ “Nudge” in the right direction

- ▶ Fill in current alignment to as-built elevation
  - Rock has settled/displaced
- ▶ Raise weir to 5-ft depth (*currently @ 7-ft depth*)
  - Further reduction in velocities (5-10%)
- ▶ Dredging
  - 13-ft showed some positive impact
- ▶ Investigate new structural solutions
  - Time +++
  - Cost +++

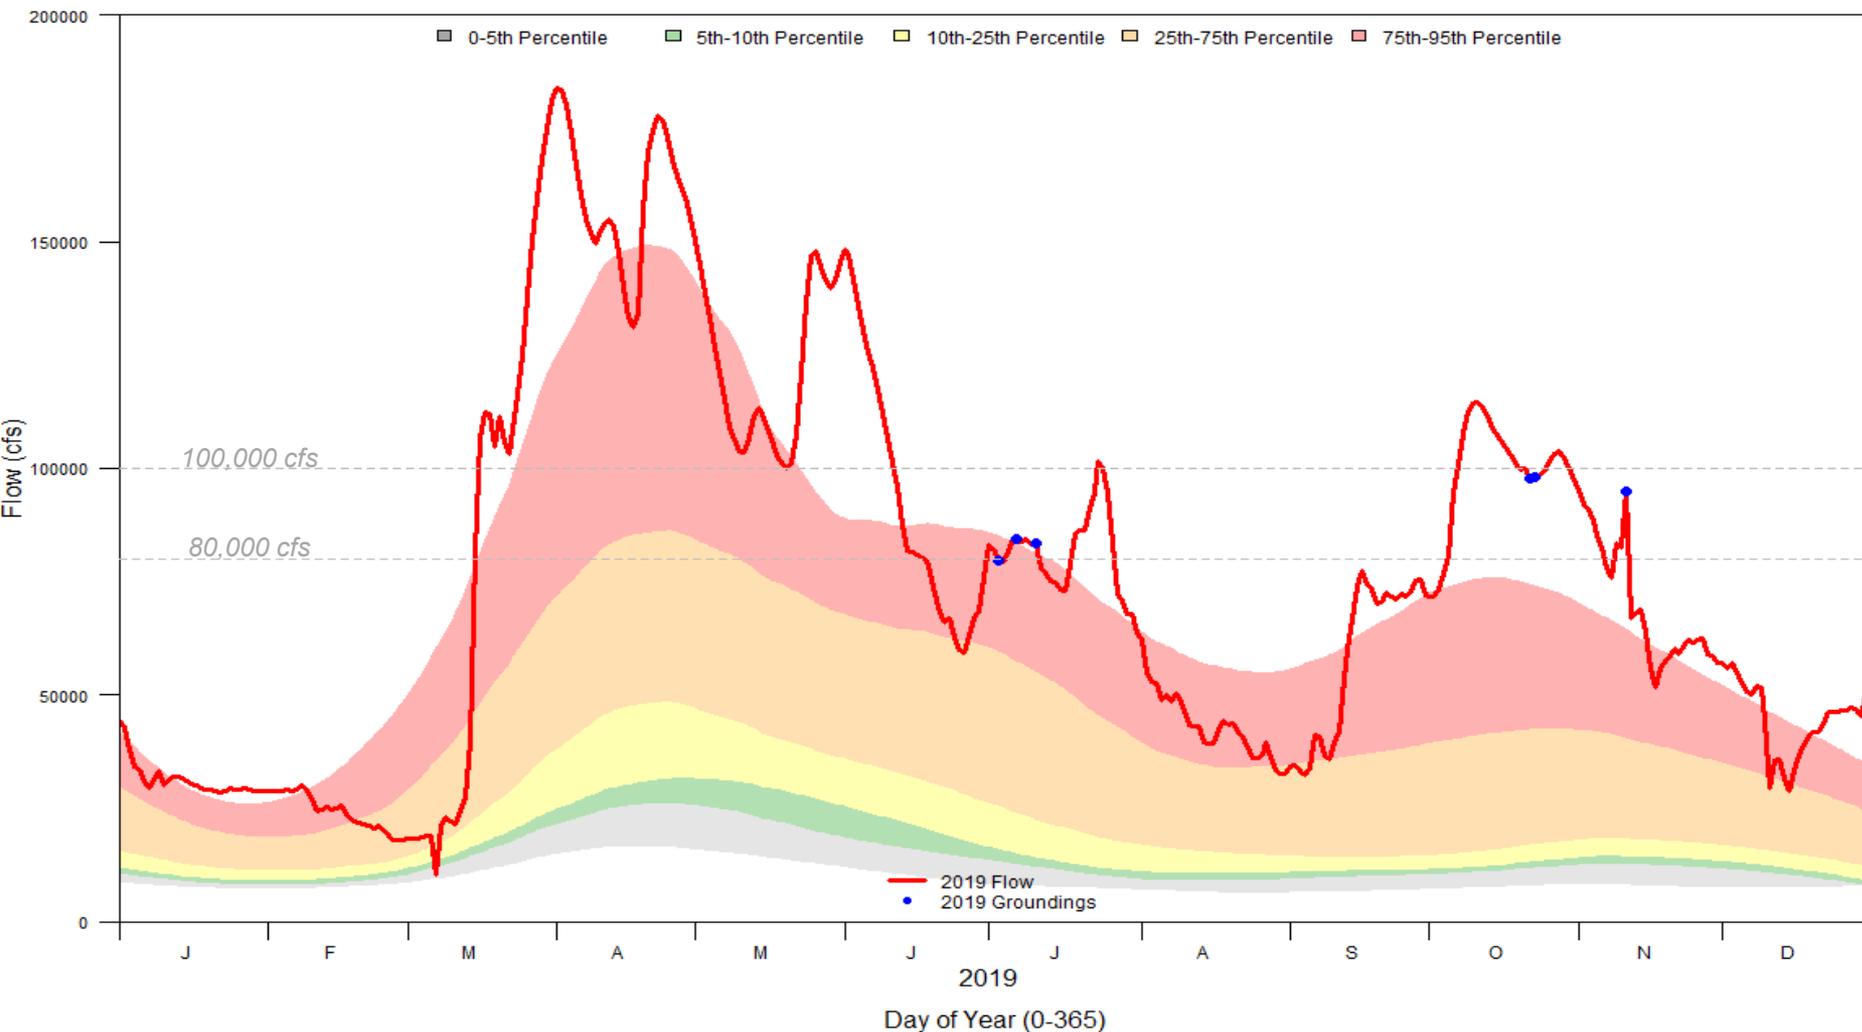
Mississippi River at Lock & Dam 7 Flow History (1959-2020)

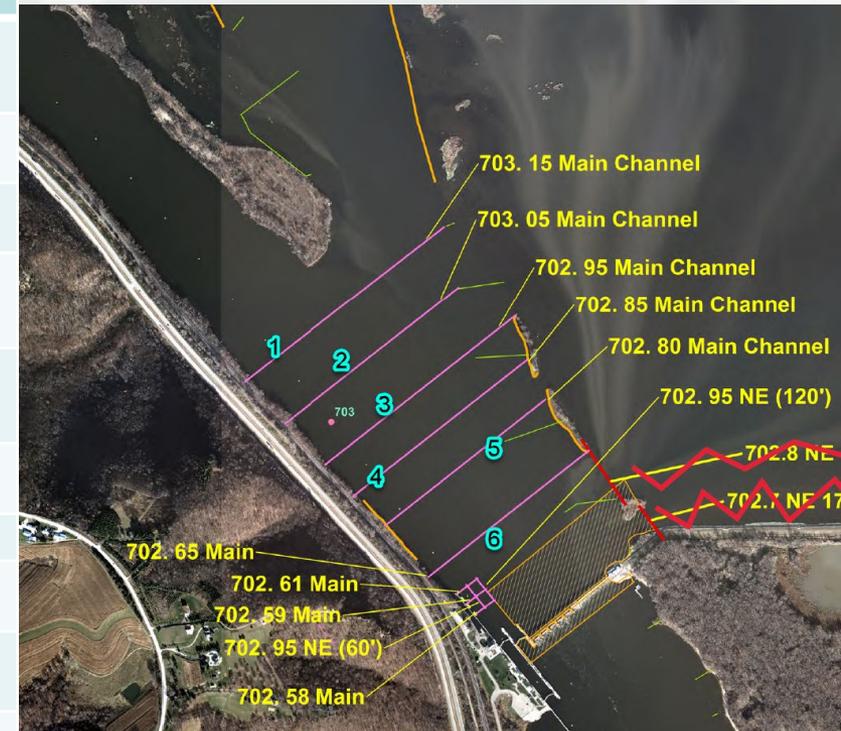
## 2019 Measured Flows vs. Modeled Flow (2-Yr, 50% ACE) Comparison Measured: Q=86,000 cfs (July 2019) Modeled: Q=93,000 cfs

Measured XS:	1	2	3	4	5	6
Mesh:	"28Aug2019 _ConditionU pdate"	"28Aug2019 _ConditionU pdate"	"28Aug2019 _ConditionU pdate"	"28Aug2019 _ConditionU pdate"	"28Aug2019 _ConditionU pdate"	"28Aug2019 _ConditionU pdate"
Model Flow Condition:	Q2_93kcfs	Q2_93kcfs	Q2_93kcfs	Q2_93kcfs	Q2_93kcfs	Q2_93kcfs
Location (RM):	703.15	703.05	702.95	702.85	702.8	702.65
Model Velocity (ft/s)	2.12	2.53	2.55	2.61	2.71	2.80
Measured Velocity (ft/s)	2.22	2.99	2.81	2.77	3.00	2.74
%-Difference	-4.4%	<b>-15.5%</b>	-9.3%	-5.8%	-9.6%	-4.1%
Model Flow (cfs)	59,904	55,821	62,527	62,483	62,550	62,645
Measured Flow (cfs)	62,204	40,720	62,920	61,240	61,980	62,950
%-Difference	-3.7%	<b>37.1%</b>	-0.6%	2.0%	-0.9%	-0.5%

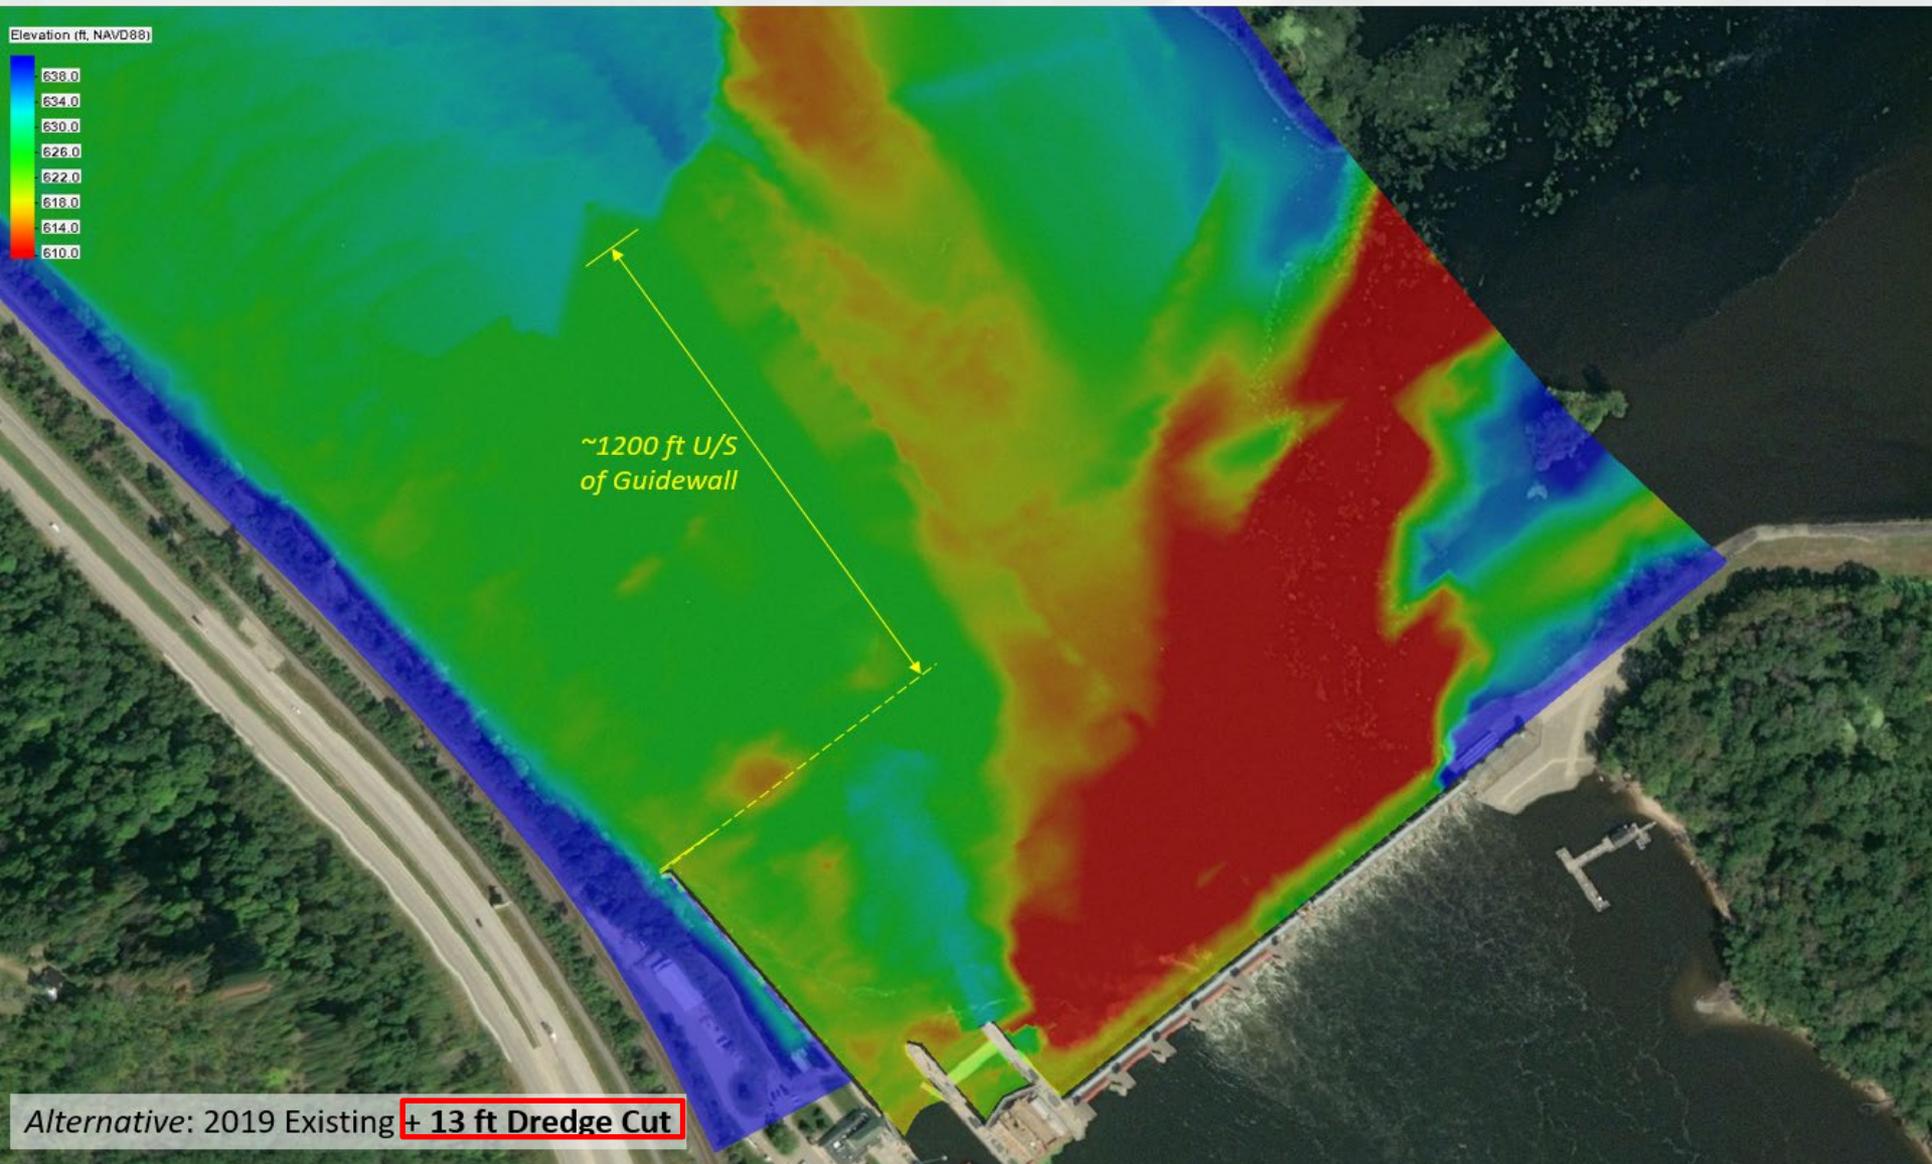
Alternative: 2019 Existing **+ 13 ft Dredge Cut**

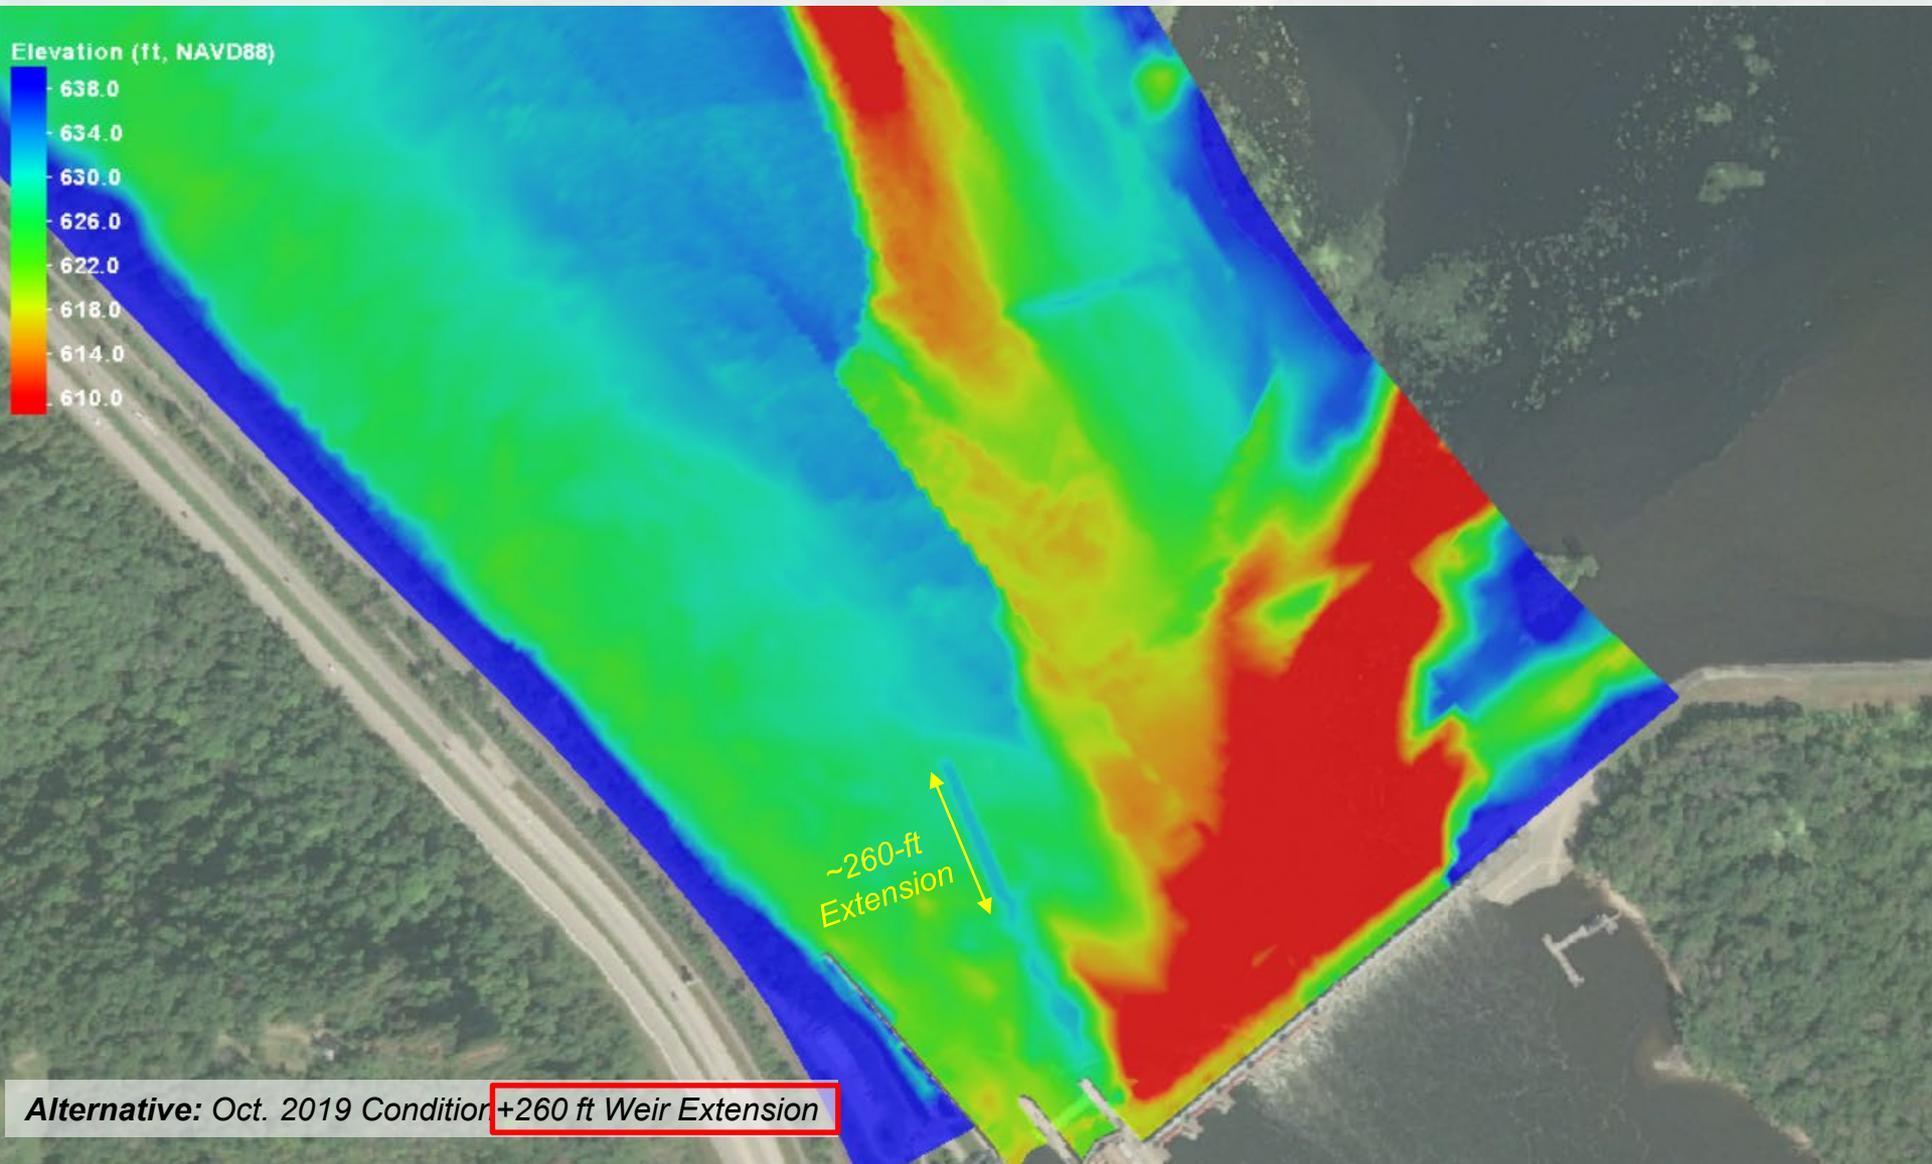
Alternative: Oct. 2019 Condition +260 ft Weir Extension

[1-ft Contours]

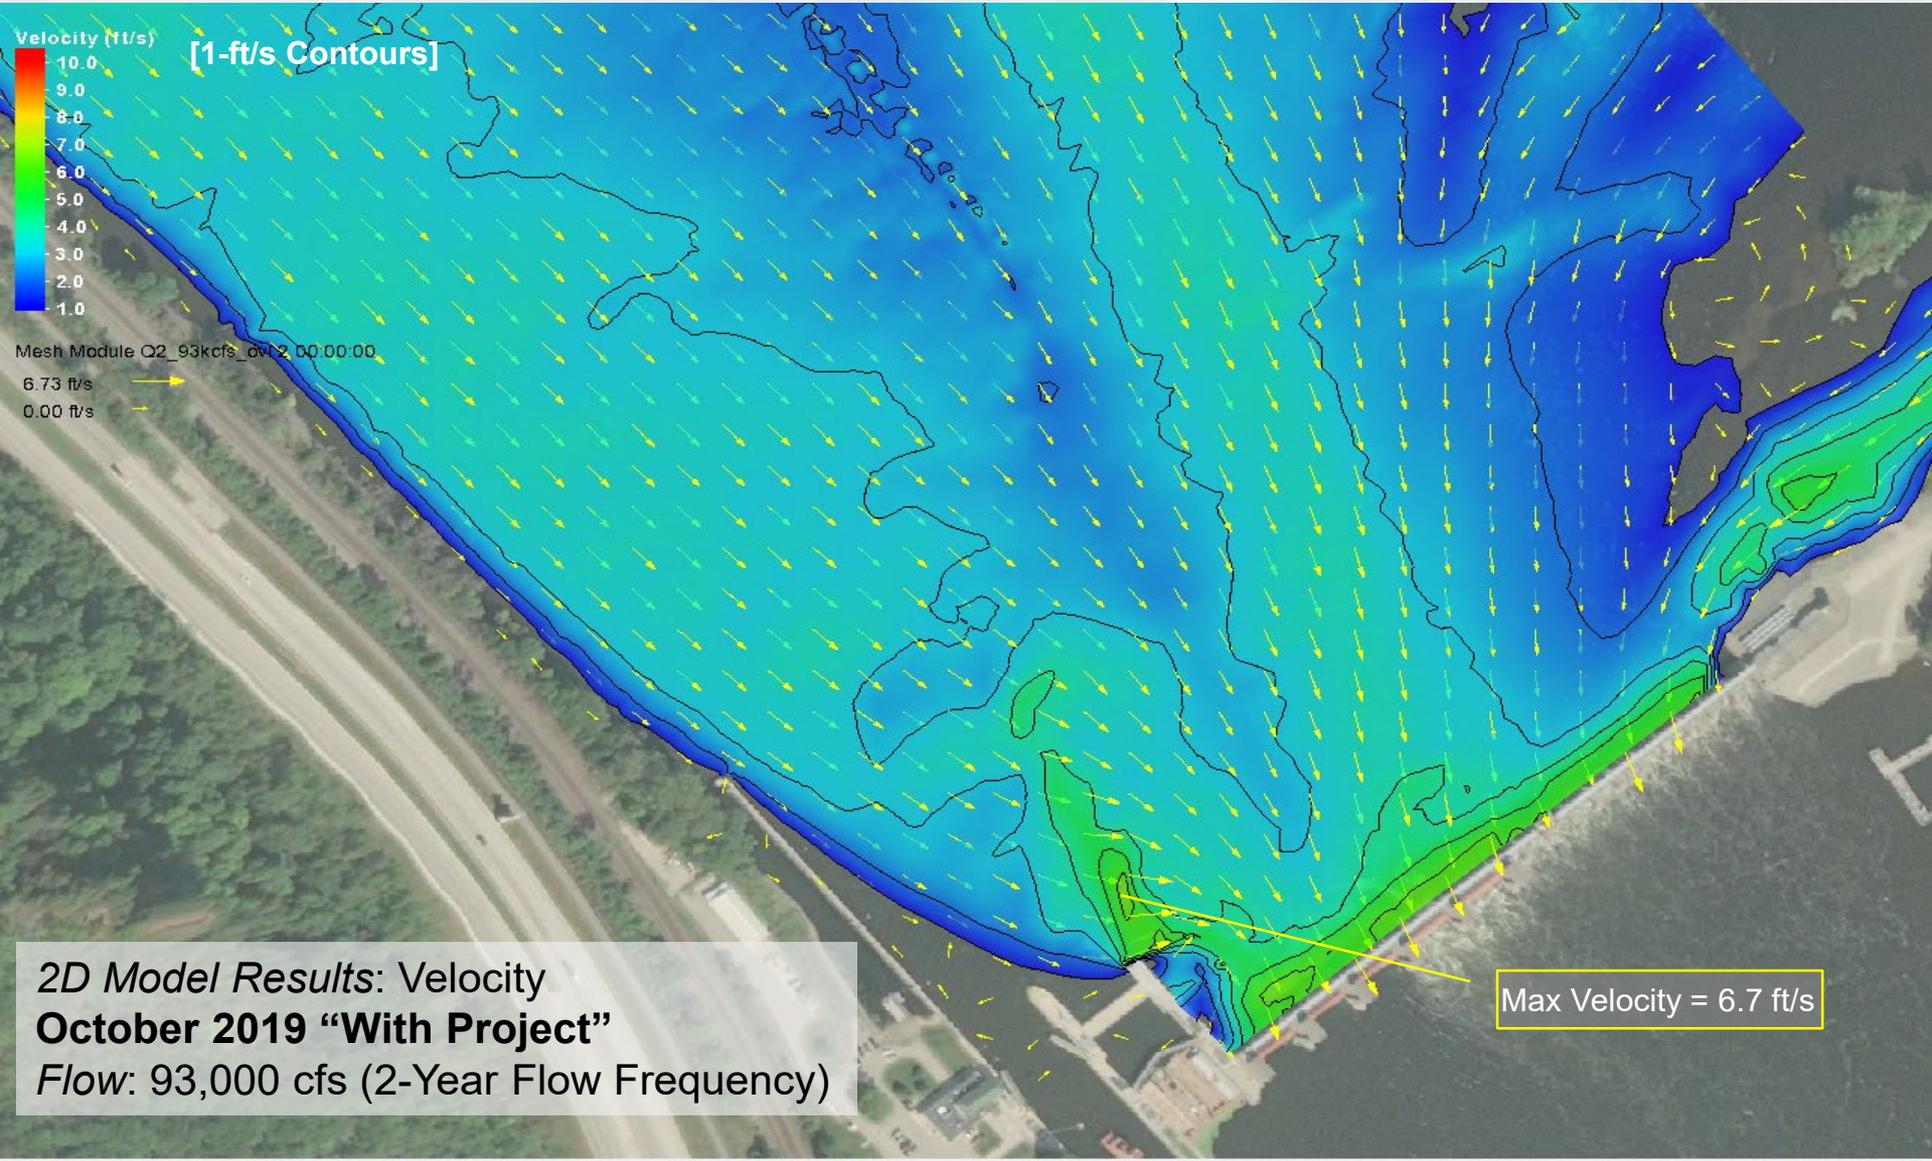
[1-ft/s Contours]

**2D Model Results: Velocity**  
**October 2019 "With Project"**  
Flow: 93,000 cfs (2-Year Flow Frequency)

Max Velocity = 6.7 ft/s

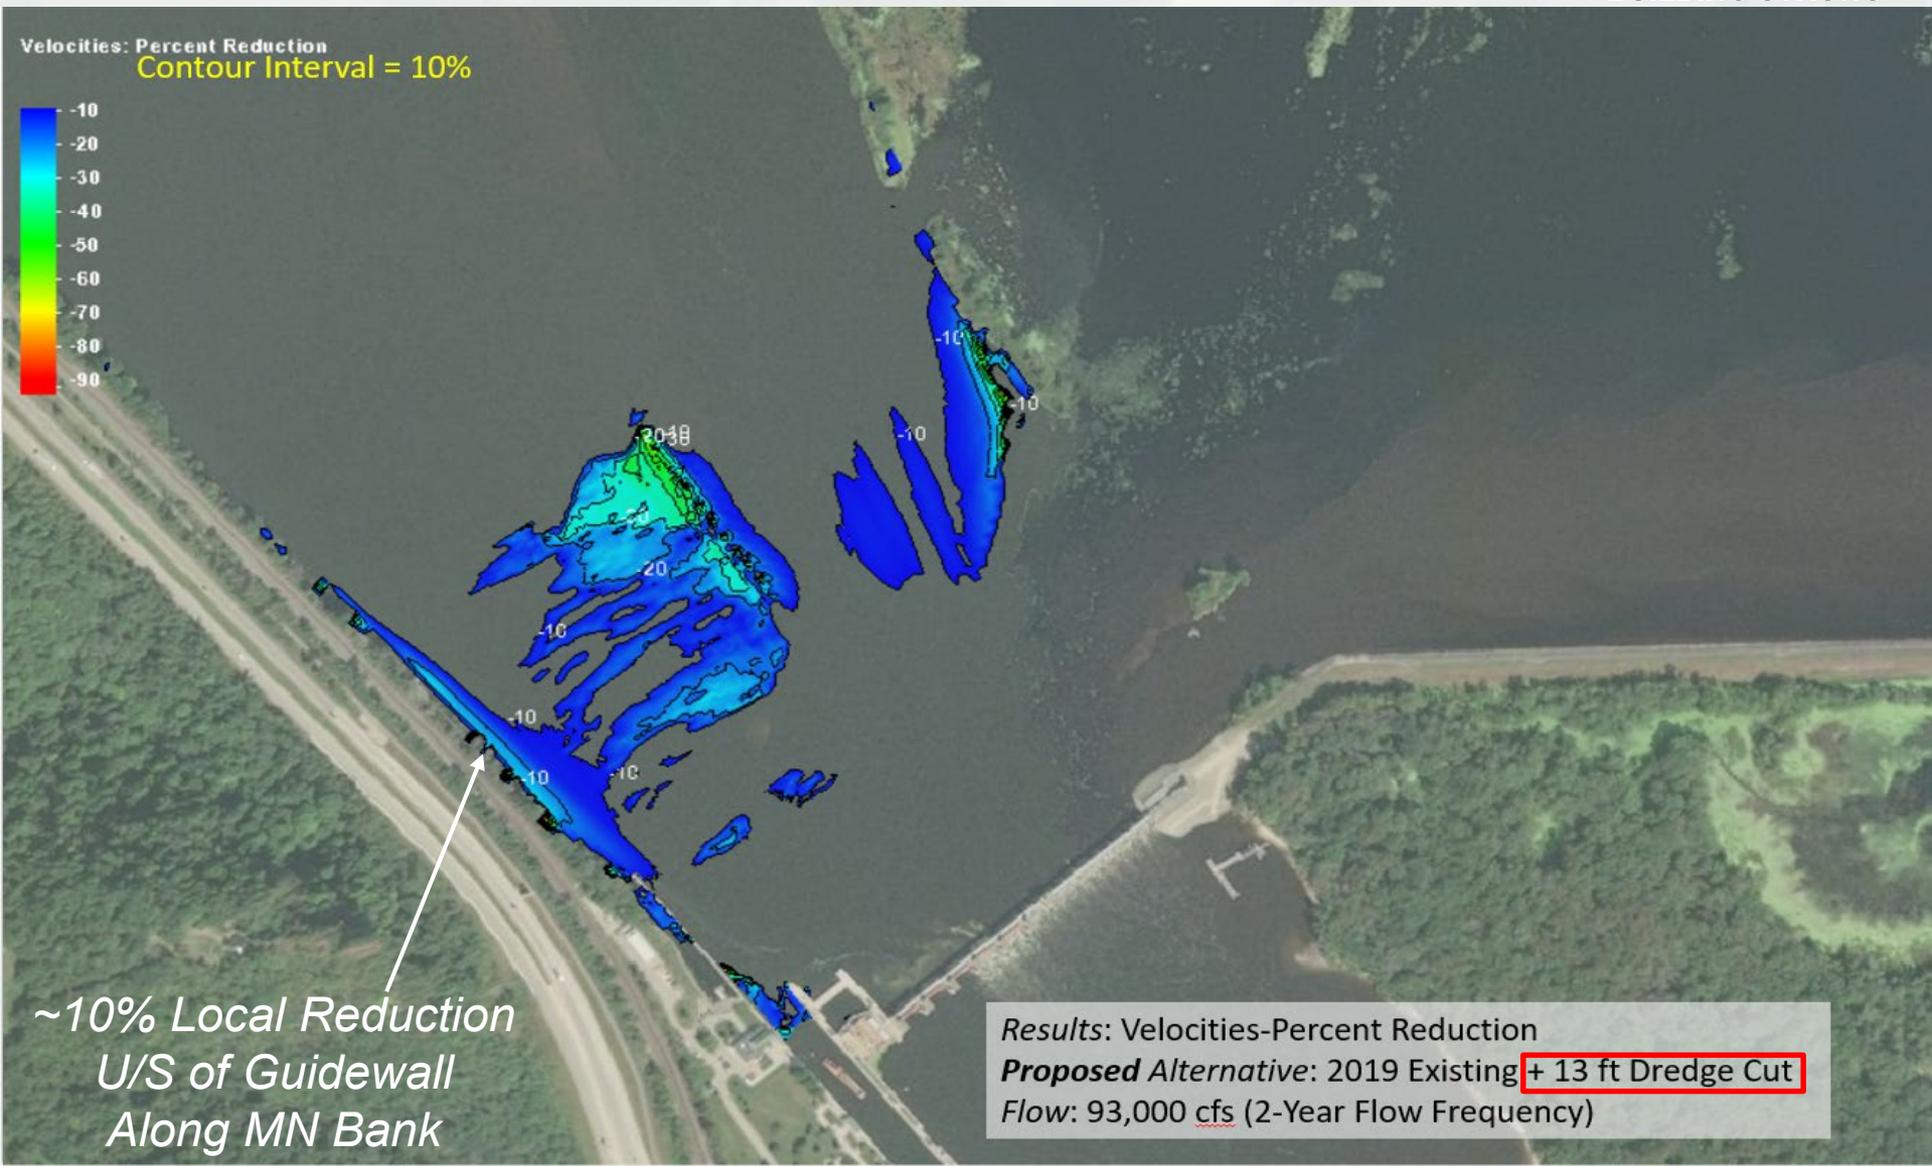
Velocities: Percent Reduction  
Contour Interval = 10%

~10% Local Reduction  
U/S of Guidewall  
Along MN Bank

Results: Velocities-Percent Reduction  
**Proposed Alternative: 2019 Existing + 13 ft Dredge Cut**  
Flow: 93,000 cfs (2-Year Flow Frequency)

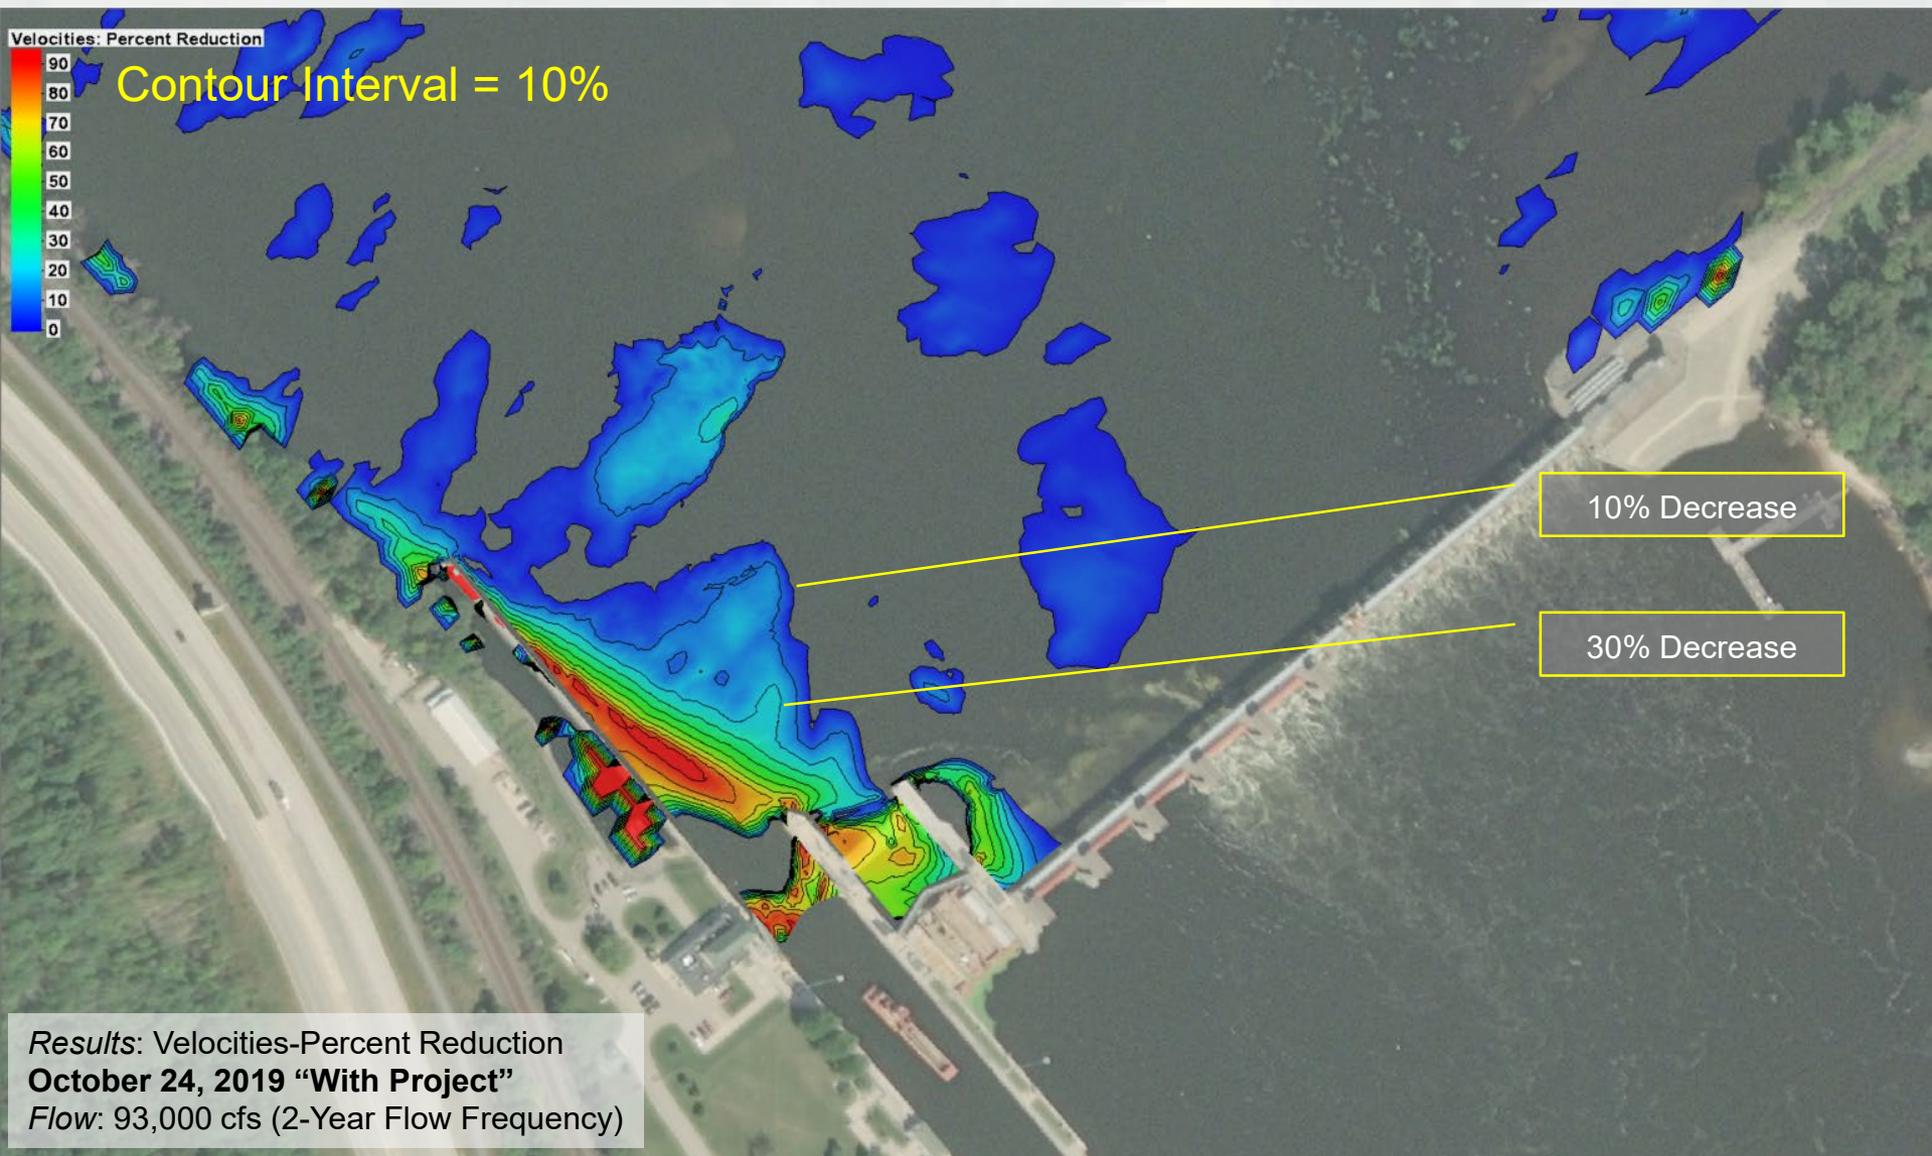
Velocities: Percent Reduction

Contour Interval = 10%

10% Decrease

30% Decrease

Results: Velocities-Percent Reduction  
October 24, 2019 "With Project"  
Flow: 93,000 cfs (2-Year Flow Frequency)
