# WETLAND DETERMINATION DATA FORM – Northcentral and Northeast Region

Project/Site: Line 5 Relocation Project City/County: Ashland Sampling Date: 2020-06-11  
 Applicant/Owner: Enbridge State: Wisconsin Sampling Point: wasc1065e\_w  
 Investigator(s): EJO/JSW Section, Township, Range: sec 03 T047N R004W  
 Landform (hillslope, terrace, etc.): Depression Local relief (concave, convex, none): Concave Slope (%): 0-2%  
 Subregion (LRR or MLRA): Northcentral Forests Lat: 46.586072 Long: -90.861226 Datum: WGS84  
 Soil Map Unit Name: Udorthents and Udipsamments, cut or fill NWI classification: \_\_\_\_\_

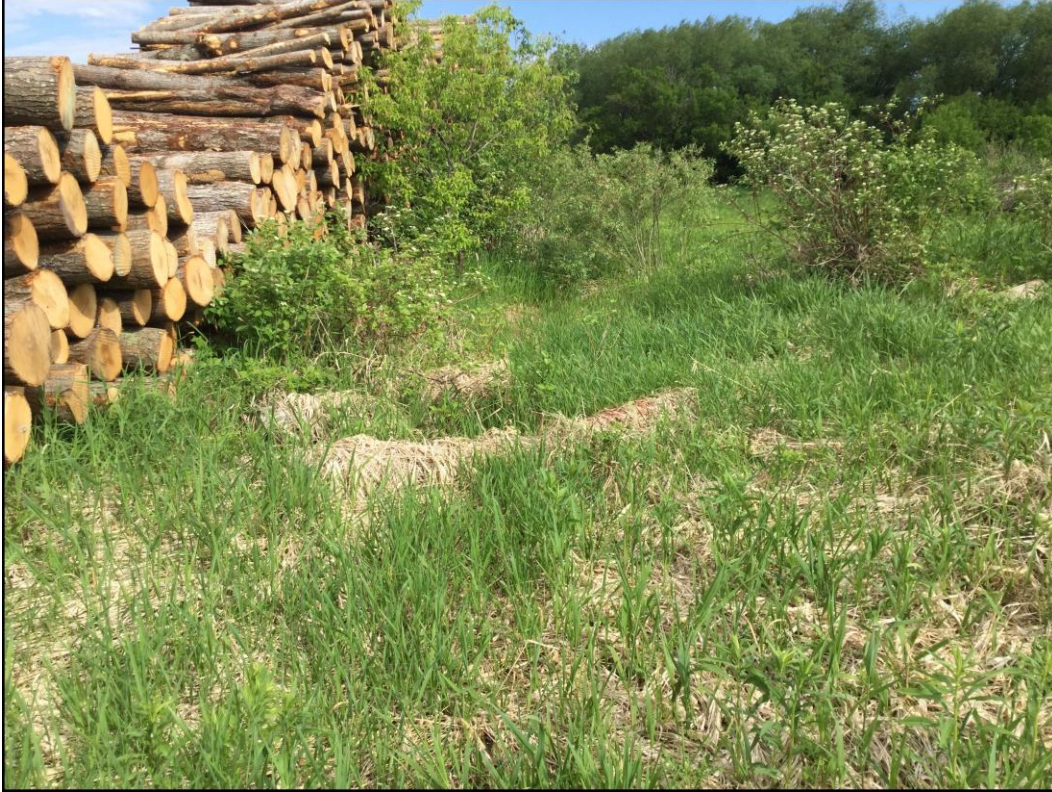
wasc1065e\_w\_NW

The wetland is located in a ditch between two gravel driveways; fill may have been used to construct the the driveways. The wetland has a high abundance of invasive species that have degraded its floristic integrity.

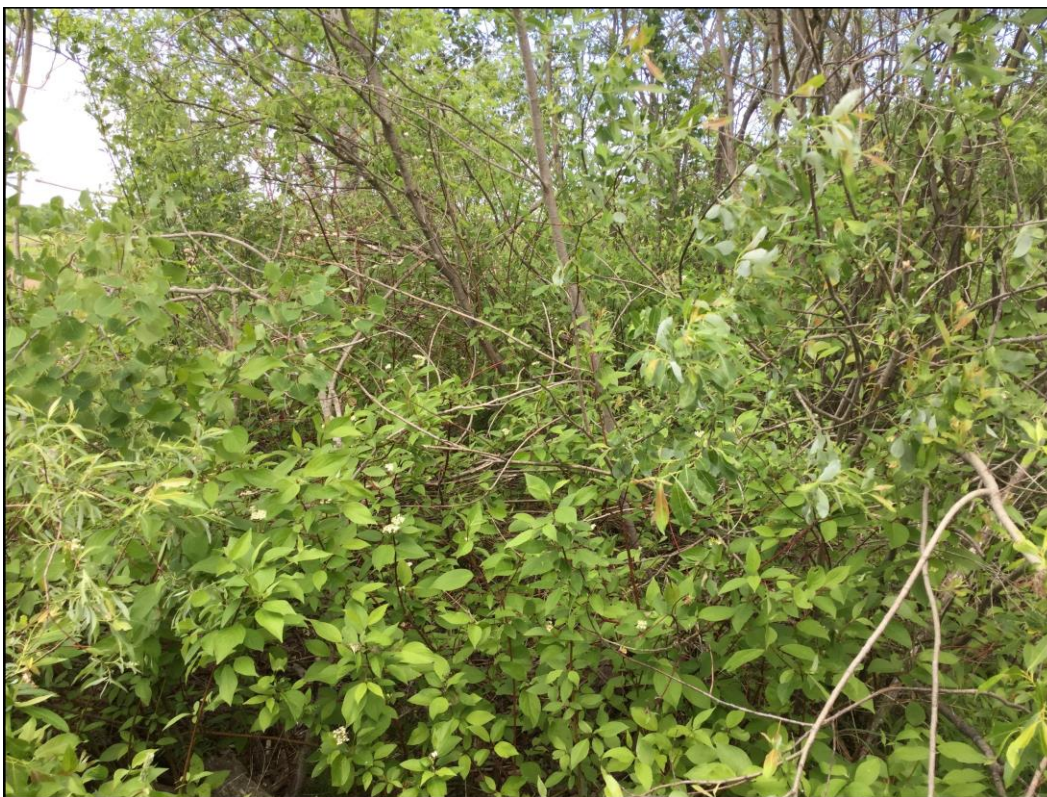
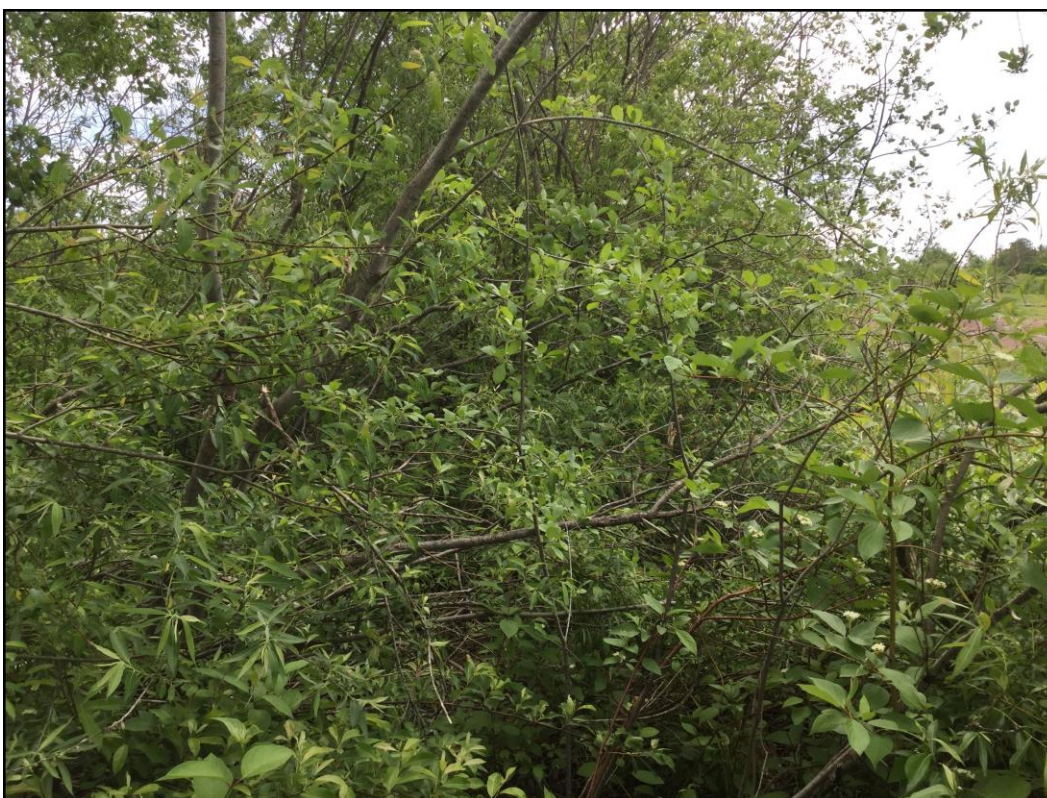
wasc1067s\_w\_NW

The soils were not sampled due to the location of the wetland within a ditch between two gravel driveways. The soils are assumed to be hydric based on the hydrology and dominance of hydrophytic vegetation.

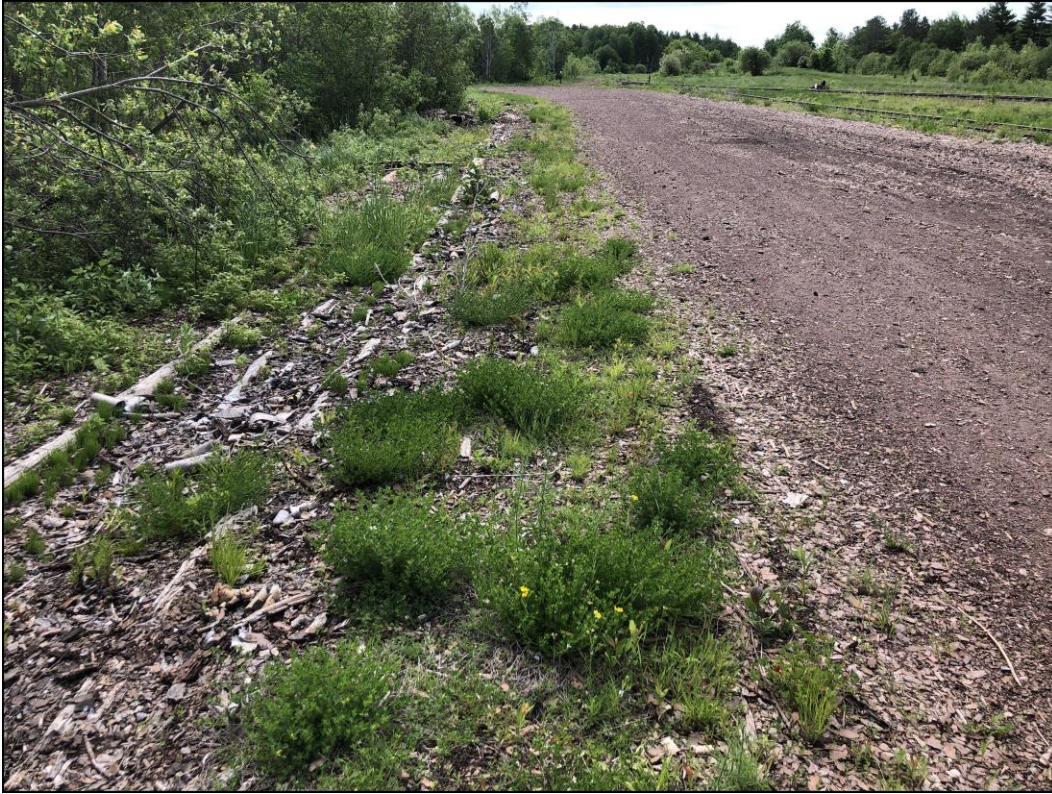
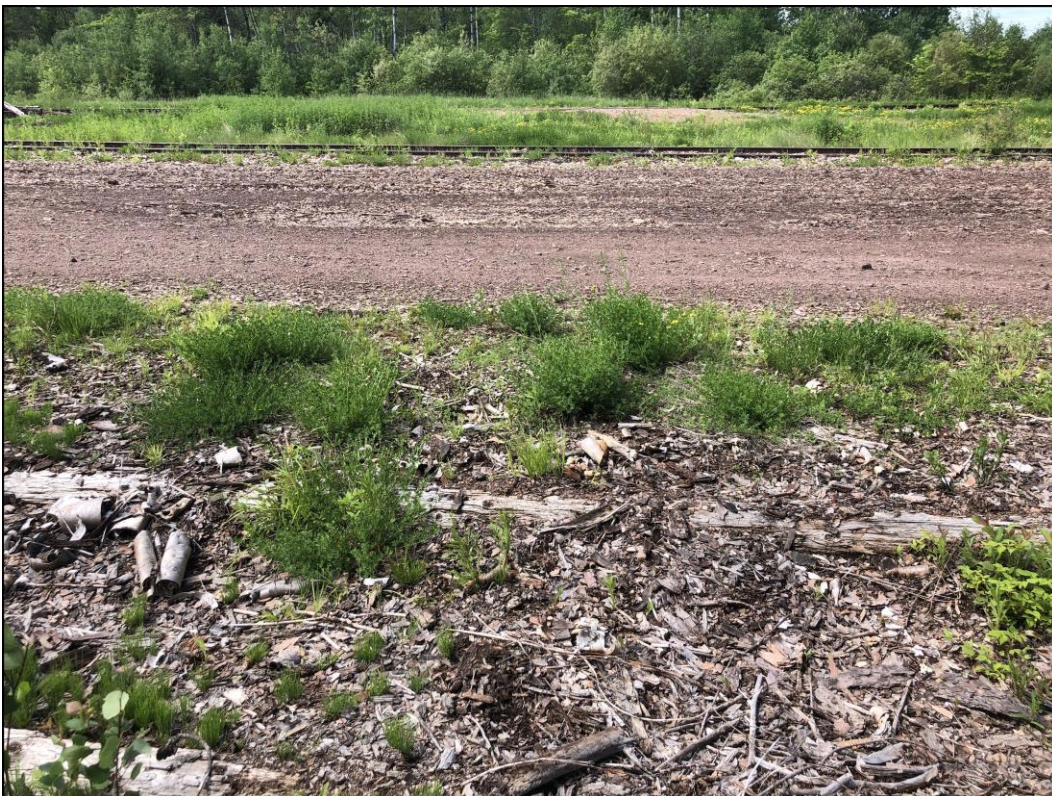
wasc1067\_u\_SE

Could not sample soil due to the roadside location. Soils are assumed to be non-hydric based on the landscape position and dominant vegetation.

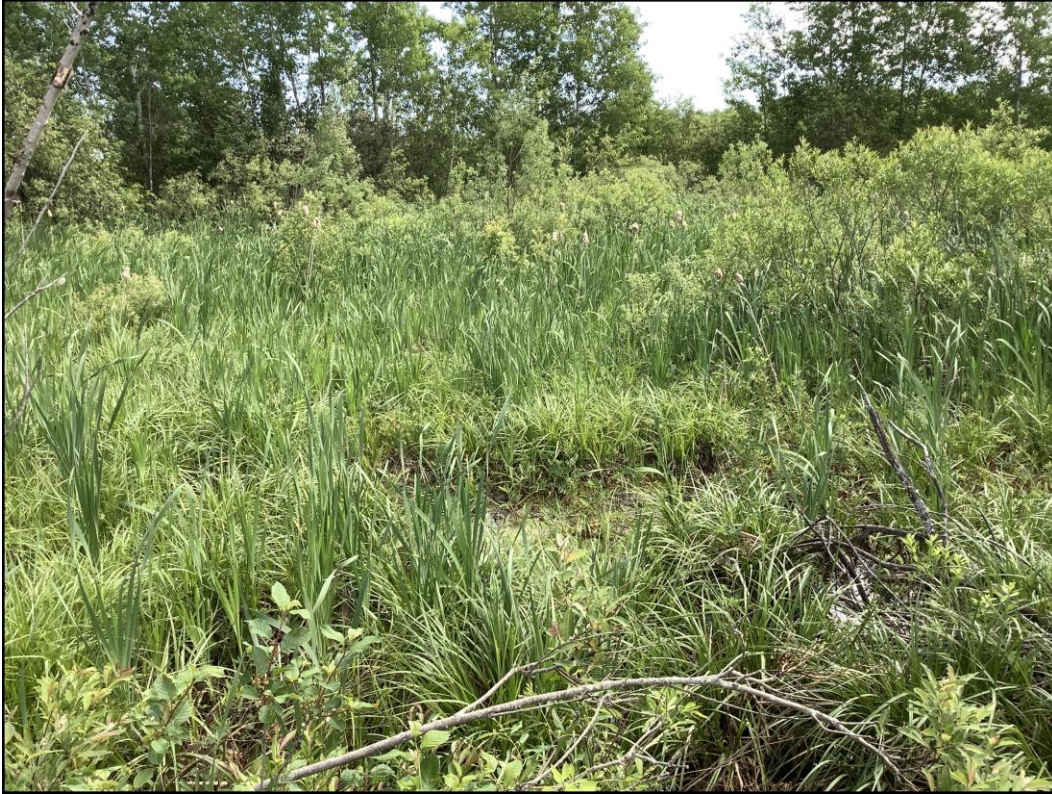
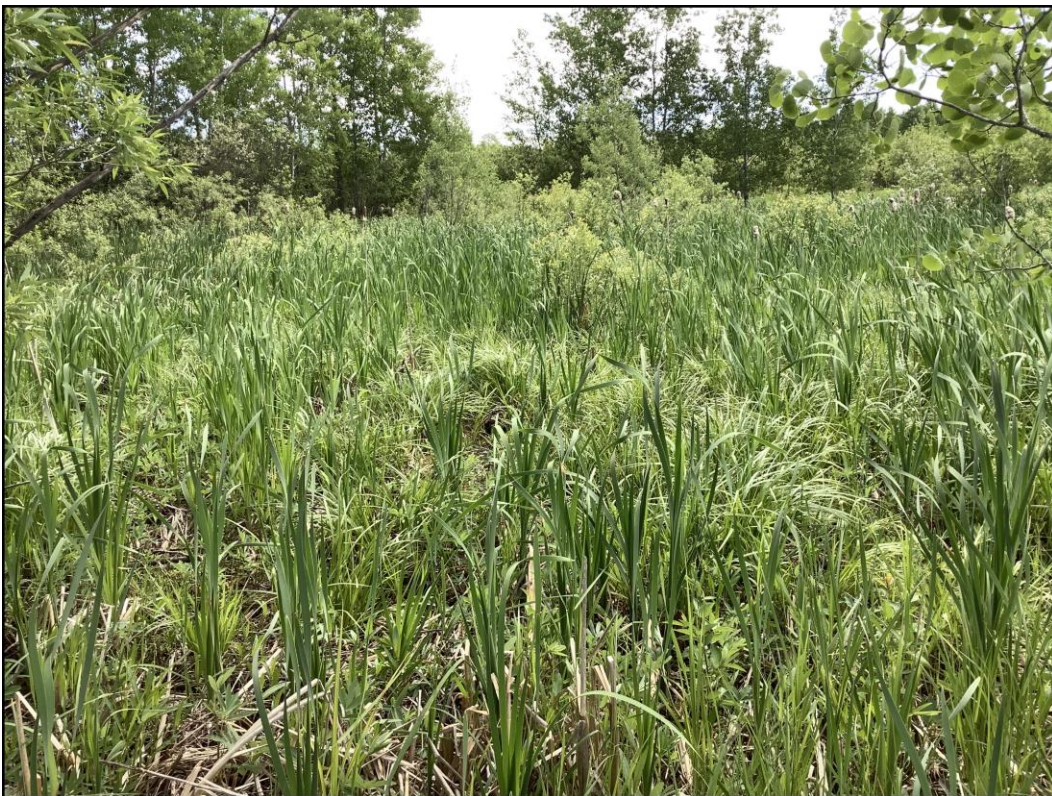
wasd1044e\_w\_E

The soils were not sampled due to the proximity of a railroad track with potential for buried utilities. The soils are assumed to be hydric based on hydrophytic vegetation and wetland hydrology.

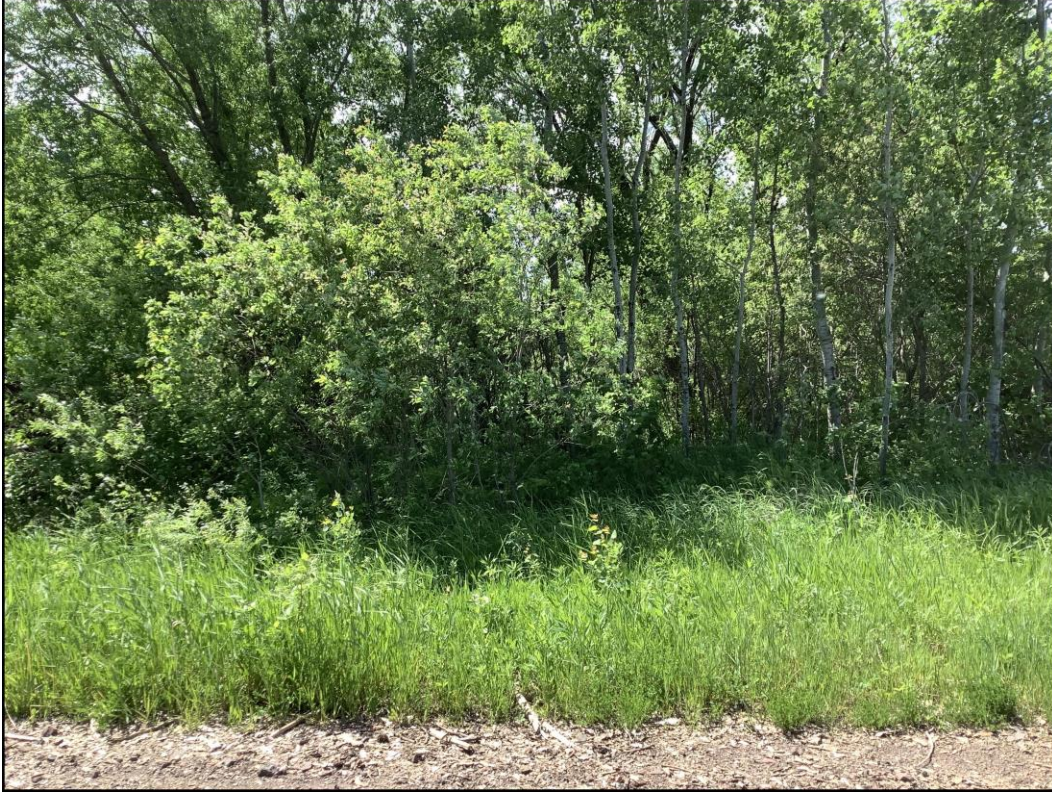
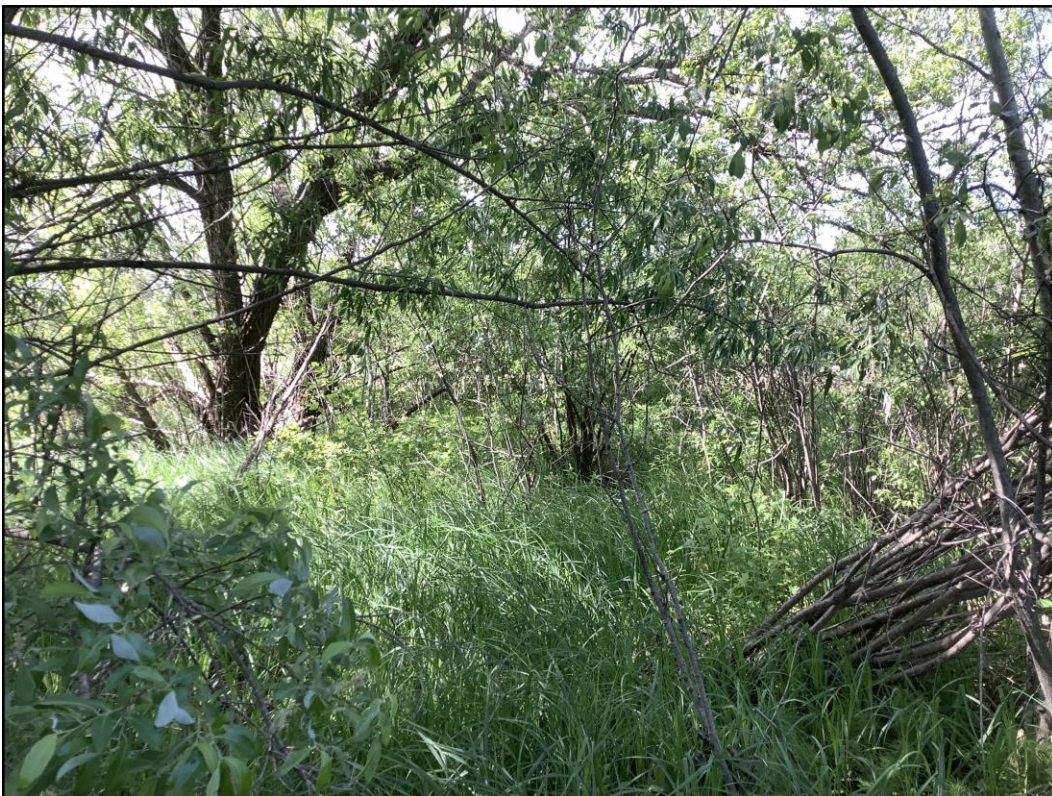
wasd1044f\_w\_S

The soils were not sampled due to the location of the wetland within a roadside ditch. The soils are assumed to be hydric based on the presence of hydrophytic vegetation and hydrologic indicators.

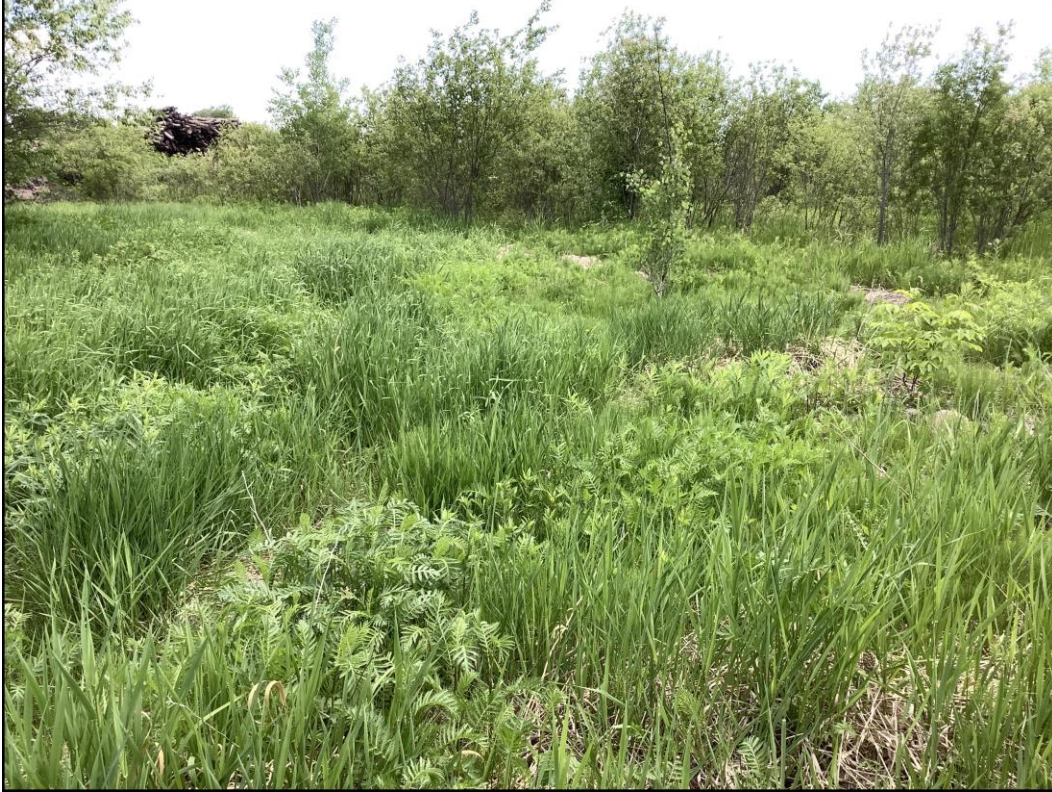
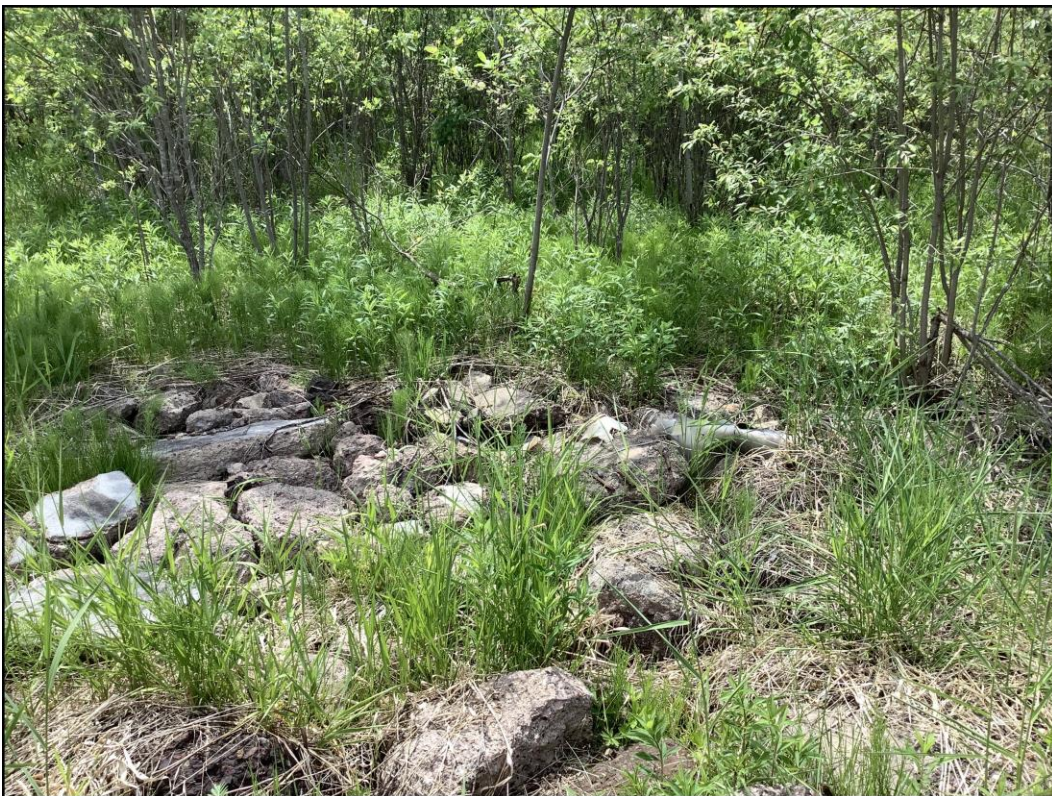
wasd1044\_u\_E

The soils were not sampled due to concrete rubble piles and the close proximity to a railroad. The soils are assumed to be non-hydric based on the landscape position and vegetative composition.

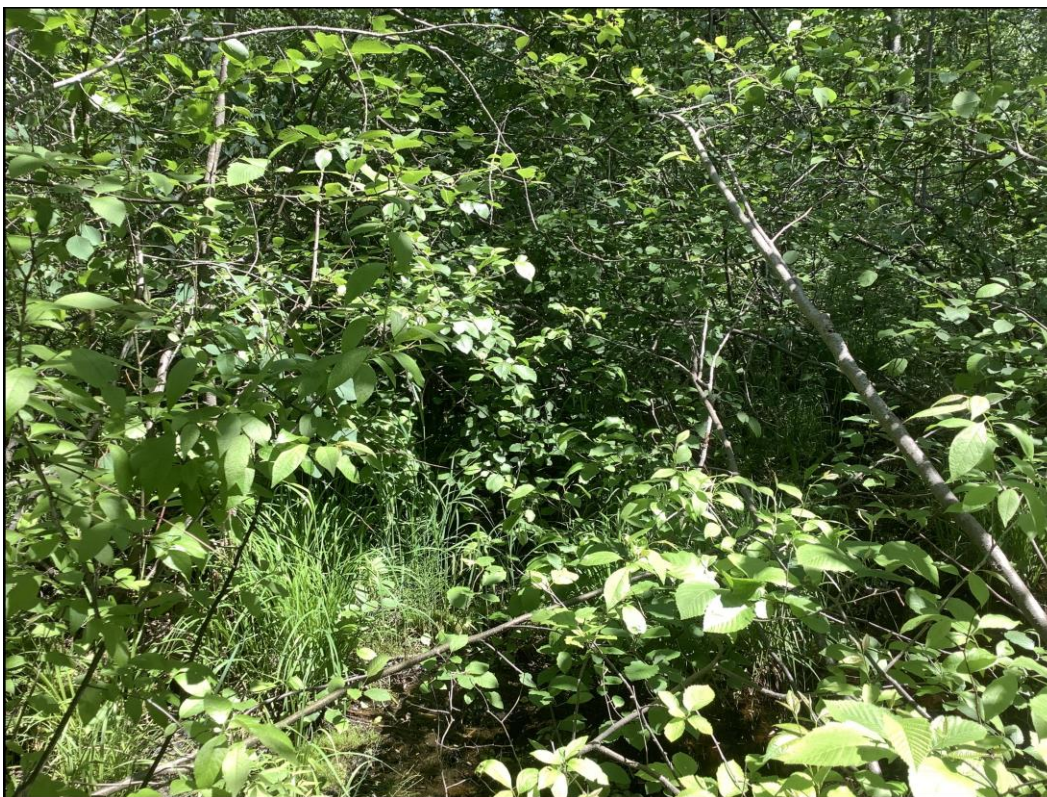
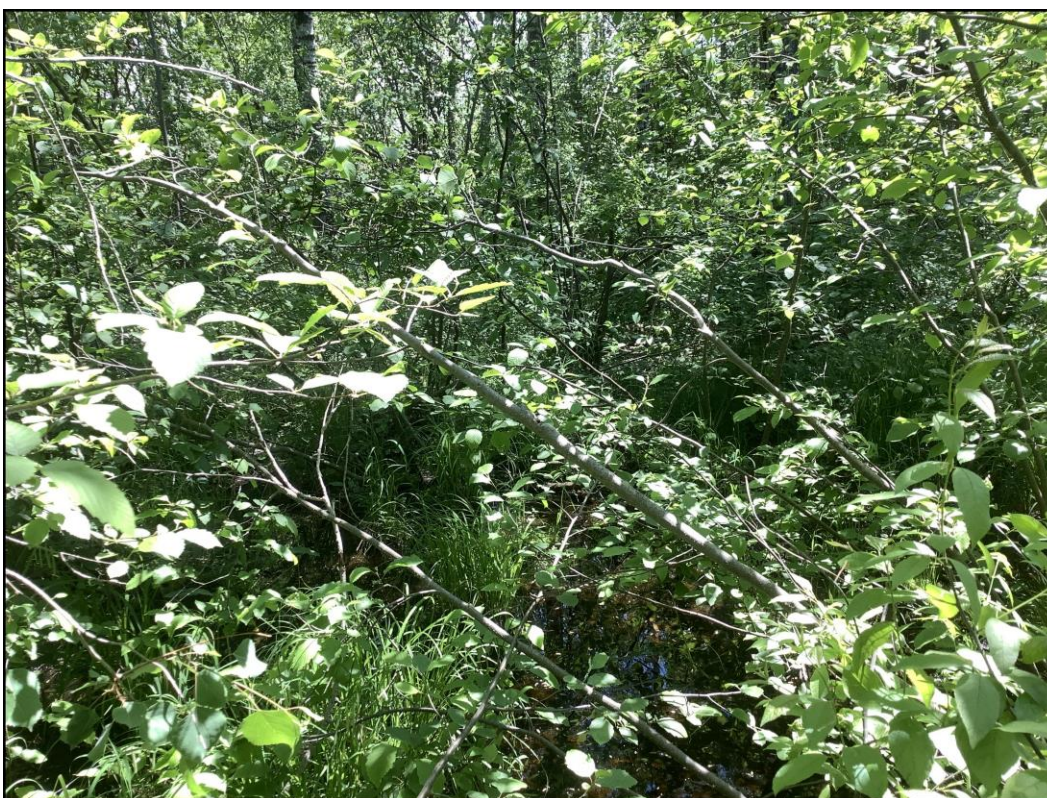
wase1062f\_w\_E

The soil profile consists of a dark clay loam over a depleted clay. Redox concentrations occur throughout the lower two layers. Two hydric indicators were met.

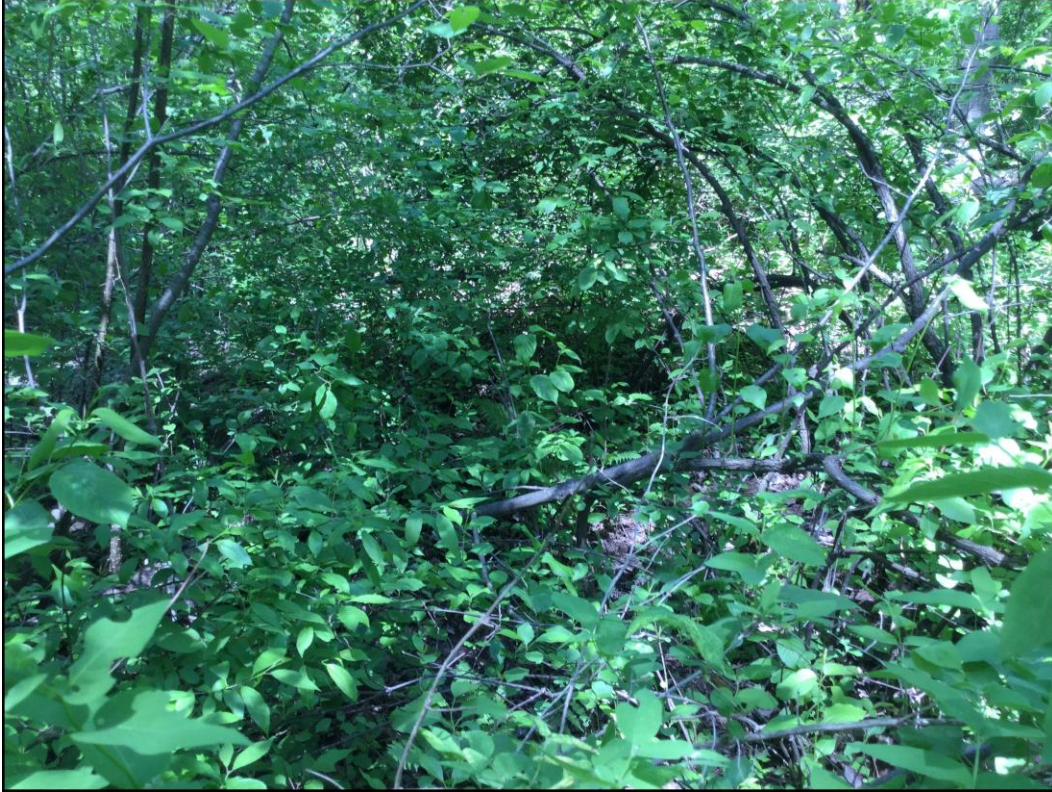
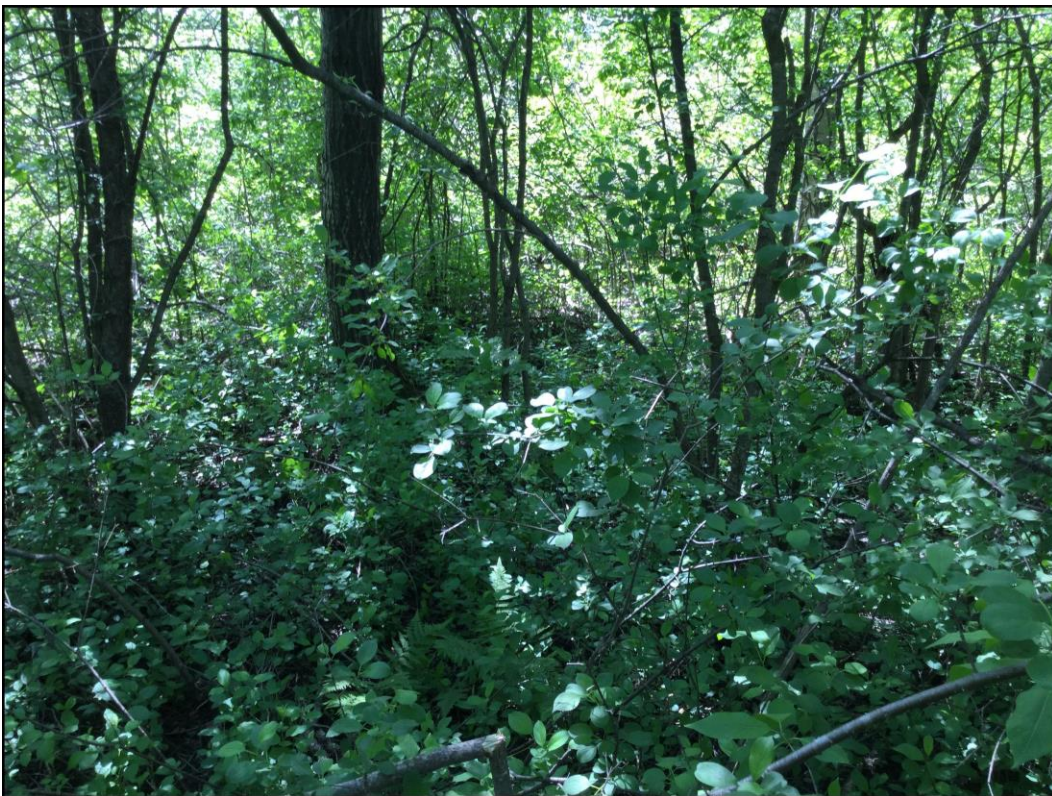
wase1062\_u\_NW

A depleted matrix with redox was observed in the soil profile.

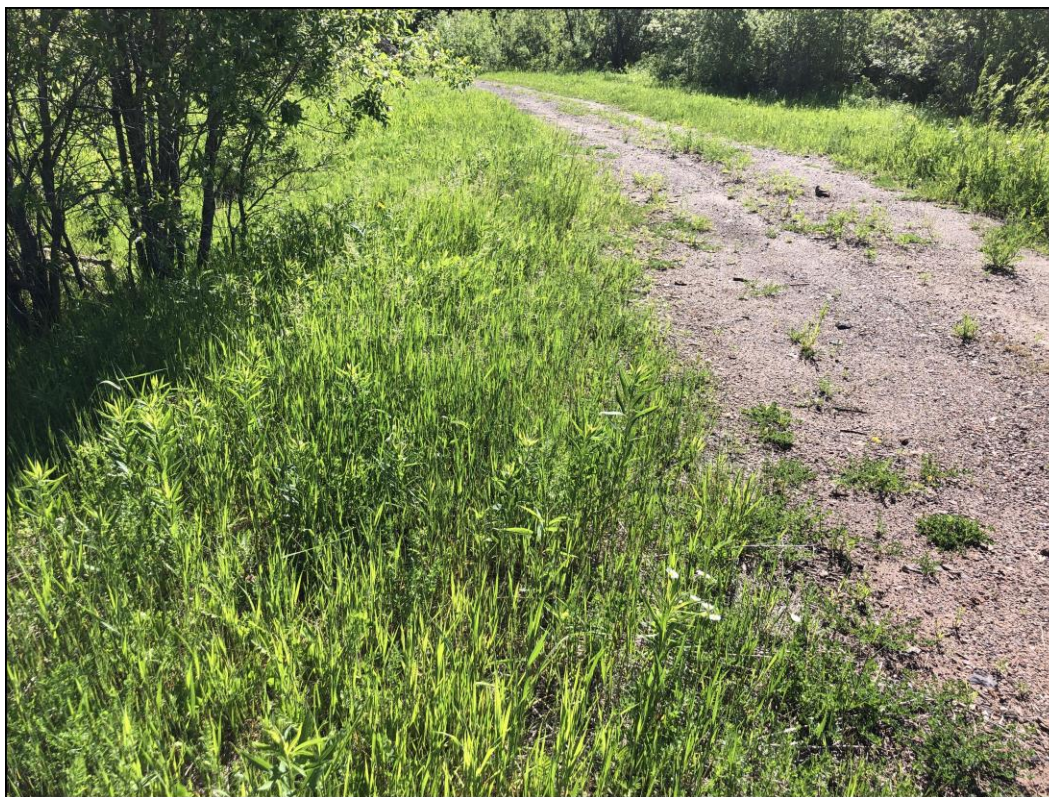
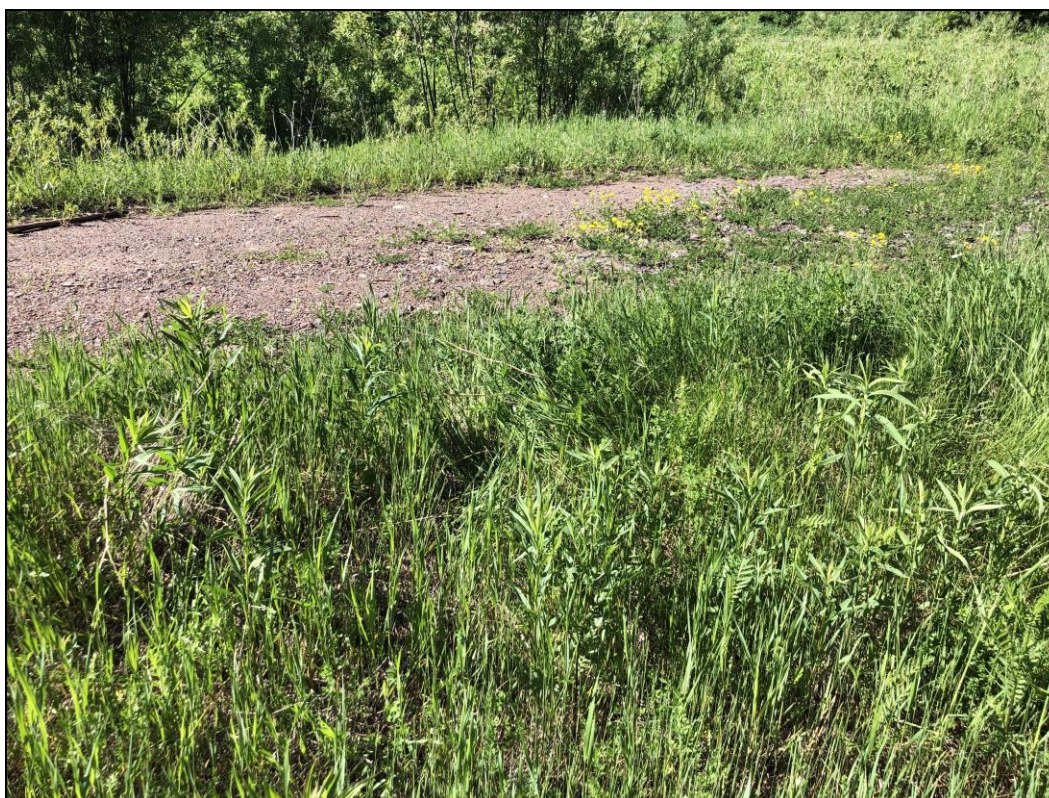
wasc1070\_u\_E

Could not sample soil beyond 3 inches due to the presence of cobble, concrete, and gravel. No indicators of hydric soil were observed.

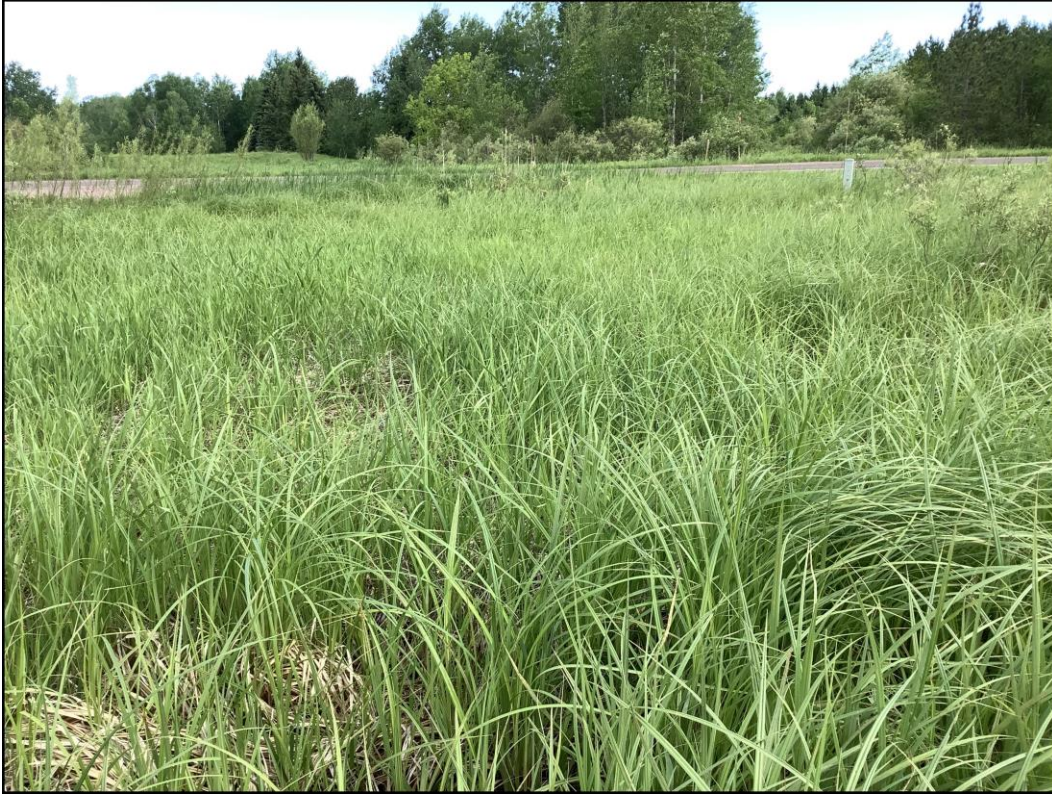
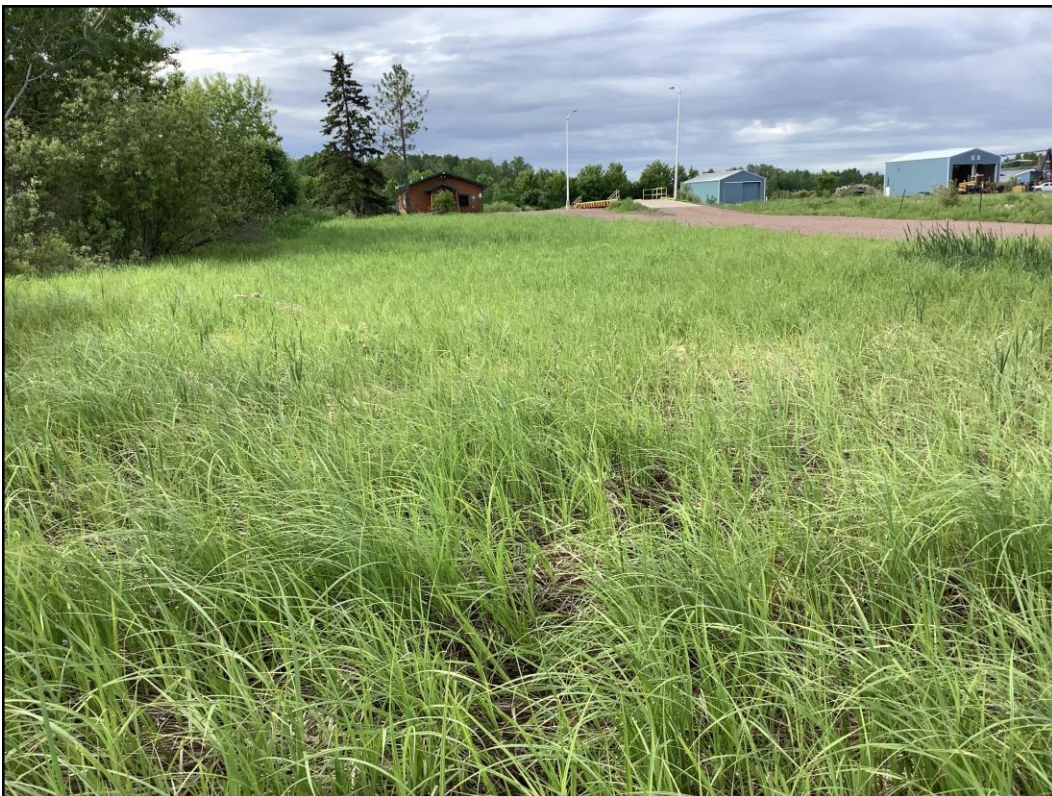
wase1061e\_w\_N

The soils were not sampled due to the location of the wetland within a roadside ditch. The soils are assumed to be hydric based on the hydrology and dominant vegetation.

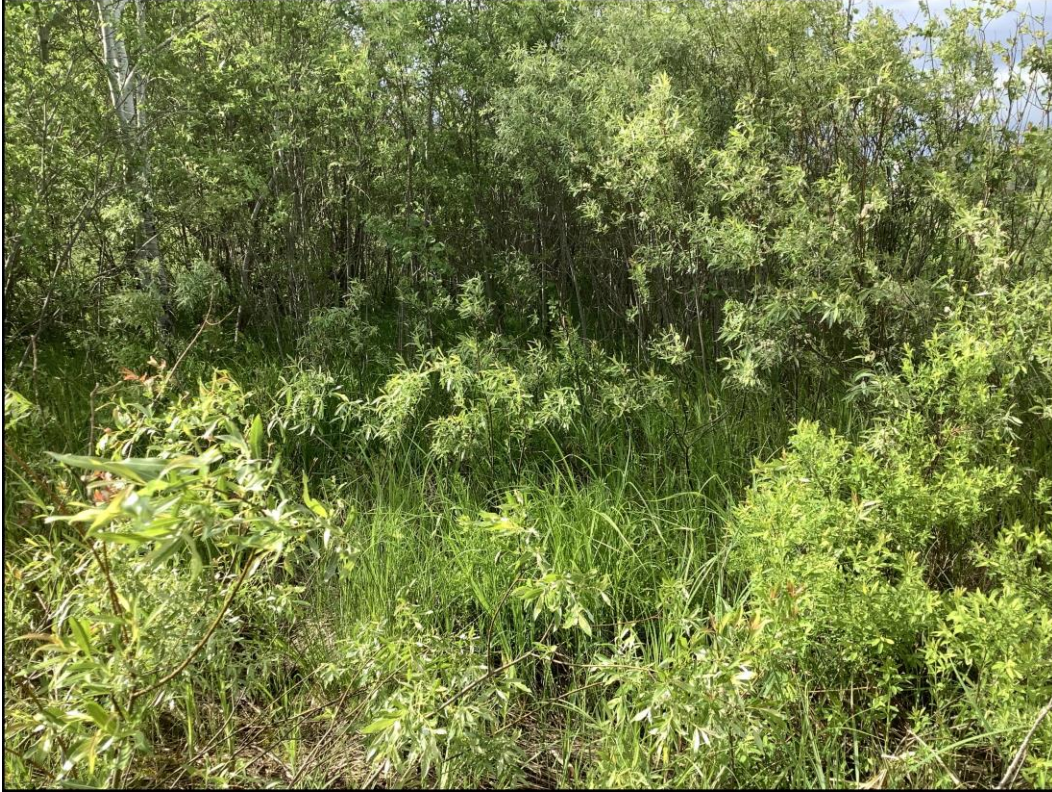
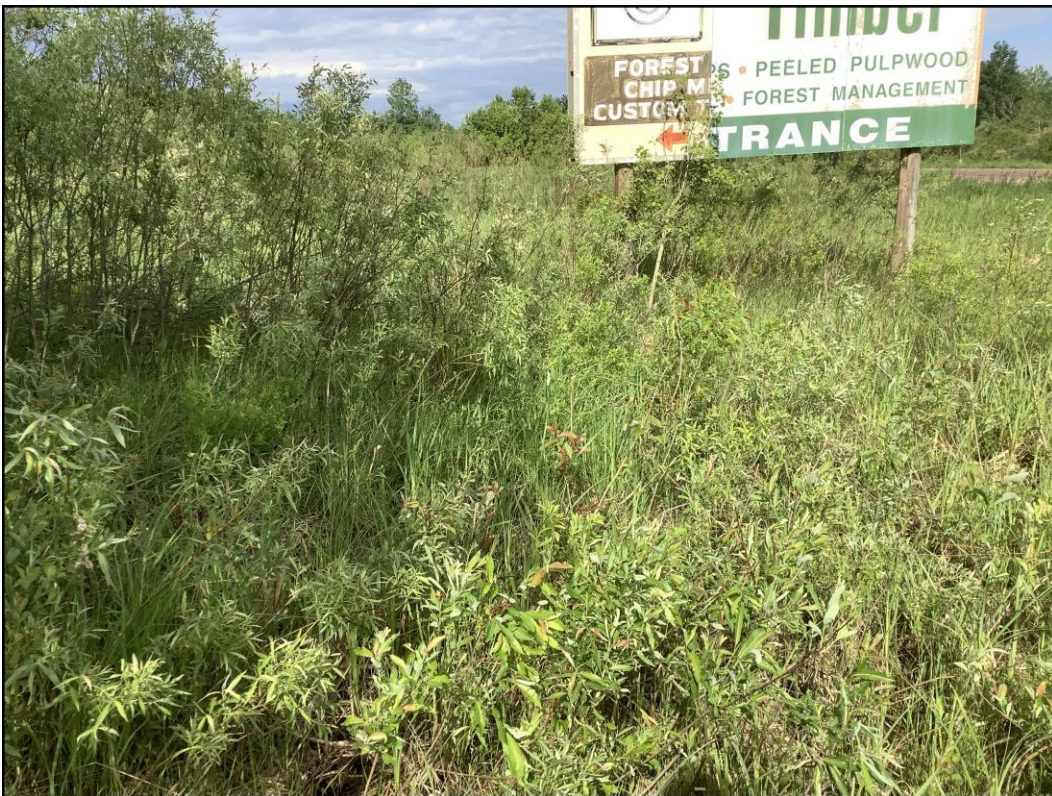
wase1061s\_w\_S

The soils were not sampled due to the location of the wetland within a roadside ditch. The soils are assumed to be hydric based on the presence of hydrophytic vegetation and hydrologic indicators.

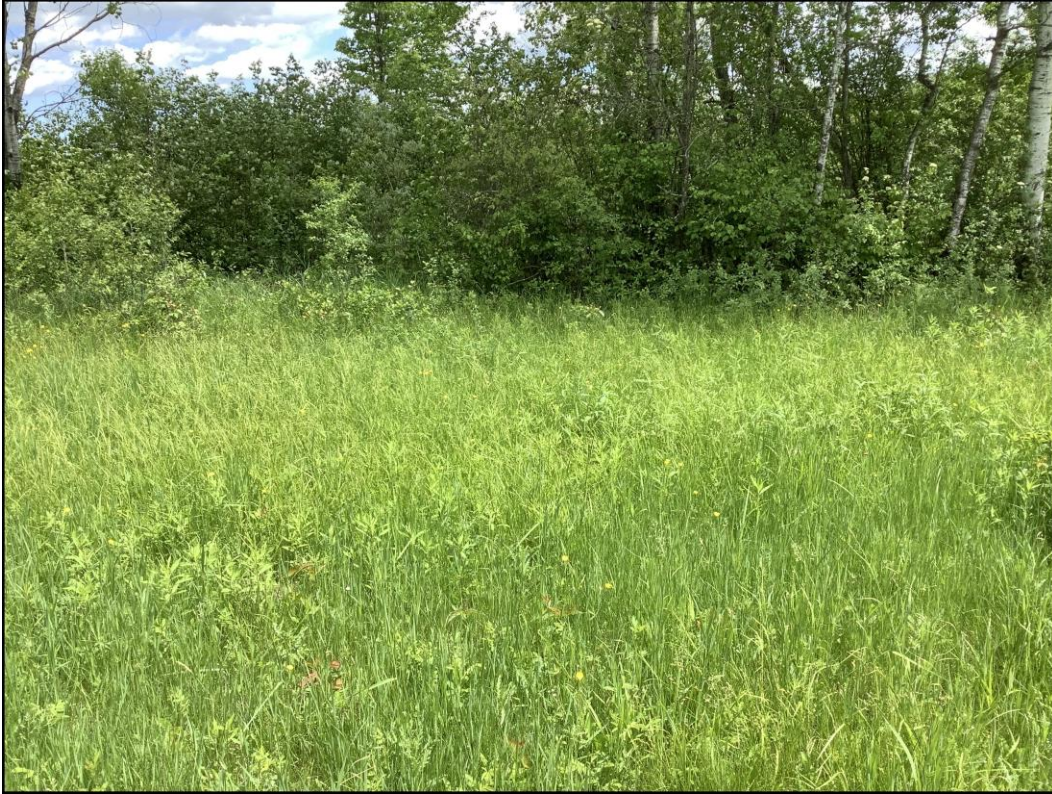
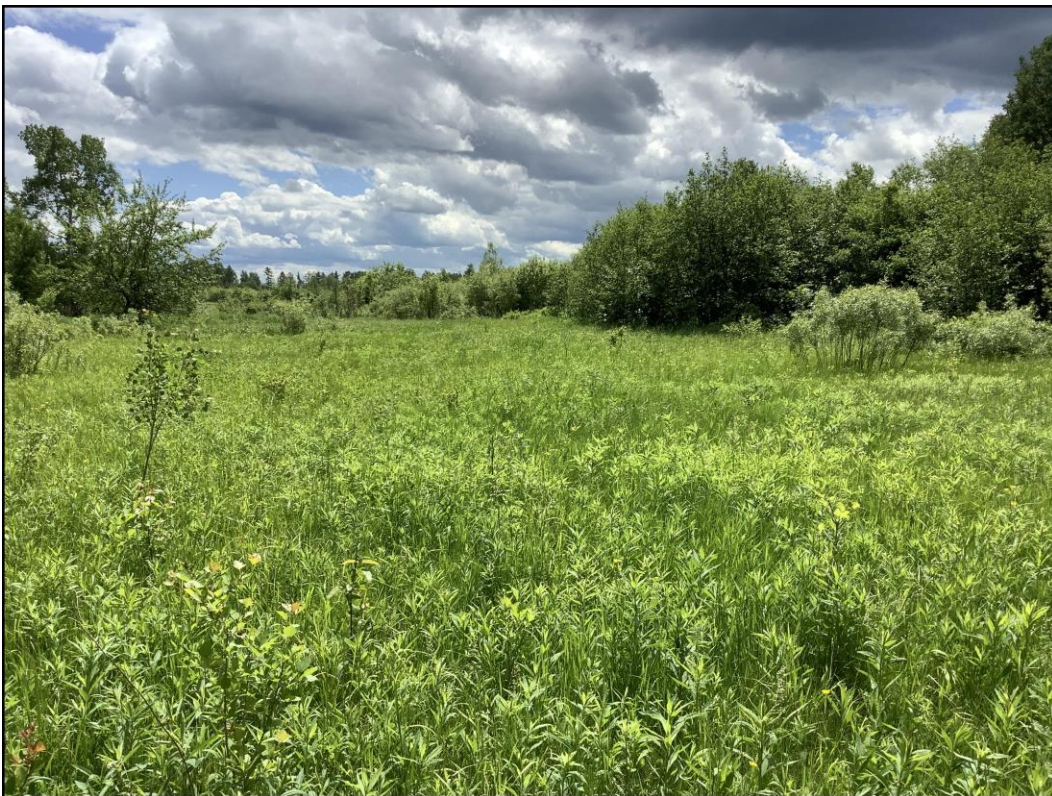
wase1061\_u2\_E

Soils are brown clay loam throughout. No indicators of hydric soils were observed.

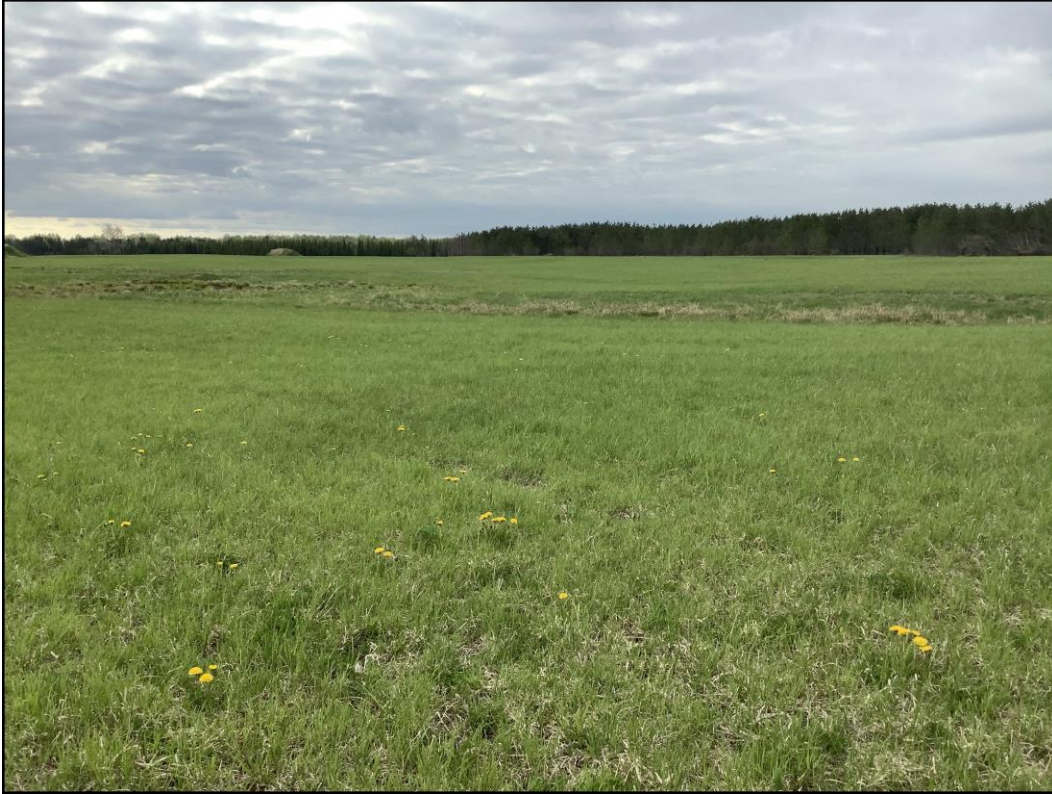
wasal025\_u\_SE

<b>Field Observations:</b> Surface Water Present? Yes _____ No <input checked="" type="checkbox"/> Depth (inches): _____ Water Table Present? Yes _____ No <input checked="" type="checkbox"/> Depth (inches): _____ Saturation Present? Yes _____ No <input checked="" type="checkbox"/> Depth (inches): _____ (includes capillary fringe)		<b>Wetland Hydrology Present?</b> Yes _____ No <input checked="" type="checkbox"/>
Describe Recorded Data (stream gauge, monitoring well, aerial photos, previous inspections), if available:		
Remarks: No indicators of wetland hydrology were observed.
