# WETLAND DETERMINATION DATA FORM – Northcentral and Northeast Region

Project/Site: Line 5 Relocation Project City/County: Ashland Sampling Date: 2020-05-19  
 Applicant/Owner: Enbridge State: Wisconsin Sampling Point: wase1005e\_w  
 Investigator(s): DMP/ARK Section, Township, Range: sec 20 T046N R004W  
 Landform (hillslope, terrace, etc.): Depression Local relief (concave, convex, none): Concave Slope (%): 0-2%  
 Subregion (LRR or MLRA): Northcentral Forests Lat: 46.447192 Long: -90.895907 Datum: WGS84  
 Soil Map Unit Name: Sanborg-Badriver complex, 0 to 6 percent slopes NWI classification: \_\_\_\_\_

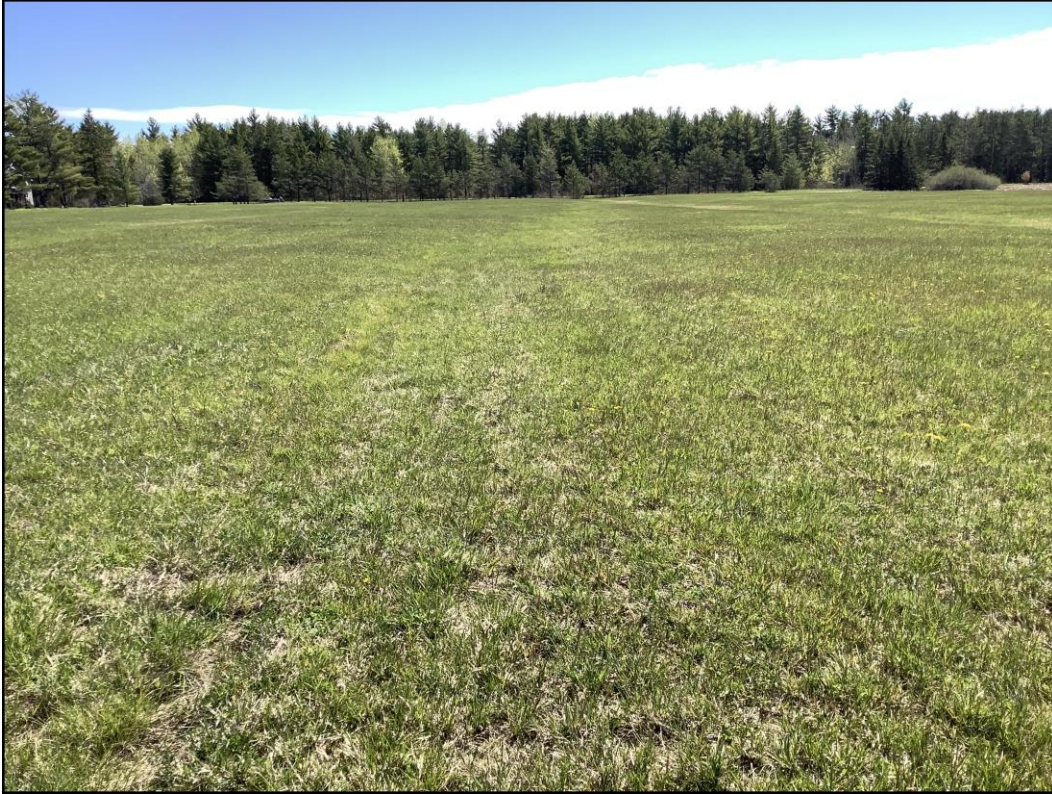
wase1005e\_w\_E

Hydric soil indicator Depleted Matrix was met; clay soils are poorly drained. The top layer has a mixed matrix.

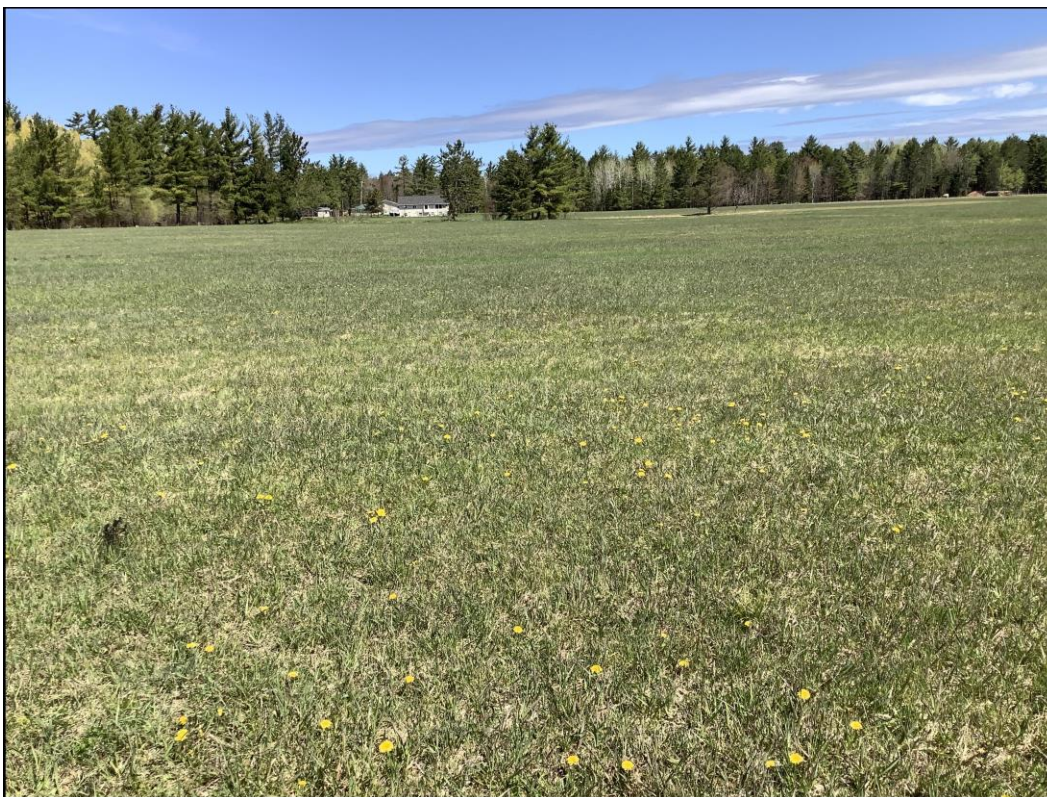
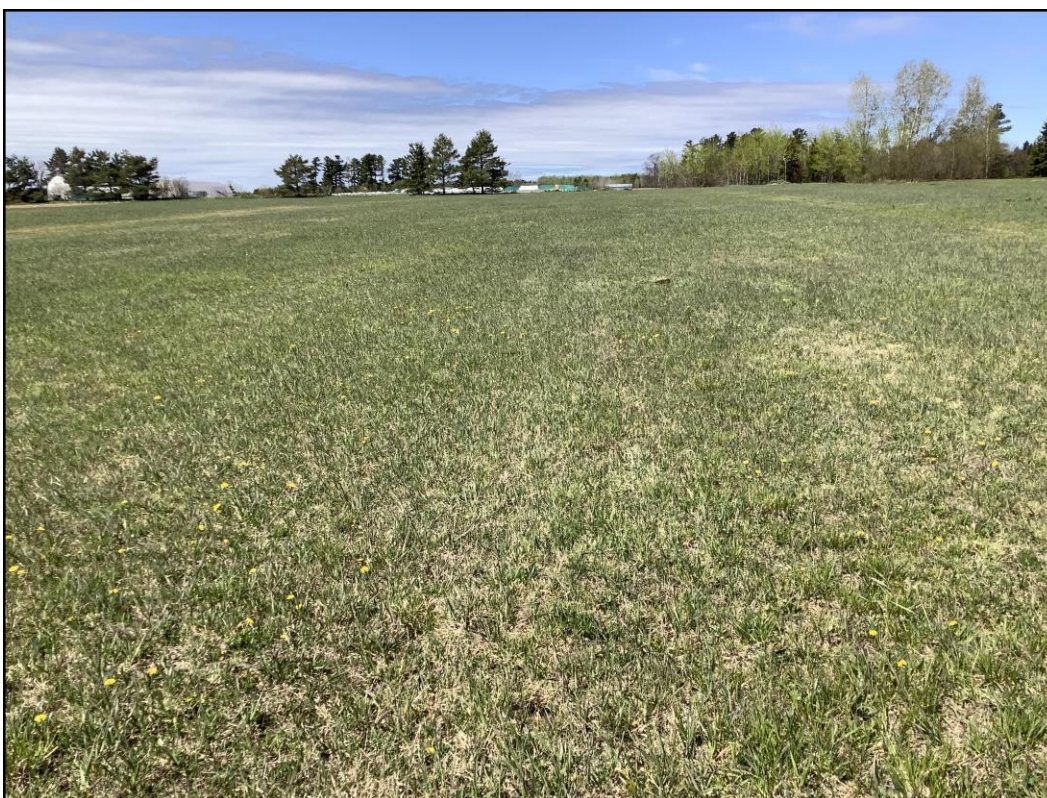
Sampling Point: wase1005\_u

<b>Field Observations:</b> Surface Water Present? Yes _____ No <input checked="" type="checkbox"/> Depth (inches): _____ Water Table Present? Yes _____ No <input checked="" type="checkbox"/> Depth (inches): _____ Saturation Present? (includes capillary fringe) Yes _____ No <input checked="" type="checkbox"/> Depth (inches): _____		<b>Wetland Hydrology Present?</b> Yes _____ No <input checked="" type="checkbox"/>
Describe Recorded Data (stream gauge, monitoring well, aerial photos, previous inspections), if available:		
Remarks: <u>No indicators of wetland hydrology were observed.</u>

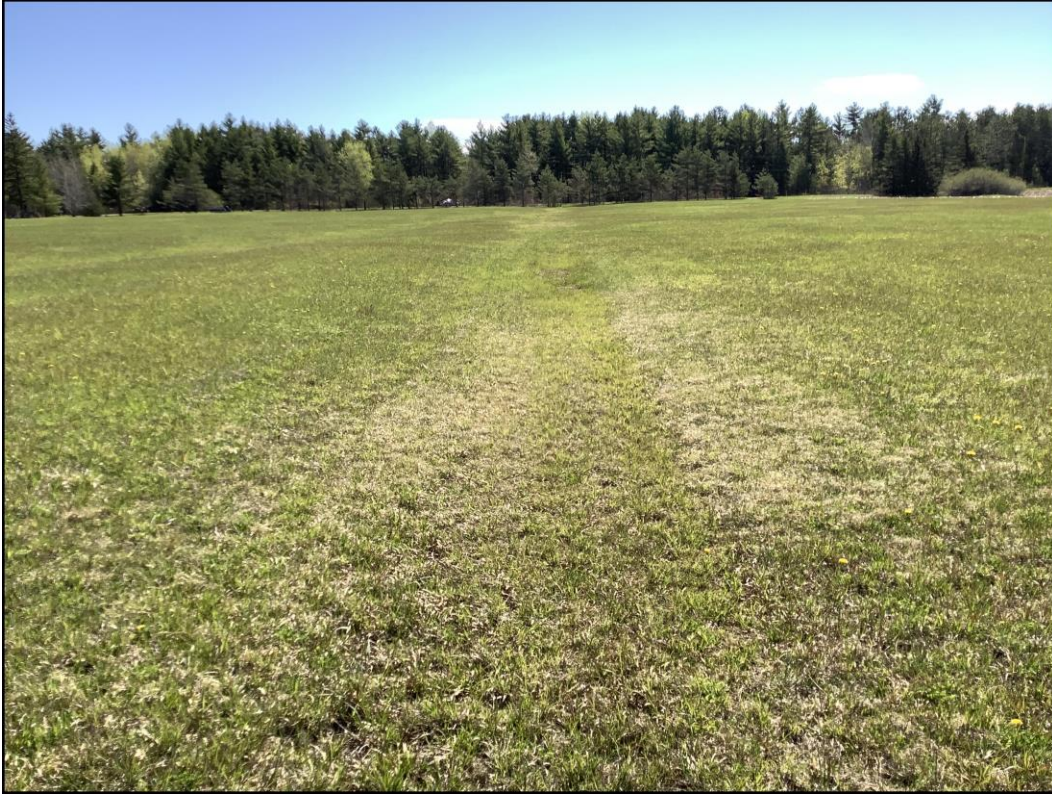
wase1004e\_w\_E

Clay soils are poorly drained and meet two hydric indicators.

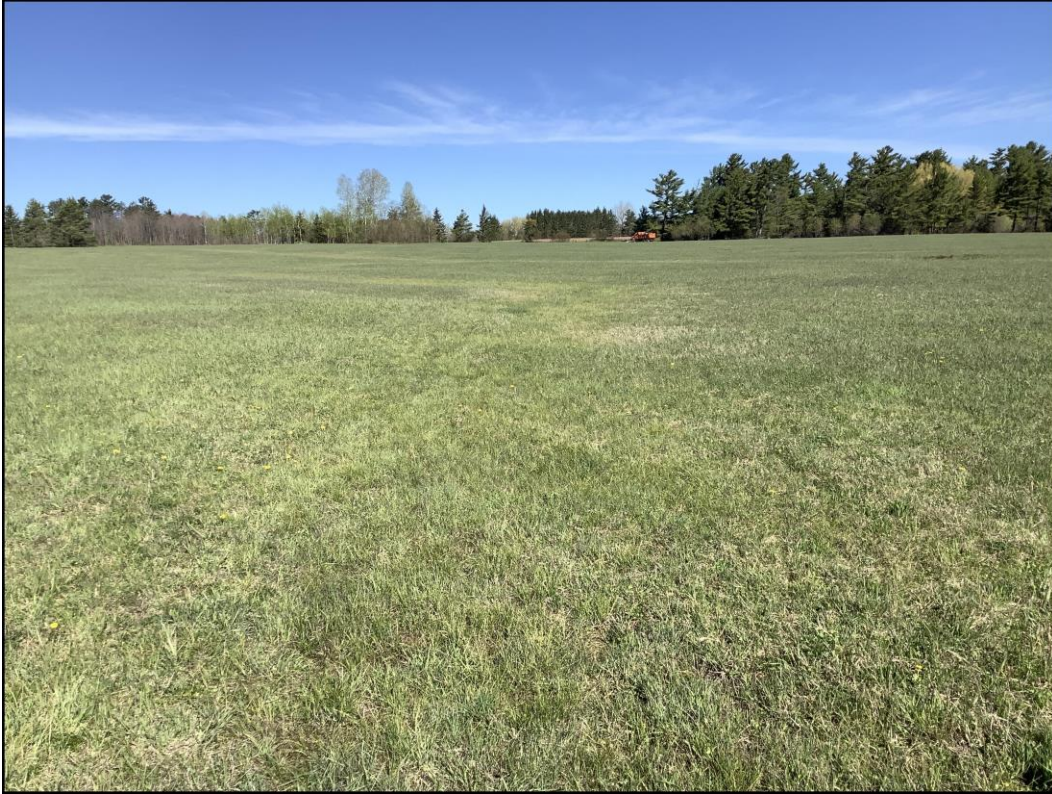
wase1003e\_w\_NW

Two hydric soil indicators are met; clay soils are poorly drained.

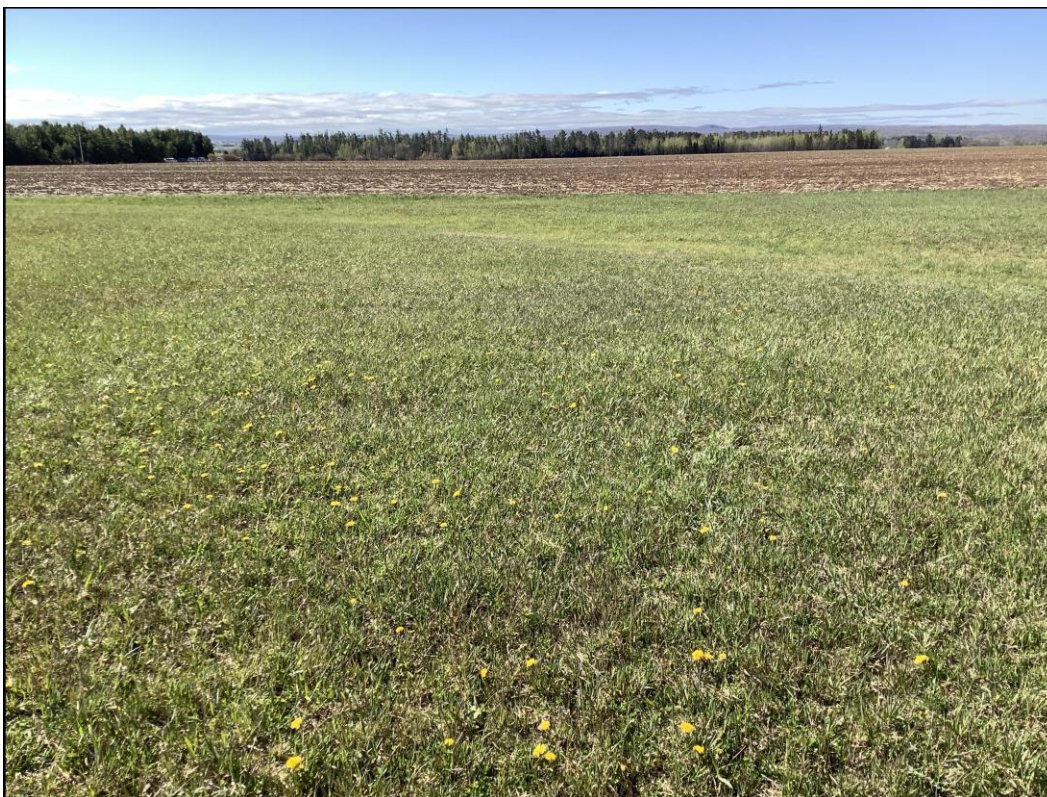
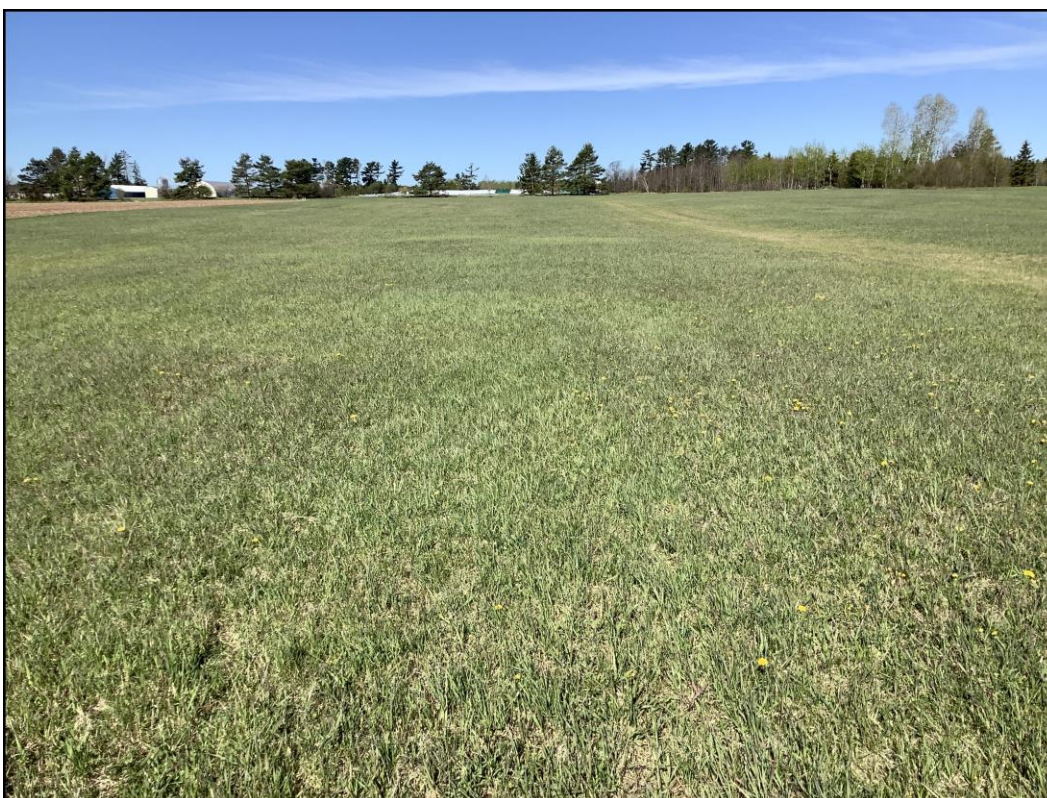
Sampling Point: wase1003\_u

<b>Field Observations:</b> Surface Water Present? Yes _____ No <input checked="" type="checkbox"/> Depth (inches): _____ Water Table Present? Yes _____ No <input checked="" type="checkbox"/> Depth (inches): _____ Saturation Present? Yes _____ No <input checked="" type="checkbox"/> Depth (inches): _____ (includes capillary fringe)		<b>Wetland Hydrology Present?</b> Yes _____ No <input checked="" type="checkbox"/>
Describe Recorded Data (stream gauge, monitoring well, aerial photos, previous inspections), if available:		
Remarks: <u>No indicators of wetland hydrology were observed.</u>

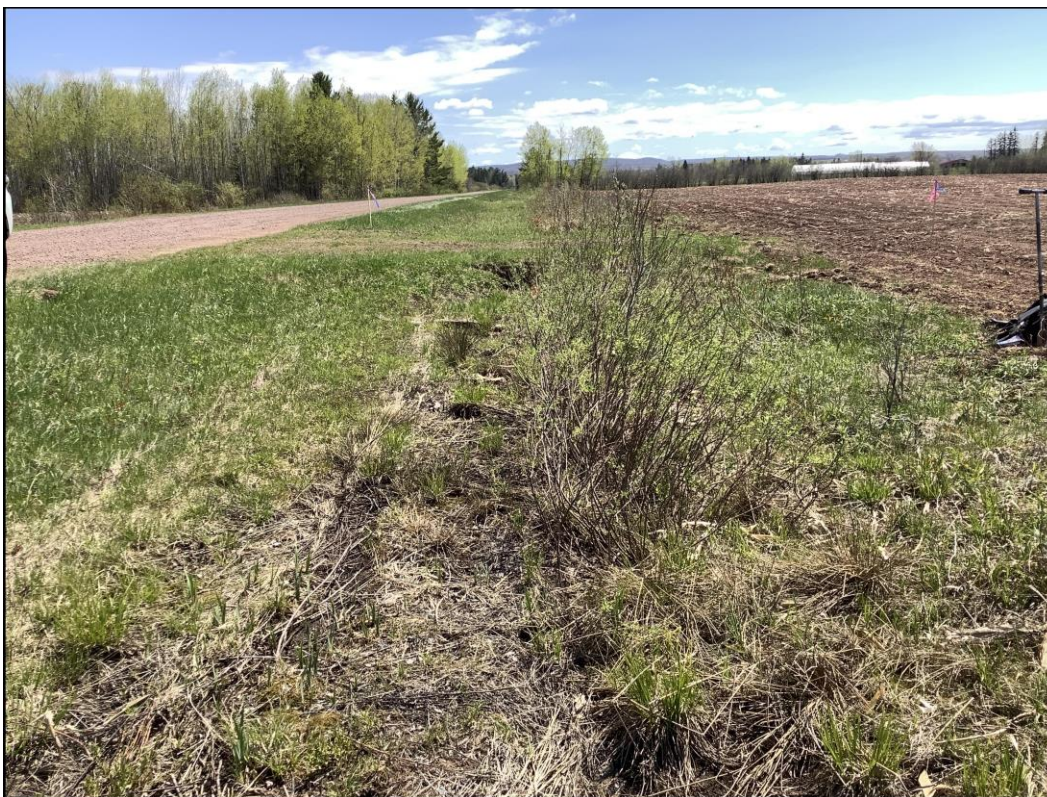
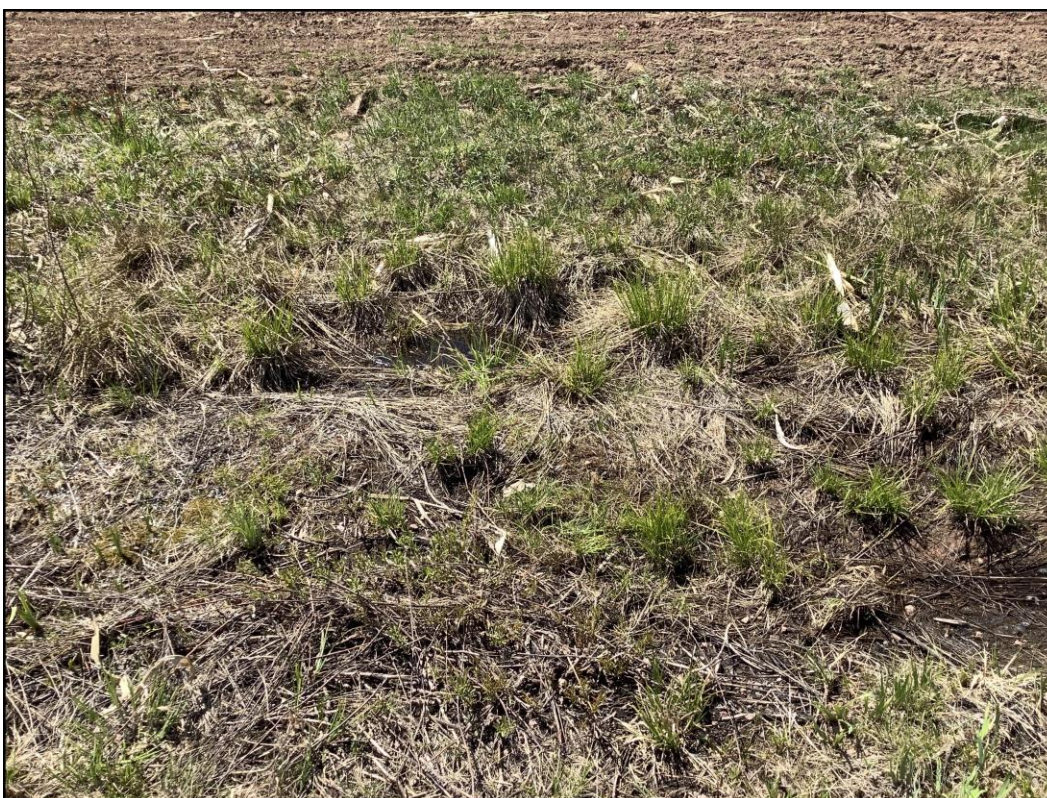
The soils were not sampled due to the location of the wetland within a roadside ditch. The soils are assumed to be hydric based on the presence of hydrophytic vegetation and hydrologic indicators.

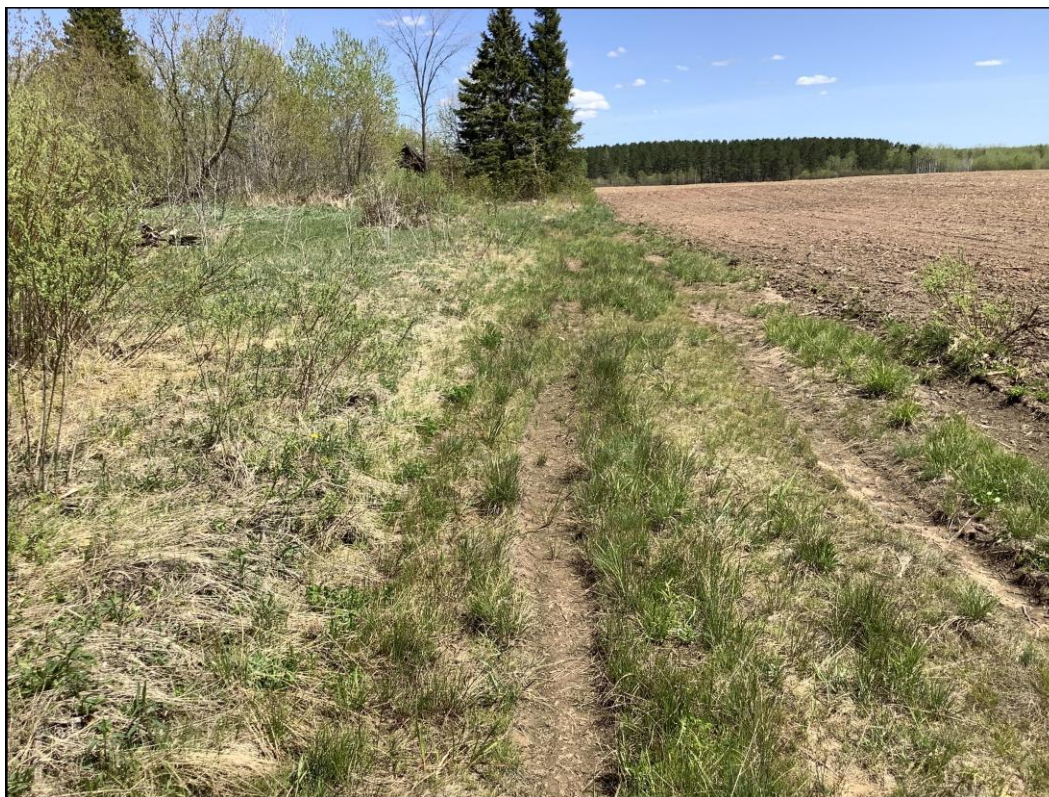
wase1010e\_w\_E

The soil profile consists of a depleted clay loam over a red clay. Depleted Matrix was observed.

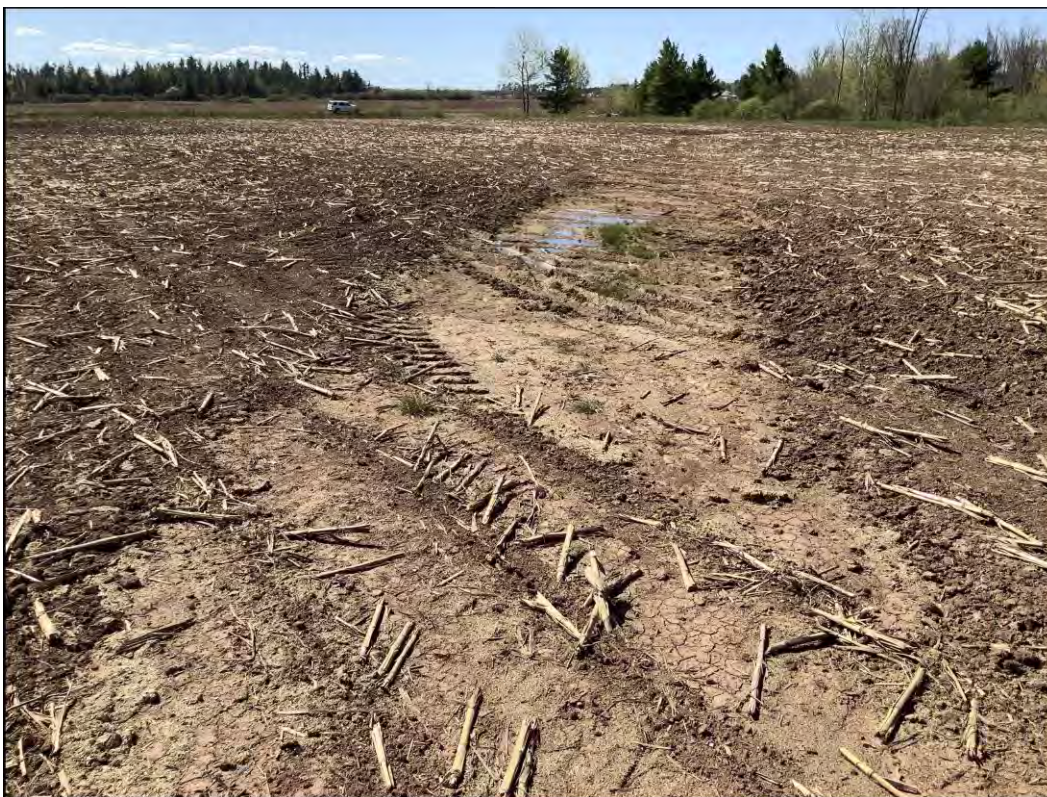
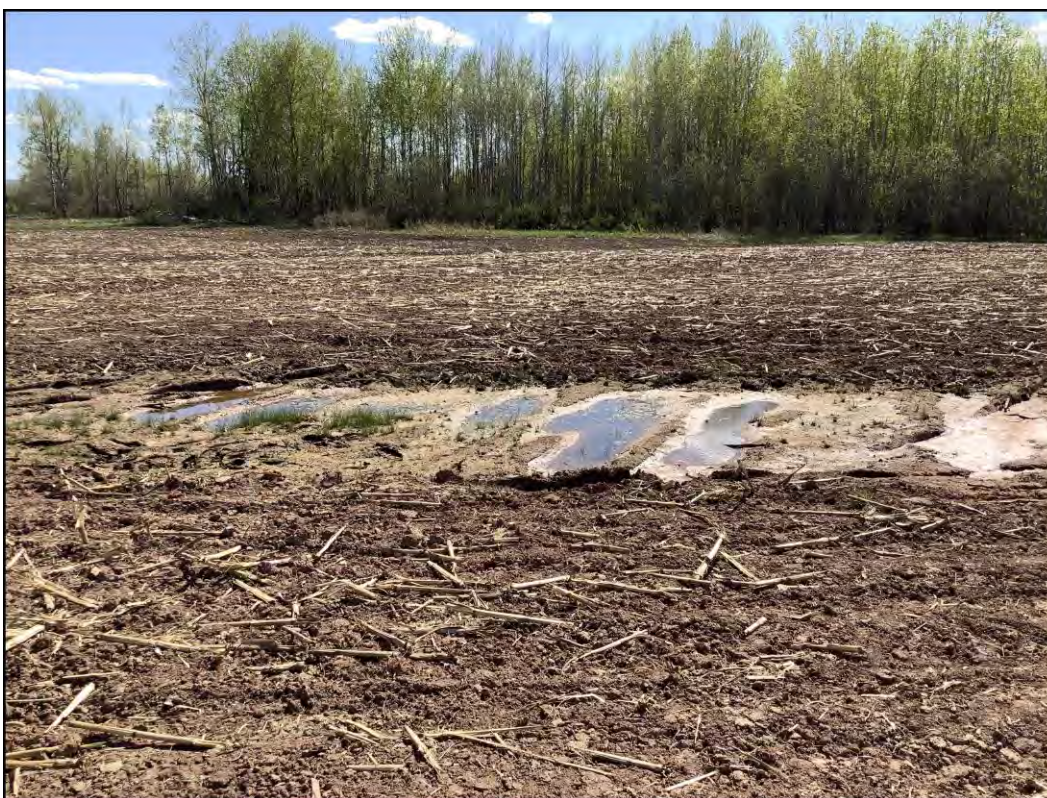
Thin layer of mucky mineral over clay with redox.

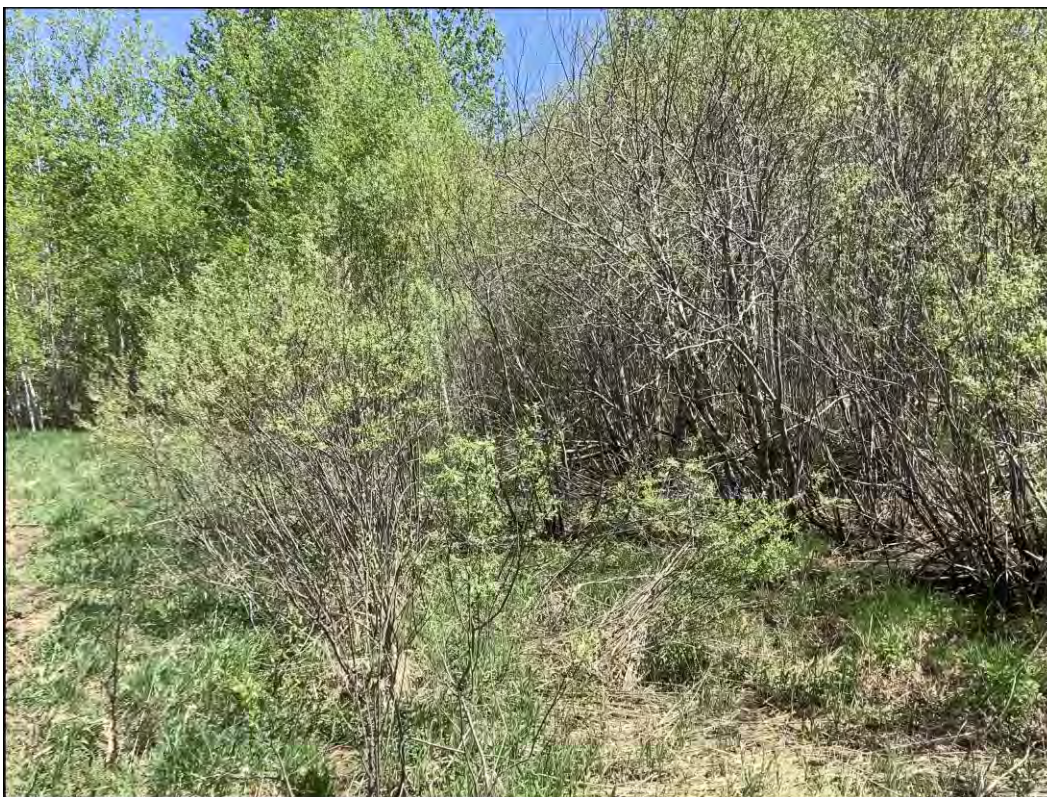
wase1012s\_w\_E

The soil profile consists of a mixed clay. A depleted matrix was observed within the lower mixed layer.

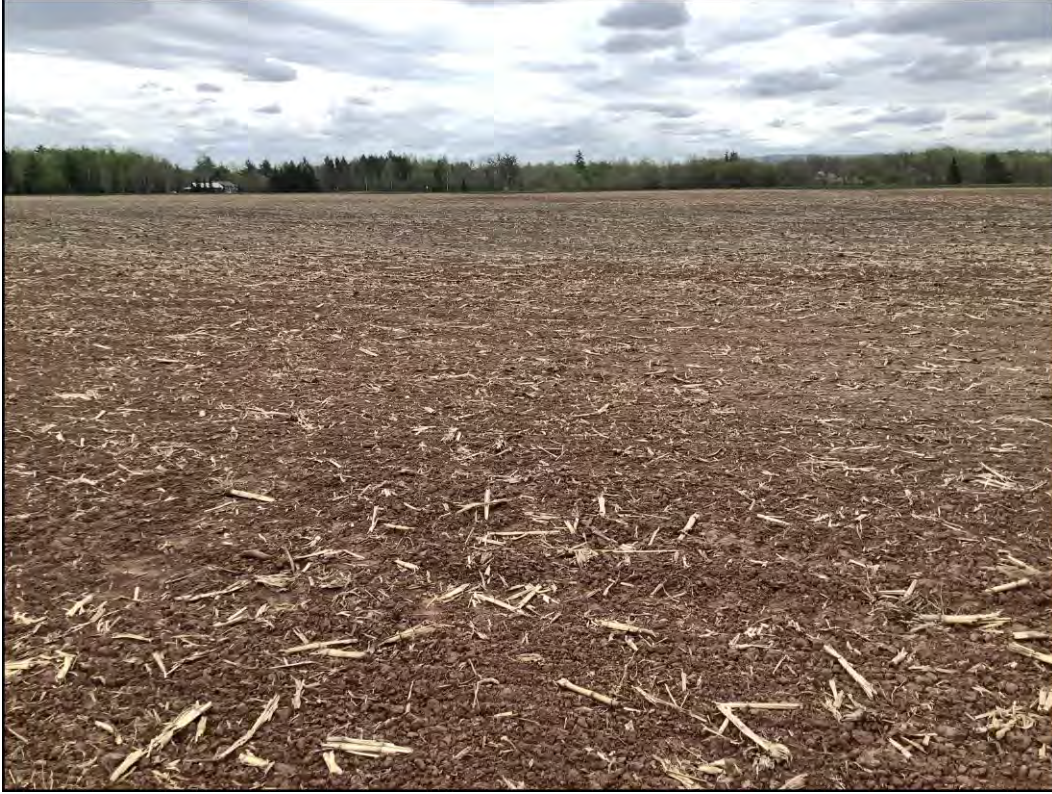
wase1013\_u4\_SE

Remarks: (Include photo numbers here or on a separate sheet.)  
 The sample plot was taken within a tilled crop field. No emerging vegetation was observed.

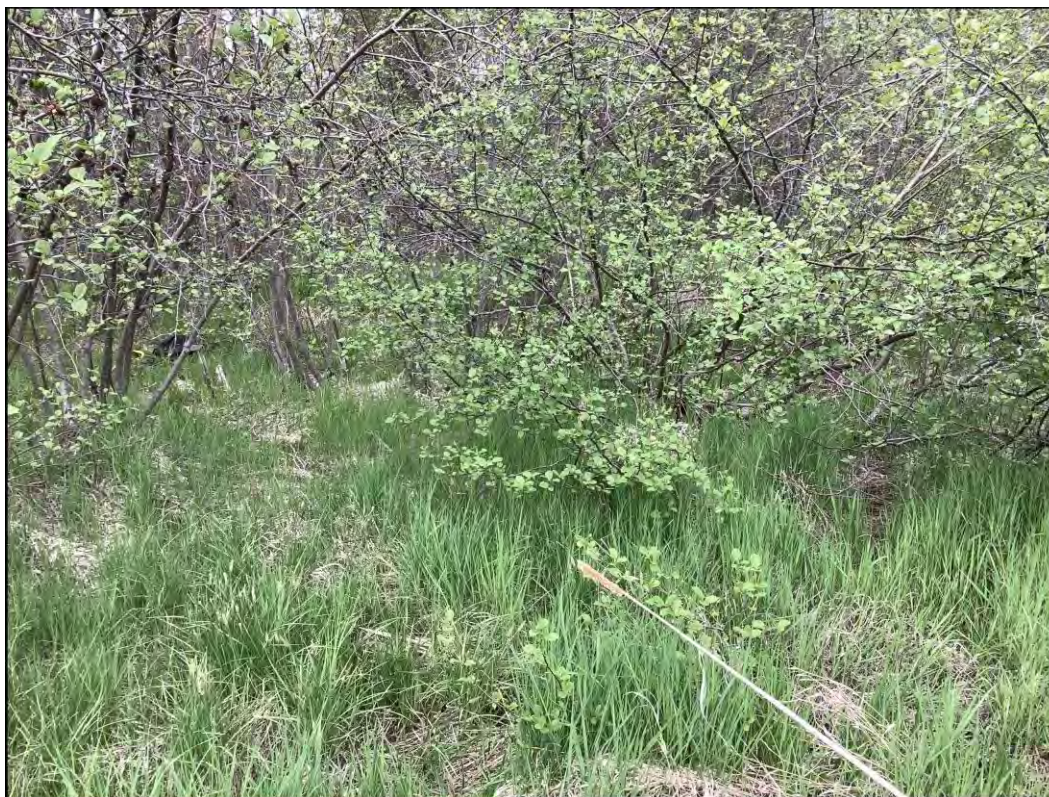
wase1014s\_w\_N

The saturated soil profile consists of fine sandy loam over fine sand. Two hydric soil indicators were observed.

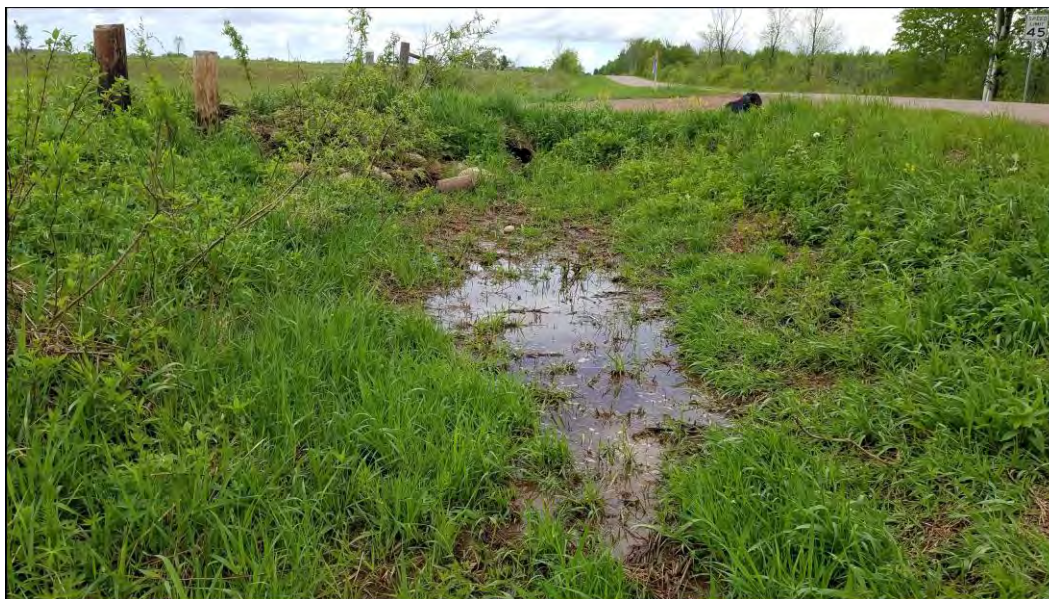
wase1022e\_w\_N

The soil profile consists of a thin dark loam over a dark clay loam and red clay. Redox concentrations were observed within the middle layer. The bottom layer is a dense red clay. Redox Dark Surface was observed.

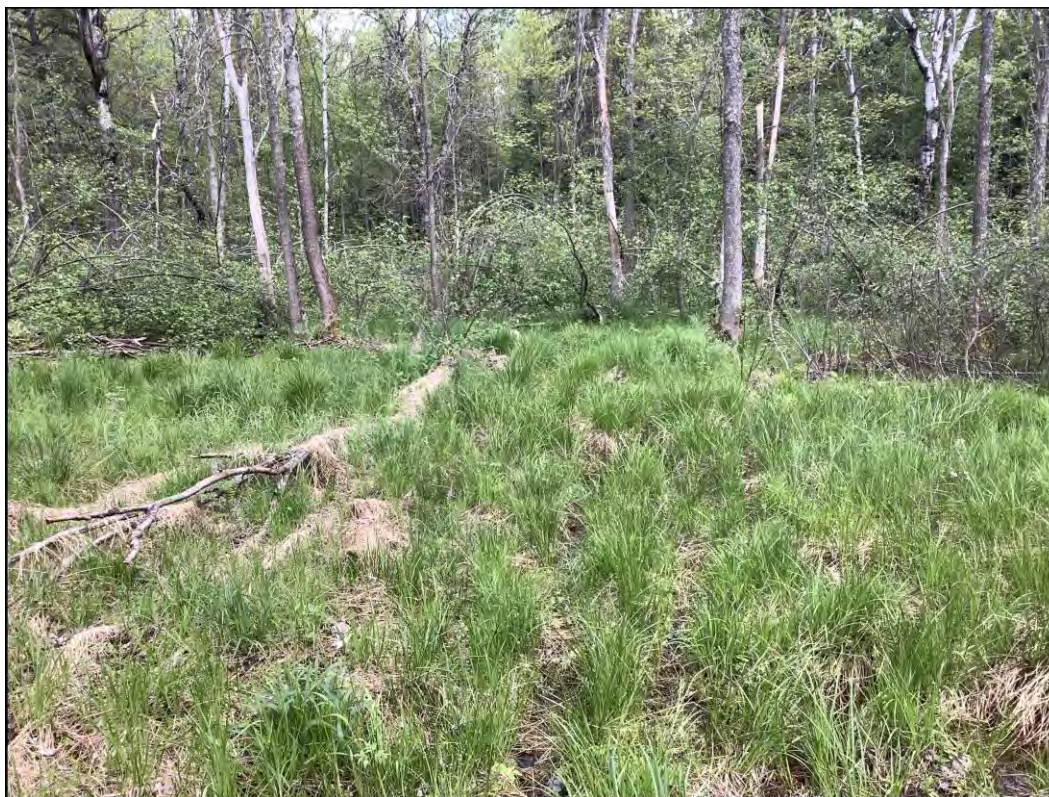
wase1016e\_w\_NW

The profile consists of a dark mucky mineral over clay and sandy clay. The soil profile appears to be disturbed. Loamy Mucky Mineral was the hydric soil indicator observed.

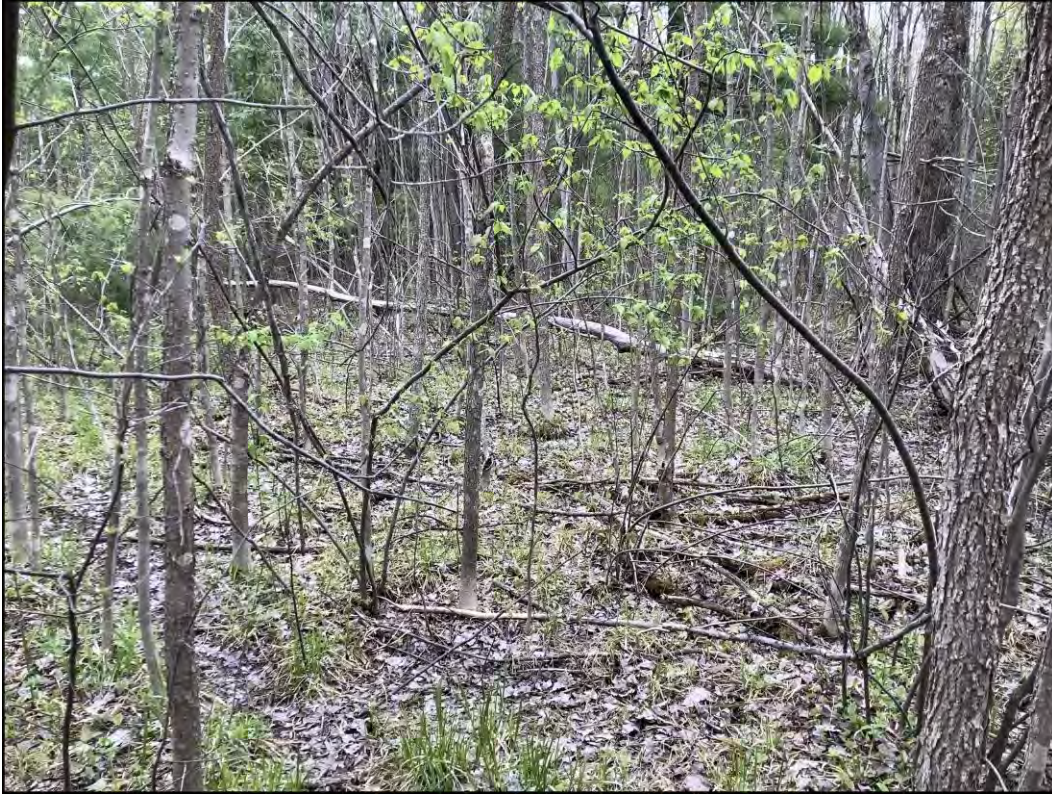
wase1016f\_w1\_S

The soil profile consists of a fine sandy loam. Hydric soil indicator Depleted Matrix was observed within the middle layer.

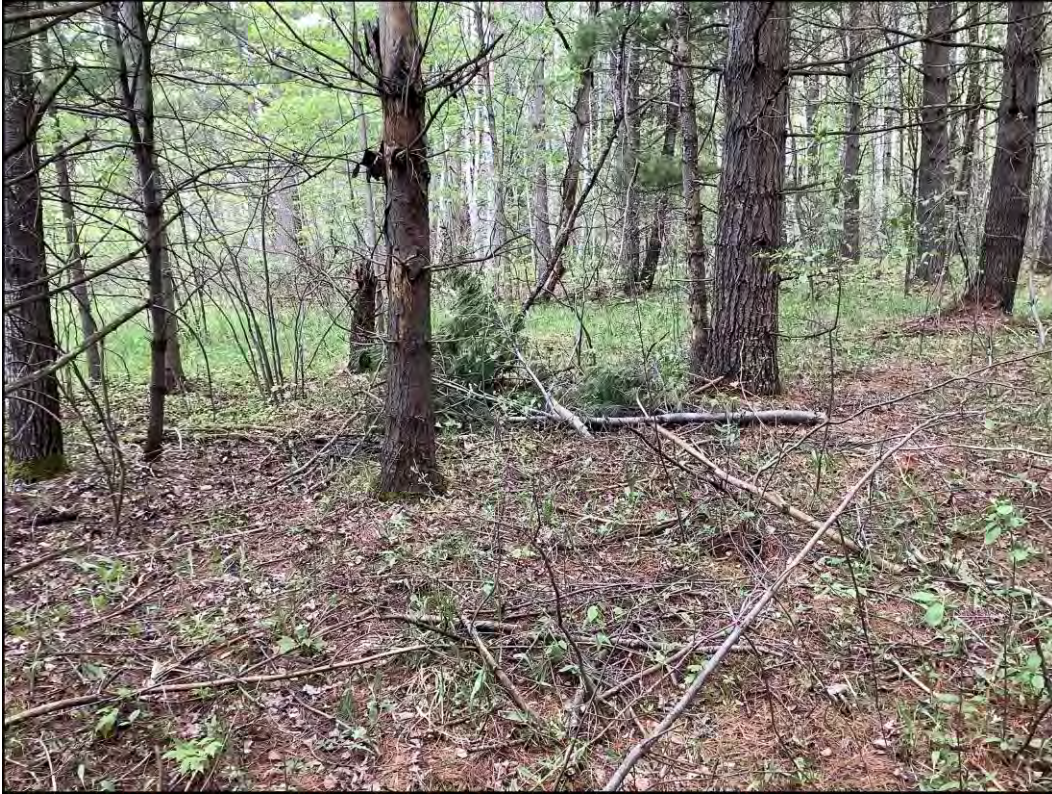
wase1016\_u4\_NW

The soil profile consists of silty loam over a mixed silty clay. The middle layer is depleted with redox concentrations. Two hydric soil indicators were observed.

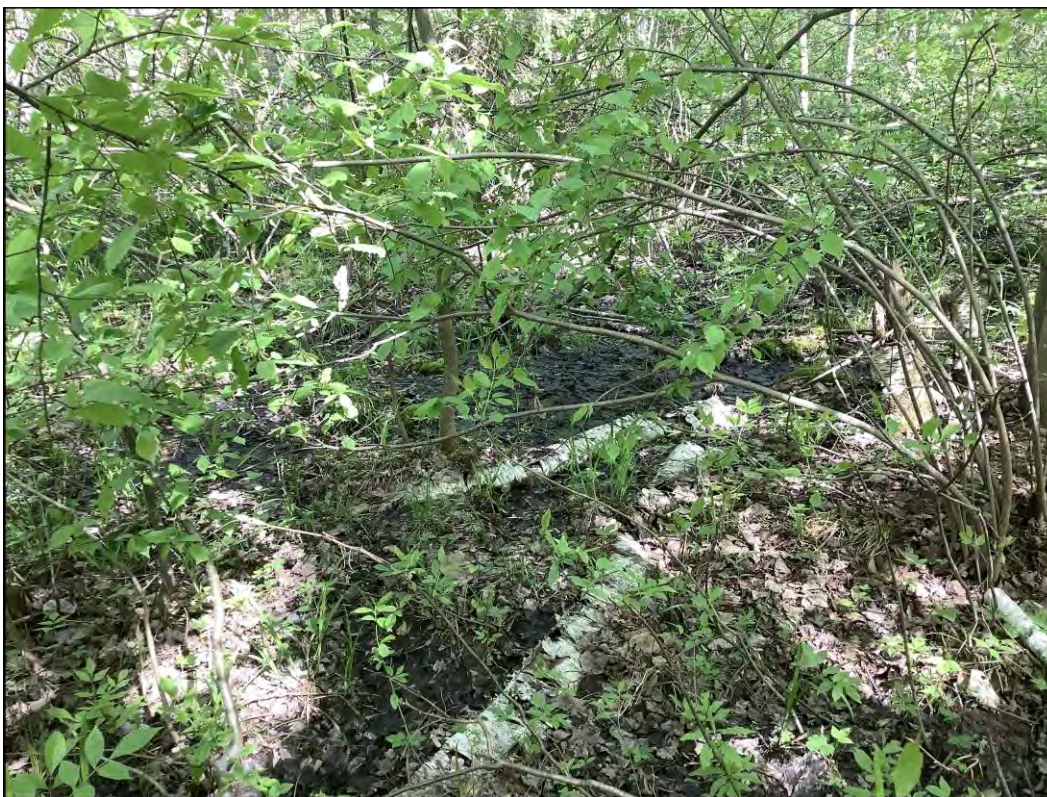
wase1036f\_w\_NW

The soil profile consists of two depleted layers over a red clay. The top layers have redox concentrations, with the middle fine sandy loam layer having a much higher percentage. Depleted Matrix was met.

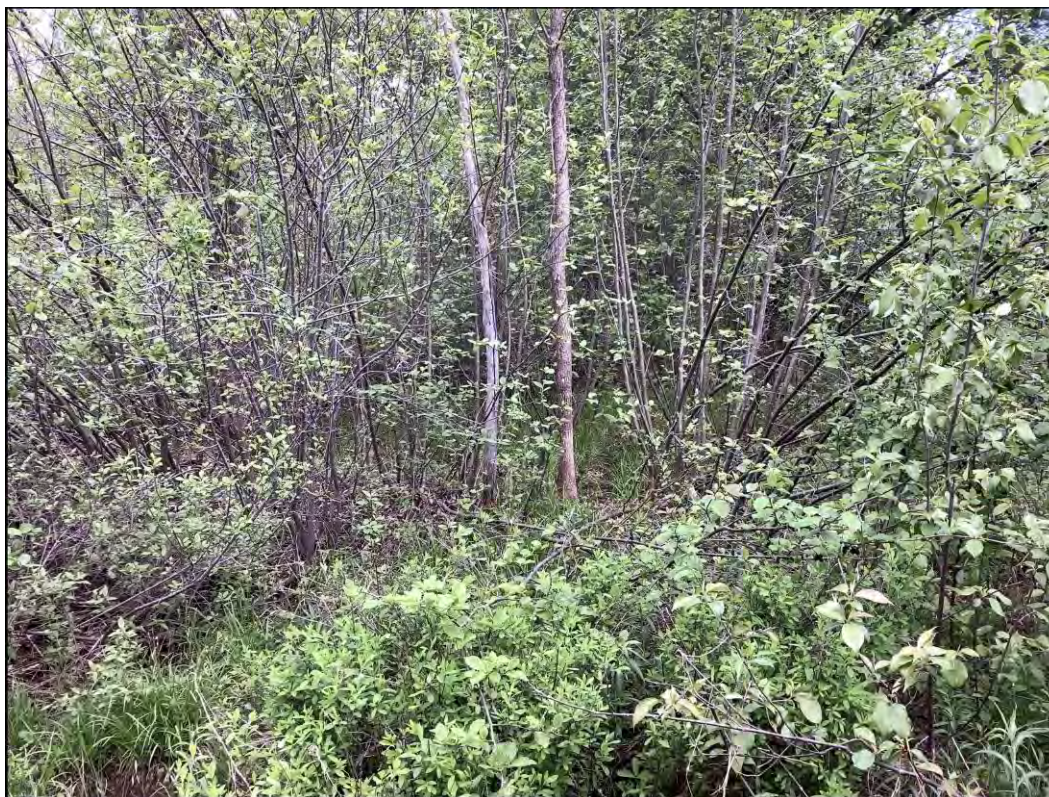
wase1021s\_w\_N

The soil profile consists of a depleted loam over a red clay. There were redox concentrations observed within the top layer and Depleted Matrix was met.

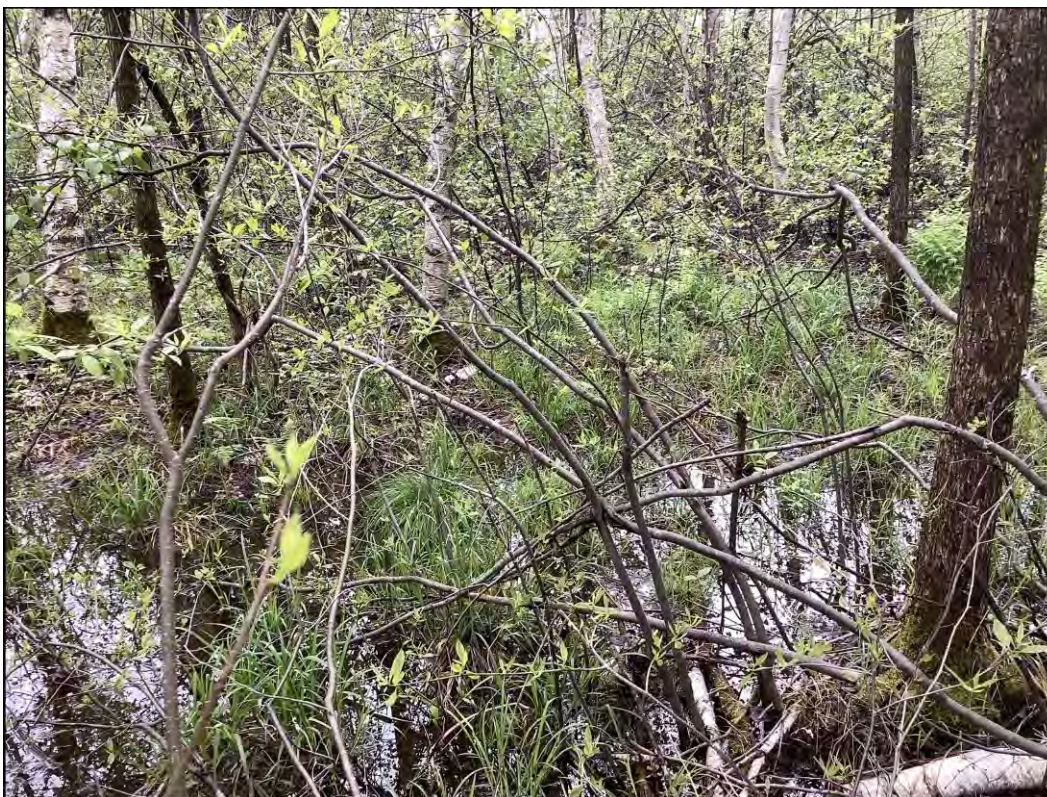
wase1021f\_w\_E

The soil profile consists of two depleted clay loam layers over a red fine sandy loam. Redox was observed within the two top layers. Depleted Matrix was observed.

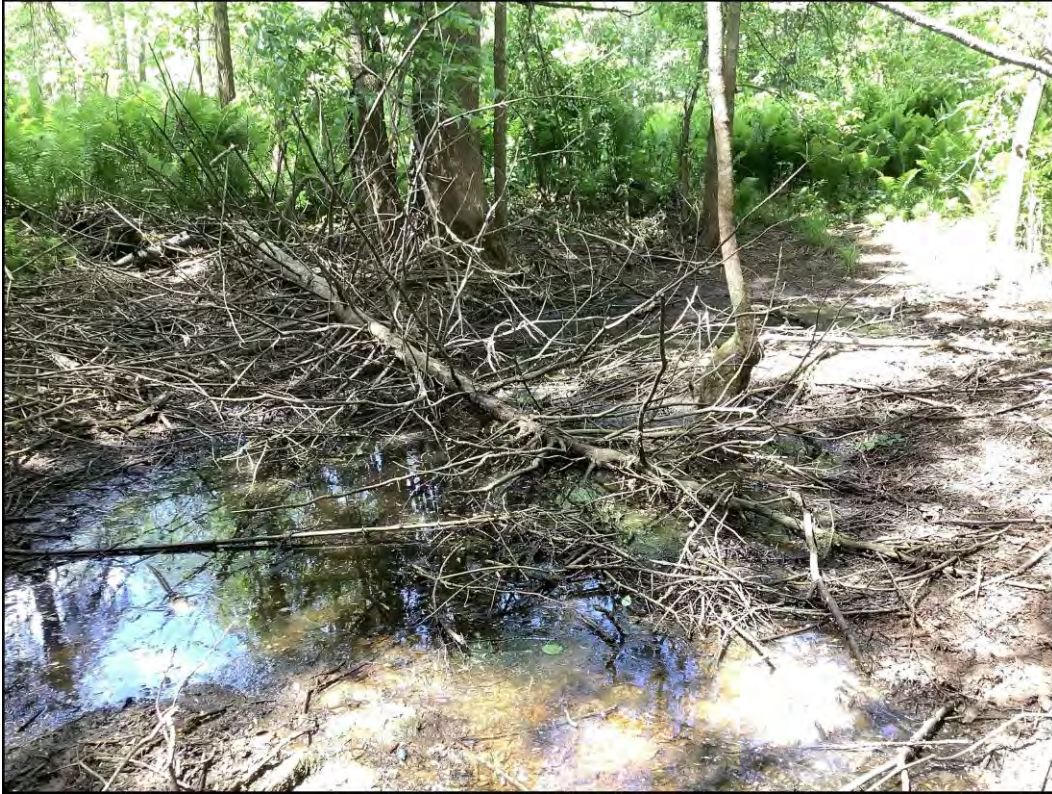
wase1056f\_w\_N

The soil profile consists of a thin dark reddish brown clay loam over a depleted reddish gray clay loam. There are redox concentrations throughout the profile.

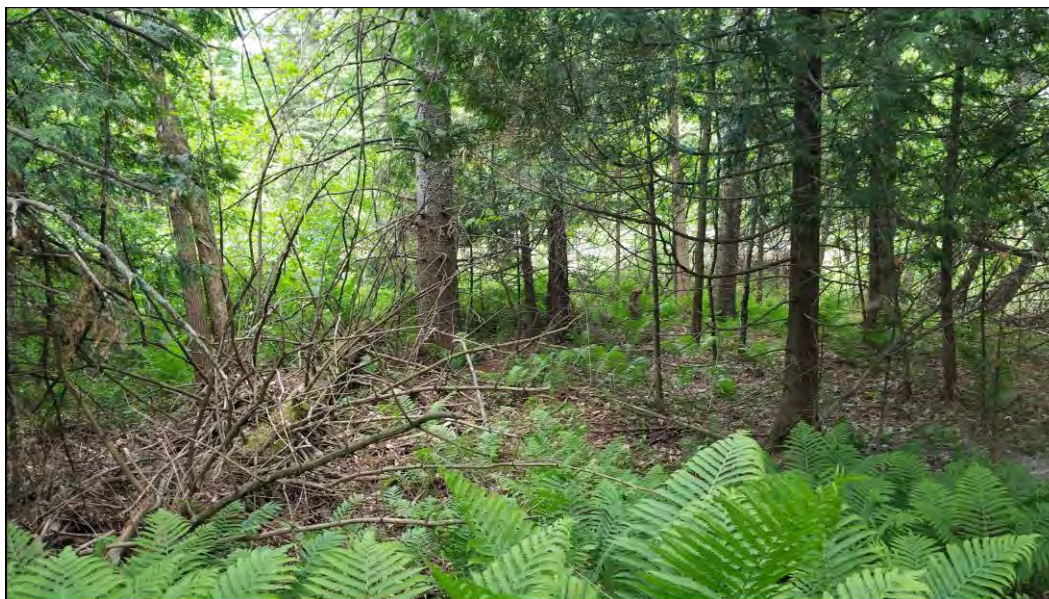
wase1056\_u\_NE

Loamy profile. No hydric soil indicators were observed.

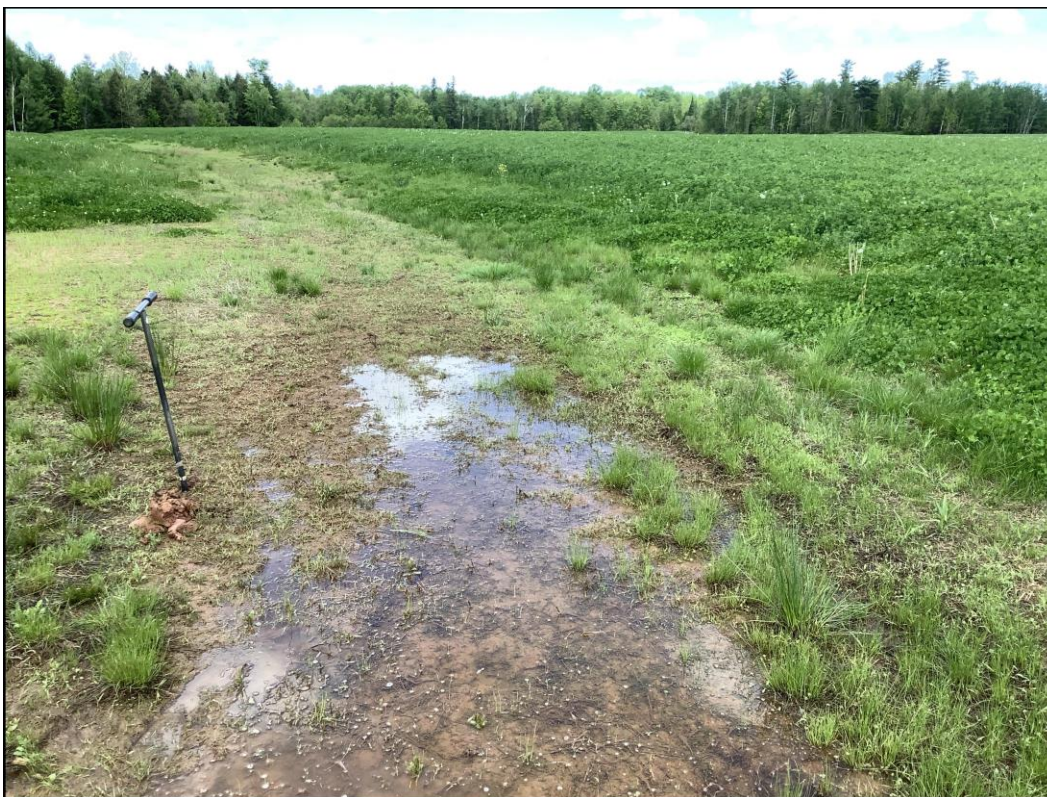
wase1038e\_w\_NE

Loamy sand over sandy clay, with redox below six inches.

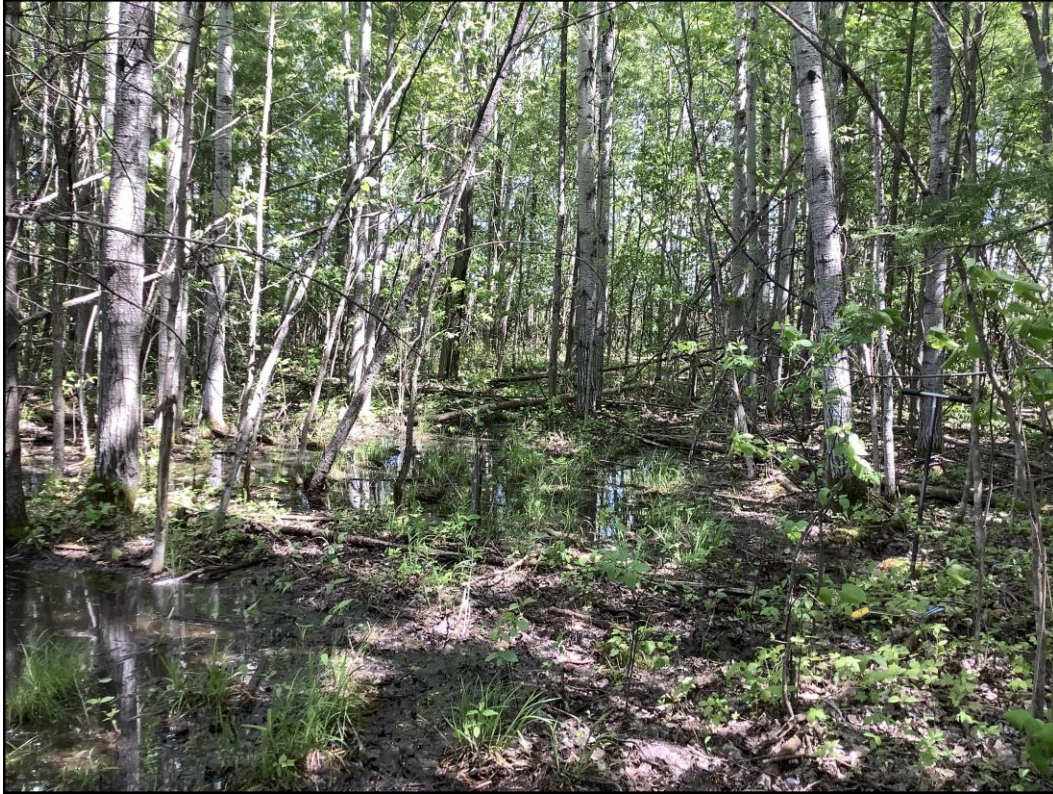
wase1039f\_w\_E

Depleted clay with redox throughout.
