# WETLAND DETERMINATION DATA FORM – Northcentral and Northeast Region

Project/Site: Line 5 Relocation Project City/County: Ashland Sampling Date: 2020-05-19  
 Applicant/Owner: Enbridge State: Wisconsin Sampling Point: wase1005e\_w  
 Investigator(s): DMP/ARK Section, Township, Range: sec 20 T046N R004W  
 Landform (hillslope, terrace, etc.): Depression Local relief (concave, convex, none): Concave Slope (%): 0-2%  
 Subregion (LRR or MLRA): Northcentral Forests Lat: 46.447192 Long: -90.895907 Datum: WGS84  
 Soil Map Unit Name: Sanborg-Badriver complex, 0 to 6 percent slopes NWI classification: \_\_\_\_\_

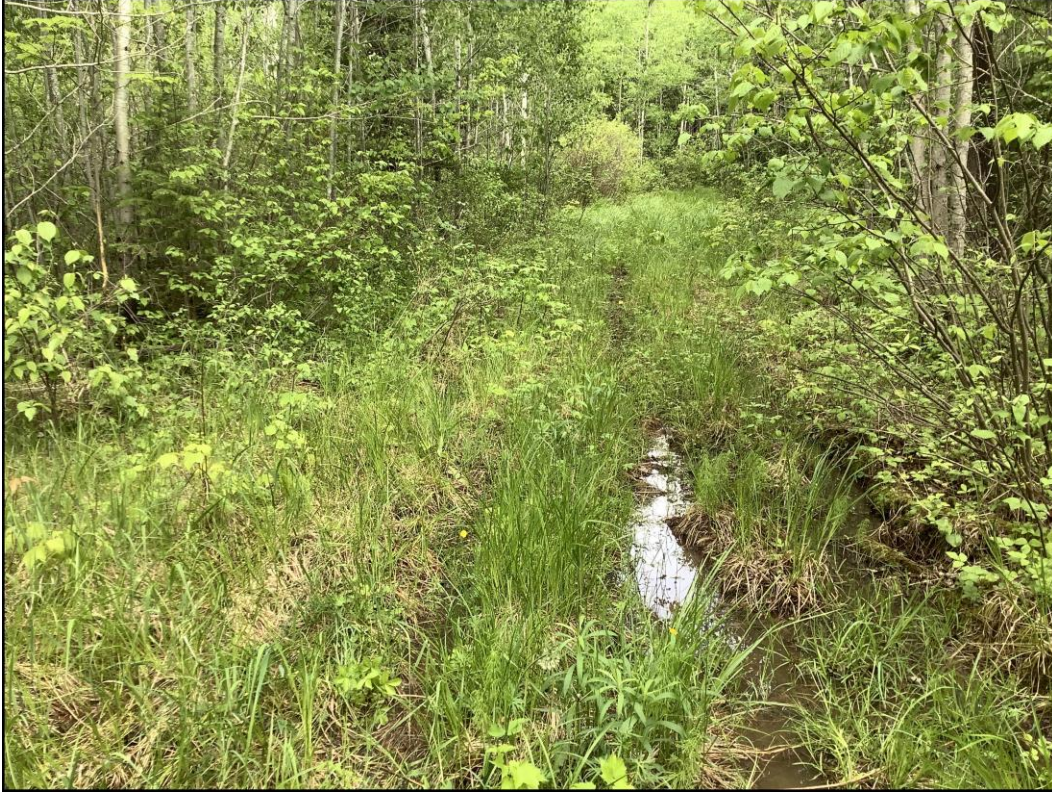
wase1043f\_w\_E

The soil profile consists of a dark clay loam over a red clay. Redox was observed within the top layer and Redox Dark Surface was met.

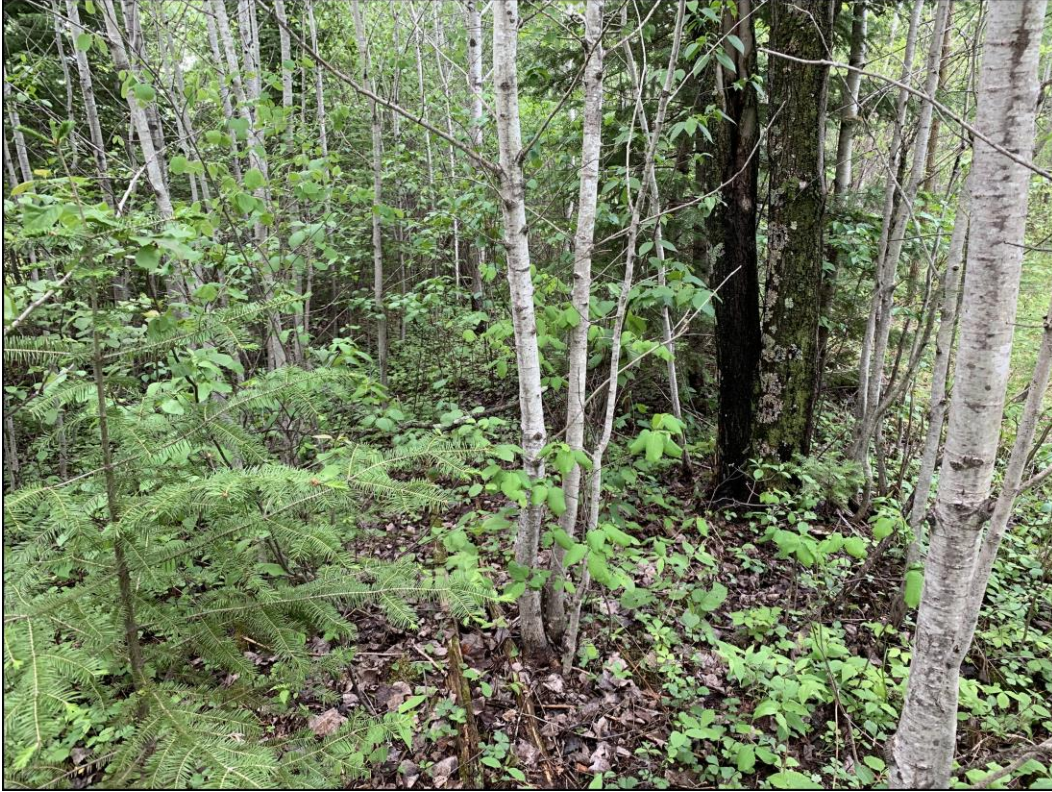
wase1043\_u\_E

The soil profile consists of a reddish brown clay loam over a red clay. No hydric soil indicators were observed.

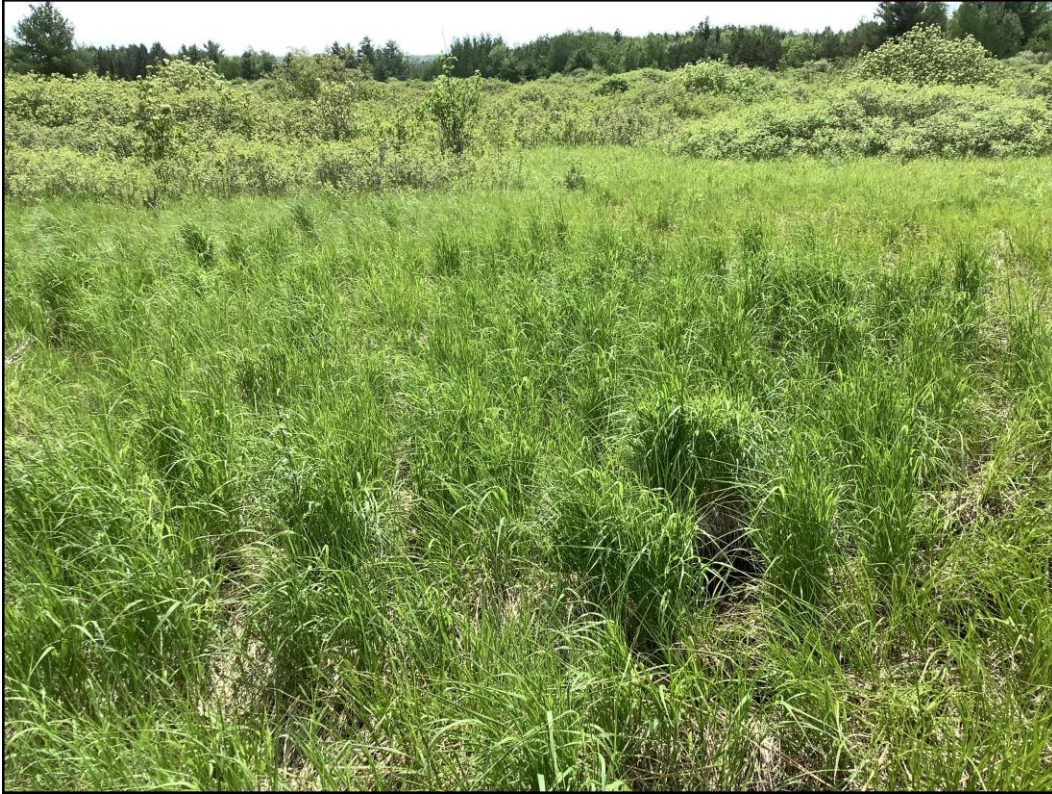
wase1045e\_w\_S

The soil profile consists of a depleted clay loam over a red clay. Redox concentrations were observed within the top layer and Depleted Matrix was met.

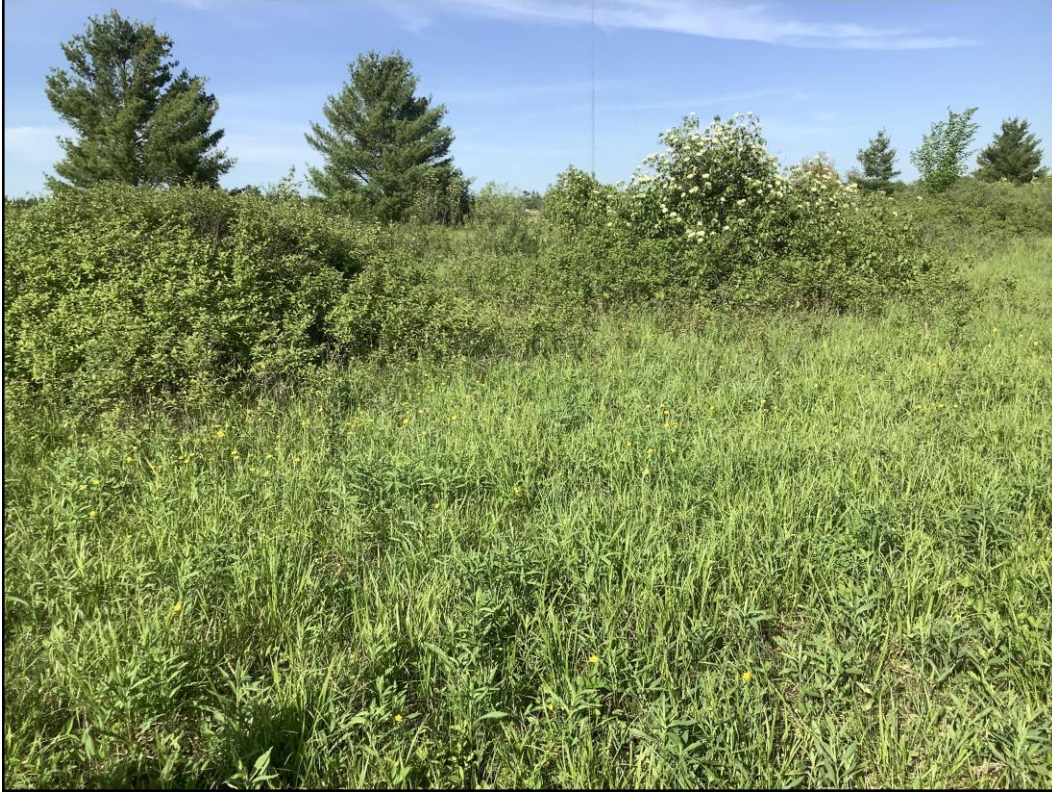
wase1050\_u\_NE

Clayey soils. No indicators of hydric soils were observed.
