# WETLAND DETERMINATION DATA FORM – Northcentral and Northeast Region

Project/Site: Line 5 Relocation Project City/County: Ashland Sampling Date: 2020-06-04  
 Applicant/Owner: Enbridge State: Wisconsin Sampling Point: wase1052e\_w  
 Investigator(s): ARK/DMP Section, Township, Range: sec 35 T046N R004W  
 Landform (hillslope, terrace, etc.): Depression Local relief (concave, convex, none): Concave Slope (%): 0-2%  
 Subregion (LRR or MLRA): Northcentral Forests Lat: 46.420334 Long: -90.827314 Datum: WGS84  
 Soil Map Unit Name: Sanborg-Badriver complex, 0 to 6 percent slopes NWI classification: \_\_\_\_\_

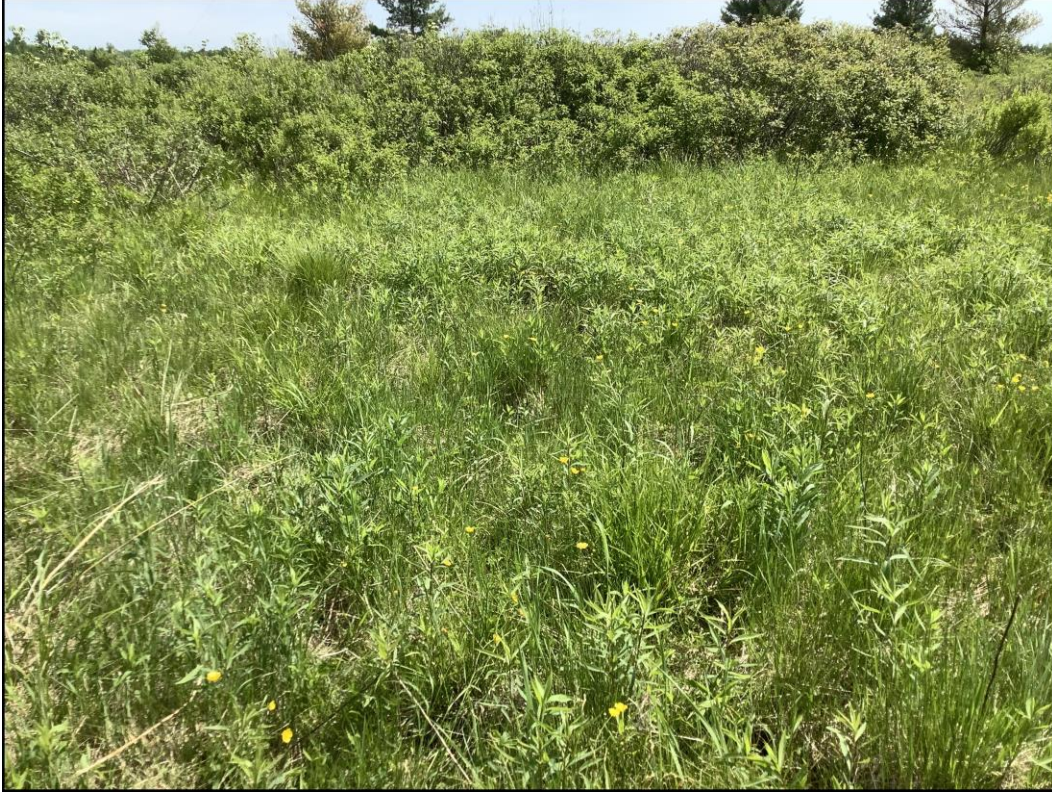
wase1052e\_w\_E

## Clay with redox.

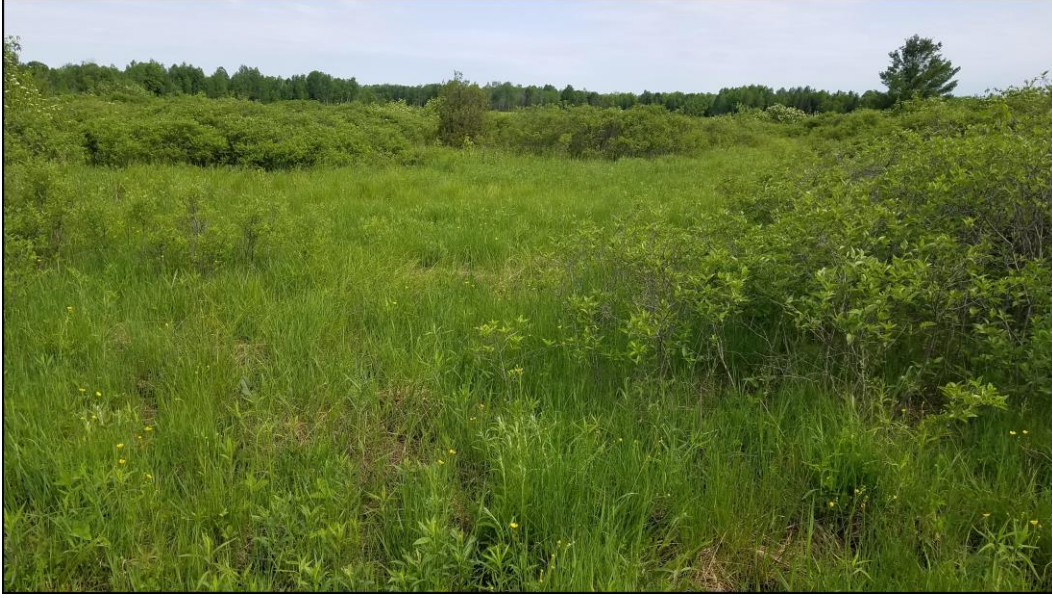
wase1053e\_w\_N

Clay with redox throughout much of the profile.

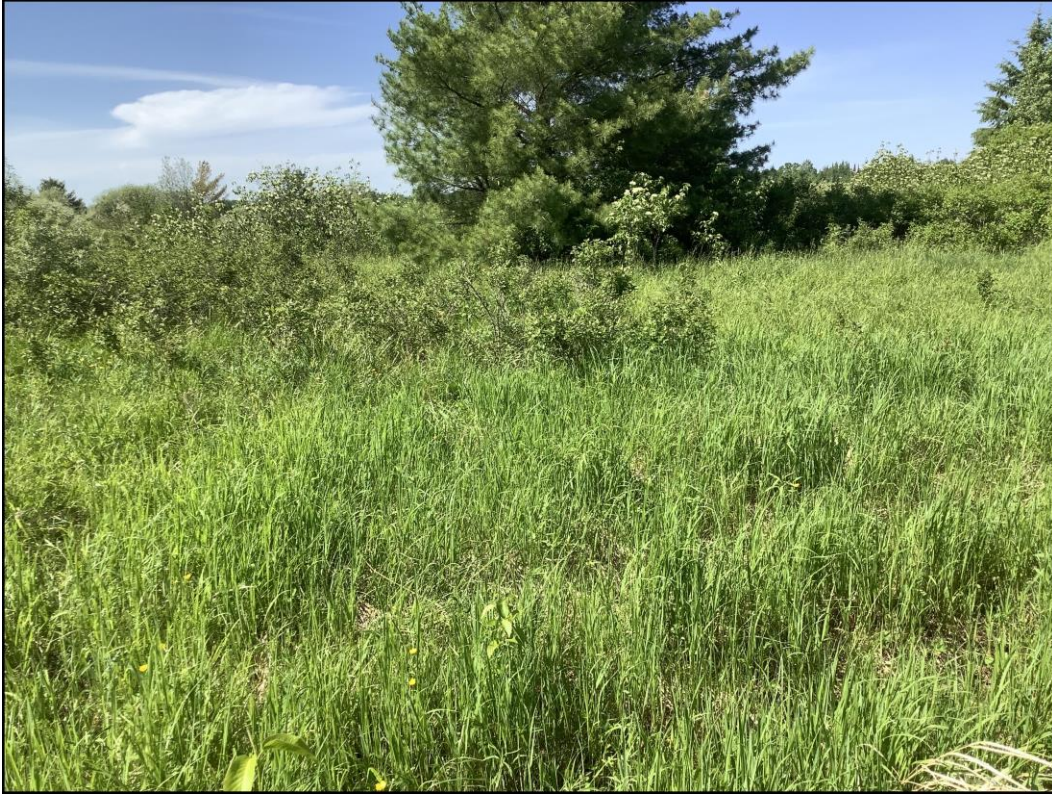
wase1049s\_w\_N

The soil profile consists of a thin dark clay loam over depleted clay. Redox is evident throughout the two bottom layers.

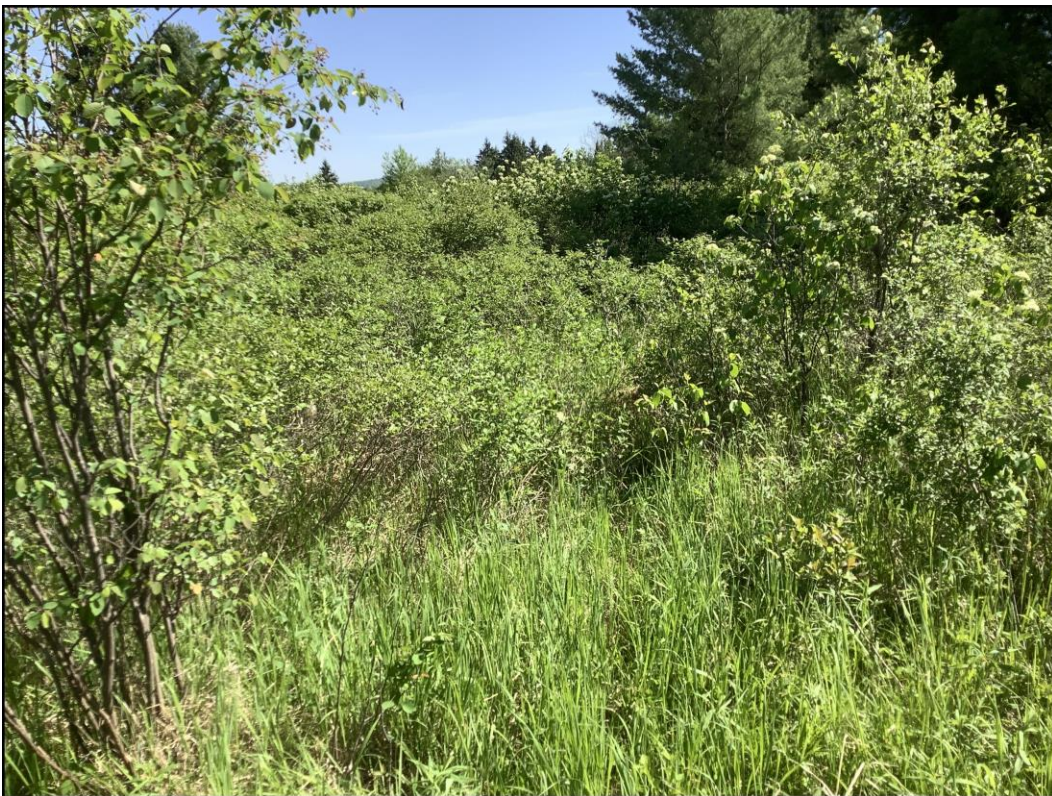
Vegetation: Plant Community Description(s): The vegetation is representative of the wetland. Gray dogwood was common throughout the feature, as was nannyberry. Canada bluejoint was the dominant herbaceous plant observed at the sample plot. Awn fruited sedge, graceful sedge and chestnut sedge were common throughout. Pale sedge was also observed. The forb cover was relatively sparse.

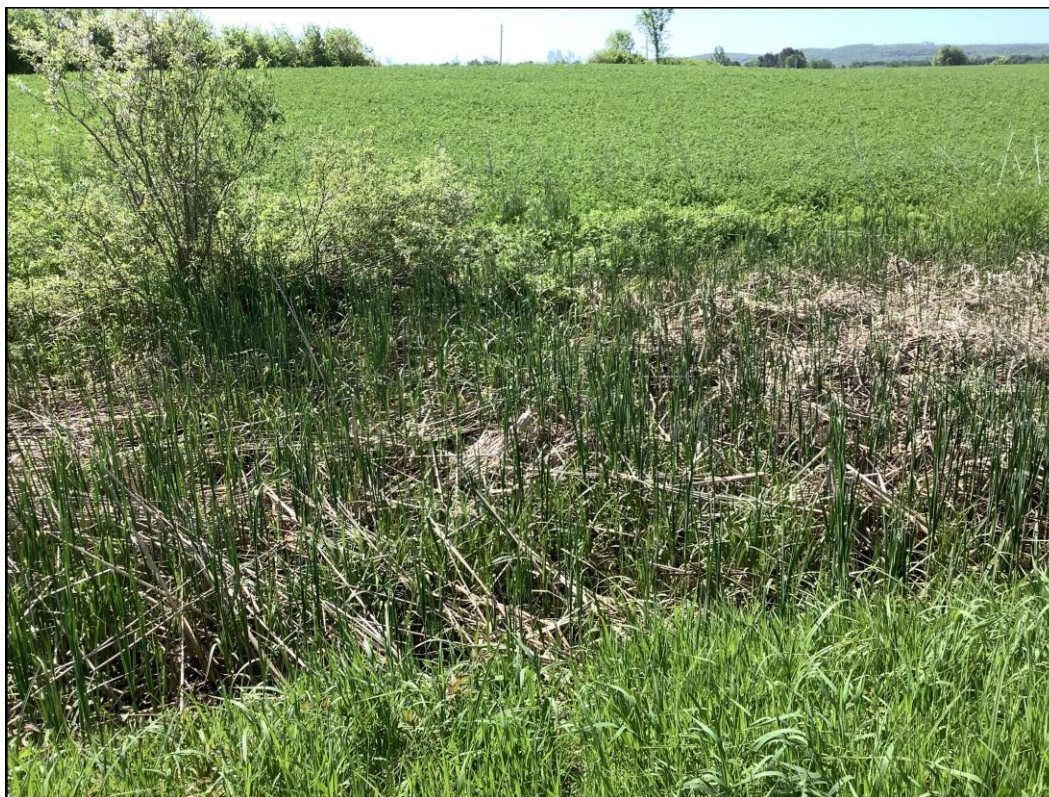
wase1048e\_w\_S

The soil profile consists of depleted clay loam over depleted clay. Redox concentrations are present below 3 inches and increase with depth. Depleted Matrix was met.

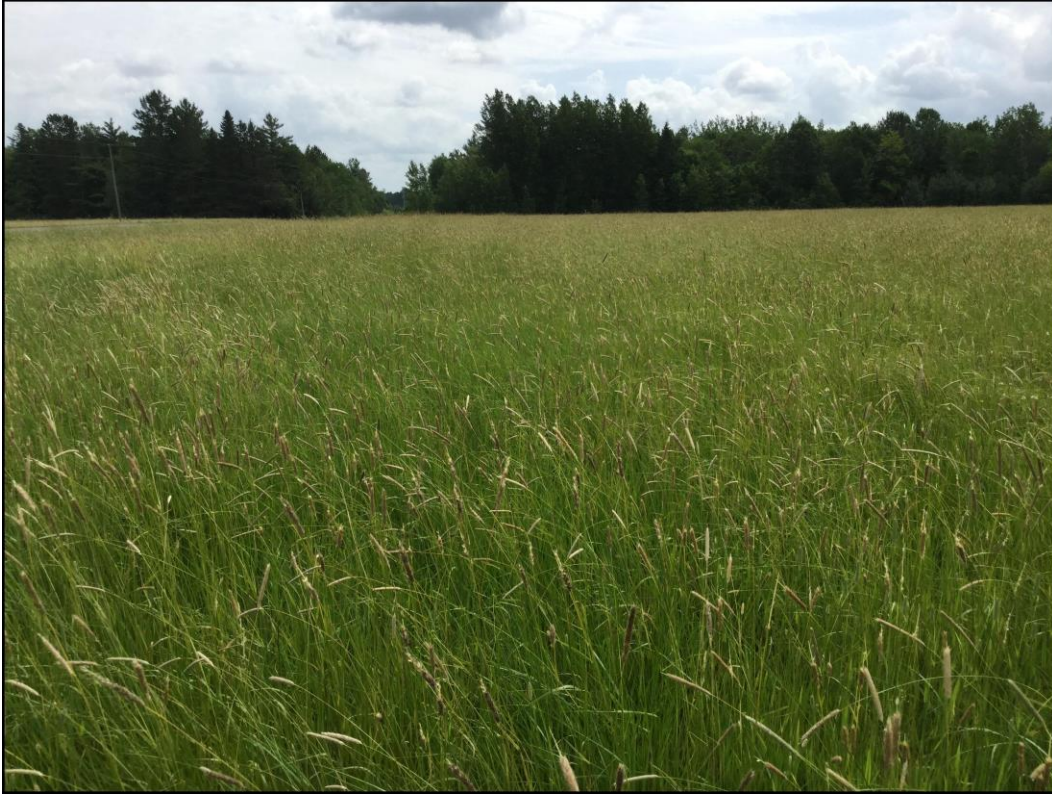
wasd1047\_u\_E

The soils were not sampled due to the location within a roadside area. The soils are assumed to be non-hydric based on the landscape position and dominant vegetation.

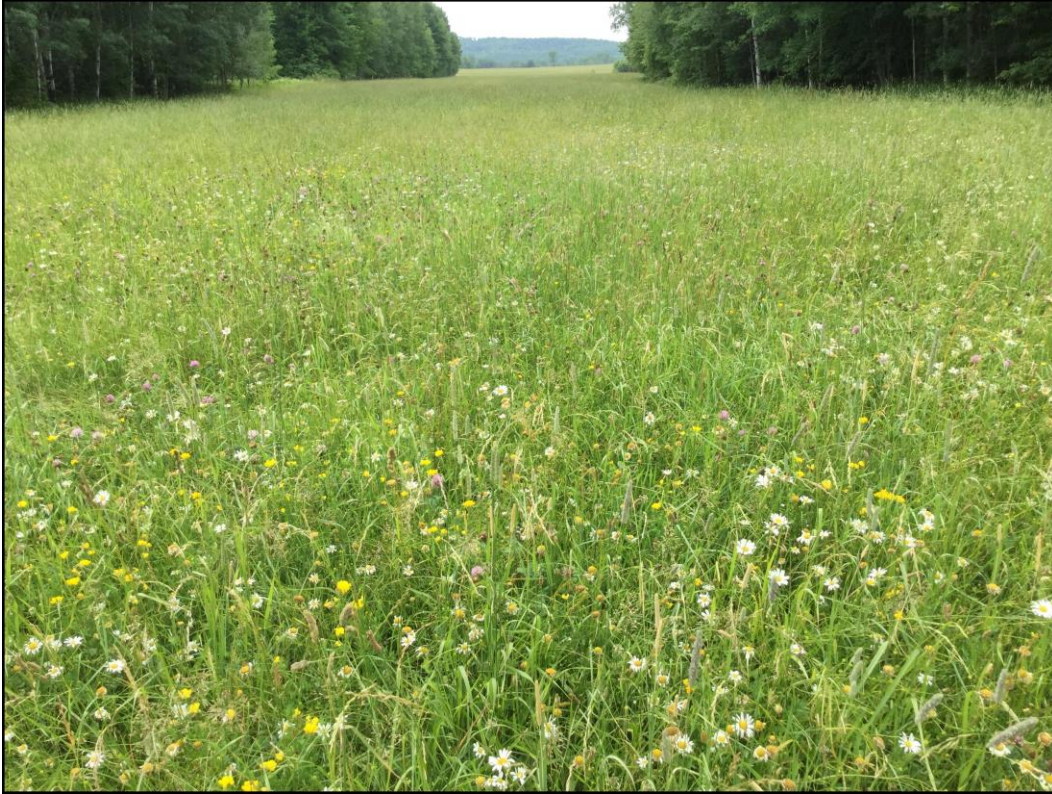
wasd1048\_u\_S

The soils were not sampled due to the location within a roadside area. The soils are assumed to be non-hydric based on the landscape position and dominant vegetation.

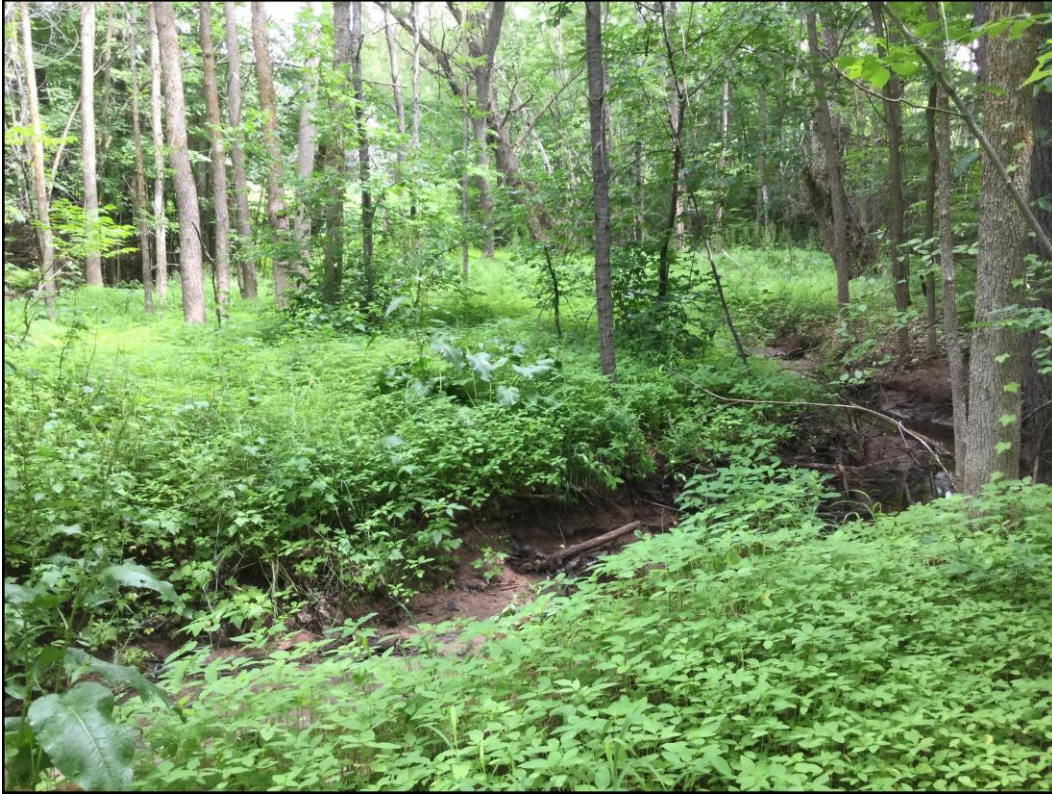
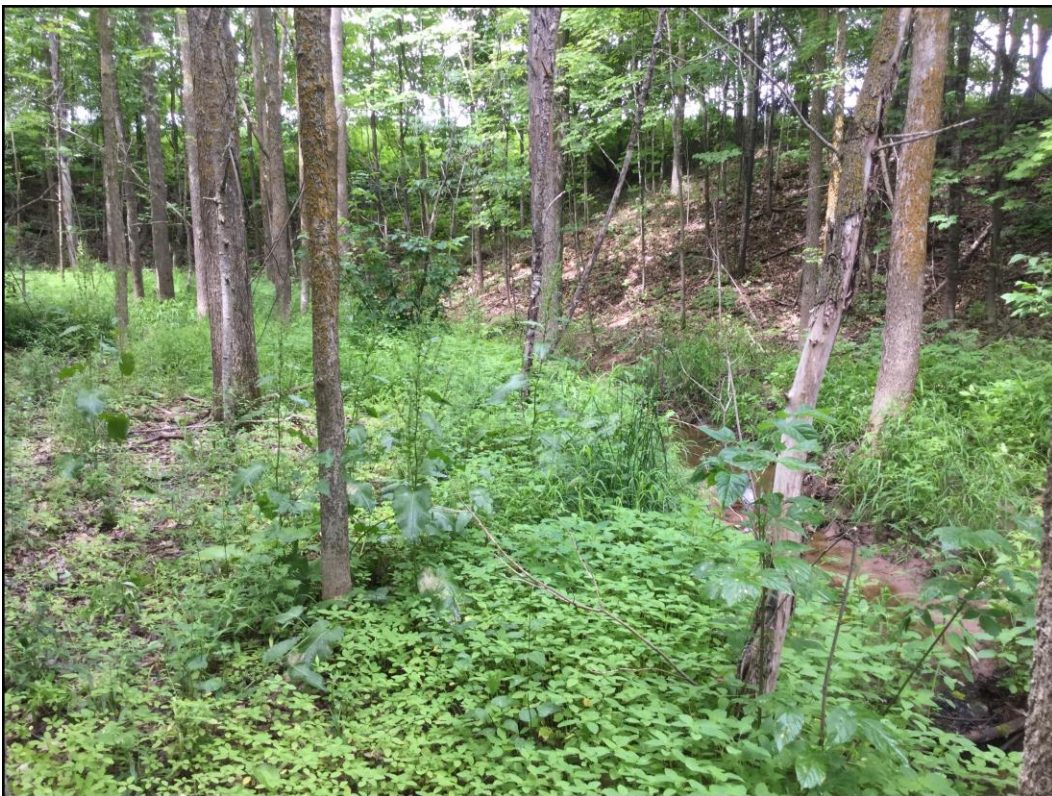
wasd1050f\_w\_NW

The soil profile consists of a depleted sandy clay loam over a depleted clay loam. Redox concentrations were observed throughout the profile and Depleted Matrix was met.

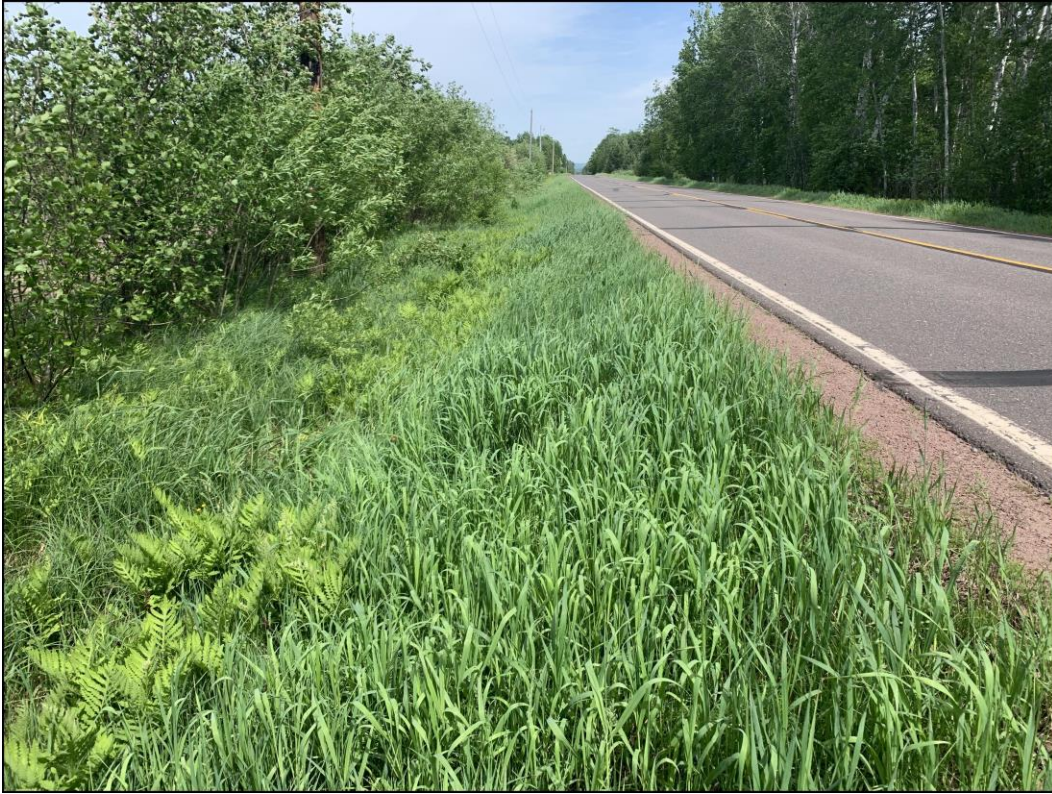
wase1054\_u\_E

The soils were not sampled due to the location within the roadside area. The soils are assumed to be non-hydric based on the dominance of upland species and the lack of hydrologic indicators.

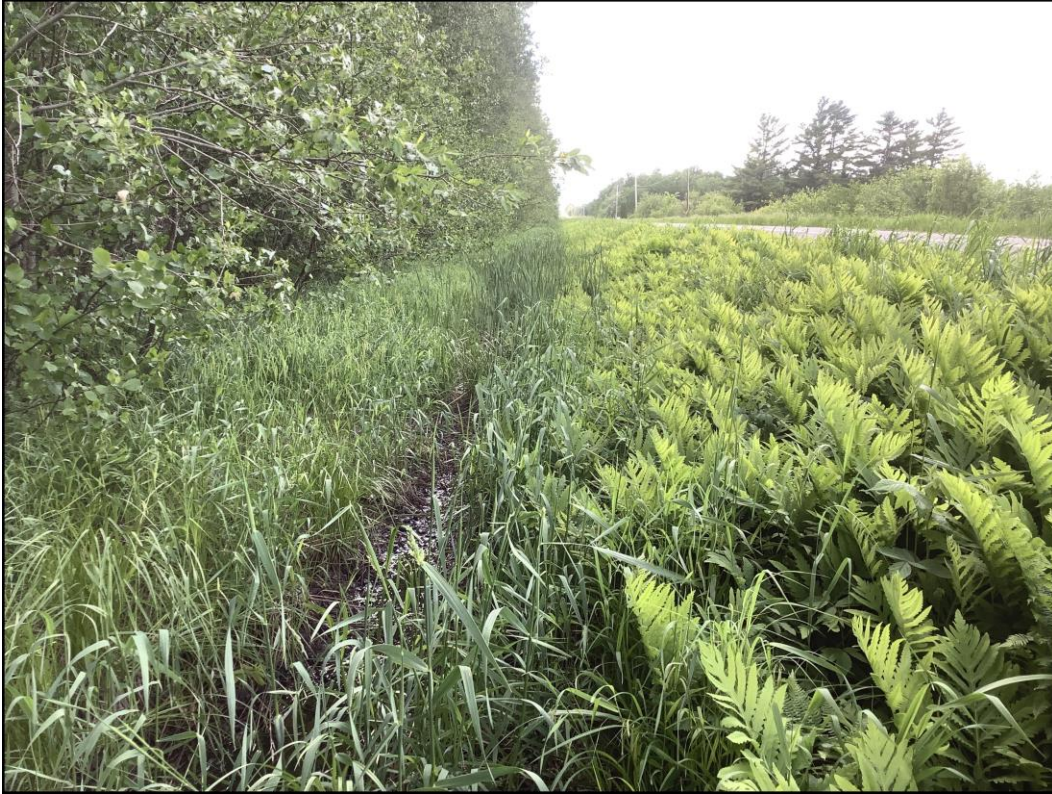
wase1060e\_w\_E

The soils were not sampled due to the location of the wetland within a roadside ditch. The soils are assumed to be hydric based on the dominance of hydrophytic vegetation and the presence of hydrologic indicators.

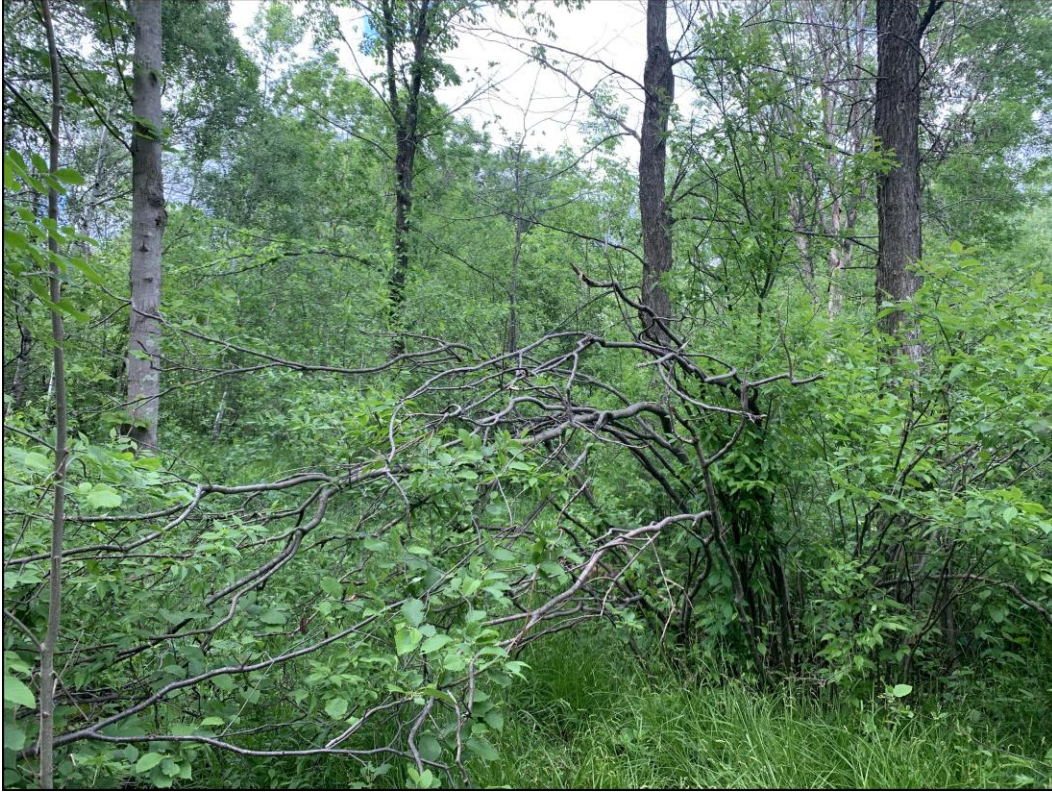
wase1060f\_w2\_N

The soils were not sampled due to the proximity to a public road. The soils are assumed to be hydric based on the landscape position and dominant vegetation.

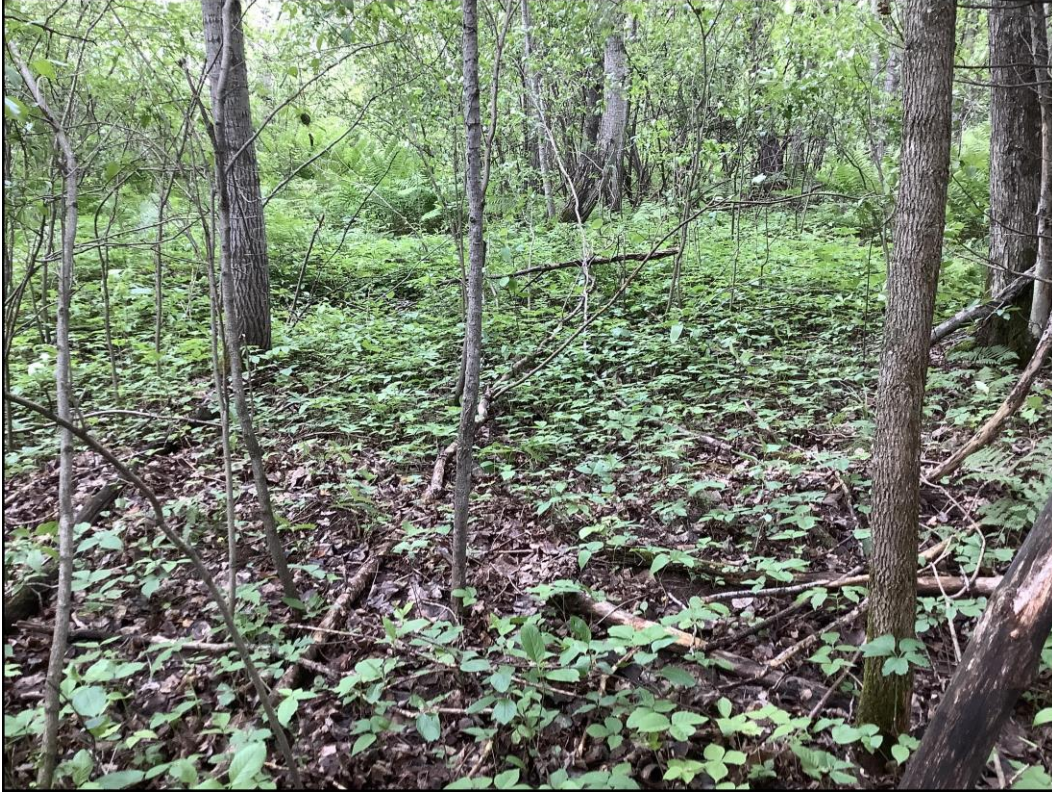
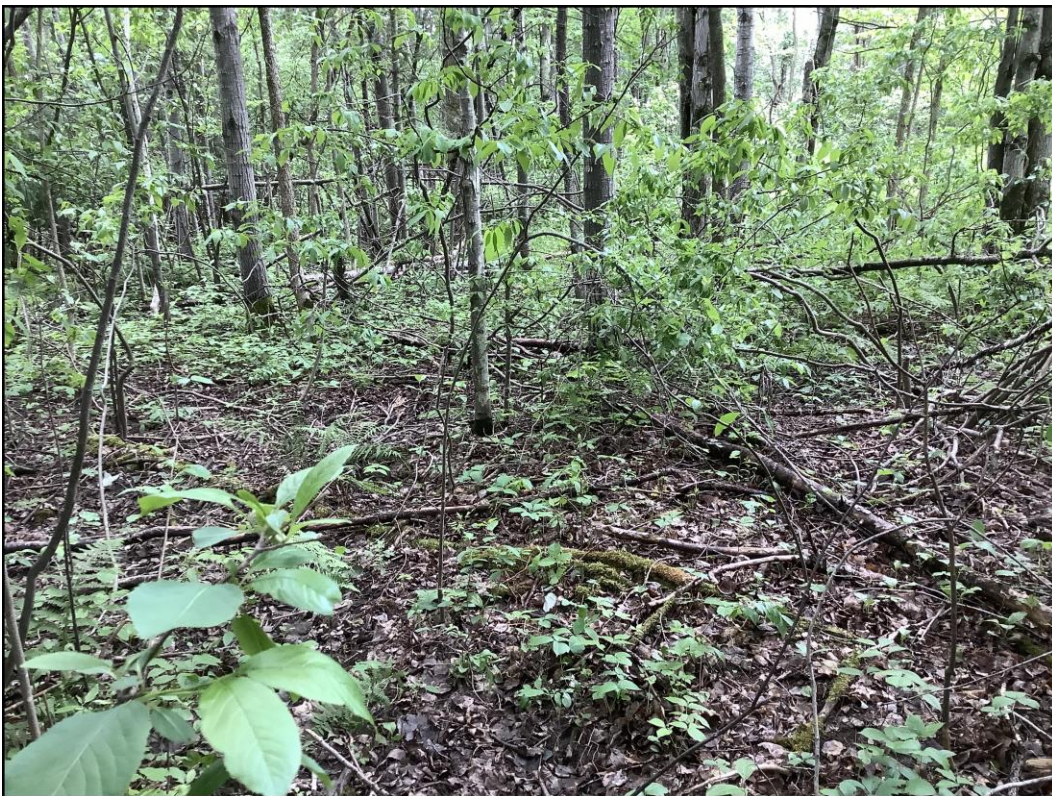
wase1059\_u\_NE

The soil profile consists of a dark fine sandy loam over a reddish brown fine sand. No hydric soil indicators were observed.

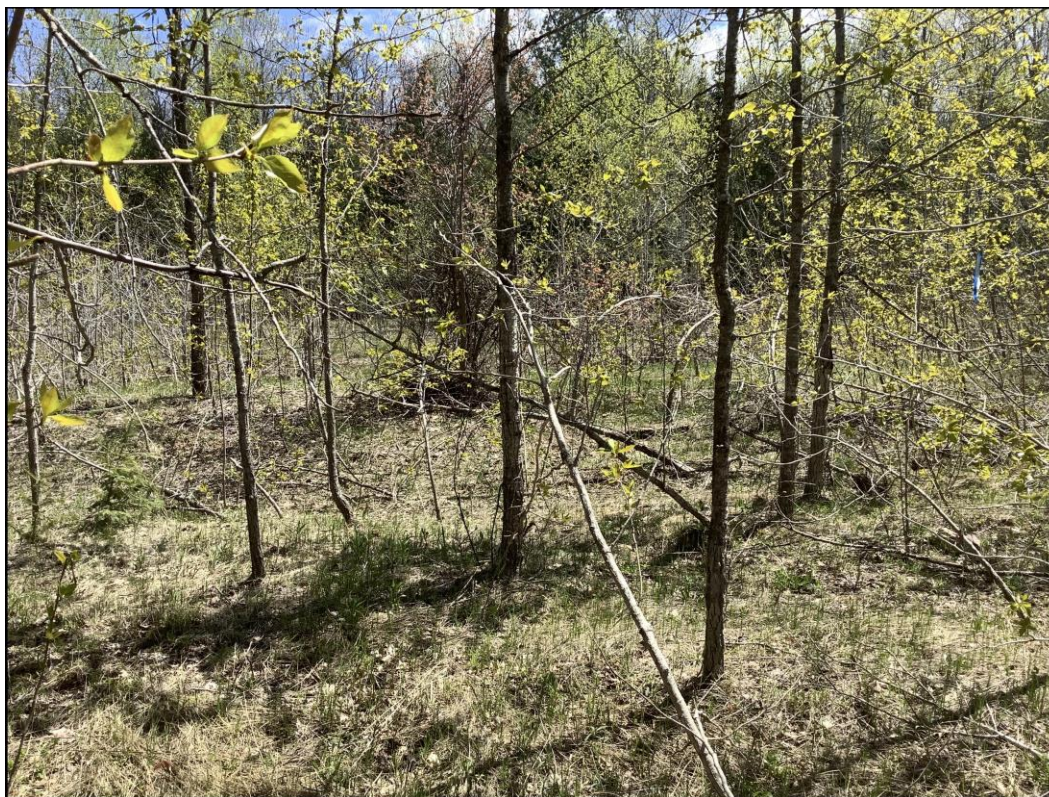
wasal005\_u\_E

Soil is sandy with an impenetrable coarse gravel layer at 12 inches.

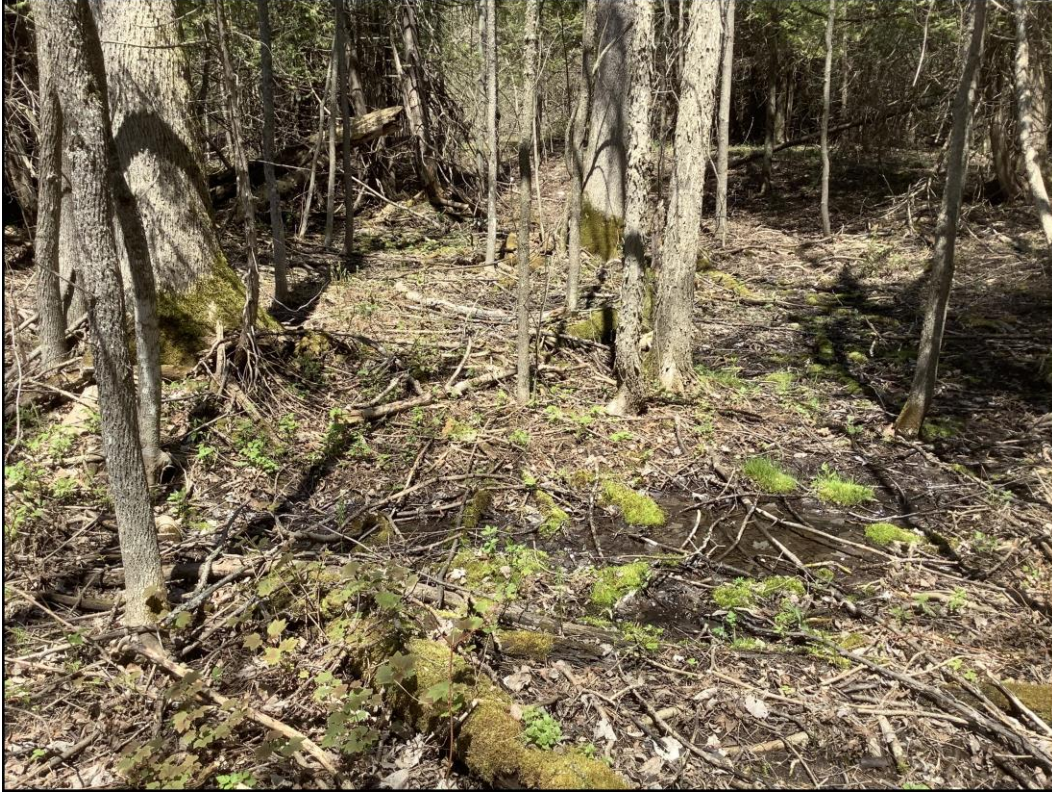
wasal006f\_w1\_N

Dark soil sample with some fibrous material in the upper 4 inches and water table present in soil pit.

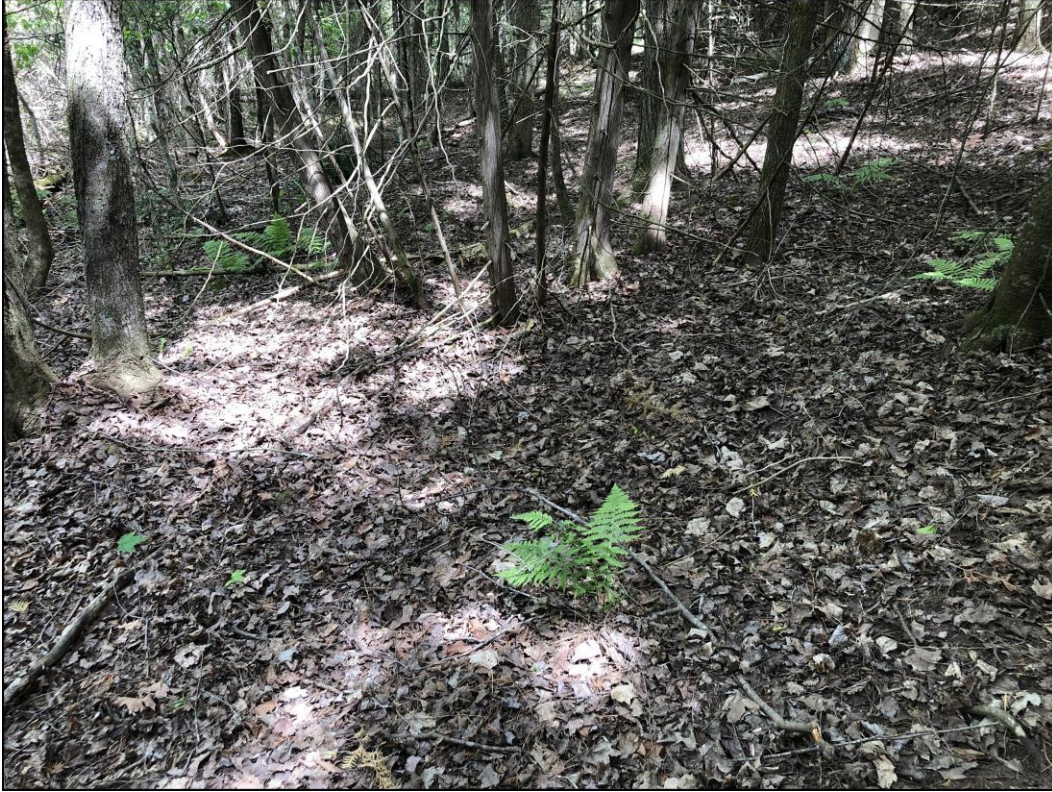
wasc1029\_u\_NE

Could not sample soil due to the proximity to occupied structures. Soils are assumed to be non-hydric based on the landscape position and dominant vegetation.

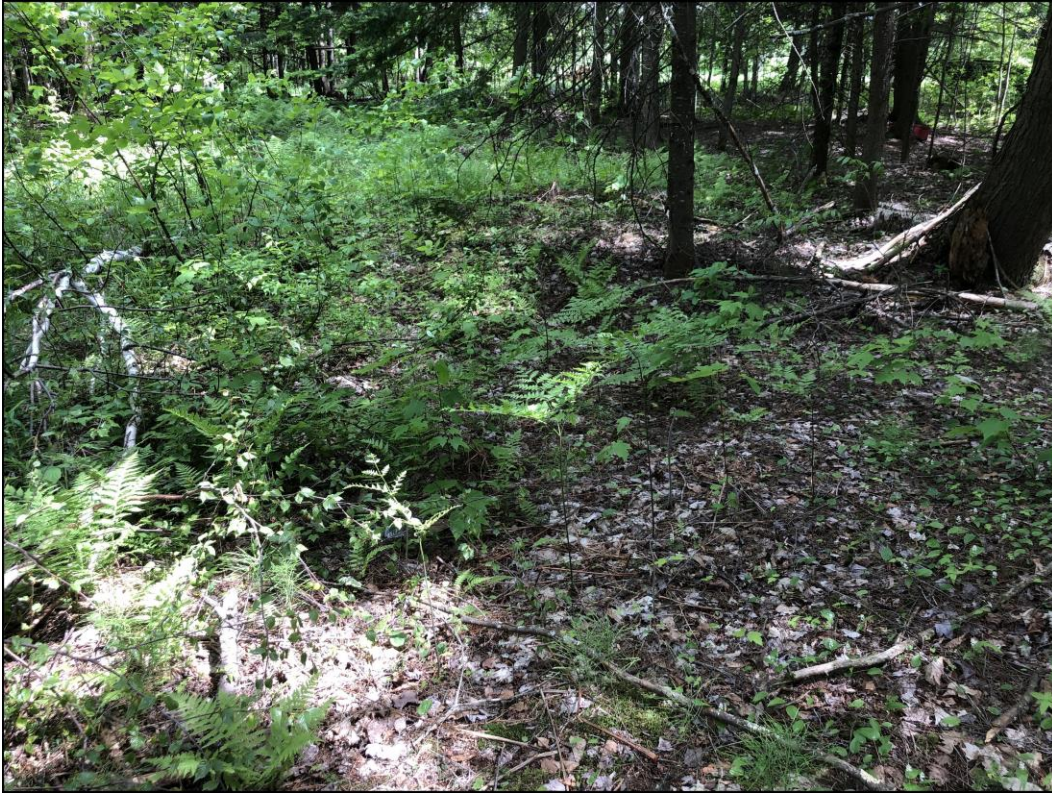
wasc1030\_u\_E

Could not sample soil due to the proximity to occupied structures. Soils are assumed to be non-hydric based on the landscape position and dominant vegetation.

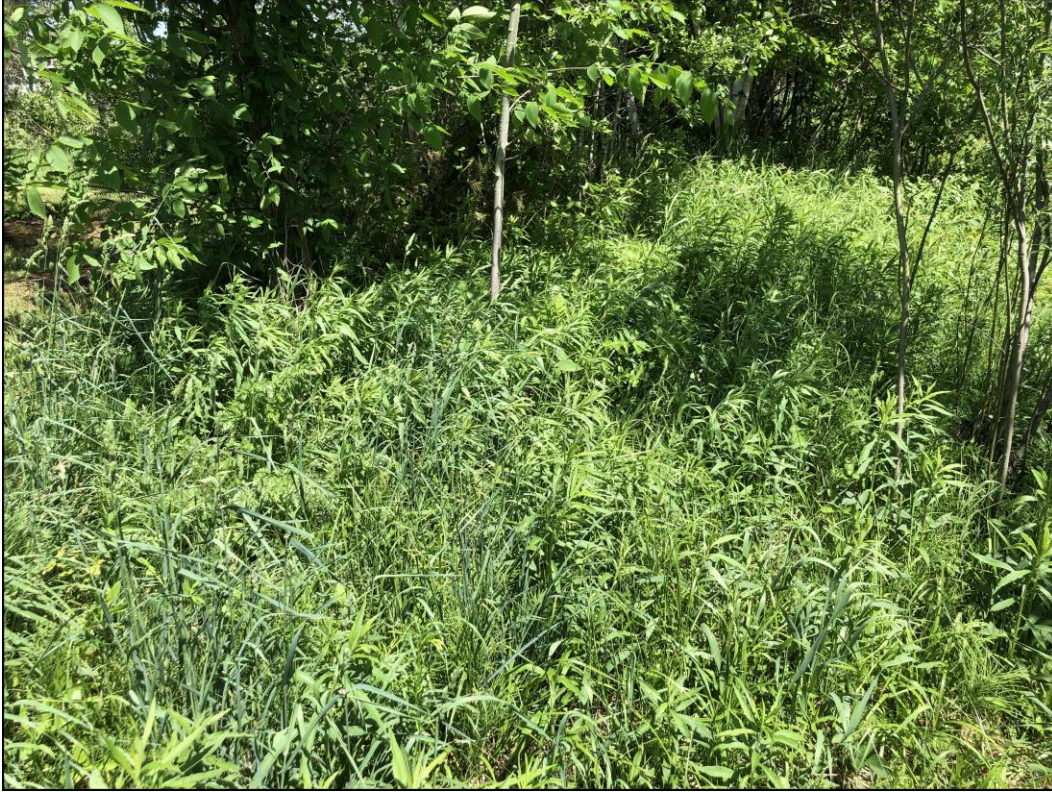
wasc1026\_u\_N

Could not sample soil due to the proximity to potential buried utilities within the roadside area. Soils are assumed to be non-hydric based on the landscape position and dominant vegetation.

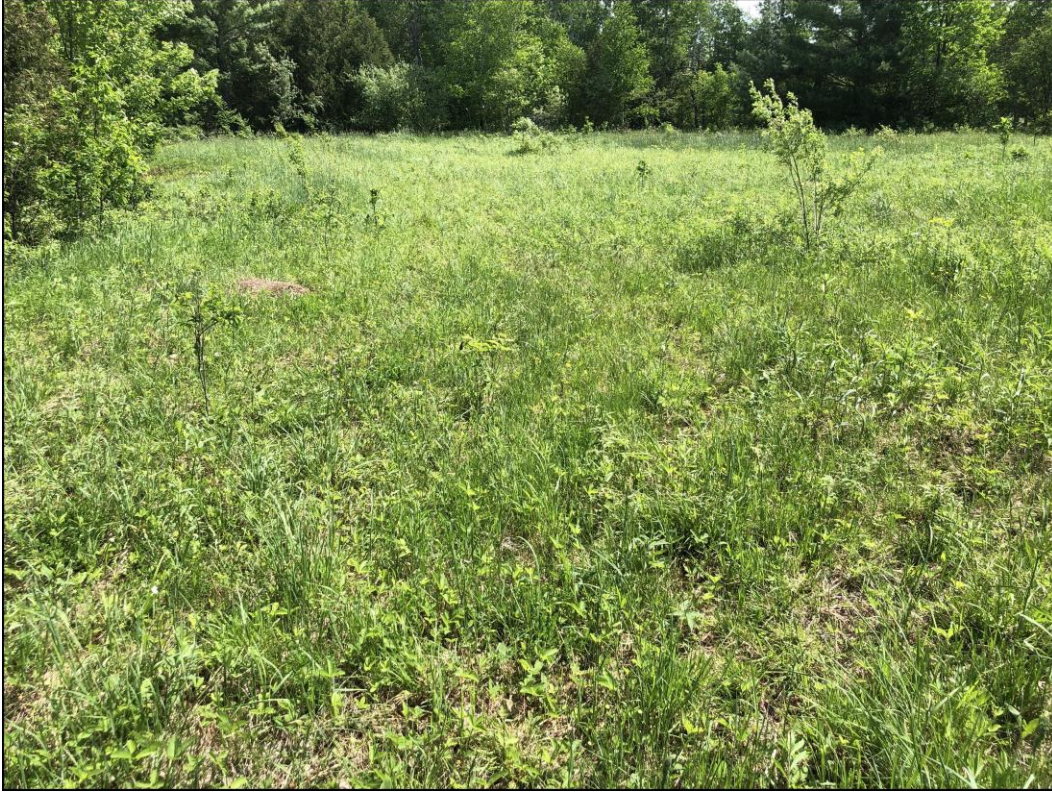
wasc1025\_u\_NE

Could not sample soil due to the proximity to occupied structures. Soils are assumed to be non-hydric based on the landscape position and dominant vegetation.

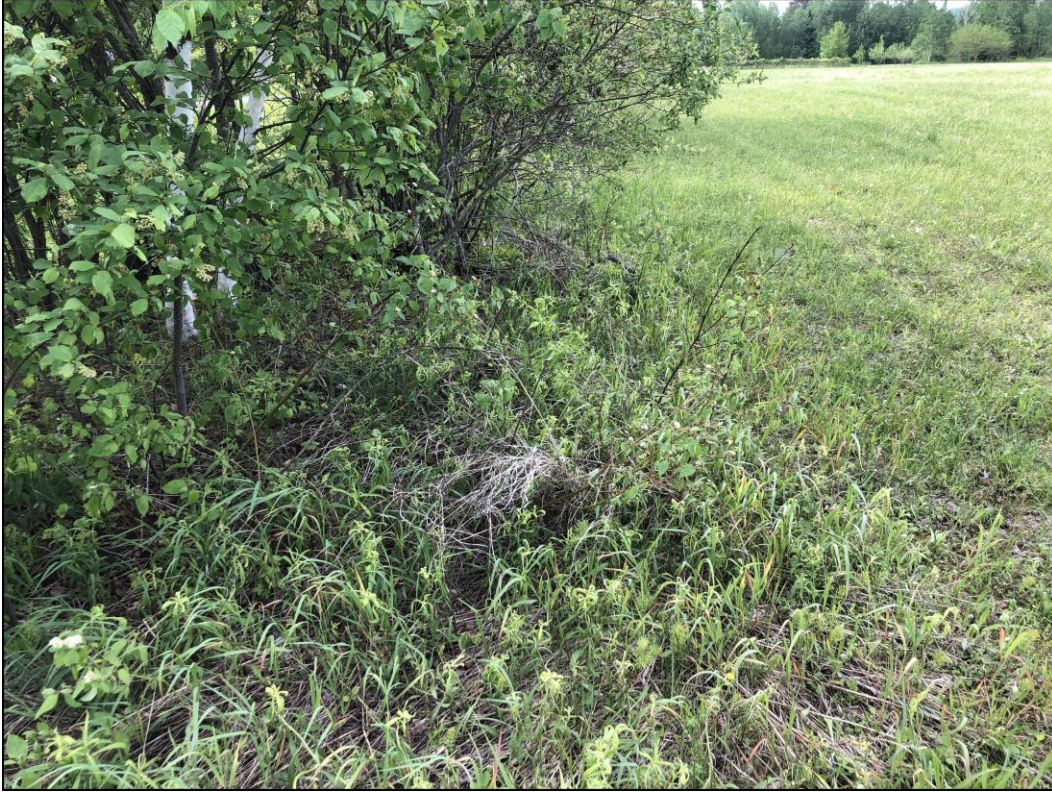
wasc1024\_u\_S

Could not sample soil due to the proximity to potential buried utilities within the roadside area. Soils are assumed to be non-hydric based on the landscape position and dominant vegetation.

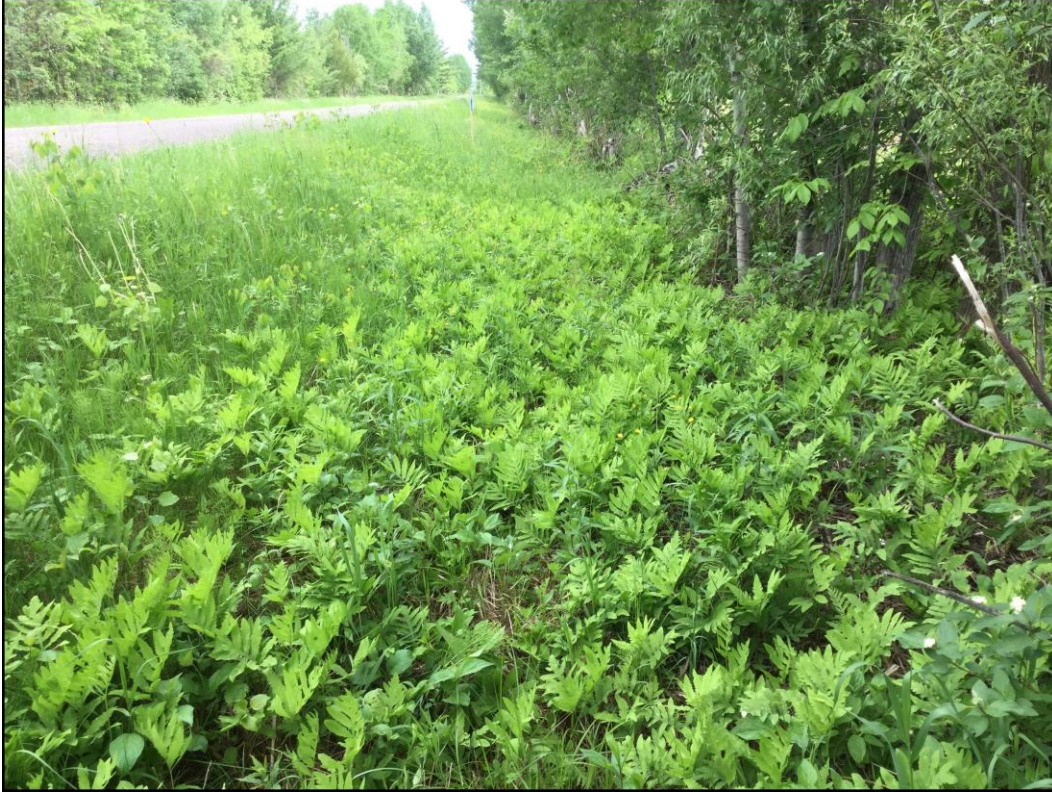
wasc1031e\_w\_N

Soils were not sampled due to the location in a roadside ditch and likely proximity to underground utilities. However, based on the landscape position and dominance of hydrophytic vegetation, the soils are assumed to be hydric.

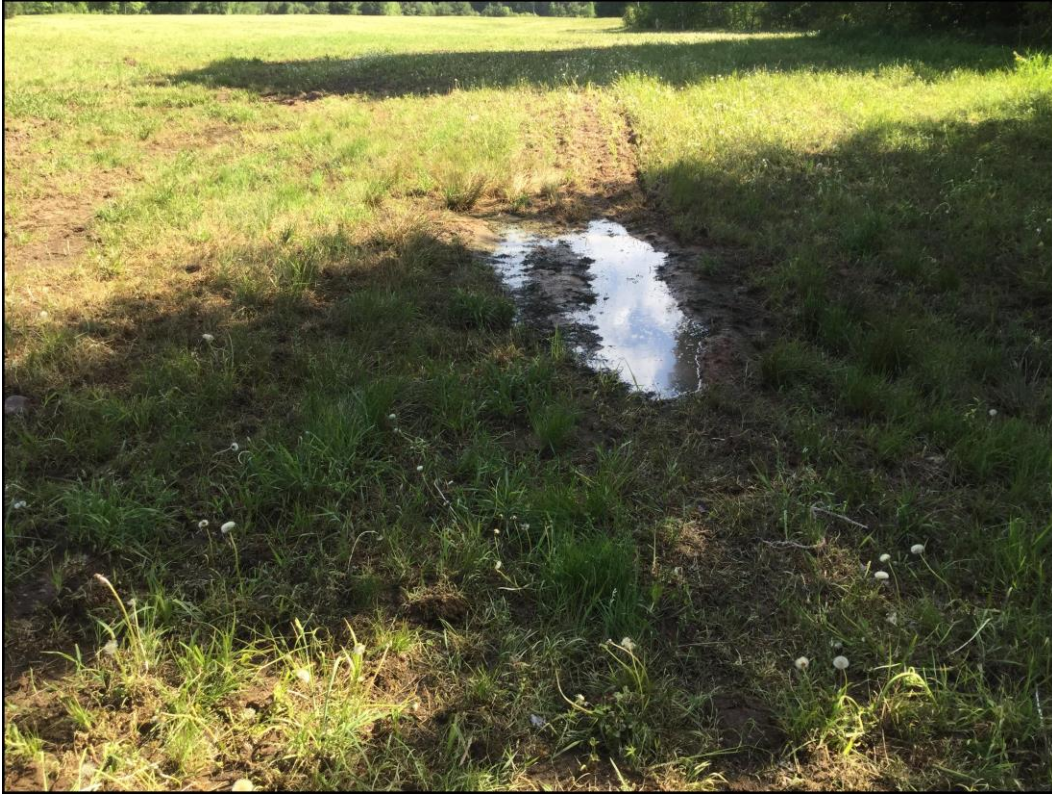
wasc1032e\_w\_NE

Hydrology: The feature is a saturated depression located within an agricultural field. Small areas of standing water were observed at the time of survey. These may partially be a result of compaction from agricultural equipment.		Vegetation: Plant Community Description(s): The feature is a wet meadow dominated by cf. mosquito bulrush and soft rush and located in a recently planted corn field. The wetland extends into an area of exposed soil. Some of the vegetation appears to have been recently sprayed with herbicide.
