Bad River Band of Lake Superior
Tribe of Chippewa Indians

Project Pollutants that Will Affect Tribal Water Quality

Mashkiiziibii Natural Resources Department Presentation #2 for the Hearing
with the US Army Corps of Engineers
May 13, 2025 – St. Paul, MN

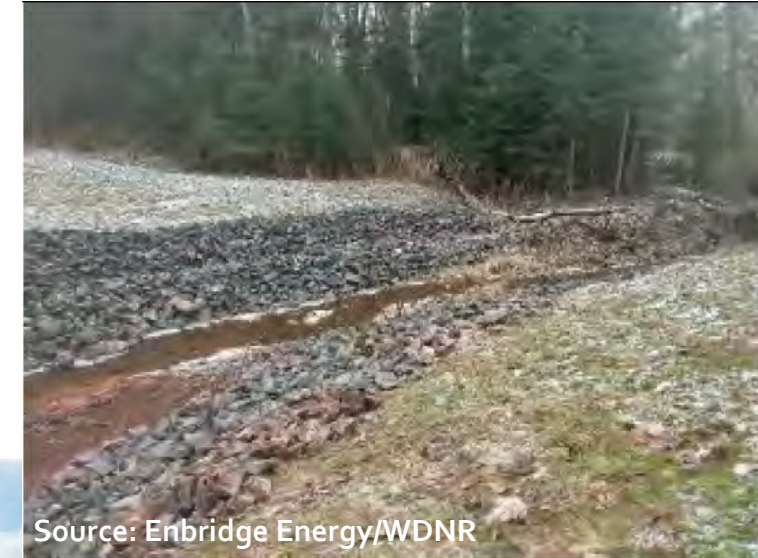
Photo of the hard armoring of a North Fish Creek Tributary triggered due to the presence of Enbridge's Line 5. Enbridge photo from 11/26/24.

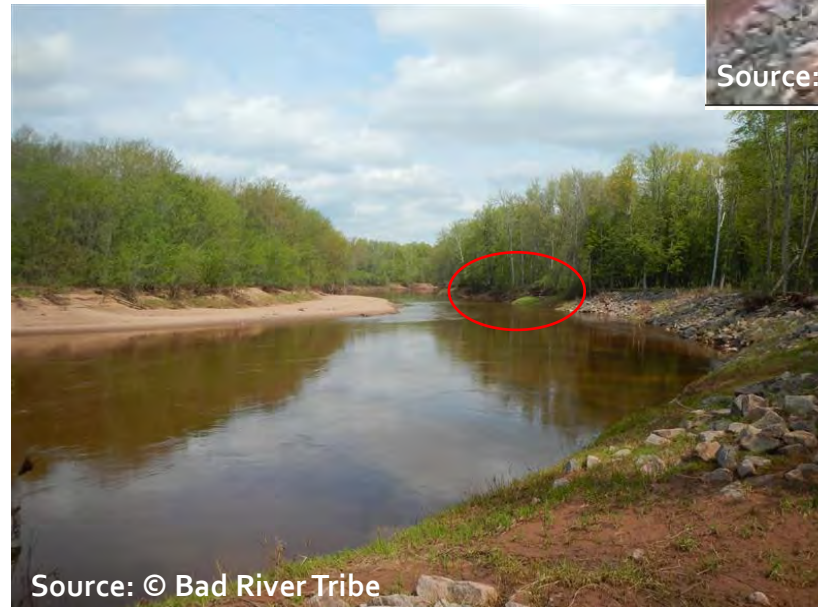
Photo of the hard armoring of the Bad River triggered due to the presence of TC Energy's 100 & 200 pipelines. The red circle highlights the area downstream where the bank is eroding at an accelerated rate since the riprap was placed. MNRD photo from 2013.

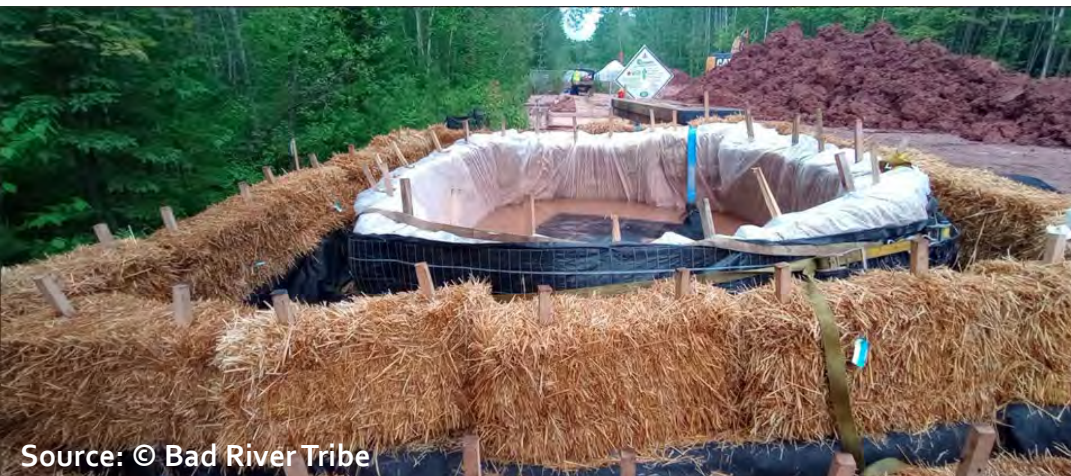
Photo of the dewatering structure and stockpiles of soil from the Enbridge check valve project the on-Reservation during the 2024 growing season. MNRD photo.

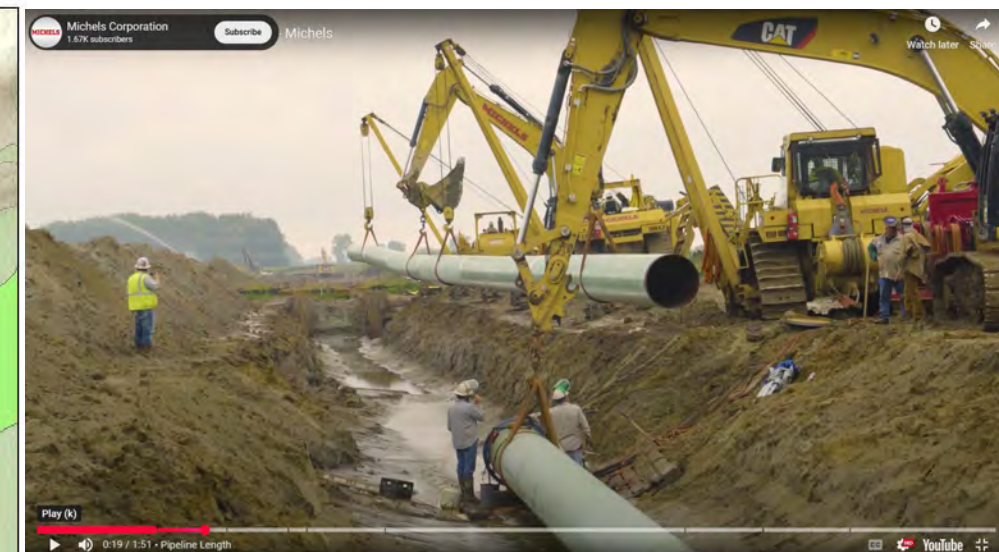
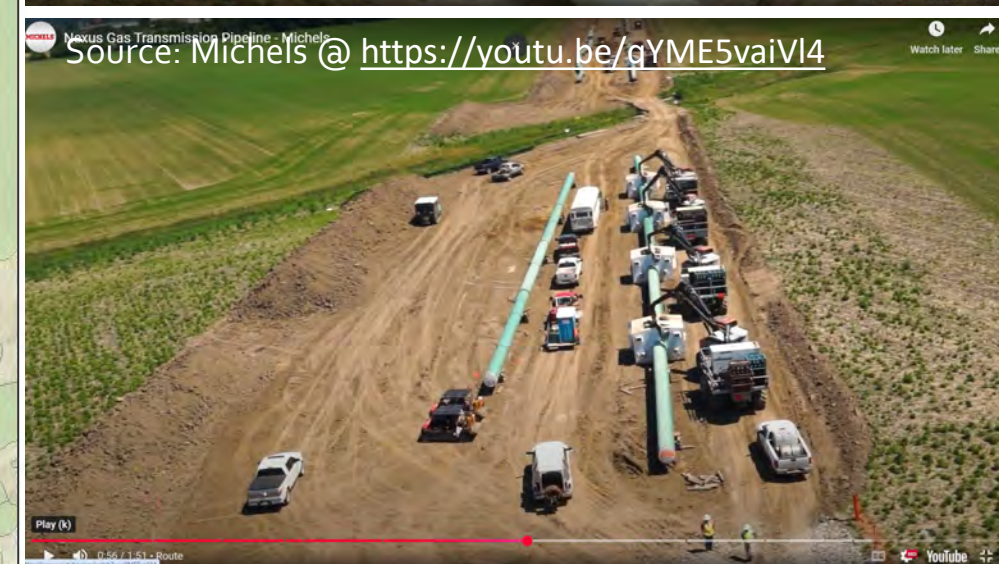
Trenching results in substantial disturbance.

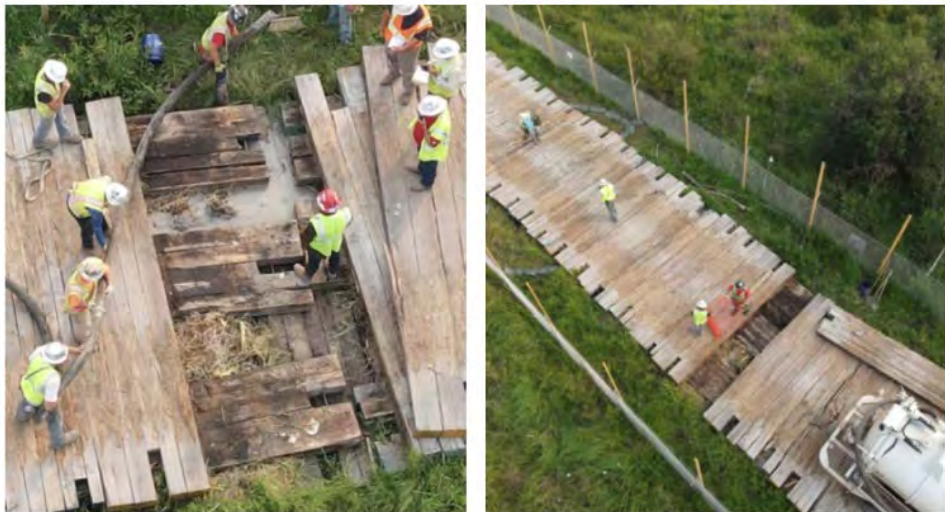
Figure 2. Drone photos of Enbridge clean-up crews trying to contain drill mud released under temporary matting associated with the HDD of the Mississippi River. Photos from Ron Turney included in Attachment 2 of Triplett-Dolph-Turney-Broberg Line 3 Fluid Losses and Aquifer Breaches.

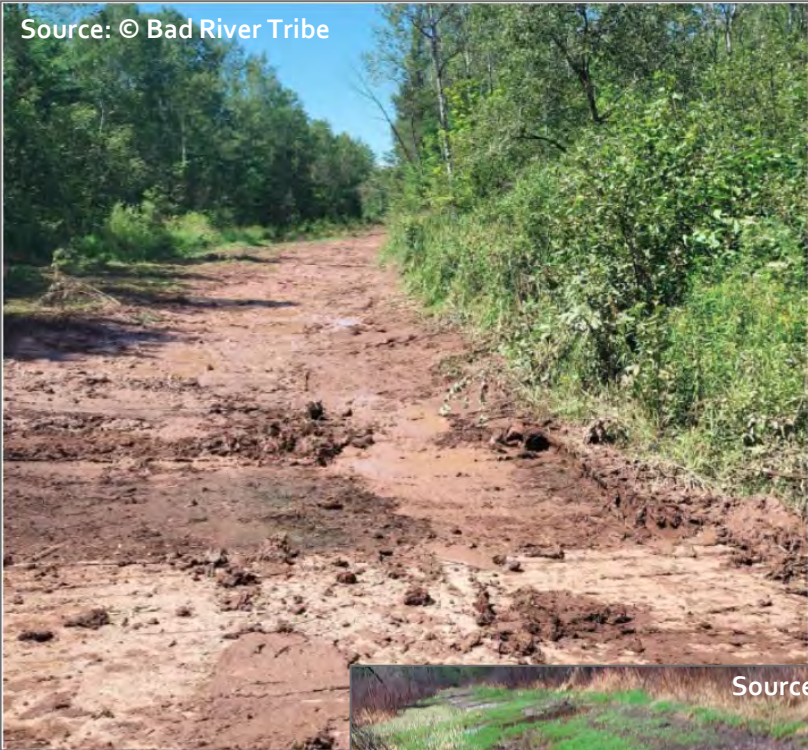
Photo shows a portion of the access route where the construction matting was removed in August 2024—in the background, the exposed soil has been “smoothed” with the backhoe bucket while the area in the foreground is still rough and uneven from the matting being installed and its removal.

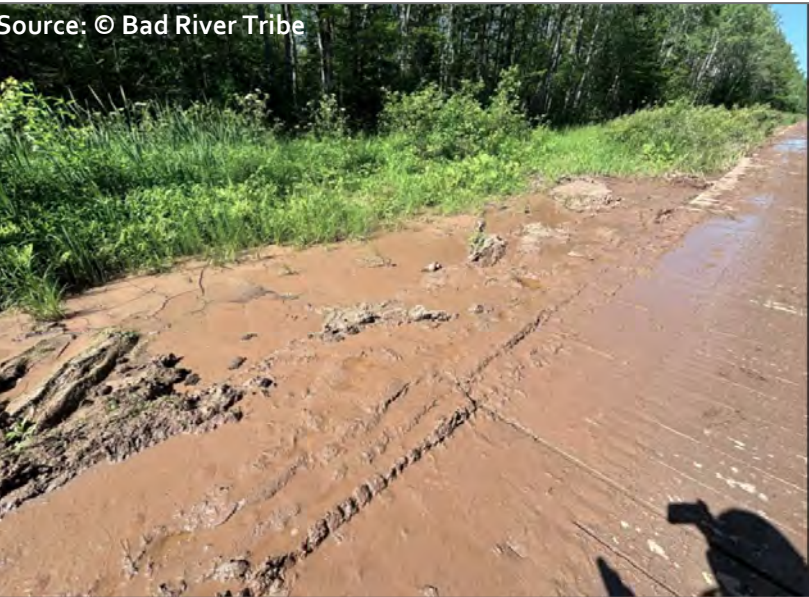
Photo shows a portion of the access route where the construction matting was placed across a wetland and the saturated soil being pushed out from underneath due to the equipment traffic and into a nearby wetland.

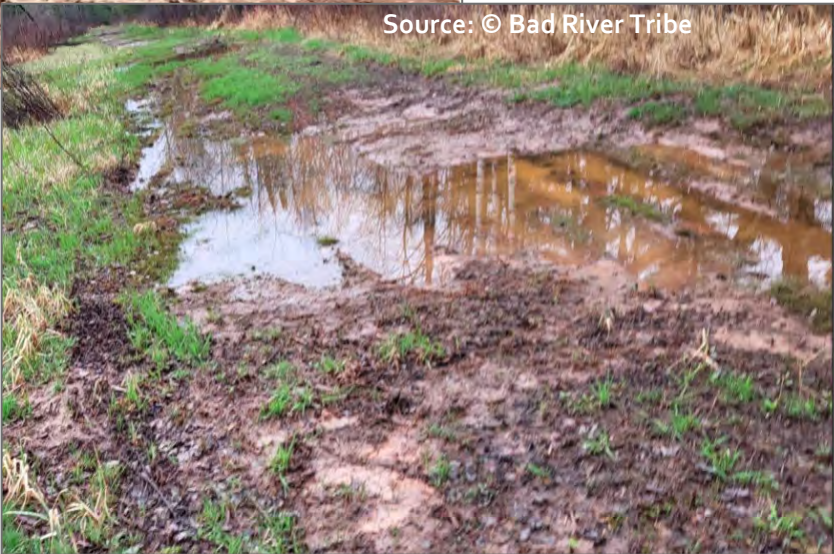
Photo shows a portion of the access route in April 2025 which still has unvegetated areas where established vegetation did not recover after the removal of the timber mats.

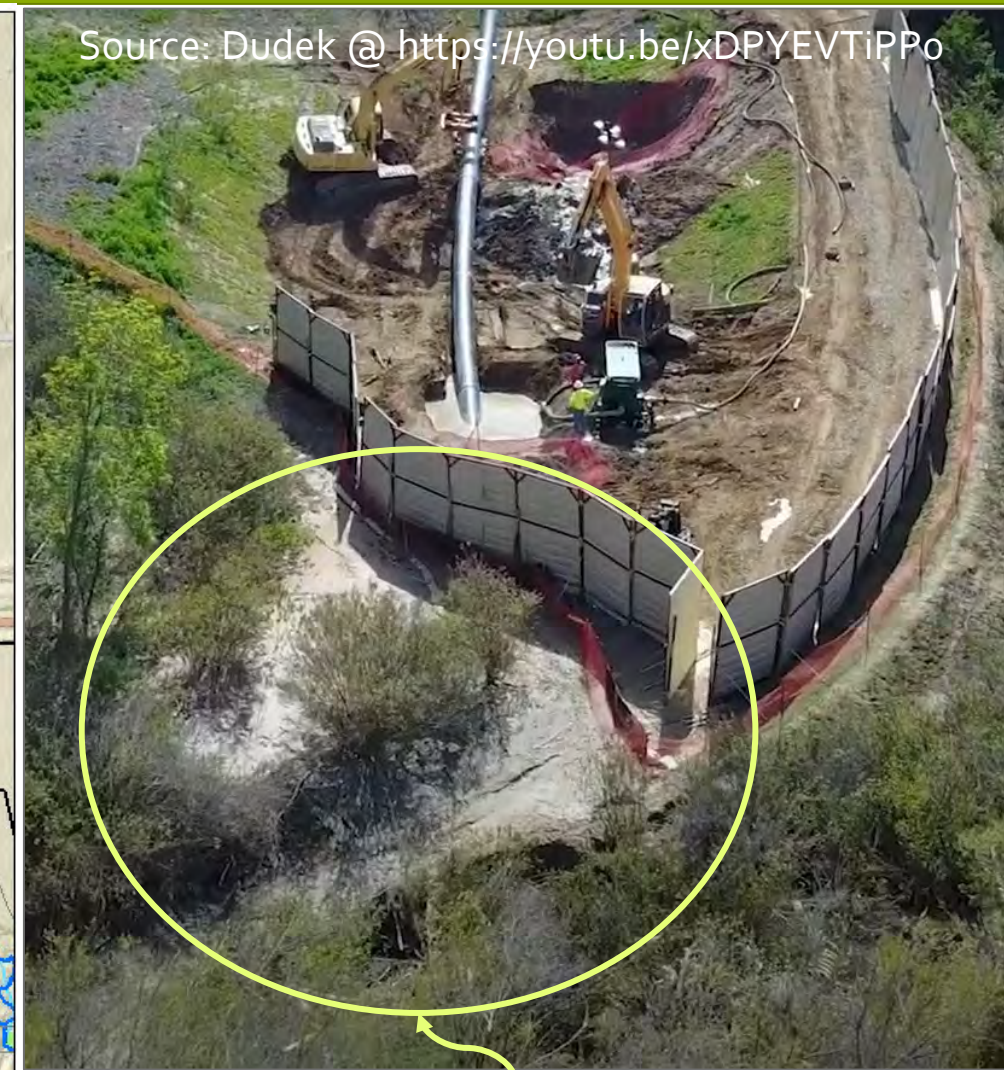
Sediment release from false ROW workspace even with BMPs installed.

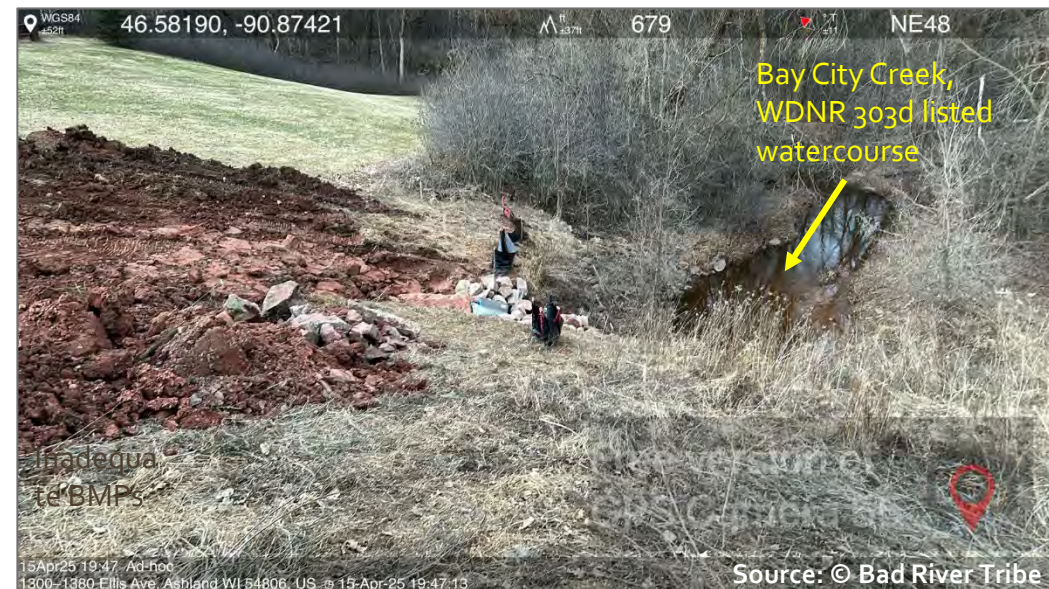
Inadequate installation of BMPs; WDOT project "WIS 13, Butterworth Road to US 2" (2025, MNRD).

Ineffective BMPs; WDOT project "WIS 13, Butterworth Road to US 2" (2025, MNRD).

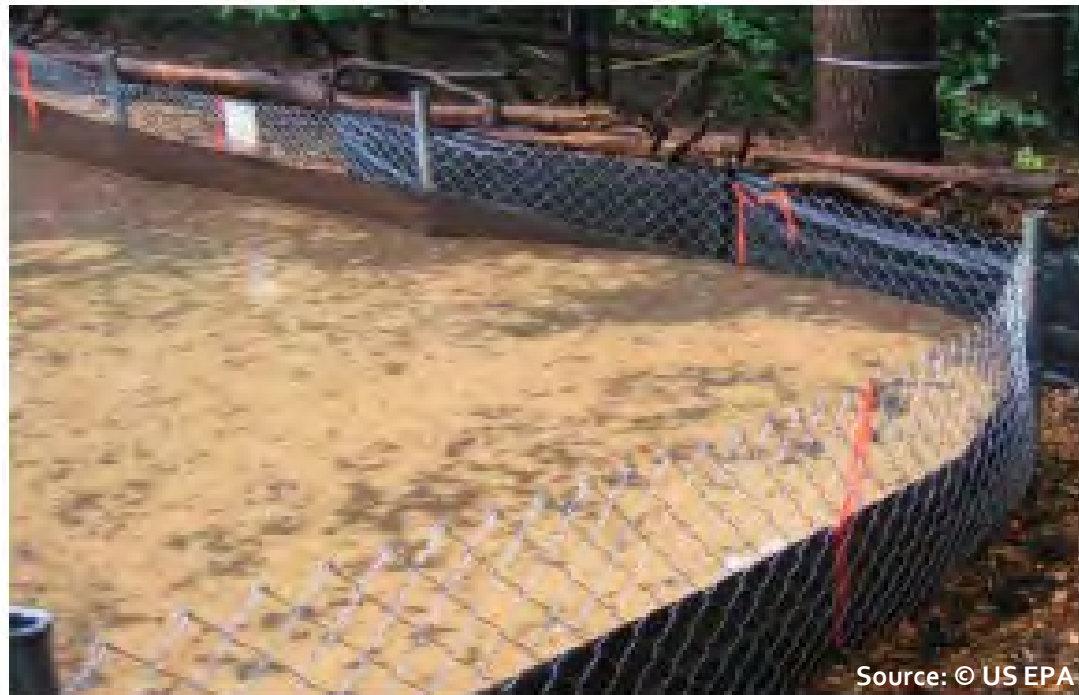
Image from US EPA NPDES: Stormwater Best Management Practice – Silt Fences shows chain link supported silt fence holding back runoff about to overtop the silt fence.

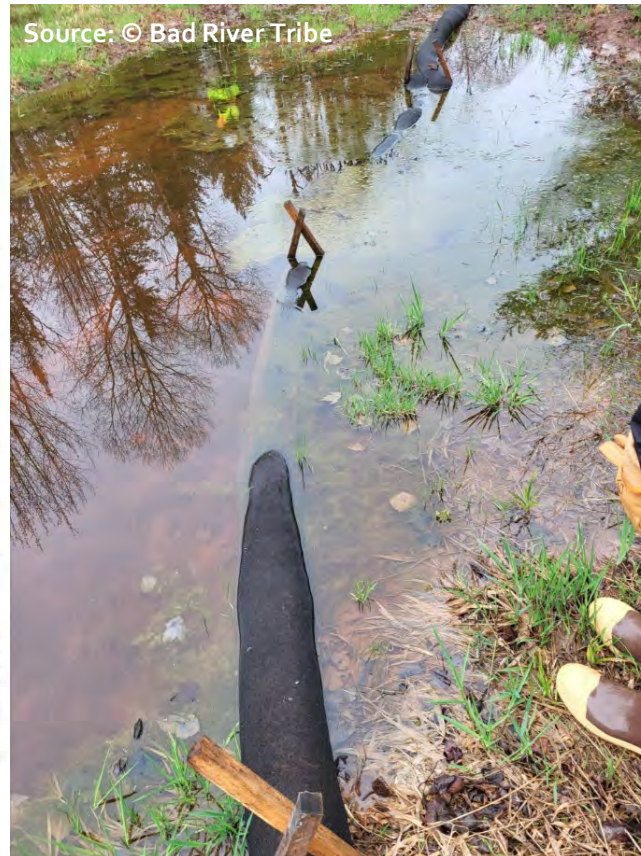
Photo of wattles/biologs placed along the access to the Check Valve site underwater during an April 2025 site inspection.

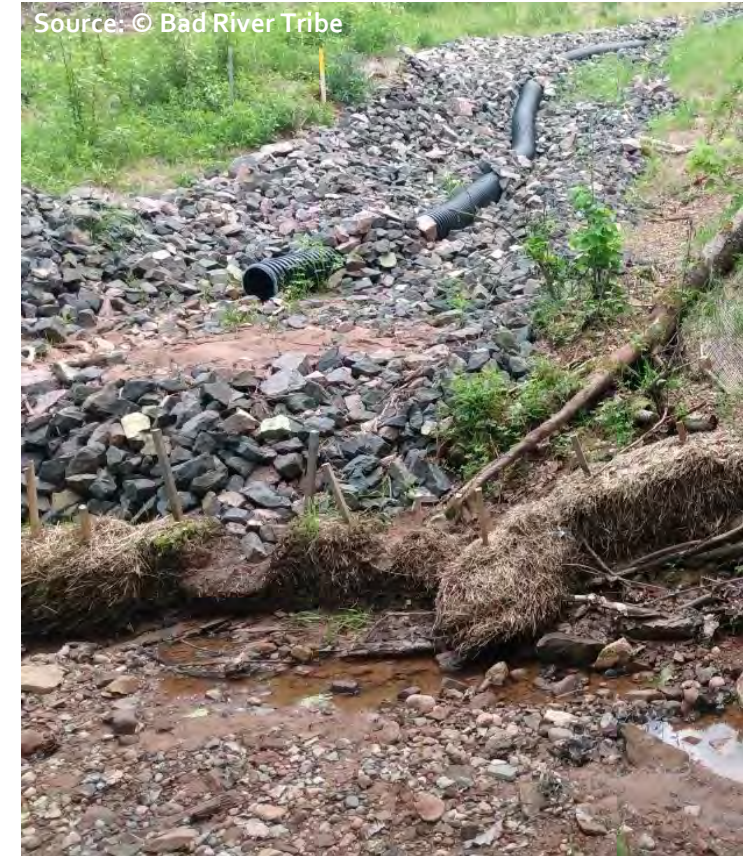
Photo of filled sediment basin and failing secondary straw bale containment in a Denomie Creek Tributary. Photo from 7/2021.

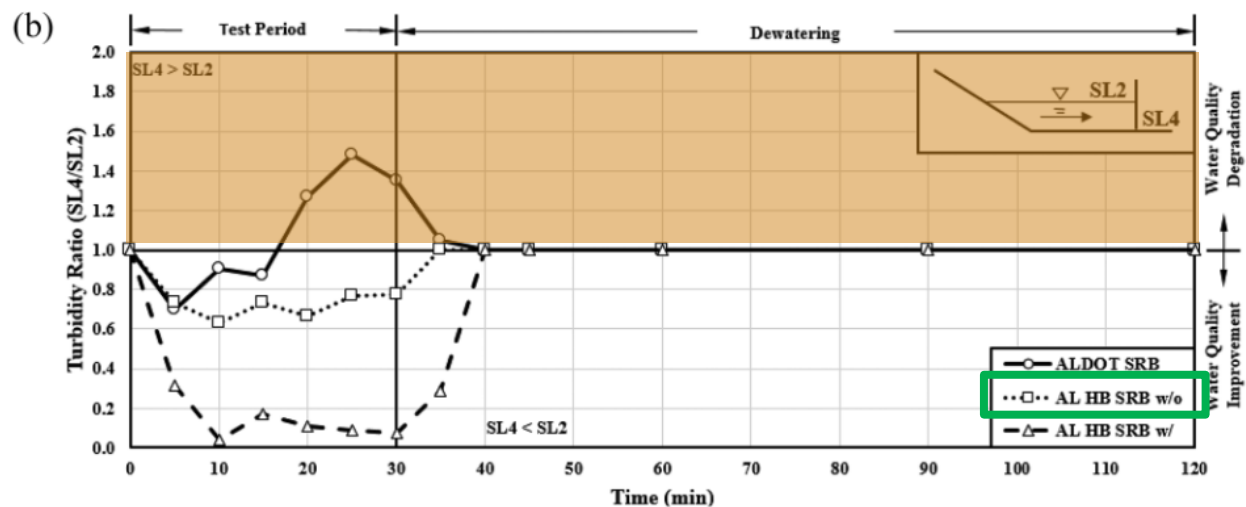
“Figure 7. Turbidity ratio comparisons of treatments: (a) manufactured silt fence systems, (b) SRBs, and (c) manufactured SB products.” (Whiteman et al., 2019)

Orange boxes highlight when water quality monitoring results showed an increase in turbidity in water leaving best management practices in study.

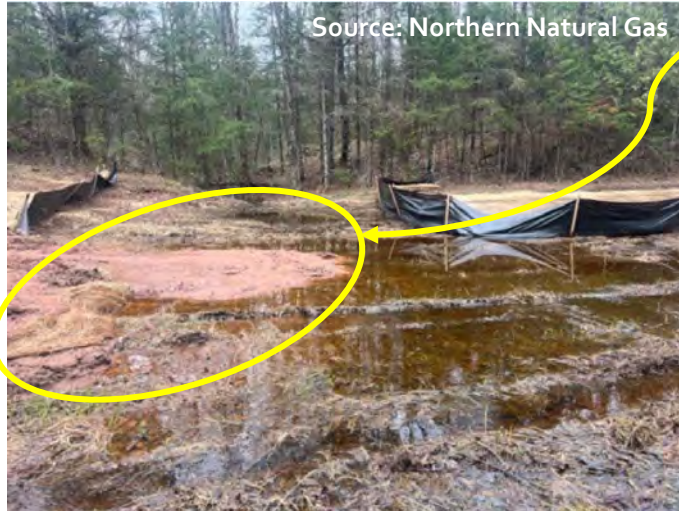
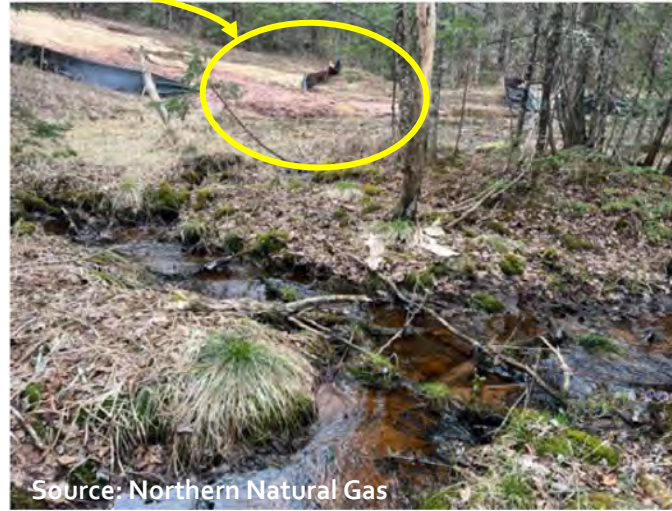
Northern Natural Gas BMP failure from sheet erosion. Soils and sediments reached a wetland downslope (left photo) and impacted the stream running through the wetland (right photo). Photos from Spring 2025.

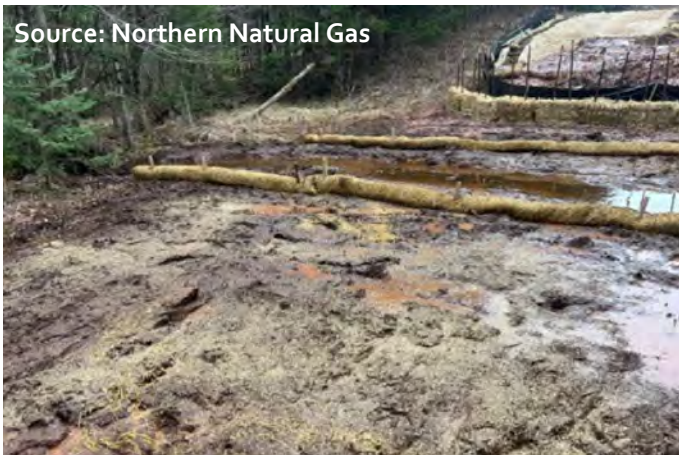
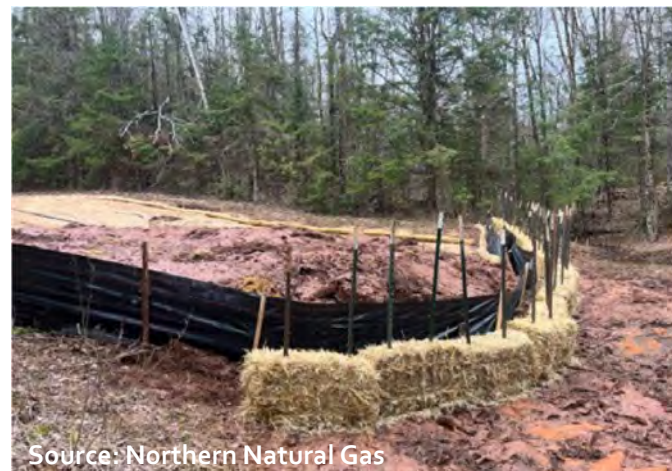
Northern Natural Gas failure from sheet erosion after additional BMPs installed. Wattles between the disturbed wetland and the stream channel (left) and silt fence with new straw bale support (right). Photos from Spring 2025.

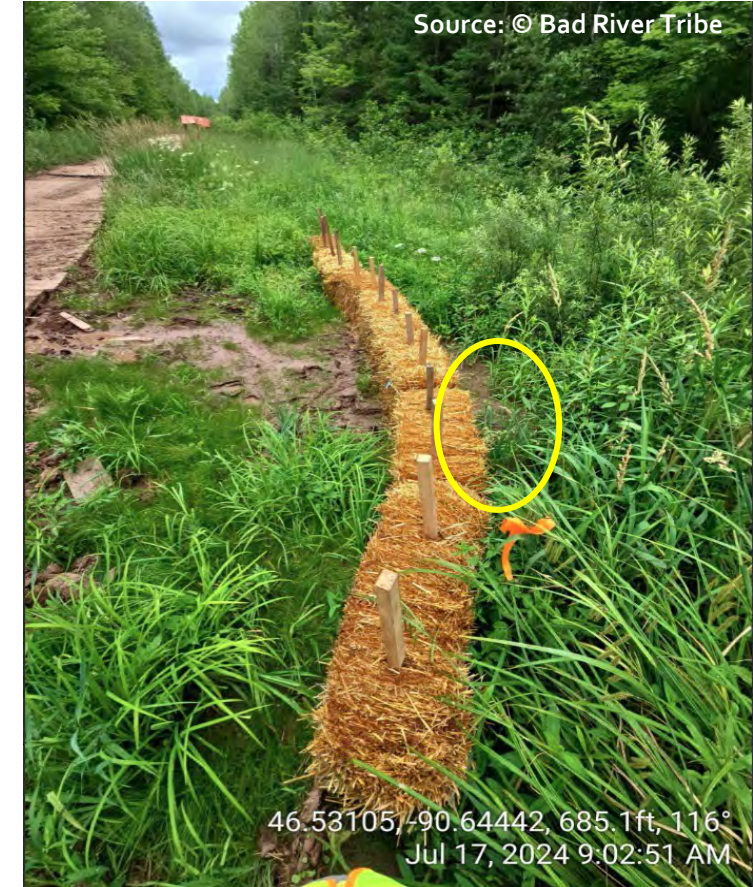
Enbridge Check Valve Project. Sediment both sides of straw bales. BMP either not implemented prior to sediment runoff or not installed correctly (2025, MNRD).

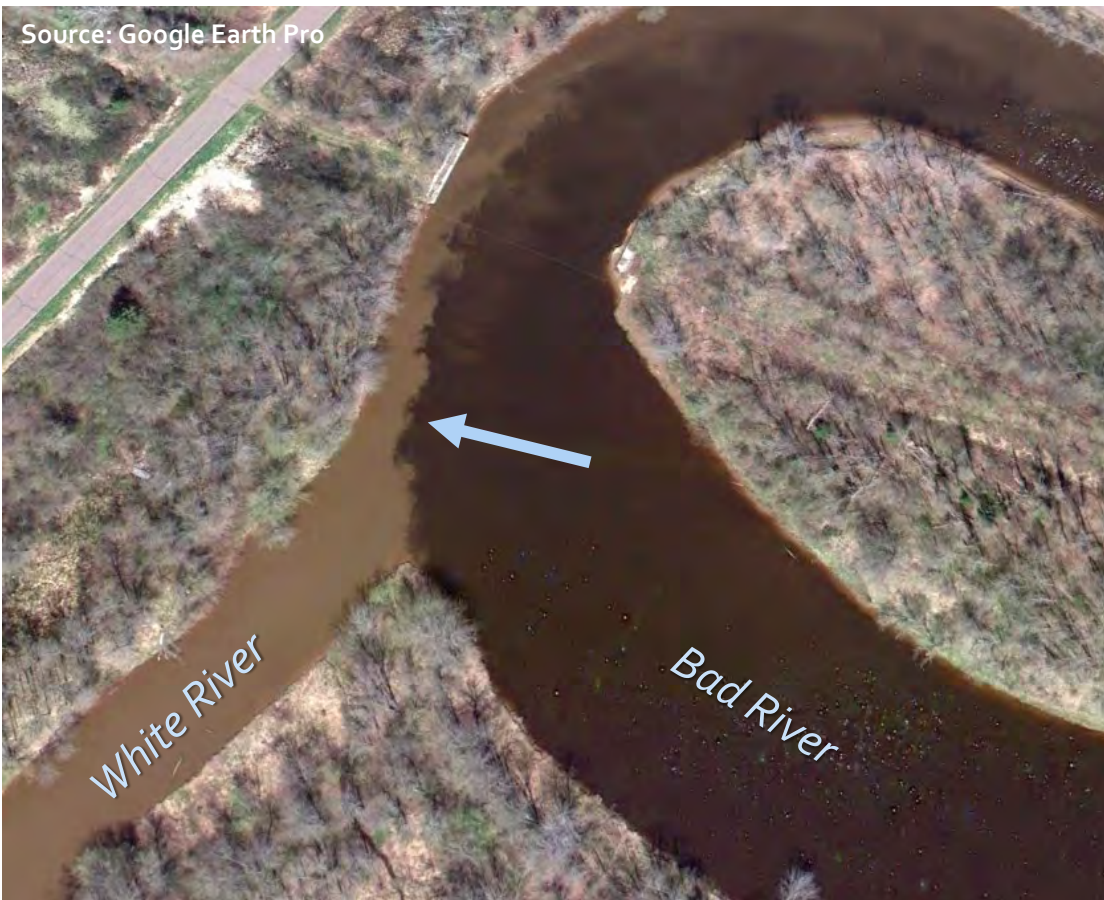
At the confluence of the White River and Bad River there is a clear difference in turbidity as the White River, having a more developed watershed, it is oftentimes much more turbid.

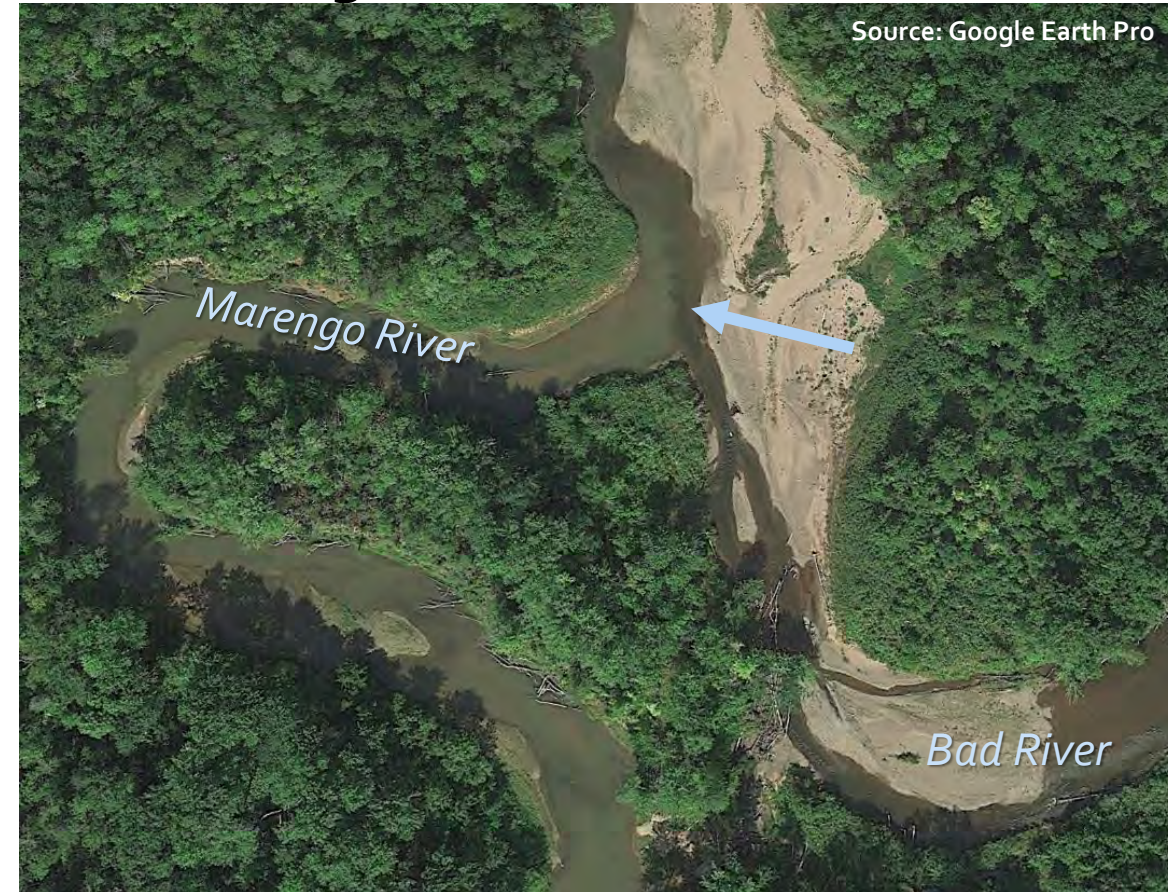
At the confluence of the Marengo River and Bad River there is a clear difference in turbidity as the Marengo has higher sediment loads and is impaired.

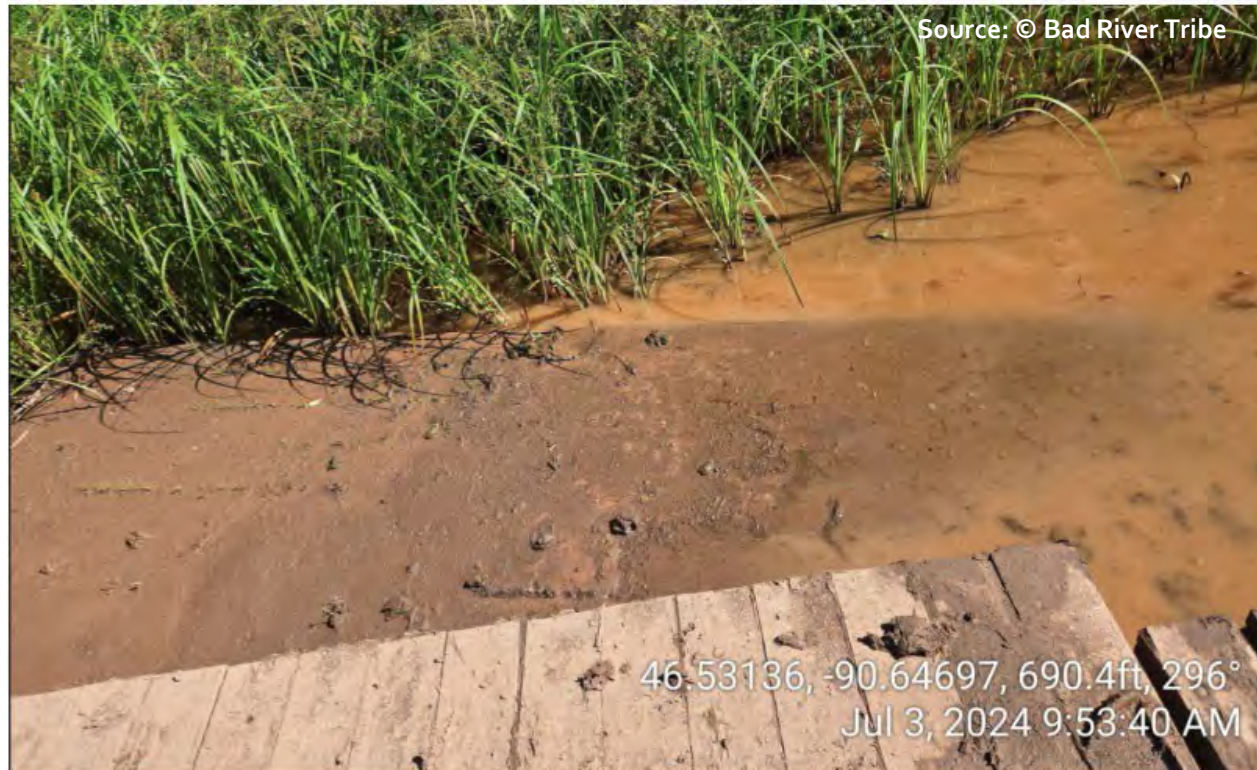
A wetland impacted by the mud pushed out from underneath the construction matting for the Enbridge Check Valve project, and the sediments released as mud transferred by vehicle traffic is left on the matting and washed off into the nearby wetland amphibians, like the adult frog in the picture, can still be found in the wetland; however, water quality was effected, and the suitability of this wetland for any larval amphibians that may have hatched out in the spring is drastically reduced. (Bad River Tribe/MNRD, 7/2024)

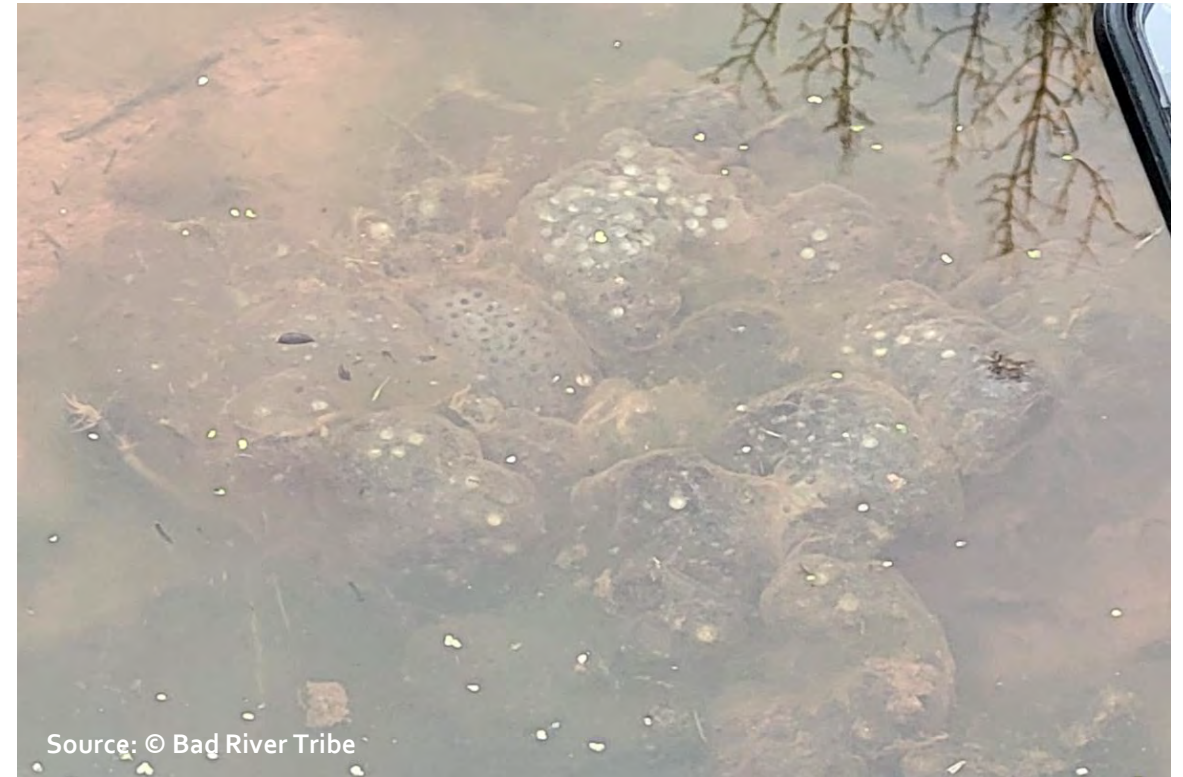
Amphibian eggs in standing water along the access route to the Enbridge Check Valve project. While these pools of water may appear suitable to the amphibians spawning, impacts and persisting site conditions left over from the construction project may ultimately mean these pools aren't going to provide the habitat necessary for these eggs to survive. (Bad River Tribe/MNRD, 4/2025)

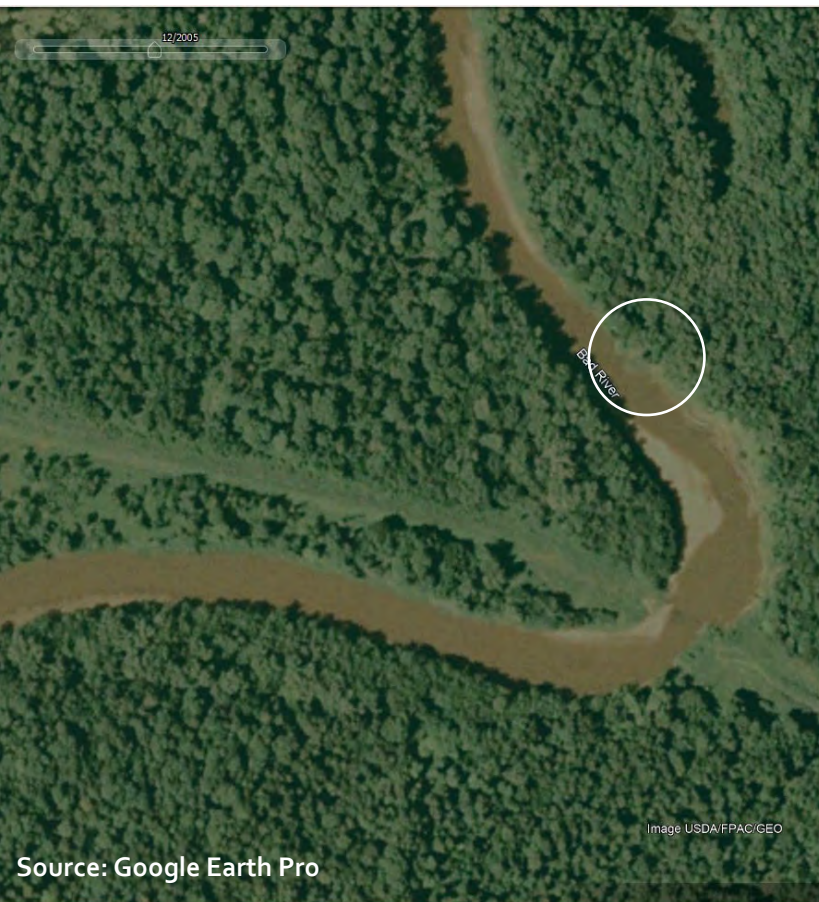
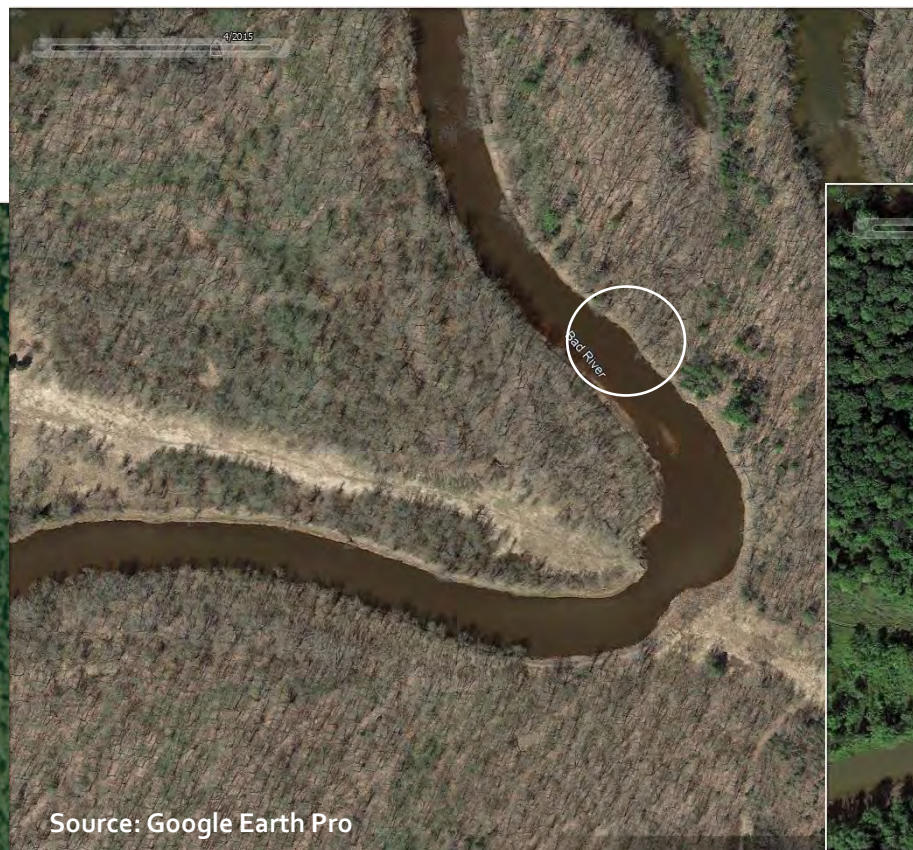
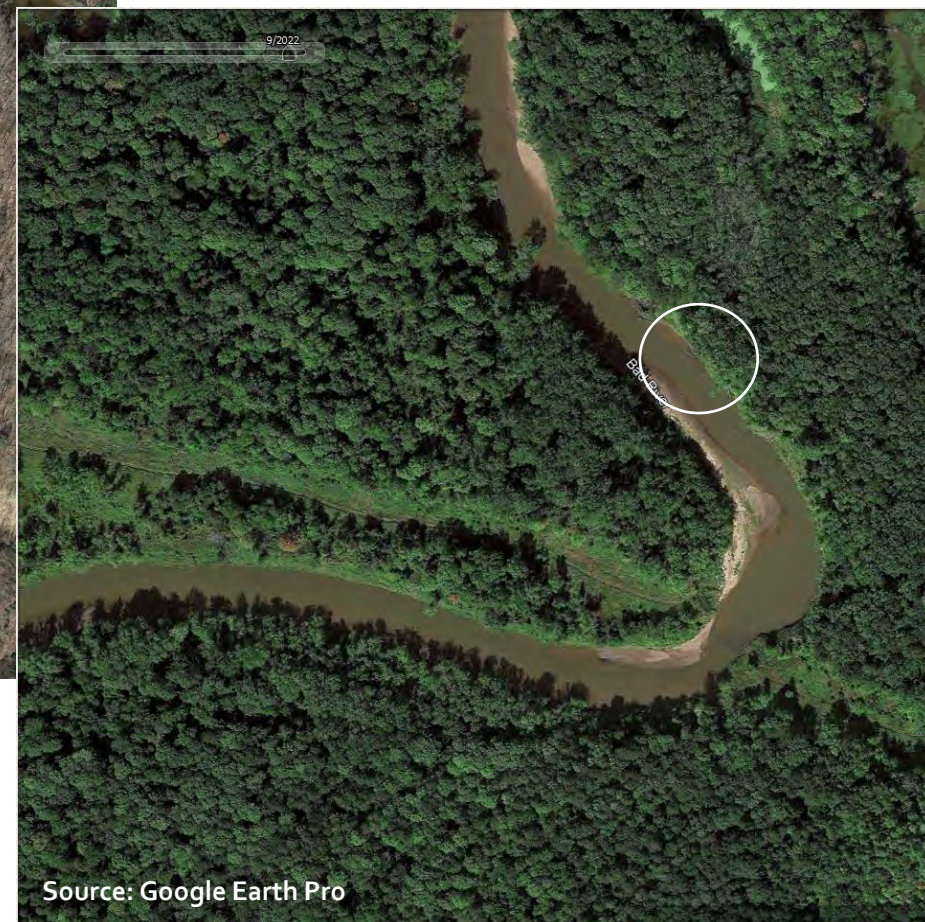
TC Energy Crossing in 2005

TC Energy Crossing
in 2015

TC Energy Crossing in 2022

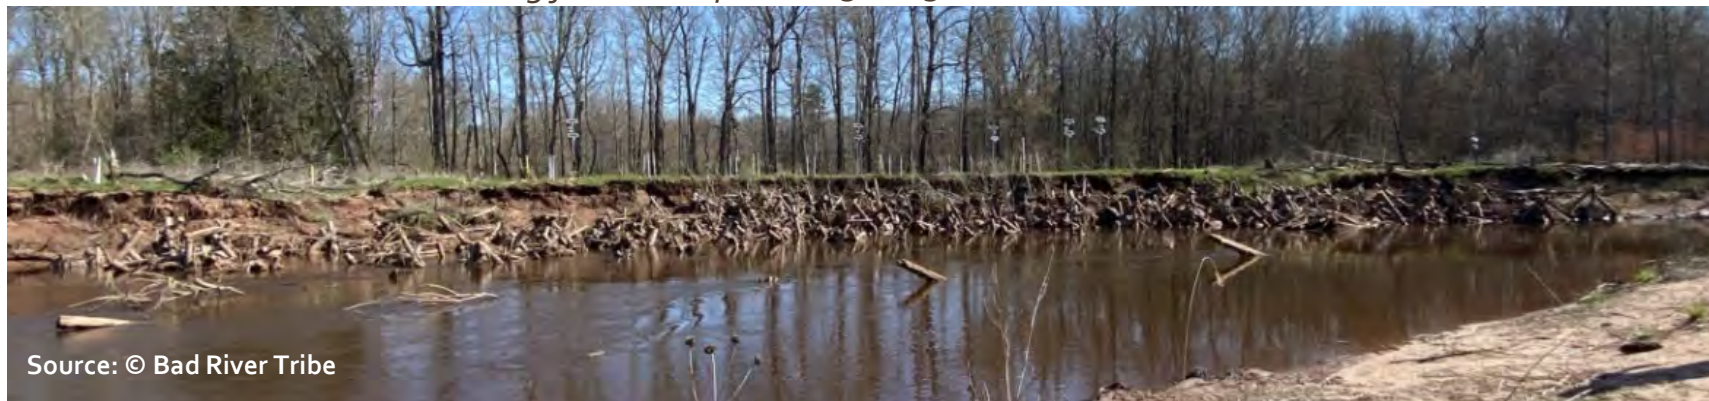
Photo of the stretch of the left bank of the Bad River on the outer part of the next bend where erosion has increased since the log jacks were placed. (5/2025)

Photo of the stretch of the right bank of the Bad River (looking north across the river) where the log jacks were placed. (5/2025)

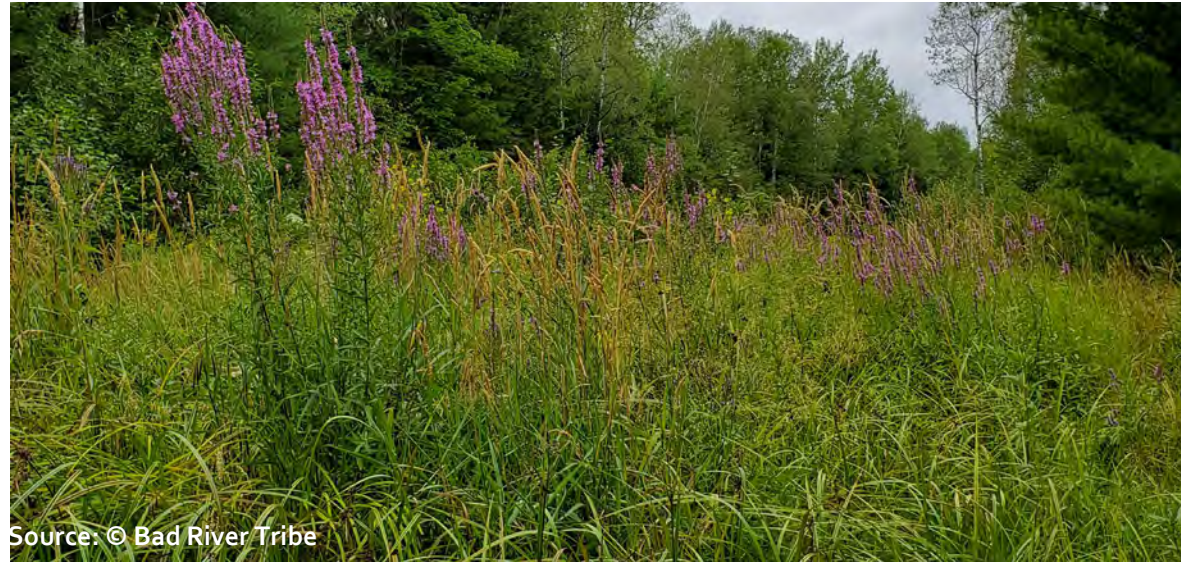
Photo of purple loosestrife growing on the Line 5 corridor west of Pine Flats Road on the Reservation. (2023 MNRD)

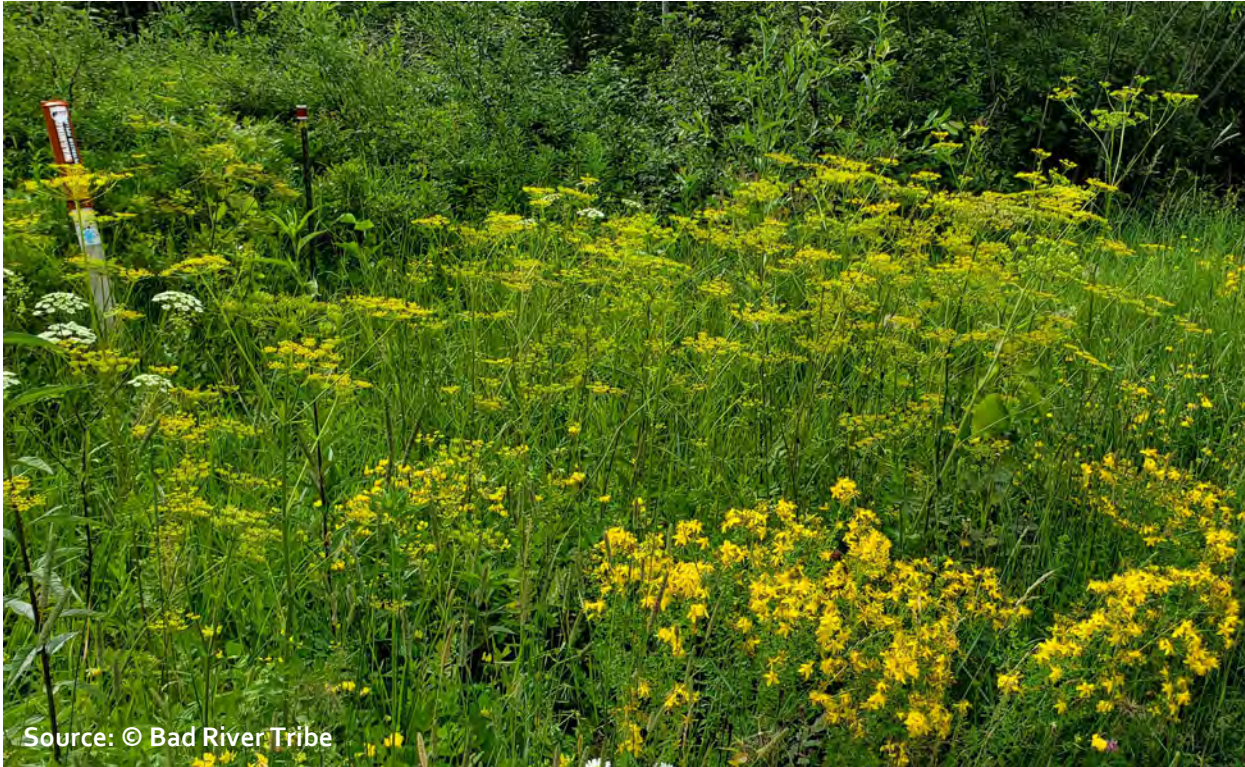
Photo of wild parsnip growing on the Line 5 corridor on the east side of Government Road on the Reservation (2023 MNRD)

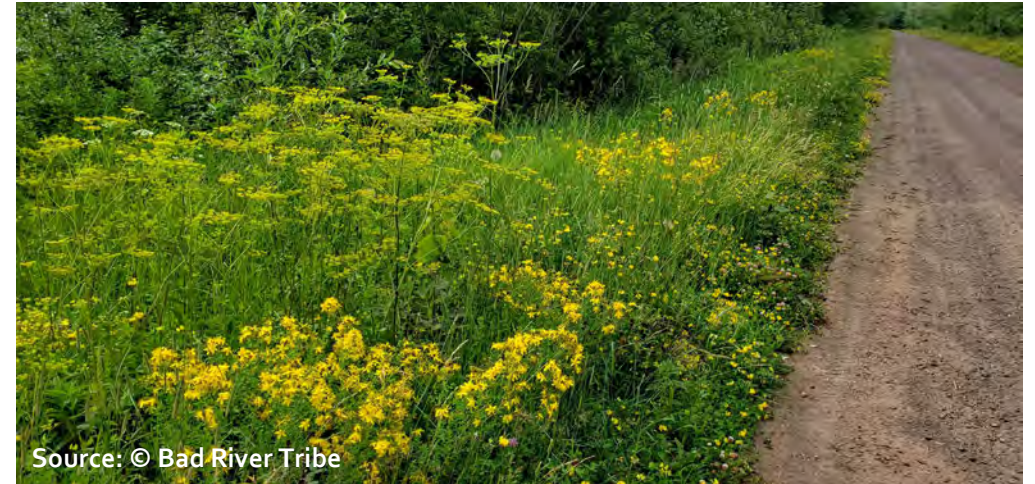
Photo of another angle of the wild parsnip growing on the **Line 5** corridor on the east side of Government Road on the Reservation (2023 MNRD)

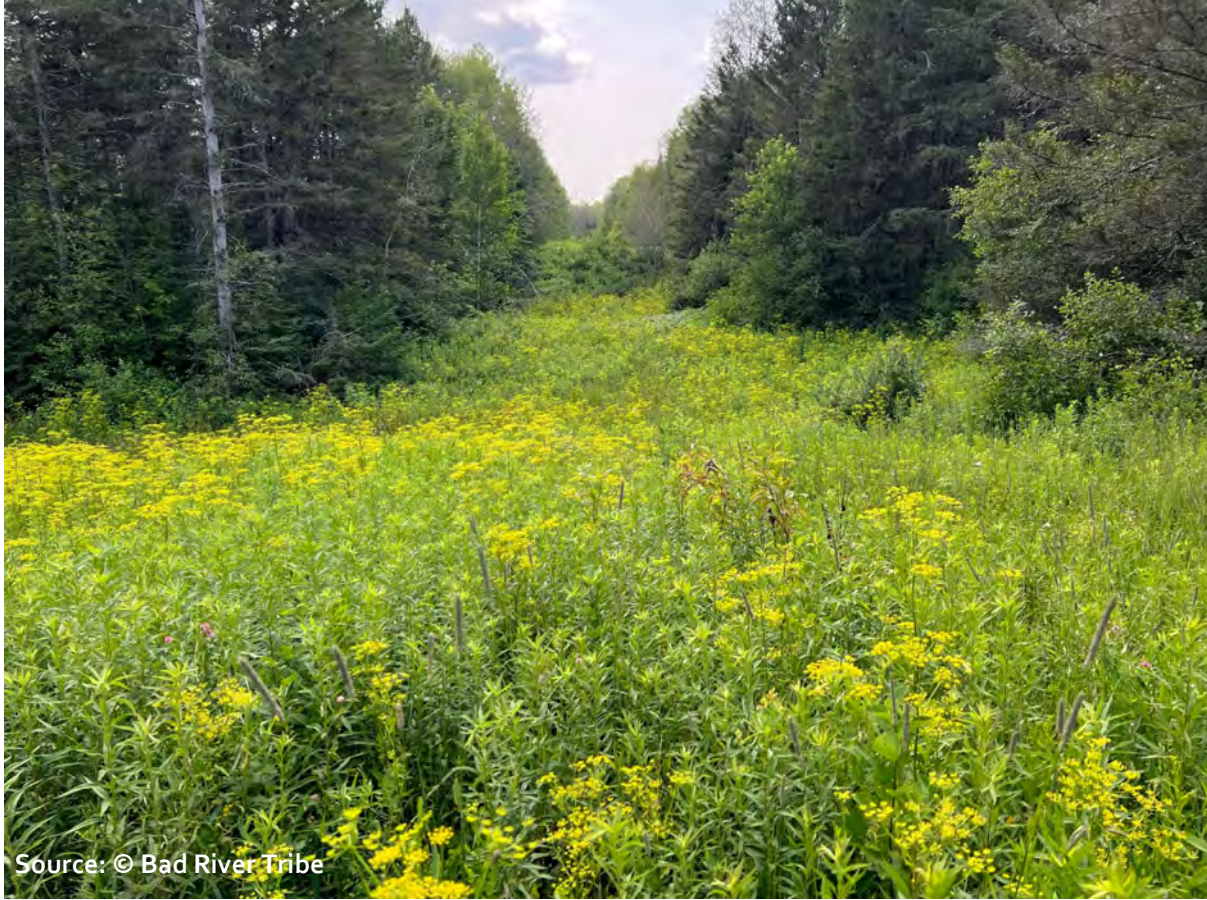
Photo of wild parsnip growing on the Xcel distribution line north of Star Route Road in Northeastern Bayfield County. (2023 GLIFWC, personal communication)
