Bad River Band of Lake Superior
Tribe of Chippewa Indians

Project Pollutants that Will Affect Tribal Water Quality

Mashkiiziibii Natural Resources Department Presentation #2 for the Hearing
with the US Army Corps of Engineers
May 13, 2025 – St. Paul, MN

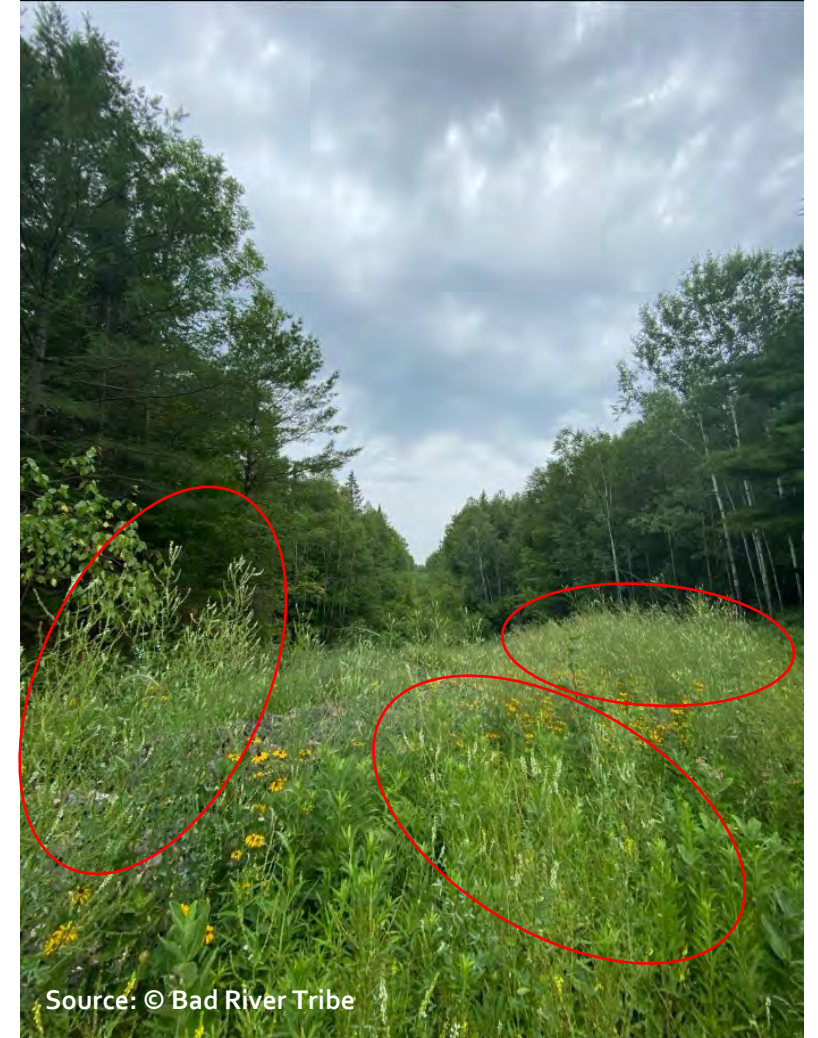
Photo of sweet clover growing at Denomie Creek site after construction activities highlighted in the red ovals.

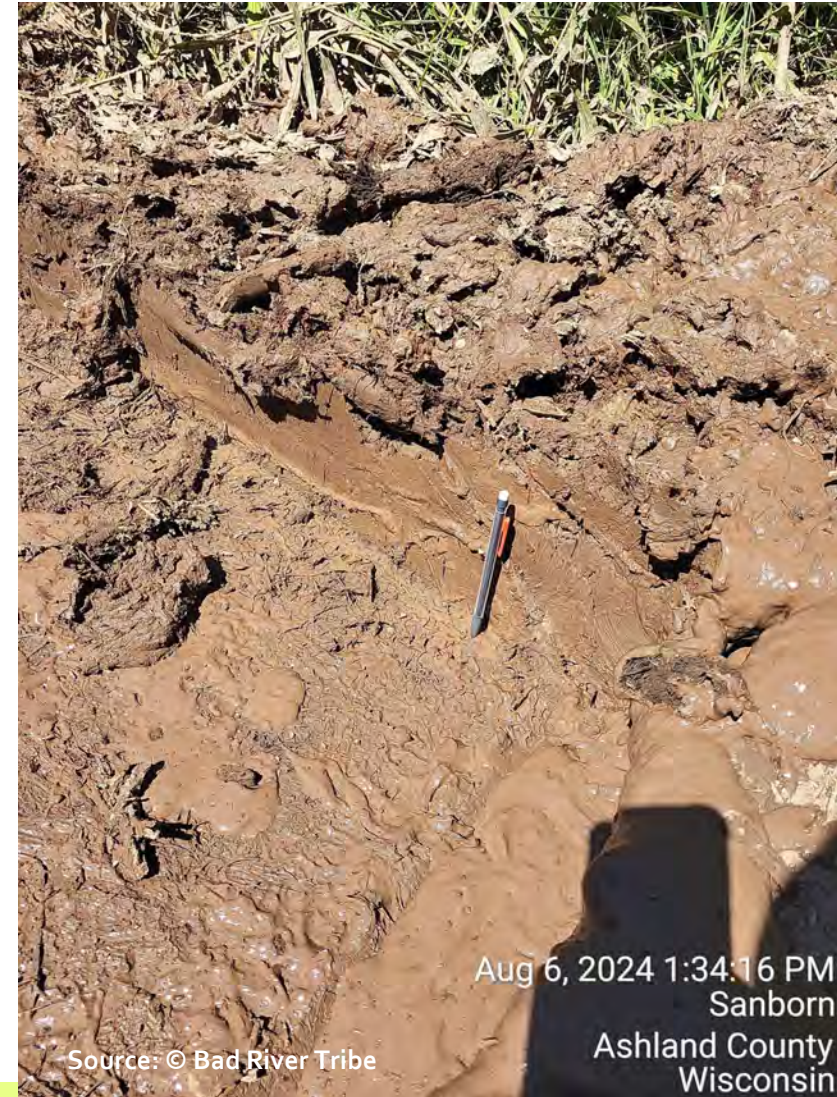
> 6 inches of
compaction
from < 90 days
of deployment
at Enbridge
check valve
project on
Reservation

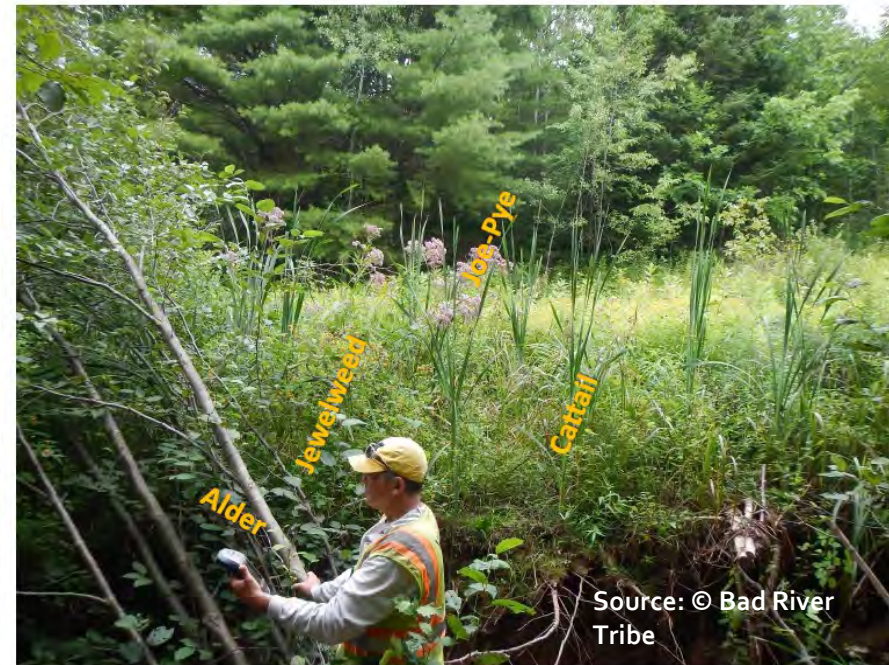
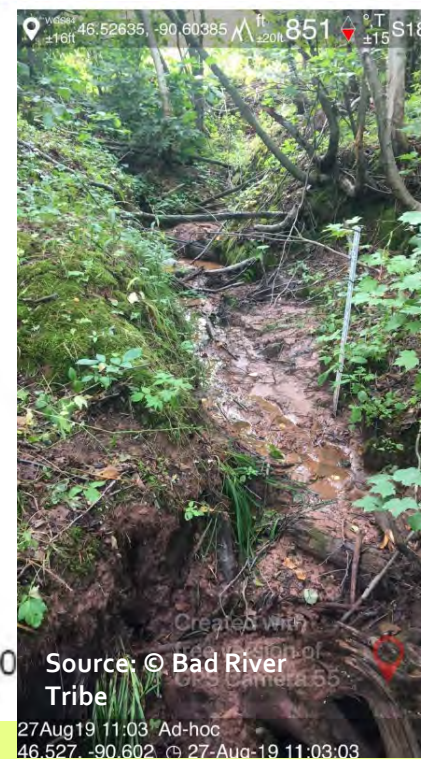
Denomie Creek Tributary Modification to an Engineered Riprap Channel Case Study

Inadequate mapping and delineation

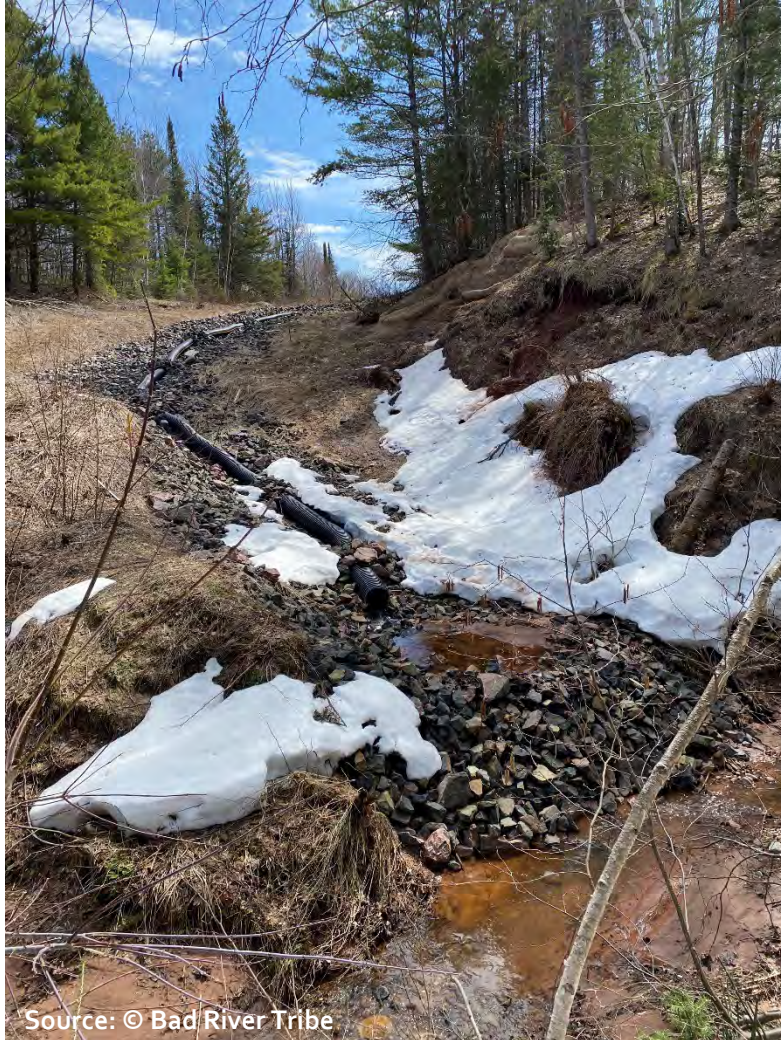
May 5, 2023

Denomie Creek Post
Engineered Riprap
Channel installation.

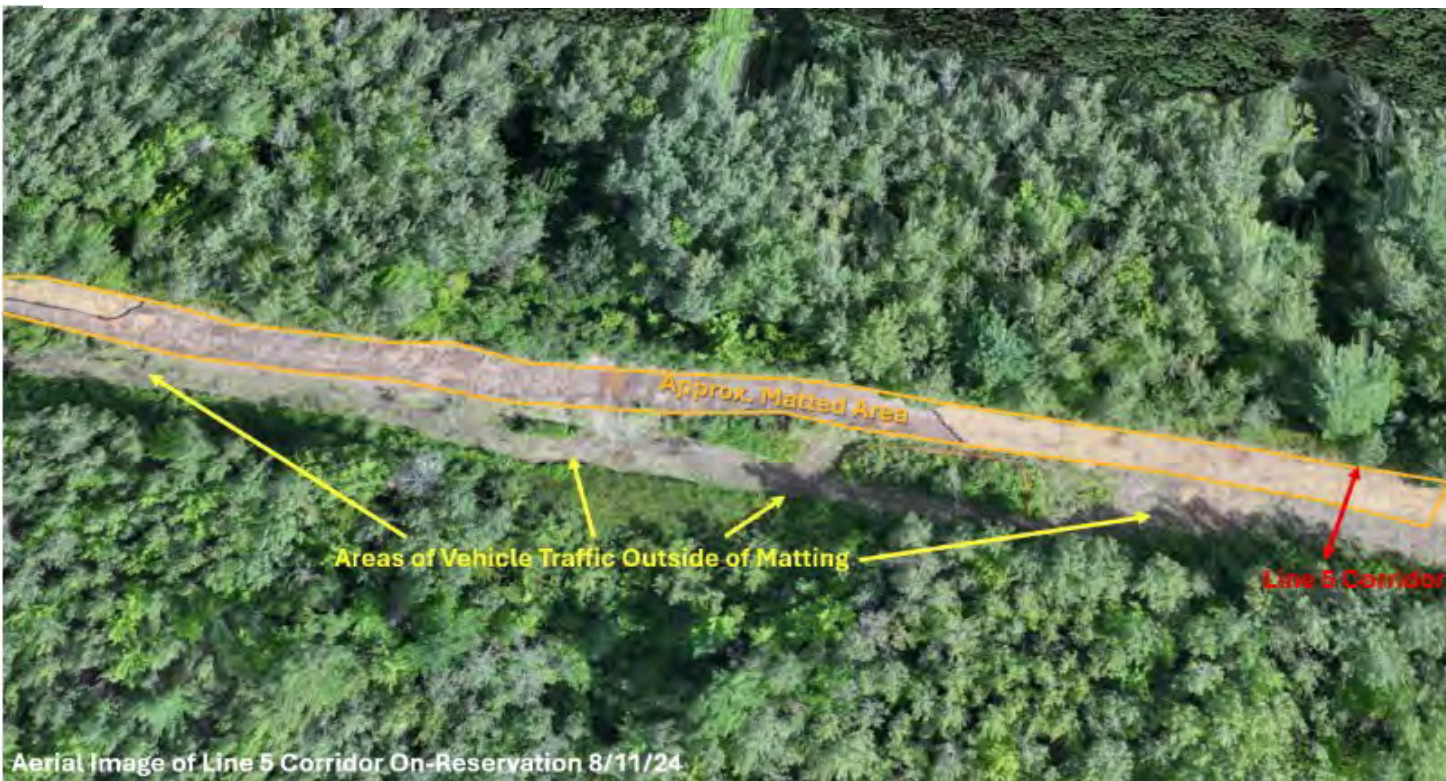
The use of the construction matting and vehicle activity beyond the matting resulted in soil compaction.

Soil compaction and dispersion from construction matting increases runoff and lessen infiltration.

Wetland impacts due to approved matting area and vehicle traffic outside of approved matting areas (2024, MNRD).

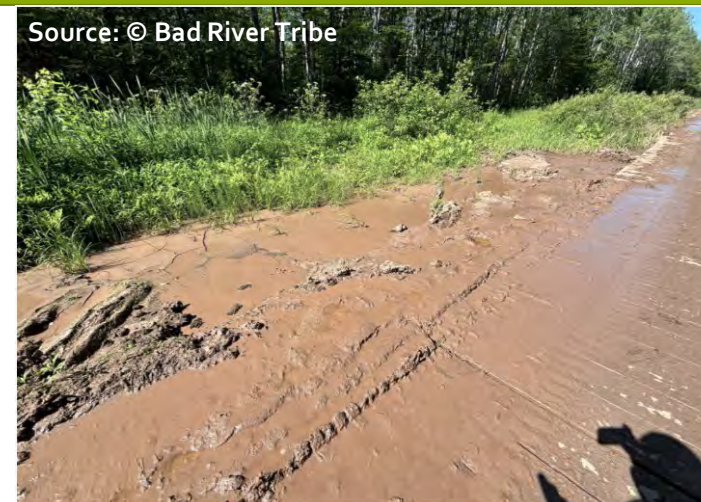
Soil pushed out from under construction matting into adjacent wetlands. Mats sinking into soft substrate of wetland (2024, MNRD).

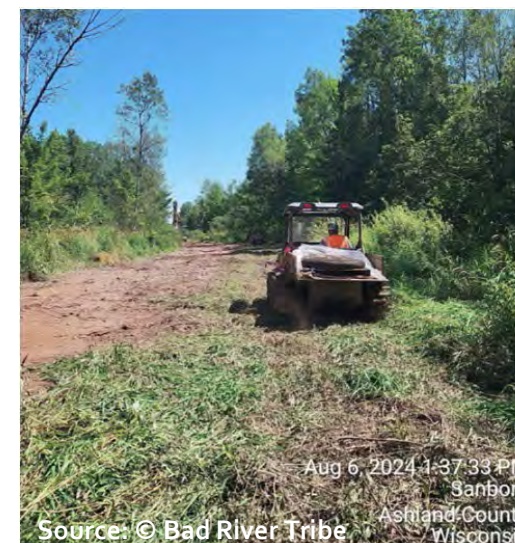
Enbridge crew member operating a tracked vehicle off the construction matting (2024, MNRD).

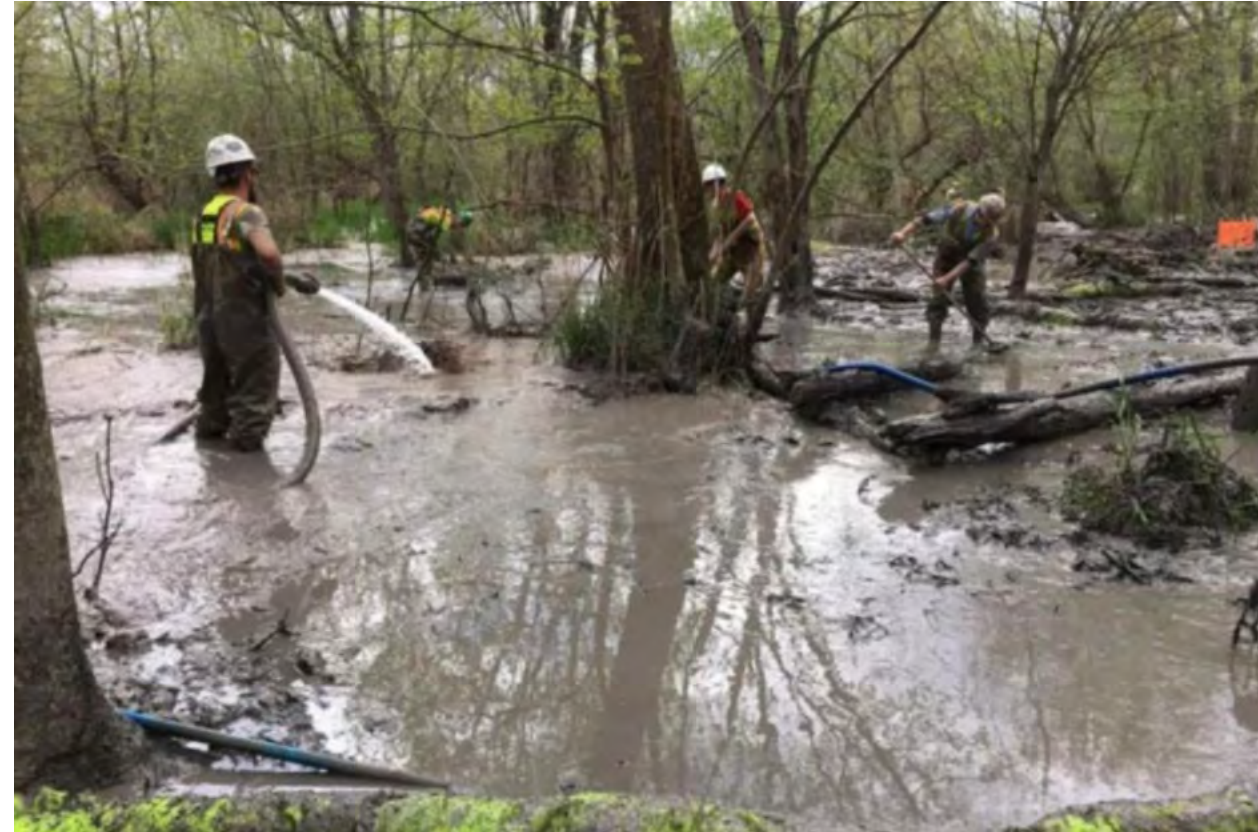
Will Affect Letter, Figure 3. Source: EPA, 2017. HDD inadvertent release – Tuscarawas River, Ohio.

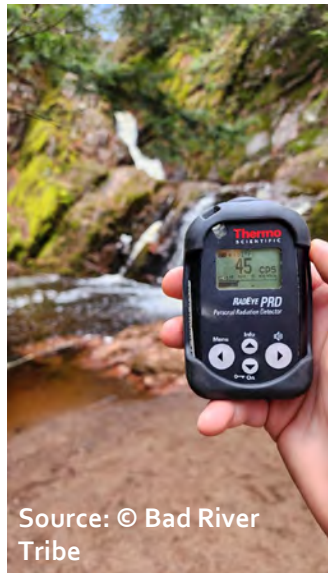
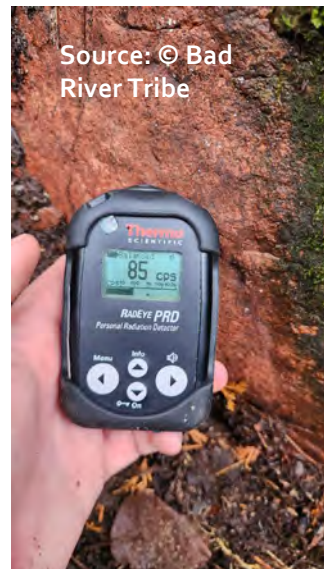
These photos of radiation readings were taken at Morgan Falls which is part of the Mellen Intrusive complex.

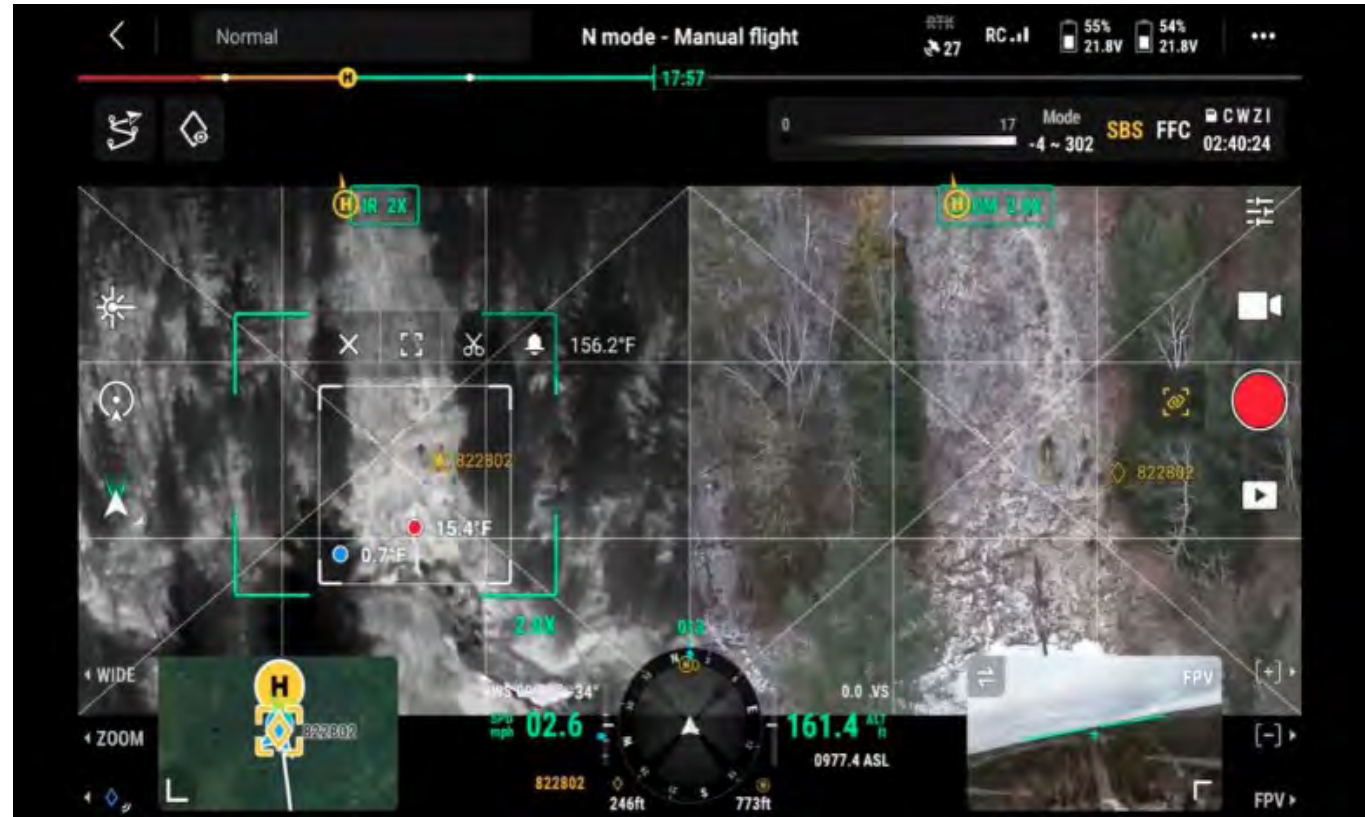
Screenshot from a drone flight over an exposed natural gas pipeline on Reservation, showing both an aerial and white-hot thermal image side-by-side. Thermal imaging is showing a temperature difference between the pipeline and the surrounding area. (Bad River Tribe, Will Affect Letter, Figure 13)
