Wetland No Points Index									
County	Feature ID	Survey Map Page	Datasheet Part Number						
Ashland	noasa1005	9	1						
Ashland	noasa1006	20, 21	3						
Ashland	noasa1007	20, 21	3						
Ashland	noasb1001	20	3						
Ashland	noasc1001	19, 20	3						
Ashland	noasc1002	19	2						
Ashland	noasc1005	19	2						
Ashland	noasc1006	19	2						
Ashland	noasc1007	18	2						
Ashland	noasc1008	3	1						
Ashland	noasc1009	3	1						
Ashland	noasd1003	27	3						
Ashland	noasd1006	22	3						
Ashland	noasd1008	3	1						
Ashland	noasd1009	20, 21	3						
Ashland	noasd1011	11	2						
Ashland	noasd1013	19	2						
Ashland	noasd1014	19	2						
Ashland	noasd1015	16	2						
Ashland	noase1001	14	1						
Ashland	noase1005	15	2						
Ashland	noase1008	15	2						
Ashland	noase1009	15	2						
Ashland	noase1010	14	1						
Ashland	noase1011	24	3						
Ashland	noase1013	17	2						
Bayfield	nobad1001	1	1						
Iron	noirc1001	46	4						
Iron	noirc1003	42	4

Project/Site: Line 5 Reloc	ation Proiect	City/0	County: Ashland	Samplin	g Date: <u>2020-06-11</u>	
Applicant/Owner: Enbridge	•			State: Wisconsin Samp		
Investigator(s): EJO/JSW						
Landform (hillslope, terrace, etc.						
Subregion (LRR or MLRA): Nor	thcentral

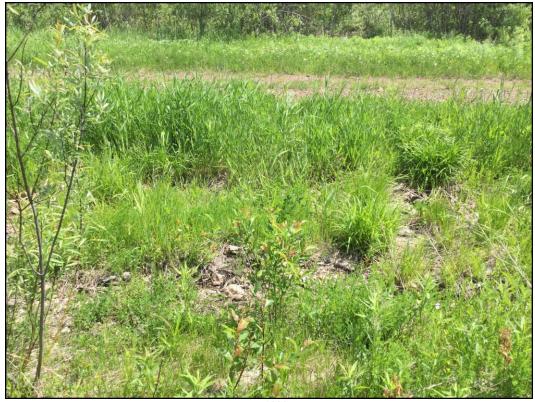
noasc1008_E

Wetland Hydrology Present?		No		d Site ID:		
Remarks: (Explain alternative			ii yes, optional wetian	d one ib.		
The sample was reco	orded in a dis	turbed ditch filled	d with cobble, co	ncrete, gravel, and	l logs.	
Scattered bulrushes,	sedges, reed	d canary grass, d	common tansy, a	nd weedy legumes	dominate the	
area. The ditch has t	wo compacte	ed, linear ruts tha	t appear to colle	ct water at times. T	he ditch	
appears to be part of	•					
		0 0,		J		
HYDROLOGY						
Wetland Hydrology Indicator	re:			Secondary Indicators (min	imum of two required)	
Primary Indicators (minimum o		book all that apply)		Surface Soil Cracks (E		
Surface Water (A1)		Water-Stained Leave	as (RQ)	Drainage Patterns (B1		
High Water Table (A2)		Aquatic Fauna (B13)		Moss Trim Lines (B16		
Saturation (A3)		Marl Deposits (B15)		Moss Trim Lines (B16) Dry-Season Water Table (C2)		
Water Marks (B1)		Hydrogen Sulfide Oc		Crayfish Burrows (C8)

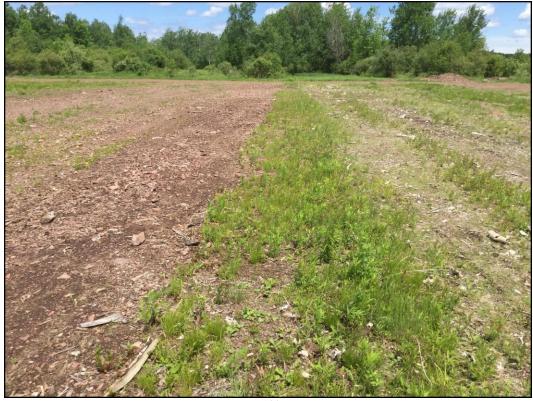
noasc1009_N

Project/Site: Line 5 Relocation Project City.	/County: <u>Ashland</u> Sampling Date: <u>2020-06-1</u> 1
•	State: Wisconsin Sampling Point: noasc1009
Investigator(s): <u>EJO/JSW</u> Sec	tion, Township, Range: <u>Sec 03 T047N R004W</u>
	elief (concave, convex, none): None Slope (%): 0-2%
	Long: <u>-90.855795</u> Datum: <u>WGS84</u>
Soil Map Unit Name: Udorthents and Udipsamments, cut	
Are climatic / hydrologic conditions on the site typical for this time of year?	
	urbed? Are "Normal Circumstances" present? Yes _ ✓ No
Are Vegetation, Soil, or Hydrology naturally probler	
SUMMARY OF FINDINGS – Attach site map showing sa	mpling point locations, transects, important features, etc.
Hydrophytic Vegetation Present? Yes No	Is the Sampled Area
Hydric Soil Present? Yes No	within a Wetland? Yes No
Wetland Hydrology Present? Yes No	If yes, optional Wetland Site ID:
Remarks: (Explain alternative procedures here or in a separate report.) The sample plot was recorded in a former lumber	vard mostly devoid of vegetation. Path rush

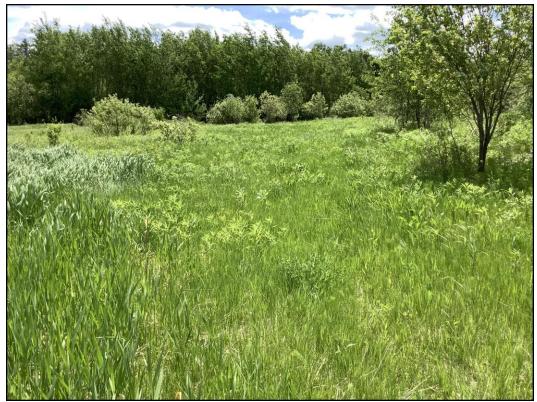
noasd1008_E

-	Mucky Mine Bleyed Matr			Depleted Dark S Redox Depressi		-7)			Floodplain Soils (F19) (MLRA 149B) dic (TA6) (MLRA 144A, 145, 149B)
-	Redox (S5)	(0 .)			0.10 (1.0)				t Material (F21)
	l Matrix (S6								ow Dark Surface (TF12)
Dark Su	rface (S7) (LRR R, N	ILRA 149E	3)				Other (Exp	lain in Remarks)
³ Indicators o	f hydrophyt	ic vegetat	ion and we	tland hydrology must	t be pres	ent. unles:	s disturbed	or problematic.	
Restrictive		-		a.ia iiyarelegy iiiae	. 50 p.00	,			
Type:									
Depth (in	ches):							Hydric Soil Pre	sent? Yes No <u>/</u>
Remarks:	,								
Soils thro	oughout	the pr	ofile ar	e a mixed mat	trix of	a brow	n clay a	and gray clay	loam. No indicators of
hydric so	oils were	obsei	ved.

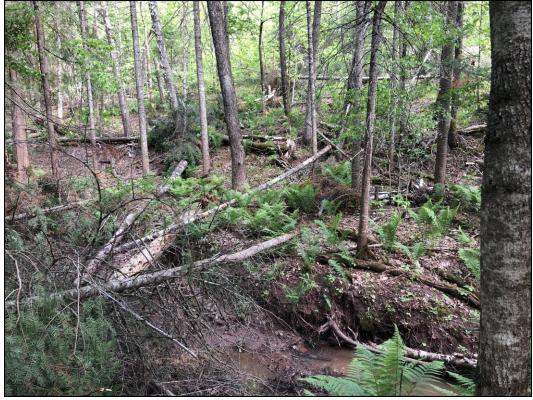
noasa1005_N

f hydrophytic vegetati Layer (if observed):	on and we	tiand nydrology musi	be prese	ent, unies:	s disturbed	or problematic.	
Type:								
Depth (in	ches):						Hydric Soil Present? Yes	No <u> </u>
Remarks:							<u> </u>	
No indica	ators of hydric	soil we	re observed.

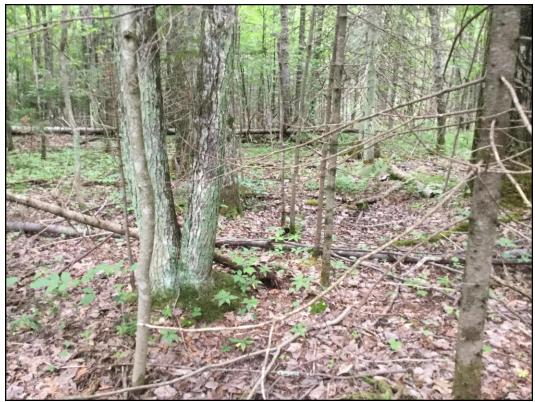
noasd1011_E

-	Matrix (S6))							v Dark Surface (TF12)	
	face (S7) (•	ILRA 1491	3)					nin in Remarks)	
3Indiantors of	h. dranh. #	ia va aatat	بيد امم مما	otland budralagu must	t ha nraa.	ant unlace	diaturbad	ar problematic		
Restrictive L		_		etland hydrology must	t be blest	ent, unies	disturbed	or problematic.		
Type:	``	,								
	:hes):							Hydric Soil Prese	ent? Yes No <u>/</u>	
Remarks:	,									
	orofile o	onsist	s of a r	eddish brown f	fine sa	andy lo	am ove	r a red fine sa	and. The profile is dry	
and no hy	ydric so	il indic	cators v	vere observed.

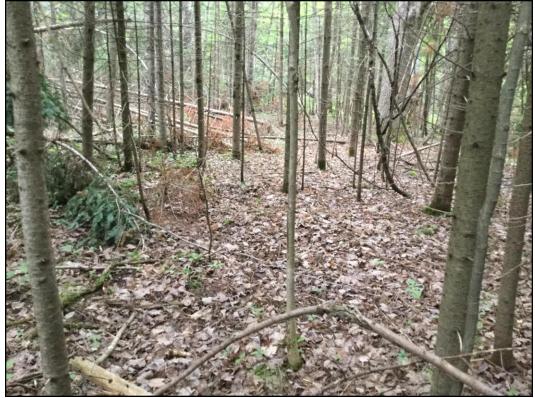
noasd1012_E

-	tedox (S5) Matrix (S6	3)							t Material (F21)	
	rface (S7)	,	LRA 149	3)				Very Shallow Dark Surface (TF12) Other (Explain in Remarks)		
Restrictive I			on and we	etland hydrology must	t be pres	ent, unless	s disturbed	or problematic.		
Type:		,.								
Depth (inc	ches):							Hydric Soil Present? Yes No		
Remarks:										
		consists	of a c	lark loam over	two re	eddish	brown	clay layers. I	No hydric soil indicators	
were obs	served.

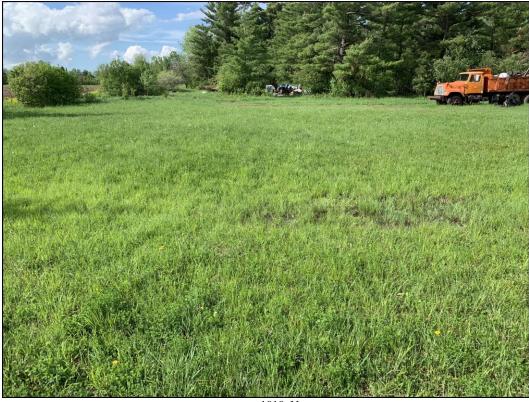
noase1010_N

-	Mucky Mineral (S1) Gleyed Matrix (S4)		Depleted Dark S Redox Depressi		- 7)			loodplain Soils (F19) (MLRA 149B) ic (TA6) (MLRA 144A, 145, 149B)
-	Redox (S5)	•	Redox Depressi	0113 (1 0)				Material (F21)
	d Matrix (S6)		_					w Dark Surface (TF12)
Dark Su	urface (S7) (LRR R, N	ILRA 149B)				Other (Expl	ain in Remarks)
	of hydrophytic vegetat		land hydrology must	t be pres	ent, unless	s disturbed	or problematic.	
	Layer (if observed):							
Type:							Hudria Sail Draa	ont? You No ./
Depth (in	nches):		<u></u>				nyaric Soil Fres	ent? Yes No
Remarks:	beneath dark	clay lo	am. No redox	ohser	ved			
Trou day	bonoan aan	ciay io	am. 110 1000x	00001	voa.

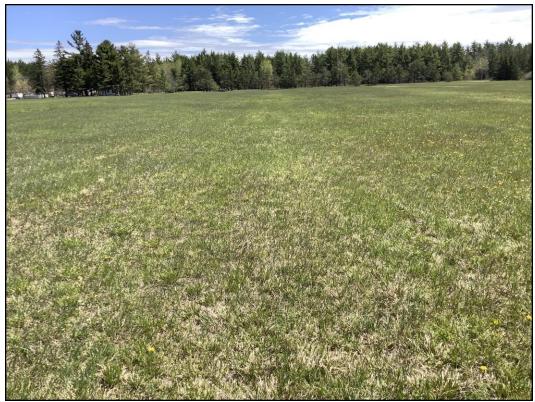
noase1001_E

-	Mucky Mineral (S1 Gleyed Matrix (S4)		Depleted Dark S Redox Depress		-7)			Floodplain Soils (F19) (MLRA 149B) dic (TA6) (MLRA 144A, 145, 149B)
-	Redox (S5)		Redex Deprese	10110 (1 0)				t Material (F21)
	d Matrix (S6)							ow Dark Surface (TF12)
Dark Su	ırface (S7) (LRR F	R, MLRA 149E	3)				Other (Exp	lain in Remarks)
³ Indicators o	of hydrophytic vege	etation and we	tland hydrology mus	t be pres	ent, unless	s disturbed	or problematic.	
Restrictive	Layer (if observe	d):						
Type:								
Depth (in	ches):						Hydric Soil Pres	sent? Yes No/
Remarks:						NI-		diantanaaa ah aan ad
The soil	profile consi	sts of a d	ark clay loam	over a	a rea ci	ay. No	nyarıc soli in	dicators were observed.

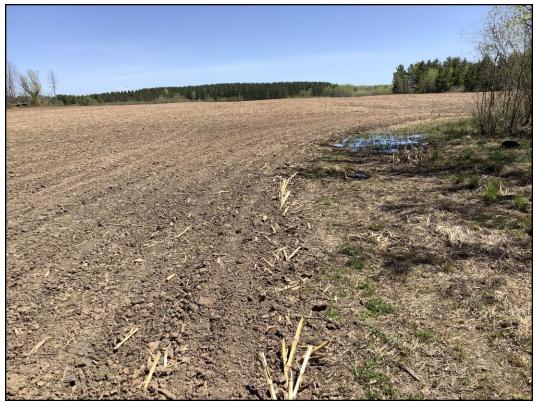
noase1005_E

• •		•		-			x Dark Surface was		
observed	d. The profile c	onsist	s of clay soils \	with a	mixed	lower la	ayer.

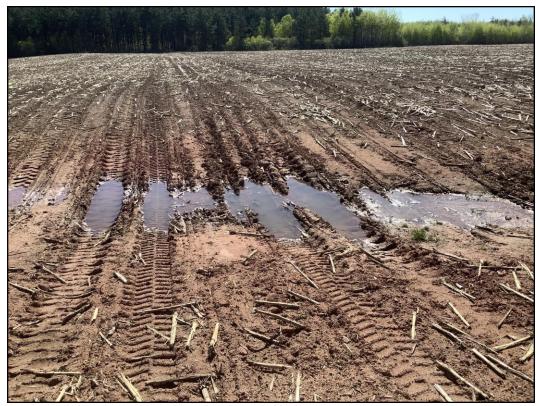
noase1008_E

-	Redox (S5)	x (34)		Redux Deplessi	0115 (F6)			Red Parent Material (F21)				
-	Matrix (S6)								Very Shallow Dark Surface (TF12)			
Dark Su	rface (S7) (I	LRR R, N	ILRA 149E	B)				Other (Expla	ain in Remarks)			
³ Indicators o	f hydrophytic	c vegetat	ion and we	tland hydrology mus	t he pres	ent unless	s disturbed	or problematic				
Restrictive			ion and we	mana nyarology mao	. 50 proo	ont, amou	o alotarboa	- Problematic.				
Type:												
Depth (in	ches):							Hydric Soil Pres	ent? Yes No <u>/</u>			
Remarks:								1				
						andy c	lay. Alt	hough the pro	ofile is saturated at the			
surface,	no hydri	c soil	indicate	ors were obse	rved.

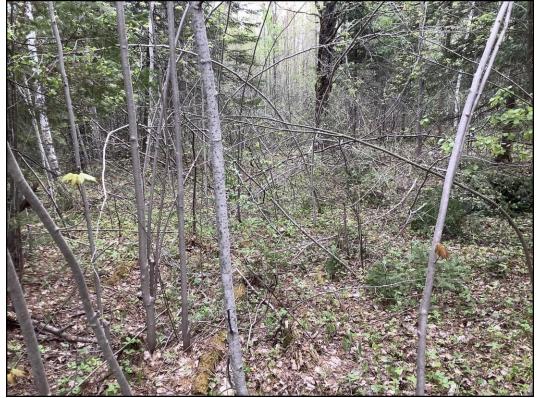
noase1009_NE

-	Gleyed Matrix (S4) Redox (S5)		Redox Depressi	ons (F8)				lic (TA6) (MLRA 144A, 145, 149B) Material (F21)
-	d Matrix (S6)							w Dark Surface (TF12)
Dark Su	ırface (S7) (LRR R, N	ILRA 149B)				Other (Expl	ain in Remarks)
³ Indicators o	of hydrophytic vegetat	ion and we	tland hydrology mus	t be pres	ent, unless	s disturbed	or problematic.	
Restrictive	Layer (if observed):							
Type:							Hardela Oall Day	
Depth (in	ches):						Hydric Soil Pres	sent? Yes No
Remarks:	nrofile consist	s of a da	ark loam over	a red	clay N	Jo hvdri	c soil indicat	ors were observed.
1110 0011	promo concion	0 01 a a	anticam over	u iou	olay. I	io nyan	o con maioat	010 11010 000011001

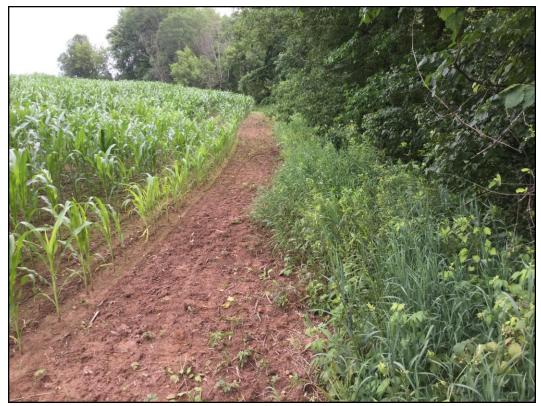
noasd1015_E

Sandy Redox (33) Stripped Matrix (S6)					ow Dark Surface (TF12)
Dark Surface (S7) (LRR R, MLRA 1	49B)				lain in Remarks)
2					
³ Indicators of hydrophytic vegetation and Restrictive Layer (if observed):	wetland hydrology mus	t be present,	unless disturb	ed or problematic.	
Type:					
				Hydric Soil Pre	sent? Yes No/
Depth (inches):				Tryunc 3011 re	Sent: 1es NO
Remarks: The soil profile consists of a	uniform dry los	my cano	Ī		
	d dillioitii diy loe	iiiy Sanc	l •

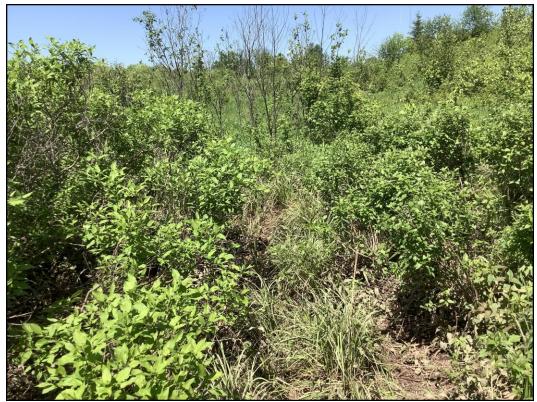
noase1013_N

-			rown clay loar	n thro	ughout	with no	o redox fea	tures. No hydric soil	
indicator	s were ob	serve	ed.

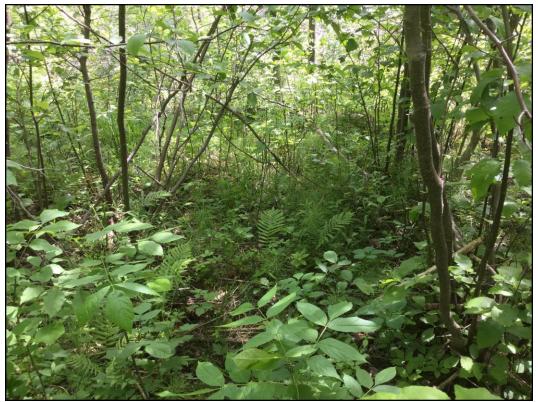
noasc1007_E

Redox (S5)							rent Material (F21)
	d Matrix (S6) urface (S7) (LRR R, M	LRA 149	В)					allow Dark Surface (TF12) explain in Remarks)
	of hydrophytic vegetati	on and w	etland hydrology mus	st be pres	ent, unles	s disturbed	or problematic.	
	Layer (if observed):							
Type:							Hydric Soil B	resent? Yes No/
Depth (in Remarks:	ches):						Tryunc 30111	resent: res No
	re observed to	be cla	y loam over c	lay. No	hydrid	soil ind	dicators we	ere observed.

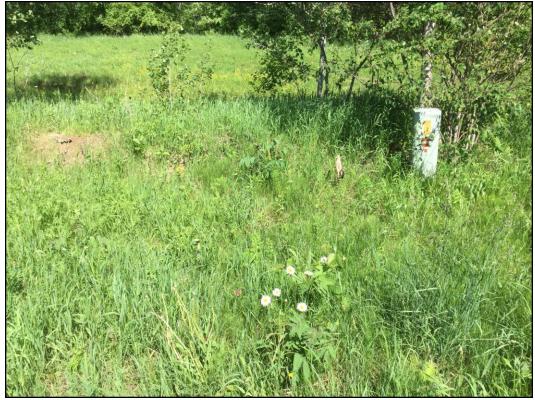
noasc1005_E

(includes capillary fringe)									
Describe Recorded Data (stream gauge, monitoring well, aerial photos, p	revious inspections), if available:								
Remarks:									
No primary indicators of wetland hydrology were	observed.

Restrictive Layer (if observed):						
Type:					Hydric Soil Prese	ent? Yes No
Remarks: Soils were not sampled due utilities. The dominant veget

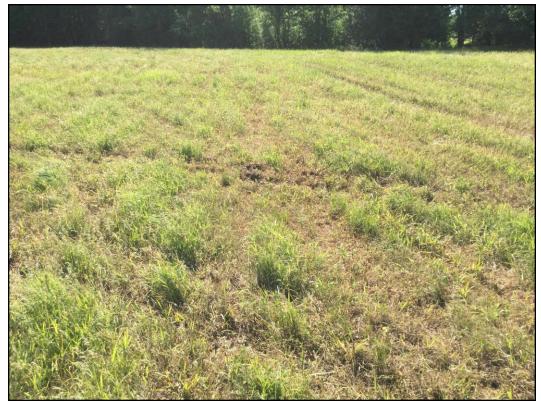
noasc1006_E

-	Gleyed Matrix (S4)		Redox	Depress	ions (F8)						
-	Redox (S5) I Matrix (S6)								arent Materiai (F21) Shallow Dark Surface (TF12)		
	rface (S7) (LRR R, M	LRA 149	B)						(Explain in Remarks)		
³ Indicators o	f hydrophytic vegetation	on and w	etland hydro	ology mus	st be prese	ent, unles	s disturbed	I or problemation	. .		
	Layer (if observed):				<u> </u>	<u> </u>		<u> </u>			
Type:											
	ches):							Hydric Soil	Present? Yes No		
Remarks:	ators of hydric	soil wa	ara ohea	rved							
INO IIIGICA	ators of flydric	SOII W	ore onse	orveu.

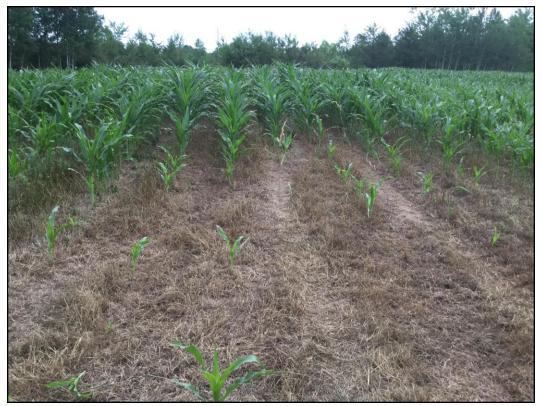
noasd1013_E

-		tland hydrology mus	t be pres	ent, unless	disturbed	or problematic.			
Restrictive	Layer (if ob	served):									
Type:											
Depth (in	ches):							Hydric Soil Pre	esent? Yes No		
Remarks:	nrofilo o	anaiat	o of two	lovers of red	diah h	rown o	lov. No	budrio goil in	adiantara wara abaamad		
The Son	prome c	OHSISI	S OI LWC	layers or red	นเรท ม	IOWII C	ay. No	riyaric son n	ndicators were observed.

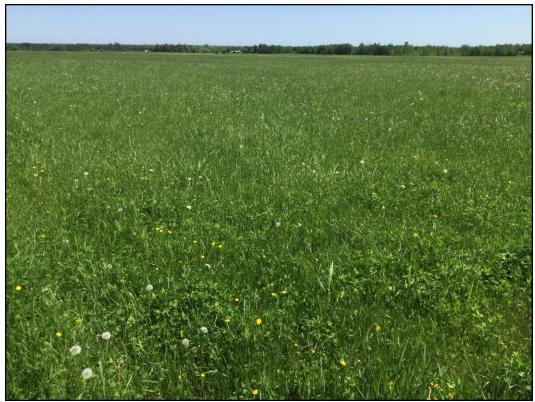
noasc1002_NE

-	Gleyed Matrix (S4)		Redox	Depress	ions (F8)			Mesic Spodic (TA6) (MLRA 144A, 145, 149B)			
-	Redox (S5) d Matrix (S6)							Red Parent Material (F21) Very Shallow Dark Surface (TF12)			
	urface (S7) (LRR R, M	LRA 149	3)					Other (Explain in Remarks)			
³ Indicators o	of hydrophytic vegetati	on and w	etland hydro	ology mus	t be prese	ent, unles	s disturbed	or problematic			
	Layer (if observed):		, , , , , , , , , , , , , , , , , , ,	3,		-, -		1			
Type:											
	ches):							Hydric Soil	Present? Yes No		
Remarks:	ators of hydric	coil w	oro obse	nyod							
INO IIIGIC	ators of flydric	SOII W	FIE ODS	siveu.

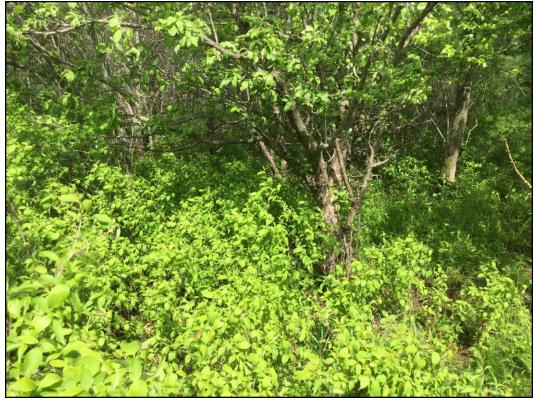
noasc1001_E

Restrictive Layer (if observed): Type: Depth (inches):					Hydric Soil Prese	ent? Yes No
Remarks: Soils were not sampled due utilities. Soils are likely nonare mapped as Portwing-He	hydric based or	n the la	ndsca	oe posi	tion and domi	nant vegetation. Soils

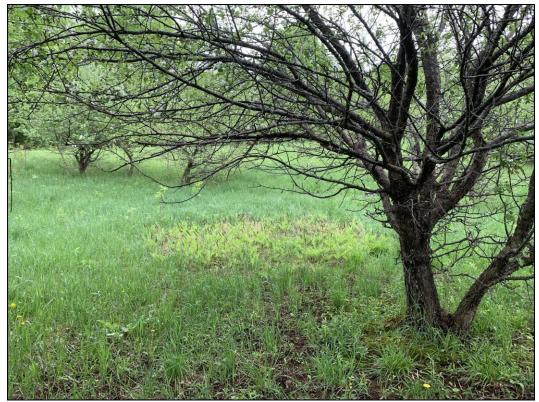
noasb1001_E

-	d Matrix (S6)								nallow Dark Surface (TF12)
	ırface (S7) (LRR R, N	ILRA 149	3)						Explain in Remarks)
31	f hduambtiaaatat			l = =					
	f hydrophytic vegetat Layer (if observed):	ion and w	etiana nyaro	logy mus	t be prese	ent, unies:	s disturbed	or problematic.	
Type:									
	ches):							Hydric Soil F	Present? Yes No/
Remarks:									
Does no	t meet Redox	Dark S	urface.

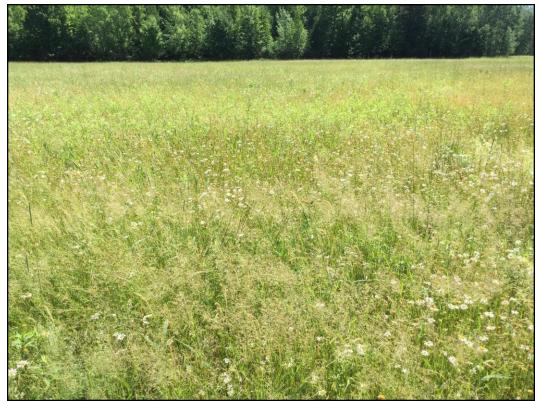
noasd1009_E

Dark ou	111400 (07) (_	LIVA 143	٥,					Other (Explain in remains)
		-	on and w	etland hydro	ology mus	t be prese	ent, unles	s disturbed	or problematic	
Restrictive	Layer (if ob	served):								
Type:										
	ches):								Hydric Soil	Present? Yes No/
Remarks:	(1)							D . I.		Control of the control
										tions were observed
througho	out the p	rone, i	out no	nyaric s	soii ina	icators	were	observe	ea.

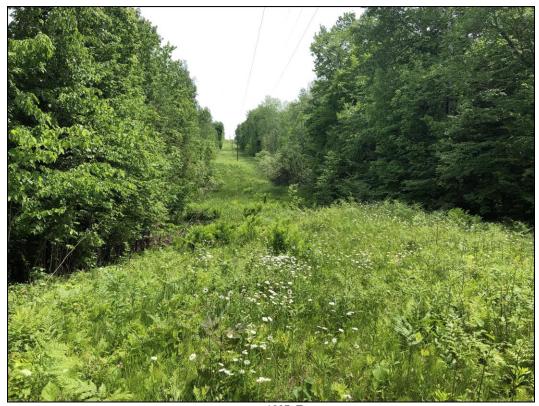
noasa1007_E

Туре:	yer (if observed):						Hydric Soil Prose	ent? Yes No	
	es):						Trydile doll i lest	JIII. 163 NO	
							vithin 100 ft. S	Soils are assumed to be c indicators.

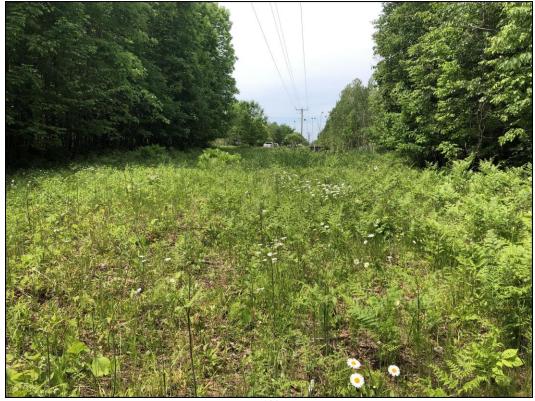
noasa1007_W

Saturation Present? (includes capillary fringe)	Yes No		_ Depth (inches):		Wetland Hy	drology Present?	Yes	No <u>~</u>	
Describe Recorded Data (st	ream daude moni	toring	well aerial photos pre	vious inspec	tions) if avail:	ahle.			
Describe Resorded Data (St	cam gaage, mom	toring	won, acriai priotos, pre	Wiodo iliopeo	tionoj, ii avaii	abio.			
Remarks:									
No indicators of we	tland hydrol	ogy '	were observed						
Î.								J

-	Gleyed Matrix (S4)		Redox Depressi		.,			(TA6) (MLRA 144A, 145, 149B)
-	ledox (S5)						Red Parent Ma	
	Matrix (S6) rface (S7) (LRR R, M	LRA 149B)				Other (Explain	Dark Surface (TF12) in Remarks)
	f hydrophytic vegetati	on and we	tland hydrology musi	t be prese	ent, unles:	s disturbed	or problematic.	
	_ayer (if observed):							
Type:	- L V						Hydric Soil Presen	t? Yes No_ <u>⊬</u> _
Remarks:	ches):						Tryuno con ricocn	100 <u> </u>
	ators of hydric	soils w	ere observed.					
	,

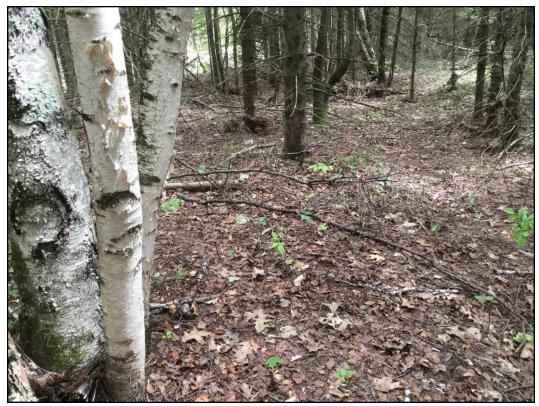
noasd1006_E

f hydrophytic vegetati Layer (if observed):	on and wetla	and hydrology must be present, unless disturbe	d or problematic.	
Type: <u>C</u>					
	ches): <u>4.0</u>		_	Hydric Soil Present?	Yes No <u>/</u>
Remarks:		s were c	observed in the upper 4 inches.

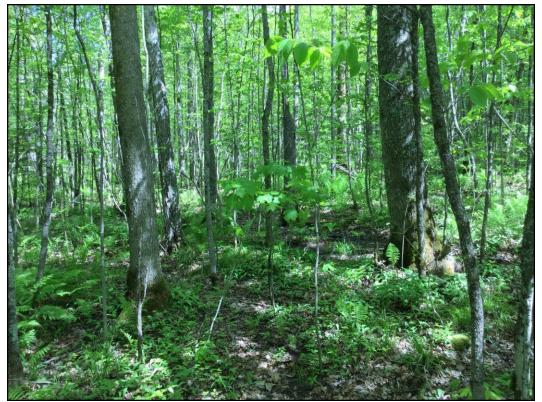
noasd1003_E

-	Gleyed Matrix (S4)	-	Redox Depressi		,			odic (TA6) (MLRA 144A, 145, 149B)
-	Redox (S5)							nt Material (F21)
	l Matrix (S6) rface (S7) (LRR R, N	U DA 440B						low Dark Surface (TF12) plain in Remarks)
Dark Su	nace (S7) (LKK K, IV	ILKA 149D	1				Office (Ex	piairi iri Kemarks)
	f hydrophytic vegetat		land hydrology must	t be prese	ent, unless	s disturbed	or problematic.	
	Layer (if observed):							
Type: Bo								
	ches): <u>10.0</u>						Hydric Soil Pro	esent? Yes No <u>/</u>
Remarks:	!! !!!		- l					
No nyari	c soil indicator	s were	observea.

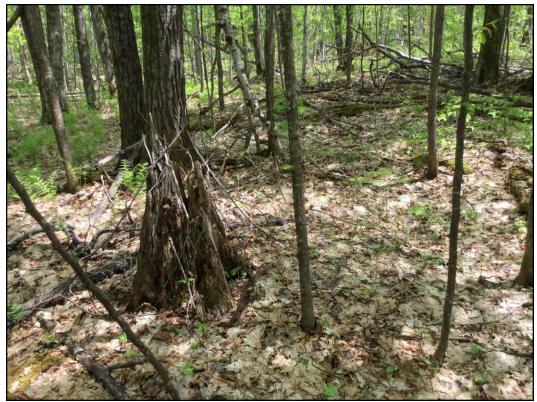
noird1001_E

Remarks: (Explain alternative The area is a mappe surrounding wetland seepage.	ed NWI polygor	n that does not r	•		-		
HYDROLOGY Wetland Hydrology Indicate	ors:			Secondary Indicato	ors (minimum of two required)		
Primary Indicators (minimum	of one is required; che	eck all that apply)		Surface Soil C	racks (B6)		
Surface Water (A1)	_	_ Water-Stained Leave			Drainage Patterns (B10)		
High Water Table (A2)		_ Aquatic Fauna (B13)			Moss Trim Lines (B16)		
Saturation (A3)		_ Marl Deposits (B15)		· · · · · · · · · · · · · · · · · · ·	/ater Table (C2)		
Water Marks (B1)		_ Hydrogen Sulfide Od		Crayfish Burro			
Sediment Deposits (B2)		_ Oxidized Rhizosphere			(C3) Saturation Visible on Aerial Imagery (C9) Stunted or Stressed Plants (D1)		
Drift Deposits (B3) Algal Mat or Crust (B4)		Presence of ReducedRecent Iron Reductio					
Iron Deposits (B5)		Thin Muck Surface (C		Shallow Aquita			
Inundation Visible on Aer		_ Other (Explain in Ren	•	Microtopograp

Dark Sur	rface (S7) (LRR R, M	ILRA 149B)		Other (Ex	xplain in Remarks)	
³ Indicators of	hvdrophytic vegetati	ion and wetl	and hydrology must be present, unless disturbed	or problematic		
	_ayer (if observed):		ana nyarangy maerizo procesn, ameeo aletaizea			
Type:			<u></u>			
Depth (inc	ches):		<u></u>	Hydric Soil Pi	resent? Yes No/	
Remarks:				1		
No hydrid	c soil indicator	s were o	observed.

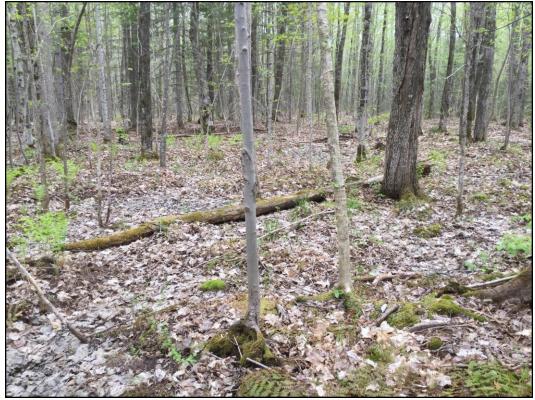
noirc1006_E

Postrictive Laver (if observed):
Type: <u>Cobble</u> Depth (inches): 18.0 Hydric Soil Present? Yes No _ ✓
Depth (inches): 18.0 Hydric Soil Present? Yes No Remarks:
No indicators of hydric soils observed.

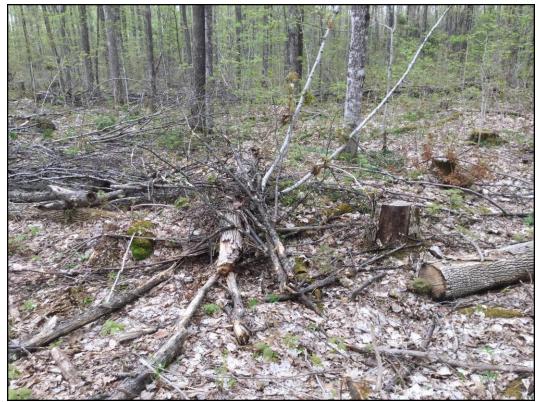
noirc1005_NE

-	Mucky Mineral (S1) Gleyed Matrix (S4)	_	Depleted Dark Surface (FRedox Depressions (F8)	7)	Piedmont Floodplain Soils (F19) (MLRA 1498		
	Redox (S5)	_	Redox Depressions (Fo)		Mesic Spodic (TA6) (MLRA 144A, 145, 145, 145, 145, 145, 145, 145, 145		
	d Matrix (S6)				Very Shallow Dark Surface (TF12)		
Dark Su	ırface (S7) (LRR R, N	/ILRA 149B)			Other (Explain	in Remarks)	
			and hydrology must be prese	ent, unless disturbed	or problematic.		
	Layer (if observed):						
Туре: <u>С</u>			<u> </u>		Undria Sail Brasant	2 Van Na v	
	ches): <u>16.0</u>		<u> </u>		Hydric Soil Present	? Yes No <u>/</u>	
Remarks:	c soil indicator	rs observ	ved				
140 Hyan		00001	vou.

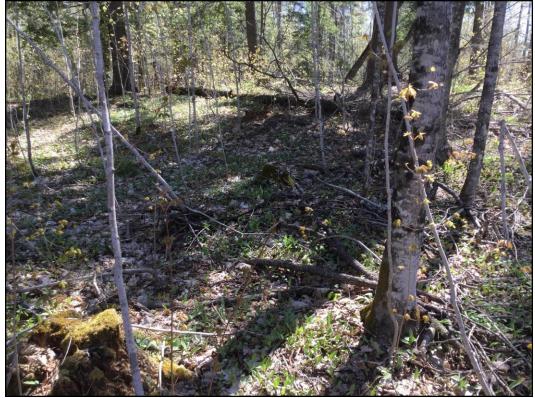
noirc1004_E

Feature is a mesic hardwood forest domin		ole and vellow birch in canopy and			
yellow trout lily in ground layer. Sample re	, , ,	• • • • • • • • • • • • • • • • • • • •			
Hardwood swamp occurs downslope of sa					
HYDROLOGY					
Wetland Hydrology Indicators:		Secondary Indicators (minimum of two required)			
Primary Indicators (minimum of one is required; check all that		Surface Soil Cracks (B6)			
	tained Leaves (B9)	Drainage Patterns (B10)			
	Fauna (B13)	Moss Trim Lines (B16) Dry-Season Water Table (C2)			
	en Sulfide Odor (C1)	Crayfish Burrows (C8)			
	Rhizospheres on Living Ro				
	e of Reduced Iron (C4)	Stunted or Stressed Plants (D1)			
	ron Reduction in Tilled Soils				
	ck Surface (C7)	Shallow Aquitard (D3)			
	explain in Remarks)	Microtopographic Relief (D4)			
Sparsely Vegetated Concave Surface (B8)	FAC-Neutral Test (D5)				
Field Observations:					
Surface Water Present? Yes No _ ✓ _ Depth (inches):

-	d Below Dark Surfac ark Surface (A12)	e (A11) _	Depleted Matrix (F3) Redox Dark Surface (F6)		k Surface (S9) (LRR K, L) ganese Masses (F12) (LRR K, L, R)			
	Mucky Mineral (S1)	-	Depleted Dark Surface (F7)		t Floodplain Soils (F19) (MLRA 149B)			
	Gleyed Matrix (S4)	_	_ Redox Depressions (F8)	Mesic Spodic (TA6) (MLRA 144A, 145, 149B)				
	Redox (S5) I Matrix (S6)			Red Parent Material (F21) Very Shallow Dark Surface (TF12)				
	rface (S7) (LRR R, I	MLRA 149B)		Other (Explain in Remarks)				
³ Indicators o	f hydrophytic yeaeta	tion and wetl	and hydrology must be present, unless disturbed	or problematic.				
	Layer (if observed):			1				
Туре: <u>сс</u>	bble		<u> </u>					
	ches): <u>16.0</u>		_	Hydric Soil Pr	resent? Yes No/			
Remarks:	c soils observ	od						
ino riyuri	c solis observ	eu.						
					!

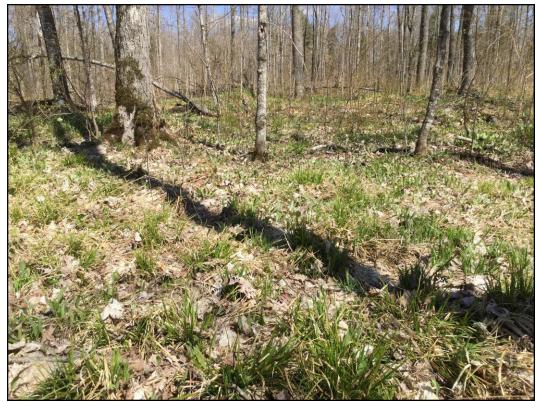
noirc1003_E

-	Eleyed Matri	x (S4)		Redox	d Depress	ions (F8)			Mesic Spodic (TA6) (MLRA 144A, 145, 149B)				
-	Redox (S5) I Matrix (S6))							Red Parent Material (F21) Very Shallow Dark Surface (TF12)				
	rface (S7) (ILRA 1491	3)					Other (Explain in Remarks)				
³ Indicators o	f hydrophyti	c vegetat	ion and we	etland hydro	ology mus	st be prese	ent, unles	s disturbed	or problemati	c.			
Restrictive	Layer (if ob	served):											
Type:													
	ches):								Hydric Soi	I Present? Yes No			
Remarks: No hydri	c soil ind	dicator	s ohse	rved									
140 Hyan	0 0011 1110	aloutoi	3 0030	i voa.

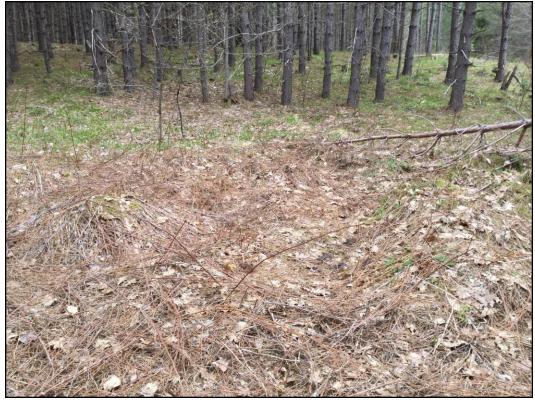
noirc1001_E

Field Observations: Surface Water Present?	Ves No	,	Depth (inches):						
Water Table Present?			Depth (inches):						
Saturation Present?			Depth (inches):		Wetland F	lydrology Present?	Yes	No 🗸	
(includes capillary fringe)									
Describe Recorded Data (str	eam gauge, monito	ring v	well, aerial photos, pre	vious inspec	tions), if ava	iilable:			
Remarks:									
No indicators of we	tland hydrolog	gy c	observed.
