Regulatory File No. MVP-2007-00060-BBY

MEMORANDUM FOR RECORD

SUBJECT: US Army Corps of Engineers (Corps) Approved Jurisdictional Determination in accordance with the "Revised Definition of 'Waters of the United States'"; (88 FR 3004 (January 18, 2023) as amended by the "Revised Definition of 'Waters of the United States'; Conforming" (8 September 2023) ,¹ MVP-2007-00060-BBY MFR 1 of 1².

O'Neil Property 101st Avenue AJD Site Visit (11/6/2024) – Private Ditch and County Ditch 17 (Springbrook Creek) Investigation

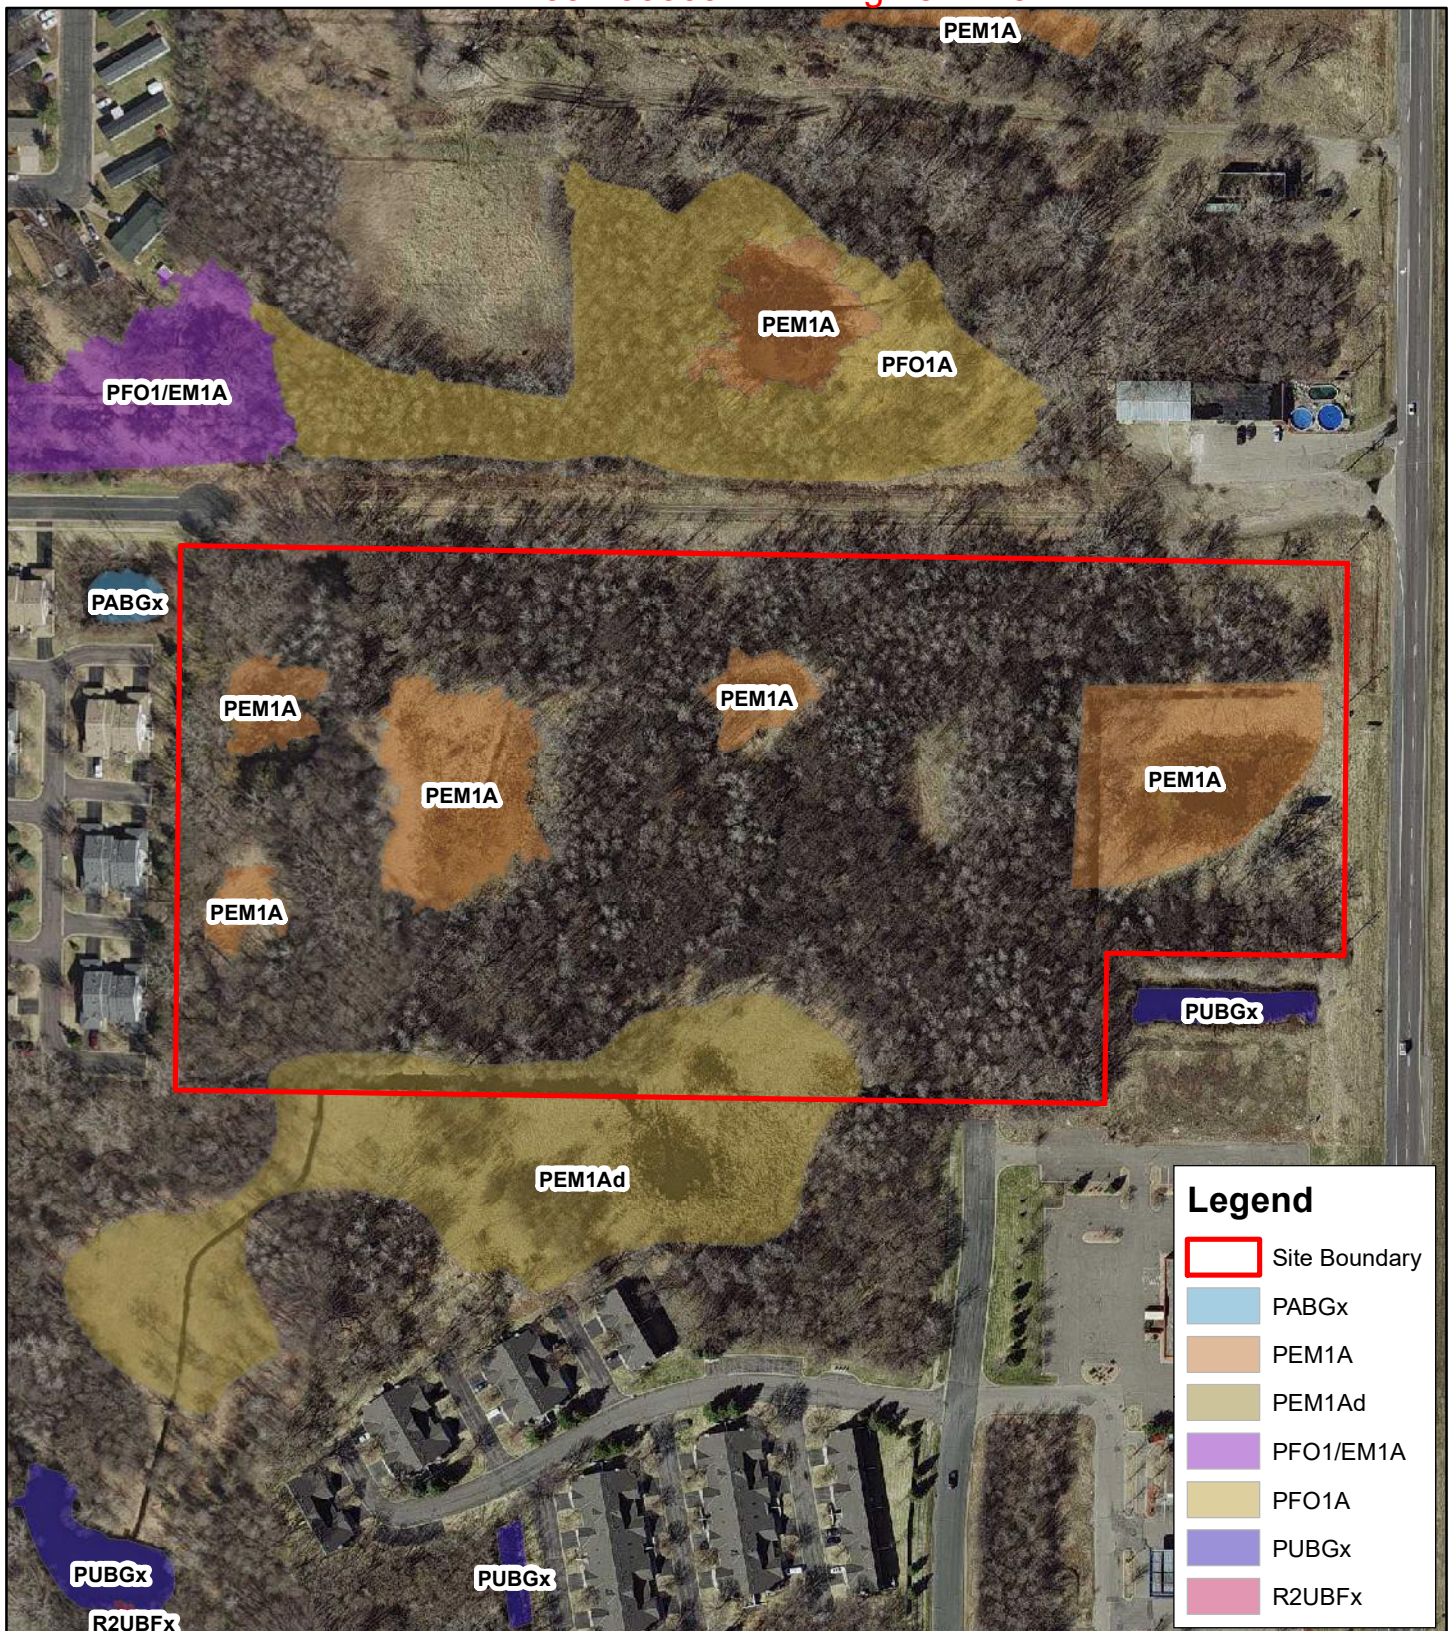
Figure 3 - National Wetlands Inventory

The National Wetland Inventory (NWI) has mapped Wetlands 3, 5, and 6 as a palustrine emergent, persistent, seasonally flooded, but does not denote a continuous surface connection to another aquatic resource. Wetland 7 is not mapped on the NWI. Aerial imagery and 2-foot LiDAR contours also support that Wetlands 3, 5, 6, and 7 are depressional basins with no continuous surface connection to another aquatic resource. Additionally, a field visit was conducted on October 1, 2024, and I walked the entire perimeter of Wetlands 3, 5, 6 and 7 and found no outlets or inlets. Given the information above, Wetlands 3, 4, 6, and 7 do not have a continuous surface connection to any surrounding aquatic resource.

The National Wetland Inventory (NWI) has mapped Wetland 4 as a palustrine emergent, persistent, seasonally flooded, but does not denote a continuous surface connection to another aquatic resource. Aerial imagery and 2-foot LiDAR contours also support that Wetland 4 is a depressional basins with no continuous surface connection to another aquatic resource. A remnant ditch is noticeable using LIDAR hillshade. This remnant ditch appears to provide a continuous surface connection from Wetland 4 to a Ditch D2, located south of Wetland 4. A field visit was conducted on October 1, 2024, and I walked the remnant ditch from Ditch D2 to Wetland 4 (see attached 20241001 Site Visit MFR). A low spot through the berm bordering the north side of Ditch D2 was observed at the location where the remnant ditch could enter Ditch D2, but this low spot was filled with dense vegetation with no signs of a discrete channel and no indicators of flow or erosion. The site visit also indicated that there was no discrete channel or indicators of erosion or flow in the portion of the remnant ditch immediately north of the berm. This area was filled with dense vegetation, comprised primarily of buckthorn. The only portion of remnant ditch that resembled a continuous surface connection started approximately 50 feet south of Wetland 4, extending towards Wetland 4. This area was sparsely vegetated indicating some ponding had occurred. That said, there was no indications that surface water flow was leaving Wetland 4 towards Ditch D2, rather than flowing into the Wetland 4. Additionally, this potential continuous surface connection only extended approximately 50 feet south from Wetland 4 towards Ditch D2 and Ditch D2 is approximately 200 feet south of Wetland 4. Given the information above, Wetland 4 does not have a continuous surface connection to any surrounding aquatic resource.

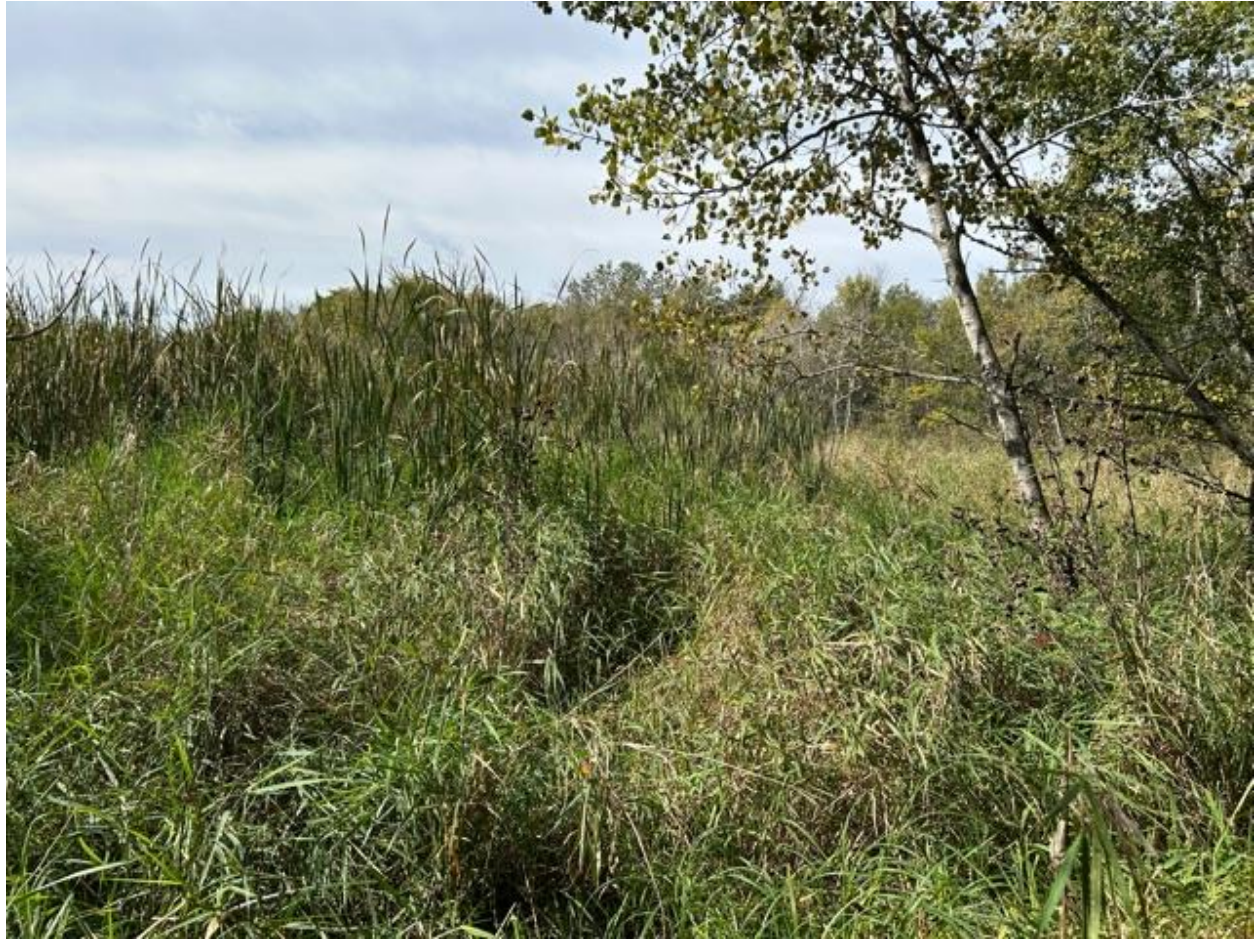
This photo above and below were taken at the location where tributary Ditch D1 enters Wetland 2. Wetland WL2 appears to have more hydrology than Wetland 1, and is dominated by cattail.

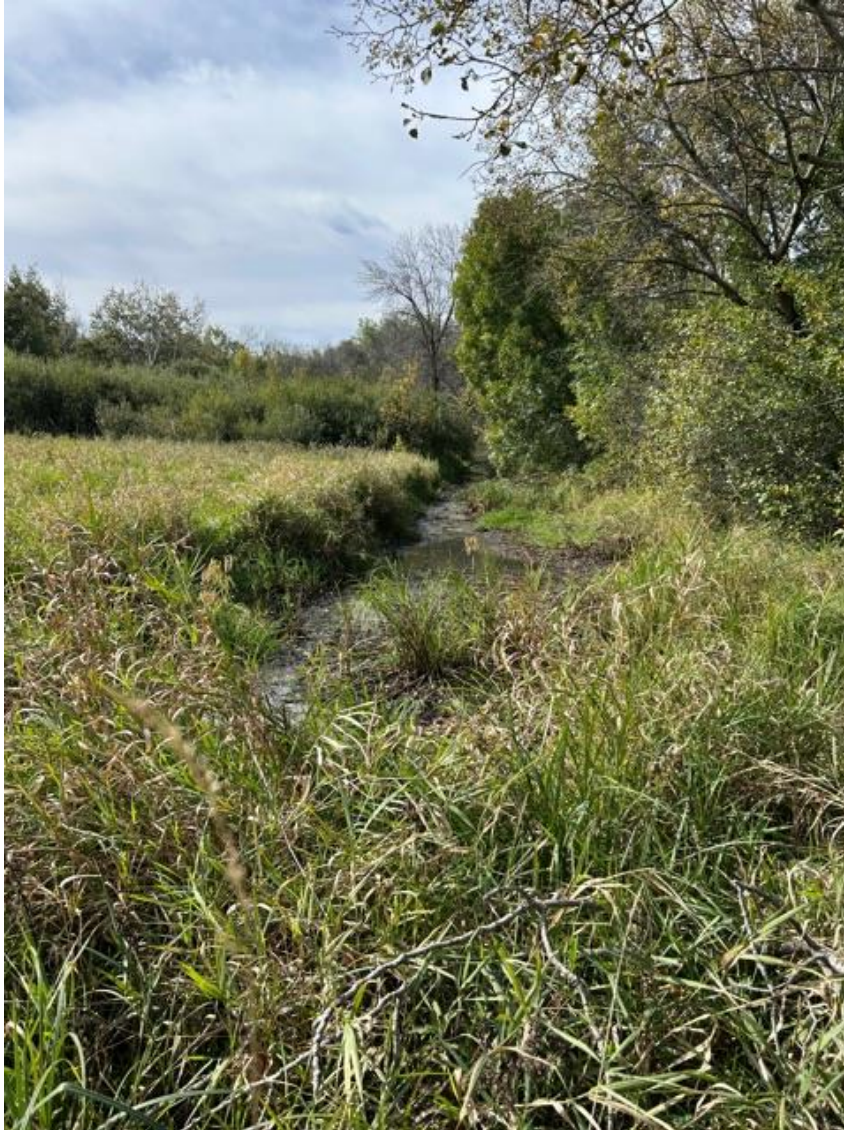
Photo was taken at the location where Wetland 2 and tributary Ditch D2 meet, facing west. Water was observed in Ditch D2 at the time of the site visit. There was a large spoil pile north of Ditch D2.

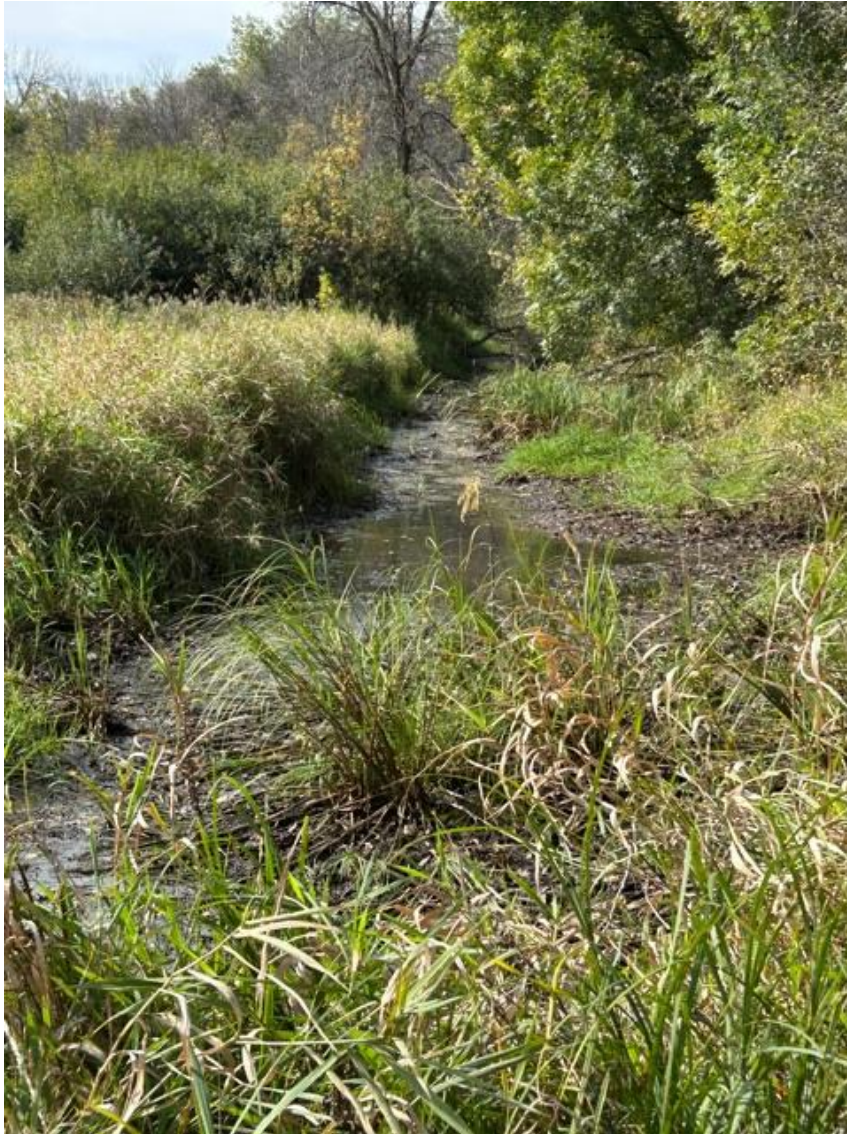
Photo (above) was taken at the location where Wetland 2 and Ditch D2 meet, facing west. Water was observed in Ditch D2 at the time of the site visit. There was a large spoil pile north of Ditch D2.

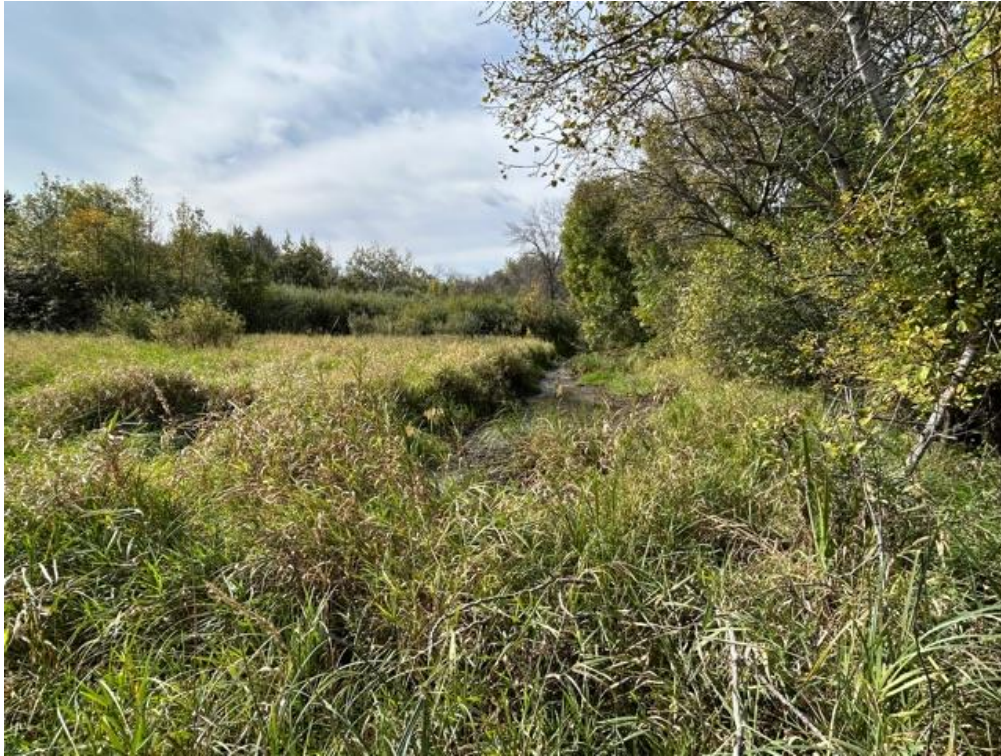
Photo was taken at the location where Wetland 2 and Ditch D2 meet, facing west. Water was observed in Ditch D2 at the time of the site visit. There was a large spoil pile north of Ditch D2.

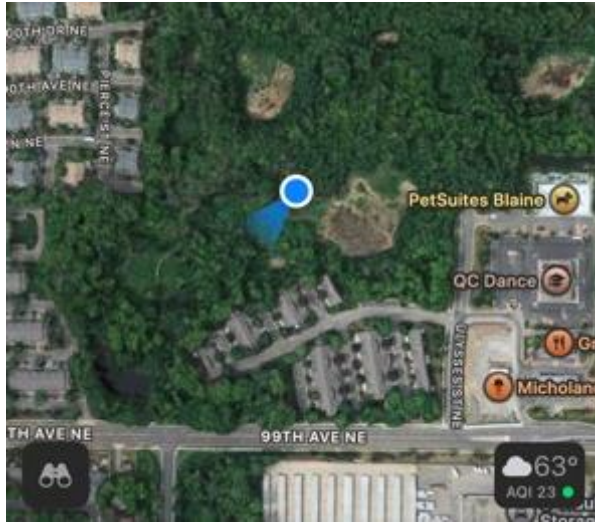
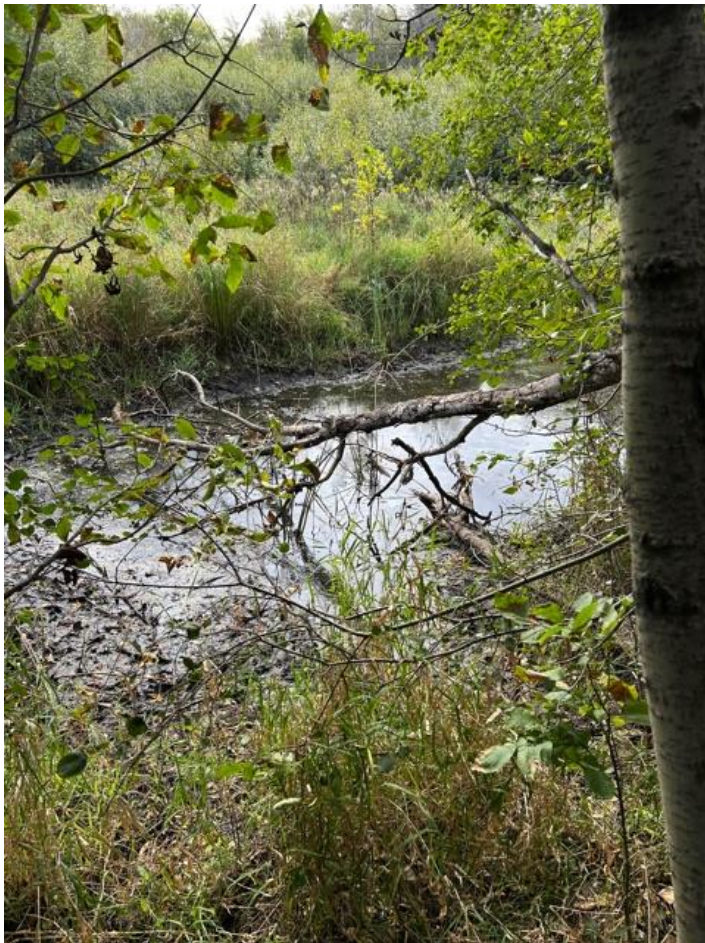
Surface water observed at the time of the site visit in Ditch D2 with small amounts of flow moving downstream (west). Much of the surface water was ponded with water observed moving between the ponded areas. The berm north of Ditch D2 is 4-5 feet tall in some areas.

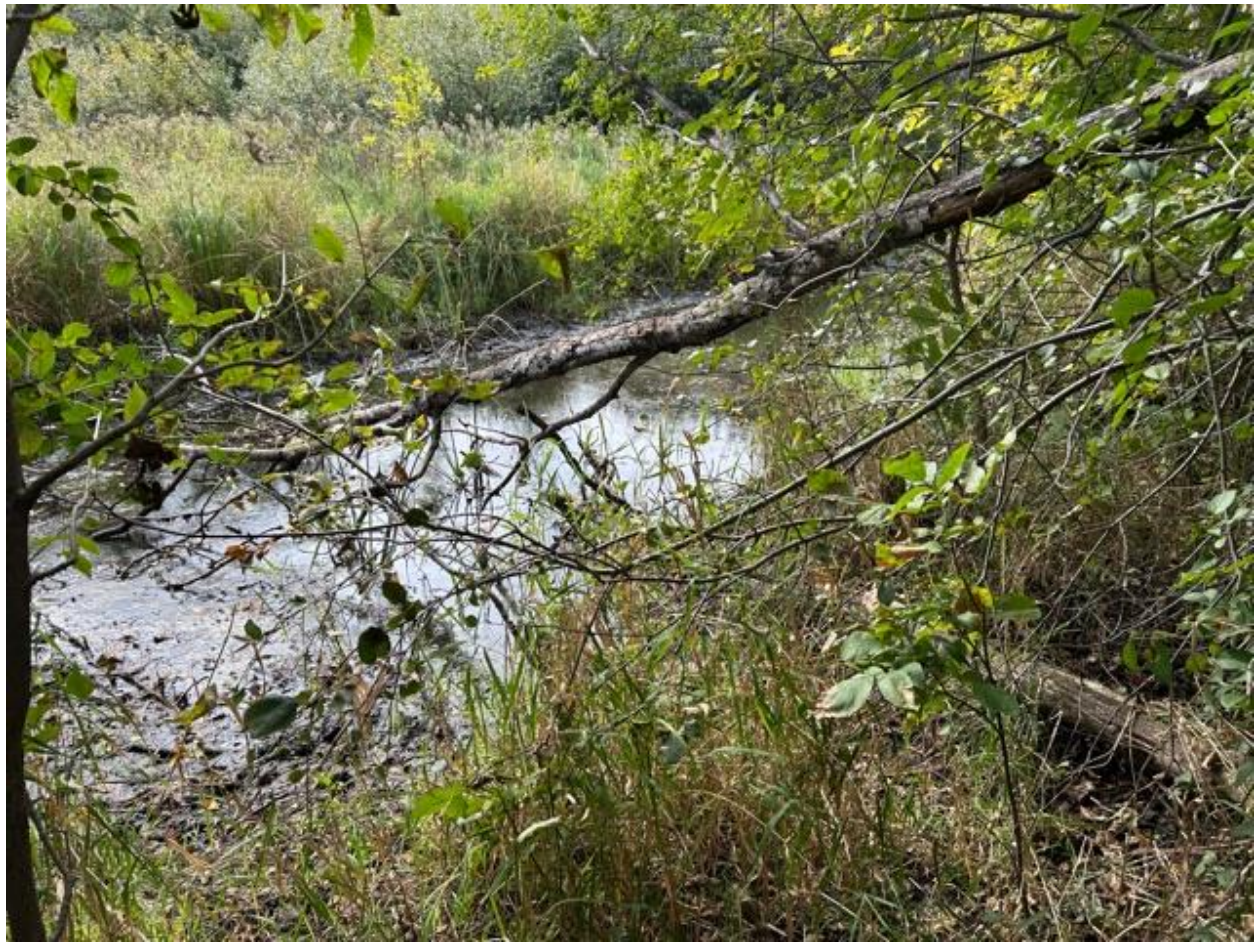
This is a picture of the berm that is located north of Ditch D2, facing east. The berm is 4-6 feet higher than the tributary.

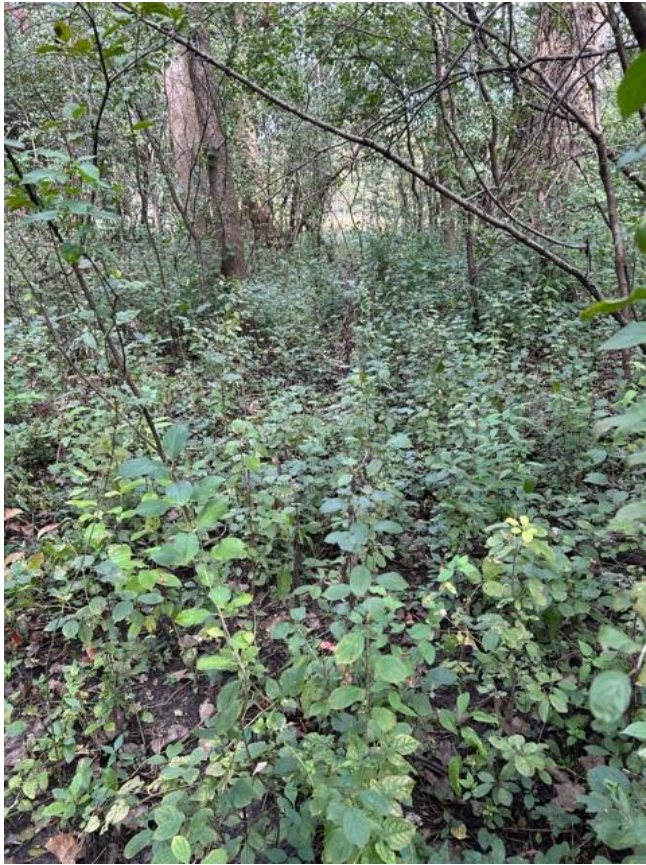
Pictures taken of remnant ditch, facing north, towards Wetland 4. The remnant ditch is filled with vegetation with no indicators of the flow. The channel is more of a swale like feature, no bed and bank observed. The remnant ditch seems to “flatten out” in some sections.

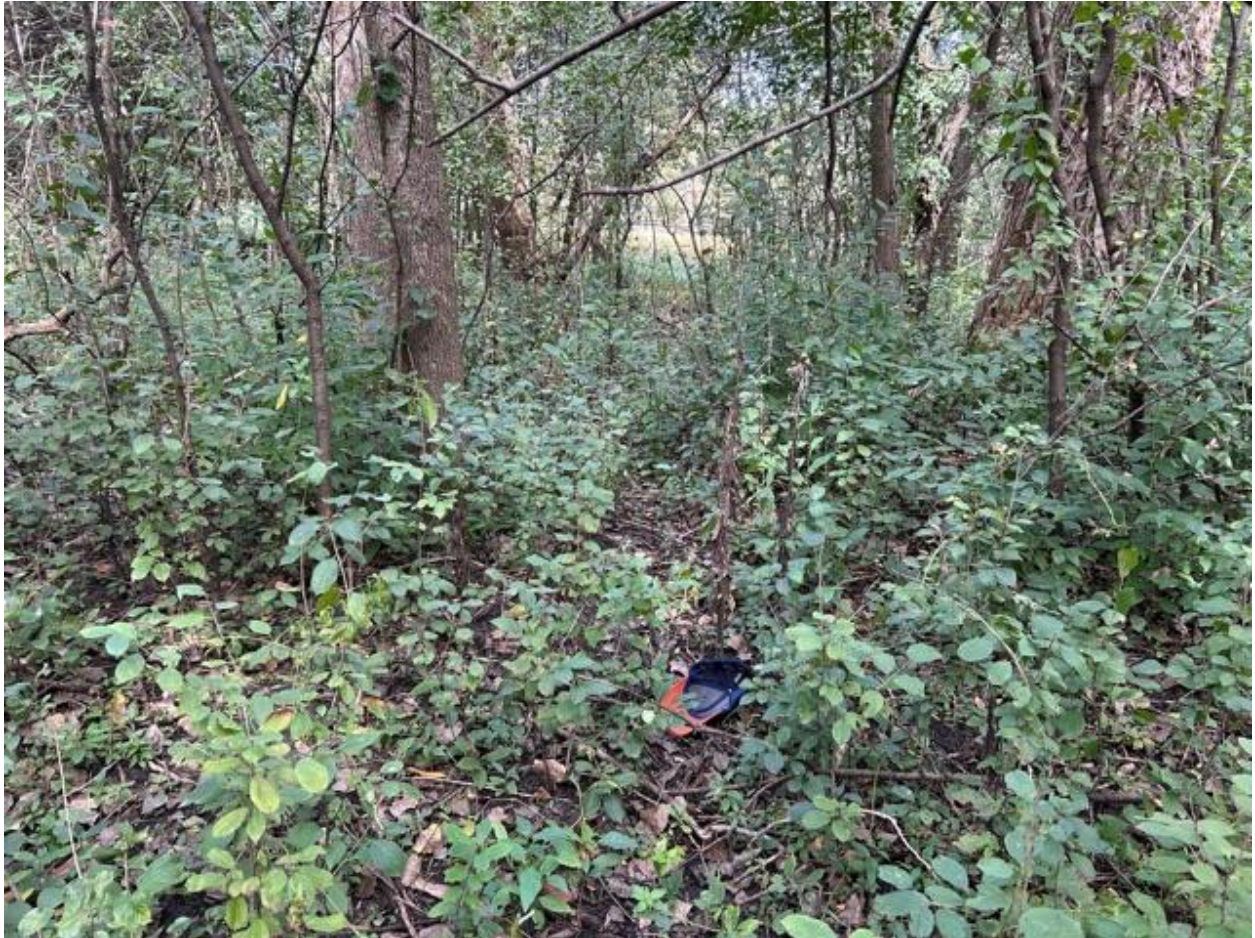
Photo taken of the remnant ditch walking towards Wetland 4, facing north. The remnant ditch is still filled with vegetation with no indicators of the flow. The channel is more of a swale like feature. No bed and bank observed. Seems to "flatten out" at portions of the channel. Hat marks approximate center location of the channel.

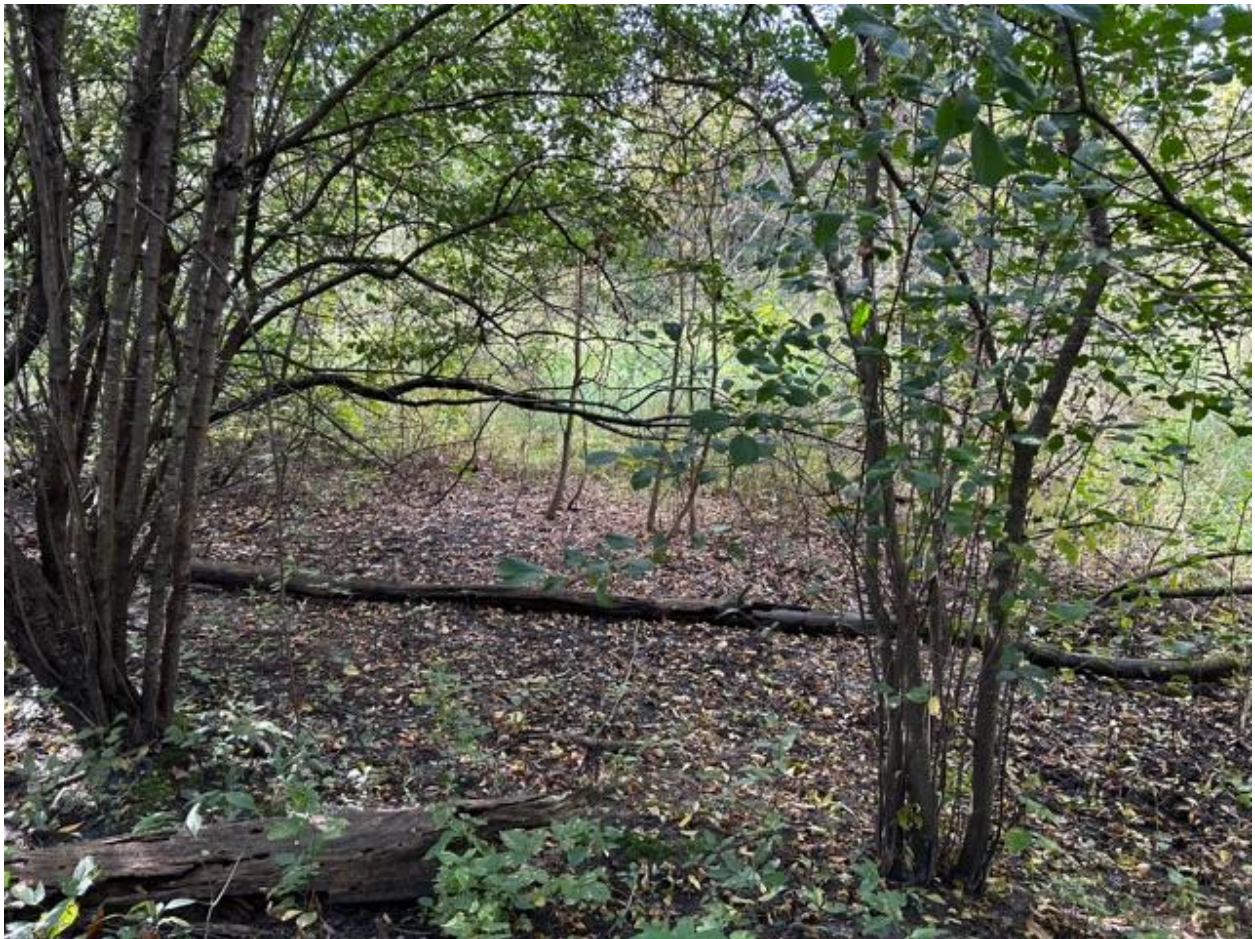
Picture taken of the area between Wetlands 4 and 6, there is no continuous surface connection between Wetlands 4 and 6.

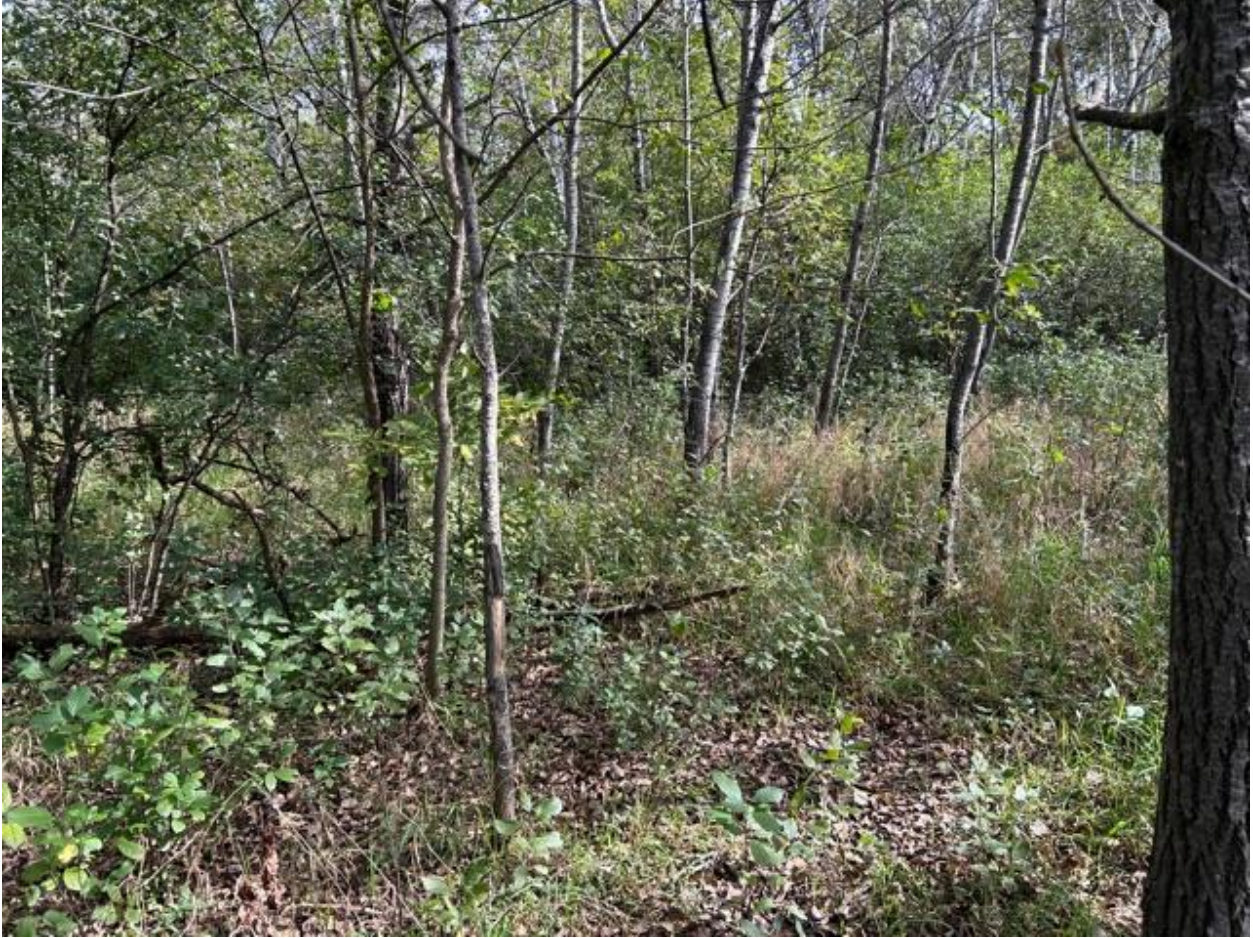
There was no continuous surface connection observed coming into Wetland 4 from the north.

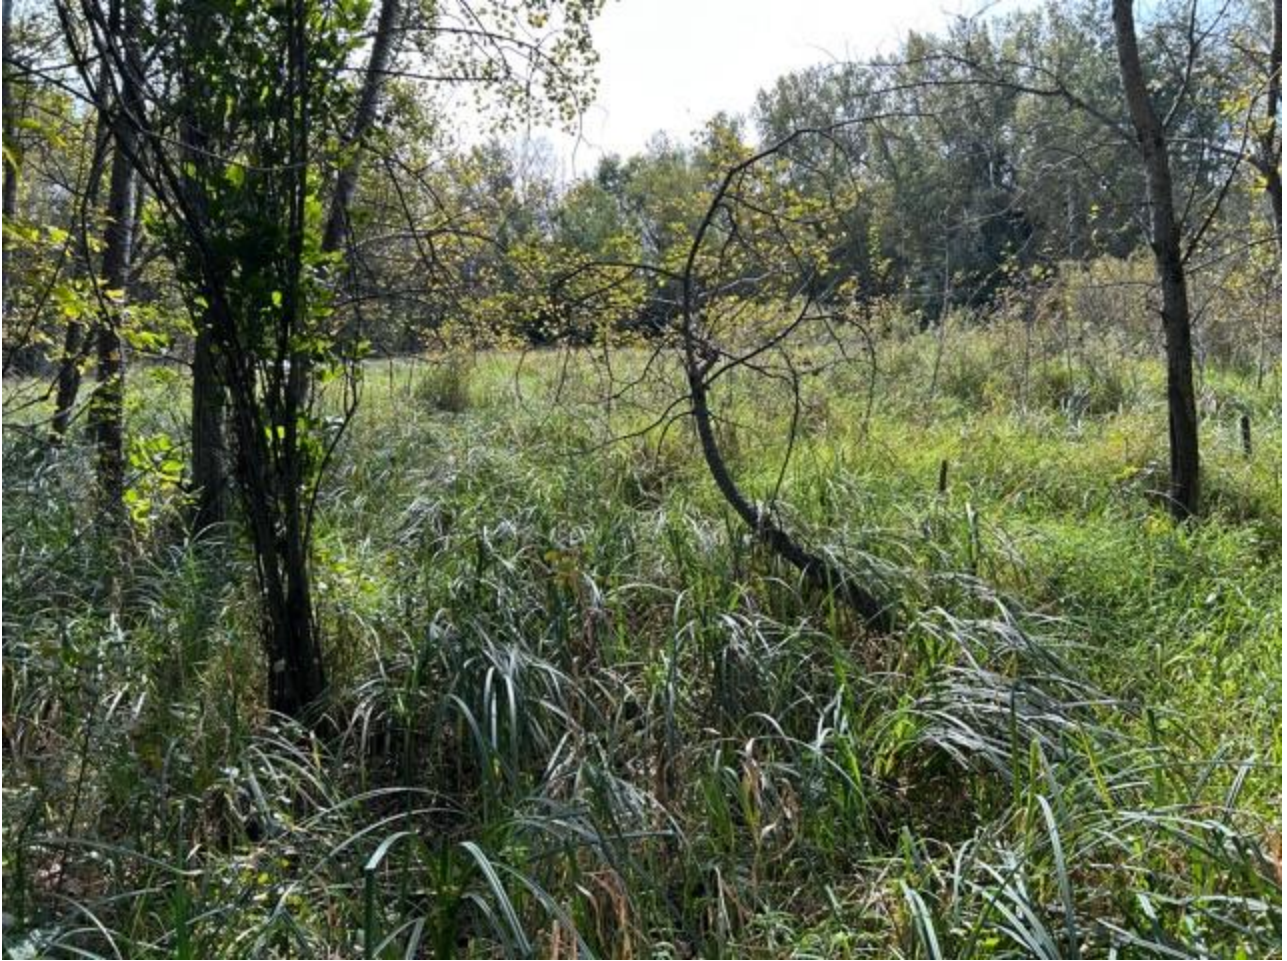
There was no continuous surface connection observed coming into Wetland 4 from the north.

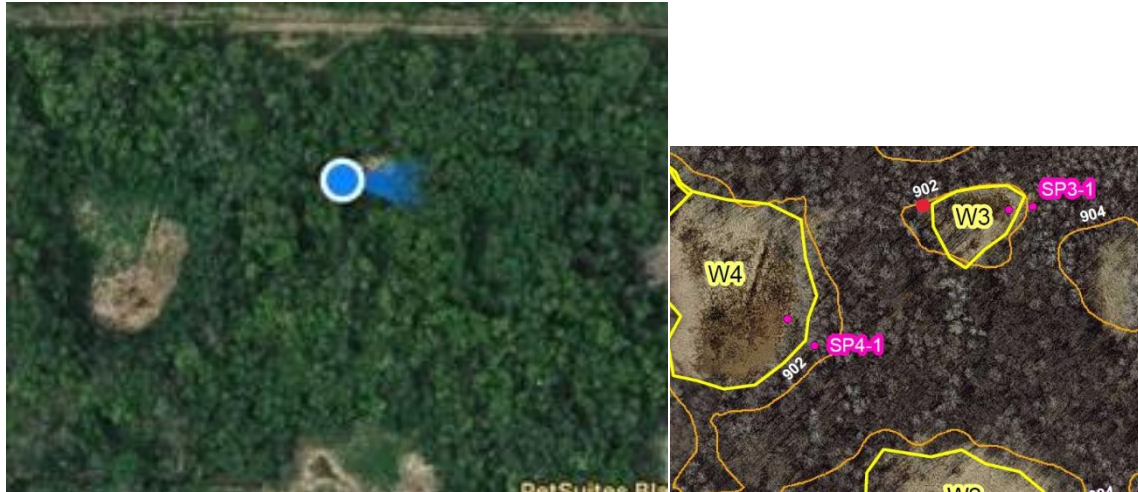
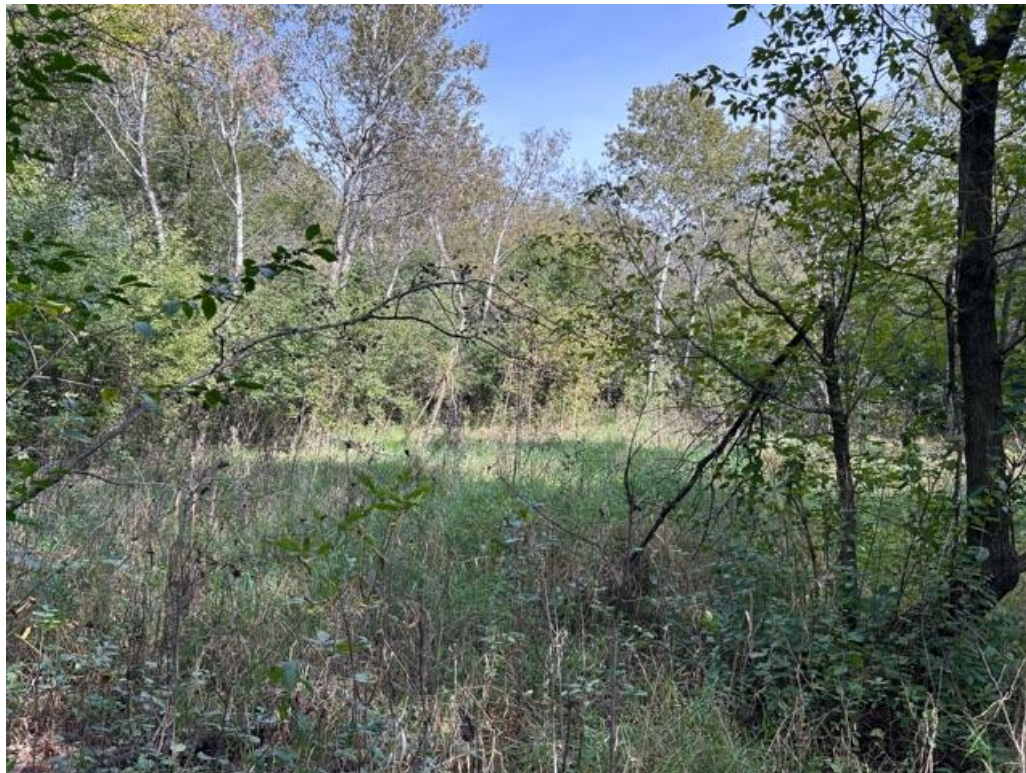
Picture of Wetland 3.

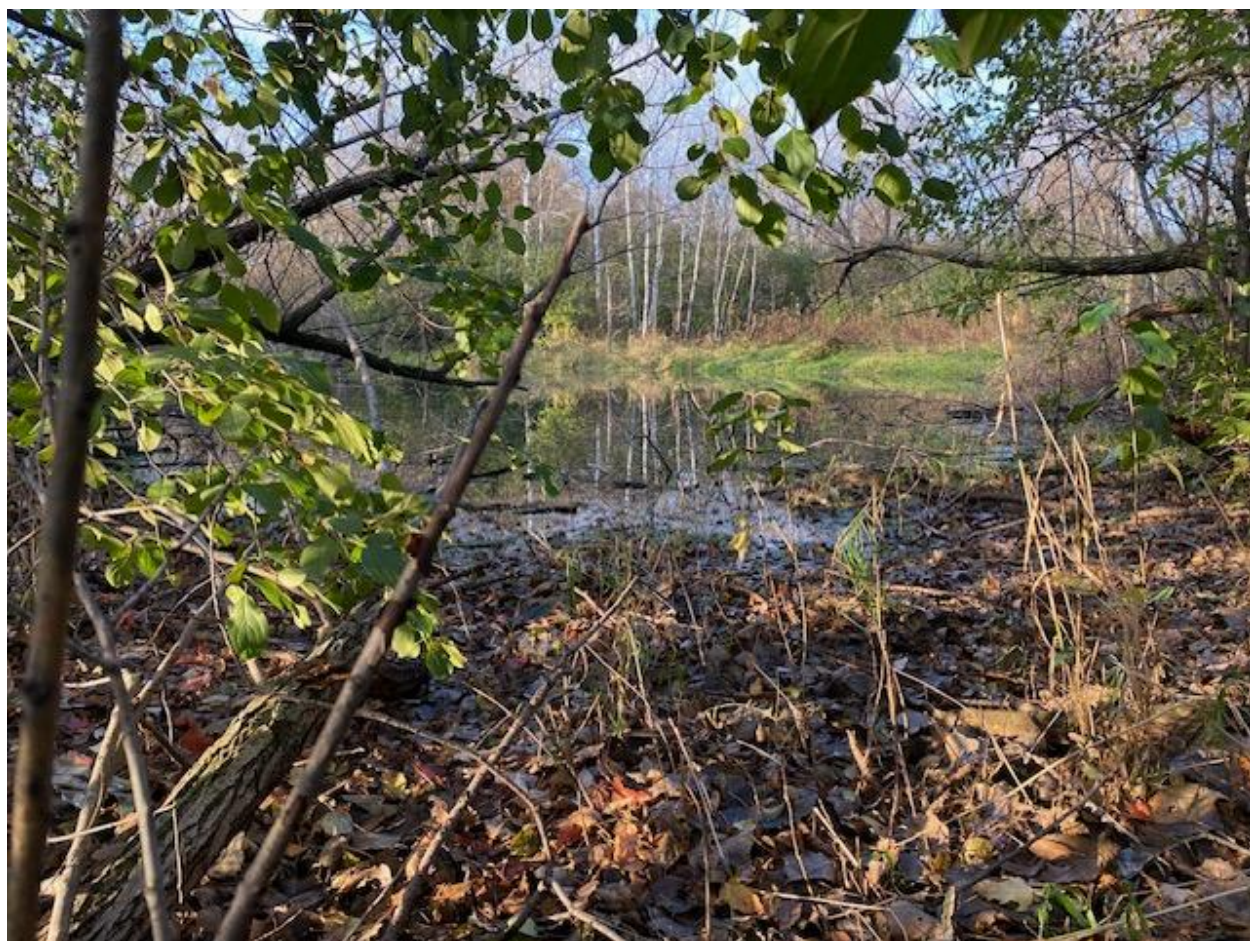
Surface water was observed in the private ditch near 99th and Buchanan. The culvert going under 99th appears to be unobstructed. The water in the private ditch appears to be stagnant as noticed by leaf and other debris not moving on the surface of the water.

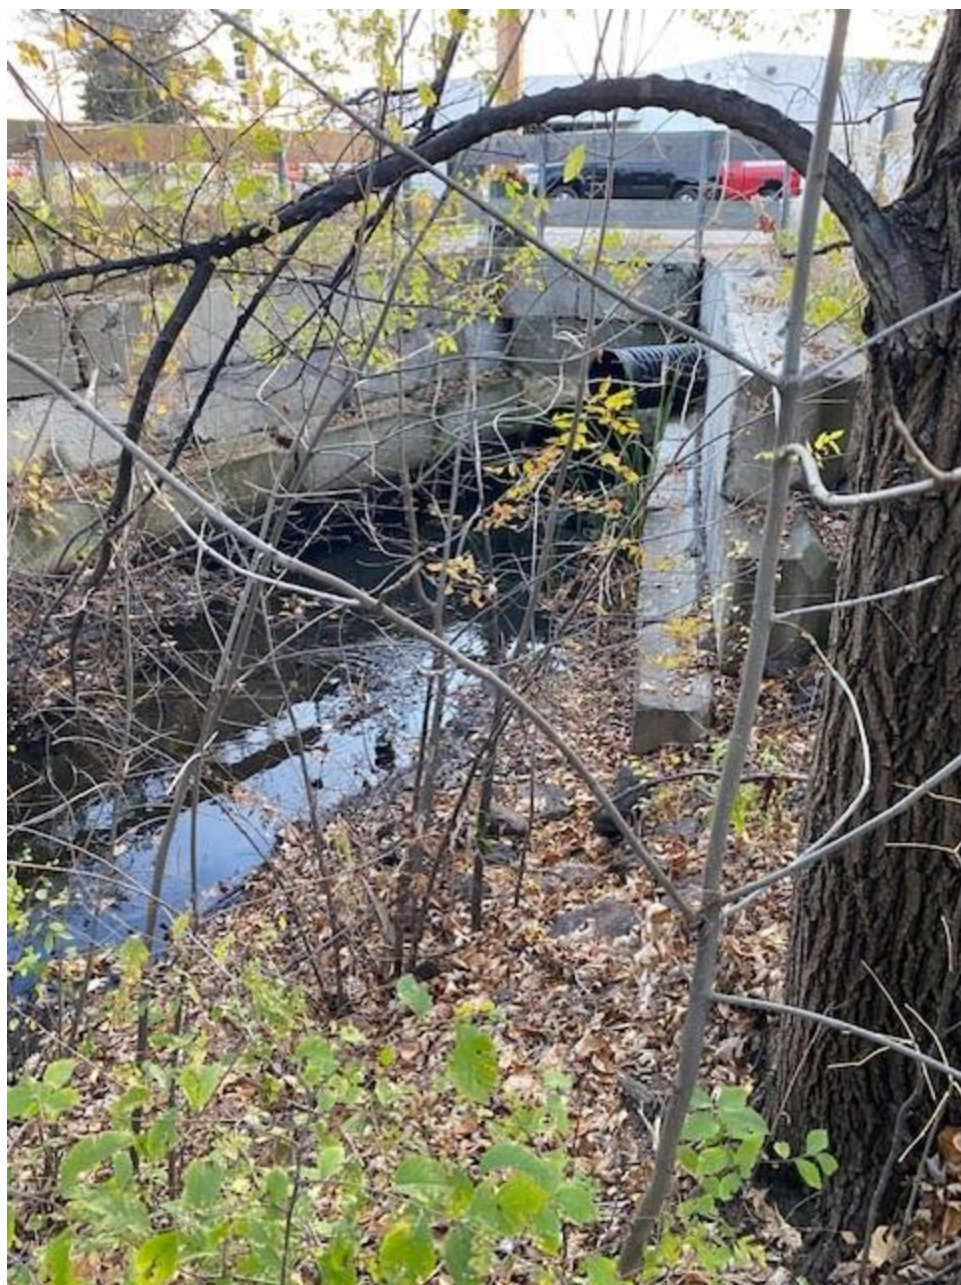
County Ditch 17, northeast of the Salvation Army, enters a culvert that flows subsurface, under the Salvation Army and Highway 10. The ditch had flowing water at the time of the site visit and the culvert was unobstructed.

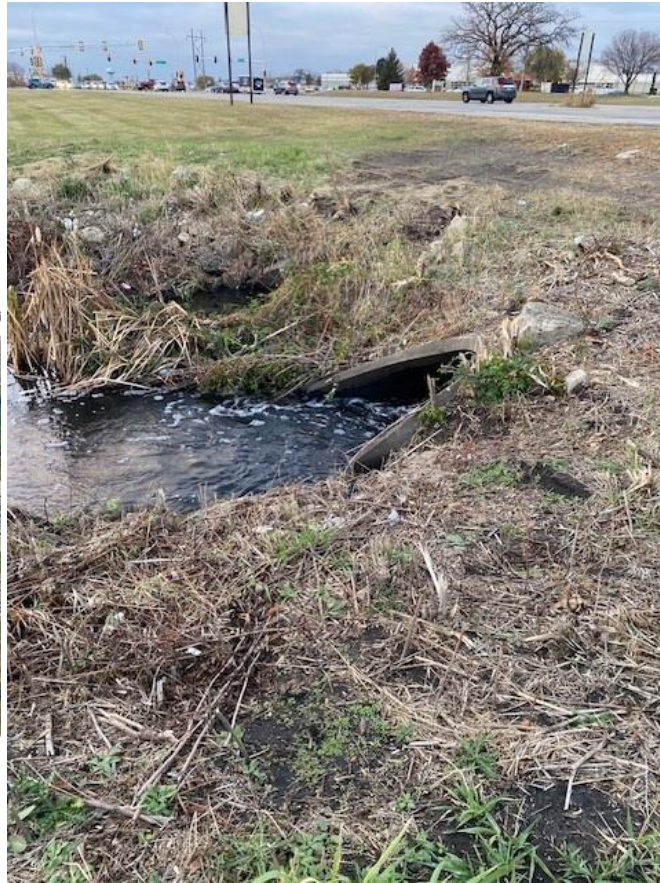
County Ditch 17 outlets near the Northtown Mall sign, west of Highway 10. Flow was observed during the site visit in an unobstructed channel.

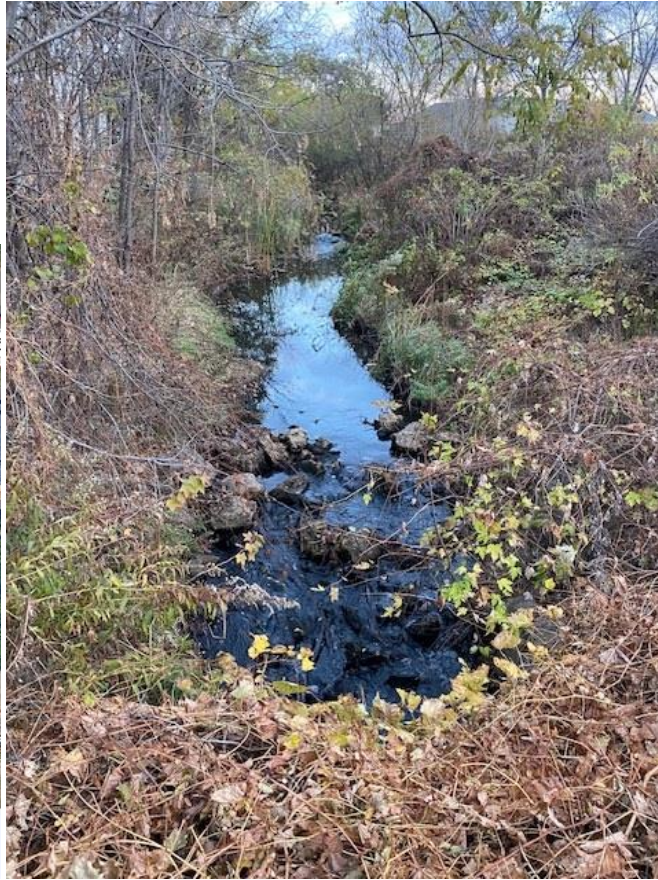
Pictures taken south of Lumber Liquidators. County Ditch 17 flows into the culvert and under the parking lot to the west.

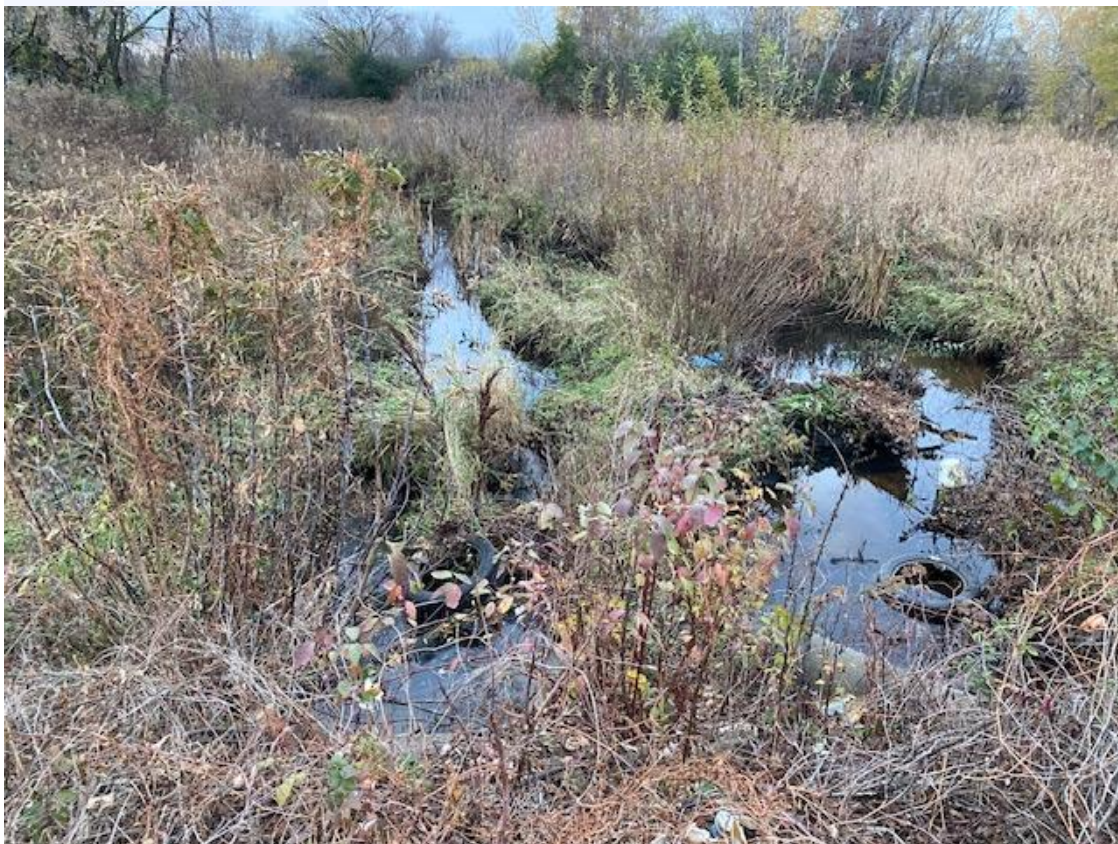
County Ditch 17 daylight north of Tires Plus parking lot. Flowing water was observed coming out of two culverts, converging to form one channel.

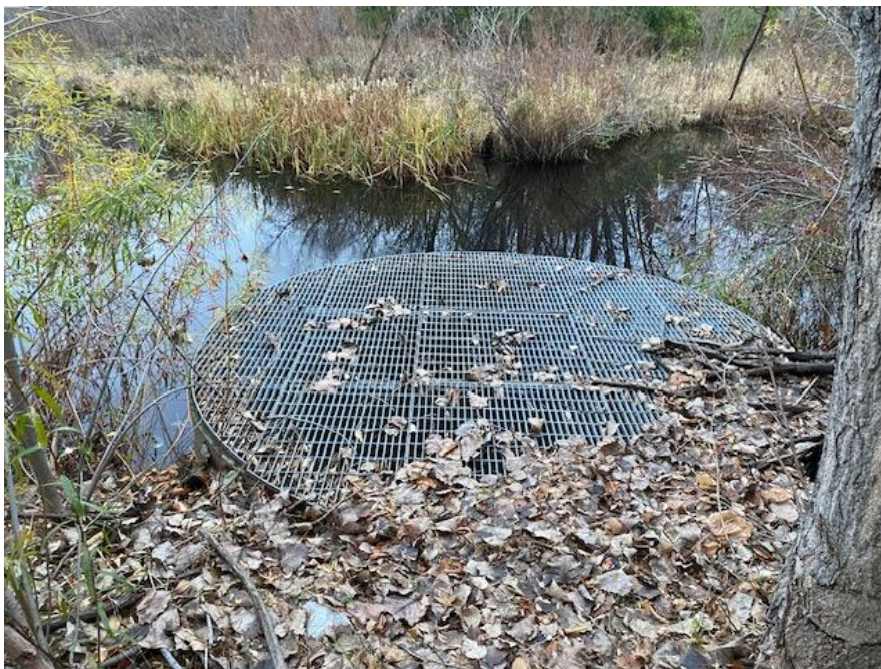
The pictures below were taken of the water control structure south of Northern Wholesale parking lot. I did not observe water flowing, but you could hear it going through the control structure at the time of the site visit. The water flows subsurface from this structure north, to a pond on the west side of Evergreen Boulevard.

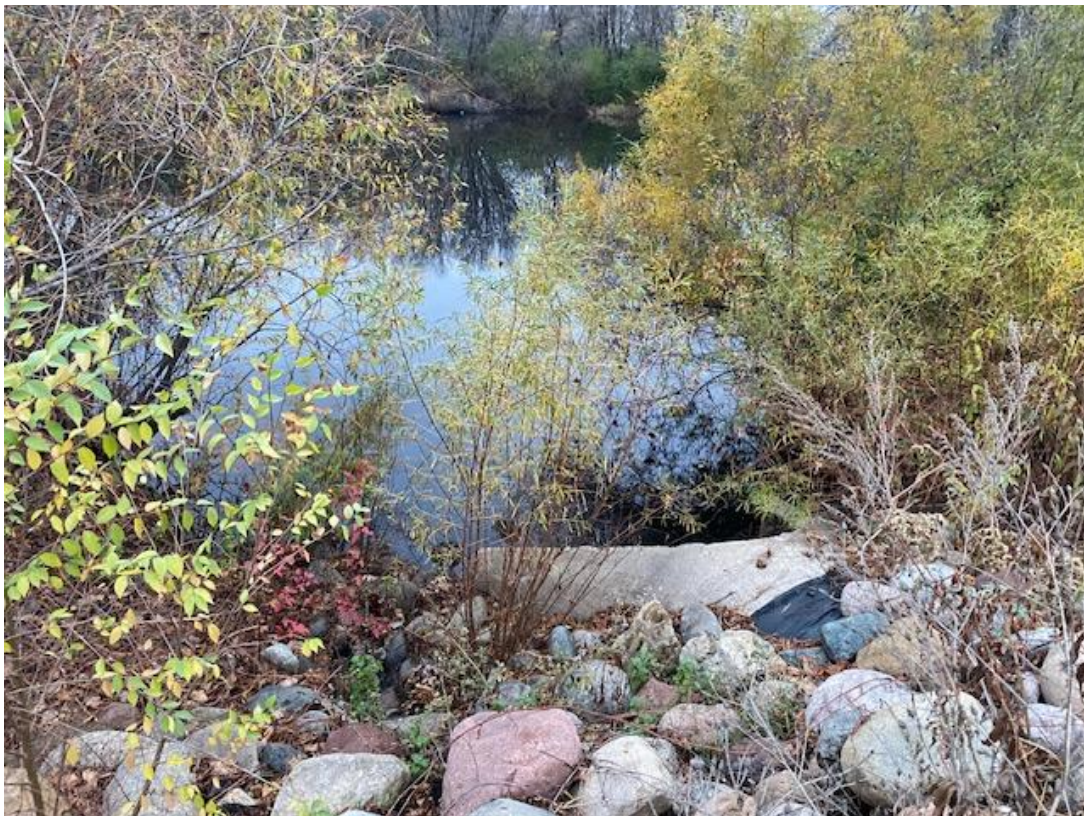
County Ditch 17 daylight into the pond west of Evergreen Boulevard through a large car culvert coming in from underneath the road. Water flow was observed at the surface during the time of the site visit.
