Regulatory File No. MVP-2007-00060-BBY

MEMORANDUM FOR RECORD

SUBJECT: US Army Corps of Engineers (Corps) Approved Jurisdictional Determination in accordance with the "Revised Definition of 'Waters of the United States'"; (88 FR 3004 (January 18, 2023) as amended by the "Revised Definition of 'Waters of the United States'; Conforming" (8 September 2023) ,¹ MVP-2007-00060-BBY MFR 1 of 1².

O'Neil Property 101st Avenue AJD Site Visit (11/6/2024) – Private Ditch and County Ditch 17 (Springbrook Creek) Investigation

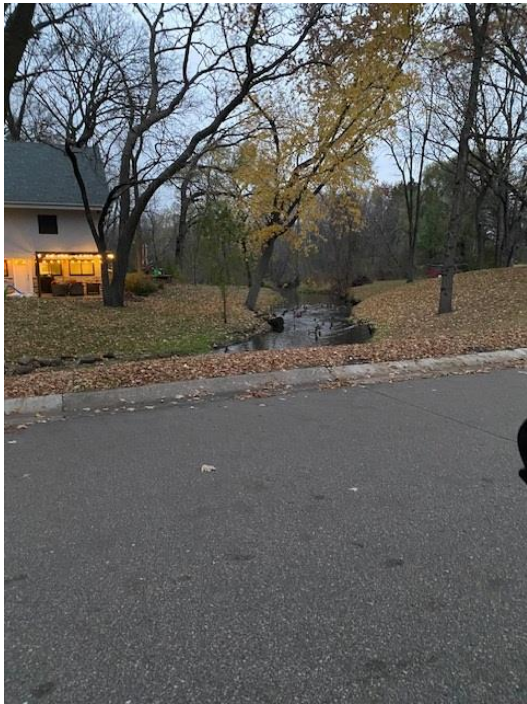
Pictures of County Ditch 17 at Ironton Street NE. Surface water flow was observed during the time of the site visit.

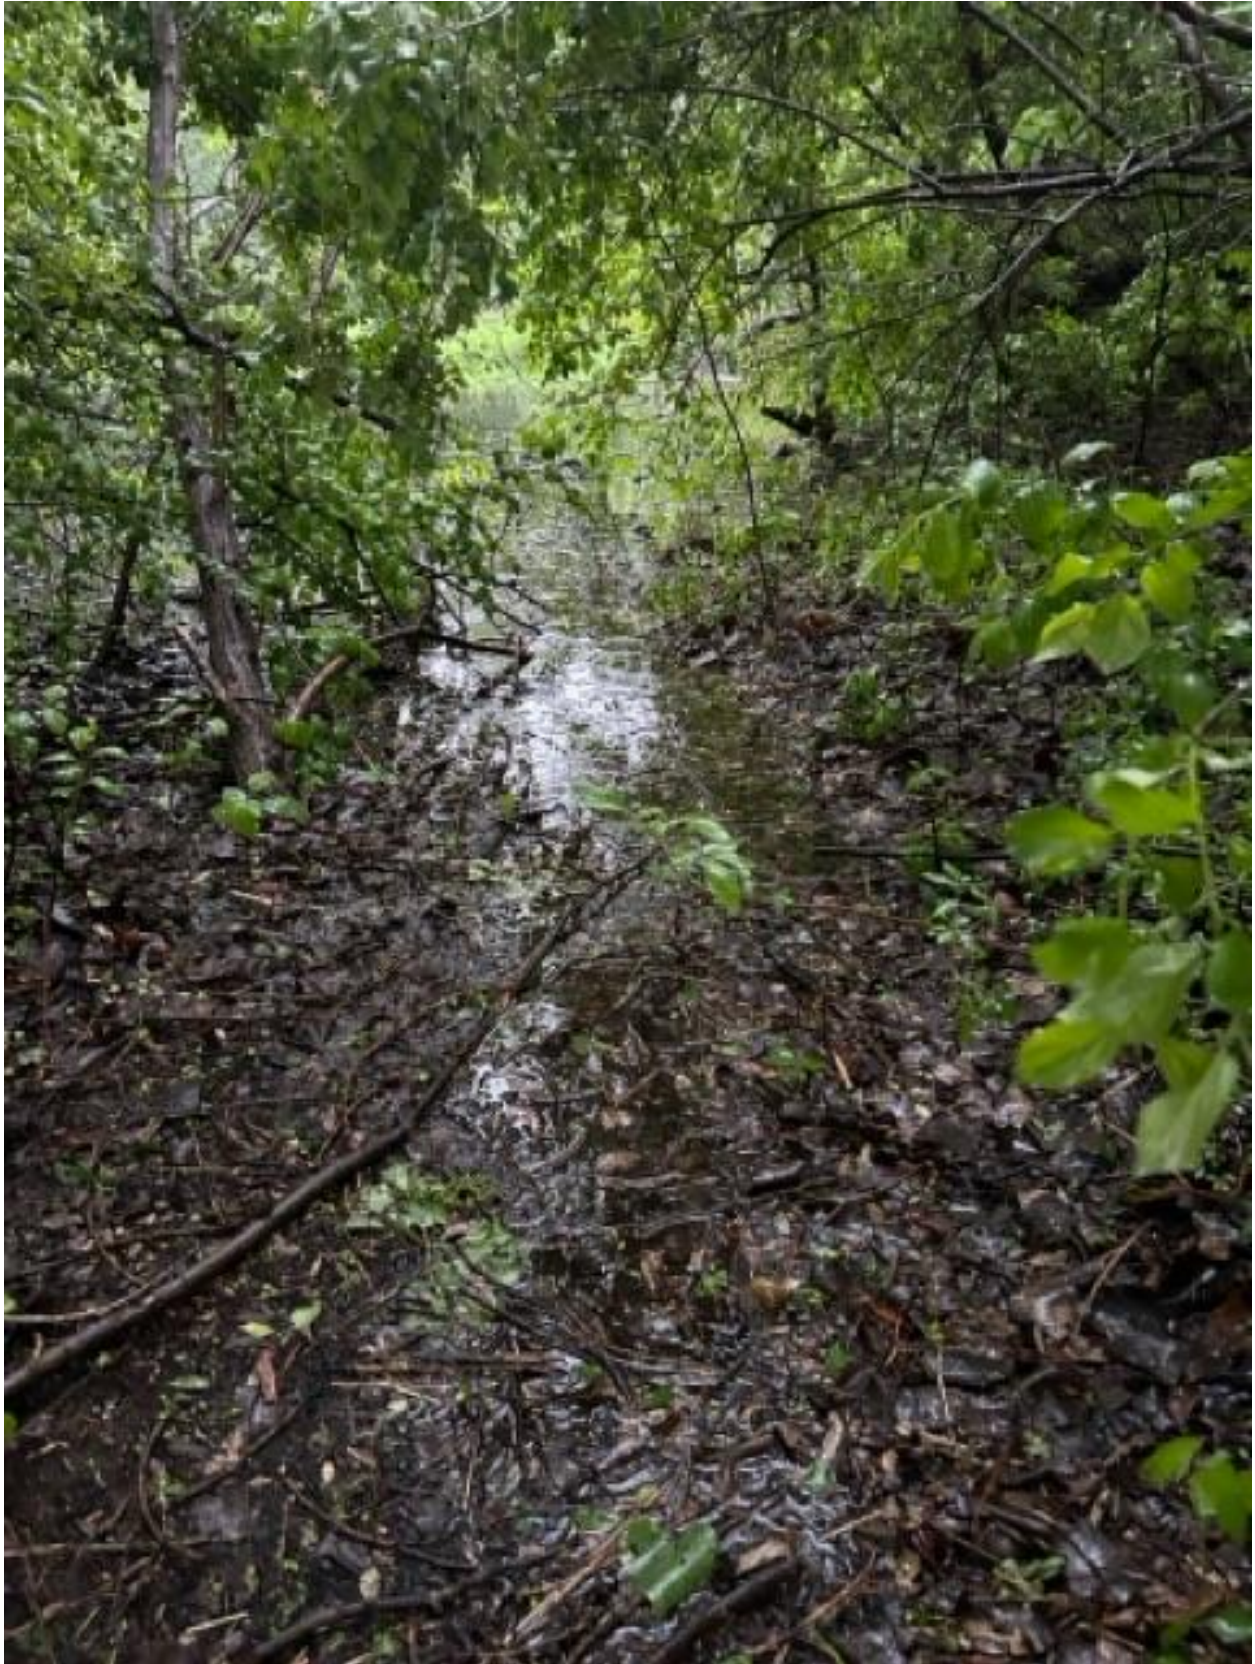
Picture taken of the swale extending from the pond towards the culvert, facing north.
