**UPPER MISSISSIPPI RIVER SYSTEM
ENVIRONMENTAL DESIGN HANDBOOK**

CHAPTER 2

SHORELINE STABILIZATION

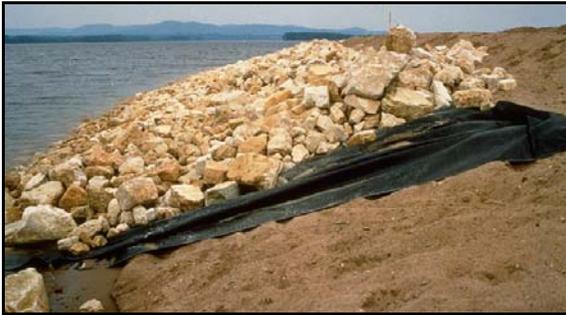
Photograph 2.1. Lake Onalaska. Riprap and geotextile filter placed on sand.

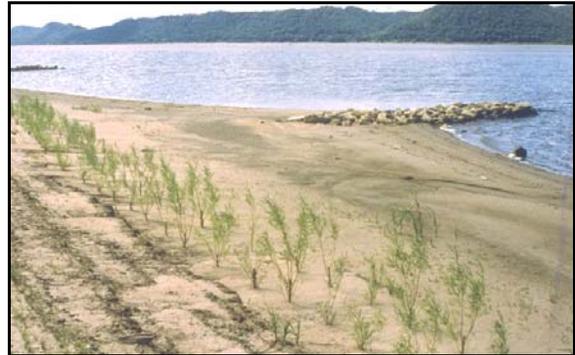
Photograph 2.2. Pool 8, Phase II, Boomerang Island. Biotechnical stabilization with groins and willows.

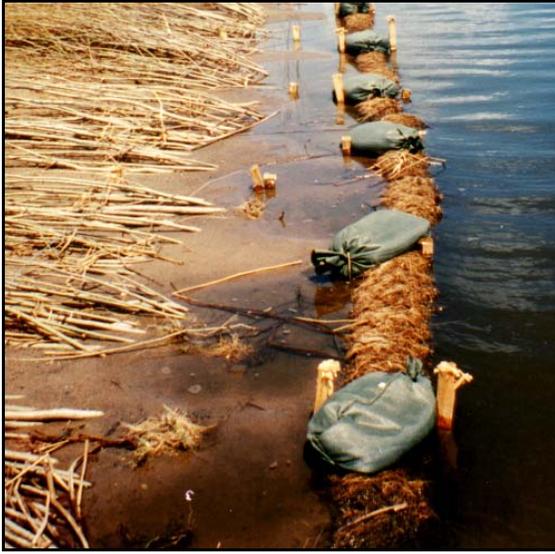
Photograph 2.3. Weaver Bottoms, Swan Island. Biotechnical Stabilization with fiber rolls, sand bags, and willow mats.

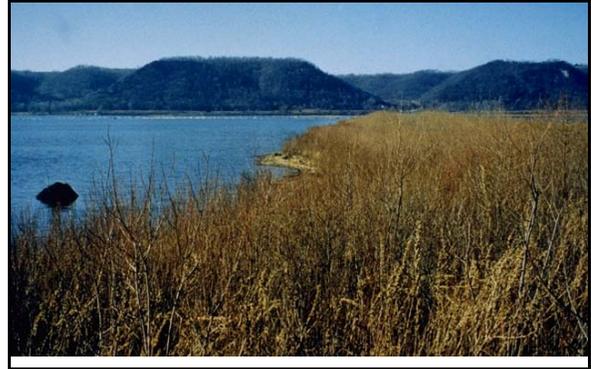
Photograph 2.4. Pool 8, Phase II, Boomerang Island. Vegetative stabilization was used on over 60-percent of the shorelines on Boomerang Island.

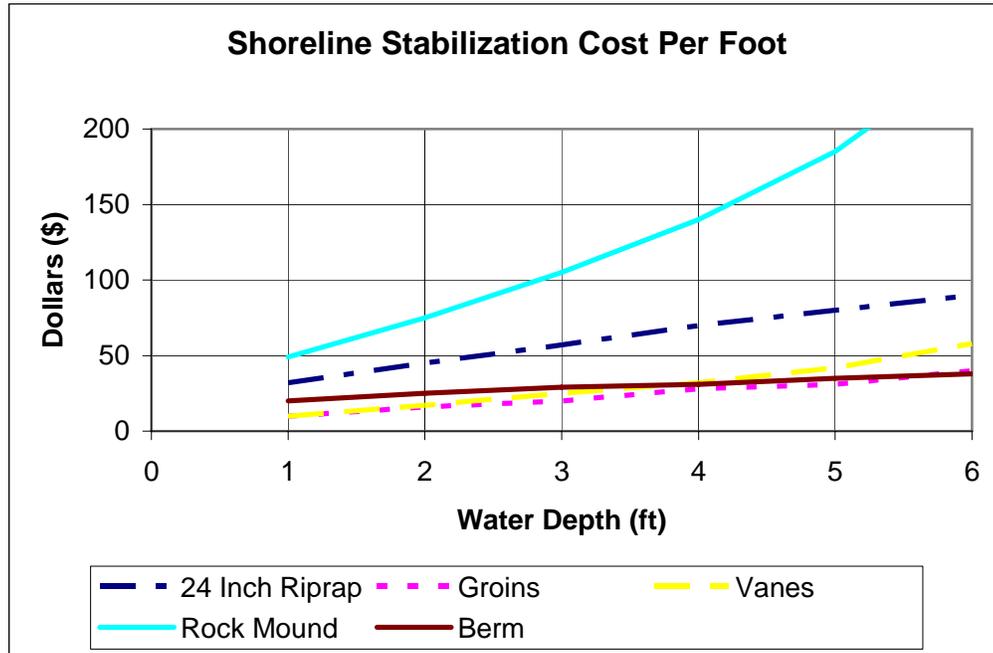
Figure 2.1. Rock Based Shoreline Stabilization Costs Per Foot of Shoreline (MVP Cost Data)

2.2.3. Cost. Shoreline stabilization costs include earth fill (granular and fines) for the berm, rock, and the cost of willow plantings. Figure 2.1 shows estimated costs, based on data collected by the St. Paul District, for constructing various types of rock based shoreline stabilization in water depths of 1 to 6 feet. The berm cost must be added to the cost of the various types of rock structures. Based on this information, groins and vanes are the cheapest rock based stabilization option, regardless of water depth. Rock mounds are the most expensive option in all cases.

Assumptions for cost estimates displayed in Figure 2.1

1. Rock cost equals \$35/ton or \$49 cubic yard in place
2. Sand cost equals \$3/cubic yard
3. Fines cost equals \$12/cubic yard
4. Height of rock structures above average water surface is 2 feet.
5. Side slope of 24 inch rock fill equals 1V:3H
6. Side slope of groins, vanes, and rock mound equals 1V:1.5H
7. Top width of groins, vanes, and rock mound equals 4'
8. Groin and vane length is 30 feet, and spacing is 180 and 90 feet respectively
9. Berm width equals 30 feet, half the berm (15 feet) is covered with topsoil to a depth of 1 foot, and willow cost is \$2 per foot for 2 rows of willows.

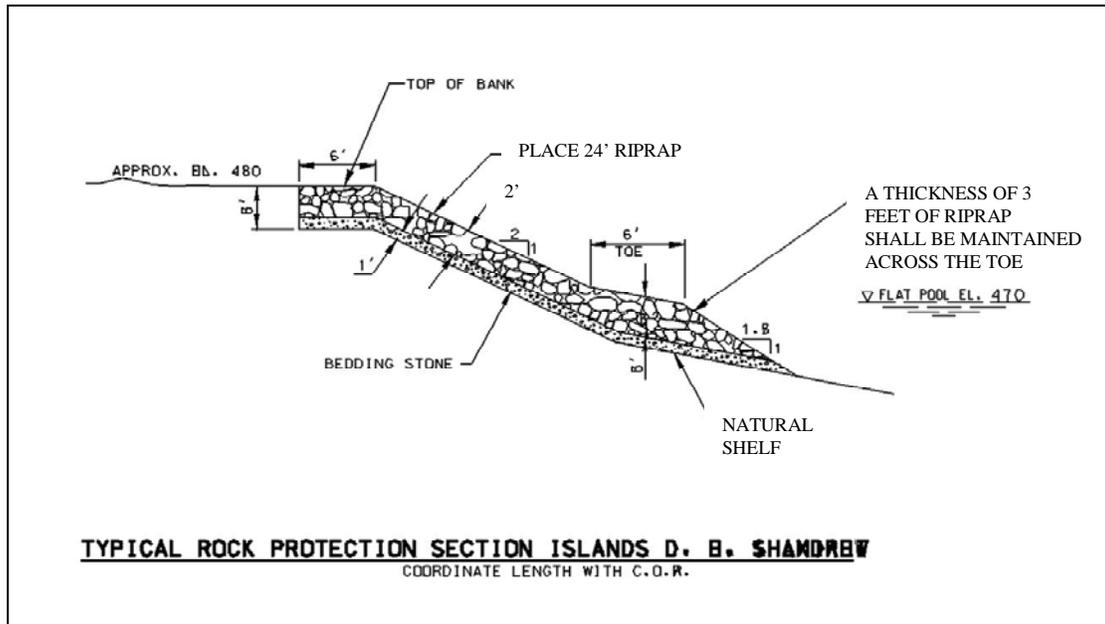
Figure 2.2. Typical Rock Protection Section

2.3.2.Plans. Drawings should include a plan view of the site indicating the length of protection. Drawings should also include select survey transects, and a typical section. Drawings should show expected slopes, thickness of rock, and rock gradation size. A typical drawing is shown in figure 2.2.

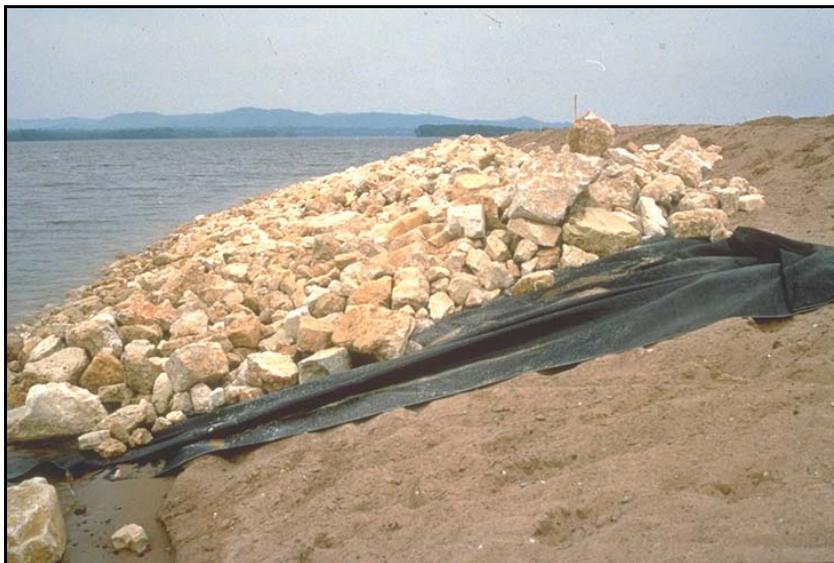
Photograph 2.5. Rock Revetment Placed on Geotextile

2.5.1.1. Design Criteria. Typical rock revetments are shown in photographs 2.5 and 2.6. Currently, two types of rock revetments are used: Revetment 1 (Graded Riprap, 18 inches thick, 1V:2.5 to 3H side slope, with geotextile fabric) can be used on new construction such as islands or dikes. Revetment 2 (Rock fill, 24 inches thick, 1V:1.5 to 3H side slope) can be used on new construction or existing shorelines which have variable slopes. The greater thickness of revetment 2 prevents piping of bank material, so no filter is required.

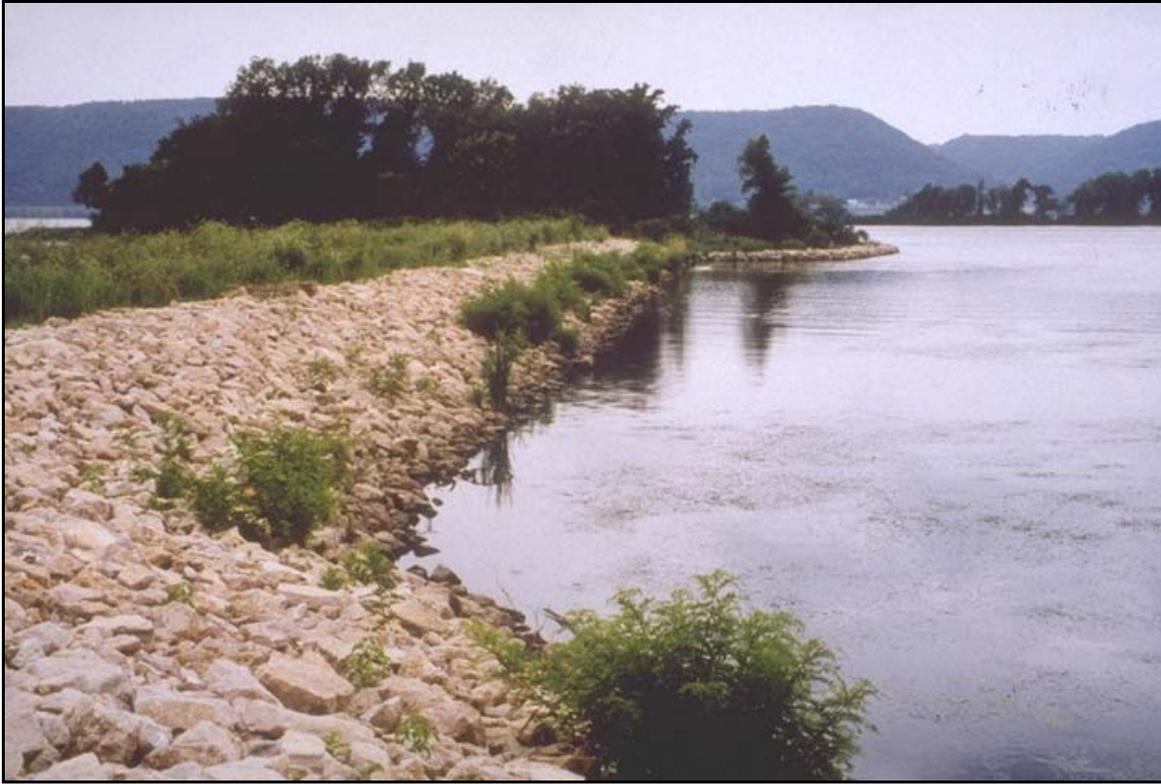
Photograph 2.6. Rock Revetment After Vegetation Growth

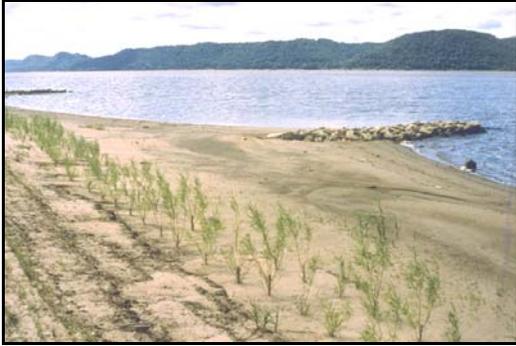
Photograph 2.7. Newly Constructed Rock Groin

2.5.2.1. Design Criteria. Rock groins, shown in photographs 2.7 and 2.8, are used mainly on new construction in shallow water where wave action and littoral drift are the dominant processes. After groins are constructed, shoreline reshaping occurs with deposition occurring near the groins and erosion occurring in the reach between two groins. This continues until a stable scalloped shape is formed. The erosion that occurs is usually acceptable for new construction, but is not acceptable on natural shorelines. The advantage of groins is cost savings (if in shallow water), creation of littoral and beach habitat, and an aesthetically pleasing shoreline.

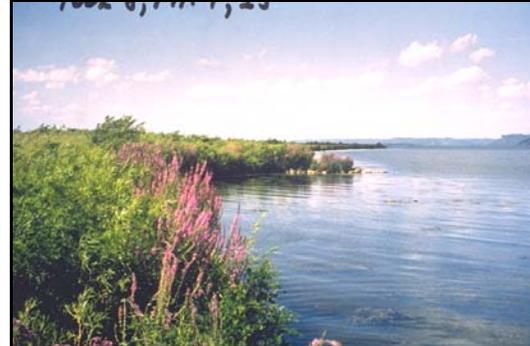
Photograph 2.8. Rock Groin After a Few Years of Vegetation Growth.

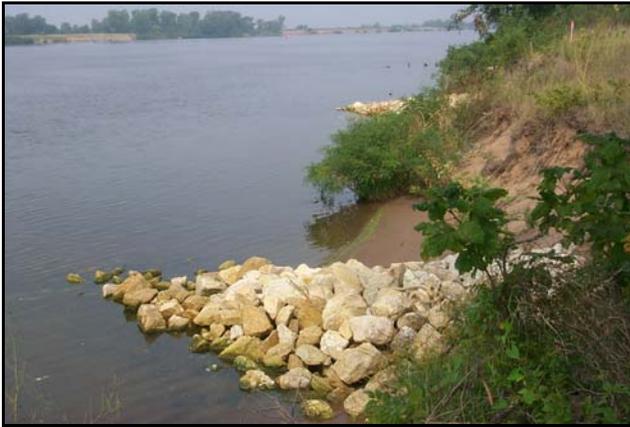
Photograph 2.9. Rock Vanes at Lost Island Chute

2.5.3.1. Design Criteria. As shown in photograph 2.9 and figure 2.3, rock vanes extend upstream from the shoreline and feature a sloping top elevation. As vanes are overtopped by high water events, they function as weirs and redirect flow away from the shore. Vanes are effective on shoreline adjacent to moving current and the sloping top elevation makes vanes more economical than groins in deeper water.

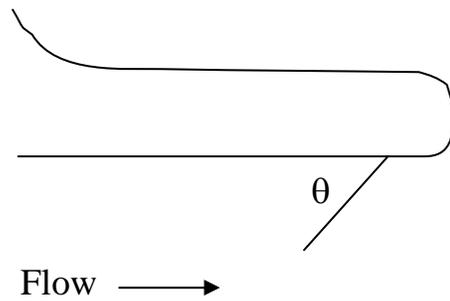
Figure 2.3. Plan View of a Vane Alignment.

Currently, three types of vanes have been utilized: traditional, traditional with a root wad, and a J-Hook Style. Plan and profile views for a traditional vane are provided in figures 2.3 and 2.4. The plan view of a J-Hook style vane is shown in figure 2.5 and a cross-section of a traditional vane with a root wad is shown in figure 2.6. Typical design criteria are presented in table 2.16.

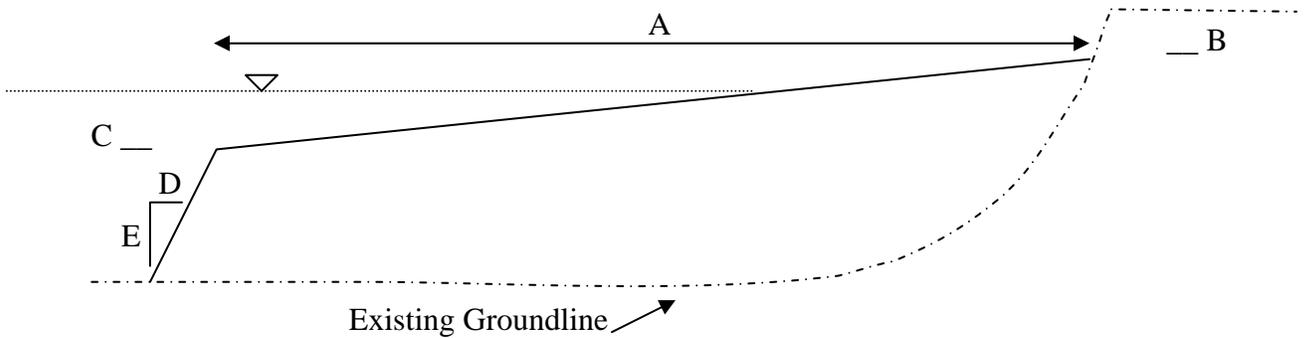
Figure 2.4. Profile View of a Rock Vane

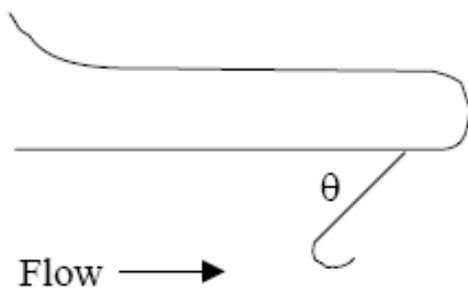
Figure 2.5. Plan View of a J-Hook Vane Alignment

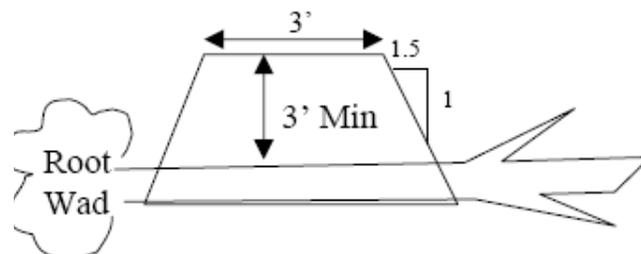
Figure 2.6. Cross-Section of a Tree Built Into a Traditional Vane

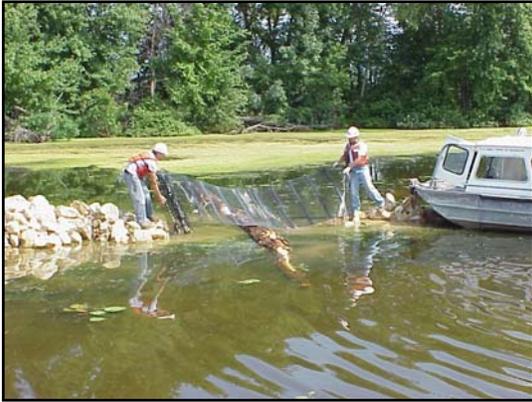
Photograph 2.10. Installation of a Rock Log Structure

2.5.5. Rock-Log Structures. In protected areas with minimal ice impacts, rock-log structures provide an economical alternative to offshore rock mounds. These structures protect existing shoreline while providing woody structure for fish and loafing areas for wildlife. Rock log structures are shown in photographs 2.10 and 2.11.

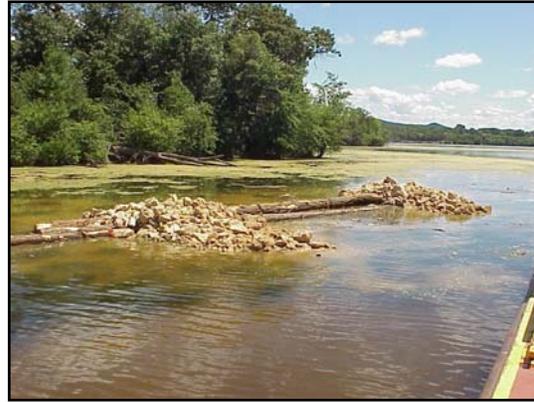
Photograph 2.11. Rock-log Structure in Place

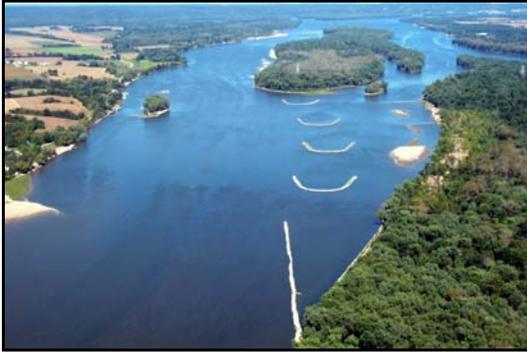
Photograph 2.12. A Series of Chevrons on the Mississippi River

2.5.6. Chevrons. Chevrons are typically used in wider reaches of the river where a flow split is desired. As shown in photographs 2.12 and 2.13, a series of chevrons can be positioned to split flow between a side channel and the main channel. Controlling the flow into the backwater areas helps protect the natural existing bankline. Additionally, eddies created by the structure erode pools on the downstream side of the chevrons. These deep pools provide overwintering habitat for fish.

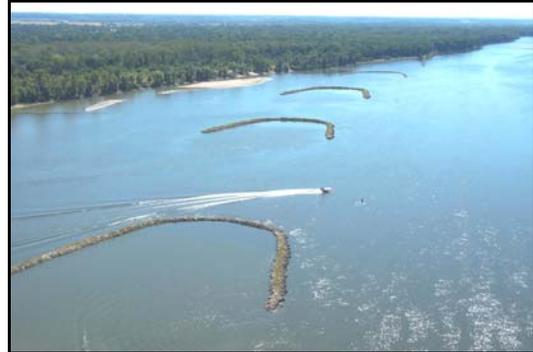
Photograph 2.13. A Series of Chevrons Aligned To Split Flow Between the Main Channel and a Side Channel, While Protecting the Existing Shoreline

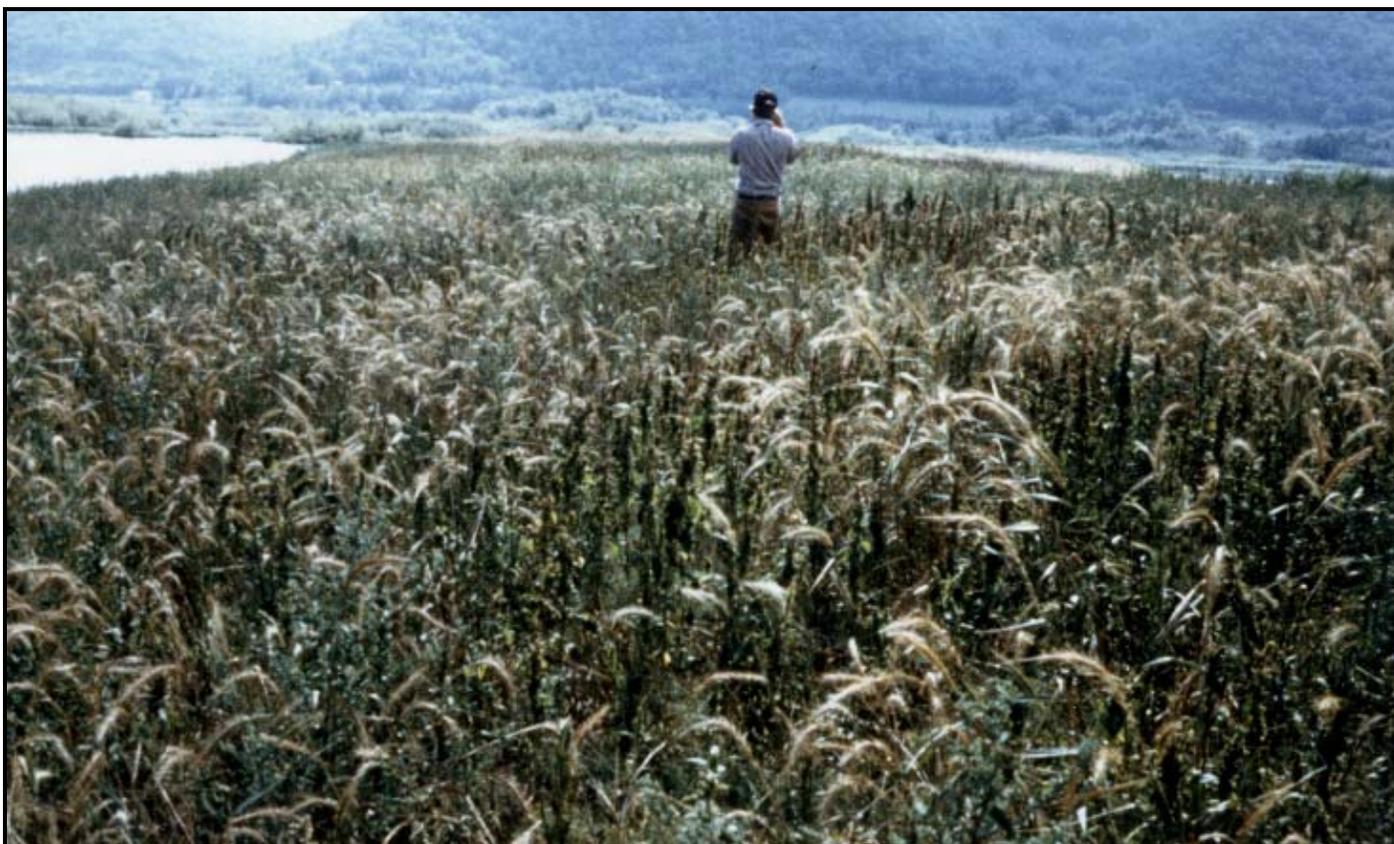
Photograph 2.14 Pool 5, Weaver Bottoms, Swan Island
Native prairie grasses were planted to provide nesting habitat and stabilize the top of the island.

2.5.7.1. Design Criteria. One of the primary purposes of the berm is to provide conditions for the growth of woody vegetation, which reduces wave action during floods. Although colonization by woody plants will occur naturally, sandbar willow (*salix exigua*) is usually planted on berms to increase the rate of colonization. Within a few years, the willows usually spread to cover 20 or 30 feet of the berm and side slopes. Other species such as False Indigo and Willow hybrids have been used in smaller quantities. Photograph 2.14 shows native prairie grass planted to provide nesting habitat and stabilize the top of the island.
