Waterbody Data Sheet

Description			
Project Name: Line 5 Relocation Project		Date: 2020-06-12	Waterbody Survey ID: sbad1001e
State: Wisconsin	County/Parish: Bayfield	USGS Waterbody Name: None	
Company: Enbridge	Crew Member Initials: KDF/AGG	Latitude: 46.575124	Longitude: -91.032516
Survey Type: <input checked="" type="checkbox"/> Centerline <input type="checkbox"/> Re-Route <input type="checkbox"/> Access Road <input type="checkbox"/> Facility <input type="checkbox"/> Other <small>(check one)</small>			
Waterbody Type: <input type="checkbox"/> River <input checked="" type="checkbox"/> Stream <input type="checkbox"/> Ditch <input type="checkbox"/> Swale <input type="checkbox"/> Canal <input type="checkbox"/> Other <small>(check one)</small>			
Water Appearance: <input type="checkbox"/> No Water <input checked="" type="checkbox"/> Clear <input type="checkbox"/> Turbid <input type="checkbox"/> Sheen on Surface <input type="checkbox"/> Surface Scum <input type="checkbox"/> Algal Mats <input type="checkbox"/> Other <small>(check one)</small>

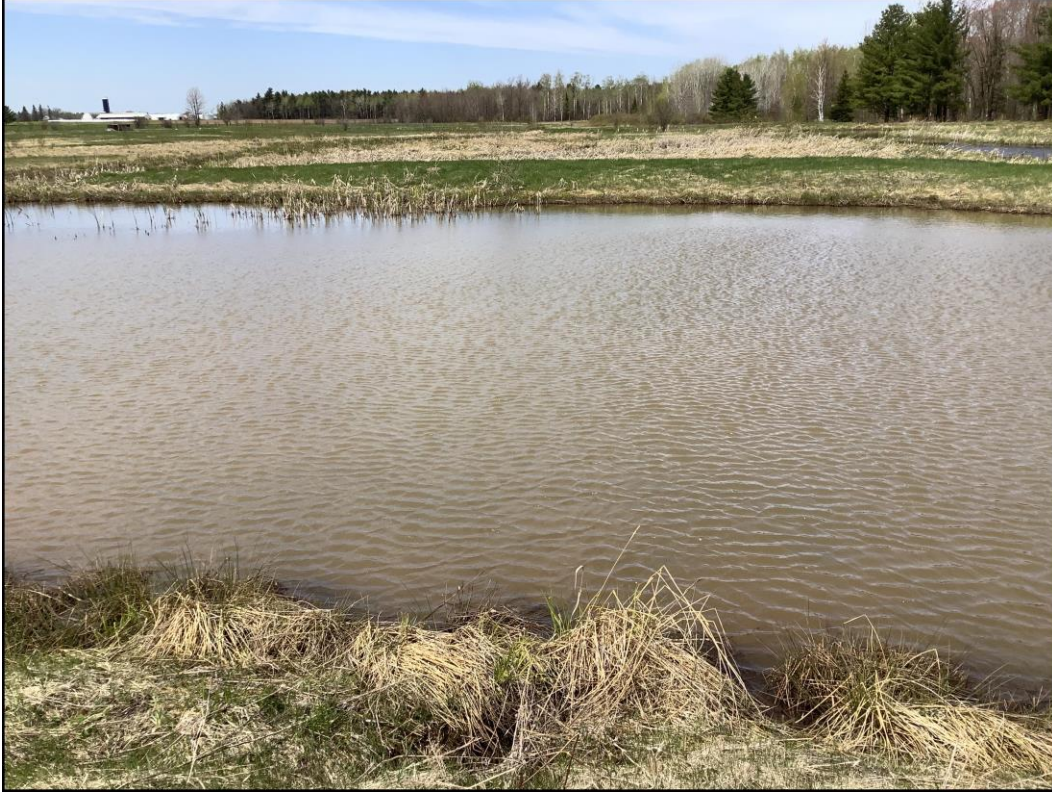
oase1001_S

Disturbances (ex: livestock access, manure in waterbody, waste discharge pipes): The feature is an artificial stock pond.			
Observation Notes: The stock pond is within a large wetland complex. The waterbody continues outside of the survey corridor.

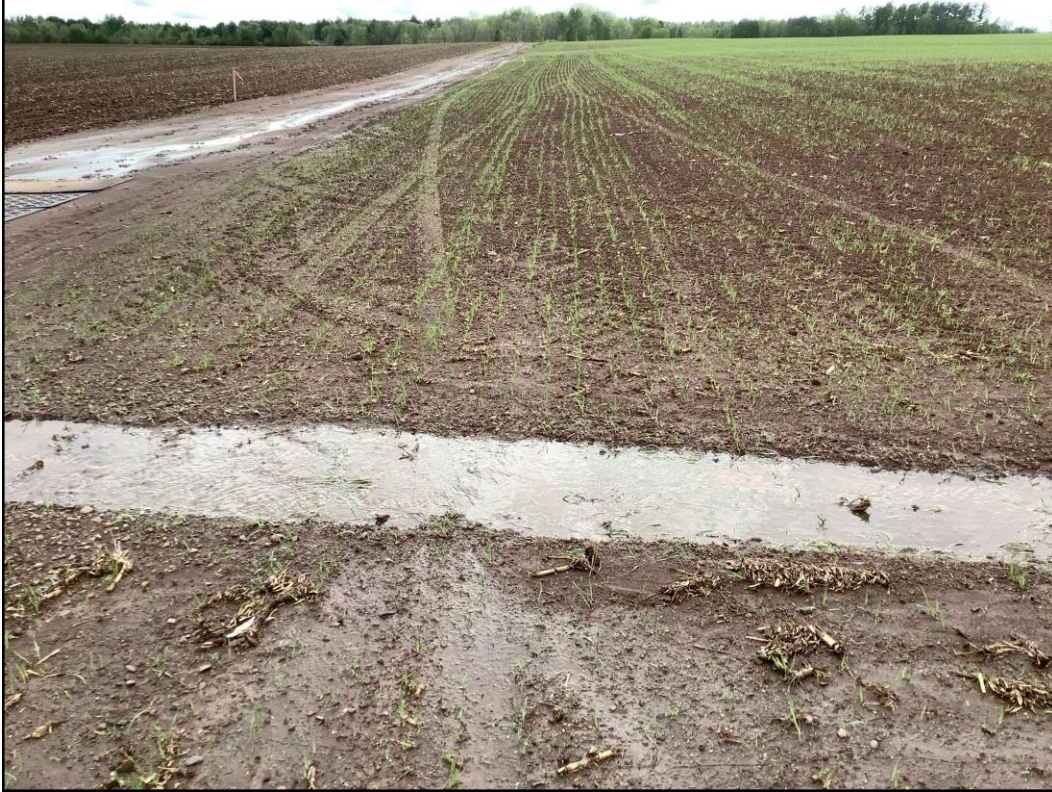
sase1004e_W (across)

Vegetation Layers: <input type="checkbox"/> Trees <input type="checkbox"/> Saplings/Shrubs <input checked="" type="checkbox"/> Herbs <small>(check all that apply)</small>			
Dominant Bank Vegetation (list): Zea mays			
Aquatic Habitats (ex: submerged or emerged aquatic vegetation, overhanging banks/roots, leaf packs, large submerged wood, riffles, deep pools, etc.): No aquatic habitat was observed.			
Aquatic Organisms Observed (list): No aquatic organisms were observed.			
Disturbances (ex: livestock access, manure in waterbody, waste discharge pipes): The feature occurs within a recently planted corn field. A field road cuts through the feature.			
Observation Notes: The ephemeral stream flows through an agricultural field. A field road cuts through the feature and there are rubber mats placed on it.

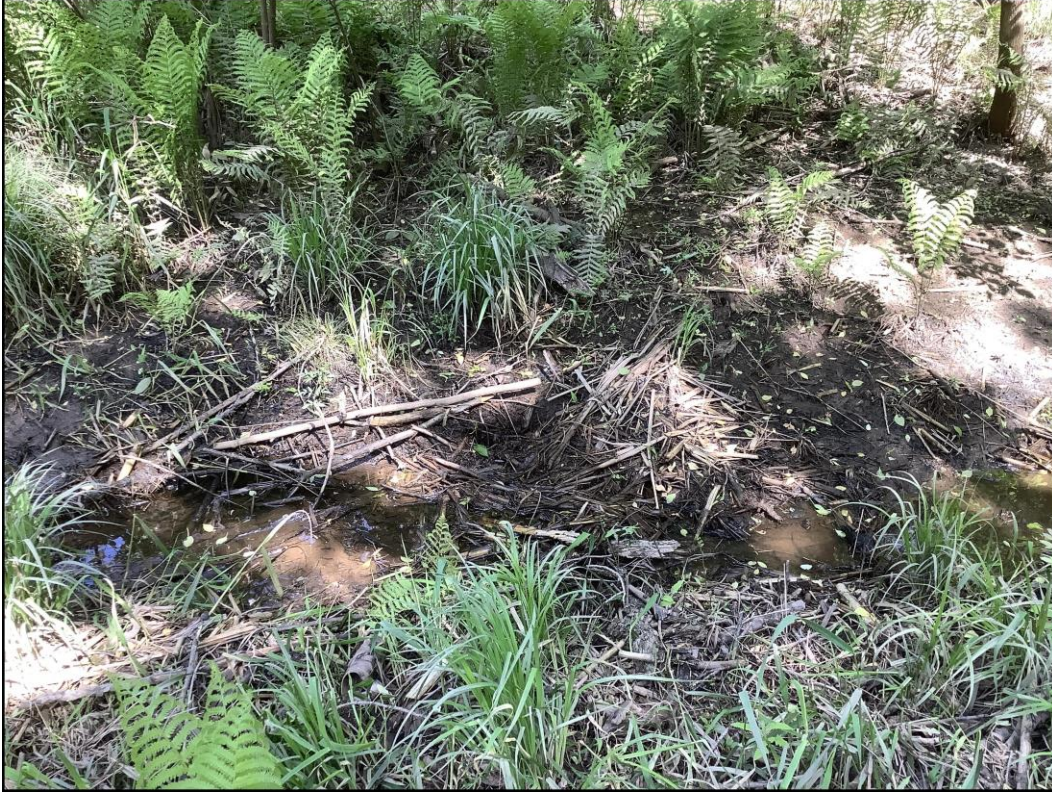
sase1019i_NW (across)

Vegetation Layers: <input checked="" type="checkbox"/> Trees <input checked="" type="checkbox"/> Saplings/Shrubs <input checked="" type="checkbox"/> Herbs <i>(check all that apply)</i>			
Dominant Bank Vegetation (list): Acer negundo, Carex crinita, Matteuccia struthiopteris, Onoclea sensibilis, Sambucus nigra, Alnus incana, Ribes americanum, Impatiens capensis, Stachys palustris, Laportea canadensis			
Aquatic Habitats (ex: submerged or emerged aquatic vegetation, overhanging banks/roots, leaf packs, large submerged wood, riffles, deep pools, etc.): Litter and debris, small pools.			
Aquatic Organisms Observed (list): Minnows and aquatic insects.			
Disturbances (ex: livestock access, manure in waterbody, waste discharge pipes): No anthropogenic disturbances were observed within the feature. Although, there is a corn field located to be north outside of the forest.			
Observation Notes: The intermittent stream flows through the forested floodplain of the Marengo River. There was groundwater seepage observed within the channel.

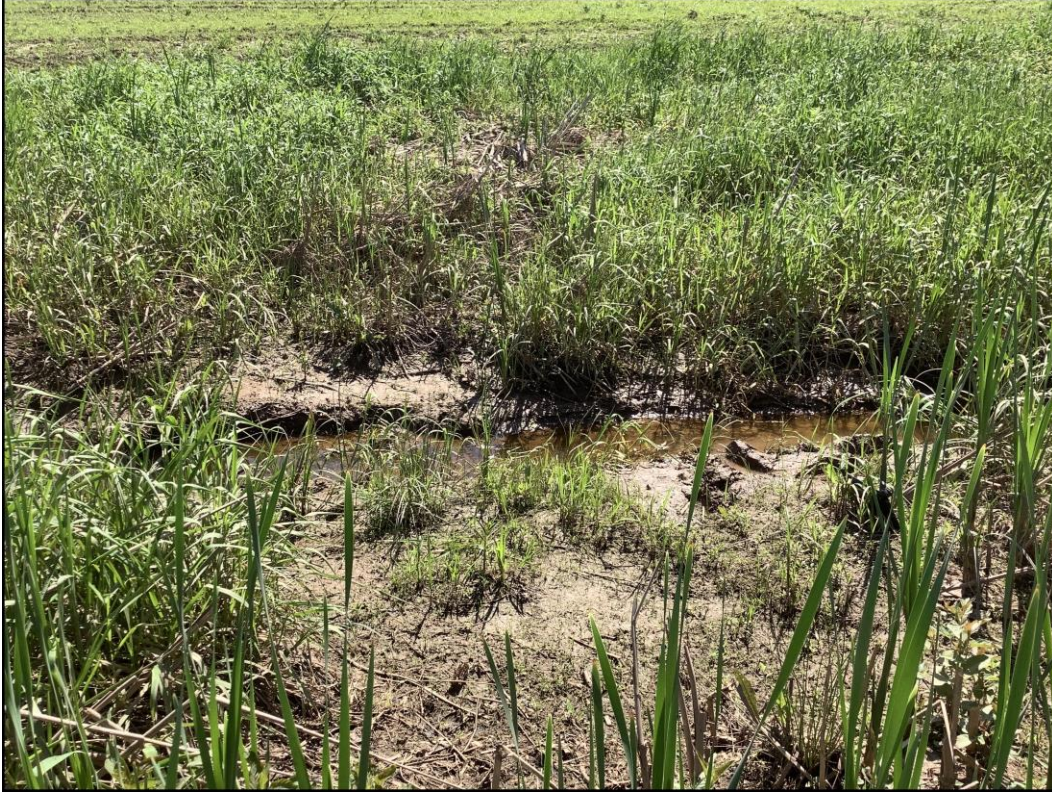
sase1018i_E (across)

Vegetation Layers: <input type="checkbox"/> Trees <input checked="" type="checkbox"/> Saplings/Shrubs <input checked="" type="checkbox"/> Herbs <i>(check all that apply)</i>			
Dominant Bank Vegetation (list): Salix petiolaris, Phalaris arundinacea, Typha sp.			
Aquatic Habitats (ex: submerged or emerged aquatic vegetation, overhanging banks/roots, leaf packs, large submerged wood, riffles, deep pools, etc.): Small pools and runs. Emergent and overhanging vegetation.			
Aquatic Organisms Observed (list): Aquatic insects, minnows and toads.			
Disturbances (ex: livestock access, manure in waterbody, waste discharge pipes): The feature is surrounded by a corn field. There is also a field road that runs over the stream/wetland towards the north end.			
Observation Notes: The intermittent stream flows north to south through a corn field and into a wooded area, where it becomes much wider. The stream is associated with wetland waste1055.

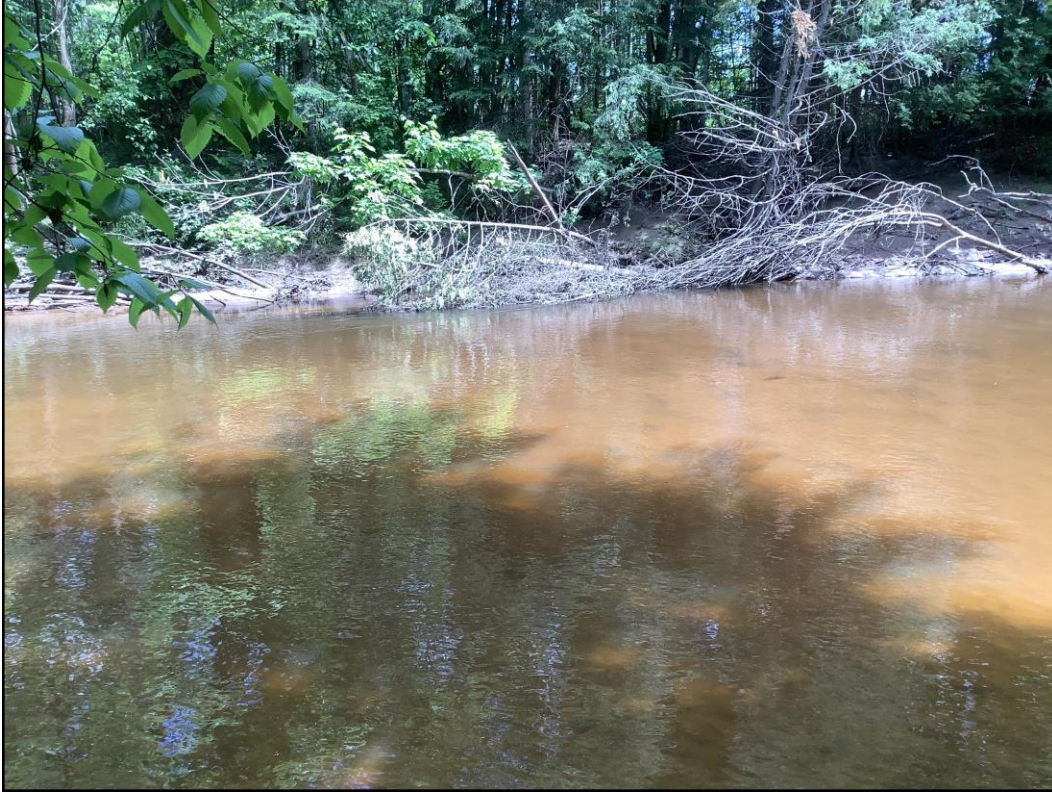
sase1020p_E (across)

Vegetation Layers: <input checked="" type="checkbox"/> Trees <input checked="" type="checkbox"/> Saplings/Shrubs <input checked="" type="checkbox"/> Herbs <i>(check all that apply)</i>			
Dominant Bank Vegetation (list): Ulmus americana, Acer saccharinum, Tsuga canadensis, Thuja occidentalis, Fraxinus pennsylvanica, Taxus canadensis, Betula alleghaniensis, Equisetum pratense			
Aquatic Habitats (ex: submerged or emerged aquatic vegetation, overhanging banks/roots, leaf packs, large submerged wood, riffles, deep pools, etc.): Large woody debris and overhanging vegetation.			
Aquatic Organisms Observed (list): Minnows and a wood frog.			
Disturbances (ex: livestock access, manure in waterbody, waste discharge pipes): There is a road bridge over the stream to the north outside of the survey corridor.			
Observation Notes: The Marengo River makes a deep bend south to north within the survey corridor. There are not many herbaceous plants along the sandy banks.

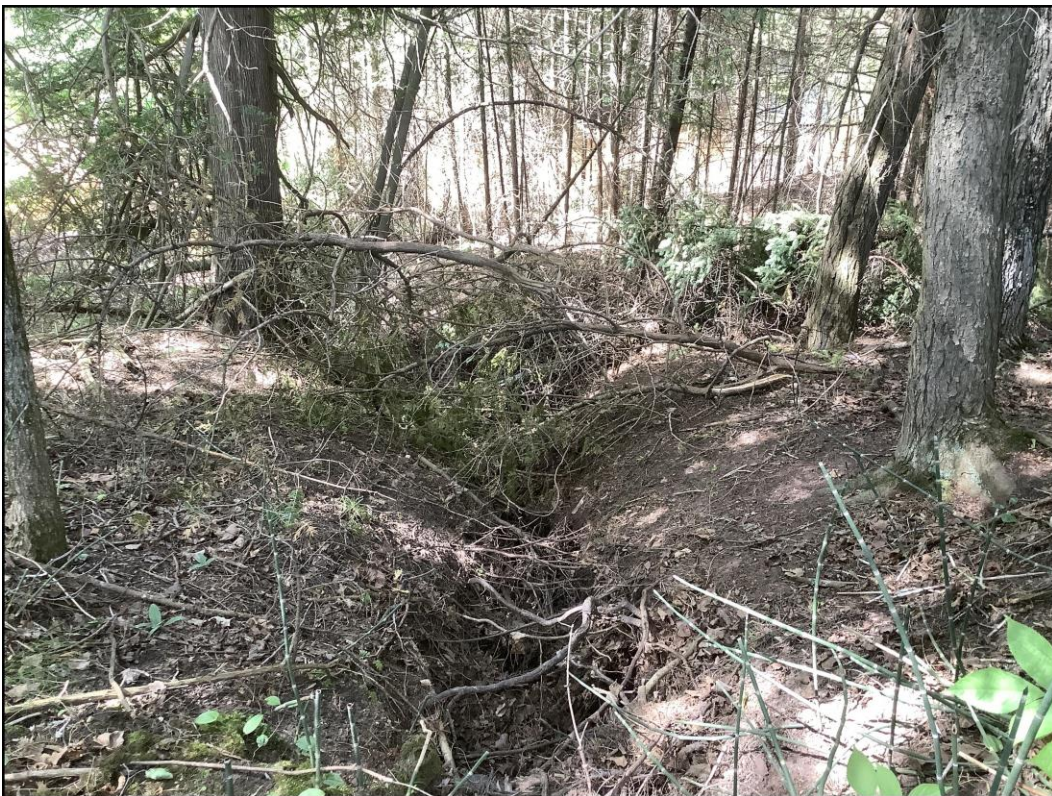
sase1021e_N (downstream)

Vegetation Layers: <input checked="" type="checkbox"/> Trees <input type="checkbox"/> Saplings/Shrubs <input checked="" type="checkbox"/> Herbs <small>(check all that apply)</small>			
Dominant Bank Vegetation (list): Thuja occidentalis, Tsuga canadensis, Acer saccharum, Anemone quinquefolia, Equisetum hyemale, Maianthemum canadense, Aralia nudicaulis			
Aquatic Habitats (ex: submerged or emerged aquatic vegetation, overhanging banks/roots, leaf packs, large submerged wood, riffles, deep pools, etc.): No aquatic habitat was observed.			
Aquatic Organisms Observed (list): No aquatic organisms were observed.			
Disturbances (ex: livestock access, manure in waterbody, waste discharge pipes): An agricultural swale leads to the feature.			
Observation Notes: The ephemeral stream is a washout feature that is derived from an agricultural swale to the south. The banks are eroded and there is a downed tree within the channel.

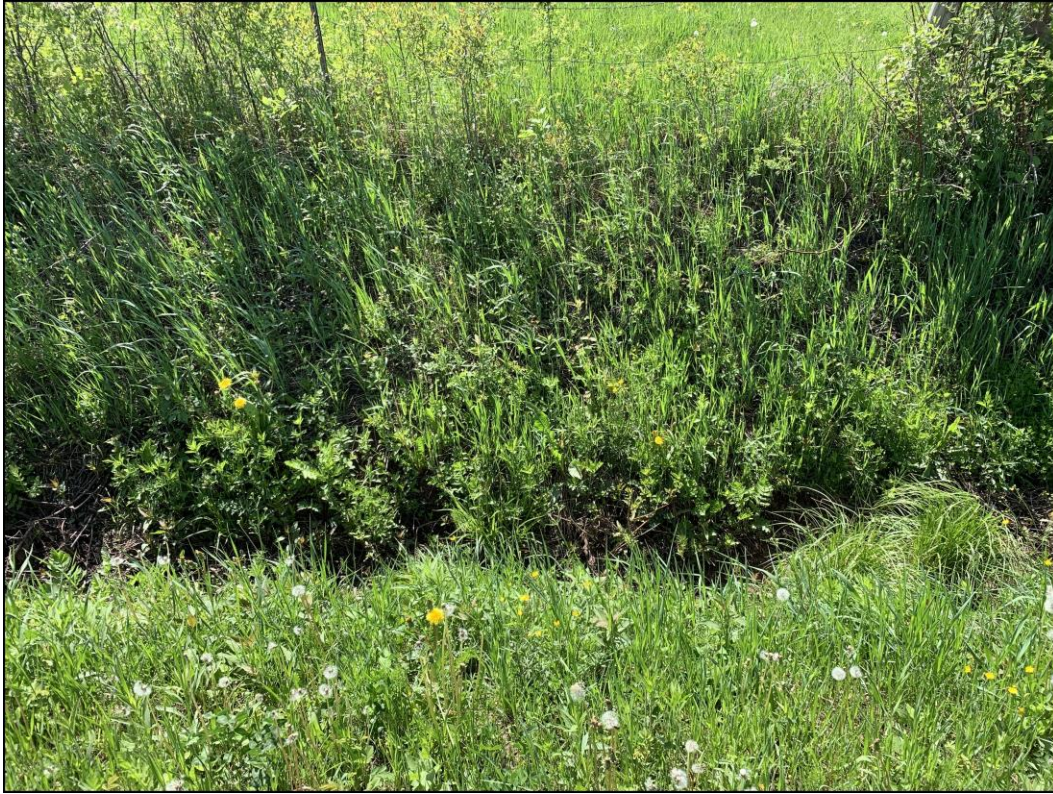
sase1008e_W (across)

Vegetation Layers: <input type="checkbox"/> Trees <input checked="" type="checkbox"/> Saplings/Shrubs <input checked="" type="checkbox"/> Herbs <i>(check all that apply)</i>			
Dominant Bank Vegetation (list): Phalaris arundinacea, Scirpus cyperinus, Ranunculus acris, Viburnum lentago, Anemone canadensis			
Aquatic Habitats (ex: submerged or emerged aquatic vegetation, overhanging banks/roots, leaf packs, large submerged wood, riffles, deep pools, etc.): Small pools of standing water were observed during the field survey.			
Aquatic Organisms Observed (list): No aquatic organisms were observed.			
Disturbances (ex: livestock access, manure in waterbody, waste discharge pipes): The feature occurs within a roadside ditch and receives runoff from the road and surrounding fields.			
Observation Notes: The ephemeral stream flows north through a roadside ditch. The feature flows through a culvert underneath a field approach.

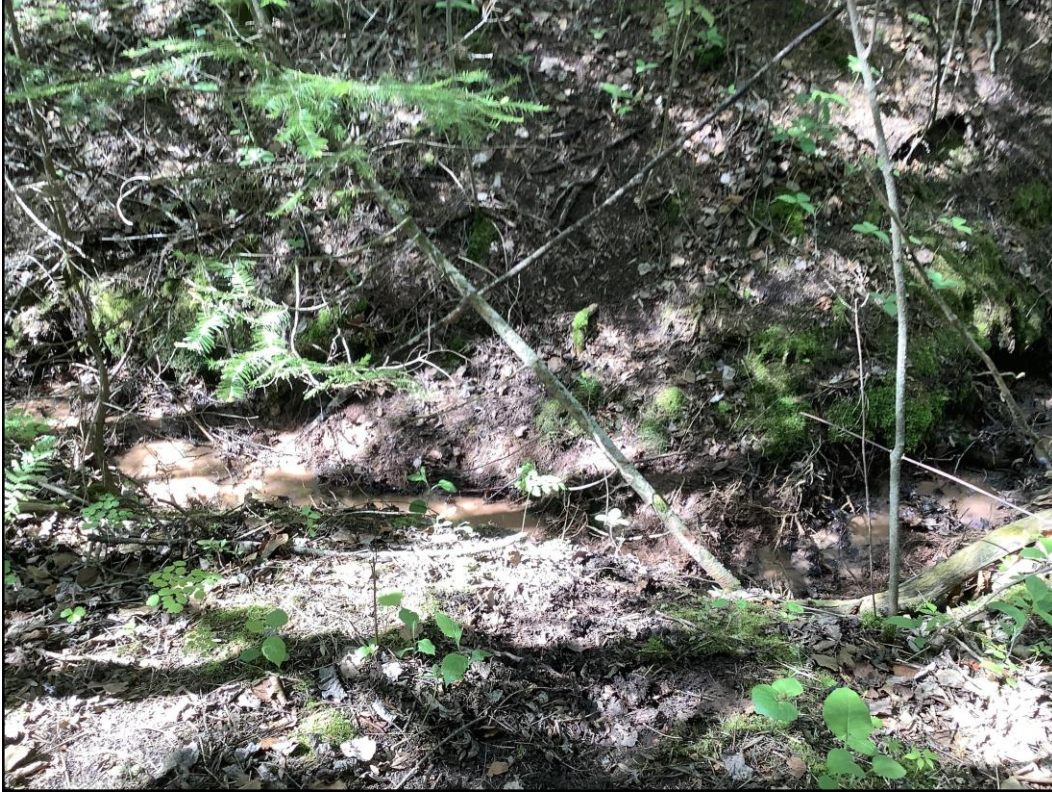
sase1009e_S (across)

Vegetation Layers: <input checked="" type="checkbox"/> Trees <input checked="" type="checkbox"/> Saplings/Shrubs <input checked="" type="checkbox"/> Herbs <i>(check all that apply)</i>			
Dominant Bank Vegetation (list): Abies balsamea, Micranthes pensylvanica, Asarum canadense, Athyrium filix-femina			
Aquatic Habitats (ex: submerged or emerged aquatic vegetation, overhanging banks/roots, leaf packs, large submerged wood, riffles, deep pools, etc.): Pools and large woody debris.			
Aquatic Organisms Observed (list): No aquatic organisms were observed.			
Disturbances (ex: livestock access, manure in waterbody, waste discharge pipes): The banks of the stream are eroded.			
Observation Notes: Th ephemeral stream begins at wetland wase1043f and flows east through a woodland until it reaches an intermittent stream.

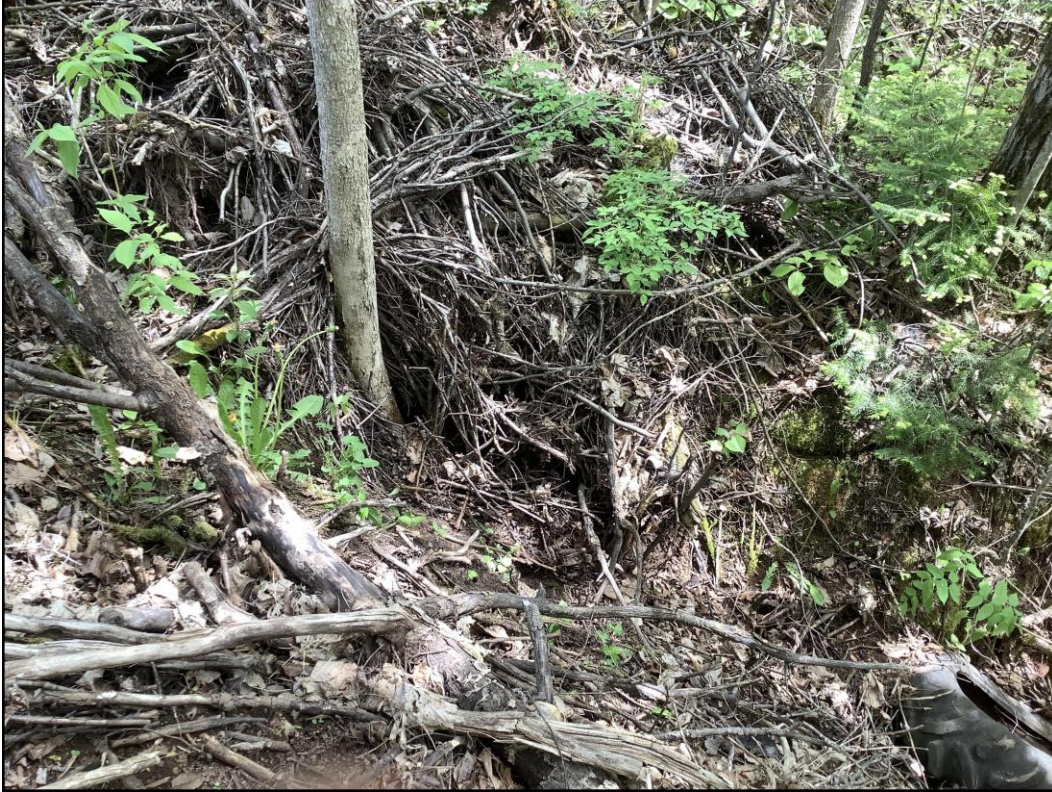
sase1012e_N (across)

Vegetation Layers: <input checked="" type="checkbox"/> Trees <input checked="" type="checkbox"/> Saplings/Shrubs <input checked="" type="checkbox"/> Herbs <i>(check all that apply)</i>					
Dominant Bank Vegetation (list): Fraxinus nigra, Viburnum lentago, Taraxacum officinale, Rubus idaeus, Cornus alba					
Aquatic Habitats (ex: submerged or emerged aquatic vegetation, overhanging banks/roots, leaf packs, large submerged wood, riffles, deep pools, etc.): Small pools and large woody debris were observed within the feature.					
Aquatic Organisms Observed (list): None.					
Disturbances (ex: livestock access, manure in waterbody, waste discharge pipes): The feature occurs along the edge of an agricultural field. The feature has been filled with sticks, stones, and a tire.					
Observation Notes: The ephemeral stream occurs along the edge of a woodland and crop field. The headwater begins at wase1041e and it flows into sase1009e.

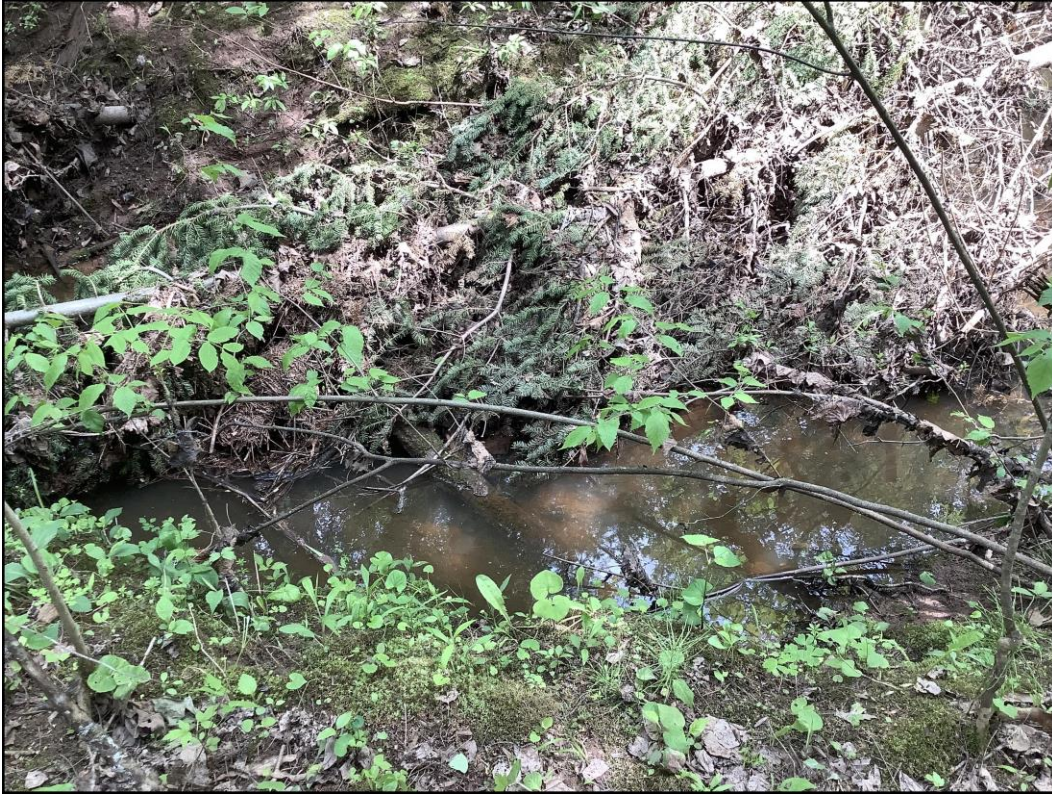
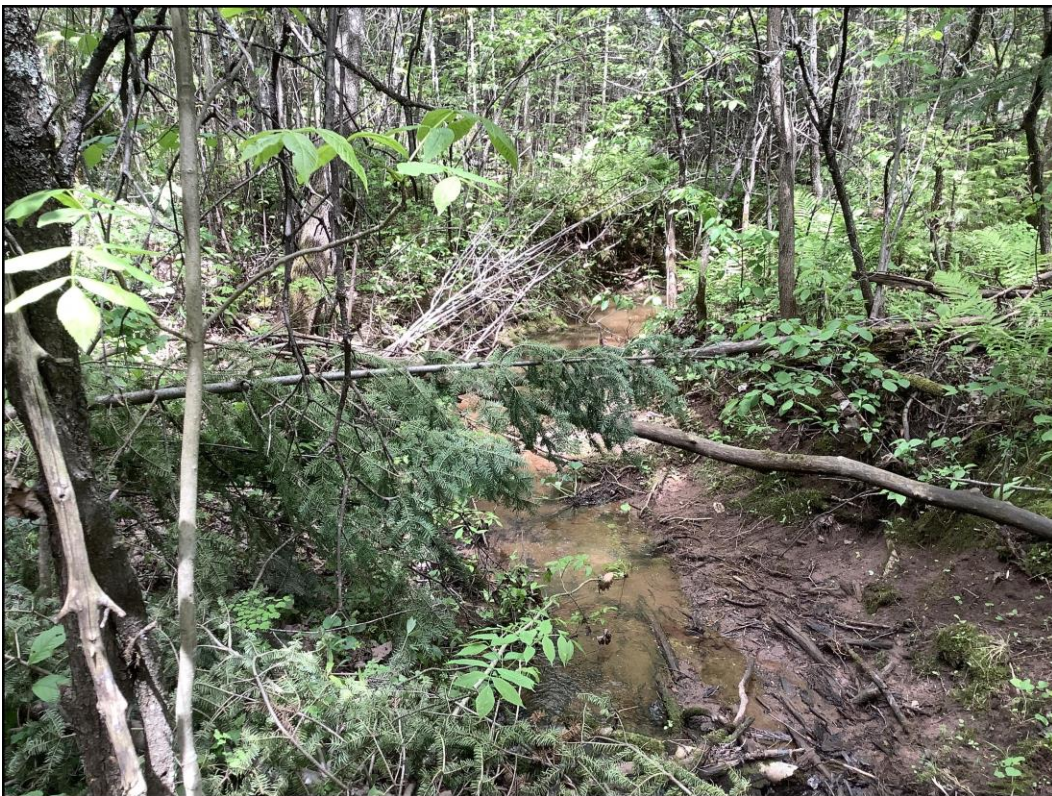
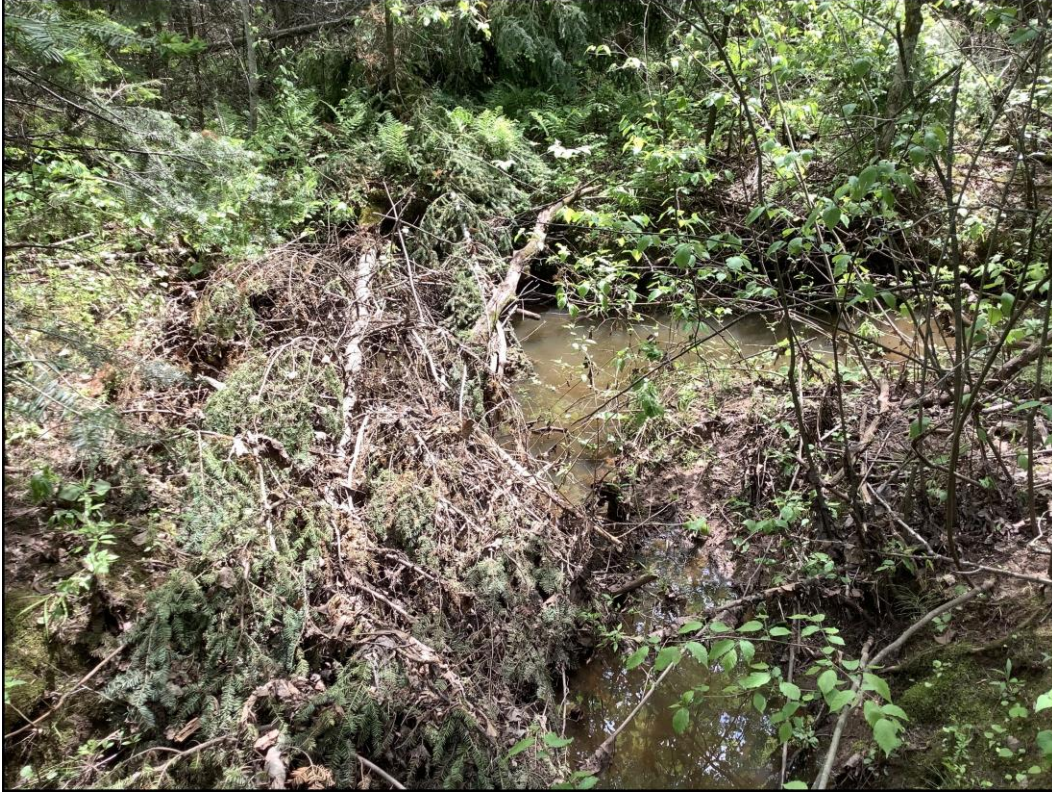
Vegetation Layers: <input checked="" type="checkbox"/> Trees <input checked="" type="checkbox"/> Saplings/Shrubs <input checked="" type="checkbox"/> Herbs <i>(check all that apply)</i>			
Dominant Bank Vegetation (list): Abies balsamea, Tilia americana, Viola pubescens, Asarum canadense, Solidago flexicaulis			
Aquatic Habitats (ex: submerged or emerged aquatic vegetation, overhanging banks/roots, leaf packs, large submerged wood, riffles, deep pools, etc.): Large woody debris and pools.			
Aquatic Organisms Observed (list): Aquatic insects were observed. Potential for amphibians and reptiles.			
Disturbances (ex: livestock access, manure in waterbody, waste discharge pipes): The banks are eroded.			
Observation Notes: The feature is contiguous with sase1011i. The feature meanders through a woodland. Sase1009e empties into this reach of the stream.

sase1010i_E (across)

sase1010i_N (downstream)

sase1010i_S (upstream)

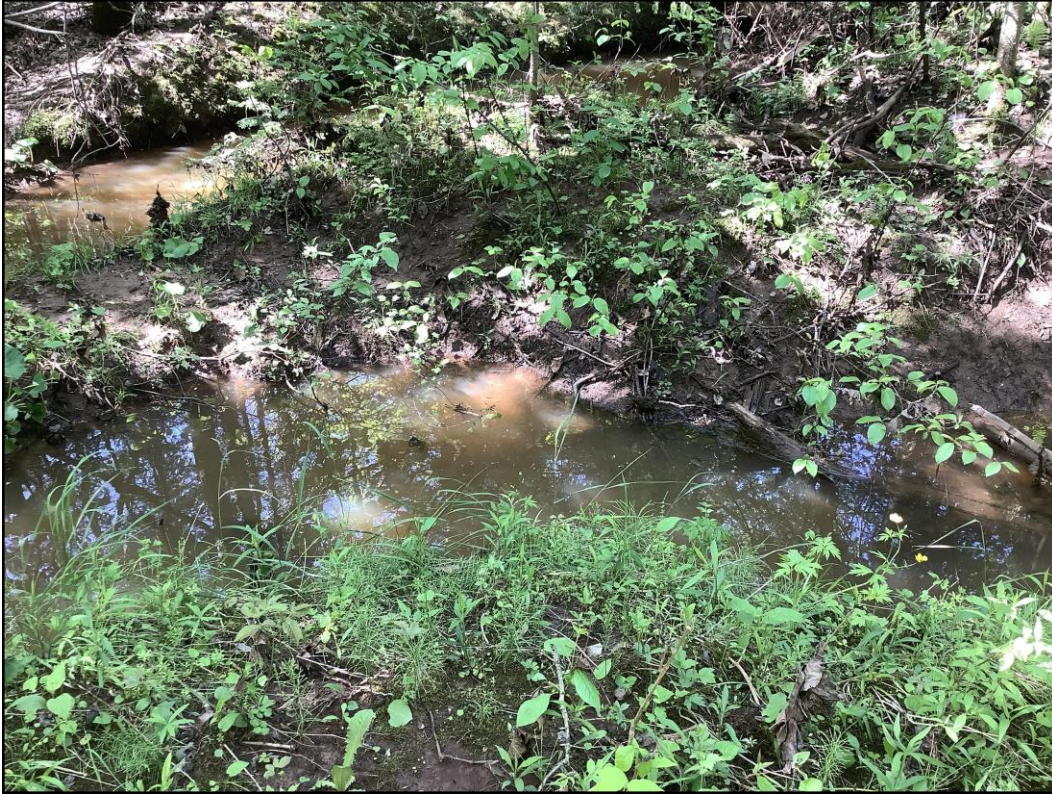
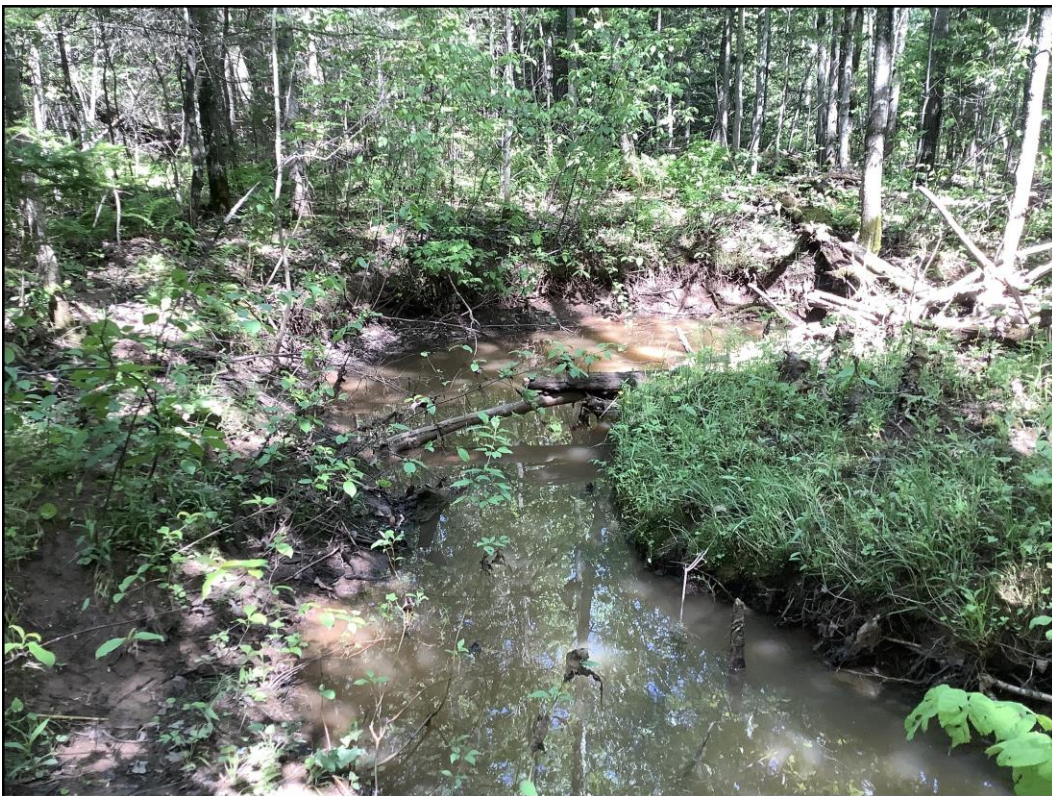
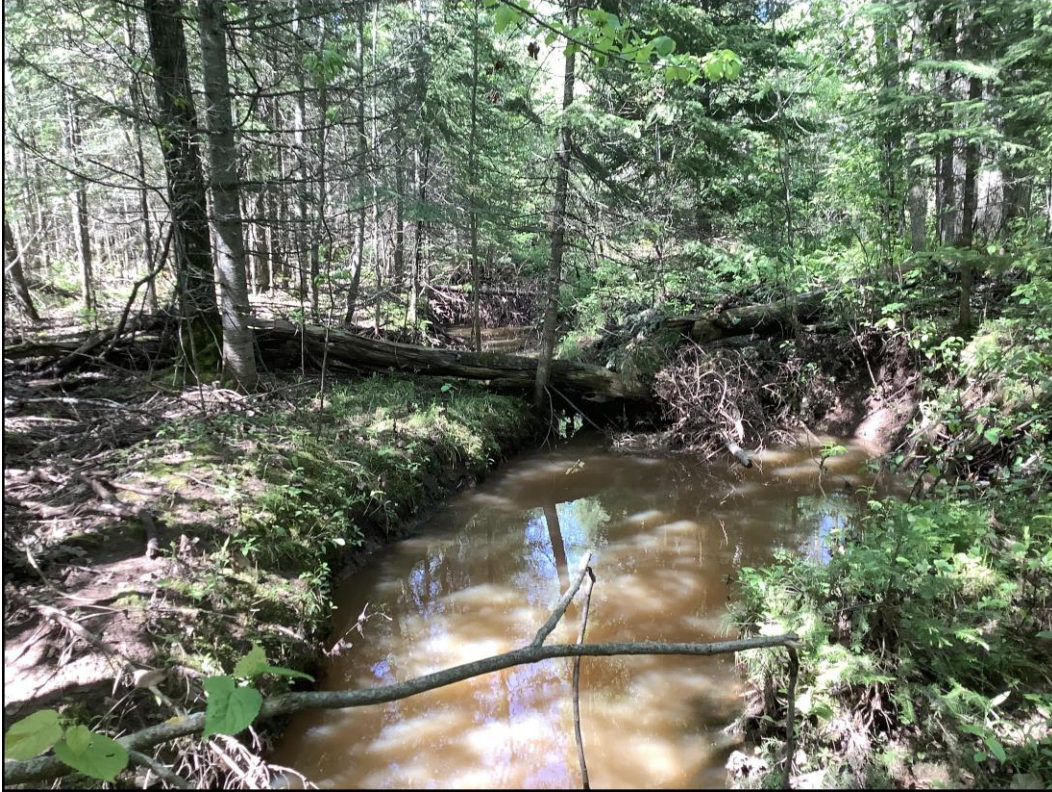
Vegetation Layers: <input checked="" type="checkbox"/> Trees <input checked="" type="checkbox"/> Saplings/Shrubs <input checked="" type="checkbox"/> Herbs <i>(check all that apply)</i>			
Dominant Bank Vegetation (list): Tilia americana, Abies balsamea, Prunus virginiana, Carex gracillima, Equisetum arvense, Caltha palustris, Salix petiolaris, Adiantum pedatum, Calamagrostis canadensis, Bromus inermis			
Aquatic Habitats (ex: submerged or emerged aquatic vegetation, overhanging banks/roots, leaf packs, large submerged wood, riffles, deep pools, etc.): Small riffles, runs, and pools. Large woody debris.			
Aquatic Organisms Observed (list): Aquatic insects were observed on the surface of the stream, and there is potential for amphibians and reptiles to utilize the feature.			
Disturbances (ex: livestock access, manure in waterbody, waste discharge pipes): The banks of the feature are eroded.

Observation Notes: The feature is an intermittent stream that meanders through a forest. The stream exits the forest into an opening at the north end. The banks are eroded, and the water is turbid. The forest is bordered by agricultural land. Sase1009e and wase1043f drain into this stream.

sase1011i_S (across)

sase1011i_NW (downstream)

sase1011i_SW (upstream)

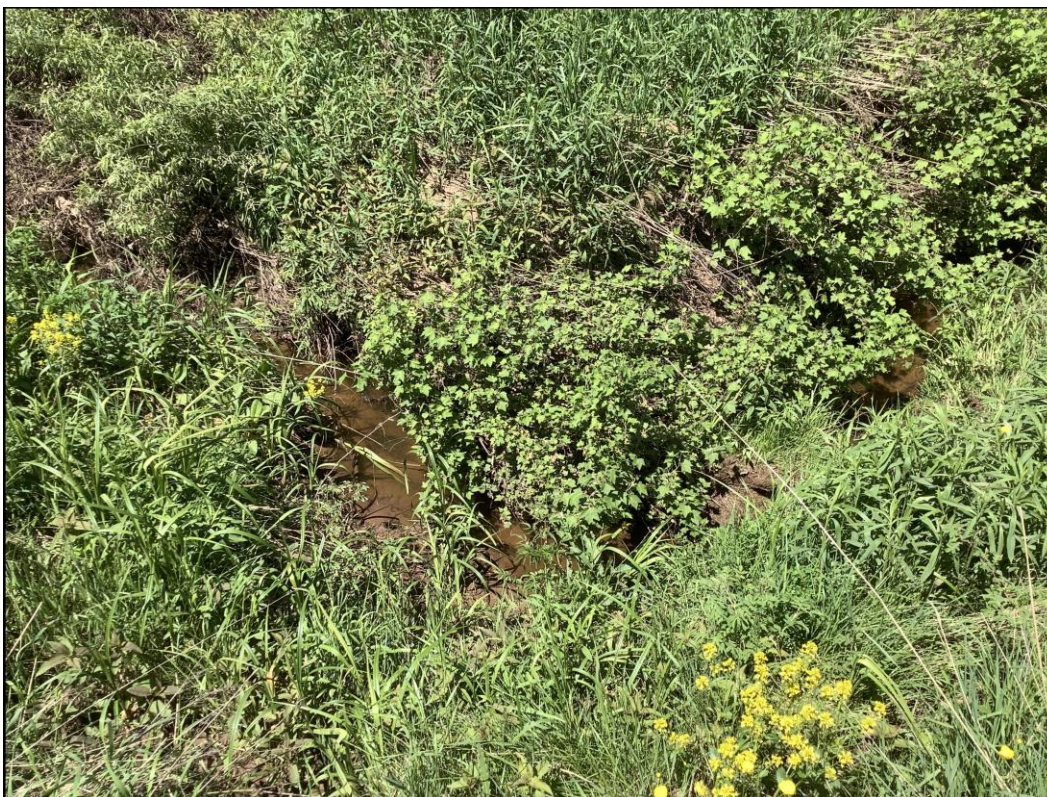
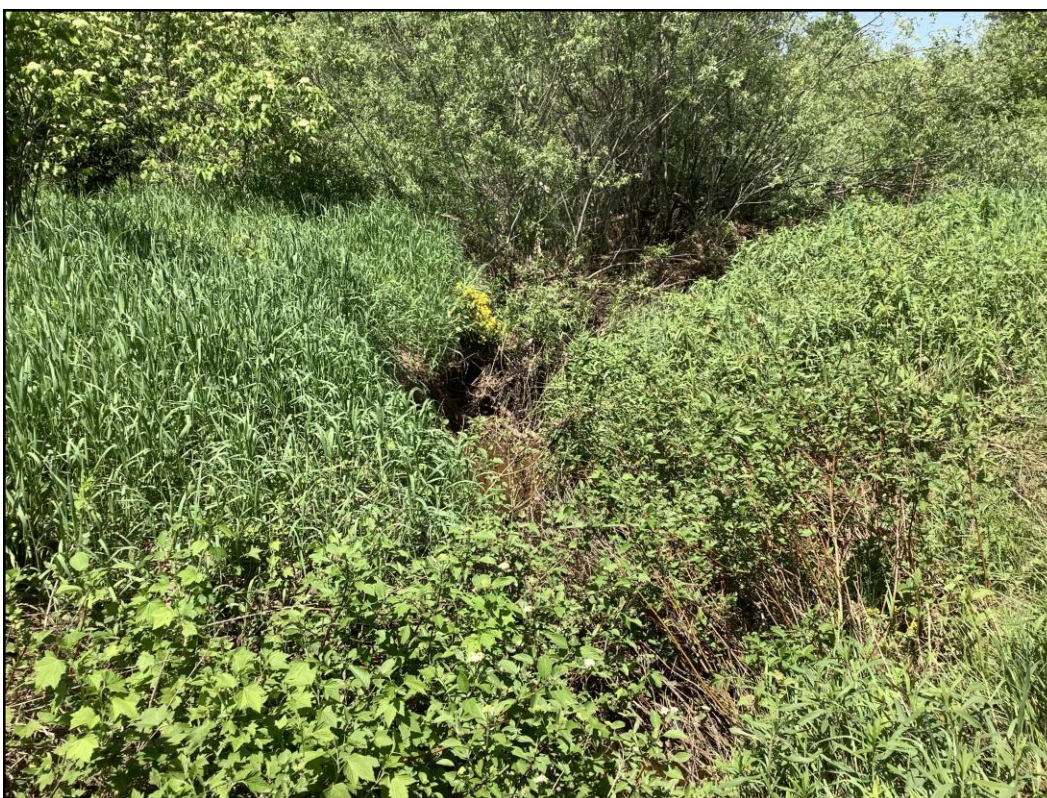
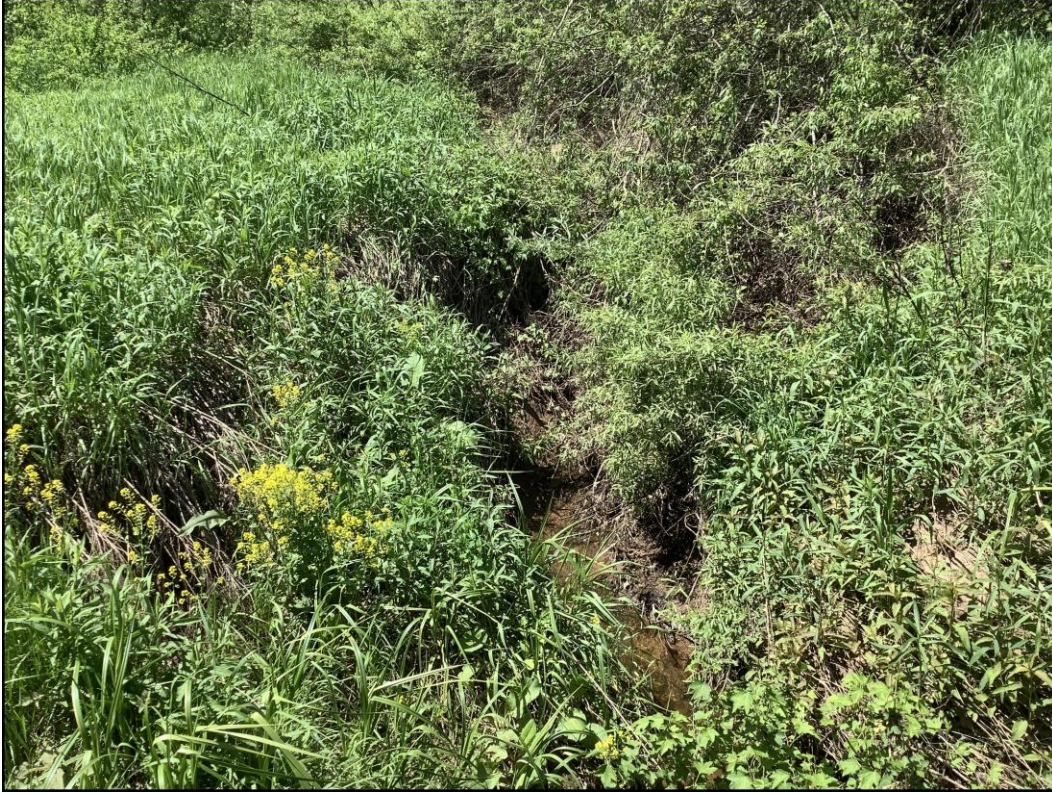
Vegetation Layers: <input type="checkbox"/> Trees <input checked="" type="checkbox"/> Saplings/Shrubs <input checked="" type="checkbox"/> Herbs <small>(check all that apply)</small>			
Dominant Bank Vegetation (list): Salix petiolaris, Ribes americanum, Cornus alba, Solidago gigantea, Bromus inermis			
Aquatic Habitats (ex: submerged or emerged aquatic vegetation, overhanging banks/roots, leaf packs, large submerged wood, riffles, deep pools, etc.): Small riffles and pools, overhanging vegetation.			
Aquatic Organisms Observed (list): Aquatic insects were observed. Amphibians and reptiles are assumed to use the feature.			
Disturbances (ex: livestock access, manure in waterbody, waste discharge pipes): The feature flows through a culvert under a lightly used field road on the north end.			
Observation Notes: The intermittent stream flows south to north through the survey area. The feature is located between a small woodland and an alfalfa field. There is a small, lightly used field road with culverts on the north end of the feature.

sase1015i_W (across)

sase1015i_NW (downstream)

sase1015i_SW (upstream)

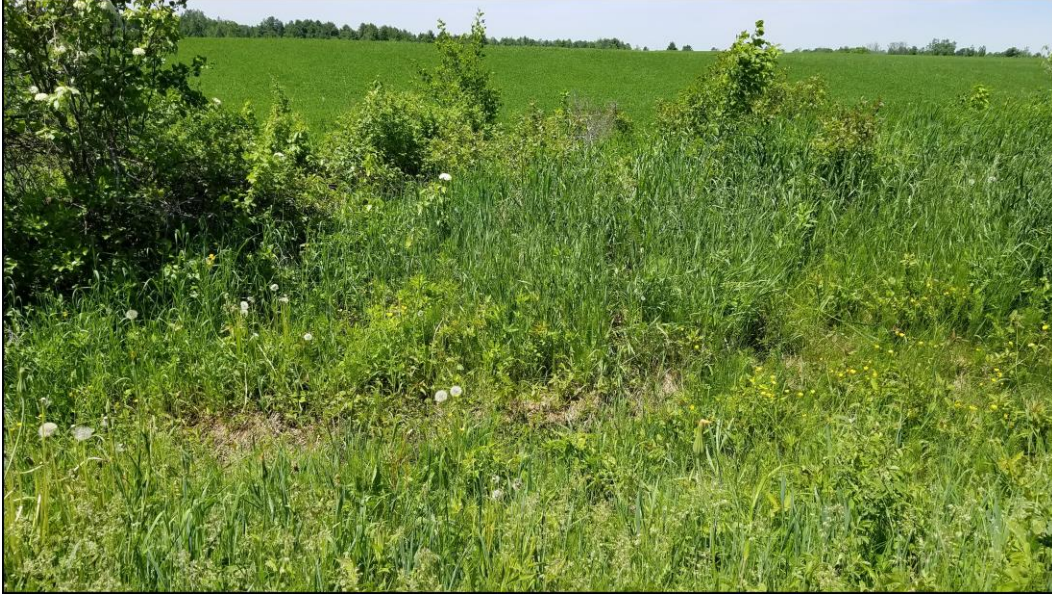
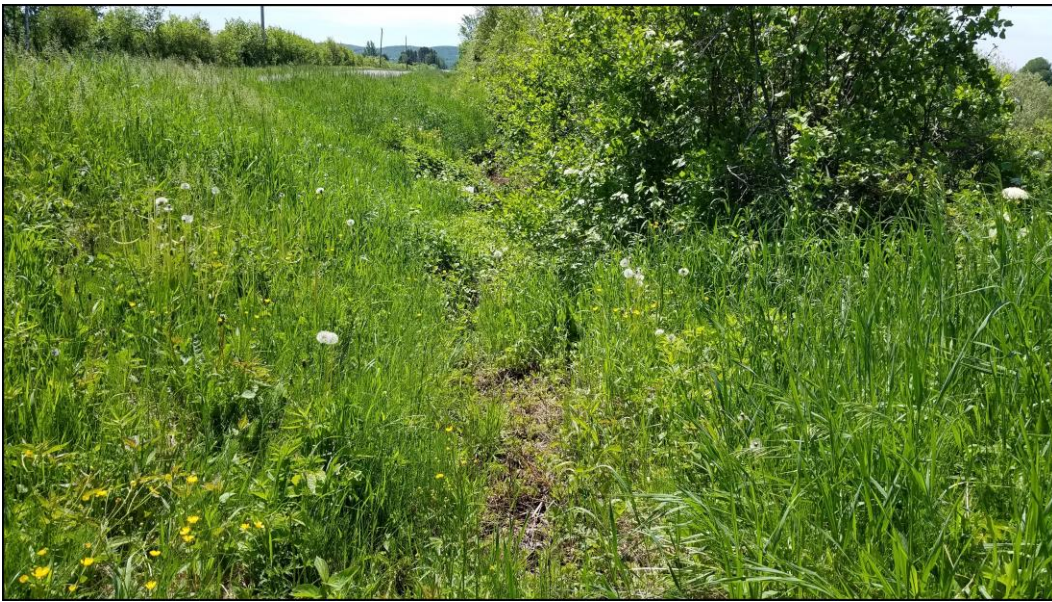
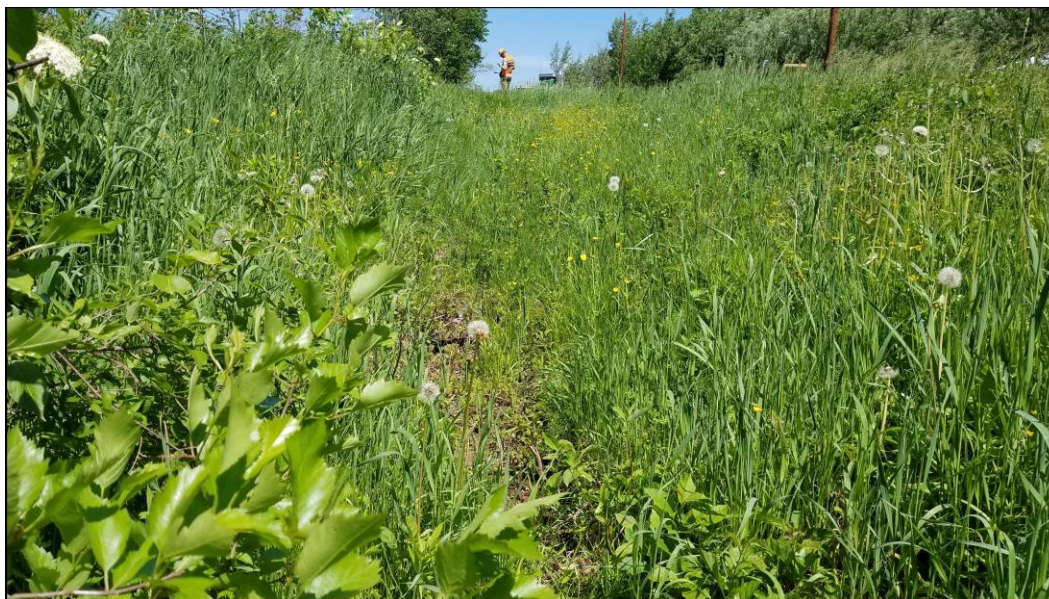
Existing Condition^a: <input type="checkbox"/> Highly Functional Stream <input type="checkbox"/> Moderately Functional Stream <input checked="" type="checkbox"/> Functionally Impaired Stream <small>(check one)</small>			
Feature Description: <input type="checkbox"/> Natural <input checked="" type="checkbox"/> Artificial, man-made <input type="checkbox"/> Manipulated <small>(check one)</small>			
Flow Regime: <input checked="" type="checkbox"/> Ephemeral <input type="checkbox"/> Intermittent <input type="checkbox"/> Perennial <input type="checkbox"/> Connecting Swale <small>(check one)</small>			
Sinuosity within Survey Corridor: <input checked="" type="checkbox"/> Straight <input type="checkbox"/> Meandering <small>(check one)</small>			
Description Notes: Ephemeral stream in the bottom of a roadside ditch. The land across the ditch from the road is a hay field. Receives input from culvert to the north.

Observations			
Riparian Zone Present: <input type="checkbox"/> Yes <input checked="" type="checkbox"/> No <small>(check one)</small>			
Vegetation Layers: <input type="checkbox"/> Trees <input type="checkbox"/> Saplings/Shrubs <input checked="" type="checkbox"/> Herbs <small>(check all that apply)</small>			
Dominant Bank Vegetation (list): Phalaris arundinacea, Equisetum arvense, Ranunculus acris, Carex stipata			
Aquatic Habitats (ex: submerged or emerged aquatic vegetation, overhanging banks/roots, leaf packs, large submerged wood, riffles, deep pools, etc.): None.			
Aquatic Organisms Observed (list): None.			
Disturbances (ex: livestock access, manure in waterbody, waste discharge pipes): Stormwater runoff from adjacent road and hay field.			
Observation Notes: None.

sase1016e_W (across)

sase1016e_S (downstream)

sase1016e_N (upstream)
