Waterbody Data Sheet

Description			
Project Name: Line 5 Relocation Project		Date: 2020-06-12	Waterbody Survey ID: sbad1001e
State: Wisconsin	County/Parish: Bayfield	USGS Waterbody Name: None	
Company: Enbridge	Crew Member Initials: KDF/AGG	Latitude: 46.575124	Longitude: -91.032516
Survey Type: <input checked="" type="checkbox"/> Centerline <input type="checkbox"/> Re-Route <input type="checkbox"/> Access Road <input type="checkbox"/> Facility <input type="checkbox"/> Other <small>(check one)</small>			
Waterbody Type: <input type="checkbox"/> River <input checked="" type="checkbox"/> Stream <input type="checkbox"/> Ditch <input type="checkbox"/> Swale <input type="checkbox"/> Canal <input type="checkbox"/> Other <small>(check one)</small>			
Water Appearance: <input type="checkbox"/> No Water <input checked="" type="checkbox"/> Clear <input type="checkbox"/> Turbid <input type="checkbox"/> Sheen on Surface <input type="checkbox"/> Surface Scum <input type="checkbox"/> Algal Mats <input type="checkbox"/> Other <small>(check one)</small>

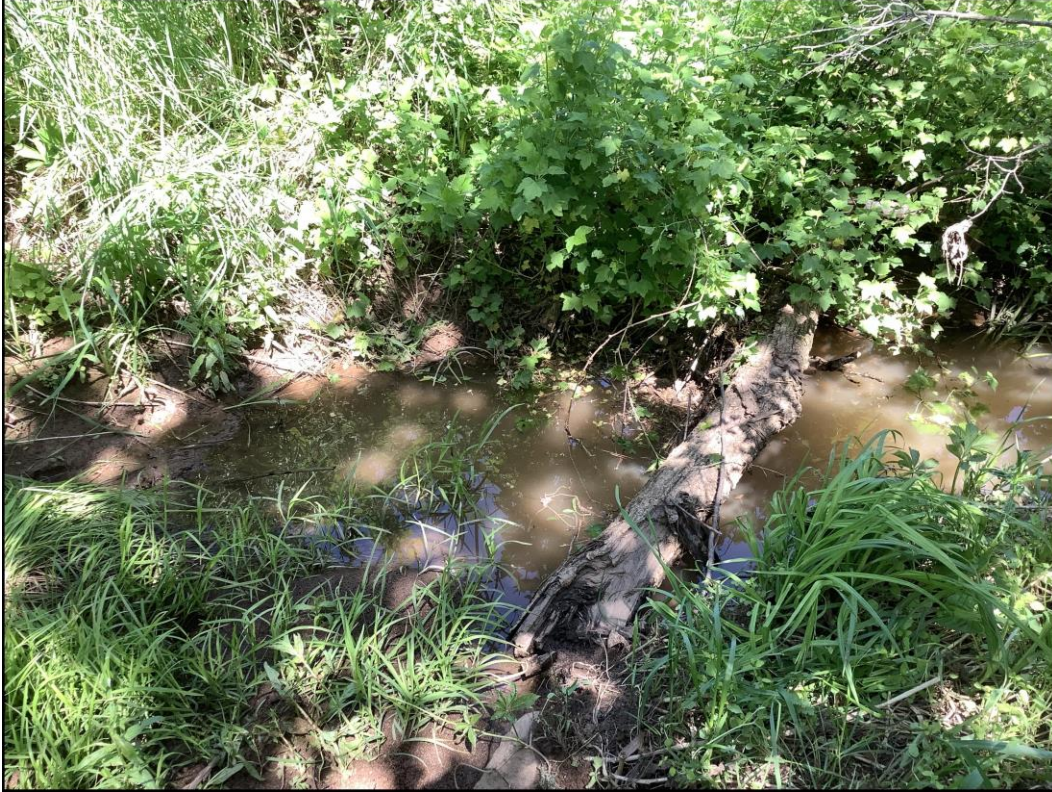
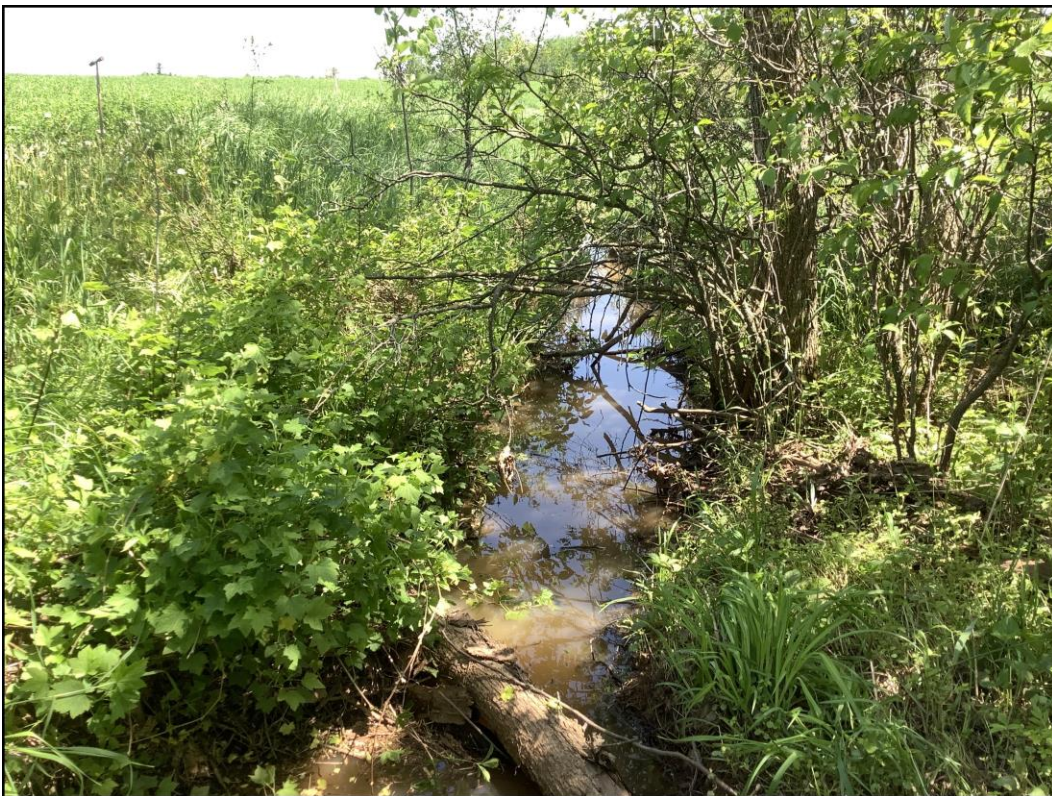
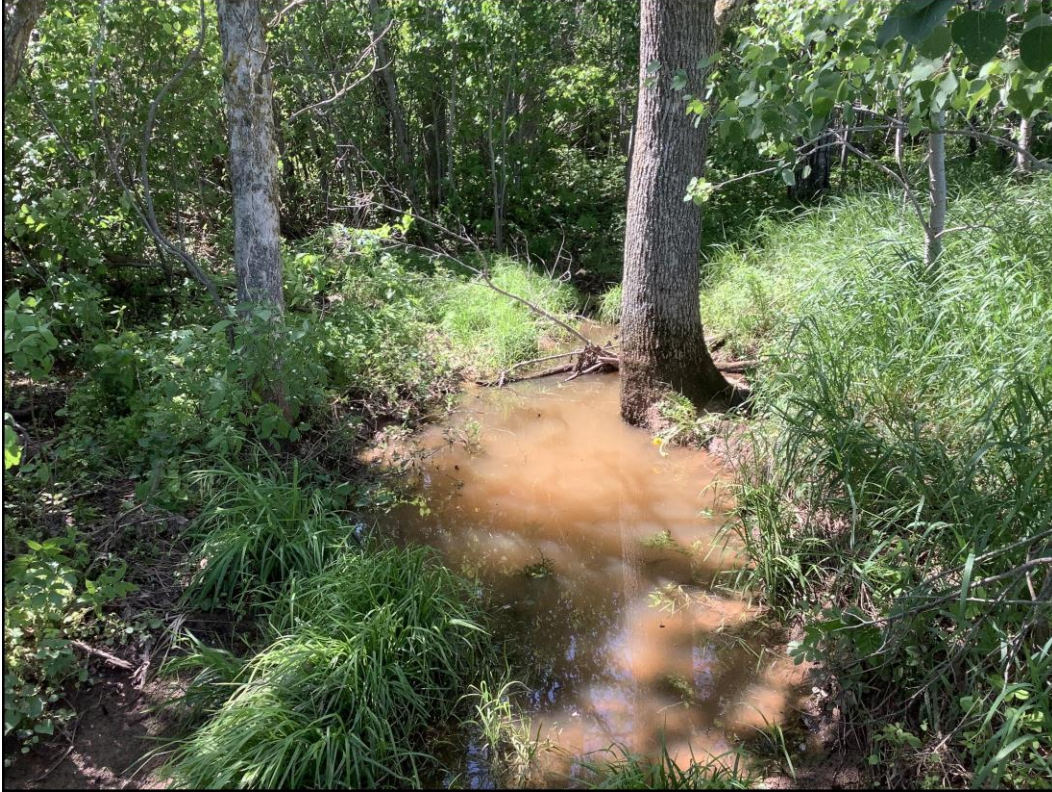
Vegetation Layers: <input checked="" type="checkbox"/> Trees <input checked="" type="checkbox"/> Saplings/Shrubs <input checked="" type="checkbox"/> Herbs <small>(check all that apply)</small>			
Dominant Bank Vegetation (list): Bromus inermis, Glyceria cf striata, Fraxinus pennsylvanica, Populus tremuloides, Ribes americanum			
Aquatic Habitats (ex: submerged or emerged aquatic vegetation, overhanging banks/roots, leaf packs, large submerged wood, riffles, deep pools, etc.): Pools, overhanging vegetation, and large woody debris.			
Aquatic Organisms Observed (list): We only observed aquatic insects, but reptiles and amphibians could utilize the feature.			
Disturbances (ex: livestock access, manure in waterbody, waste discharge pipes): The feature is surrounded by alfalfa fields.			
Observation Notes: The feature flows west to east through agricultural land. The feature terminates into wetland wase1048e.

sase1013e_N (across)

sase1013e_E (downstream)

sase1013e_SW (upstream)

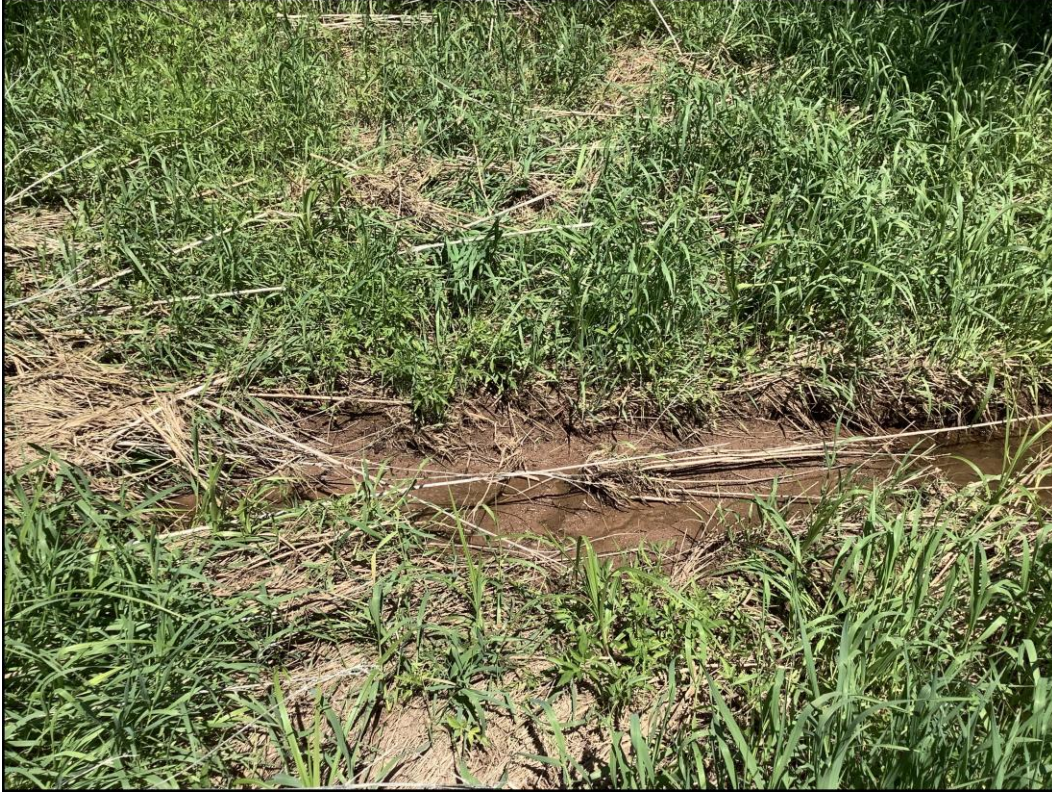
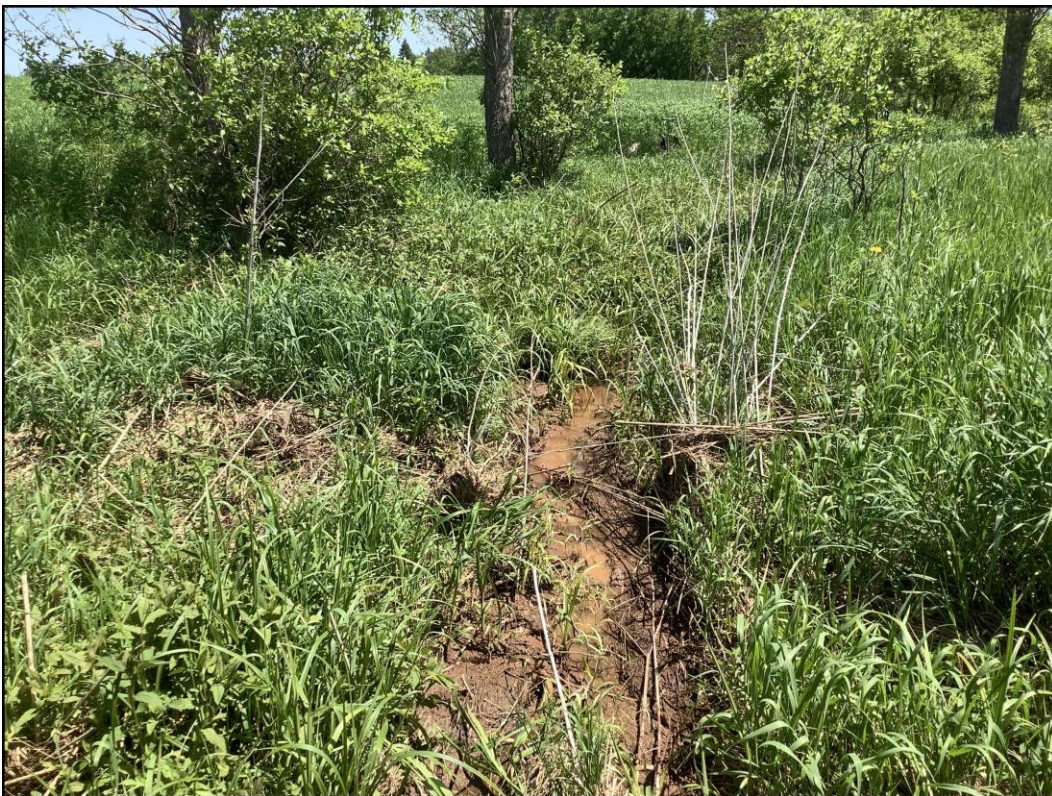
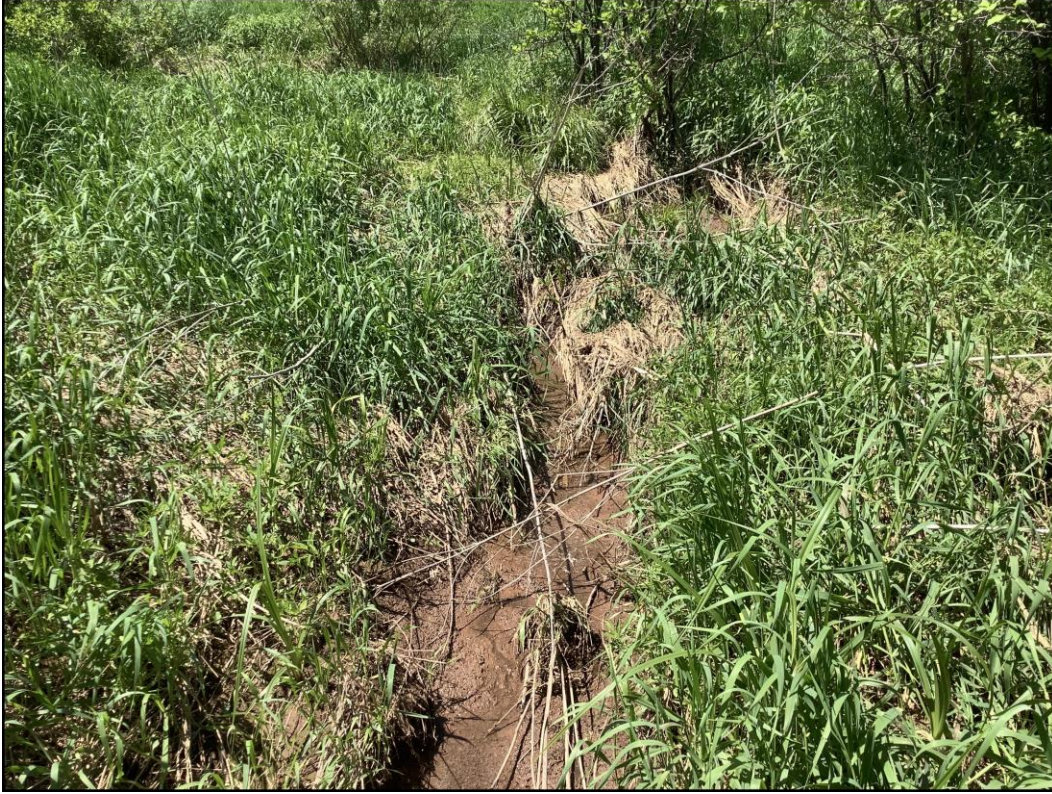
Vegetation Layers: <input checked="" type="checkbox"/> Trees <input checked="" type="checkbox"/> Saplings/Shrubs <input checked="" type="checkbox"/> Herbs <small>(check all that apply)</small>			
Dominant Bank Vegetation (list): Fraxinus nigra, Crataegus sp., Malus pumila, Bromus inermis, Scirpus microcarpus, Lysimachia ciliata			
Aquatic Habitats (ex: submerged or emerged aquatic vegetation, overhanging banks/roots, leaf packs, large submerged wood, riffles, deep pools, etc.): Pools and overhanging vegetation.			
Aquatic Organisms Observed (list): None.			
Disturbances (ex: livestock access, manure in waterbody, waste discharge pipes): The stream is surrounded by alfalfa field.			
Observation Notes: The ephemeral stream flows west to east through agricultural land. This feature is contiguous with stream sase1013e and eventually leads to wetland wase1048e to the east.

sase1014e_N (across)

sase1014e_E (downstream)

sase1014e_W (upstream)

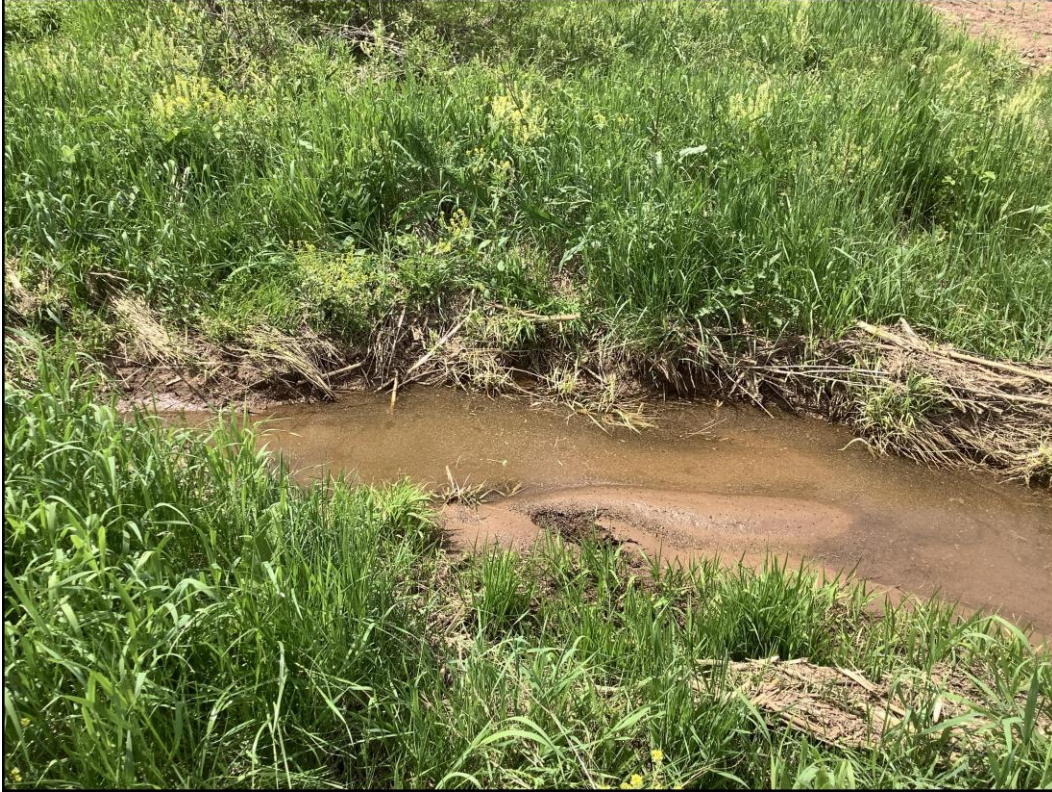
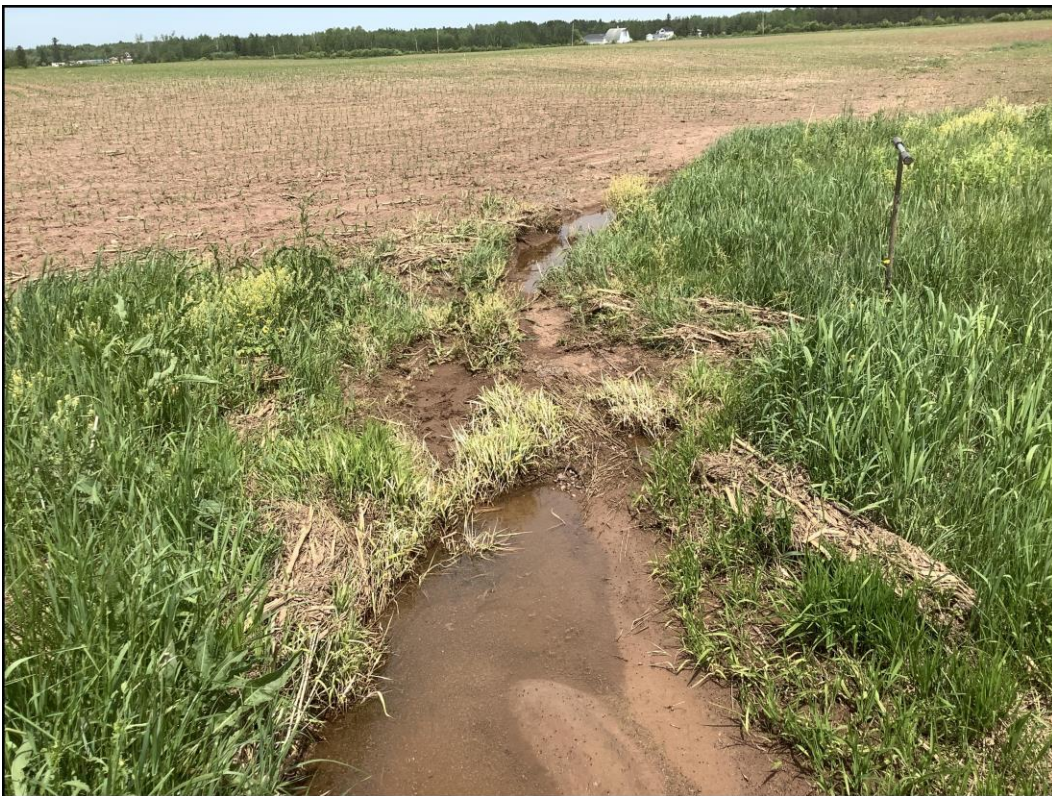
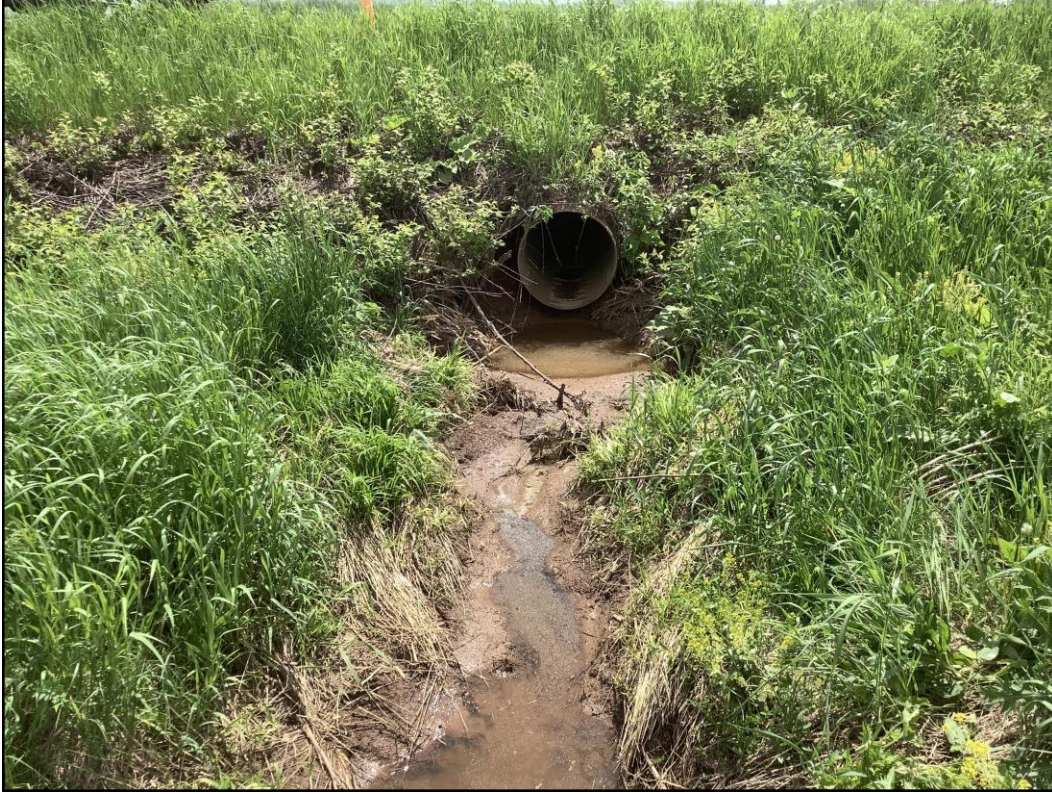
Existing Condition^a: <input checked="" type="checkbox"/> Highly Functional Stream <input type="checkbox"/> Moderately Functional Stream <input checked="" type="checkbox"/> Functionally Impaired Stream <small>(check one)</small>			
Feature Description: <input type="checkbox"/> Natural <input type="checkbox"/> Artificial, man-made <input checked="" type="checkbox"/> Manipulated <small>(check one)</small>			
Flow Regime: <input checked="" type="checkbox"/> Ephemeral <input type="checkbox"/> Intermittent <input type="checkbox"/> Perennial <input type="checkbox"/> Connecting Swale <small>(check one)</small>			
Sinuosity within Survey Corridor: <input type="checkbox"/> Straight <input checked="" type="checkbox"/> Meandering <small>(check one)</small>			
Description Notes: There was no flowing water within the stream during the survey. However, a turbid pool of water was observed near the culvert.

Observations			
Riparian Zone Present: <input type="checkbox"/> Yes <input checked="" type="checkbox"/> No <small>(check one)</small>			
Vegetation Layers: <input type="checkbox"/> Trees <input type="checkbox"/> Saplings/Shrubs <input checked="" type="checkbox"/> Herbs <small>(check all that apply)</small>			
Dominant Bank Vegetation (list): Barbarea vulgaris, Bromus inermis			
Aquatic Habitats (ex: submerged or emerged aquatic vegetation, overhanging banks/roots, leaf packs, large submerged wood, riffles, deep pools, etc.): Small pool.			
Aquatic Organisms Observed (list): Aquatic insects.			
Disturbances (ex: livestock access, manure in waterbody, waste discharge pipes): The feature flows under a road through a culvert. The feature also flows into a planted corn field.			
Observation Notes: The ephemeral stream flows south to north through crop fields. The feature begins on the south side of the road within a swale in a corn field. It flows under the road through a culvert and terminates in another cropland swale.

sase1017e_SW (across)

sase1017e_NE (downstream)

sase1017e_SW (upstream)
