Appendix D: Geotechnical Engineering and Geology

Kinnickinnic River Continuing Authorities Program Section 206 Feasibility Report and Integrated Environmental Assessment

May 2025

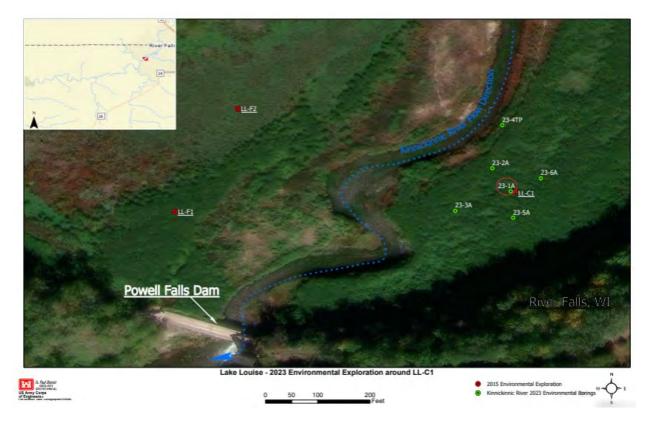
Figure D-1: Map of Lake Louise USACE environmental boring locations taken in 2023 around boring LL-C1.

A total of 5 hand augured soil borings and 1 test pit were conducted as part of the sediment quality exploration on 25 October 2023 (Attachment D-2). These borings were drilled to depths of 4 to 6 feet below the existing ground surface. Soils encountered in these borings were classified in the field as primarily silty clay with fine sand with slight laminations and was dark grey in color. Minor constituents include occasional roots and vegetation, occasional silty sand pockets or lenses with traces of iron oxide staining and shell fragments. Five bag samples were collected for chemical analysis of metals and holes were backfilled with the existing nearby soils. One jar sample was collected near the stream bank from a shallow test pit.

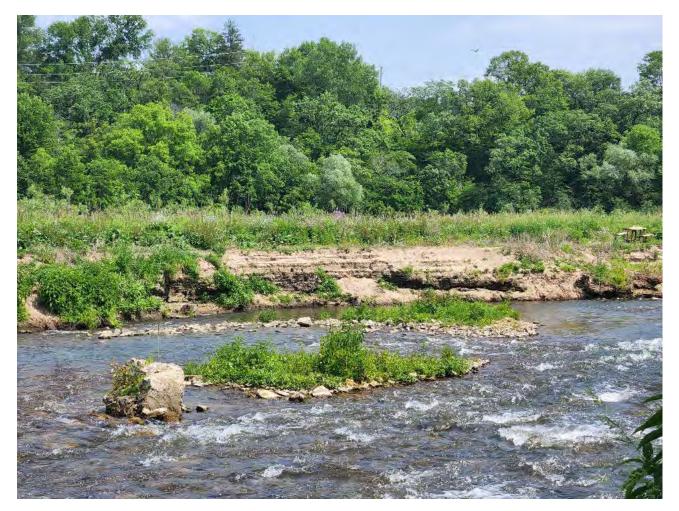
Figure D-2: Photo looking southwest at the left cut bank showing alluvial sands actively eroding and deposited above gravels and cobbles along the existing riverbed at the Kinnickinnic River valley floor.

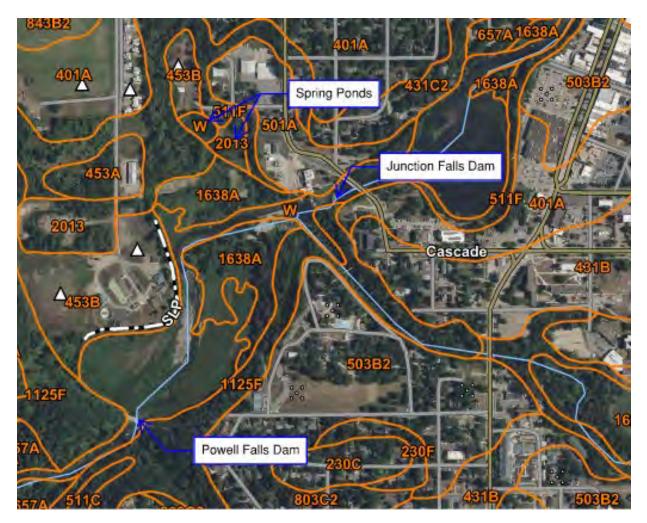
Figure D-3: Web Soil Survey for the project area consisting of glacial and alluvial materials with adjacent finer soils. The mapped units around the project area include water (W) along the Kinnickinnic River, Lake George, Lake Louise, and the northern spring pond; river valley material (1638A); loam and sandy loam terrace deposits (401A, 431C2); sand slopes (511F); loamy sand (501A); silt loam (657A); and stony soils (1125F). The area near the spring ponds is identified as gravel pits (2013).

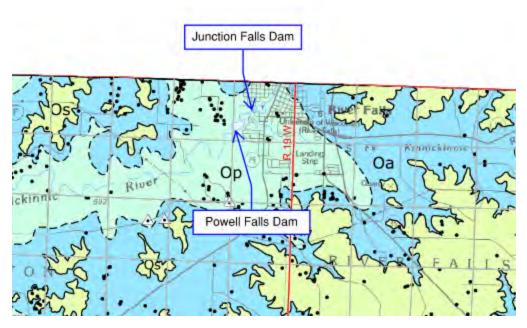
Figure D-4: Bedrock Map for Pierce County, Wisconsin (Evans et al., 2007) showing the project area consisting of Prairie du Chien Group dolomite (Op).

Bedrock in the project vicinity primarily consists of either dolomite, sandy dolomite, or dolomitic sandstone (Figure D-4). An approximate 40-foot bedrock outcrop adjacent to the junction of the Kinnickinnic River with the South Fork River were described in sequence as massive to thinly bedded sedimentary rocks of sandy dolostone, thinly interbedded mudstone with sandstone, and sandy dolostone, sandstone with traces of iron oxide staining, dolomitic sandstone, and sandy dolostone with traces of chert above the existing water surface. Physical properties were described as slightly crystalline and moderately hard with some interbedded soft friable rock, tan to buff in color, horizontal bedding planes and possible ripple mark textures within the mudstone and sandstone units. Bedding varied from massive, 4 to 5 foot thick beds, to thinly bedded and blocky in fractures. Undercutting of approximately up to 1 foot to 4 feet vertically and up to 4 feet to 5 feet horizontally into material near the thinly bedded units of interbedded mudstone, and sandy dolostone was observed beneath the falls near the existing and past water surface. Small, weathered pockets with iron oxide staining were scattered within the outcrops. It was noted in document review that there were small abandoned and reclaimed quarries in the vicinity of Lake Louise that utilized the Prairie du Chien Group dolomites.

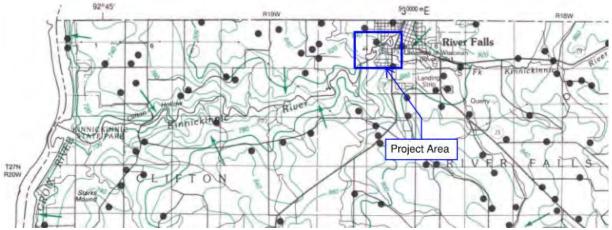
Figure D-5: Generalized water-table elevation map for the project area (Lippelt, 1990). Green contours represent elevation of the groundwater level and green arrows show direction of groundwater flow

Although site specific groundwater data is not available from nearby soil borings, groundwater can be interpreted to flow east to west from River Falls, WI into the St. Croix River along the Kinnickinnic River and valley floor. Adjacent to the Kinnickinnic River, groundwater levels likely follow topography flowing toward the river valley. Groundwater levels can be interpreted to be near the water surface of the Kinnickinnic River or of Lake George. Removal of the Junction Falls Dam would lower the groundwater levels in Lake George to the river bed elevation. Lake Louise has been dewatered since 2020, so it is anticipated that groundwater levels are near the elevation that would be achieved with removal of the Powell Falls Dam. These assumed groundwater trends are confirmed by Generalized water-table elevation map of Pierce County (Figure D-5).

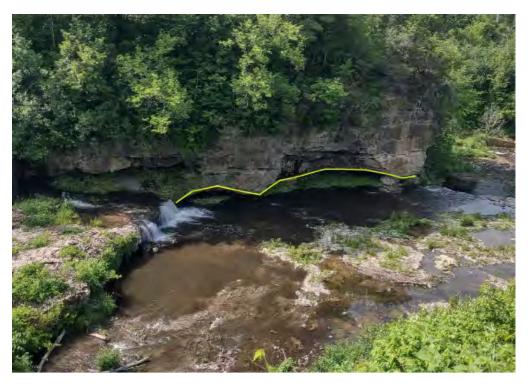
Figure D-6: Photo looking south at the alluvial valley rock face downstream of the Junction Falls Dam. Yellow line highlighting areas where recessive layers have been undercut by water flow. This natural erosion will progress until the overhanging rock block becomes unstable and falls into the valley.

The existing dolostone outcrops on the side of the alluvial valley walls currently appear stable. The rock face conditions were observed by the PDT during a site visit on 9 June 2023. The rock conditions were described as slightly weathered, hard crystalline dolostone with layers of sandstone. There were more recessive areas of the rock outcrop that were moderately weathered, soft to moderately hard, sandstone interbedded with mudstone, that was weakly cemented. These more recessive layers in the Prairie du Chien formation were evident in areas near the waterline where the rock has been eroded by water flow along the sidewall forming an overhanging block of rock, refer to Figure D-6. These are natural occurrences that are ongoing around the project under the current condition with the dams in place.

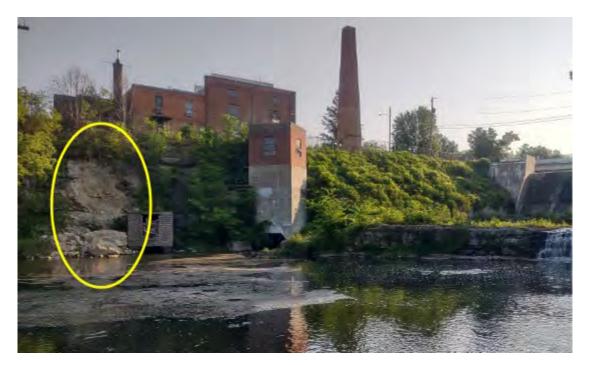
Figure D-7: Photo looking north to the alluvial valley rock wall downstream of the Junction Falls Dam showing the scar from a rock slide, inside of yellow oval.

Over time, on the order of 100s of years or more, this erosion will ultimately lead to instability of portions of the rock wall which will result in a slide. There are remnants of a previous rock slide on the north valley wall downstream of the Junction Falls Dam, refer to Figure D-7. A systematic evaluation of jointing in the Prairie du Chien formation was not performed for this study. Based on the observations during the site visit, these undercutting conditions are limited to the area near the Junction Falls Dam. Removal of the Junction Falls Dam is not anticipated to increase the occurrence of undercutting. From a risk perspective, the erosion on the existing rock face appears to be progressive with the overhang becoming larger as erosion occurs, but instability of the overhanging block of rock is anticipated to be a brittle failure occurring without deformation of the wall. In addition, there did not appear to be structures constructed at the top of the valley walls where undercutting was observed. Although there were no indications of imminent slides, additional exploration and study may provide insight to the likelihood of future slides.

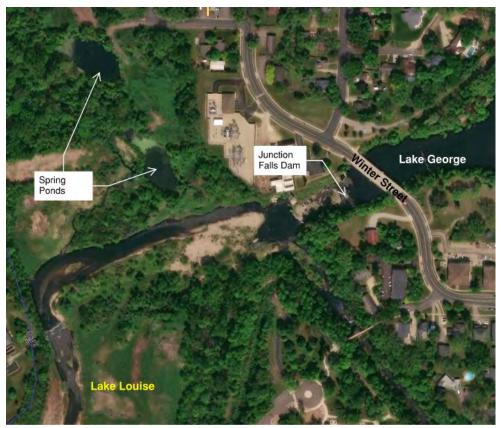
Figure D-8: Location of the spring ponds.

Lake Louise is currently dewatered and the Kinnickinnic River flows out of the open sluice gate. No additional impacts on the Lake Louise lakebed are anticipated except for fluvial deposition and erosion processes on the lakebed material. On the upstream side of Lake Louise on the north bank are two spring fed ponds that discharge into the Kinnickinnic River, refer to Figure D-8. These ponds have culvert outlets to manage the existing pond levels. These culverts were deteriorated at the time of the site visits and the PDT discussed rehabilitating the outlets. A more natural outlet solution such as stone weirs or porous weirs would provide a more natural outlet condition.

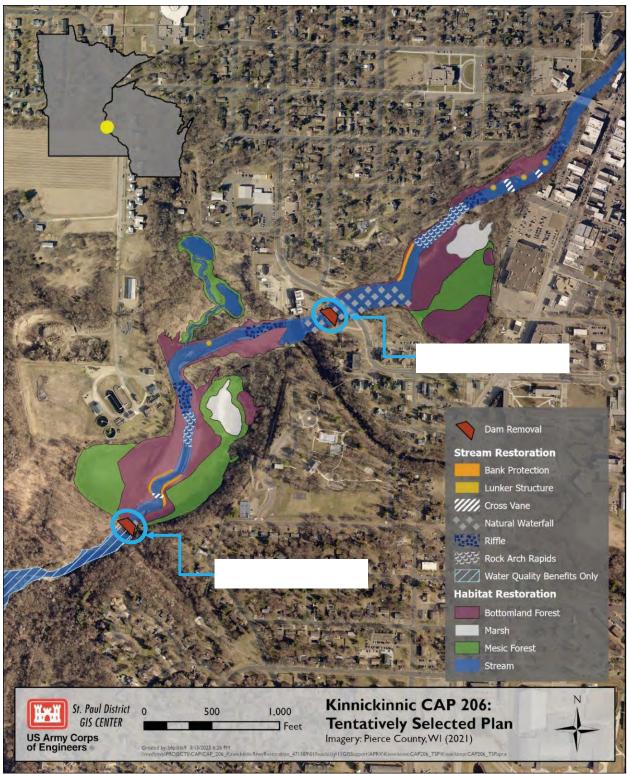
Figure 1: Kinnickinnic CAP Tentatively Selected Plan.

The proposed USACE project features and boundaries are shown in Figure 1.

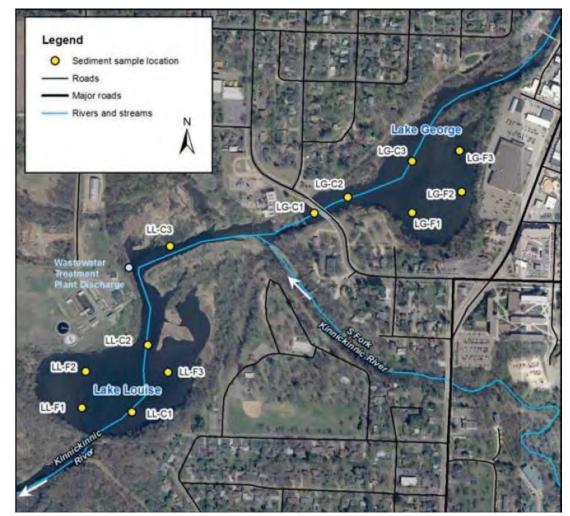
Figure 2: Sediment sampling locations within Lake George and Lake Louise (Inter-Fluve Inc., Lake George and Lake Louise Sediment Assessment Report, 2016).

In 2015, one sediment sample taken in Lake Louise showed arsenic concentrations above the WI DNR background levels of 8.3 mg/kg. At sample location LL-C1 (**Figure 2**), arsenic concentrations of 35.4 mg/kg were discovered. The sampling results were reviewed during the 2021 Powell Falls Decommissioning Plan by Ayres Associates in consultation with the WI DNR following the drawdown of Lake Louise. The WI DNR recommended that additional sediment confirmation sampling around LL-C1 should be conducted to determine if the elevated levels of arsenic are reproducible or if the sample results were an anomaly.

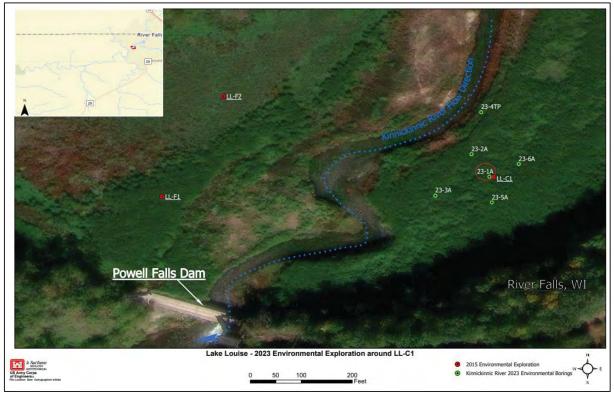
Figure 3: Map showing five hand augers conducted by USACE for chemical analysis to investigate arsenic contamination at the previous Inter-Fluve Inc. sampling location (LL-C1).

Subsequently in 2023, USACE collected additional samples for metals near this location (**Figure 3**). The results from the 2023 USACE confirmation sampling indicated that the prior arsenic levels in 2016 were not reproducible, arsenic was not found above background levels. These data and prior studies are summarized in Appendix F.

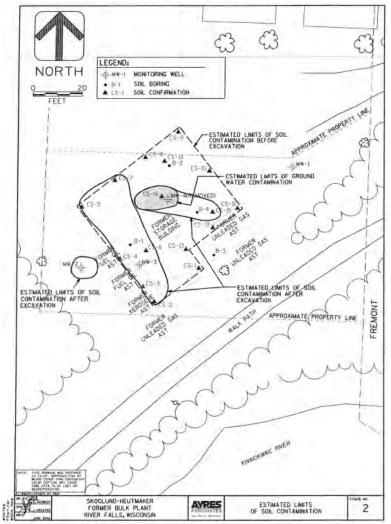
Figure 4: Estimated limits of soil contamination at the former Bulk Plant (Ayres Associates, 2005).

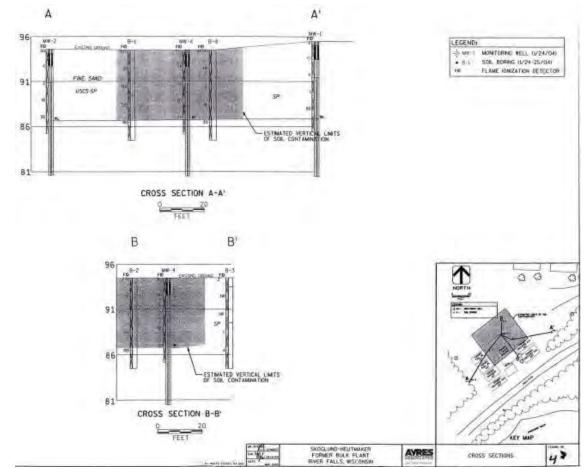
Figure 5: Geologic cross sections showing the estimated vertical limits of soil contamination at the former Bulk Plant in River Falls, WI (Ayres Associates, 2005).

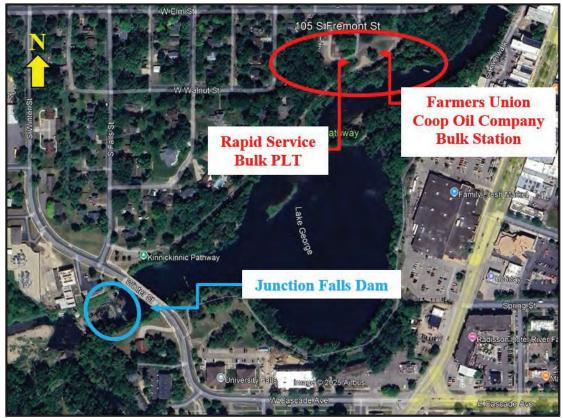
Figure 8: Known HREC locations (denoted in red) around Lake George with petroleum contamination.

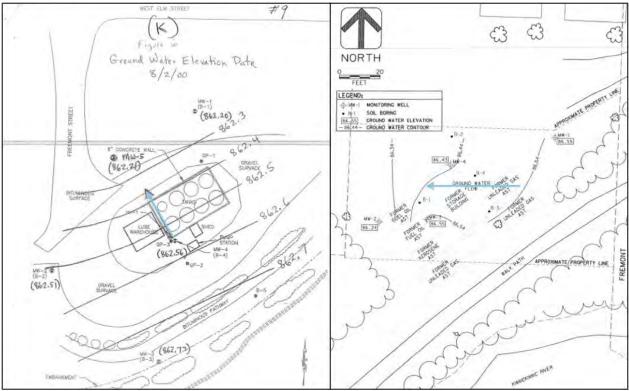
Figure 9: Groundwater contour maps, flow directions shown with blue arrow. Left: Farmers Union Coop Oil Company Bulk Station (WCEC, 2000) Right: Bulk Plant (Ayers Associates, 2005).

Lake George and Lake Louise impoundments likely have caused changes in local groundwater gradients that may vary outside of the typical regional groundwater regime. On the north end of Lake George, site specific data from WCEC and Ayers Associates, indicates that the groundwater is flowing away from Lake George (losing stream). Removal of the Junction Falls Dam would lower the groundwater levels in

the vicinity of Lake George. Lake Louise has been dewatered since 2020, so it is anticipated that groundwater levels are near the elevation that would be achieved with removal of the Powell Falls Dam. Localized groundwater trends on the northern perimeter of Lake George are shown in **Figure 9**.

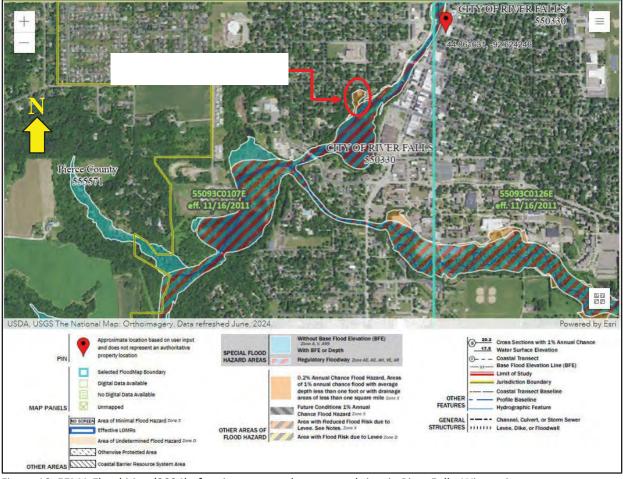
Figure 10: FEMA Flood Map (2024) <u>of project area at dam removal sites in River Falls, Wisconsin</u> (<u>https://msc.fema.go</u>v/portal/).

The topographical gradients vary across the subject property but are generally towards the Kinnickinnic River. The subject property is mapped within the Special Flood Hazard Area, Regulatory Floodway zone (**Figure 10**).

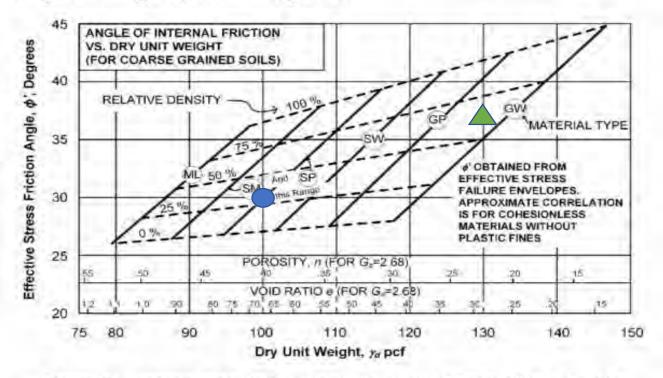
A correlation for the drained friction angle as a function of relative density, dry unit weight and soil type is presented in Figure 8-1.

Notes: Correlations for drained friction angle of fine-grained soils based on Unified Facilities Criteria Soil Mechanics DM 7.1 (2022)

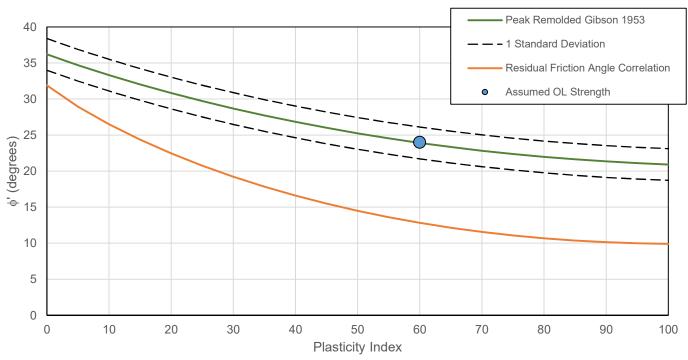
Soil P	roperties	- Organic	Silt
--------	-----------	-----------	------

Notes: Correlations for drained friction angle of fine-grained soils based on Unified Facilities Criteria Soil Mechanics DM 7.1 (2022) and Carter and Bentley, Soil Properties and Their Correlations, 2nd. Ed. (2016).

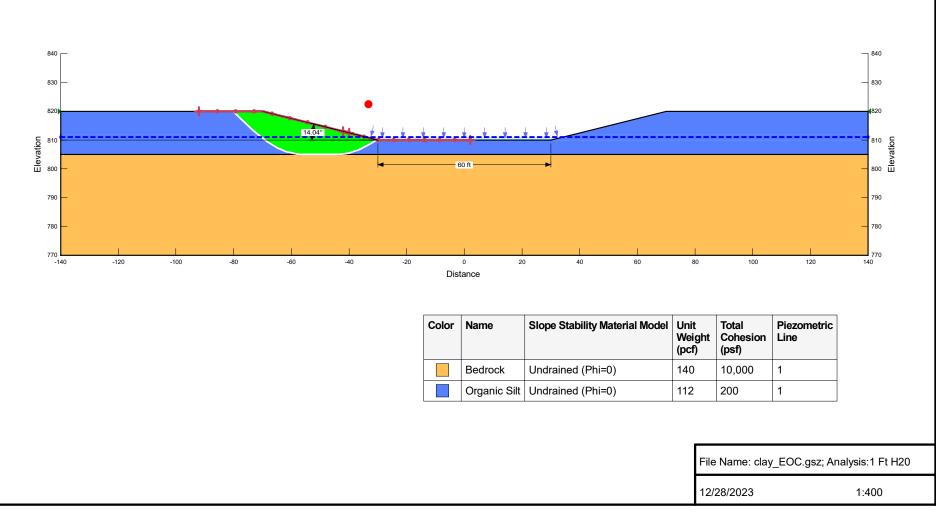
River Depth: 1 Foot of Water

Analysis Type: Spencer

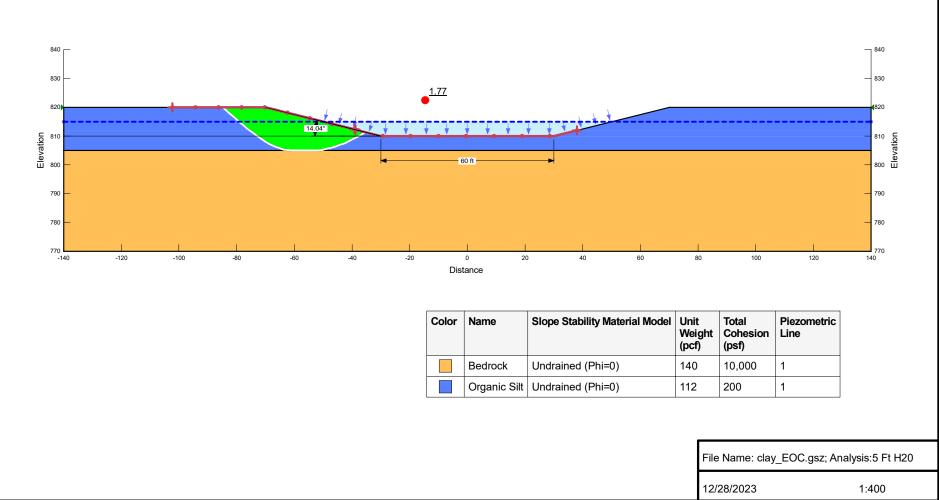
End of Construction Condition

River Depth: 5 feet of Water

Analysis Type: Spencer

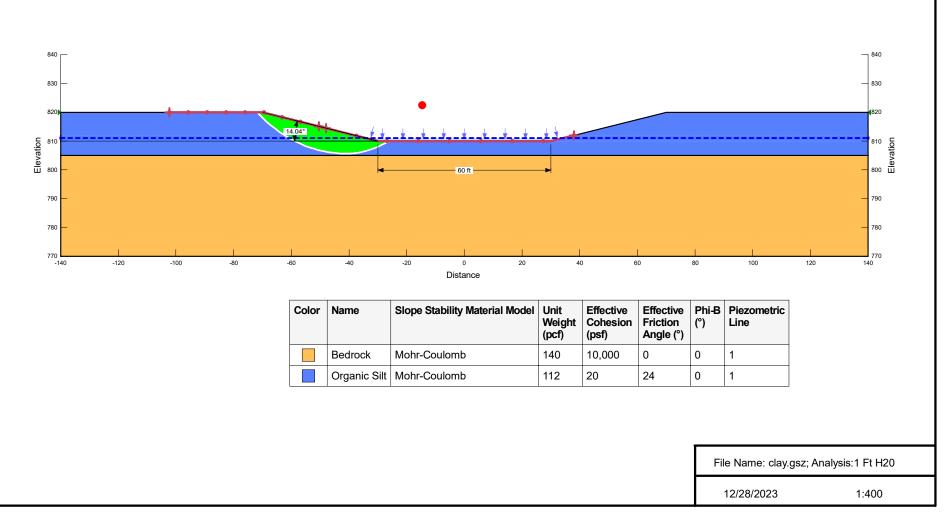
Long-Term Condition

River Depth: 1 Foot of Water

Analysis Type: Spencer

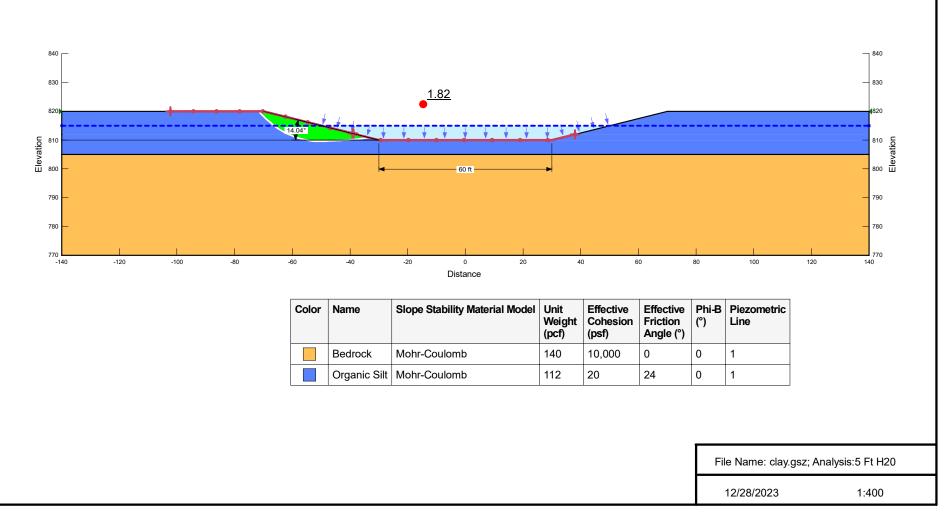
Long-Term Condition

River Depth: 5 feet of Water

Analysis Type: Spencer

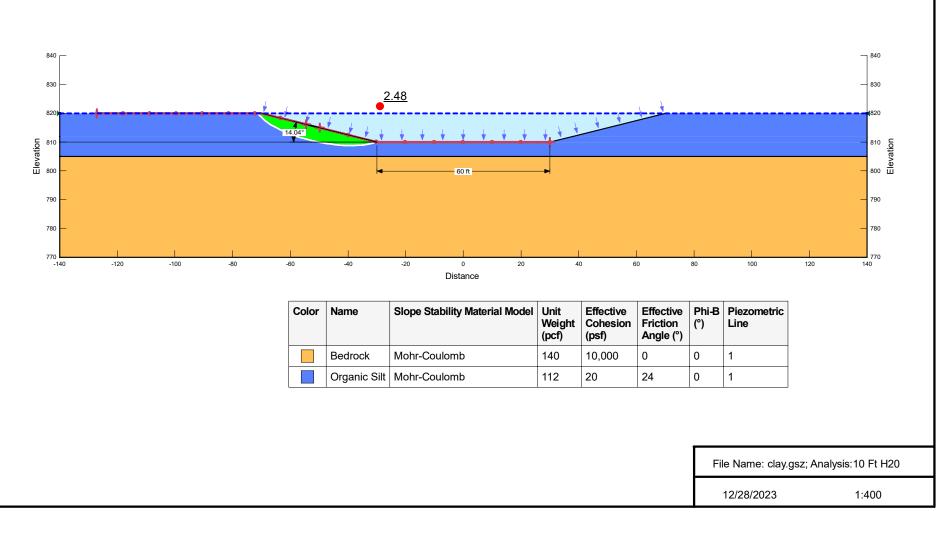
Long-Term Condition

River Depth: 10 Feet of Water

Analysis Type: Spencer

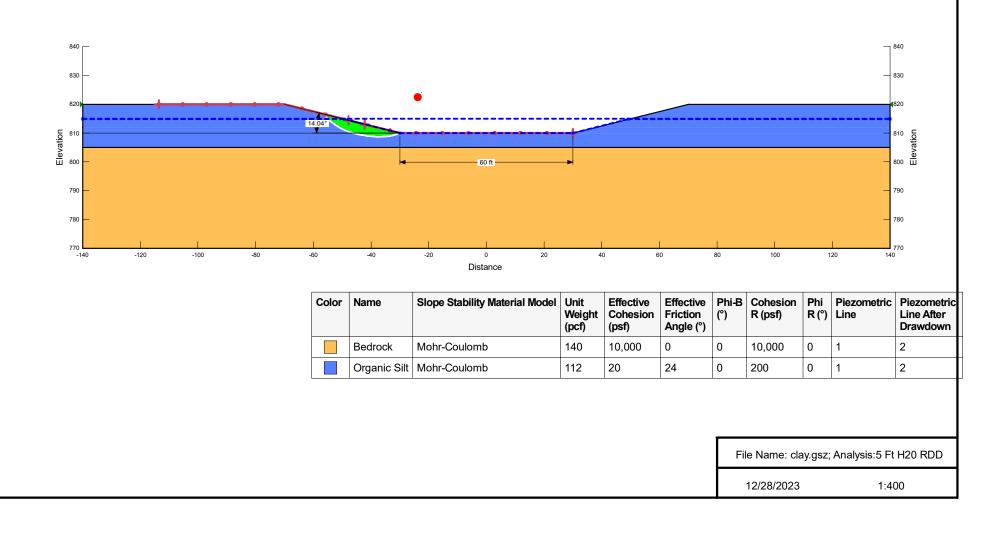
Rapid Drawdown Analysis: 5 Feet of Water to 1 Foot of Water

Analysis Type: Spencer

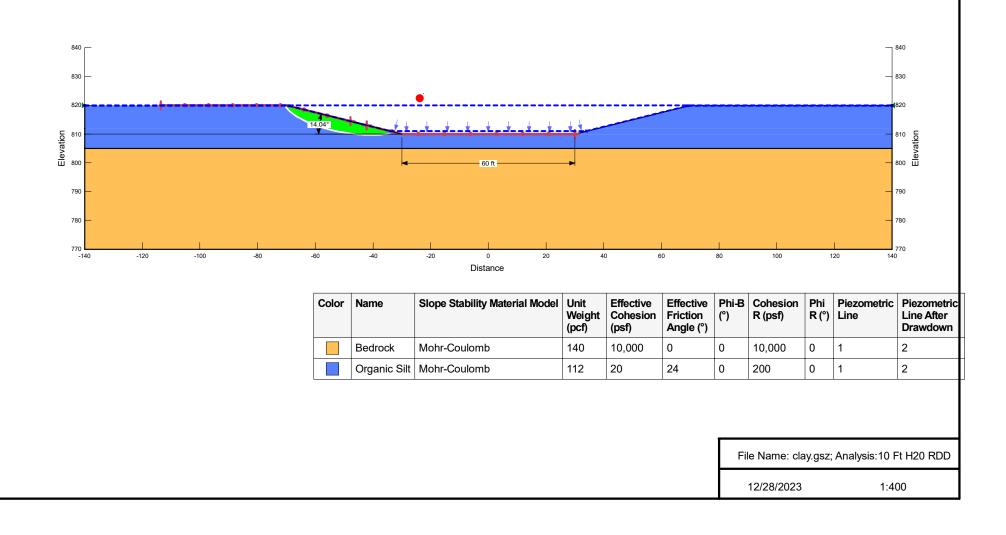
Rapid Drawdown Analysis: Bankfull to 1 Foot of Water

Analysis Type: Spencer

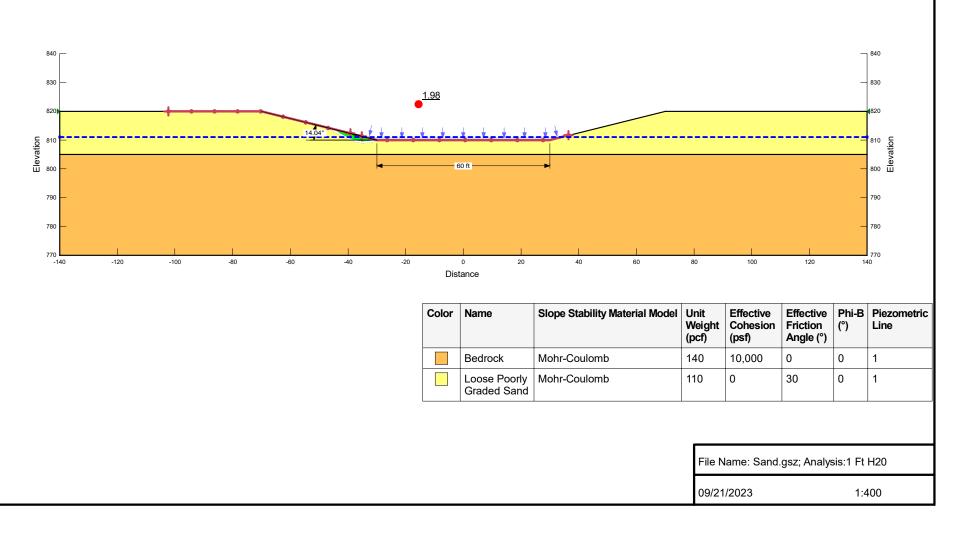
SAND STABILITY PLATES

Long-Term Condition

River Depth: 1 Foot of Water

Analysis Type: Spencer

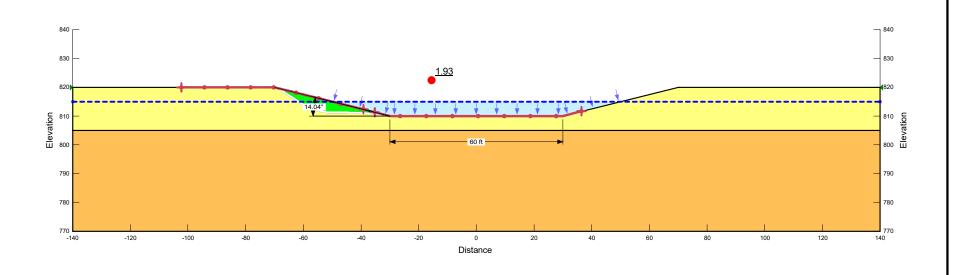
Long-Term Condition

River Depth: 5 feet of Water

Analysis Type: Spencer

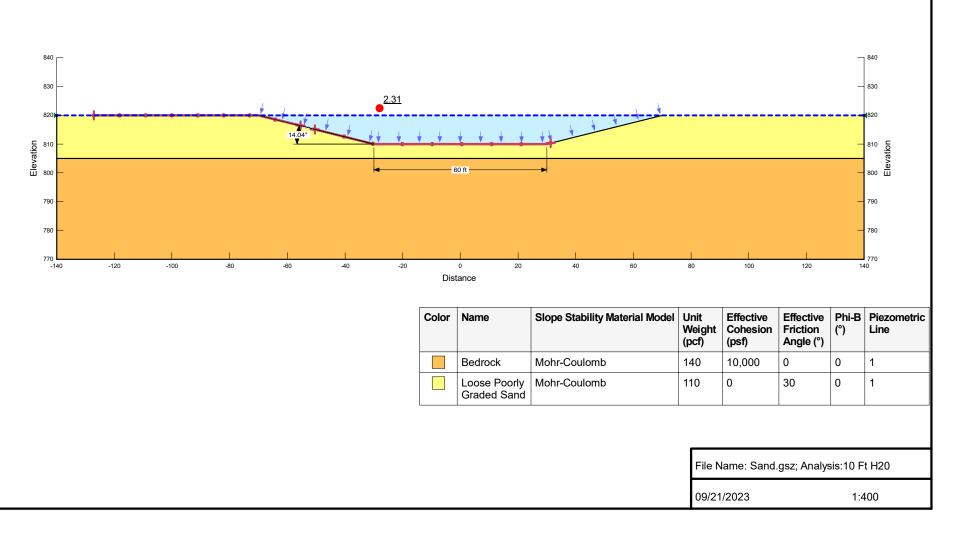
Long-Term Condition

River Depth: 10 Feet of Water

Analysis Type: Spencer

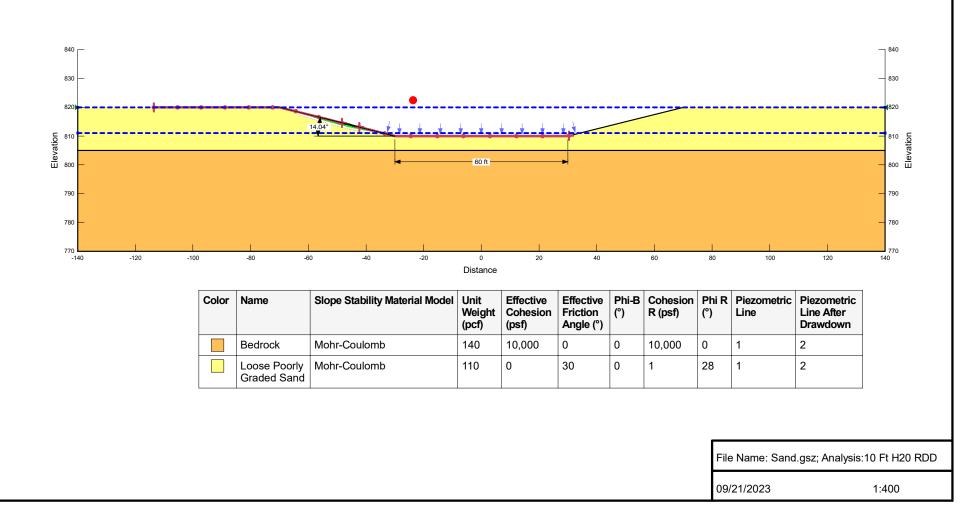
Rapid Drawdown Analysis: Bankfull to 1 Foot of Water

Analysis Type: Spencer

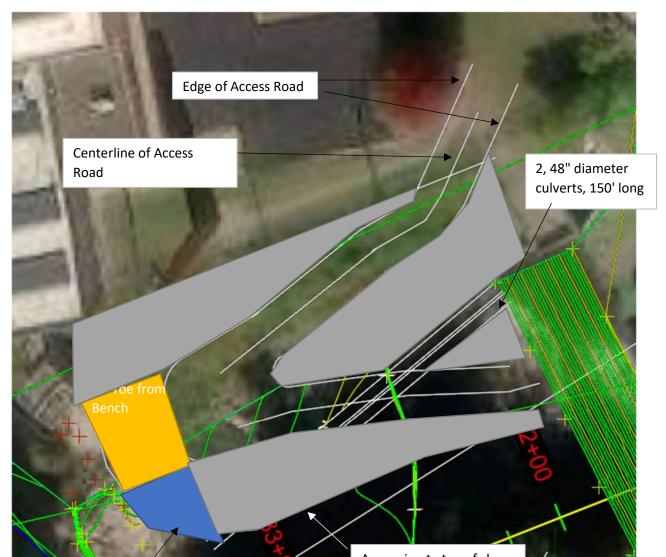
Site restoration will be needed at the top of slope: repair pavement, replace top soil and reseed

Access Road Water Management: Consider adding culverts for 150 feet of the access road. Two 48-inch diameter culverts shown. Note that this was not sized for hydraulic constraints.

In the river we should include some perimeter controls and sed traps to assist limiting sediment transport downstream.

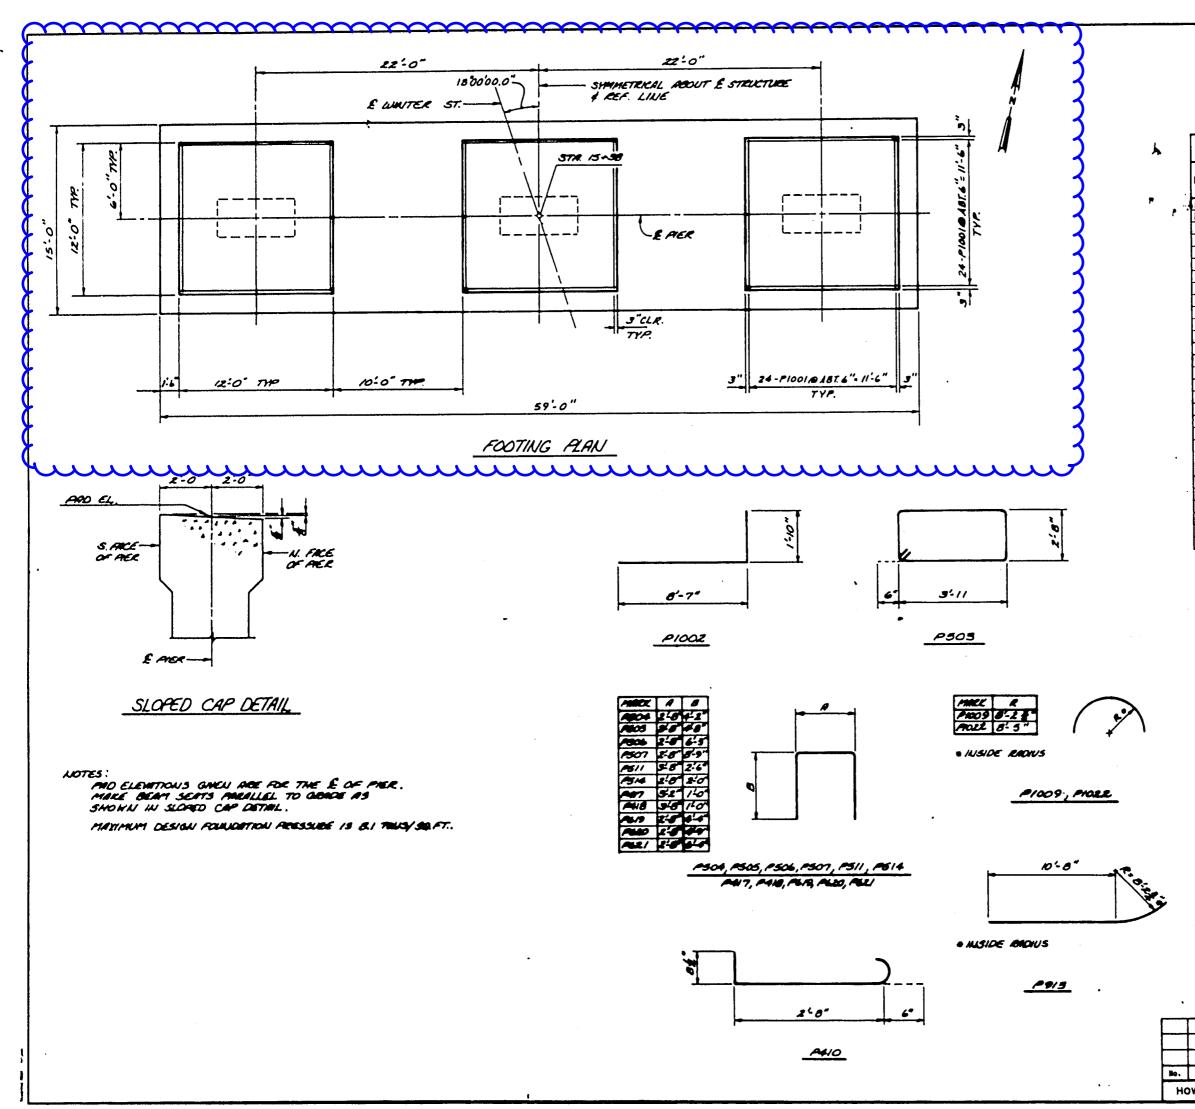
BILL	OF REINF	ORCEM	ENT -	- PIER	~2
BAR MARK	COAT	NO. REQ'D	LENGTH	BEND	CUT DIAG.	BUN- DLE	
P1001		144	11'- 6*				FOOTING
P1002	i – I	90	10'- 5*				FOOTING DOWELS
P503		72	14' - 2"				COLUMN TIES
P504		16	11'- 0"				COLUMN TIES
P505		8	12'- 0*				COLUMN TIES
P506		16	15' - 2*				COLUMN TIES
P507	1	4	20'- 2"				COLUMN TIES
P608		8	49'- 8"			L	CAP
P1009	i	8	25 ' - 10 *				CAP
P410		70	3'- 7*	<u> </u>	1		COLUMN TIES
P511	1	8	8'- 8"				END OF CAP
P912		74	22'- 0'				COLUMN VERTICALS
P913	1	18	18' - 1*				COLUMN VERTICALS
P514	I	4	8'- 8*				END OF CAP
F615	1	28	12' - 7*				CAP
P416	1.	21	12' - 7*	1			CAP
P417	1	6	5'- 2"				GIRDER 4 SEAT
P418		5	5'- 8"				GIRDER 4 SEAT
P619	1	2432			1		CAP STIRRUP
P620		5210	12' - 2*		1		CAP STIRRUP
P621		32,10	15' - 4"				CAP STIRRUP
P1022	· · · · ·	8	26'- 5*				CAP
P1023		8	50' 1 6'				CAP
8724	-	36	3'-2"				PIAPN. (PIER)

•	DEPAI	STATE OF WISCONSIN DEPARTMENT OF TRANSPORTATION						
			S	STRUCTURE E						
			Const. 1989	By JCH	Checkee DLC					
Dete	tevisions	07	PIER FOOTING &		SHEET 13 OF 29					
WARD NE	EDLES TAMMEN BERG	BENDOFF	BILL	OF REINE	X83342					
			.

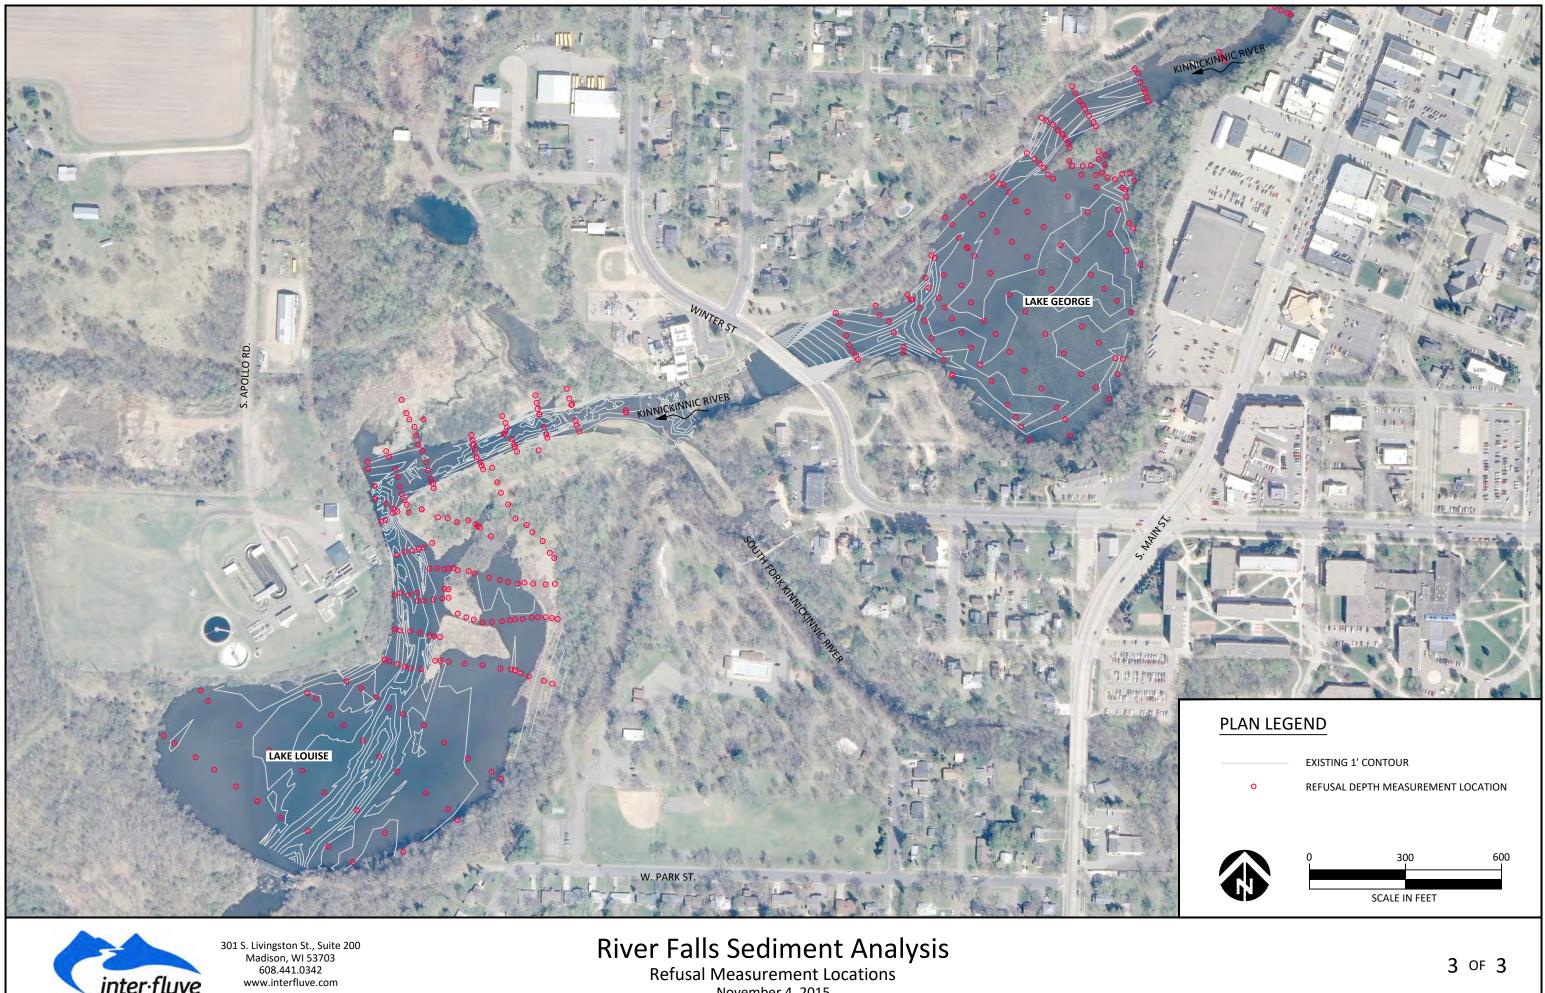
2 OF 3

Refusal Measurement Locations November 4, 2015
