Enbridge

Line 5 – Deer Creek HDD Crossing

HDD INADVERTENT RETURN MITIGATION AND CONTINGENCY PLAN

**MICHELS TRENCHLESS INCORPORATED (MTI)**  
**INADVERTENT RETURN MITIGATION AND CONTINGENCY PLAN**  
**ENBRIDGE LINE 5 PROJECT**  
**MP 6 – 30-INCH DEER CREEK HDD CROSSING**

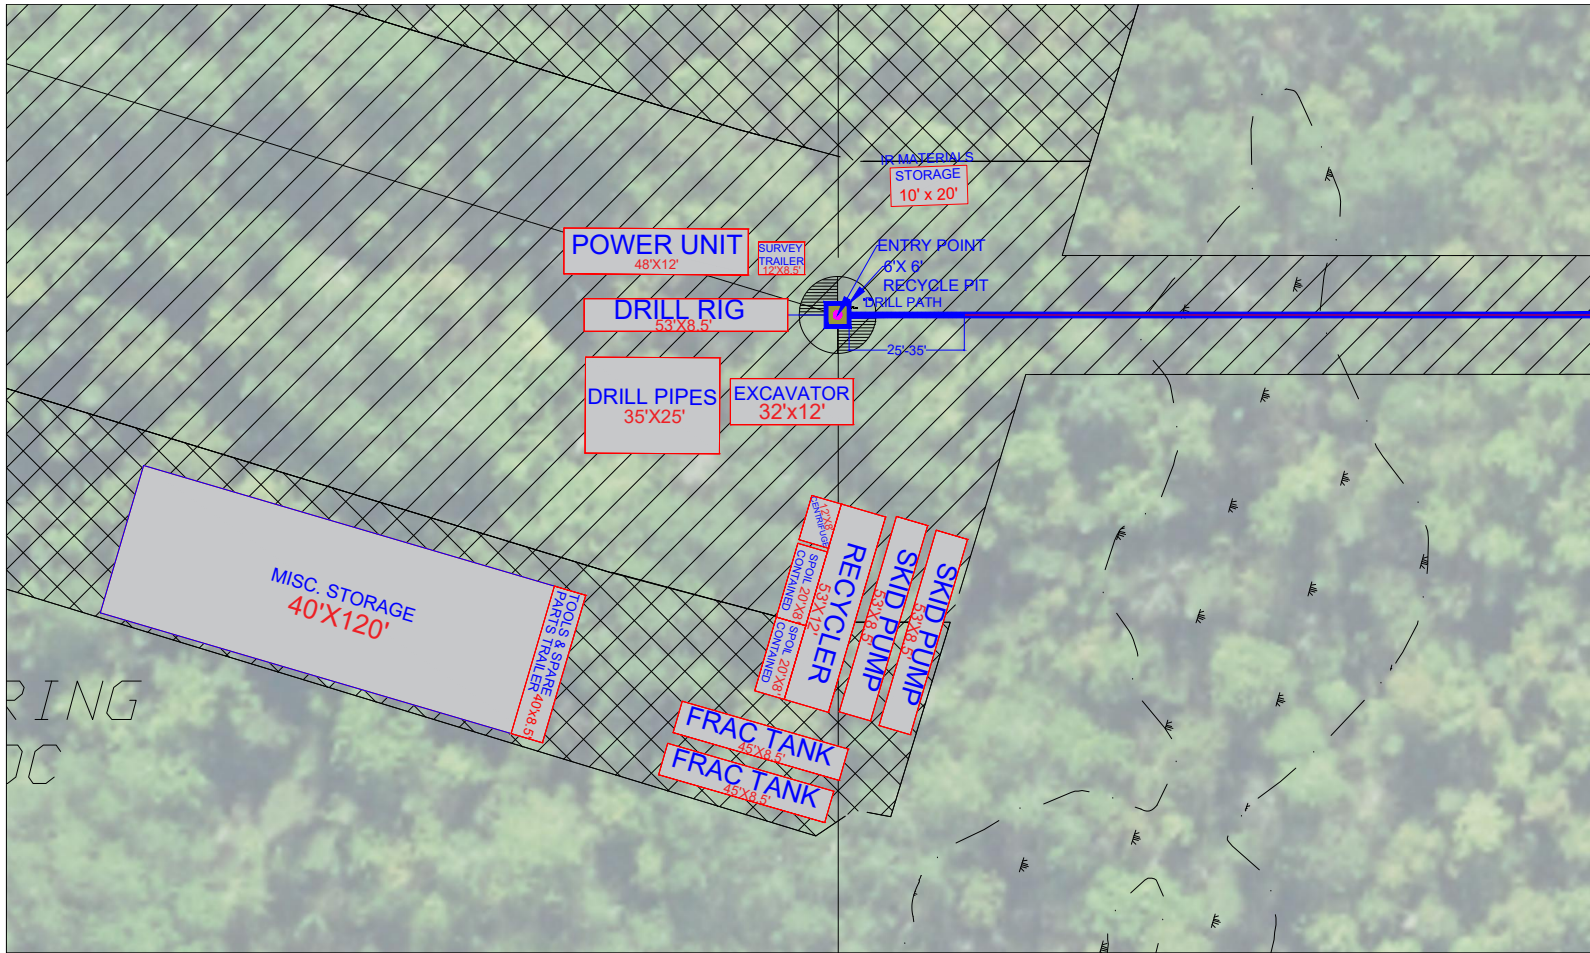
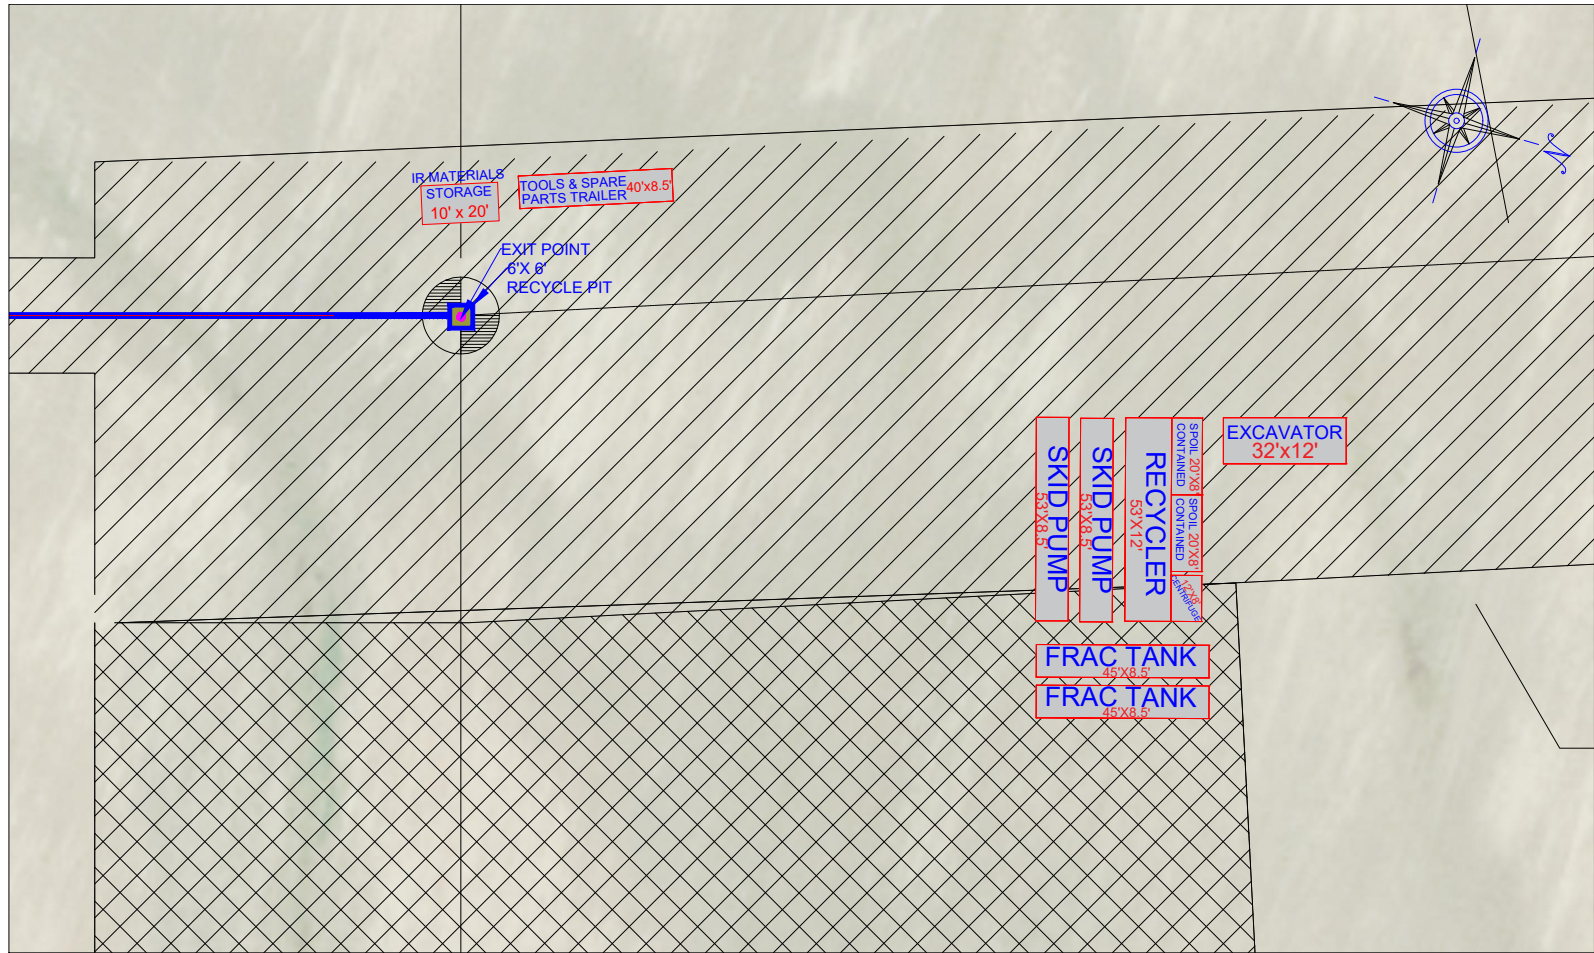
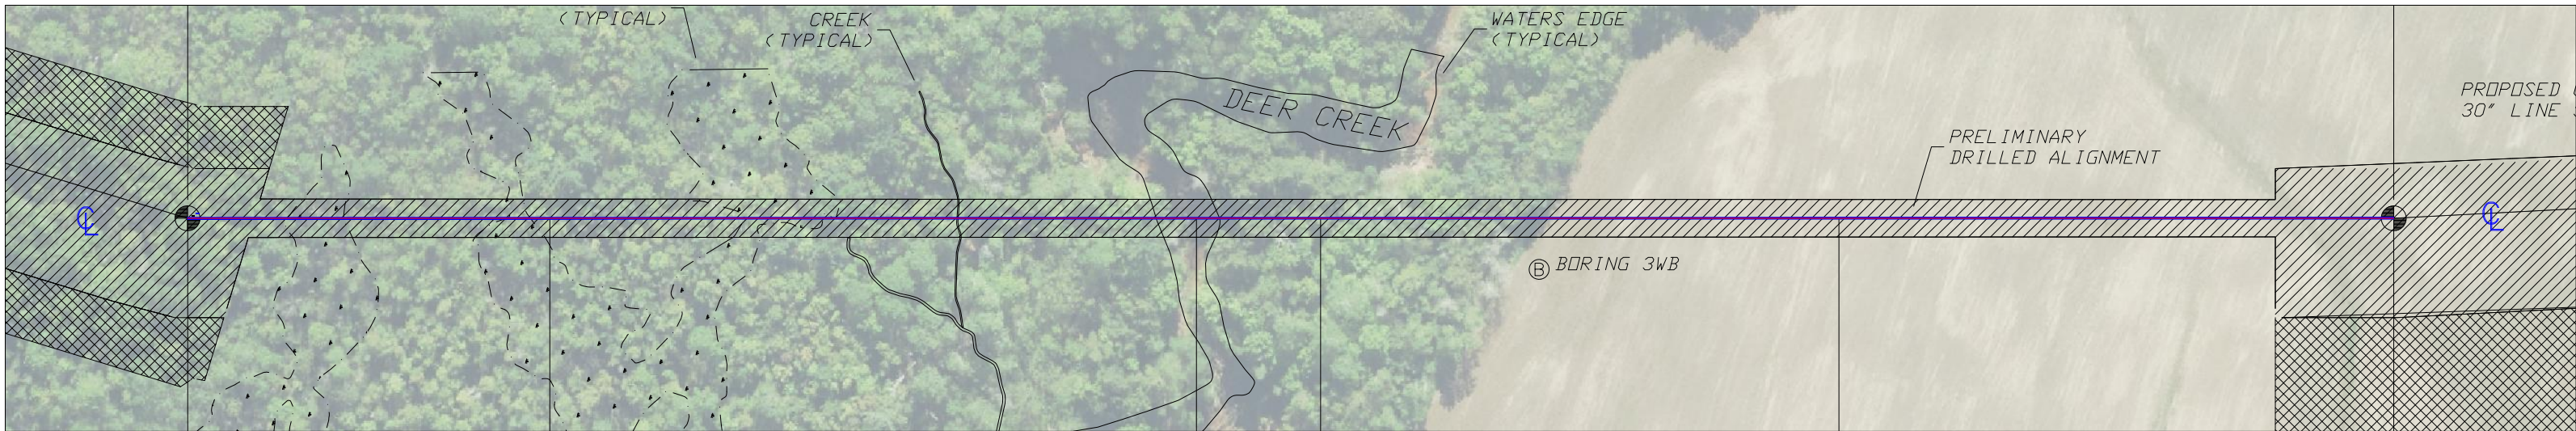
## EQUIPMENT AND CONTAINMENT SITE LAYOUT

817 W. MAIN ST. DEER CREEK, WISCONSIN 53006 PHONE: 918-88-3137 FAX: 818-88-3137	
DIRECTIONAL BORE FOR:	
ENBRIDGE	
PROJECT:	
LINE 5 PIPELINE PROJECT	
DRAWING:	
CONCEPTUAL WORKSPACE DESIGN DRAWING	
CROSSING REFERENCE:	
MP6 - DEER CREEK HDD	
PRODUCT PIPES SIZE (INCHES): 30"	
LOCATION: ASHLAND COUNTY, WISCONSIN	
DRAWN BY: C.L.G.	JOB NUMBER: XXXXXXX
DATE: 11/18/22

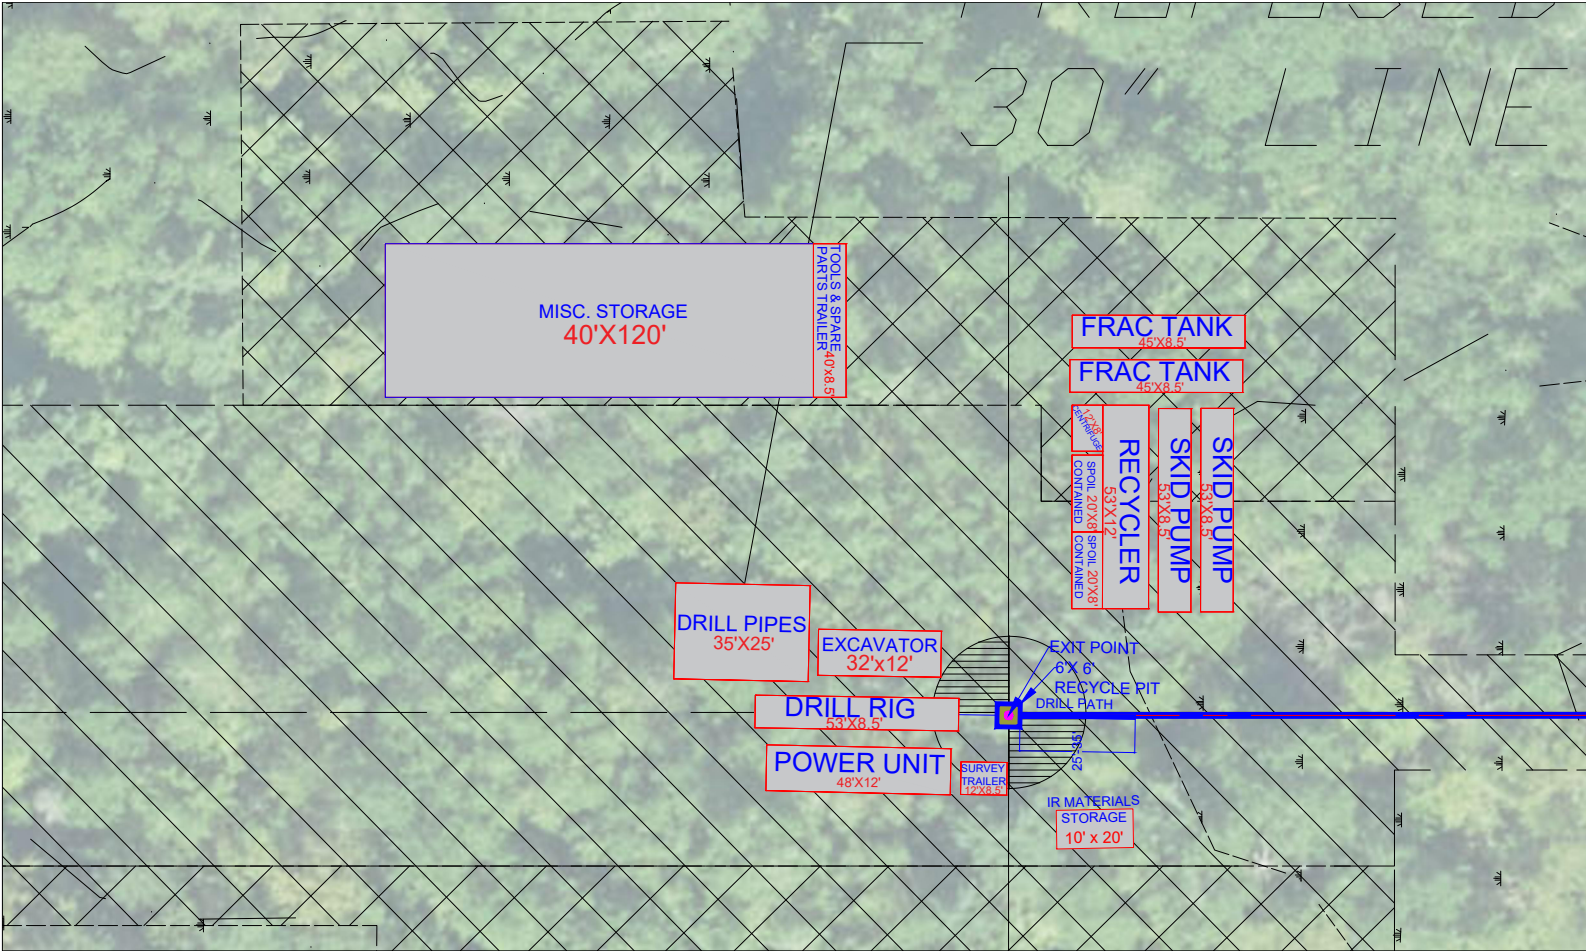
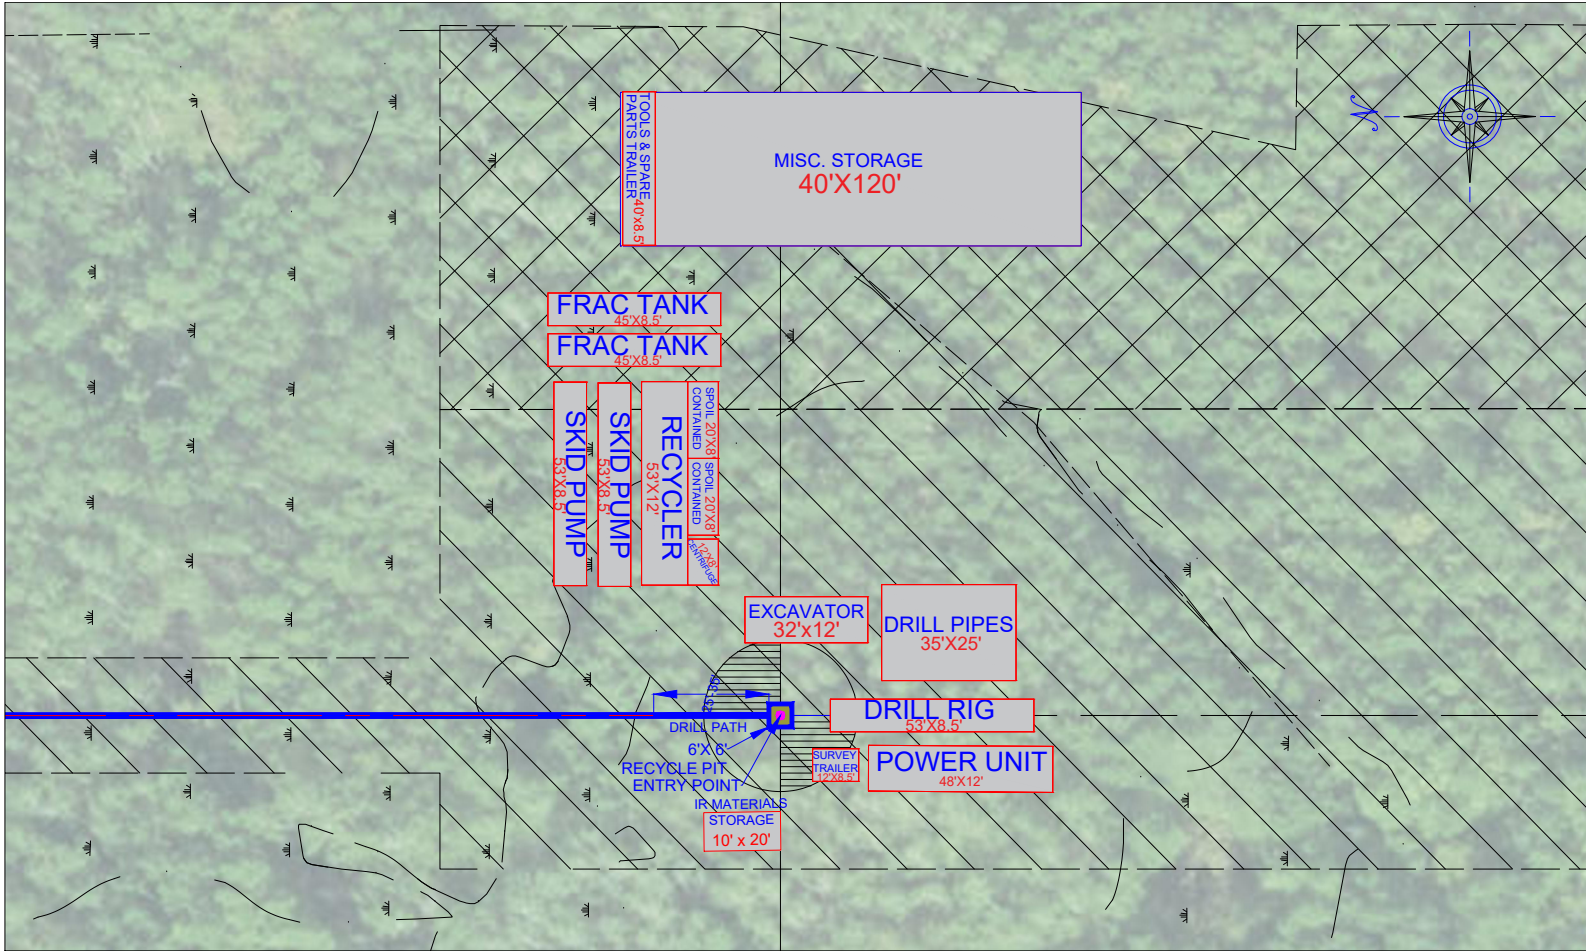
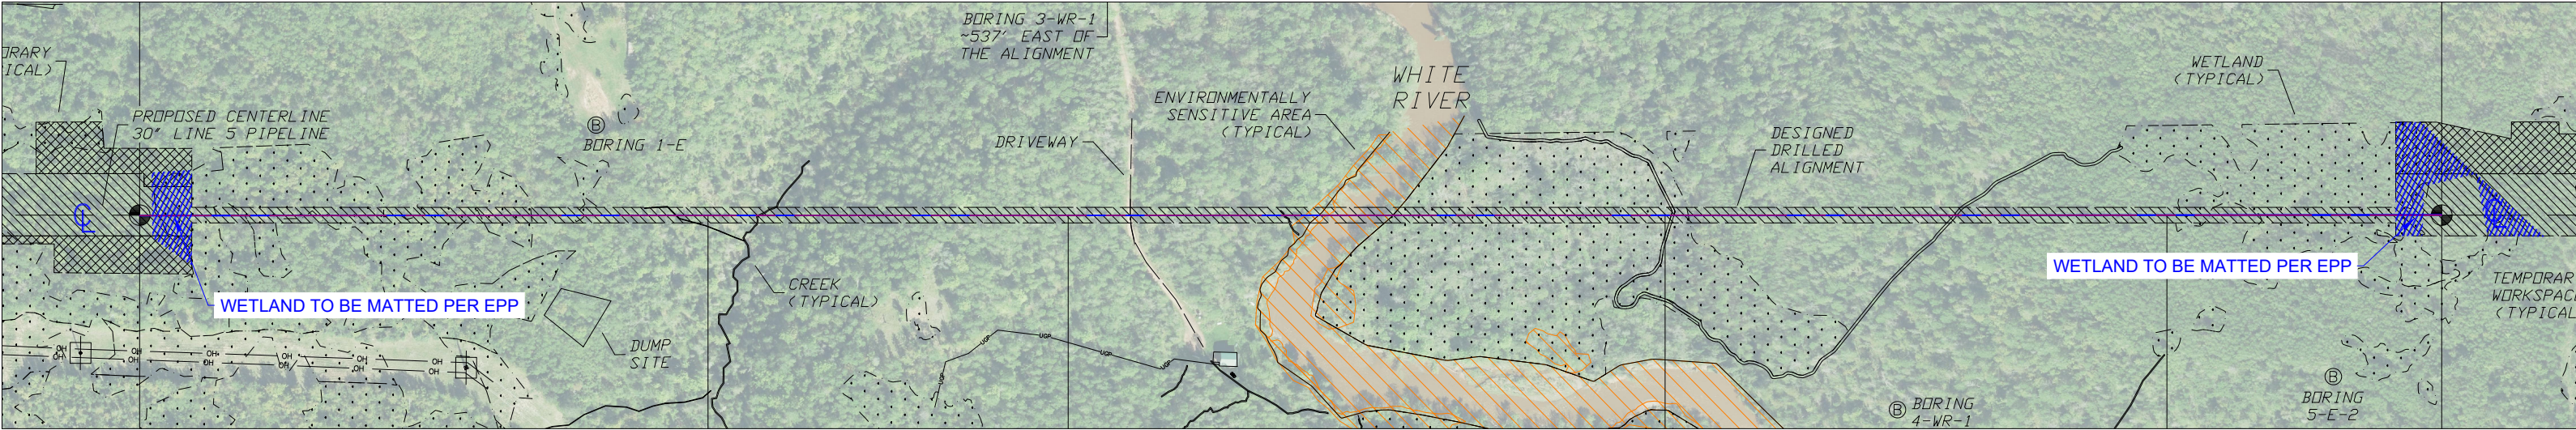
## EQUIPMENT AND CONTAINMENT SITE LAYOUT

PLAN

OVERALL PLAN VIEW

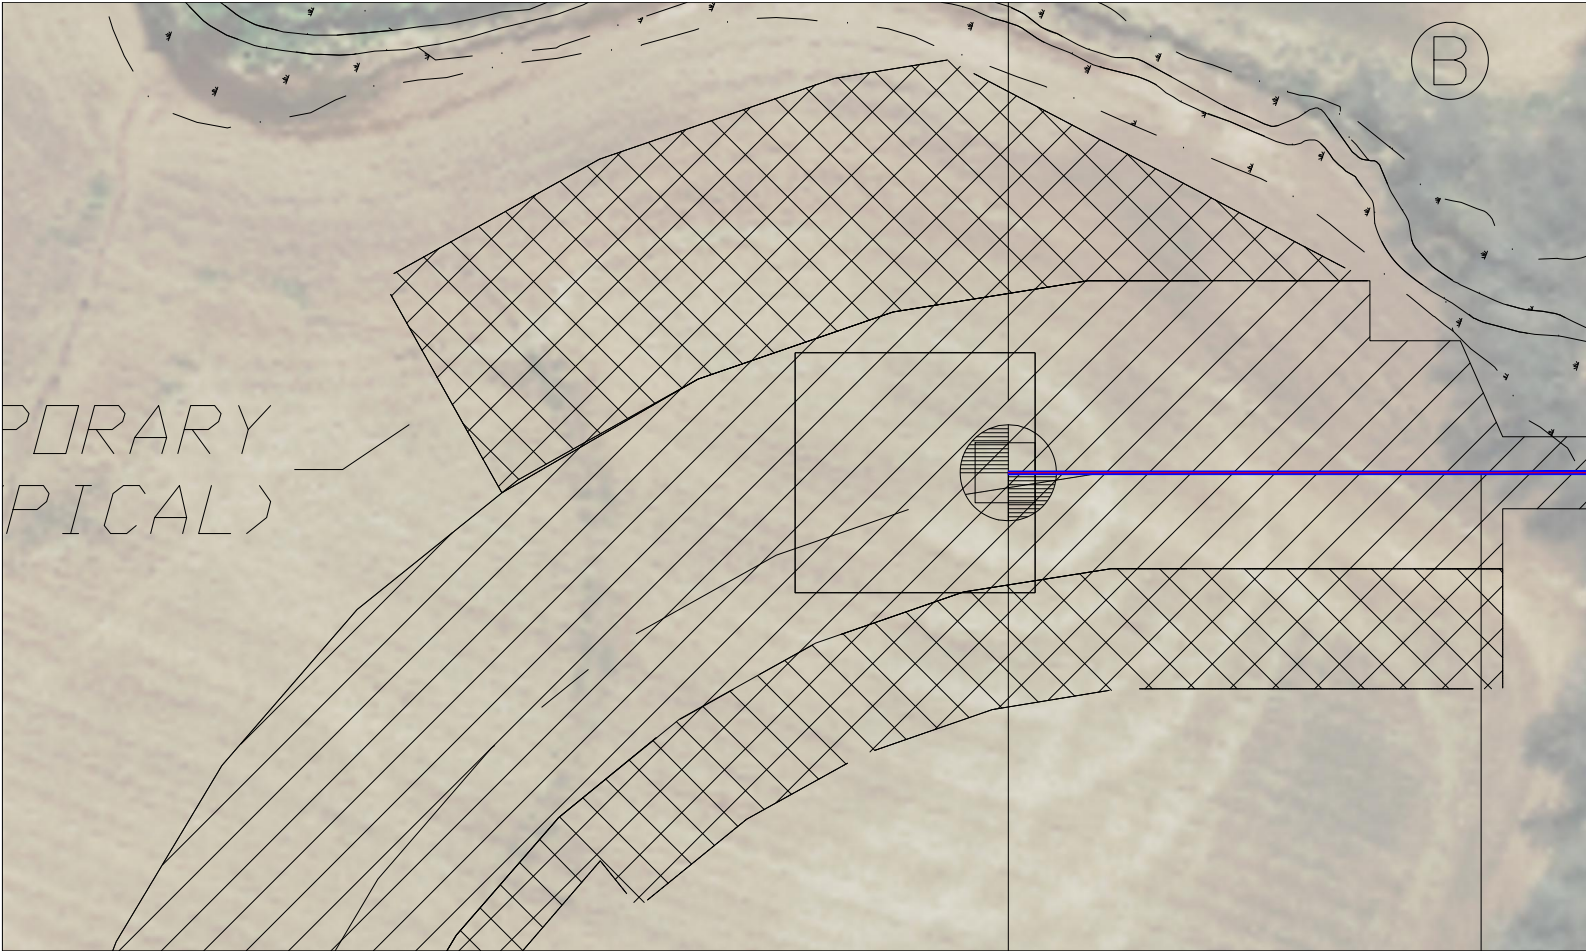
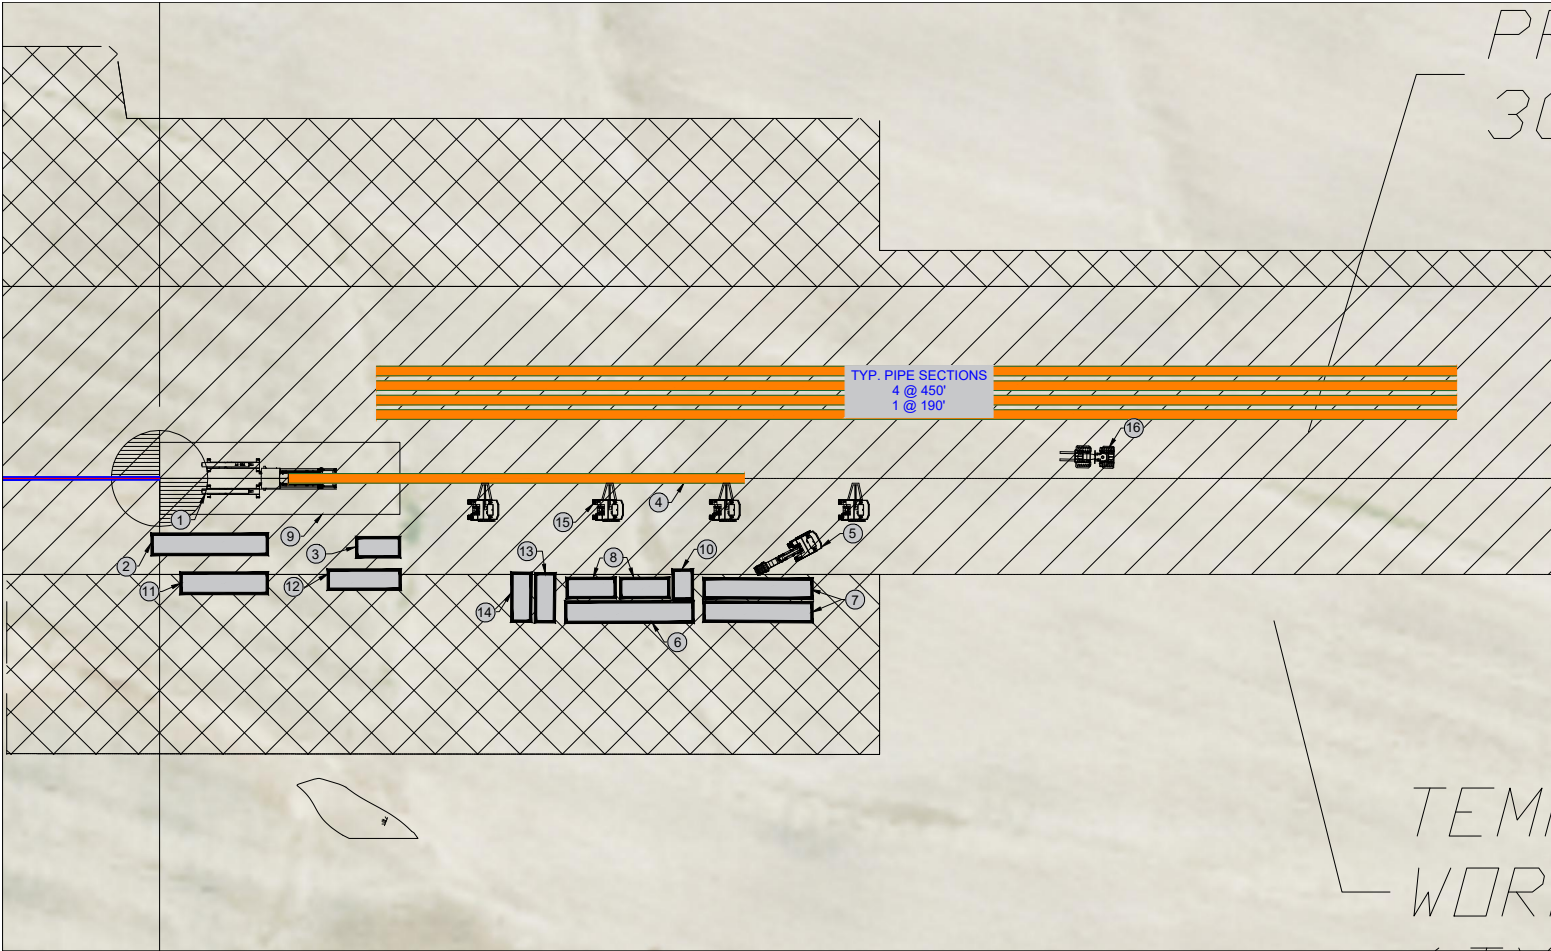
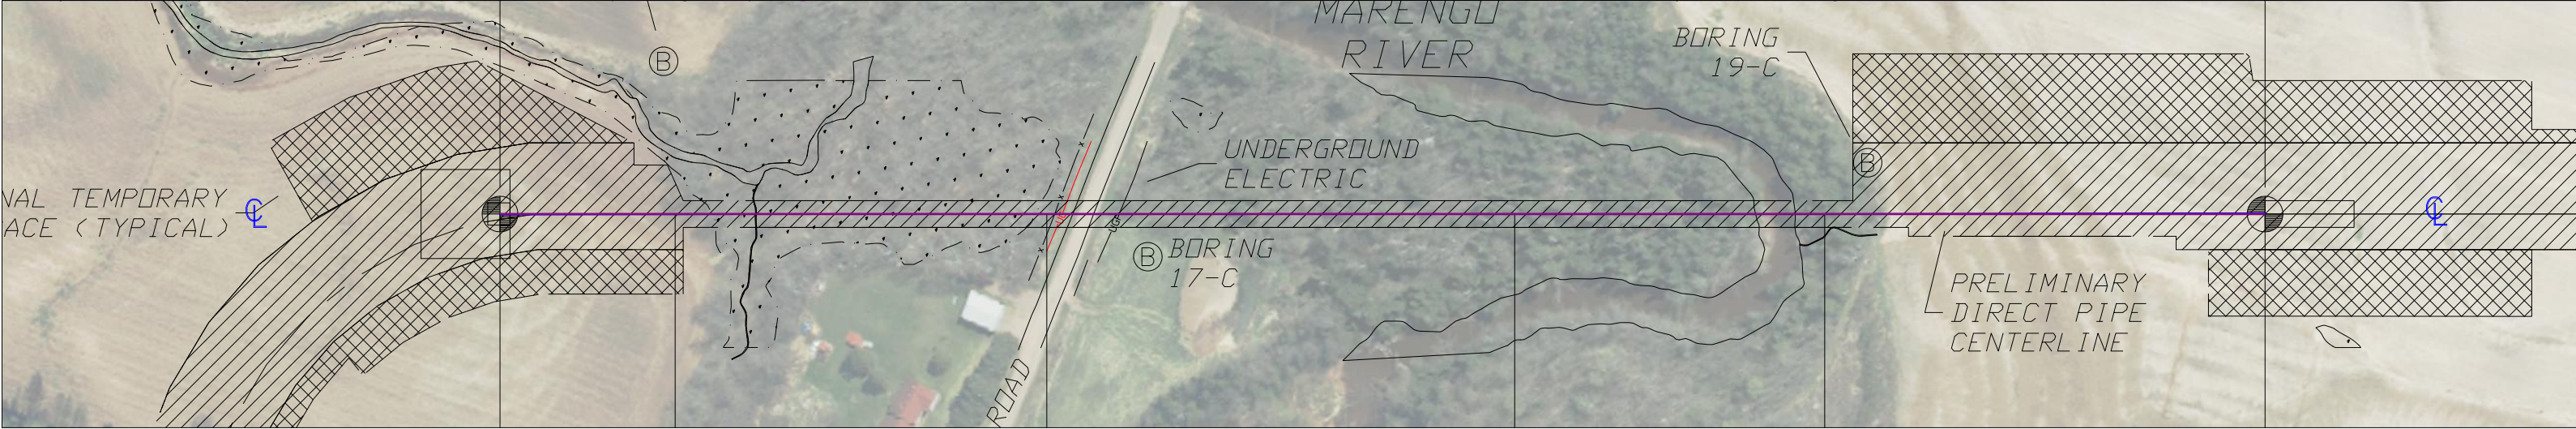
## EQUIPMENT AND CONTAINMENT SITE LAYOUT

PLAN  
SCALE: 1"=80'

OVERALL PLAN VIEW  
SCALE: 1" = 175'

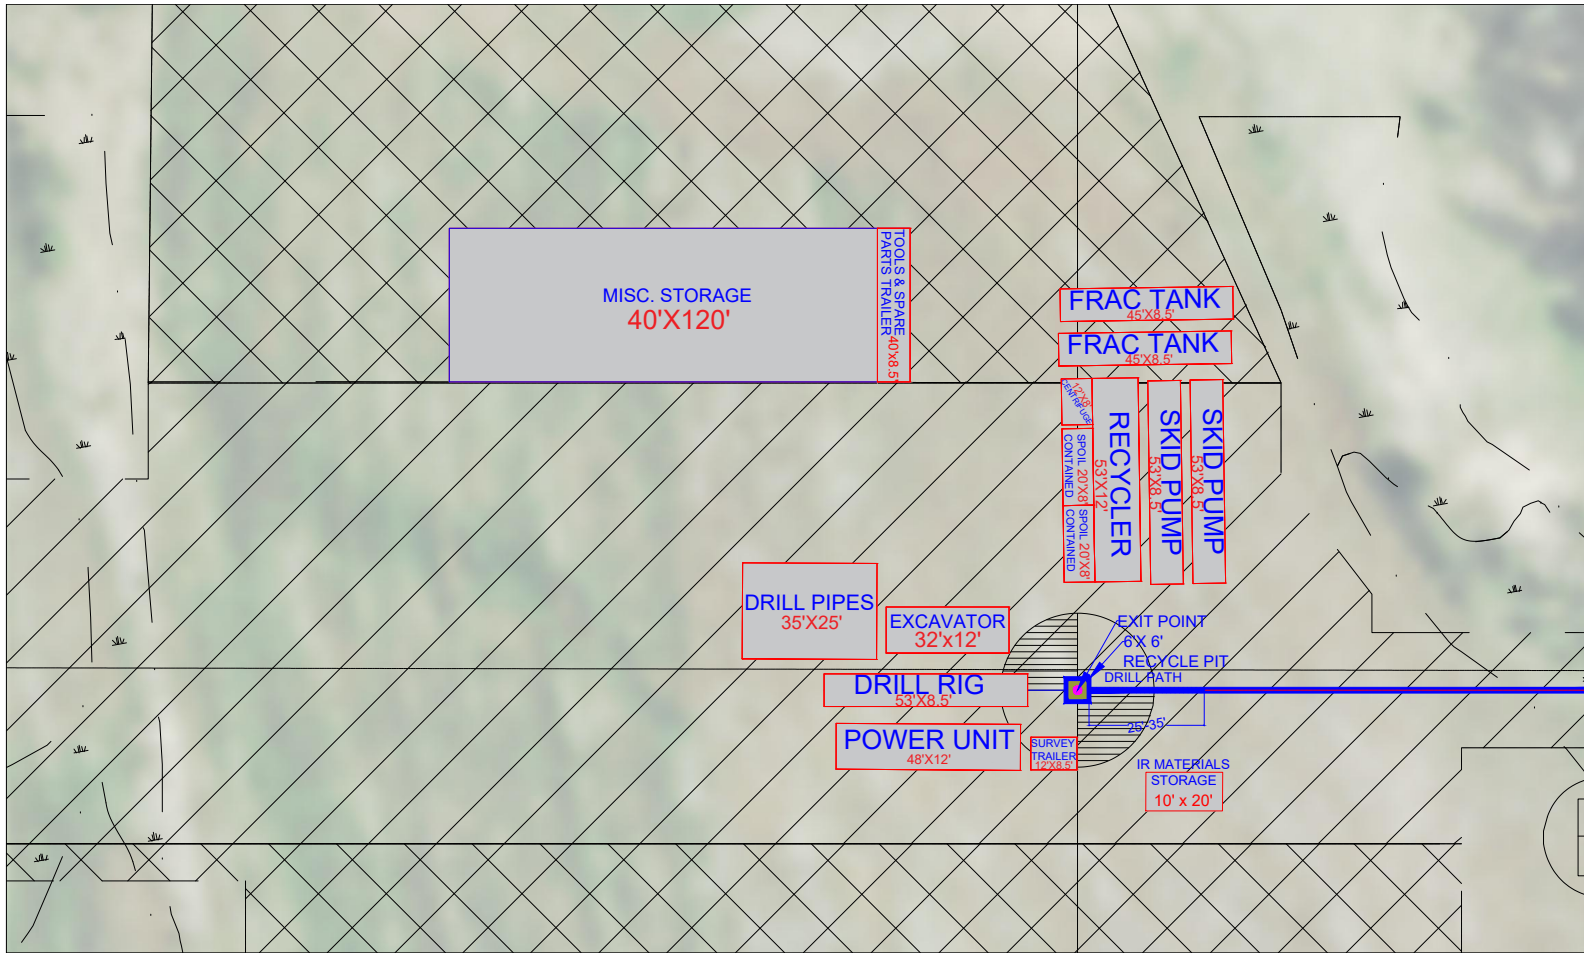
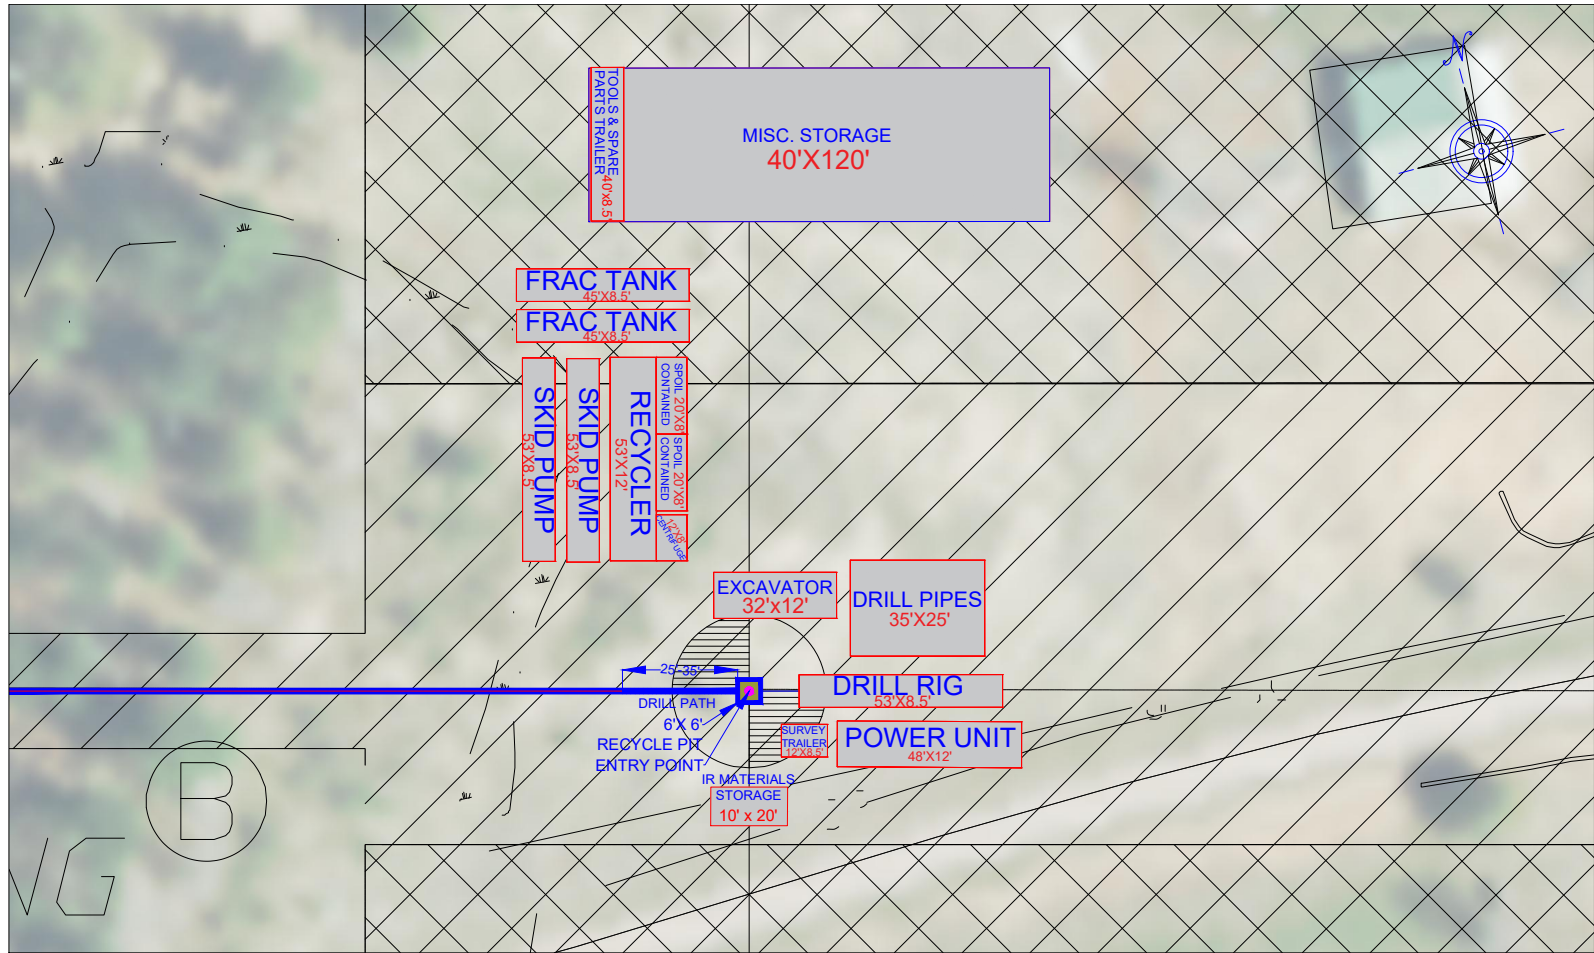
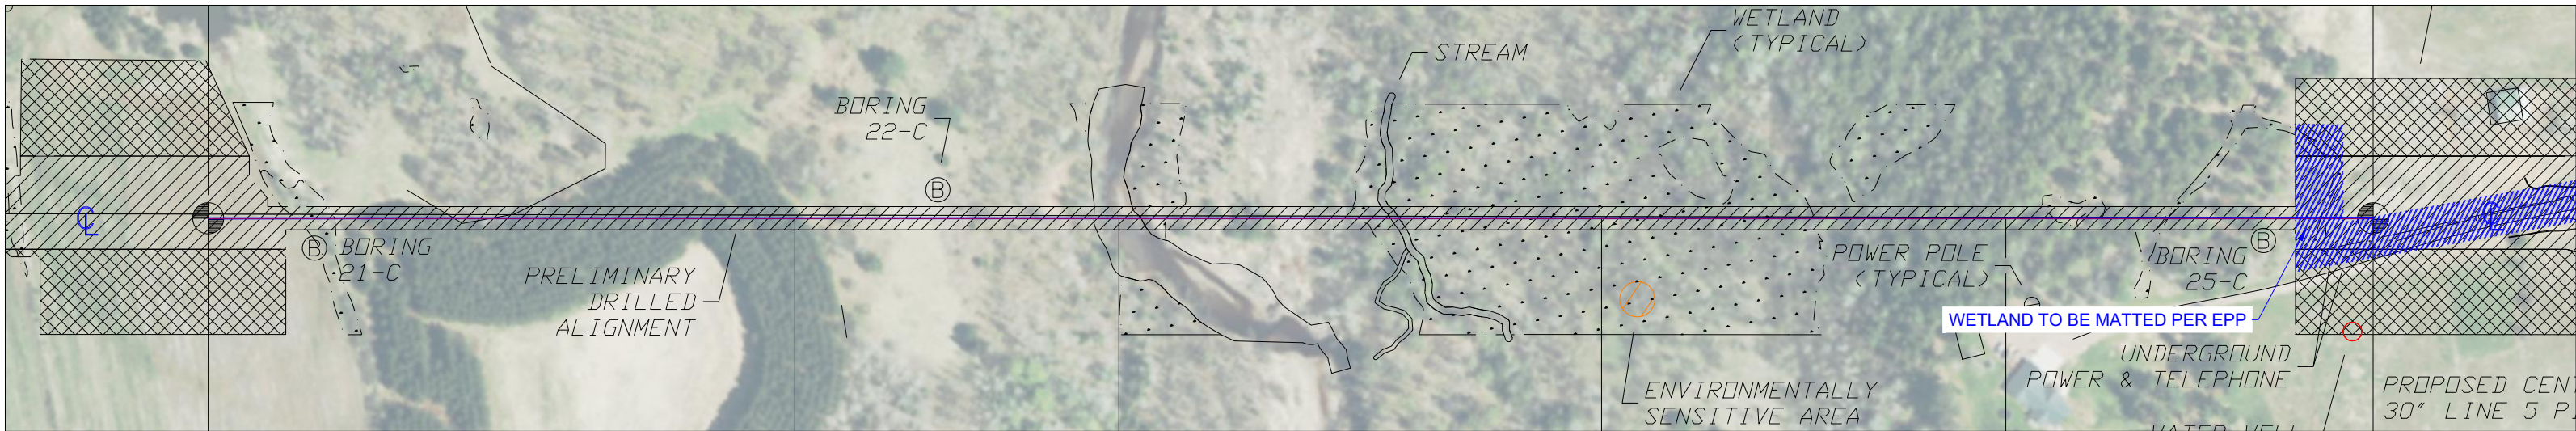
## EQUIPMENT AND CONTAINMENT SITE LAYOUT

PLAN

SCALE: 1" = 200'

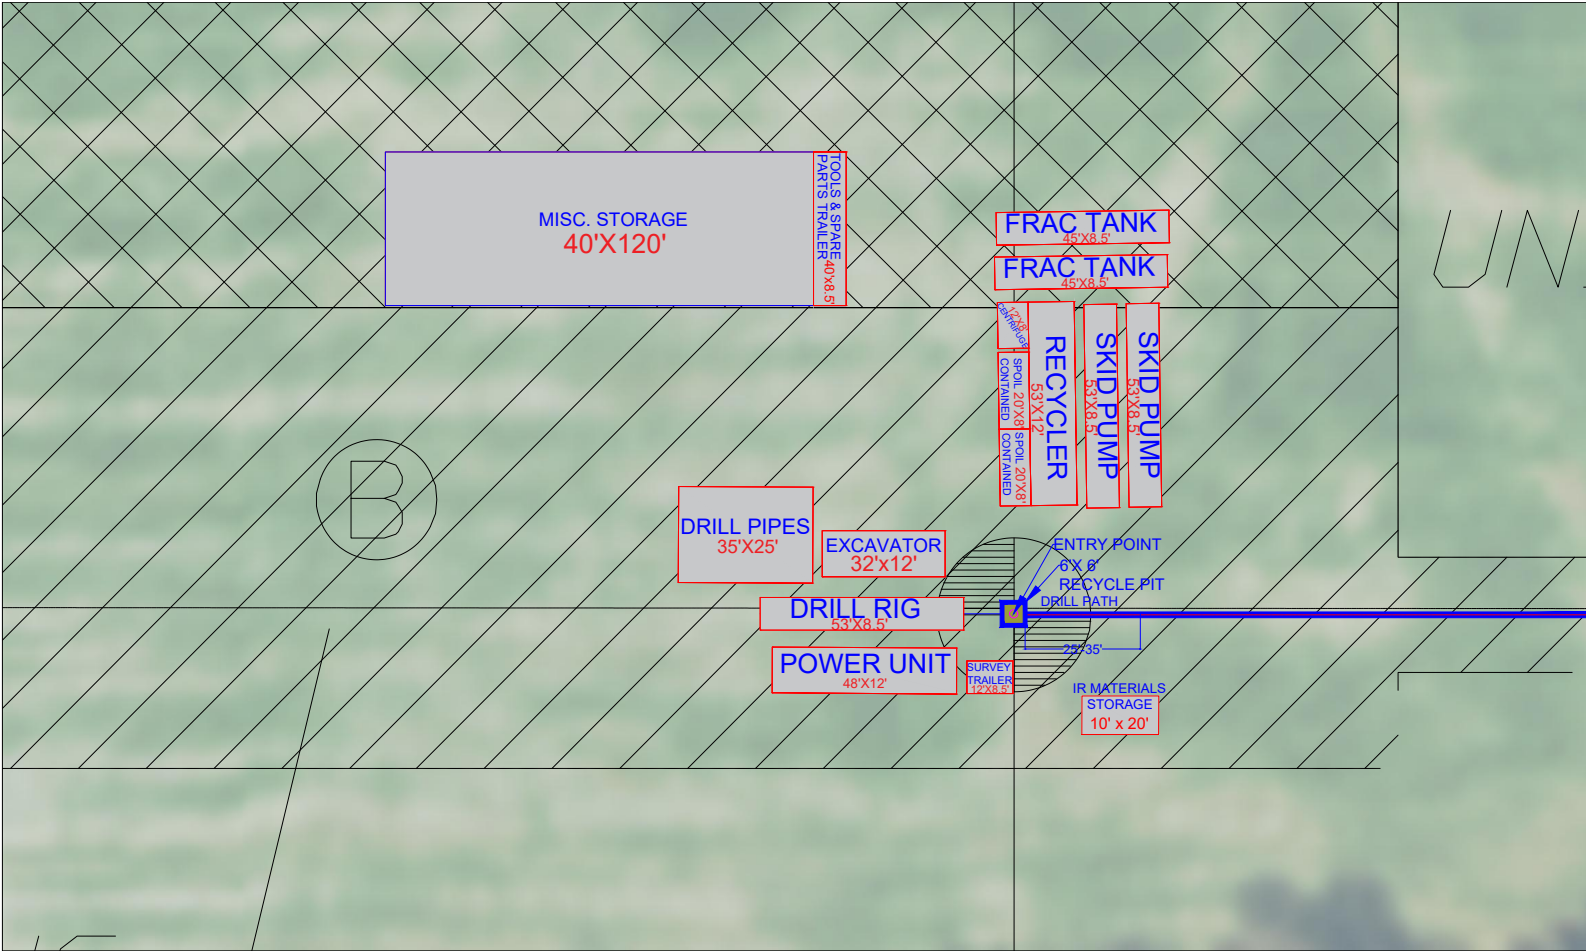
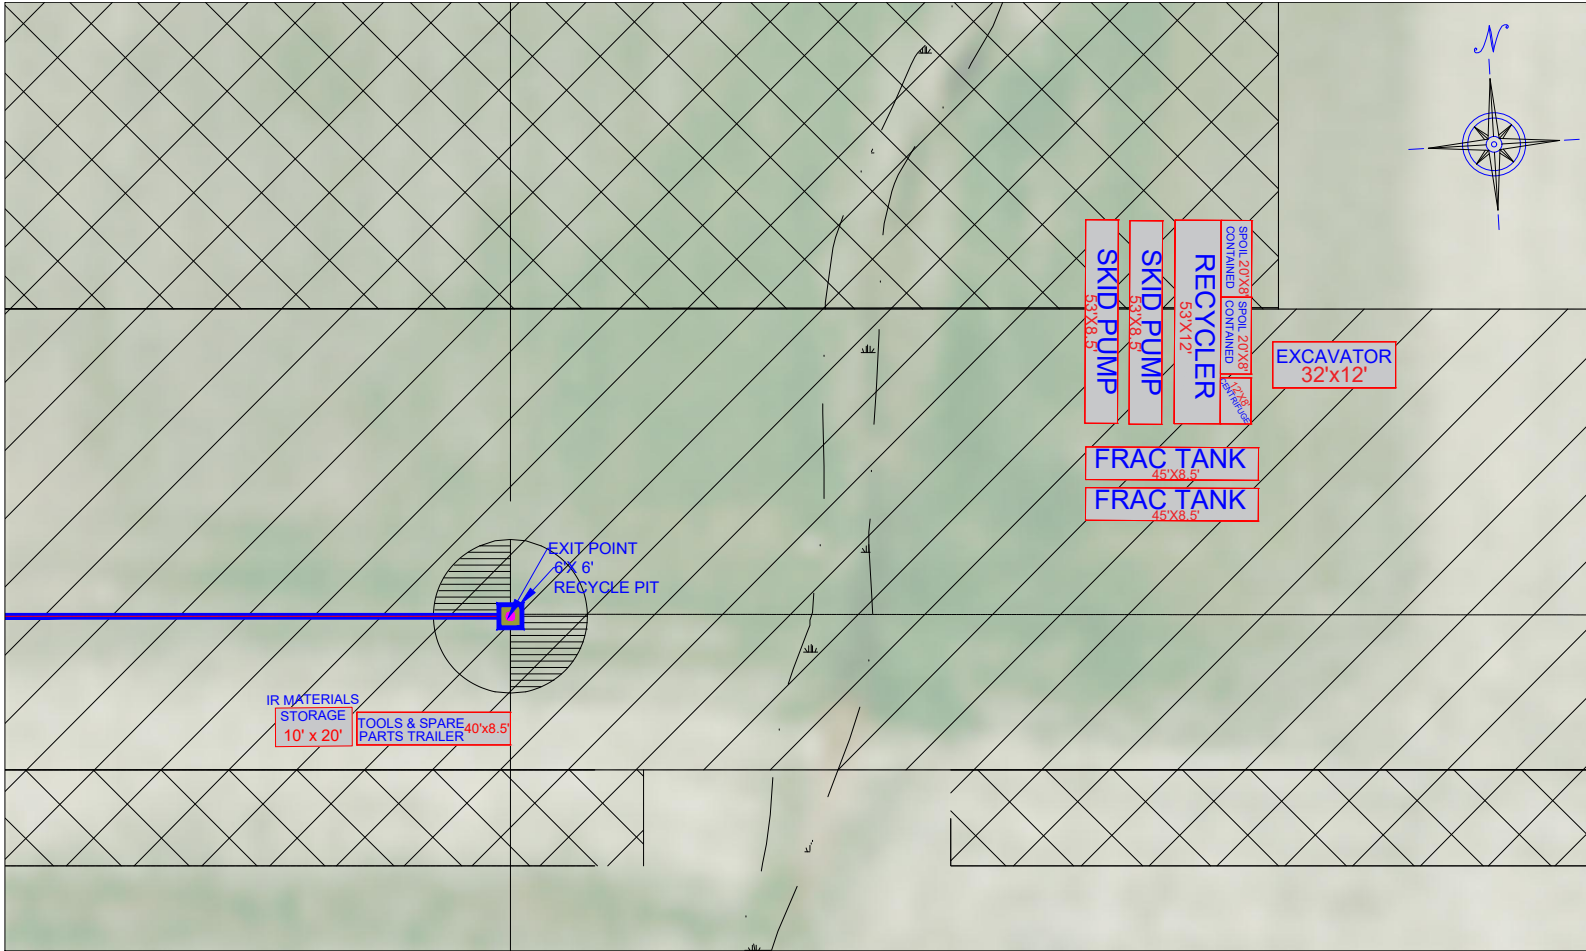
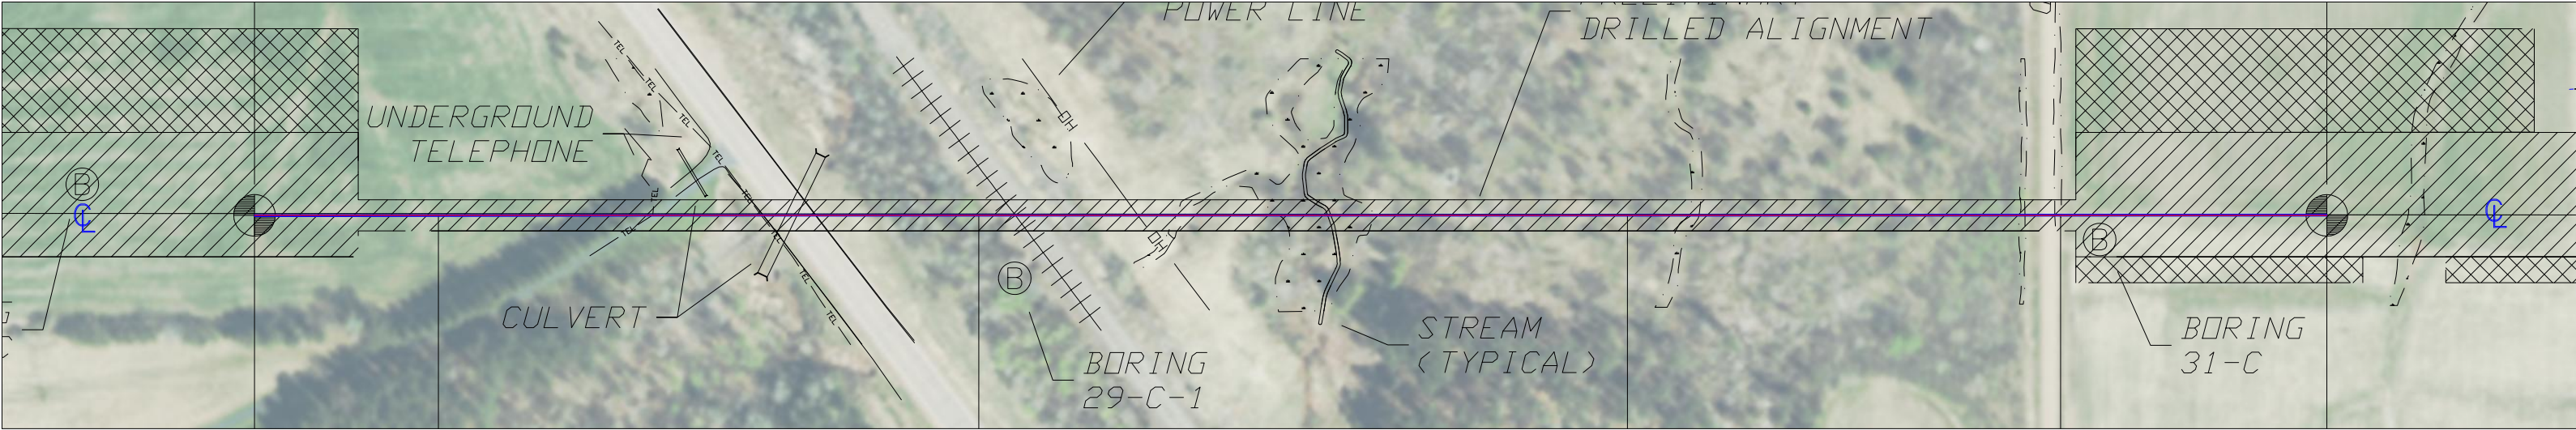
## EQUIPMENT AND CONTAINMENT SITE LAYOUT

PLAN

OVERALL PLAN VIEW
