Enbridge

Line 5 – Deer Creek HDD Crossing

HDD INADVERTENT RETURN MITIGATION AND CONTINGENCY PLAN

**MICHELS TRENCHLESS INCORPORATED (MTI)**  
**INADVERTENT RETURN MITIGATION AND CONTINGENCY PLAN**  
**ENBRIDGE LINE 5 PROJECT**  
**MP 6 – 30-INCH DEER CREEK HDD CROSSING**

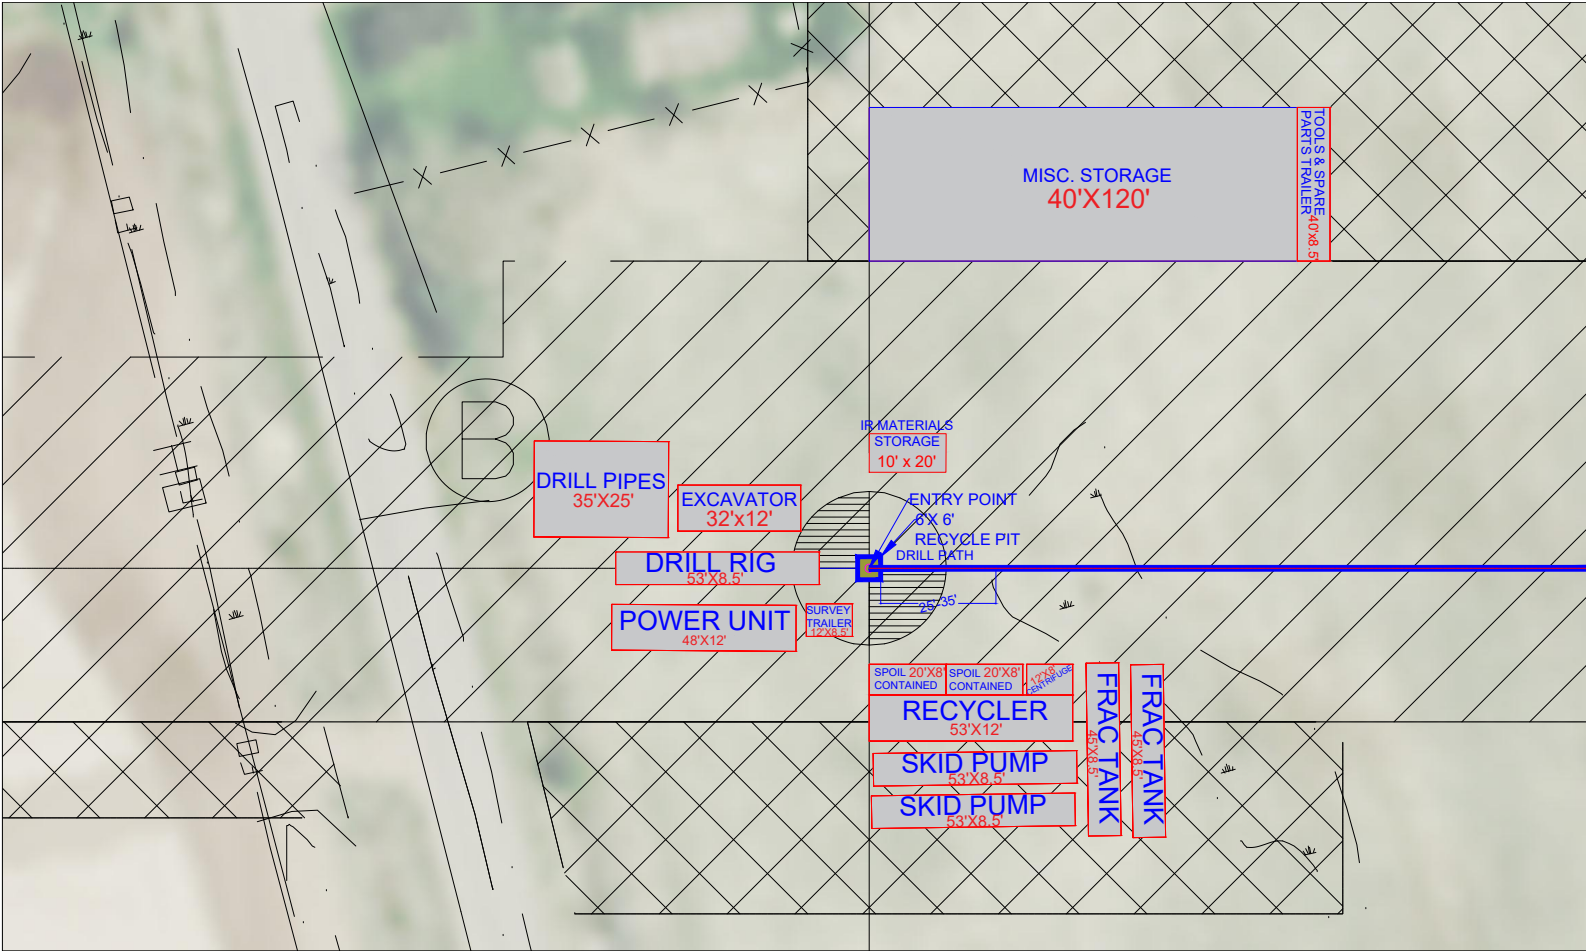
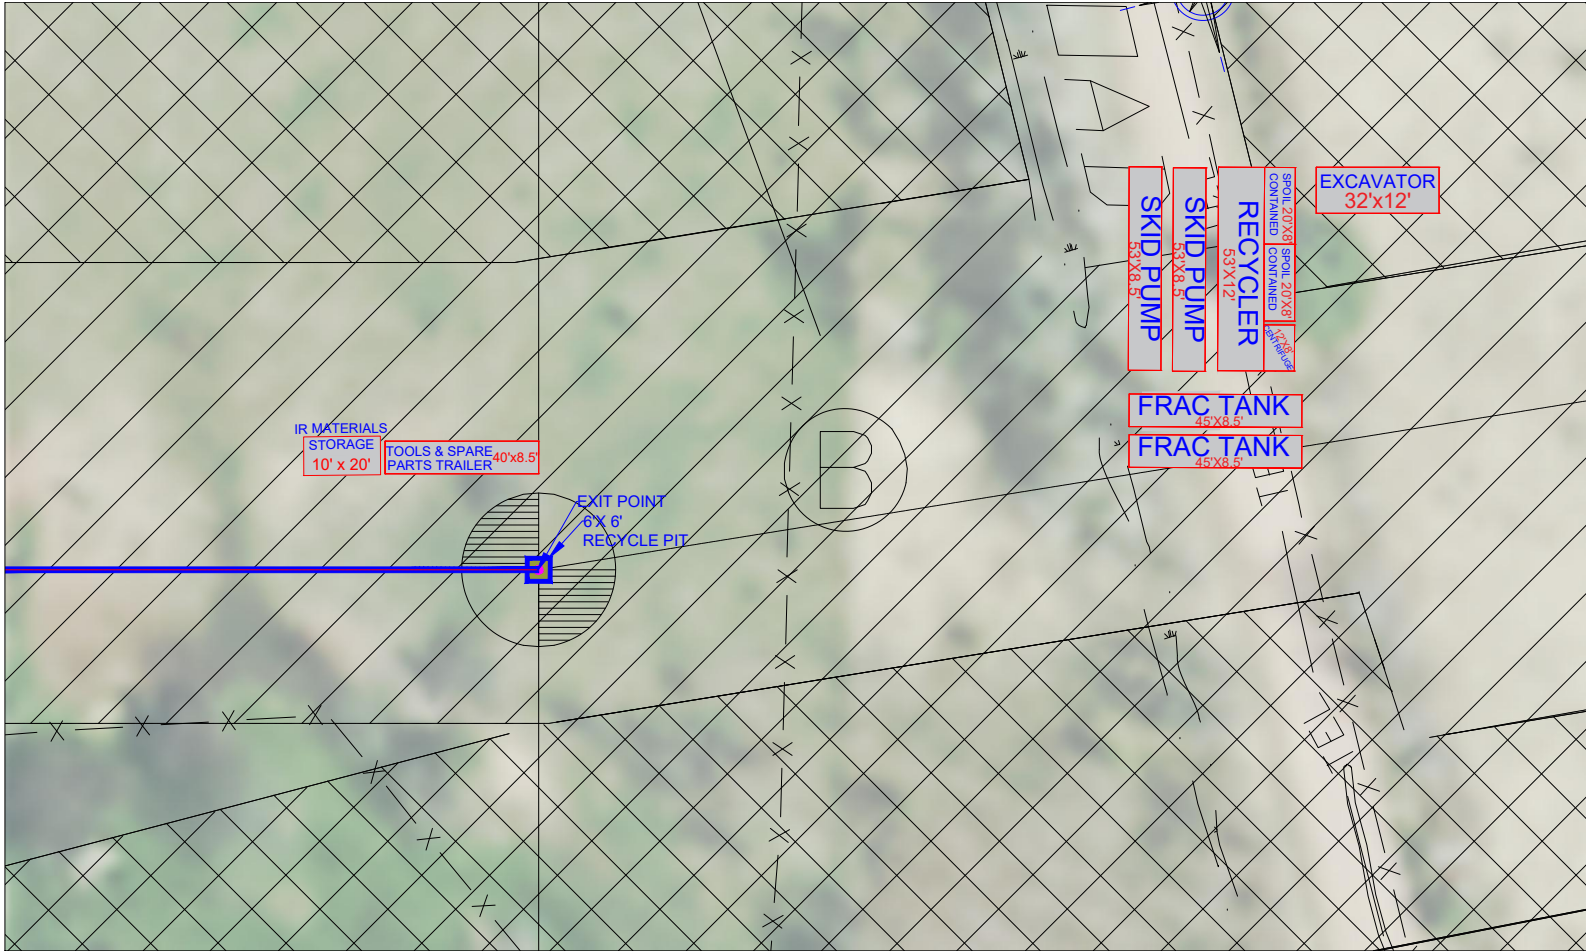
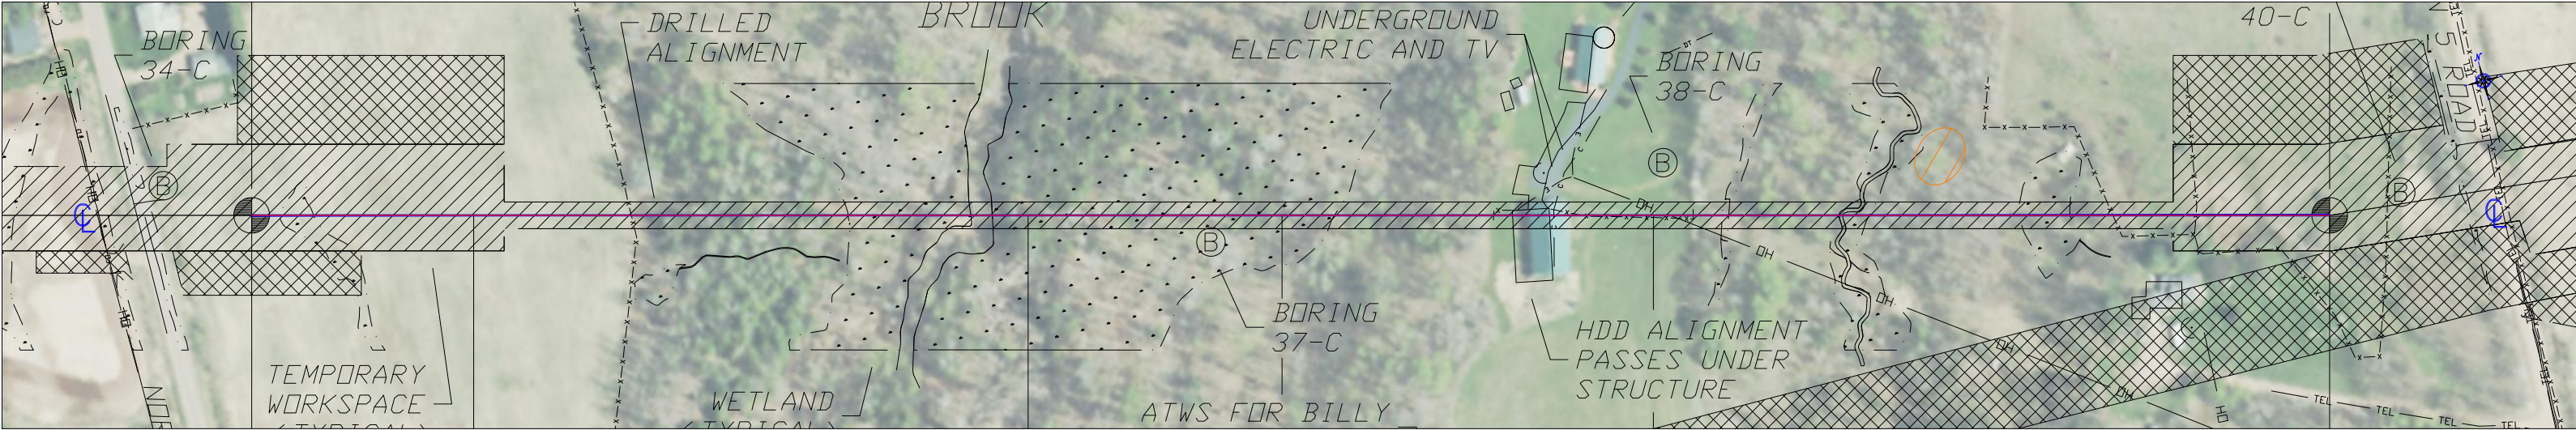
## EQUIPMENT AND CONTAINMENT SITE LAYOUT

PLAN  
SCALE: 1"=50'

OVERALL PLAN VIEW  
SCALE: 1" = 150'

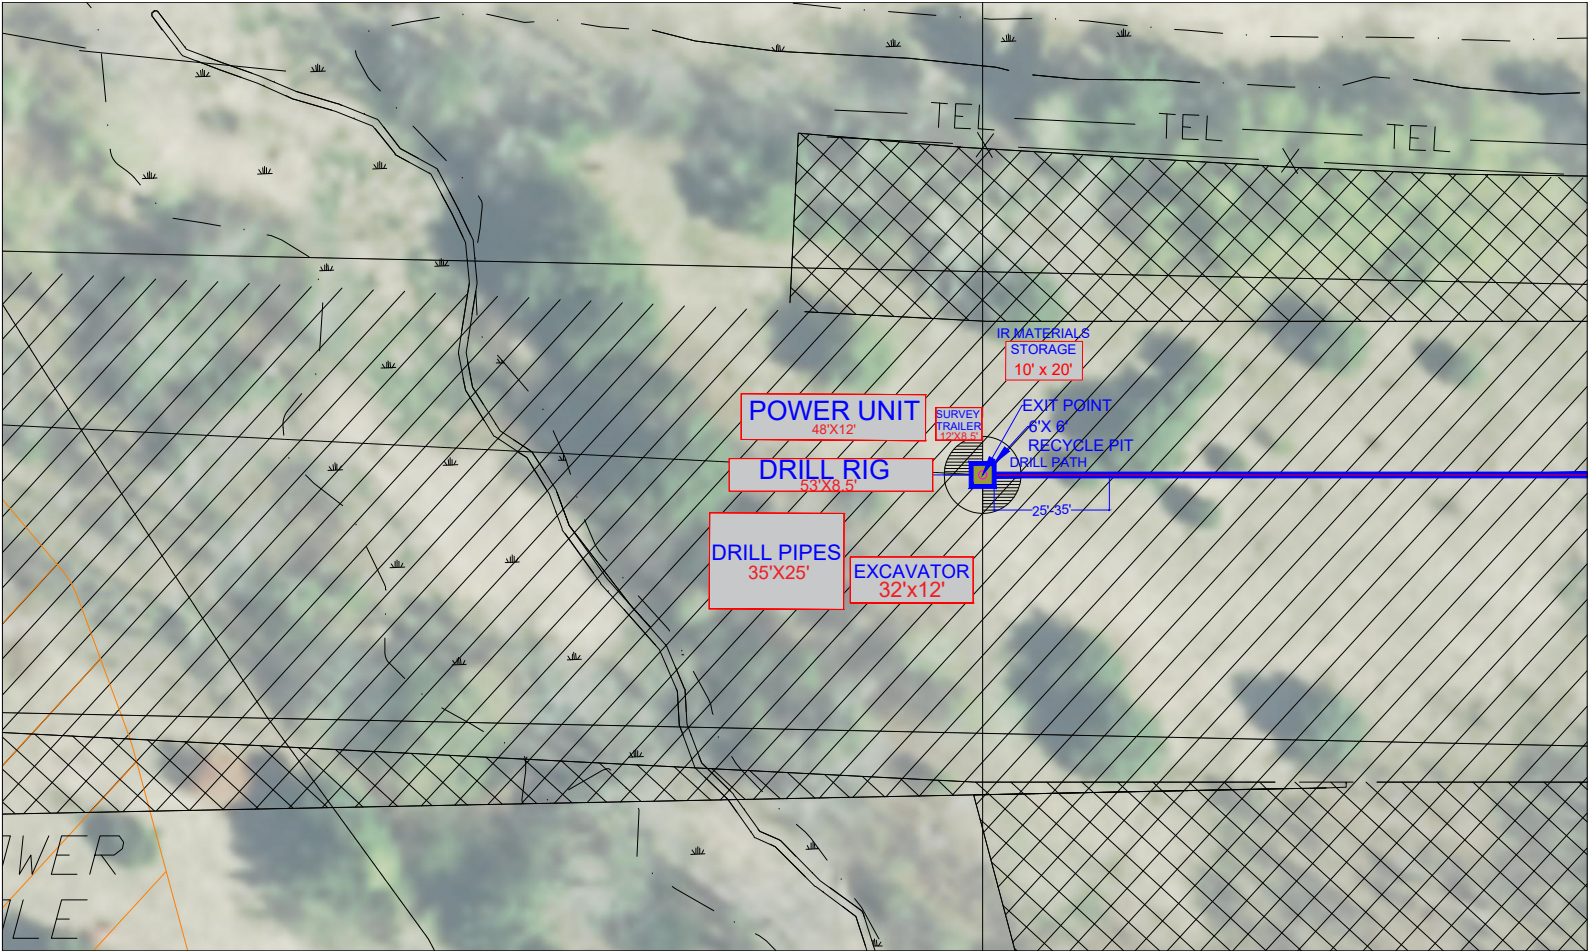
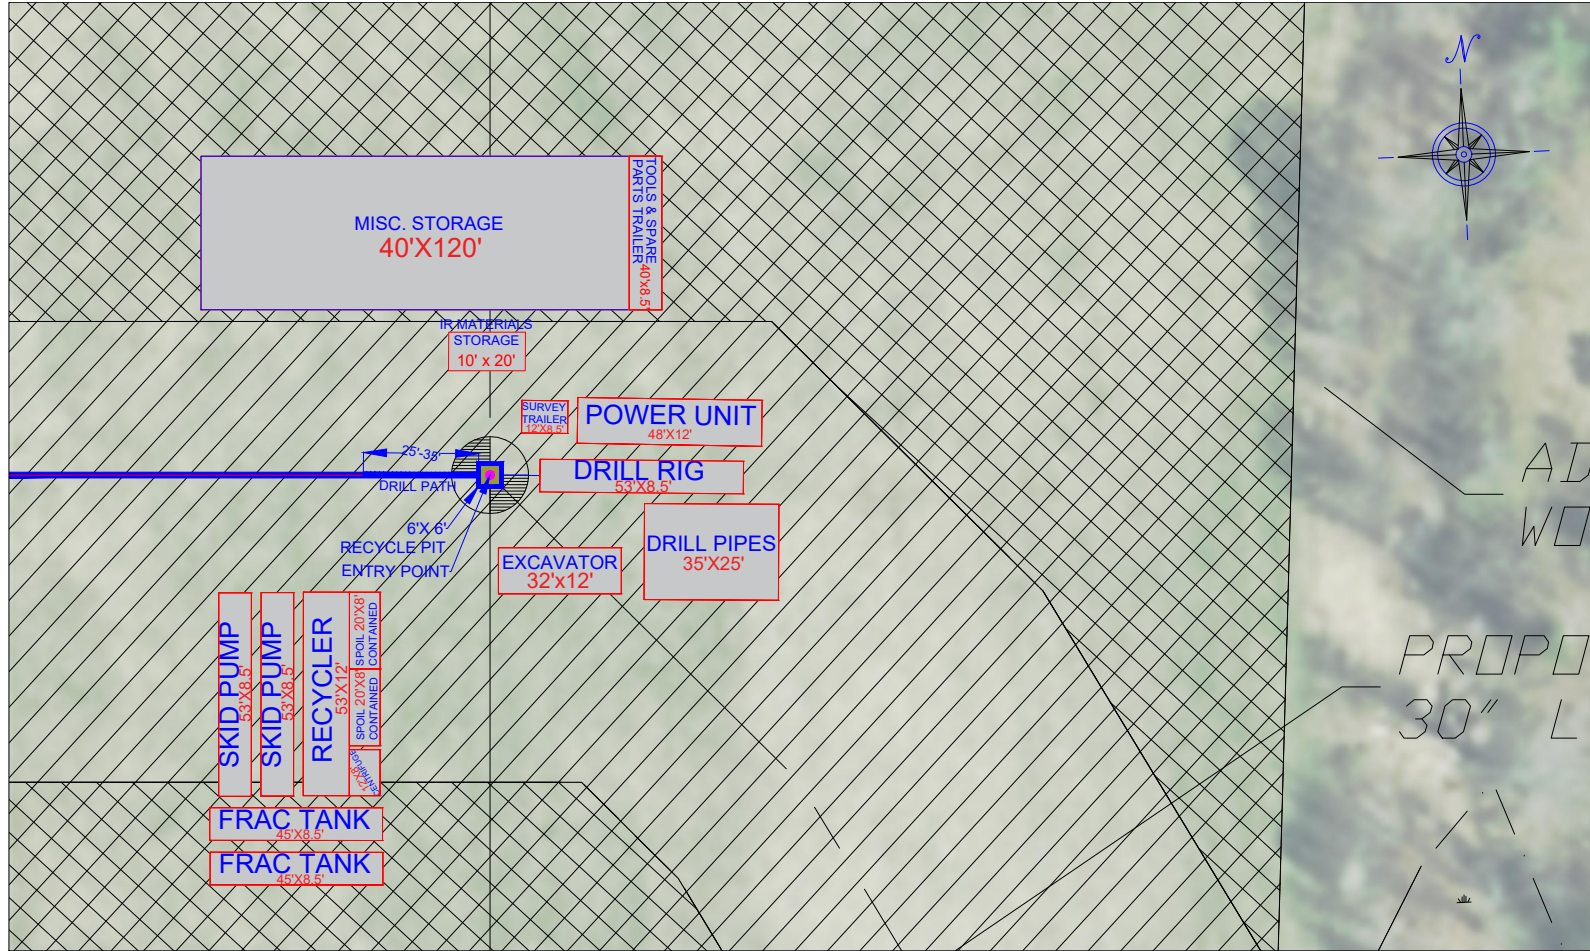
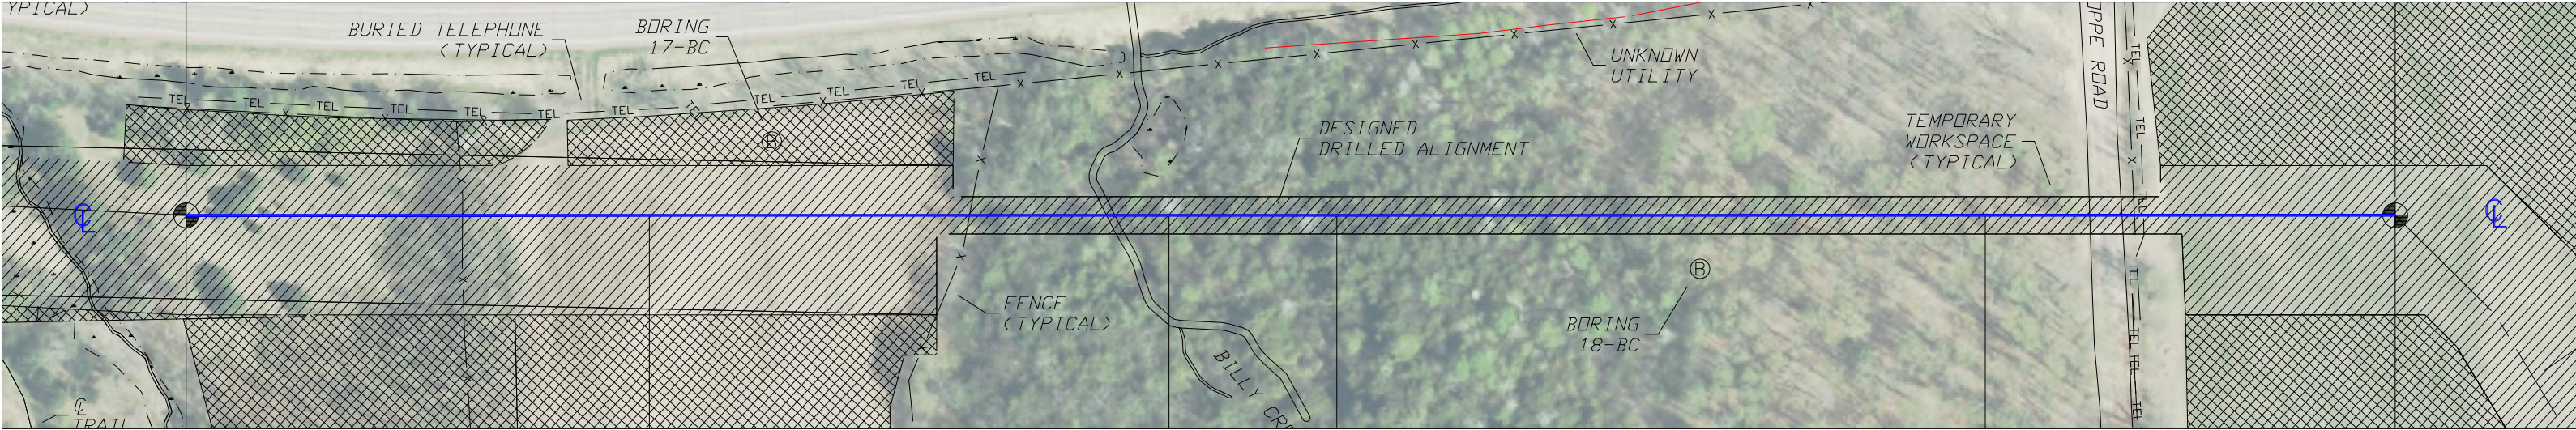
## EQUIPMENT AND CONTAINMENT SITE LAYOUT

PLAN

OVERALL PLAN VIEW

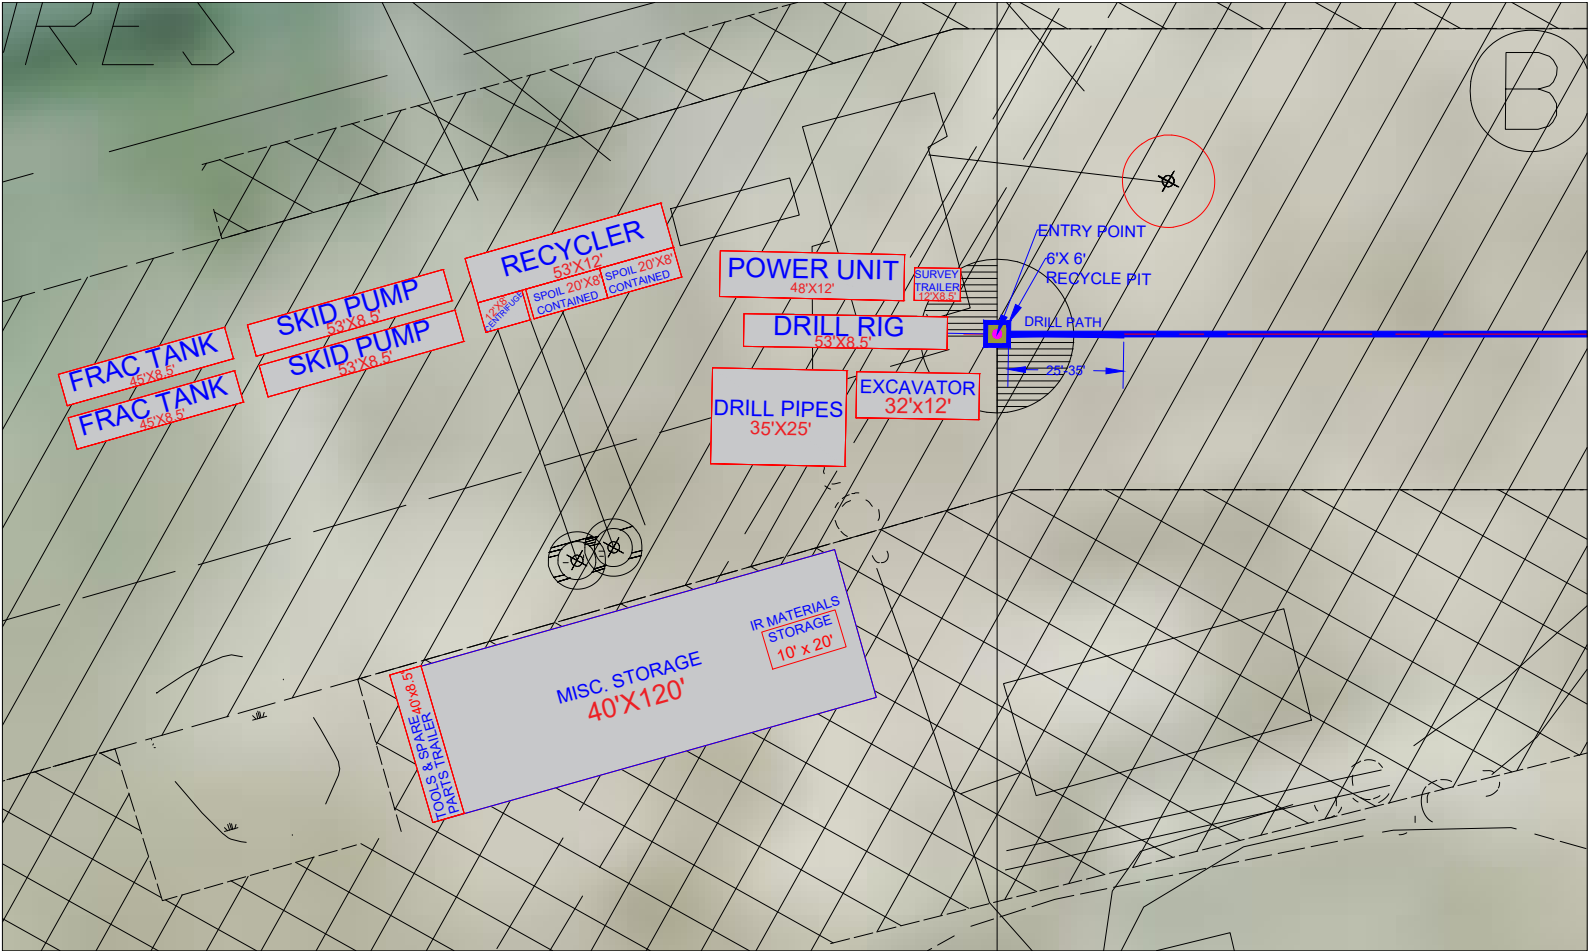
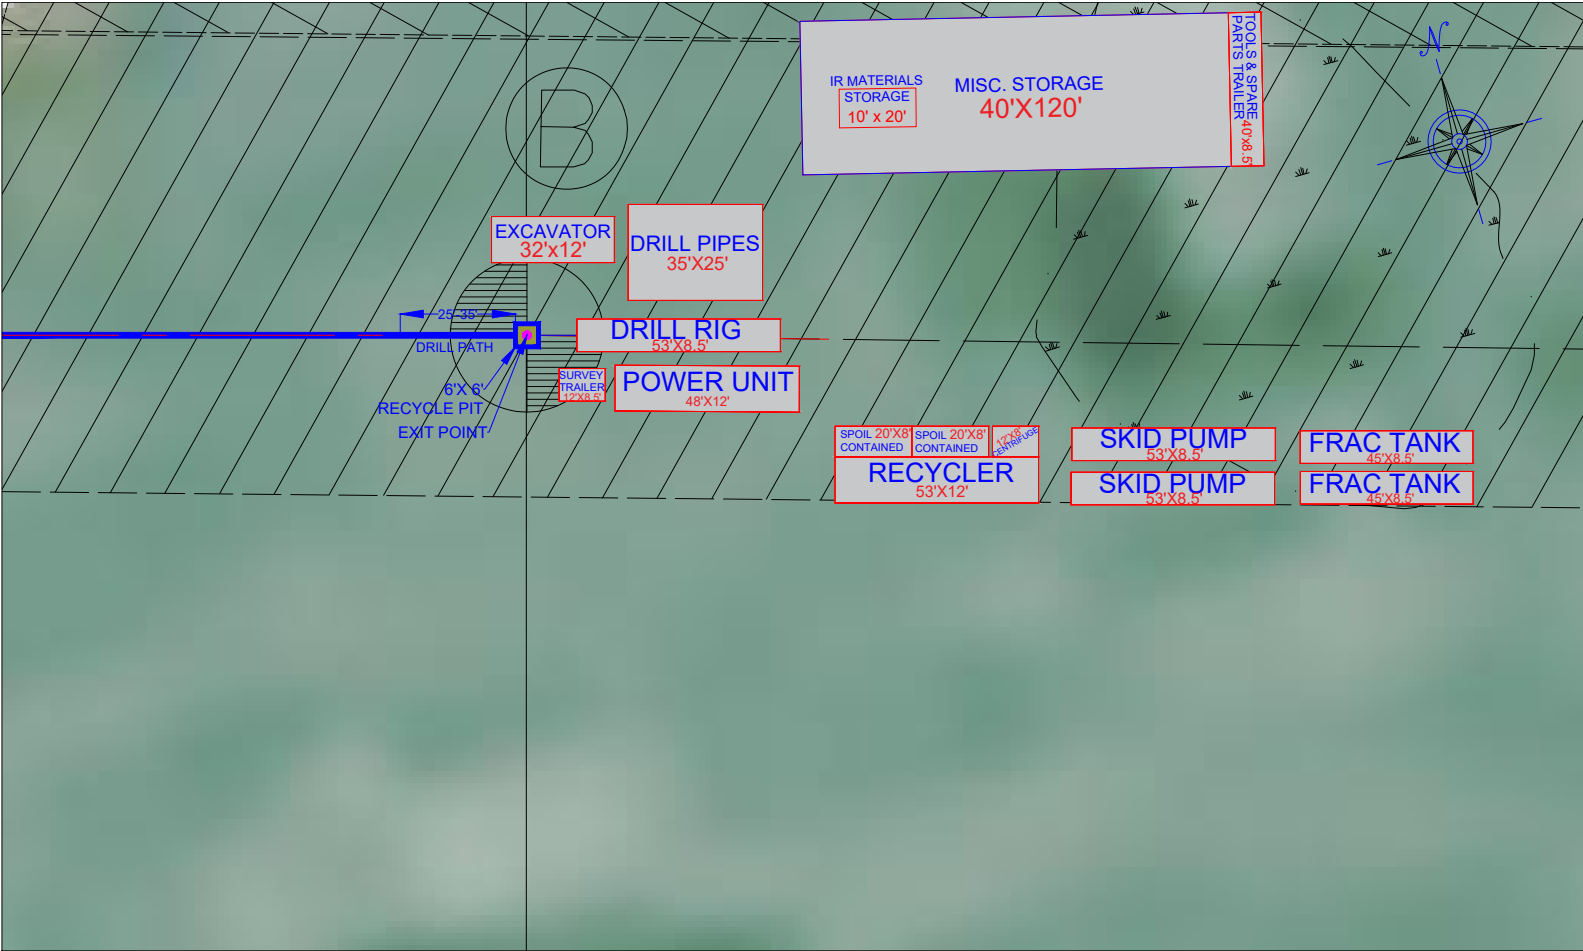
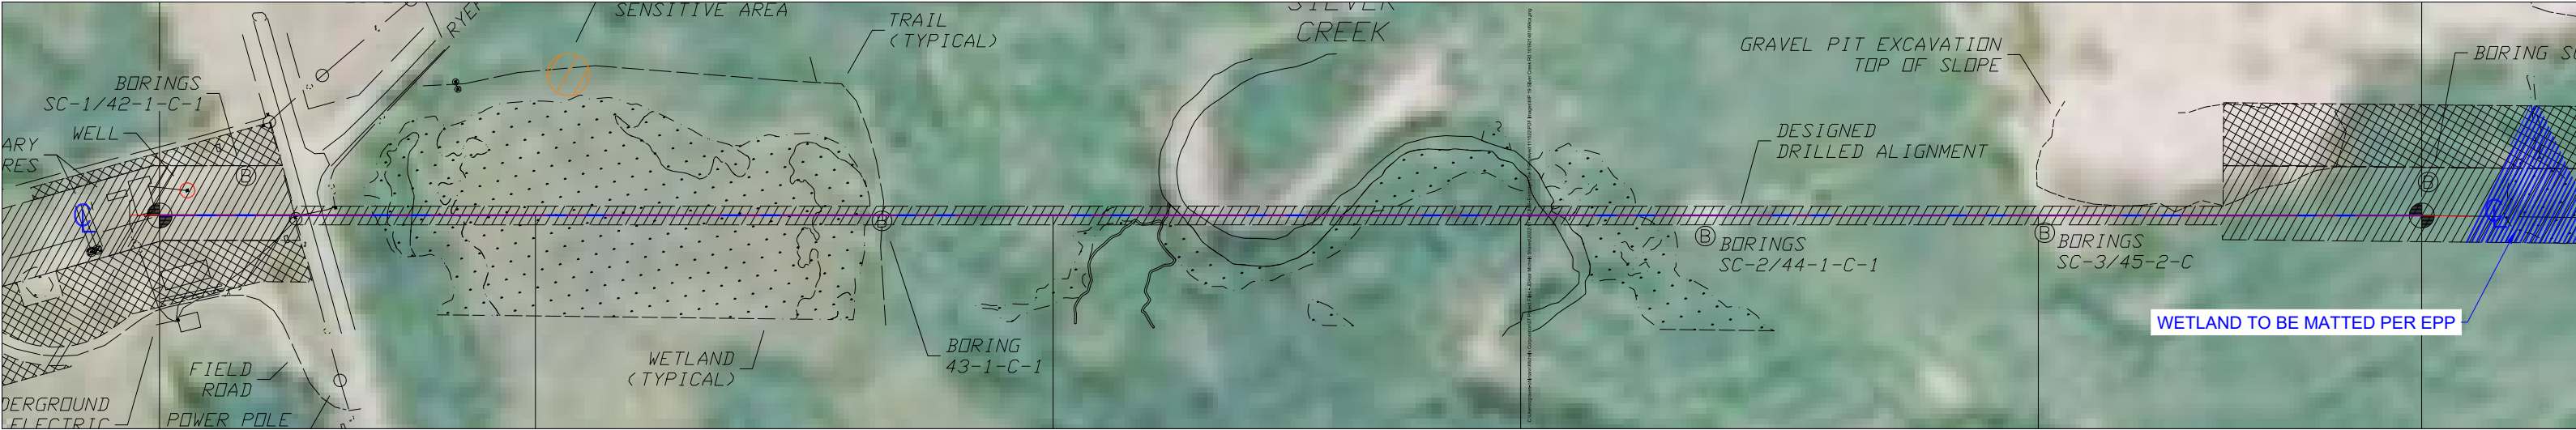
## EQUIPMENT AND CONTAINMENT SITE LAYOUT

PLAN

OVERALL PLAN VIEW

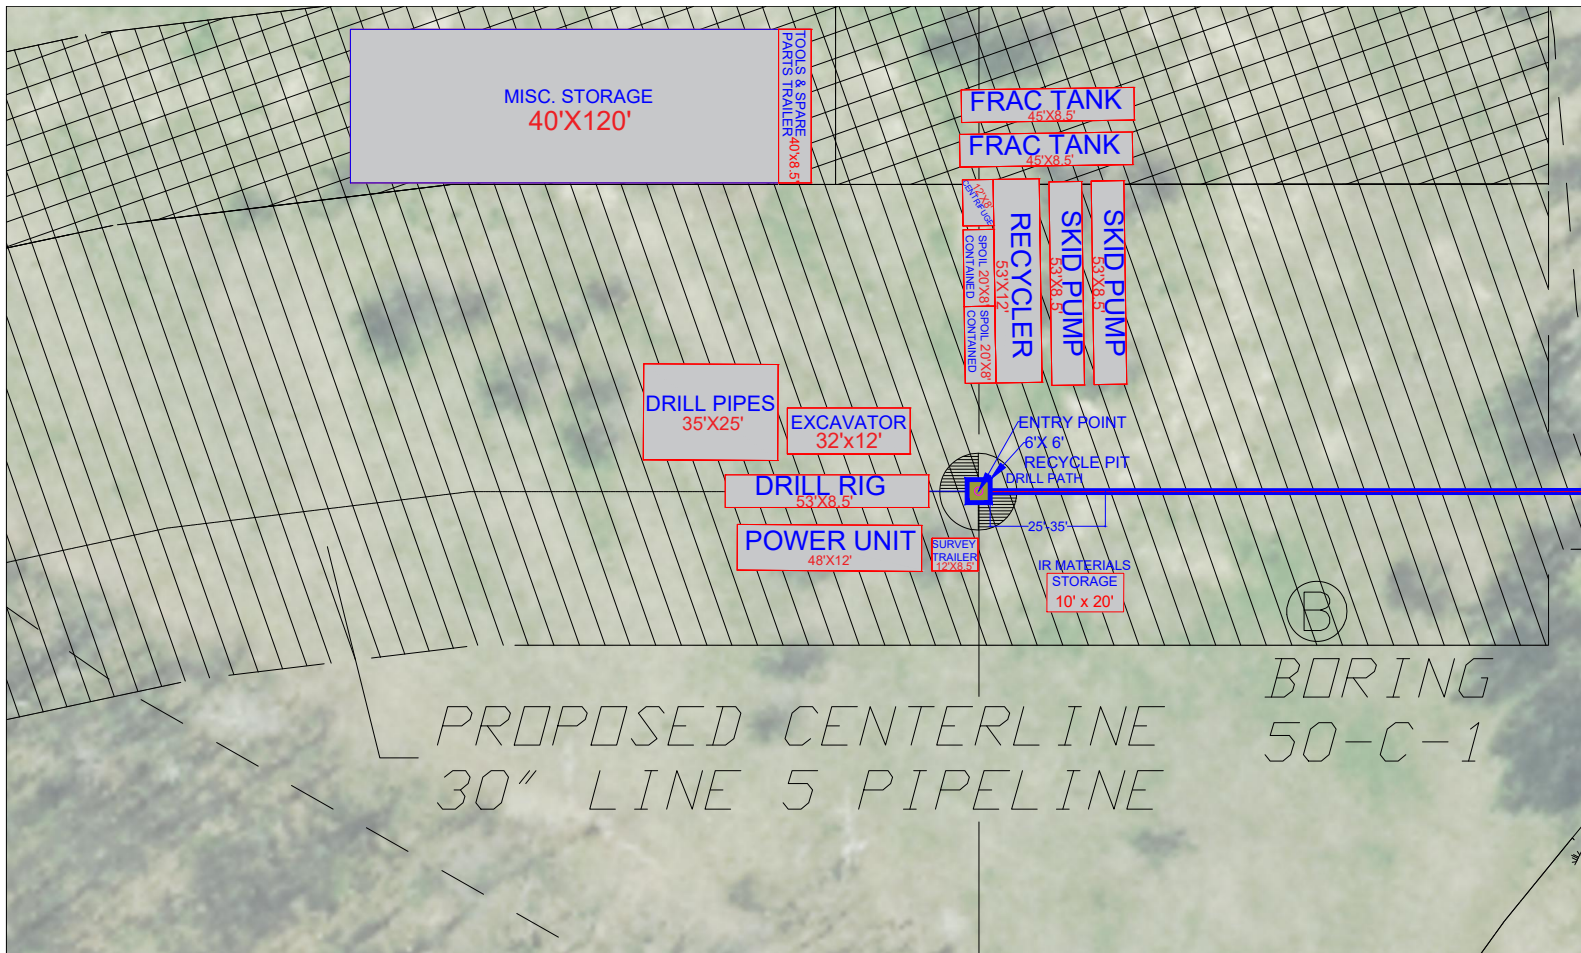
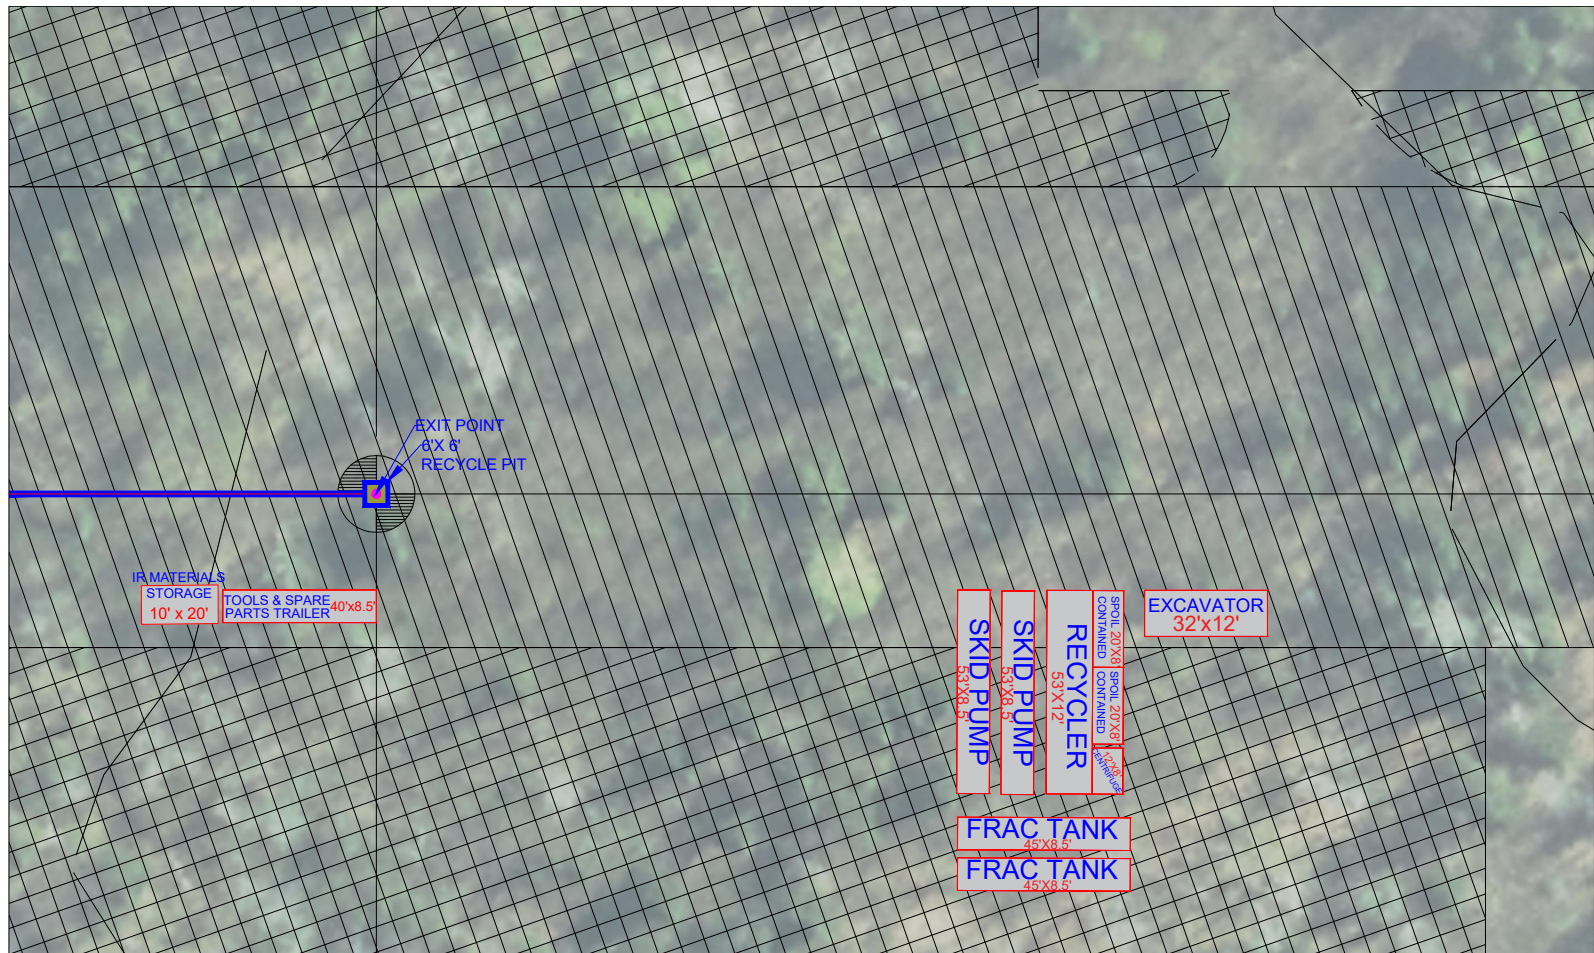
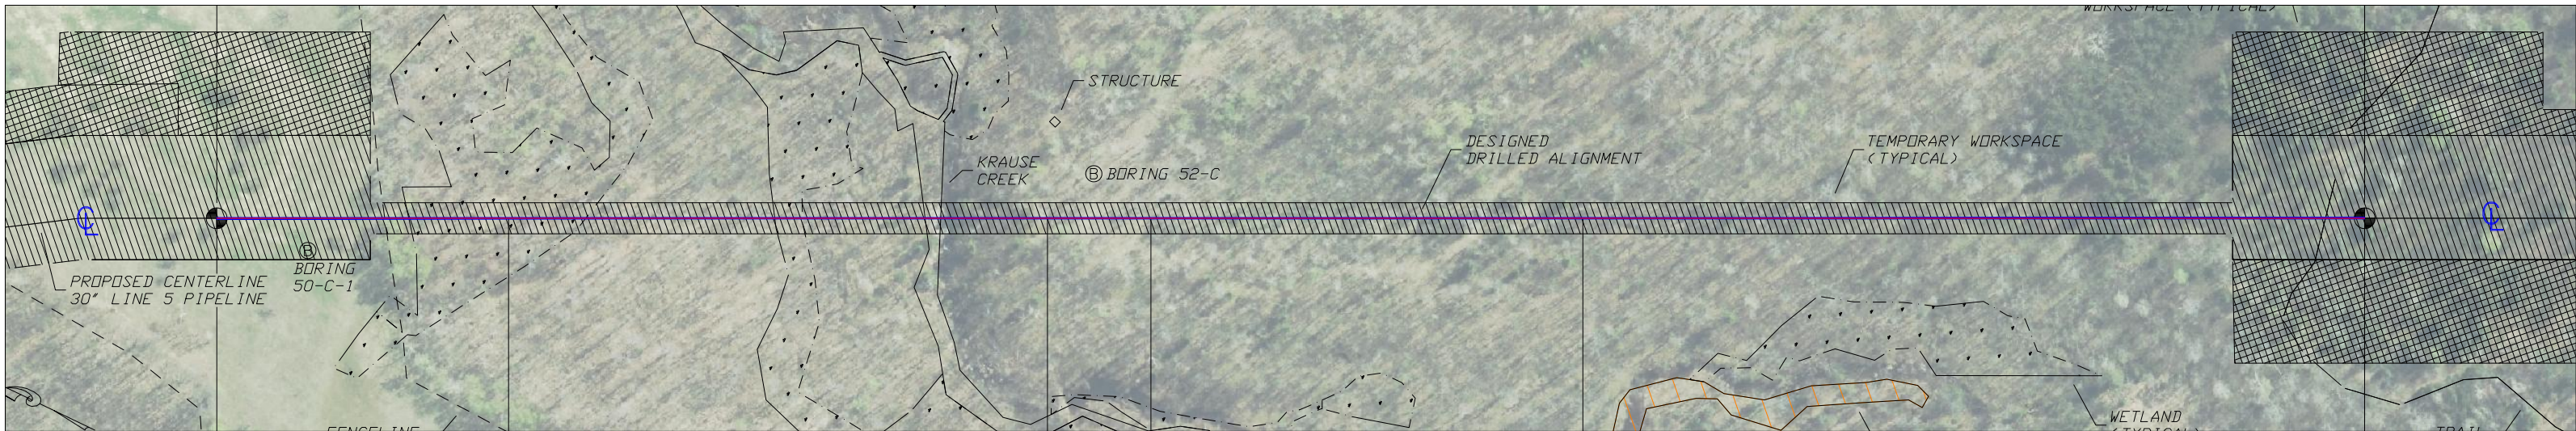
## EQUIPMENT AND CONTAINMENT SITE LAYOUT

**PLAN**

SCALE: 1"=50'

PLAN

**OVERALL PLAN VIEW**

SCALE: 1" = 150'

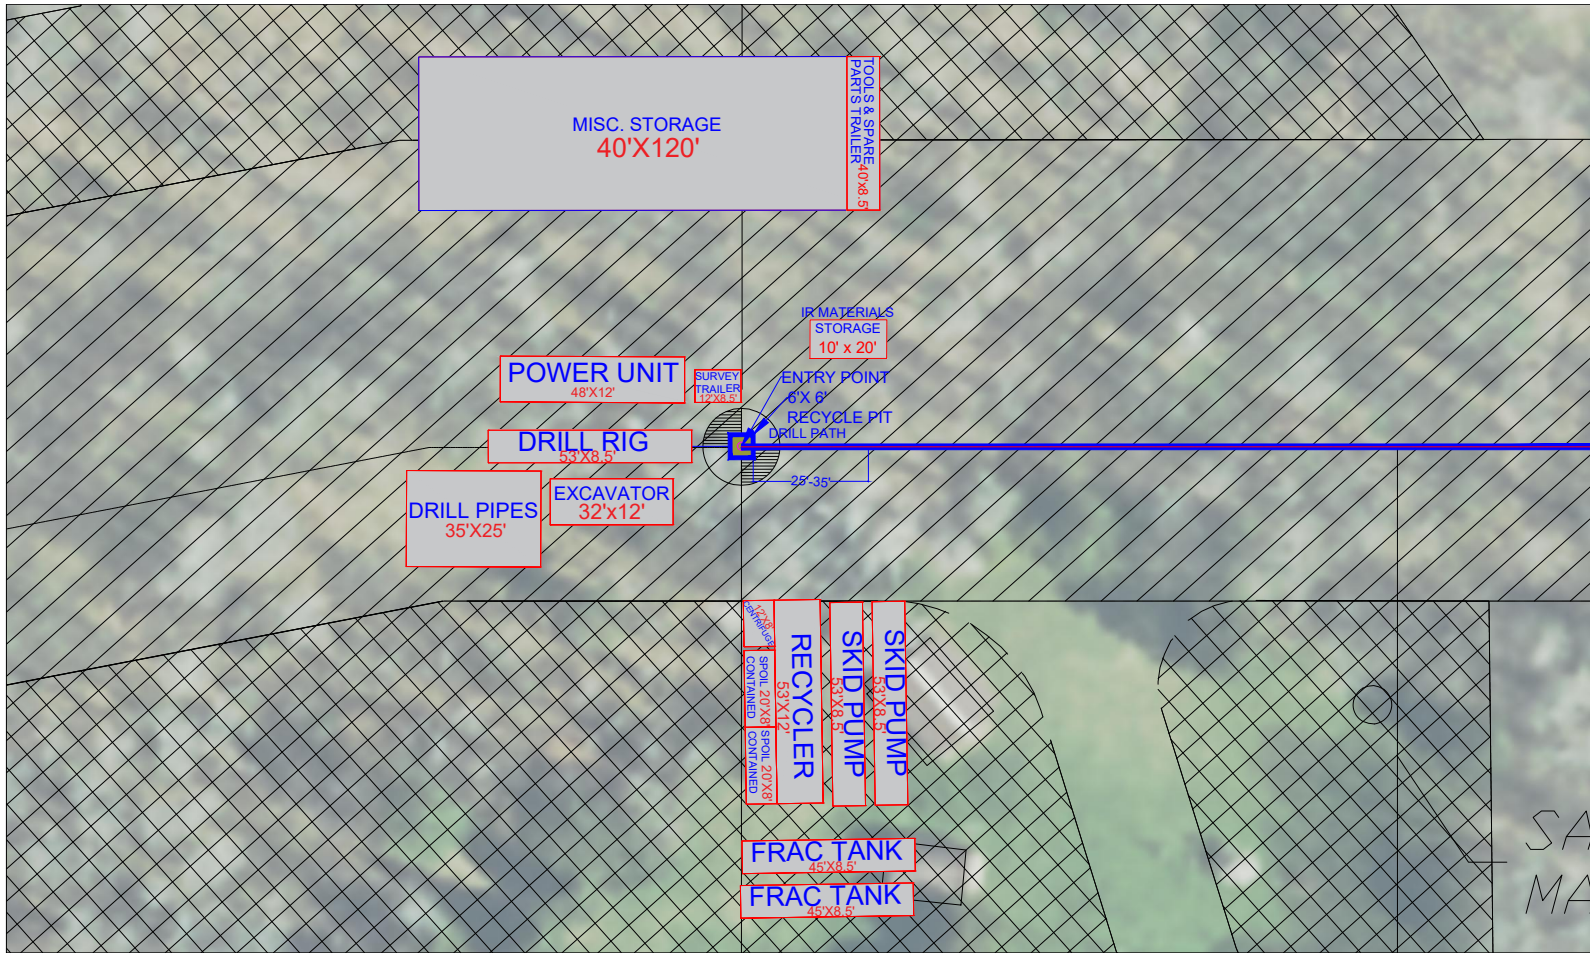
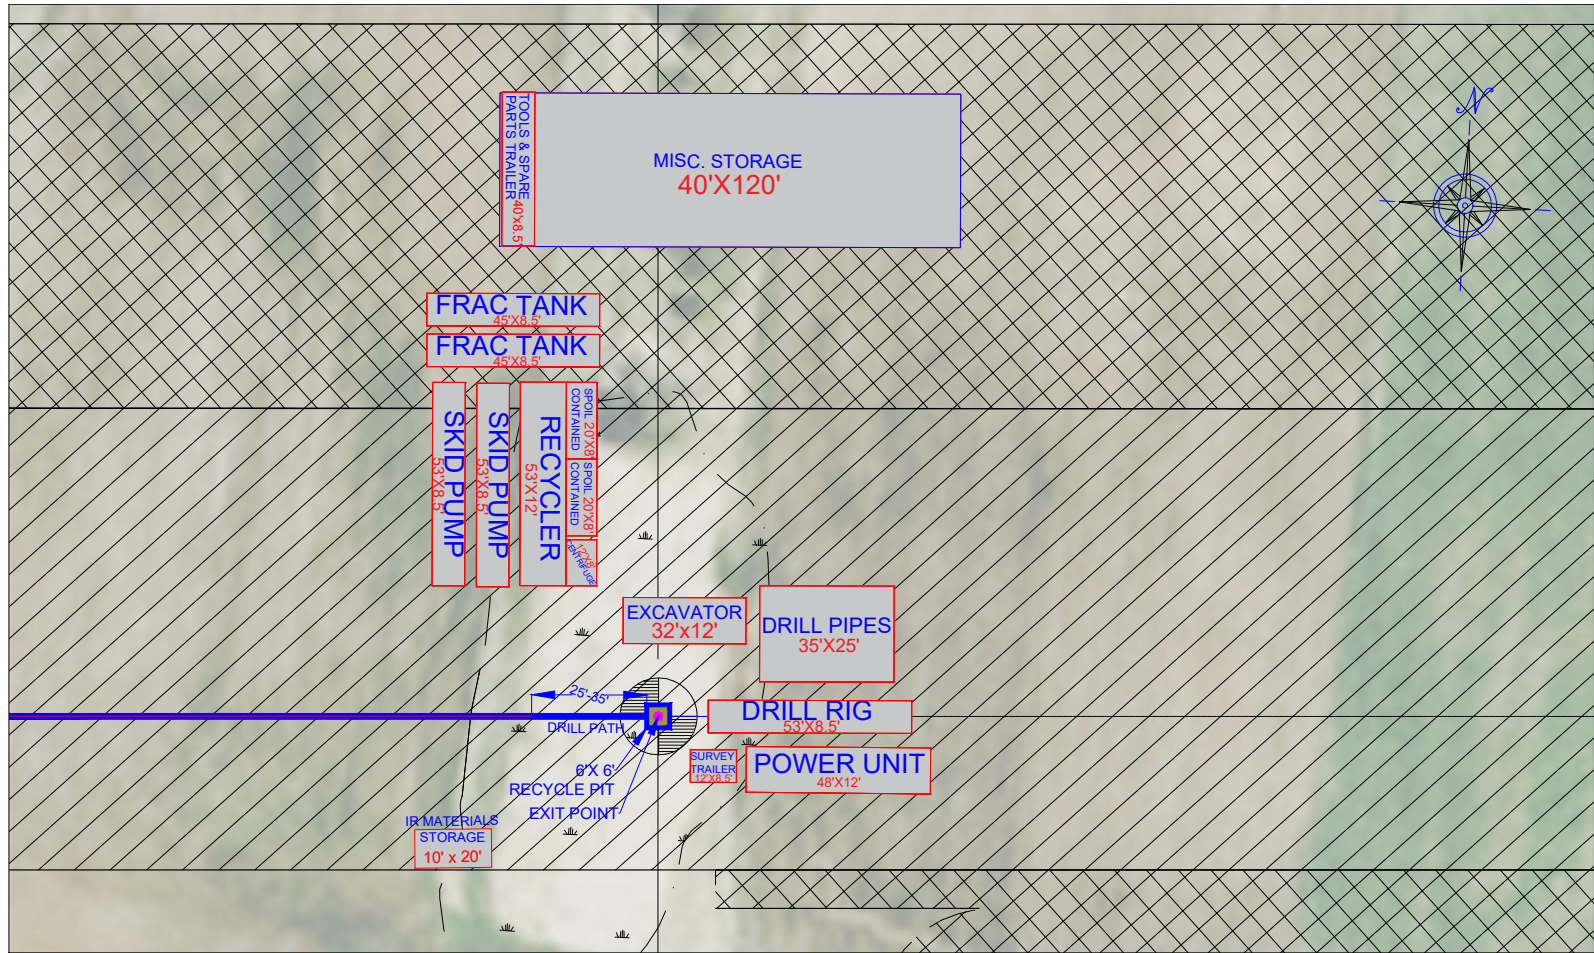
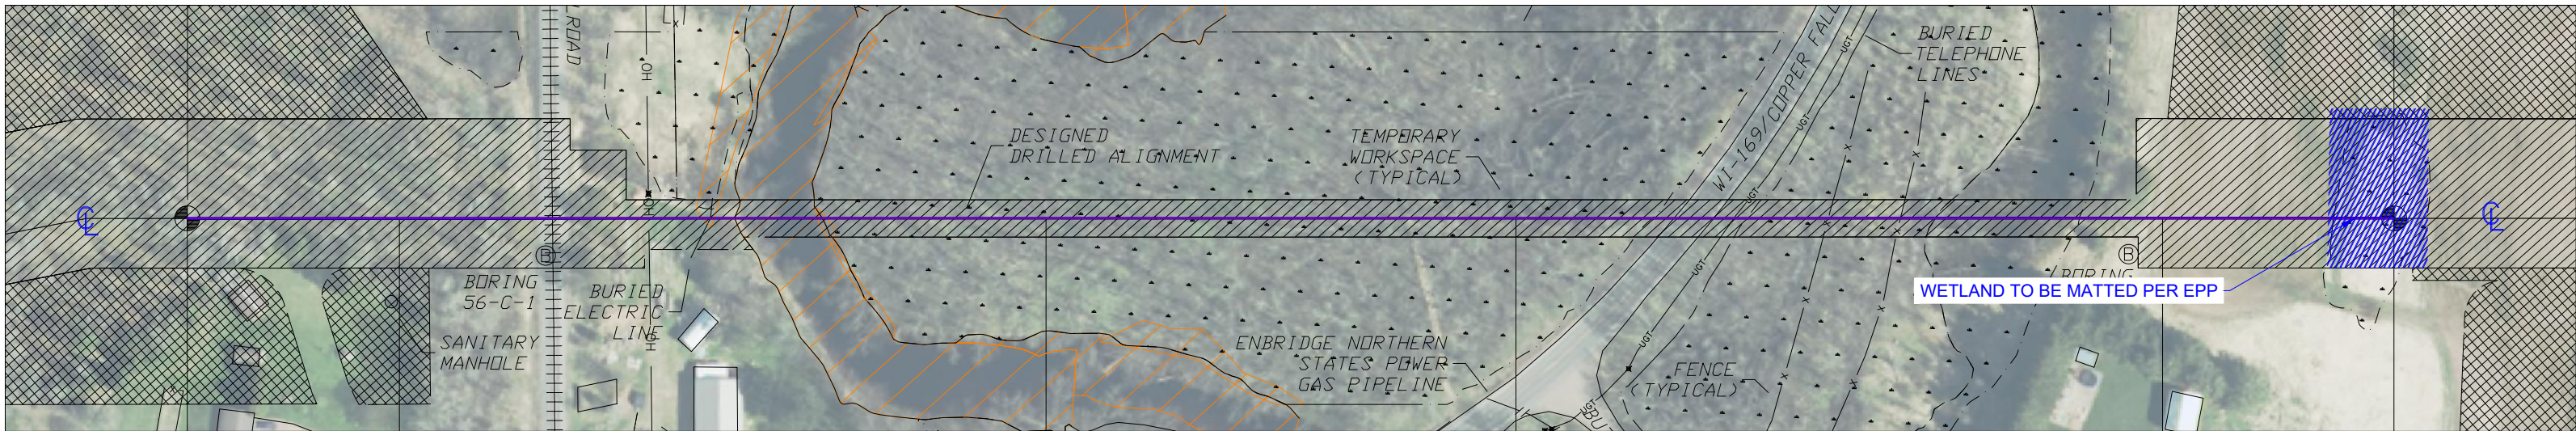
## EQUIPMENT AND CONTAINMENT SITE LAYOUT

- CONSTRUCTION NOTES:
1. EROSION CONTROL MEASURES TO BE IMPLEMENTED IN ACCORDANCE WITH EPP.
  2. IN THE EVENT OF INADVERTENT RETURNS, CONSTRUCTION EFFORTS SHALL CEASE UNTIL PERMITTED BY ENBRIDGE.
