Enbridge

Line 5 – Deer Creek HDD Crossing

HDD INADVERTENT RETURN MITIGATION AND CONTINGENCY PLAN

**MICHELS TRENCHLESS INCORPORATED (MTI)**  
**INADVERTENT RETURN MITIGATION AND CONTINGENCY PLAN**  
**ENBRIDGE LINE 5 PROJECT**  
**MP 6 – 30-INCH DEER CREEK HDD CROSSING**

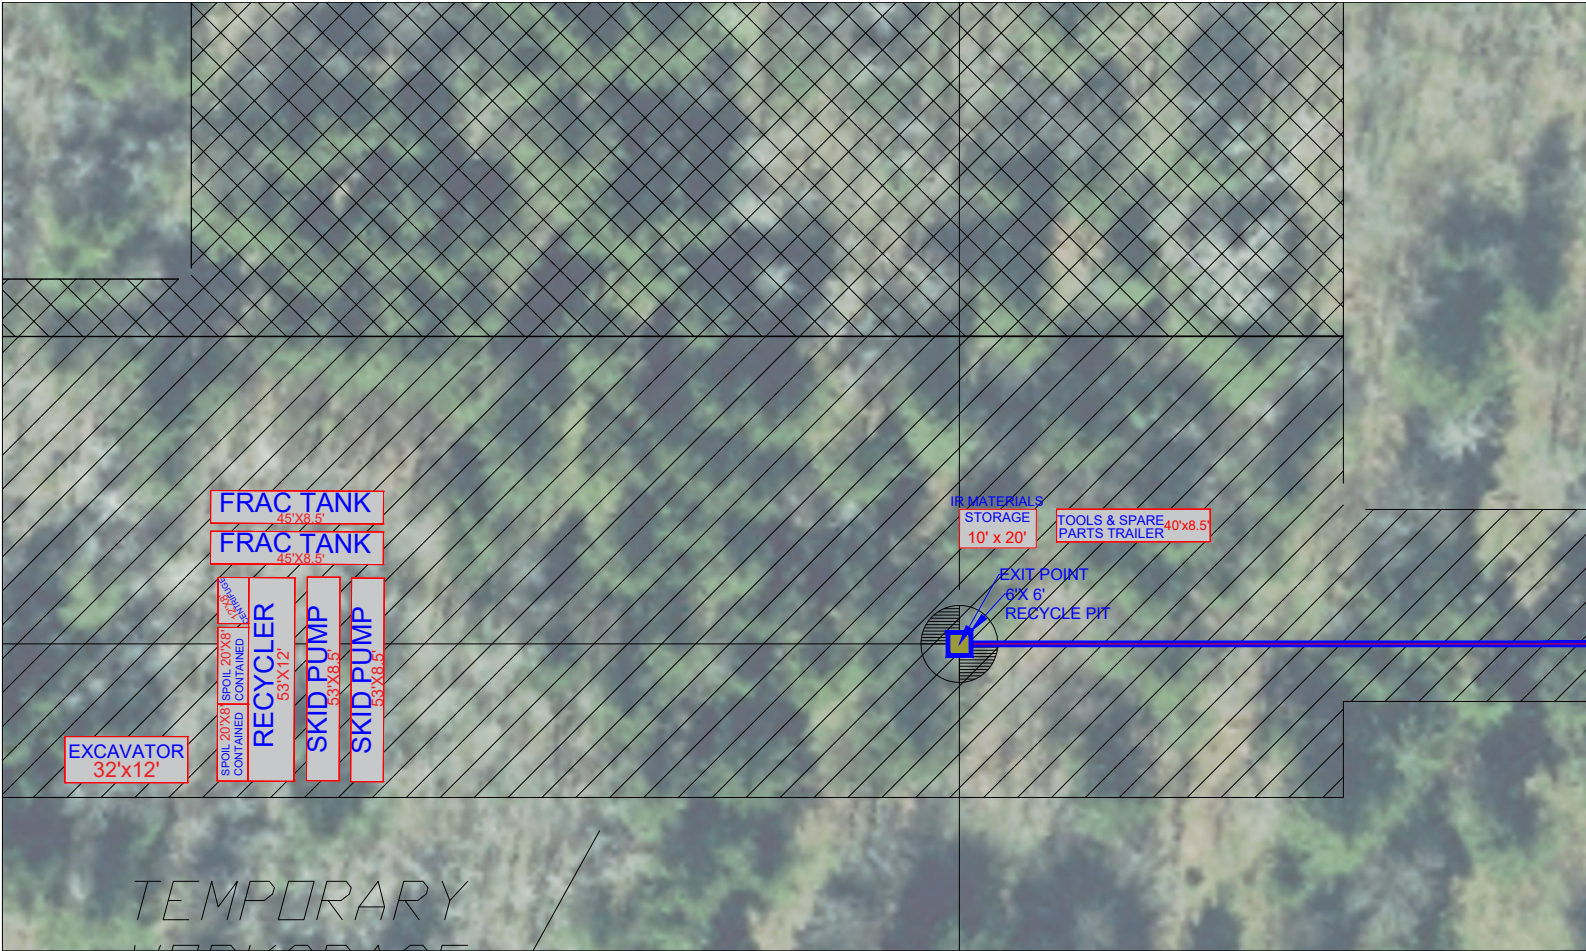
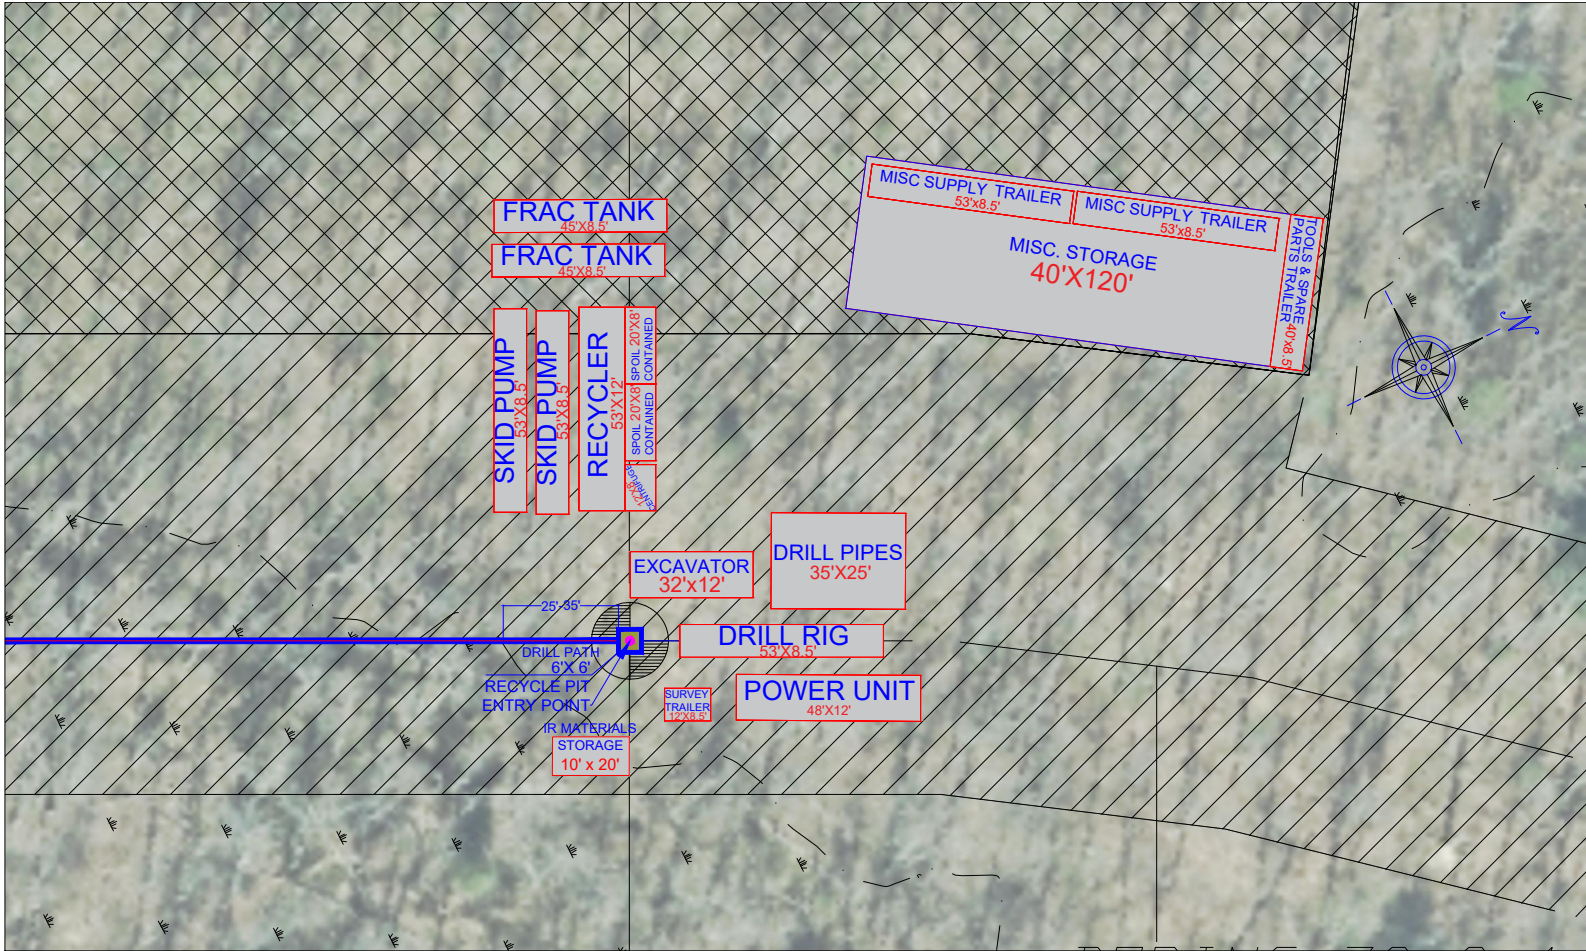
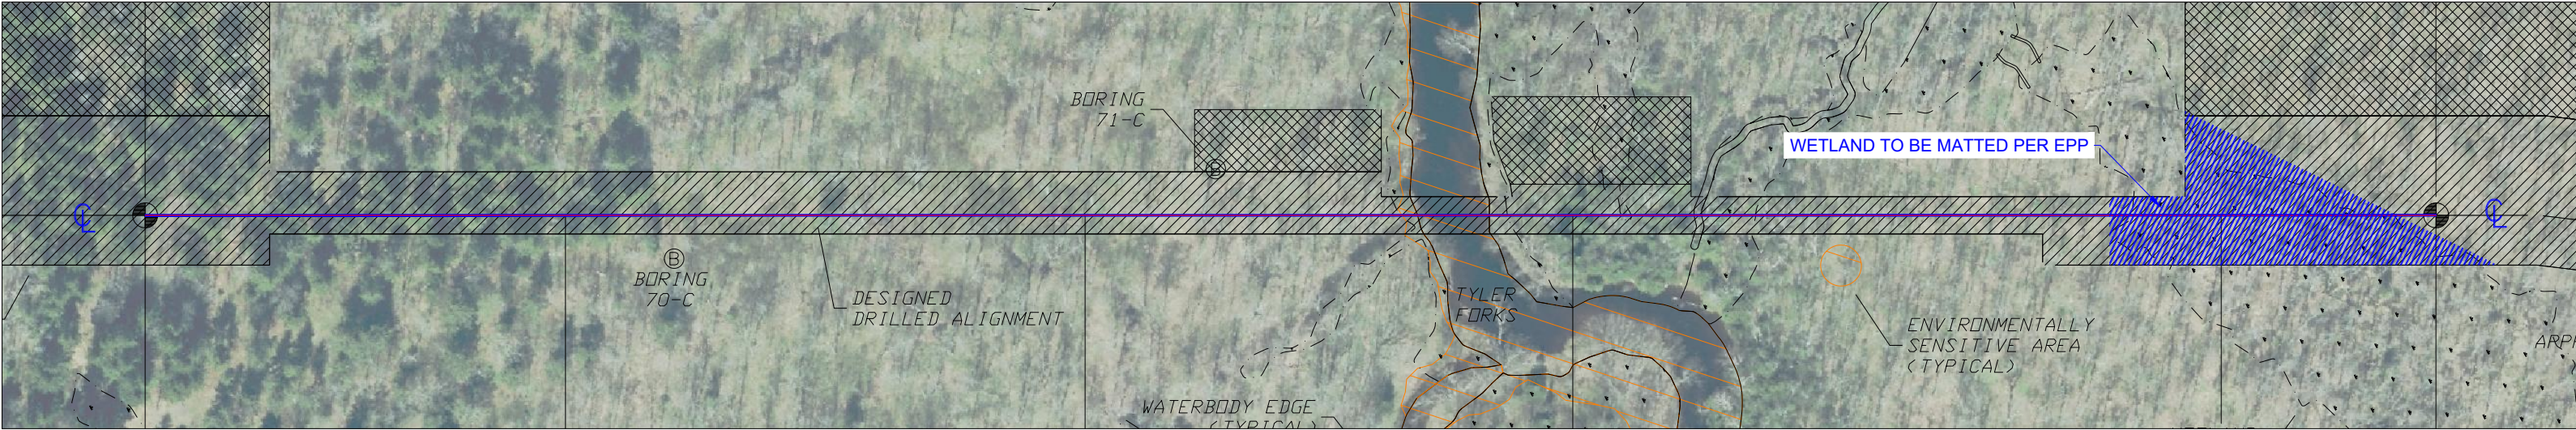
## EQUIPMENT AND CONTAINMENT SITE LAYOUT

PLAN  
SCALE: 1"=50'

OVERALL PLAN VIEW  
SCALE: 1" = 125'

- CONSTRUCTION NOTES:
- EROSION CONTROL MEASURES TO BE IMPLEMENTED IN ACCORDANCE WITH EPP.
  - IN THE EVENT OF INADVERTENT RETURNS, CONSTRUCTION EFFORTS SHALL CEASE UNTIL PERMITTED BY ENBRIDGE.
- NOTES
- PRELIMINARY DESIGNED DRAWING MAY BE MODIFIED IN FIELD BASED ON CONDITIONS ENCOUNTERED.
  - FIELD VERIFICATION OF STATIONS AND ELEVATIONS REQUIRED.
  - PLACEMENT OF DRILL RIG(S) IS NOT FIXED BY DESIGNATED ENTRY AND EXIT POINTS. MICHELS RESERVES THE RIGHT TO DETERMINE PLACEMENT OF DRILL RIG AND/OR NEED FOR DUAL RIGS (1-RIG AT ENTRY AND 1-RIG AT EXIT) FOR OVERALL SAFETY AND CONSTRUCTABILITY OF PROPOSED HDD CROSSING.
  - DRAWING IS PROPRIETARY TO MICHELS CORPORATION. ANY UNAUTHORIZED USE OF DUPLICATION IS STRICTLY PROHIBITED. RECEIPT OF THIS DRAWING SIGNIFIES ACCEPTANCE OF SAID CONDITIONS.
- © COPYRIGHT, MICHELS DIRECTIONAL CROSSINGS, A DIVISION OF MICHELS CORPORATION, 2022.

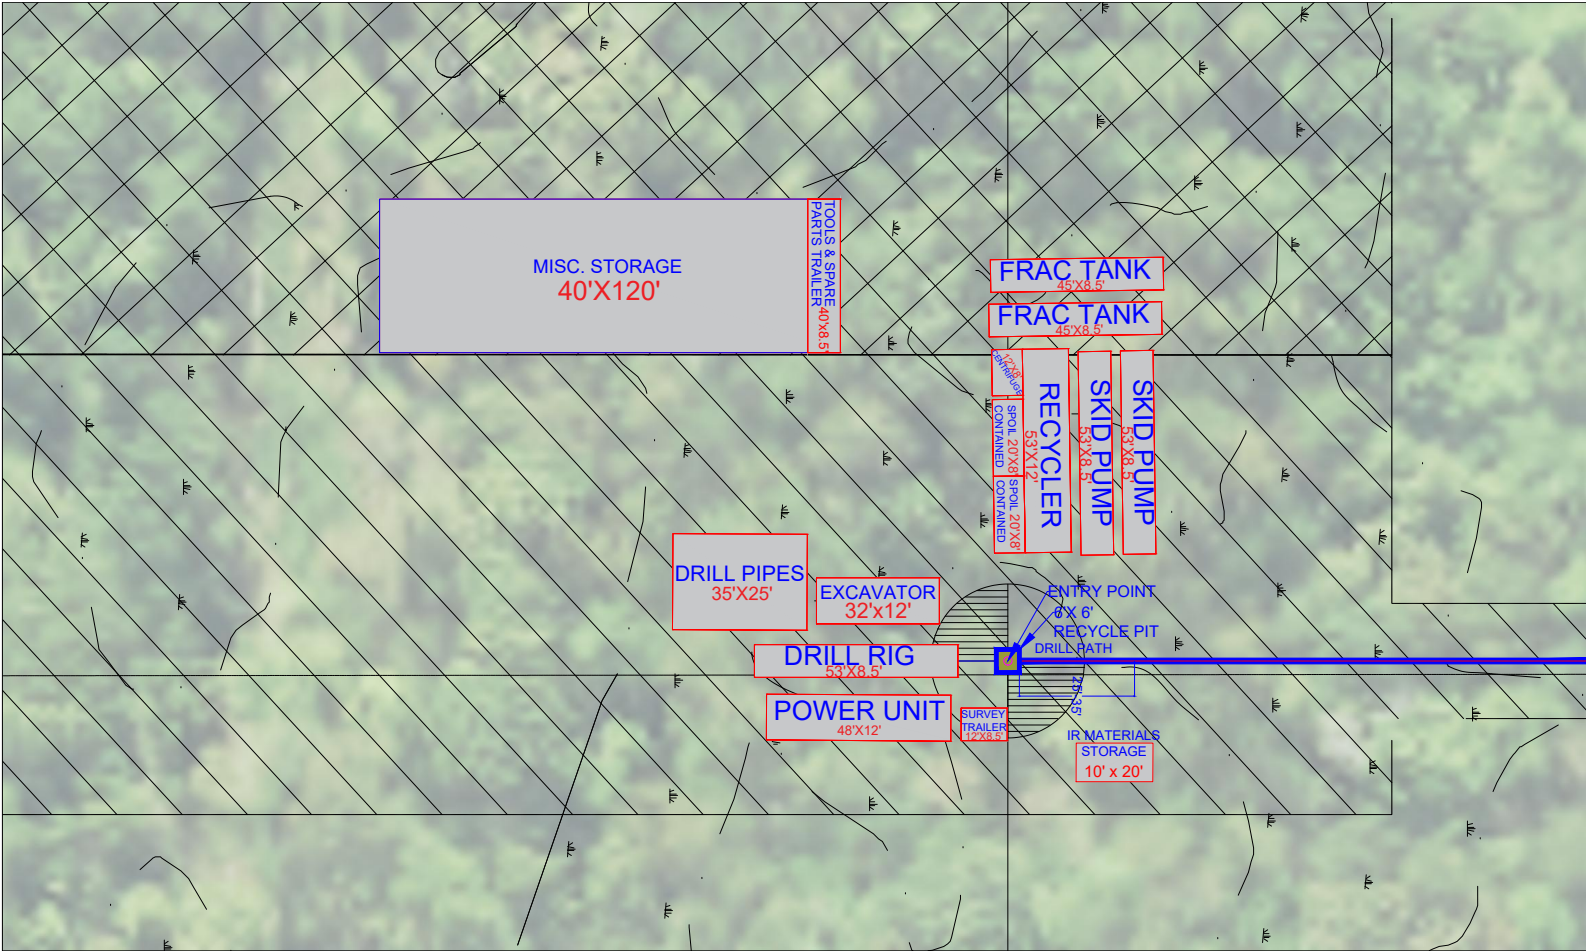
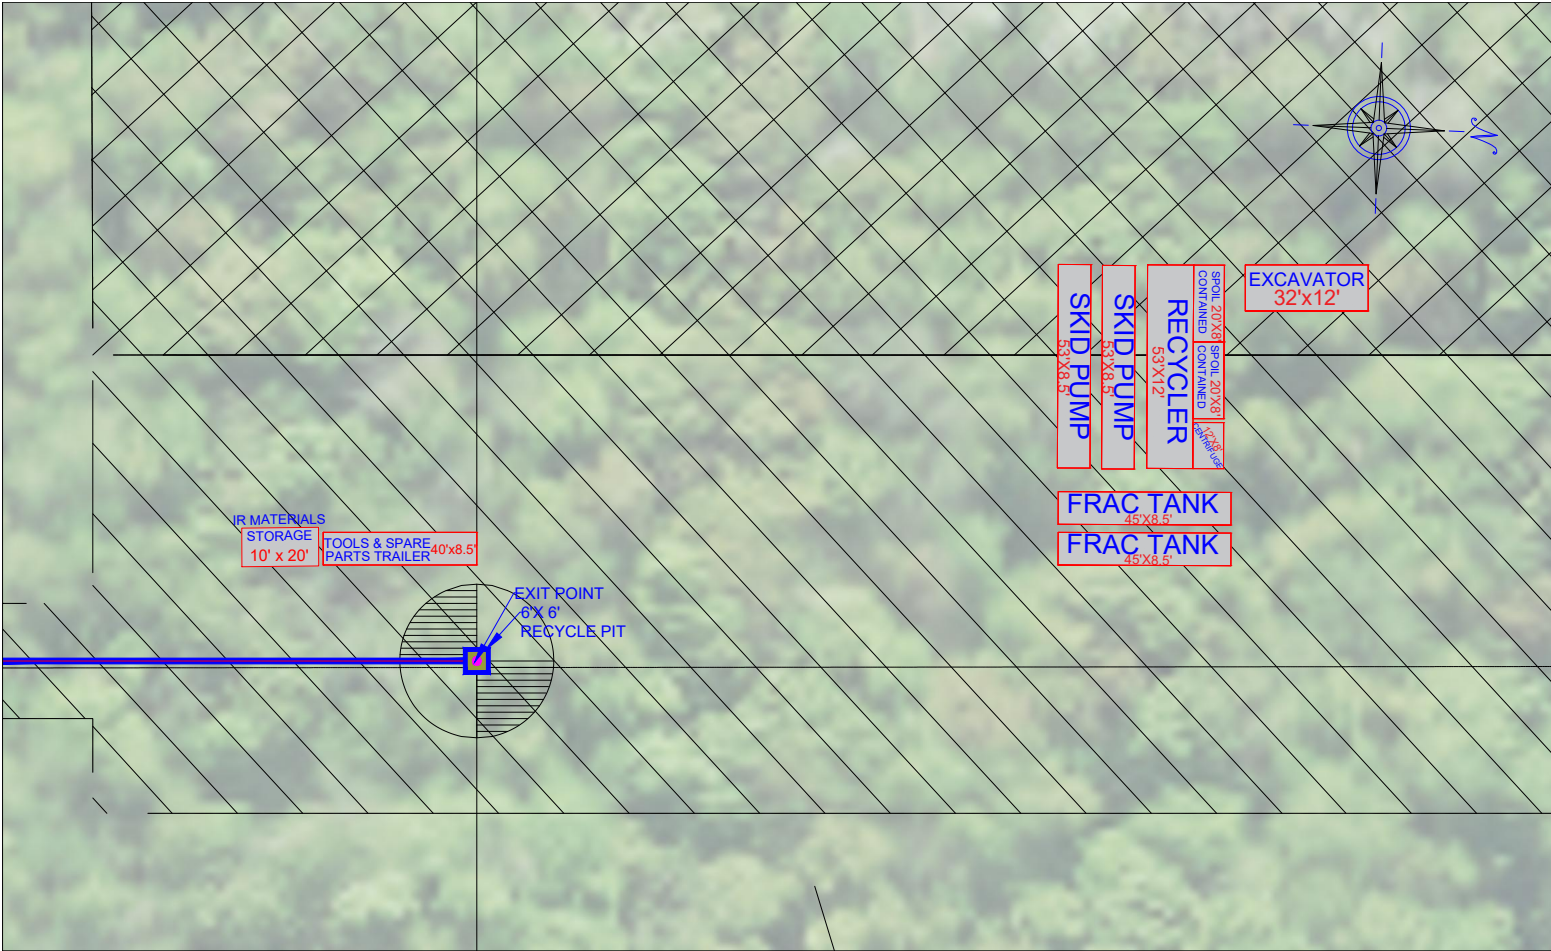
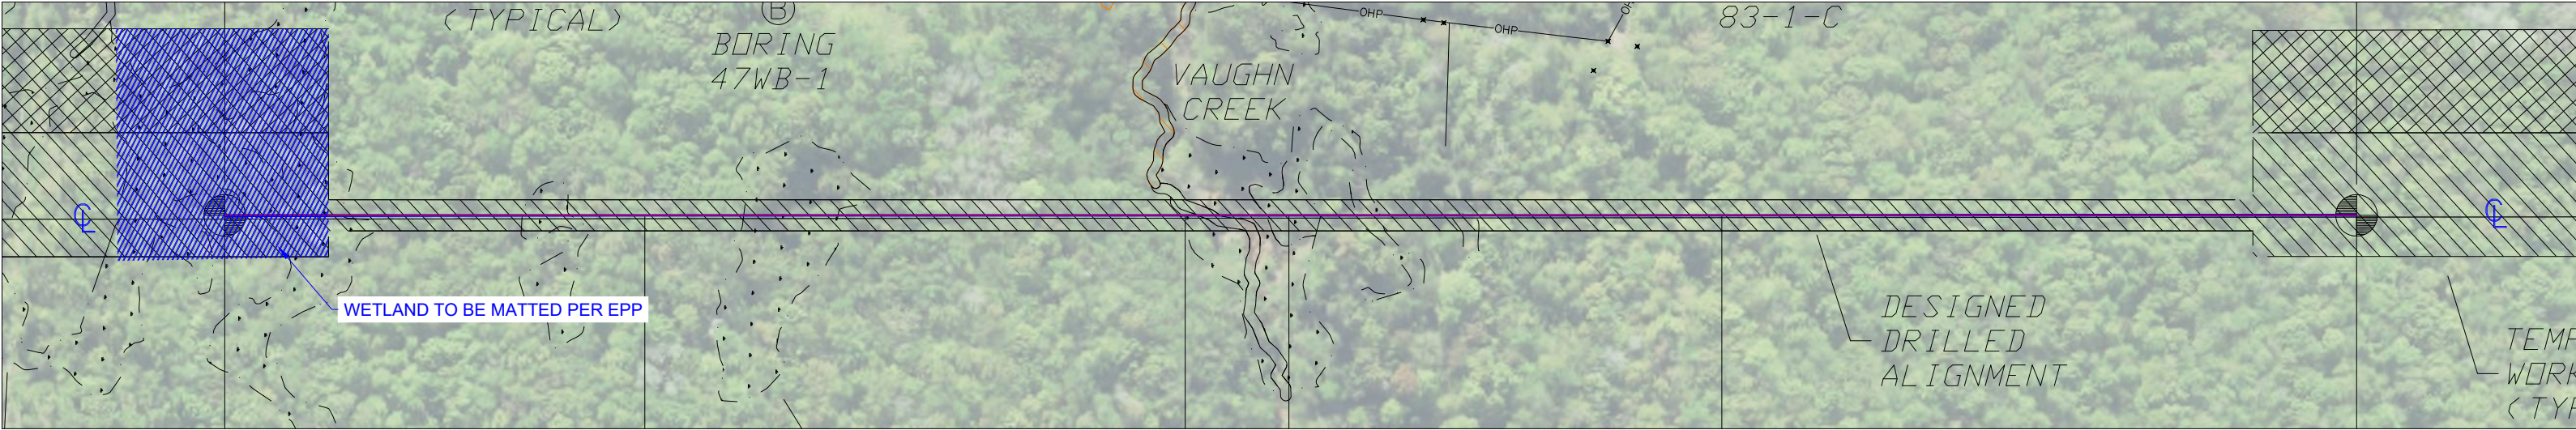
## EQUIPMENT AND CONTAINMENT SITE LAYOUT

PLAN

SCALE: 1"=50'

OVERALL PLAN VIEW

SCALE: 1" = 250'
