Project/Site: Line 5 Relocation Project	City/County: Ashland Sampling Date: 2020-06-04
Applicant/Owner: Enbridge	State: Wisconsin Sampling Point: wasd1024e_w
Investigator(s): AGG/OTG	Section Township Range: Sec 15 T045N R003W
Landform (hillslope torrace ate.): Depression	real relief (concerve, convex, none): $Concerve, Since (%): 0-2%$
Northcentral Forests	
Subregion (LRR or MLRA):	Long: <u>-90.733728</u> Datum: <u>VVG384</u>
Soil Map Unit Name: Cublake-Croswell-Ashwabay compl	ex, 0 to 6 percent slopes NWI classification:
Are climatic / hydrologic conditions on the site typical for this time of year	ar? Yes No (If no, explain in Remarks.)
Are Vegetation, Soil, or Hydrology significantly	disturbed? Are "Normal Circumstances" present? Yes <u>v</u> No
Are Vegetation, Soil, or Hydrology naturally pro	blematic? (If needed, explain any answers in Remarks.)
SUMMARY OF FINDINGS – Attach site map showing	sampling point locations, transects, important features, etc.

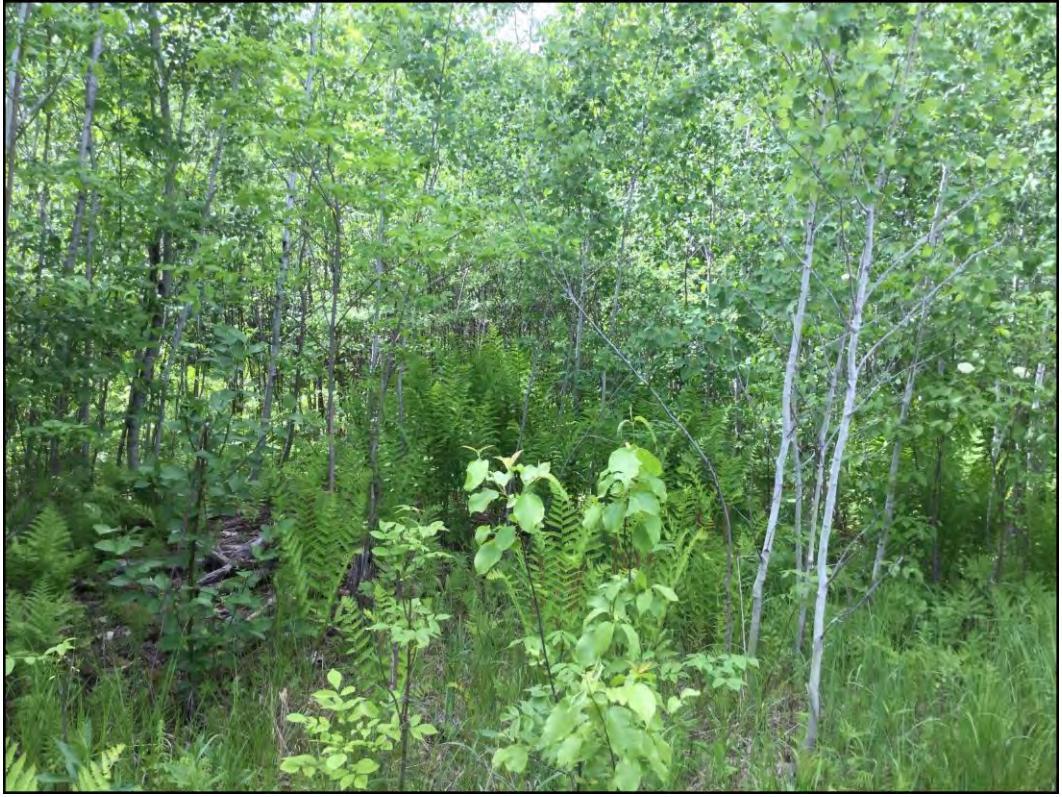
wasd1024f1_w_N

A dark surface layer with redox concentrations was observed.

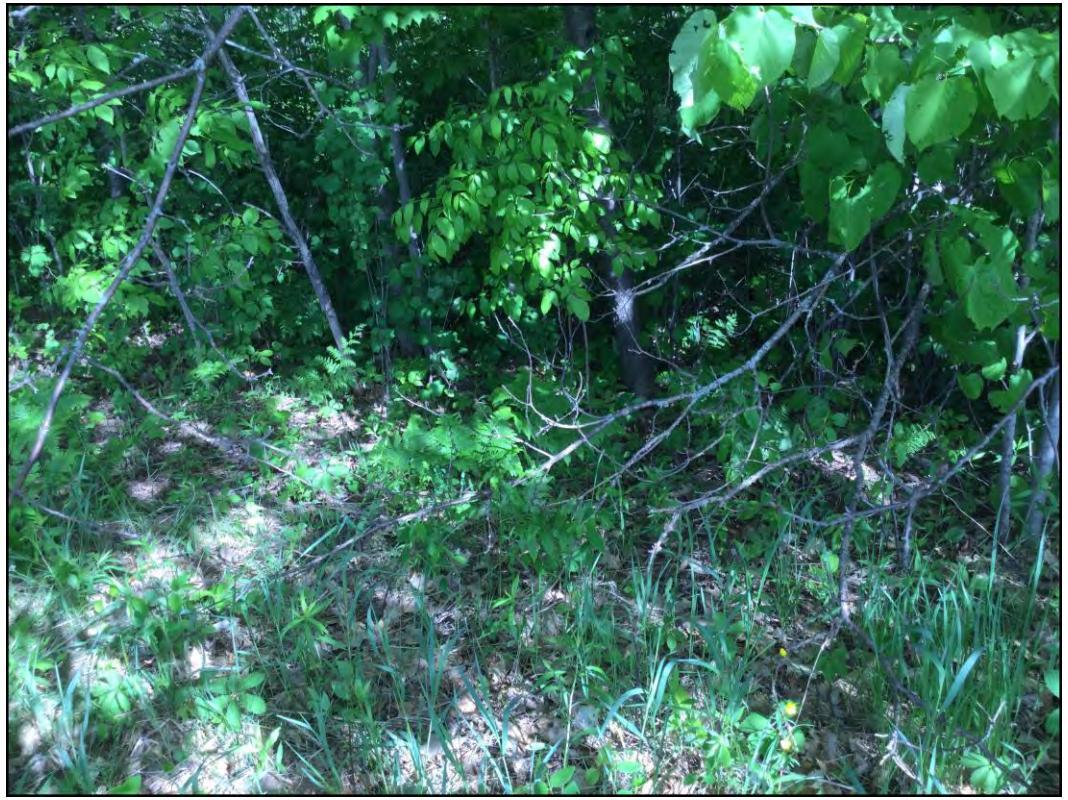
wasd1024_u1_S

Saturation Present? Yes No Depth (inches): [includes capillary fringe) Describe Recorded Data (stream gauge, monitoring well, aerial photos, previous inspect Remarks: No indicators of wetland hydrology were observed.	Wetland Hydrology Present? Yes No
Sampling Point: wasd1024_u1

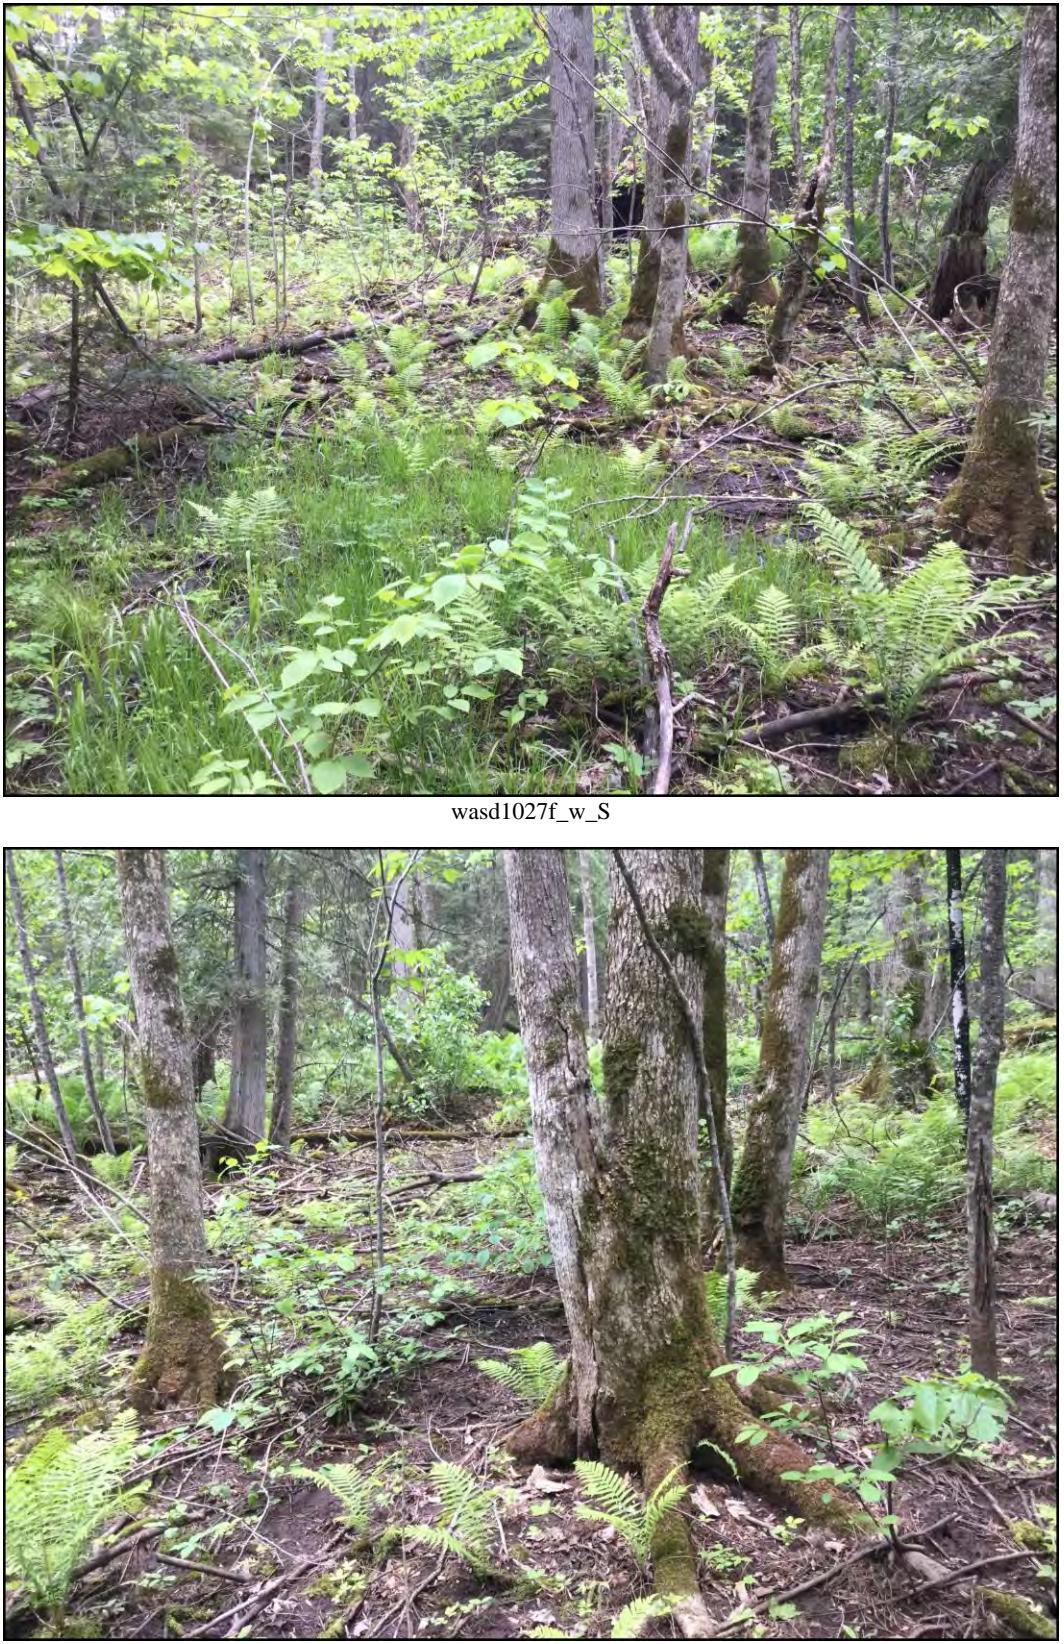
wasd1027f_w_W

Sandy C	Gleyed Matrix (S4)		Redox	Depress	ions (F8)			Mesic	Spodic (TA6) (MLRA 144A, 145, 149B)
Sandy F	Redox (S5)							Red Pa	arent Material (F21)
Stripped	d Matrix (S6)							Very S	hallow Dark Surface (TF12)
Dark Su	irface (S7) (LRR R, M	ILRA 1498	3)					Other	(Explain in Remarks)
³ Indicators o	f hydrophytic vegetat	ion and we	atland bydr		t ha nrasi	ant unless	e disturbed	or problematic	,
Restrictive	l aver (if observed):			Jogy mus	t be prese	ent, unies:	Suistuibeu		
Type:									
Type.									Present? Ves // No
Depth (in	ches):							Hyaric Soli	Present? Yes v No
Remarks:									
A dark s	hallow layer w	ith redo	ox was (observ	ed.

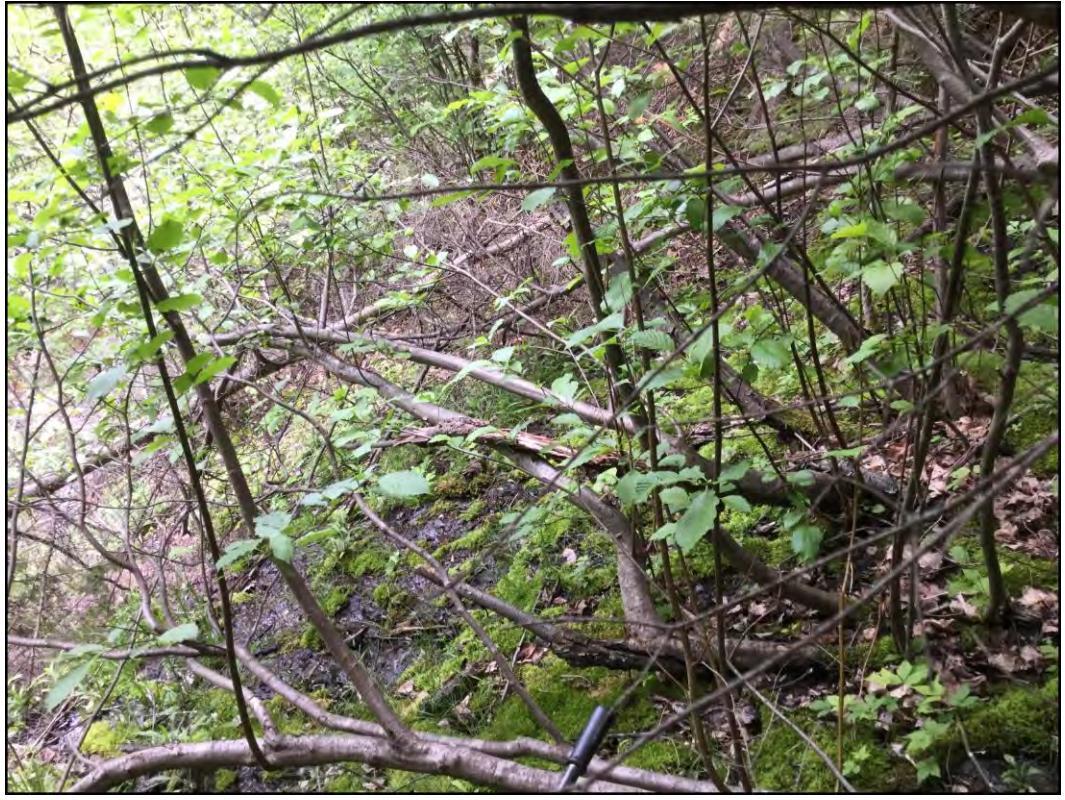
wasd1029s_w_N

Thick Da	ark Surface	(A12)	(ATT)	Redo	x Dark Su	rface (F6)			Iron-M	andanese Masses (F12) (LRR K. L. R)
Sandy M	lucky Mine	, , ral (S1)		Deple	ted Dark S	Surface (F	7)		Piedmo	ont Floodplain Soils (F19) (MLRA 149B)
Sandy G	Bleyed Matr	ix (S4)		Redo	x Depress	ions (F8)			Mesic	Spodic (TA6) (MLRA 144A, 145, 149B)
Sandy R	ledox (S5)	`							Red Pa	arent Material (F21)
Dark Su	rface (S7) () (LRR R, M	LRA 149	B)					Other (Explain in Remarks)
_	()(,		/						,
³ Indicators of	f hydrophyt	ic vegetati	on and w	etland hydr	ology mus	t be prese	nt, unless	s disturbed	or problematic	2.
Type:	Layer (II of	Servea):								
Donth (in	abaa).								Hydric Soil	Present? Yes ✔ No
Depth (Ind	cnes):									
Redox co	oncentr	ations	vere c	bserved	d within	n red sa	andv lo	am		
				5001100		1100 00		Jann

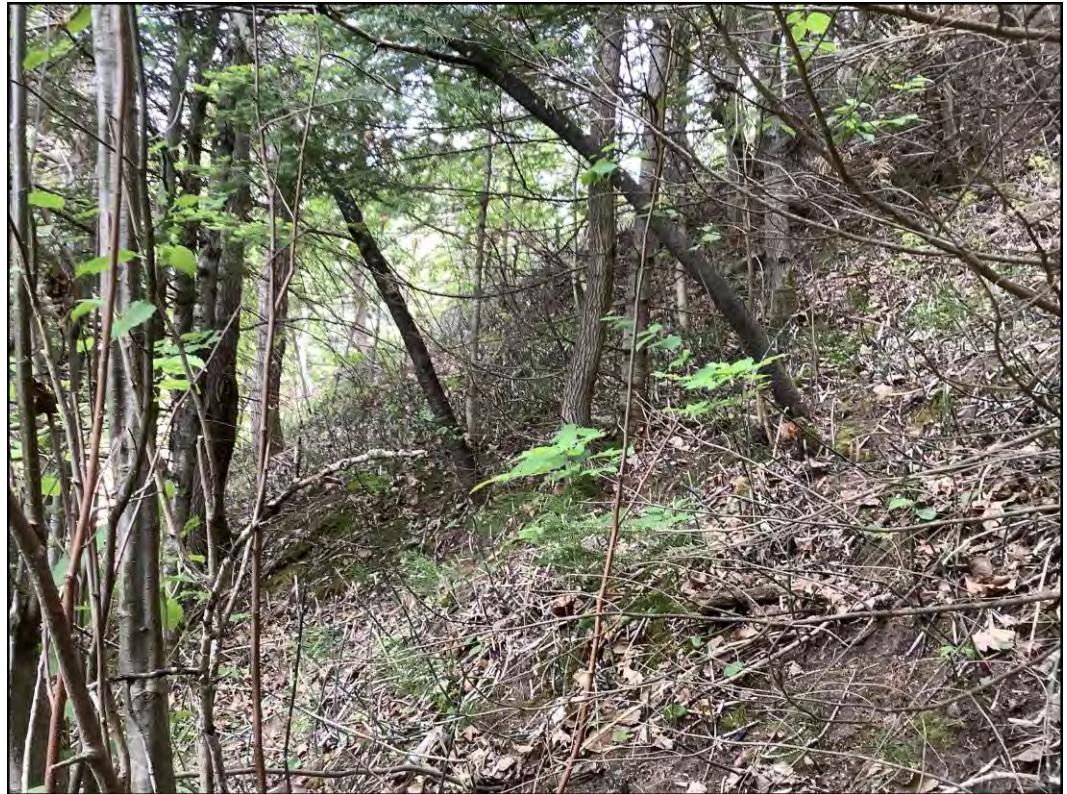
wasd1029_u_N

Depth (Inc	cnes):									
Remarks:					н.,					
Soils are loamy sand throughout the profile. No indicators of hydric soil were observed. Soils are										
well-drained.

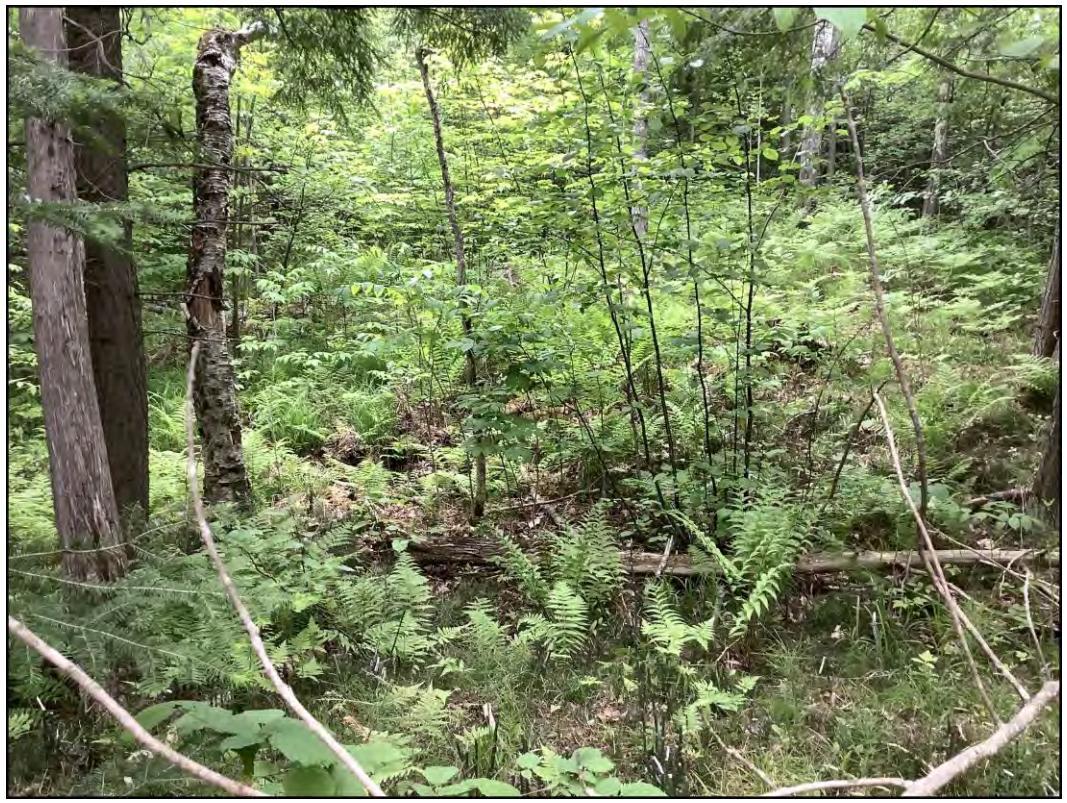
wasd1028_u_E

Thick Da	ark Surface (A12)	- (ATT) _	Redox Dark Surface (F6)	Iron-Mangai	nese Masses (F12) (LRR K. L. R)
Sandy N	/ucky Mineral (S1)	-	Depleted Dark Surface (F7)	Piedmont Fl	oodplain Soils (F19) (MLRA 149B)
Sandy G	Gleyed Matrix (S4)	-	Redox Depressions (F8)	Mesic Spod	ic (TA6) (MLRA 144A, 145, 149B)
Sandy F	Redox (S5)			Red Parent	Material (F21)
Dark Su	rface (S7) (LRR R, M	LRA 149B)	Other (Expla	ain in Remarks)
		,			,
³ Indicators o	f hydrophytic vegetati	on and wet	land hydrology must be present, unless disturbed o	or problematic.	
Type.	Layer (il observed).				
Dopth (in	choc):			Hvdric Soil Pres	ent? Yes No ✔
Bemarks:	cnes).				·····
Soils are	drv loam thro	uahout [.]	the profile. No indicators of hydric	soil were ob	served.

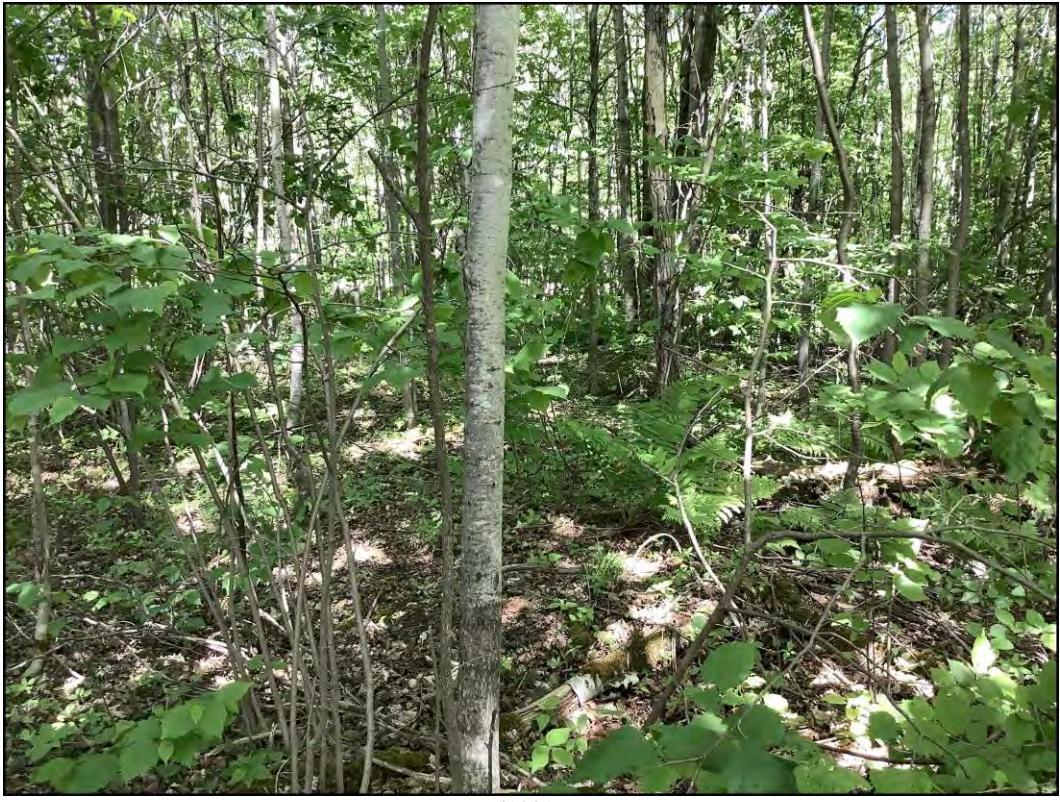
wasd1031_u_E

Depth (in	ches):						Hyune Son P		
Remarks:			NU 11 11 1			.,		<u> </u>	
Soils are	loam above s	lit Ioam	. No indicator	s of h	yarıc so	oll were	observed.	Solls are well-drained.

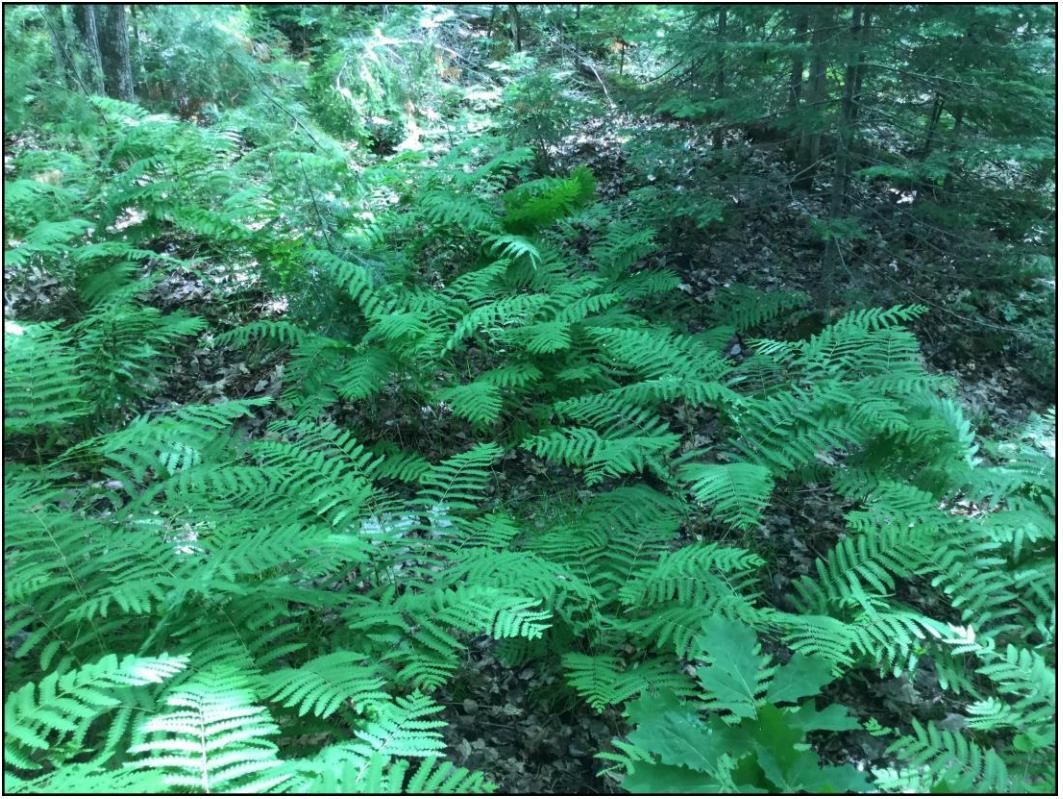
wbad1003f_w_E

The soil profile consists of three sandy layers. The first layer is a dark sand. The second is a depleted sand with redox concentrations, and the third layer is a reddish brown sand. Two hydric indicators were observed.
