Project/Site: Line 5 Relocation Project City/Cour	nty: Ashland Sampling Date: 2020-06-06
Applicant/Owner: Enbridge	State: Wisconsin Sampling Point: wasc1039e_w
Investigator(s): FJO/JSW Section.	Township, Range: Sec 08 T045N R003W
Landform (hillslope terrace etc.): Depression	(concave convex none): Concave Slope (%): 0-2%
Subracian (I RP or MLPA): Northcentral Forests Lat: 16 300810	Long: -90 776997 Dotum: WGS84
Sublegion (LRK of MERA) Lat. 40.590019	
Are climatic / hydrologic conditions on the site typical for this time of year? Yes	No (If no, explain in Remarks.)
Are Vegetation, Soil, or Hydrology significantly disturbed	Are "Normal Circumstances" present? Yes _ ✓ No
Are Vegetation, Soil, or Hydrology naturally problematic	? (If needed, explain any answers in Remarks.)
SUMMARY OF FINDINGS – Attach site map showing sampl	ing point locations, transects, important features, etc.
Hydrophytic Vegetation Present? Yes No Is Hydric Soil Present? Yes No w	the Sampled Area ithin a Wetland? Yes <u><</u> No

Project/Site: Line 5 Relocation Project	City/County: Ashland	Sampling	Date: 2020-06-06
Applicant/Owner: Enbridge		State: Wisconsin Sampli	ng Point: <u>wasc1039_u</u>
Investigator(s): <u>J

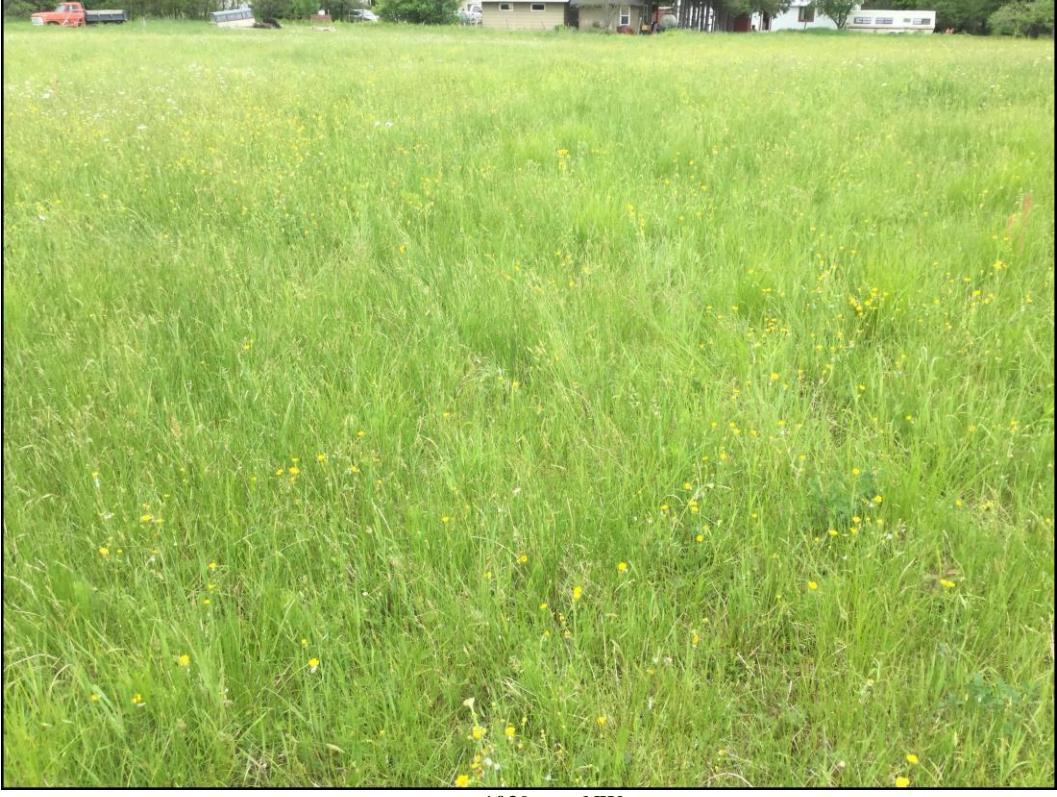
wasc1039e_w_NW

Sparsely Vegetated Concave Surface (B8)	✓ FAC-Neutral Test (D5)
Field Observations:	
Surface Water Present? Yes <u>No</u> Depth (inches):	
Water Table Present? Yes <u>No</u> Depth (inches):	
Saturation Present? Yes <u>No</u> Depth (inches): <u></u>	Wetland Hydrology Present? Yes <u>v</u> No
Describe Recorded Data (stream gauge, monitoring well, aerial photos, previou	us inspections), if available:
Demotion	
The feature is a seasonally saturated depression with	hin a hav field.

Restrictive Layer (if observed):		
Type:		Hydric Soil Present? Yes 🗸 No
Deptil (IIChes).		
Soils were not sampled due to	the proximity to a residential pror	perty and potential to encounter
ndarground utilition Howova	r bacad on the landscape position	and dominance of hydrophytic

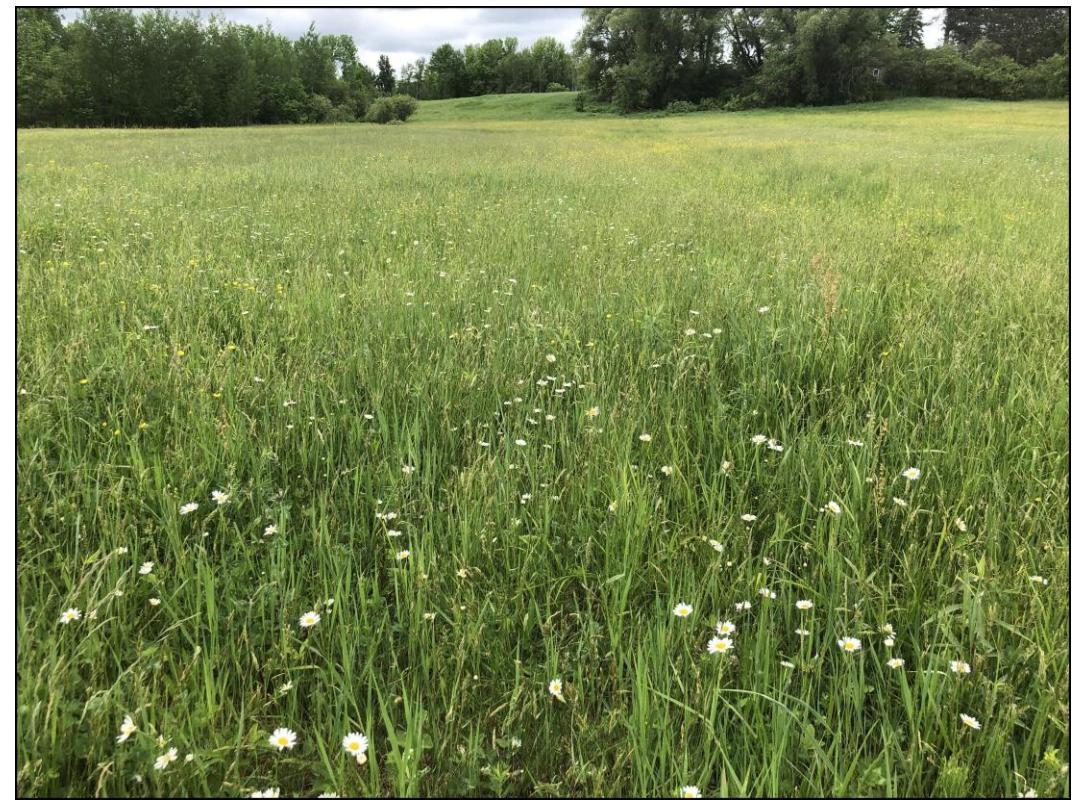
wasc1039_u_S

-	
Remarks: No indicators of wetland bydrology were observed	
The indicators of wetland frydrology were observed.

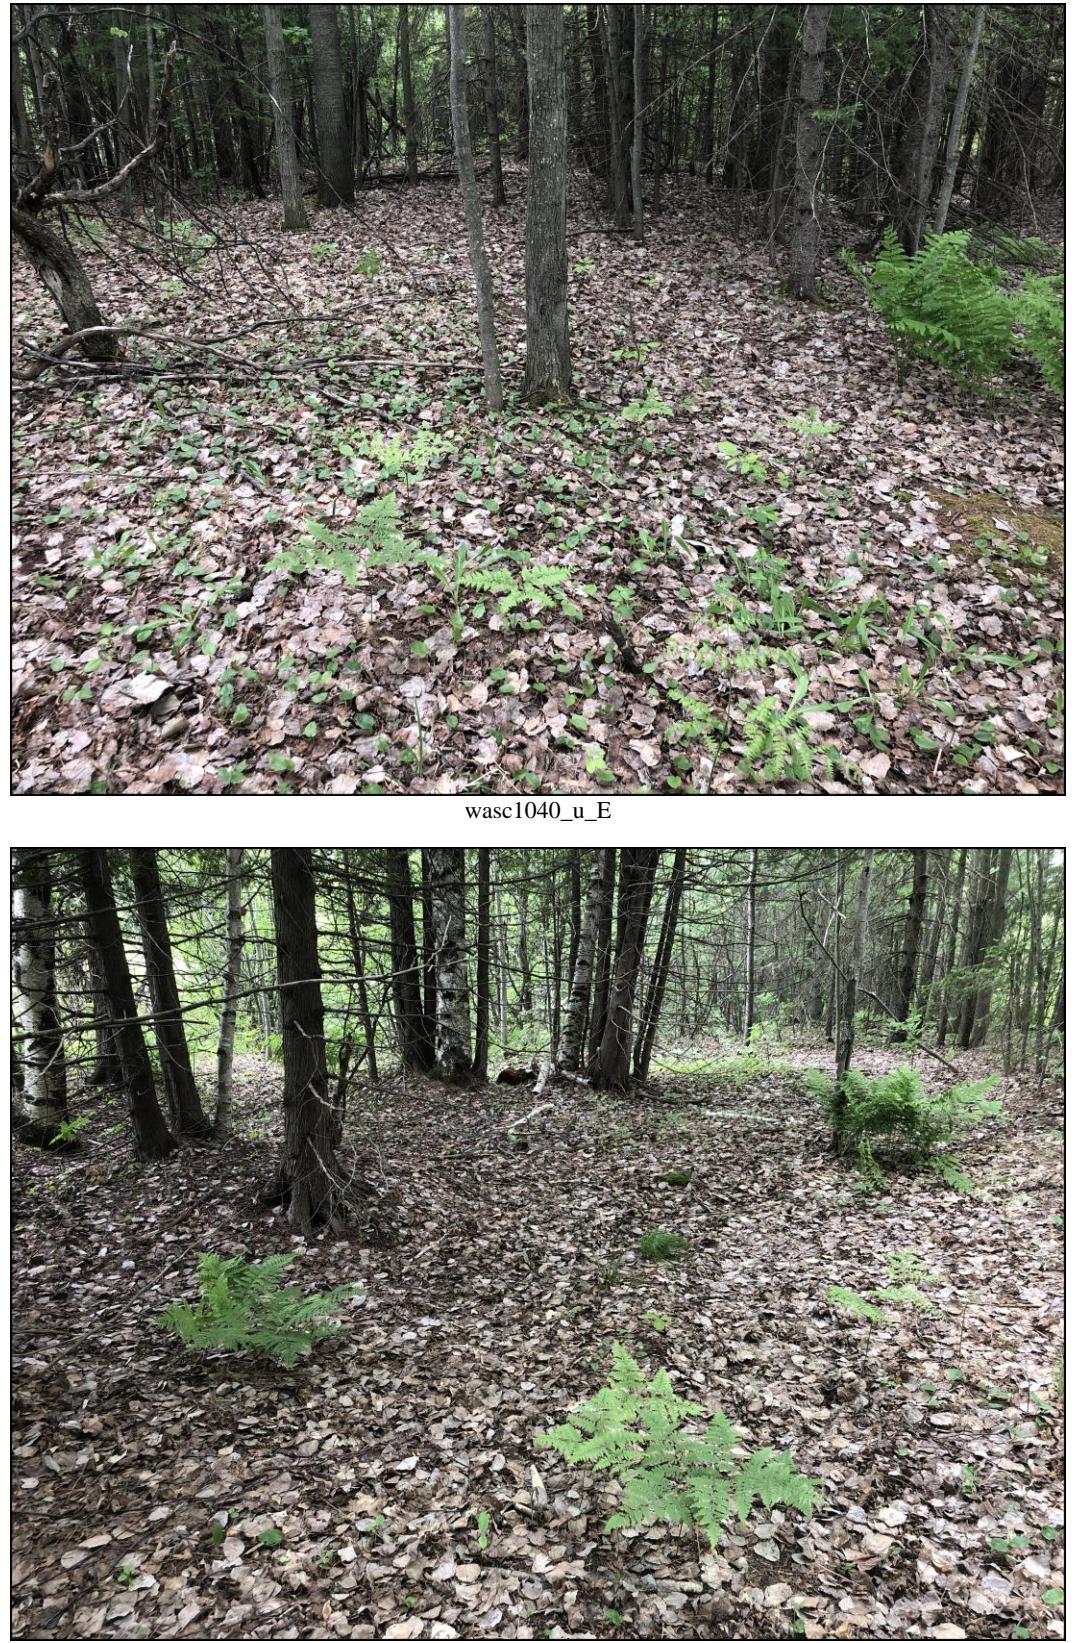
wasc1040_u_N

Thick Da	ark Surface (A12 /ucky Mineral (S) 1)	Redox Dark Surface (F6) Depleted Dark Surface (F7)	Iron-Manga Piedmont F	nese Masses (F12) (LRR K, L, R) loodplain Soils (F19) (MI RA 149B)	
Sandy G	Gleyed Matrix (S4	l)	Redox Depressions (F8)	Mesic Spod	ic (TA6) (MLRA 144A, 145, 149B)	
Sandy F	Redox (S5)			Red Parent	Material (F21)	
Stripped	Matrix (S6)		N N	Very Shallow Dark Surface (TF12)		
Dark Su	rface (S7) (LRR	R, MLRA 1498)	Other (Expl	ain in Remarks)	
³ Indicators o	f hydrophytic veg	etation and we	tland hydrology must be present, unless disturbed	or problematic.		
Restrictive	Layer (if observ	ed):				
Туре:				Hudria Sail Drag	anto Vac Na d	
Depth (in	ches):			Hydric Soli Pres		
No indica	ators of hyd	lric soil we	re observed.

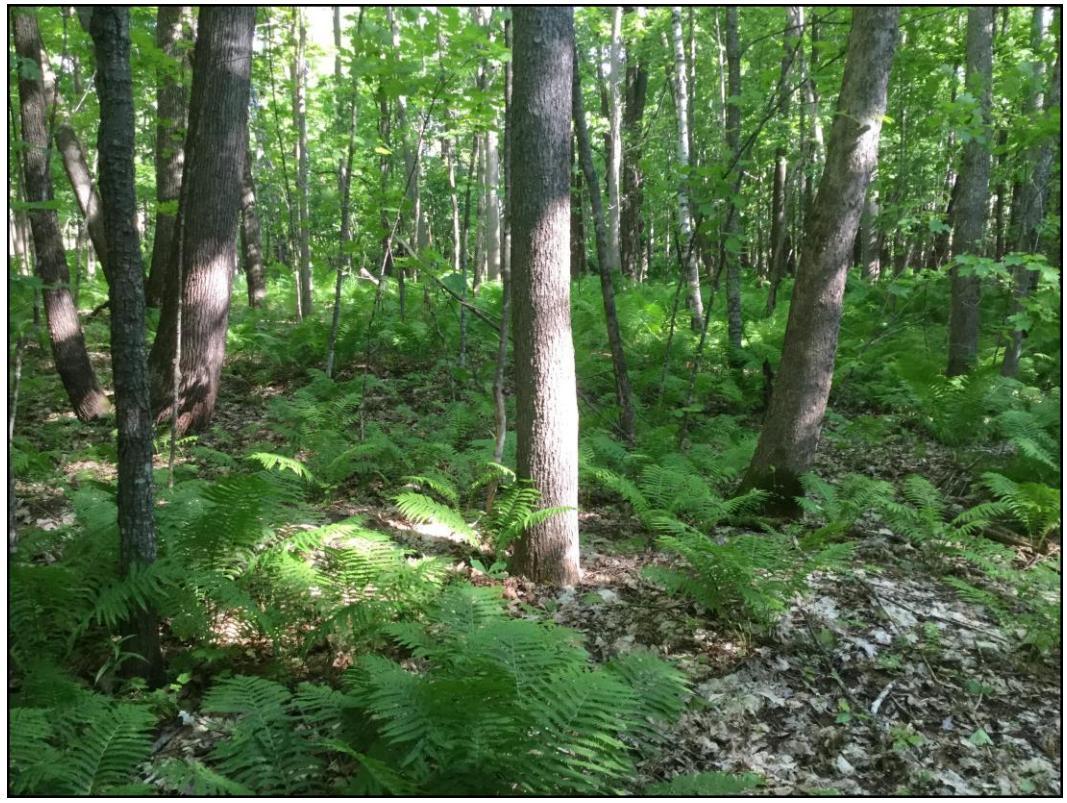
wasc1041f_w2_NW

4.				Vegetation				
	0	= Total Cov	ver	Present? Yes <u>v</u> No				
Remarks: (Include photo numbers here or on a separate	sheet.)		-	<u> </u>				
The feature is a floodplain forest domin	nated by	black a	sh and	red maple in the canopy, and ostrich				
fern in the ground layer.								
Depth	Matrix		Redo	x Feature	s			
--	---	-----------------------------------	--	--	--	---------------------------	---	--
(inches)		·	Color (moist)		<u></u>			Remarks
¹ Type: C=Co Hydric Soil Ir	ncentration, D=Depl	letion, RM=	Reduced Matrix, M	S=Masked	d Sand Gr	 ains.	² Location: PL: Indicators for F	=Pore Lining, M=Matrix. Problematic Hydric Soils ³ :
Histosol (Histic Epi Black His Hydroger Stratified Depleted Thick Dar Sandy Mi Sandy Gi Sandy Re Stripped Dark Surl	A1) ipedon (A2) itic (A3) n Sulfide (A4) Layers (A5) Below Dark Surface rk Surface (A12) ucky Mineral (S1) leyed Matrix (S4) edox (S5) Matrix (S6) face (S7) (LRR R, N	e (A11) ILRA 149B	Polyvalue Belor MLRA 149B Thin Dark Surfa Loamy Mucky N Loamy Gleyed Depleted Matrix Redox Dark Su Depleted Dark Redox Depress)	w Surface) ace (S9) (I Mineral (F Matrix (F2 < (F3) Irface (F6) Surface (F6) Surface (F8)	(S8) (LRF LRR R, Mi 1) (LRR K 2) 57)	R R, LRA 149B) , L)	2 cm Muck Coast Prairi 5 cm Mucky Dark Surface Polyvalue B Thin Dark S Iron-Manga Piedmont F Mesic Spod Red Parent Very Shallo Other (Expl	(A10) (LRR K, L, MLRA 149B) ie Redox (A16) (LRR K, L, R) / Peat or Peat (S3) (LRR K, L, R) be (S7) (LRR K, L) Below Surface (S8) (LRR K, L) Surface (S9) (LRR K, L) nese Masses (F12) (LRR K, L, R) loodplain Soils (F19) (MLRA 149E lic (TA6) (MLRA 144A, 145, 149B Material (F21) w Dark Surface (TF12) ain in Remarks)

"Indicators of Restrictive L	hydrophytic vegetat ayer (if observed):	ion and we	land hydrology mus	st be pres	ent, unless	s disturbed	or problematic.	
Type: Depth (inc	hes):						Hydric Soil Pres	sent? Yes∽_No
Remarks: Soils were undergrou dominanc	e not sampled und utilities. T ce of hydrophy	d due to The soils ytic veg	the proximity are assume etation.	y to a r d to be	esiden e hydric	tial proj based	perty and pot on the lands	ential to encounter cape position and

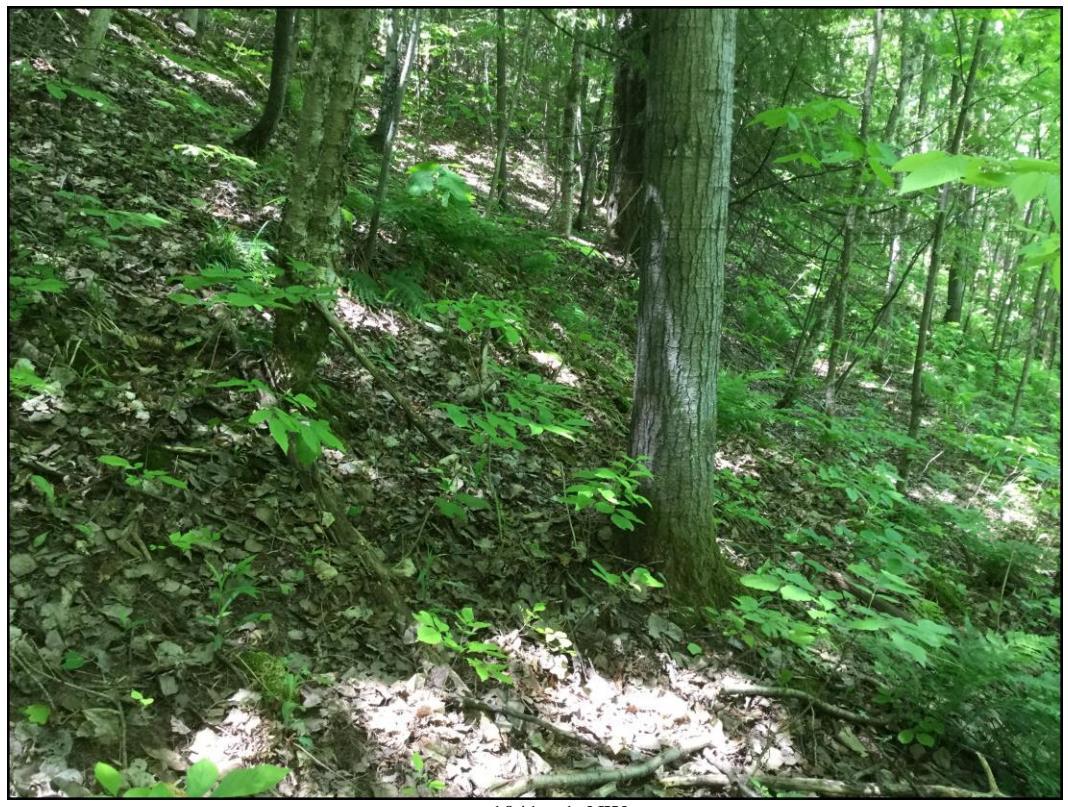
wasc1041_u1_NW

Stratified	d Layers (A5)		_ Loamy Gleyed Matrix (F2)	Polyvalu	ue Below Surface (S8) (LRR K, L)
Depleted	d Below Dark Surface	e (A11)	_ Depleted Matrix (F3) Redox Dark Surface (F6)	Thin Da	rk Surface (S9) (LRR K, L)
Sandy N	lucky Mineral (S1)		Depleted Dark Surface (F7)	Piedmo	nt Floodplain Soils (F19) (MLRA 149B)
Sandy G	Bleyed Matrix (S4)	_	Redox Depressions (F8)	Mesic S	podic (TA6) (MLRA 144A, 145, 149B)
Sandy F	Redox (S5)			Red Pa	rent Material (F21)
Stripped	Matrix (S6)			Very Sh	allow Dark Surface (TF12)
Daik Su		ILKA 149D)			
³ Indicators o	f hydrophytic vegetat	ion and wetla	and hydrology must be present, unless disturbed	or problematic.	
Restrictive	Layer (if observed):				
Type:				Hudria Sail E	Procent? Voc No /
Depth (in	ches):				
Soils we	re observed to	be siltv	clav loam. No hydric soil indicato	ors were of	oserved
		, so only

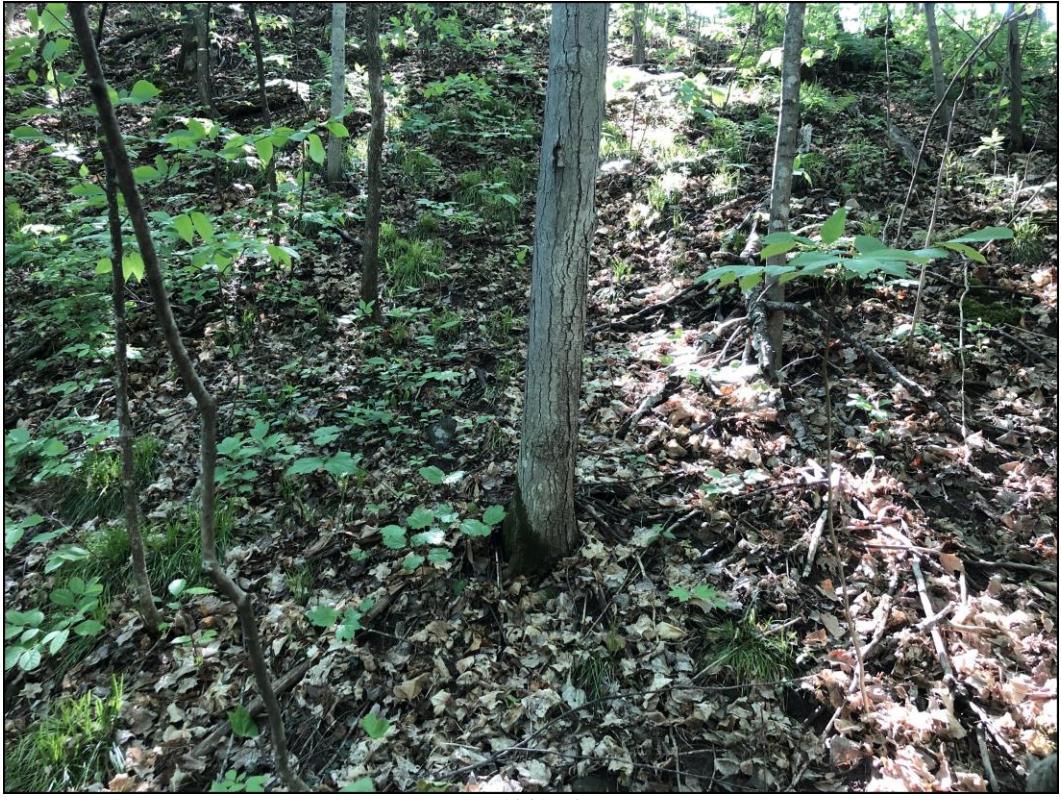
wasc1041_u2_E

Restrictive Layer (if obse Type:	rved):						
Depth (inches):						Hydric Soil Prese	ent? Yes No 🖌
Remarks: Could not sample non-hydric based o	soil due to t on the lands	he proximity scape position	to occu n and d	pied st omina	tructure nt vege	es. Soils are a	ssumed to be

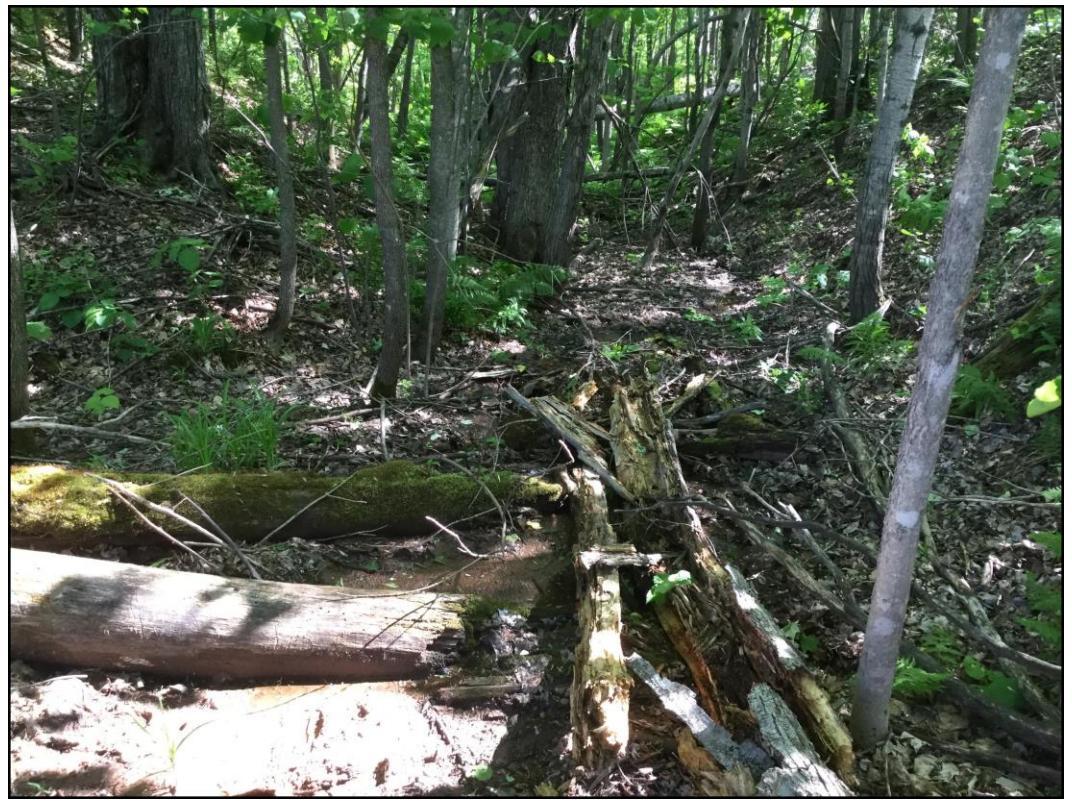
wasc1046f_w_NE

ndicators of hydrophytic vegetation and wetland hydrology must be present, unless disturbed	or problematic.
estrictive Layer (if observed):	
Туре:	
Depth (inches):	Hydric Soil Present? Yes 🔽 No
emarks:	
oils were not sampled due to the proximity to a residential pror	perty and potential to encounter
nderground utilities. The soils are assumed to be hydric based	on the landscape position and
aminance of hydrophytic vogetation	on the landscape position and
Similance of hydrophylic vegetation.

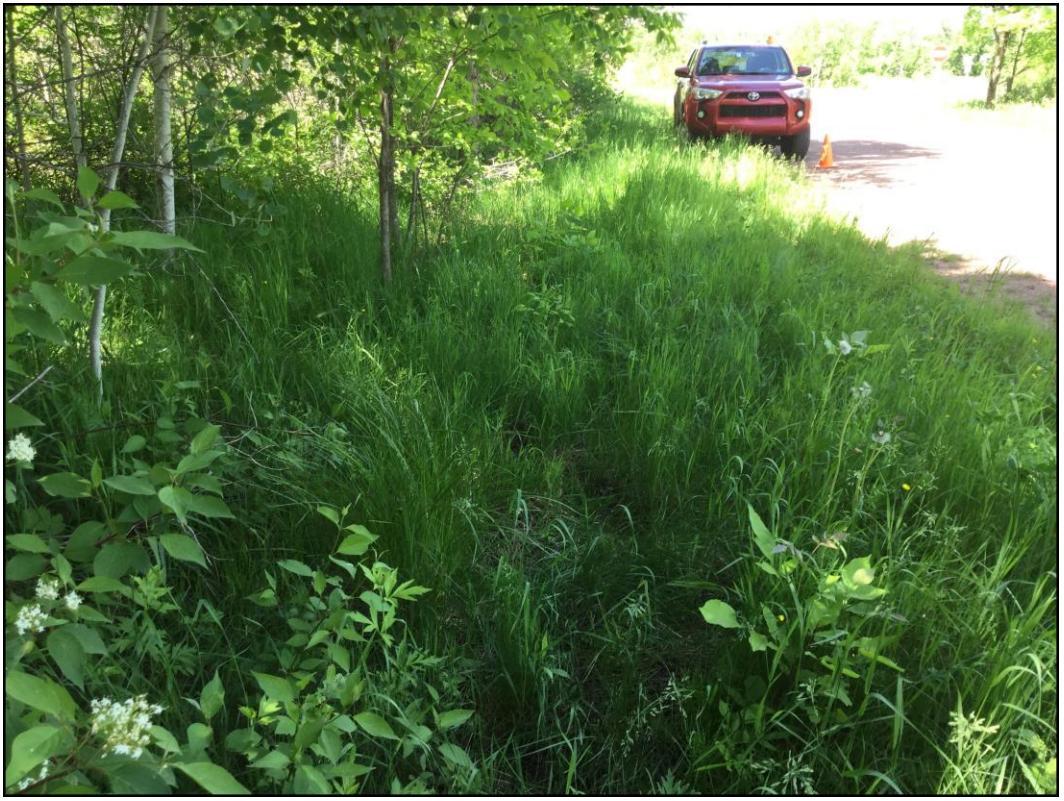
wasc1042e_w_N

Soils were not sampled due to the location in a roadside ditch and likely proximity to underground utilities. However, based on the landscape position and dominance of hydrophytic vegetation, the soils are assumed to be hydric.

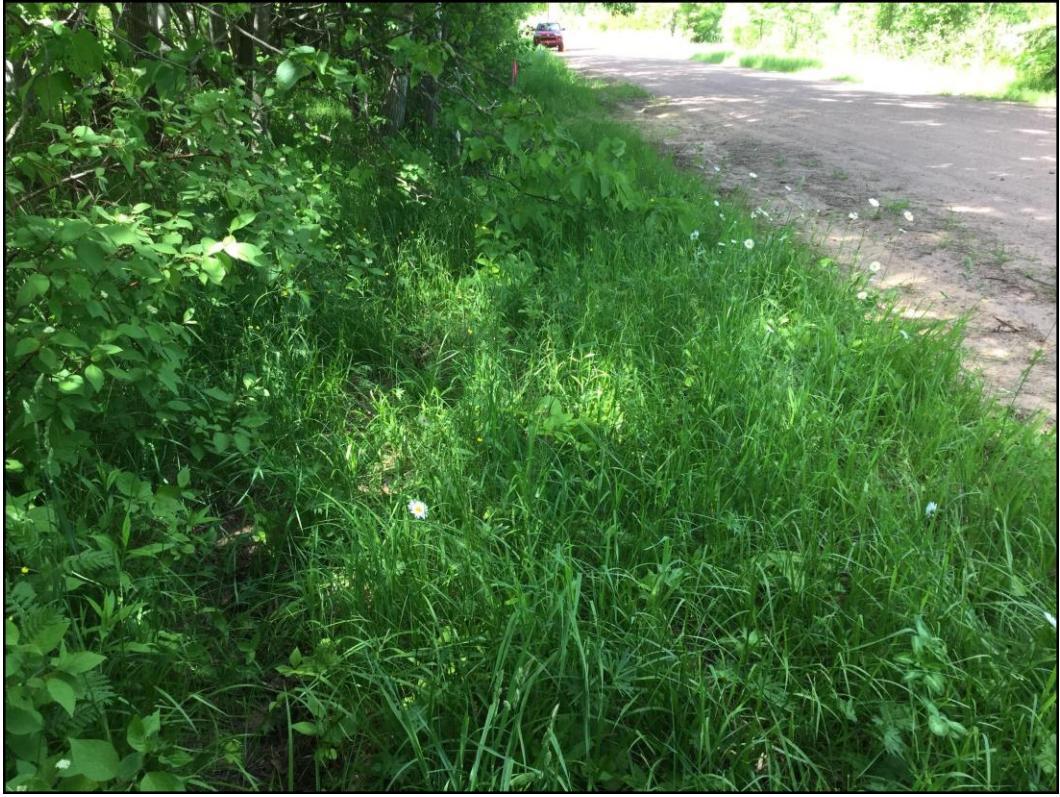
wasc1043e_w_N

utilities. However, based on the landscape position and dominance of hydrophytic vegetation, the soils are assumed to be hydric.

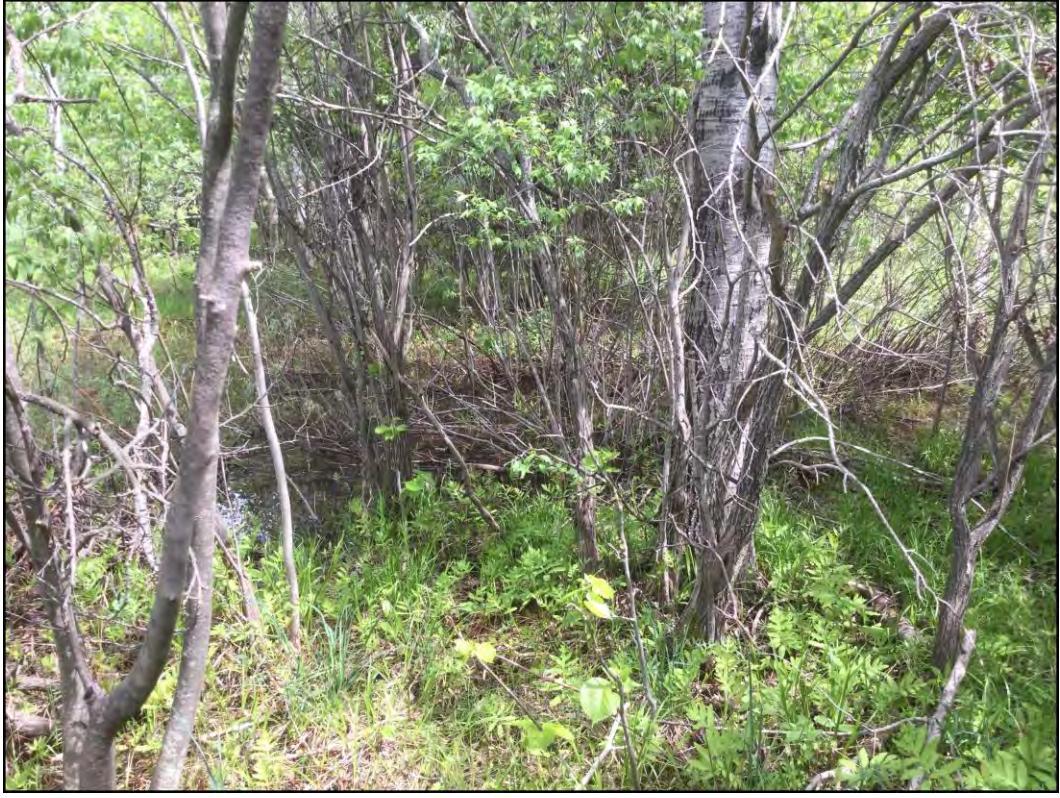
wasb1004s_w_E

D)					
³ Indicators o	f hydrophytic vegeta	ion and w	etland hydrology mus	t be pres	ent, unless	s disturbed	or problematio	
Restrictive	Layer (if observed):							
Туре:								
Depth (in	ches):						Hydric Soil	Present? Yes <u><</u> No
Remarks:							· 	
Soils are	silt loam abo	ve san	dy loam with re	edox p	resent	from 0-	-14 inches	below the soil surface.
The soils	s meet the F6	indicat	or for hydric so	oils.

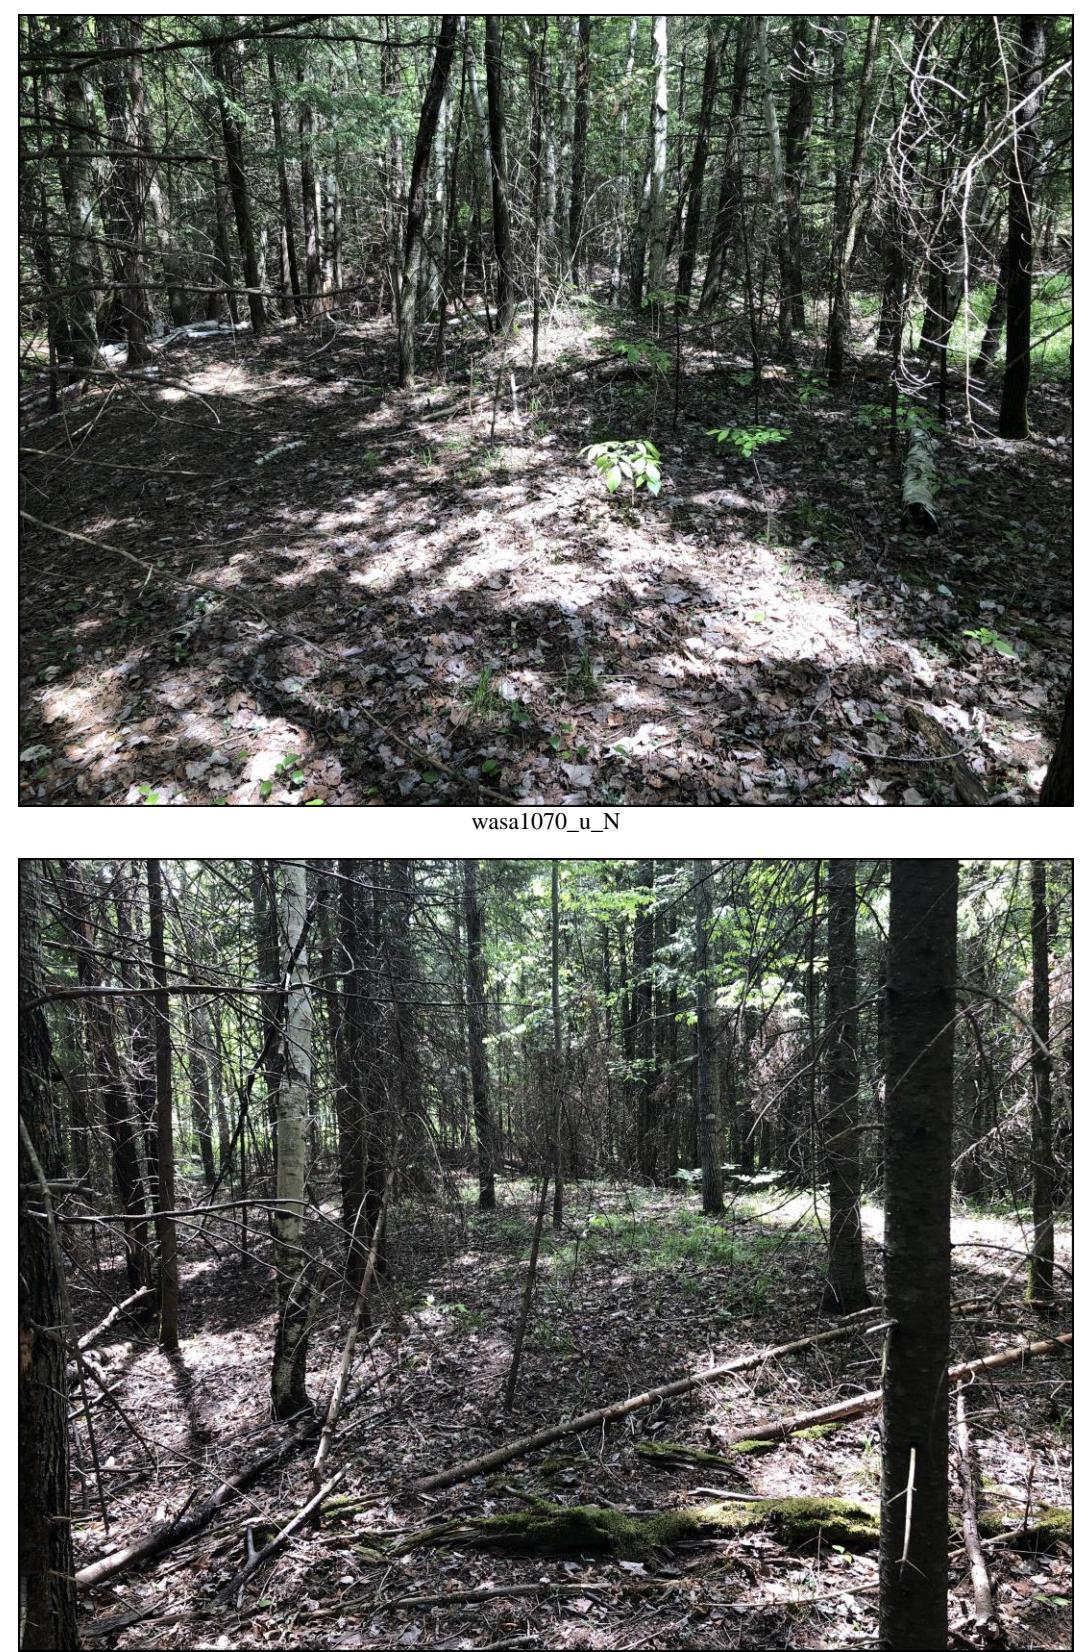
wasa1070_u_S

Sandy Mucky Mineral (S1) Depleted Dark Surface (F7) Piedmont Floodplain Soils (F19) (MLRA 149B)
Sandy Gleyed Matrix (S4) Redox Depressions (F8) Mesic Spodic (TA6) (MLRA 144A, 145, 149B)
Sandy Redox (S5) Red Parent Material (F21)
Stripped Matrix (S6) Very Shallow Dark Surface (TF12)
Dark Surface (S7) (LRR R, MLRA 149B) Other (Explain in Remarks)
"Indicators of hydrophytic vegetation and wetland hydrology must be present, unless disturbed or problematic.
restrictive Layer (if observed):
Type:
Depth (inches): No _
Remarks:
A reddish soil with no observed redox.

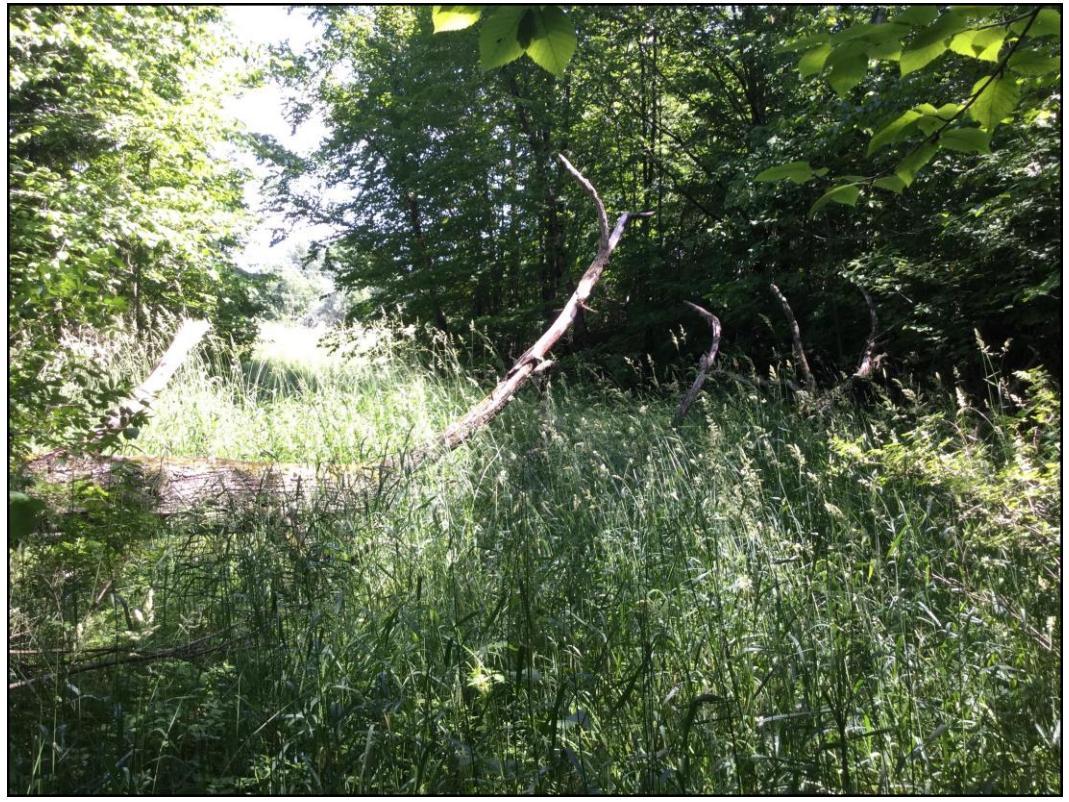
wasw033f_xw_NE

Туре:										
Depth (in	ches):							Hydric Soil	Present? Yes <u><</u> No	
Remarks:										
The soil	profile consis	ts of a t	thin dark	loam	over a	deplet	ted san	dy loam. I	Redox concentrations were	
observed	d throughout t	he low	er layer a	and tw	o hydr	ic indic	cators v	vere met.		
1

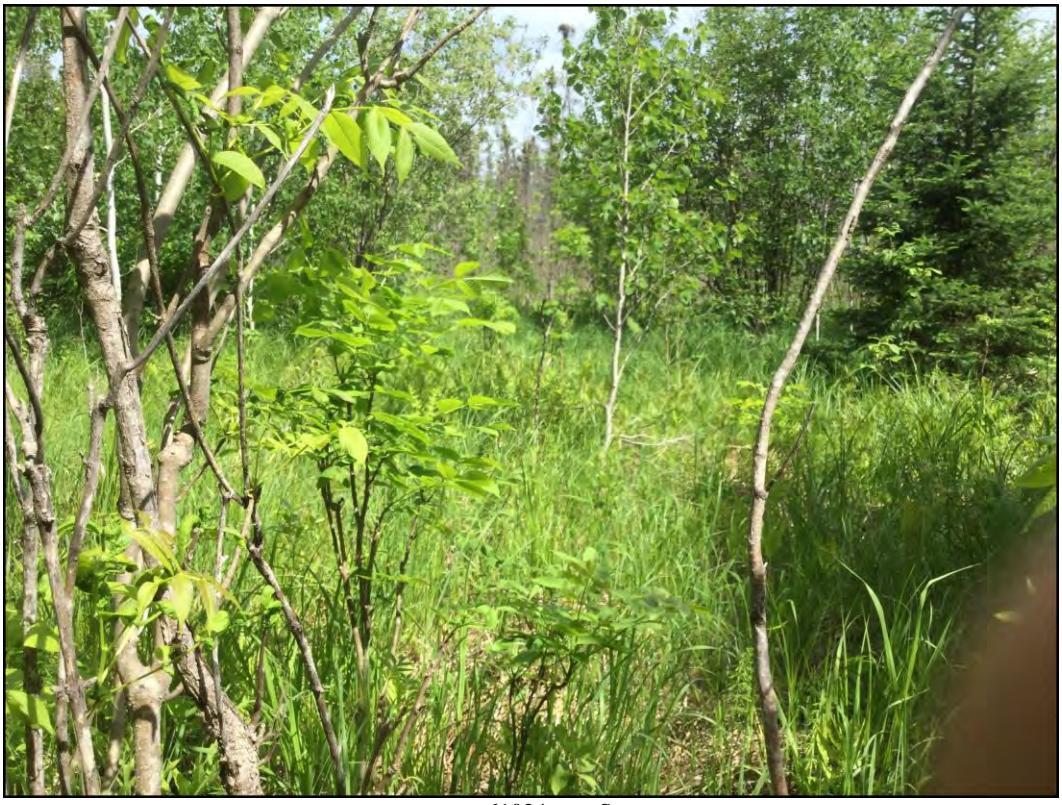
wasd1024e_w_S

Restrictive Layer (if observed): Type: Depth (inches): Remarks: A dark surface layer with redox concentrations was observed.	3						
Type:	Indicators of hydrophytic vegetation and w	etland hydrology mus	t be prese	nt, unless	sdisturbed	or problematic.	
Type:	Restrictive Layer (if observed):						
Depth (inches):	Туре:						X / N
Remarks: A dark surface layer with redox concentrations was observed.	Depth (inches):					Hydric Soil Present?	Yes <u>/</u> No
A dark surface layer with redox concentrations was observed.	Remarks:						
	A dark surface layer with red	ox concentratio	ons wa	s obse	erved.

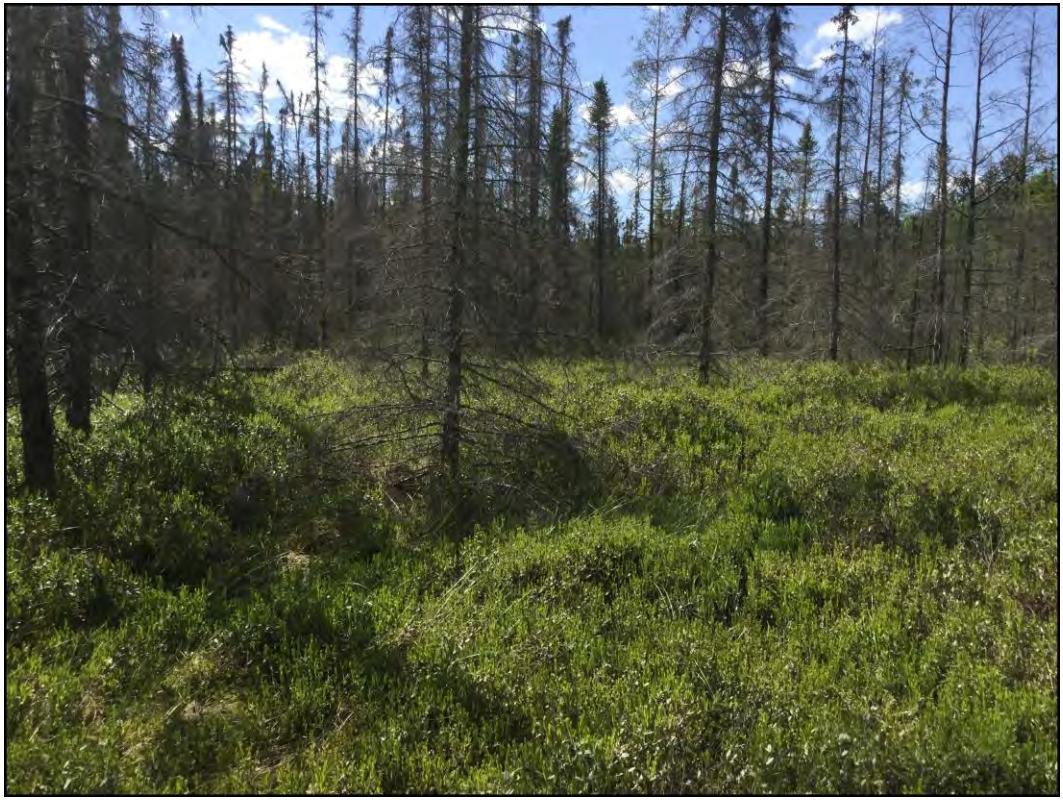
wasd1024s_w_E

Indicators of hydrophytic vegetation Restrictive Layer (if observed): Type: Depth (inches): Remarks: Peat extending past the ndicator.	length of the auger	. Soils were no	Hydric Soil F	Present? Yes <u>~</u> No <u></u> early meet the Histosol

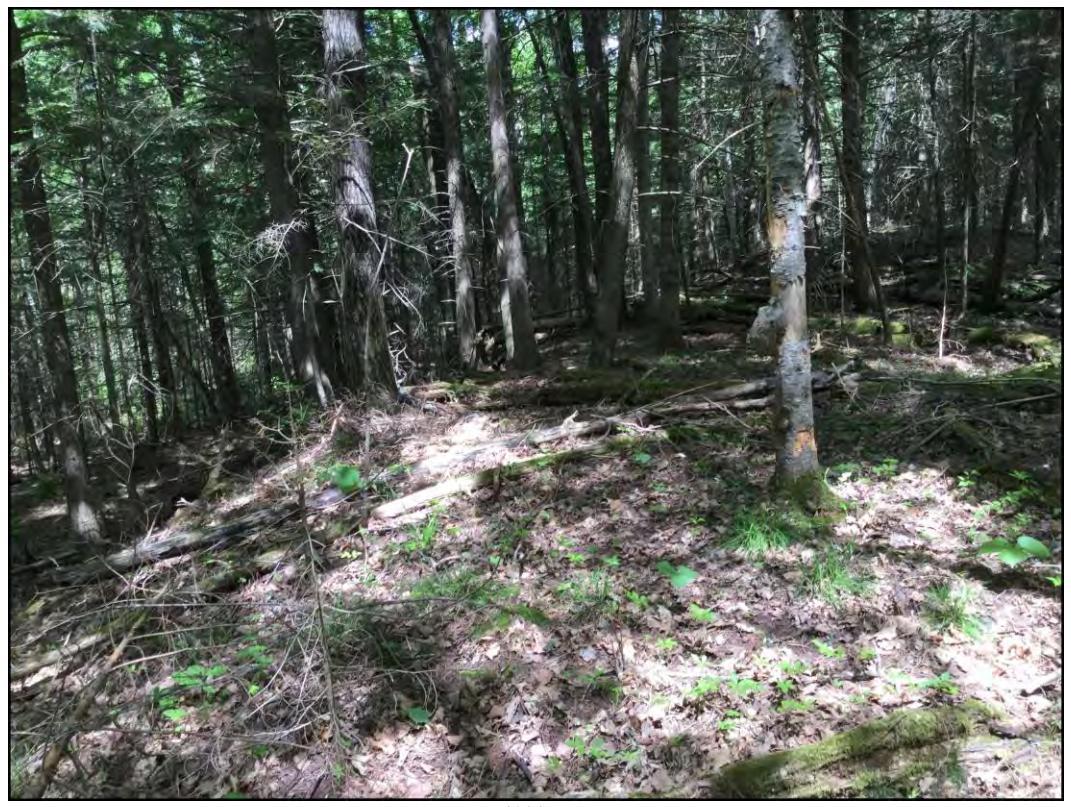
wasd1027_u_E

Thick Da	ark Surface (A12)	-	Redox Dark Surface (F6)	Iron-Manganese Masses (F12) (LRR K, L, R)					
Sandy M	Nucky Mineral (S1)	-	Depleted Dark Surface (F7)	Piedmont Floodplain Soils (F19) (MLRA 149B)					
Sandy G	Redox (S5)	-	Redox Depressions (F8)	Mesic Spodic (TA6) (MLRA 144A, 145, 149B) Red Parent Material (F21)					
Stripped	Matrix (S6)			Very Shallow Dark Surface (TF12)					
Dark Su	rface (S7) (LRR R, M	ILRA 149B)		Other (Explain in Remarks)					
³ Indicators of	f hydrophytic vegetati	ion and wetl	and hydrology must be present, unless disturbed o	pr problematic.					
Restrictive I	Layer (if observed):			•					
Туре:									
Depth (ind	ches):			Hydric Soil Present? Yes No 🗸					
Remarks:									
The soils	are well drain	ied and	sandy.
