A History Tour:

Upper Mississippi River

Headwaters Dam and Recreation Sites

St. Paul District

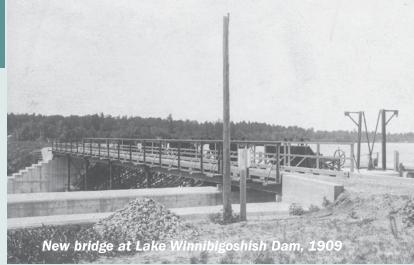
The present concrete structure was constructed between 1899 and 1900. In 2006, the stop logs and gates were replaced with two concrete bulkheads and one leaf gate in each of the five main spillway gate bays. A leaf gate was installed in the 12-foot log sluice

bay. A 5-foot fishway constructed in 1912 is no longer in use.
