# WATER LEVEL MANAGEMENT ON THE UPPER MISSISSIPPI RIVER

## -- NEW TOOLS FOR HABITAT RESTORATION

### WATER LEVEL MANAGEMENT LESSONS FROM DOWNSTREAM MAY BE APPLICABLE IN HEADWATERS

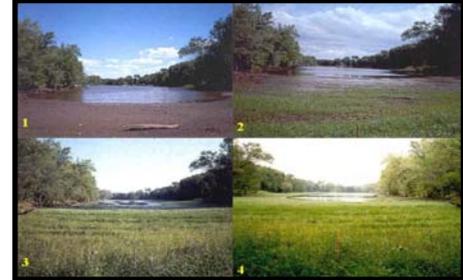
Small Bay West, MN

Small Bay West (Pool 5) in Summer 1996, Lizzy Pauls Pond (Pool 5) in Summer 1998, and with Peck Lake (Pool 9) in Summers of 1997-99

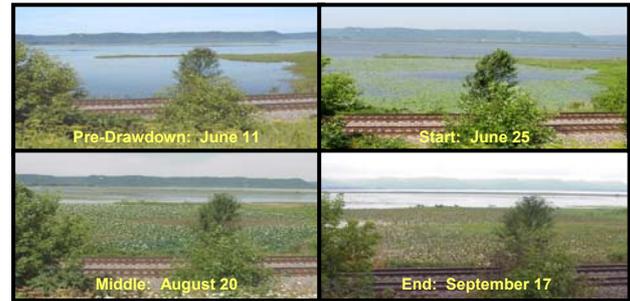
Near Stoddard, WI (in 2001)

The plant community on the exposed sites shifted from annuals, such as false pimpernel, teal love grass, nodding smartweed, and barnyard grass in 2001 to perennials, such as arrowhead, water stargrass, rice cutgrass and chufa flatsedge in 2002.
